Coastal Resilience: Salt Marsh Sustainability in New England

Cathleen Wigand
US EPA ORD Atlantic Ecology Division (AED)

New England State Commissioners' Visit to AED
June 19, 2018

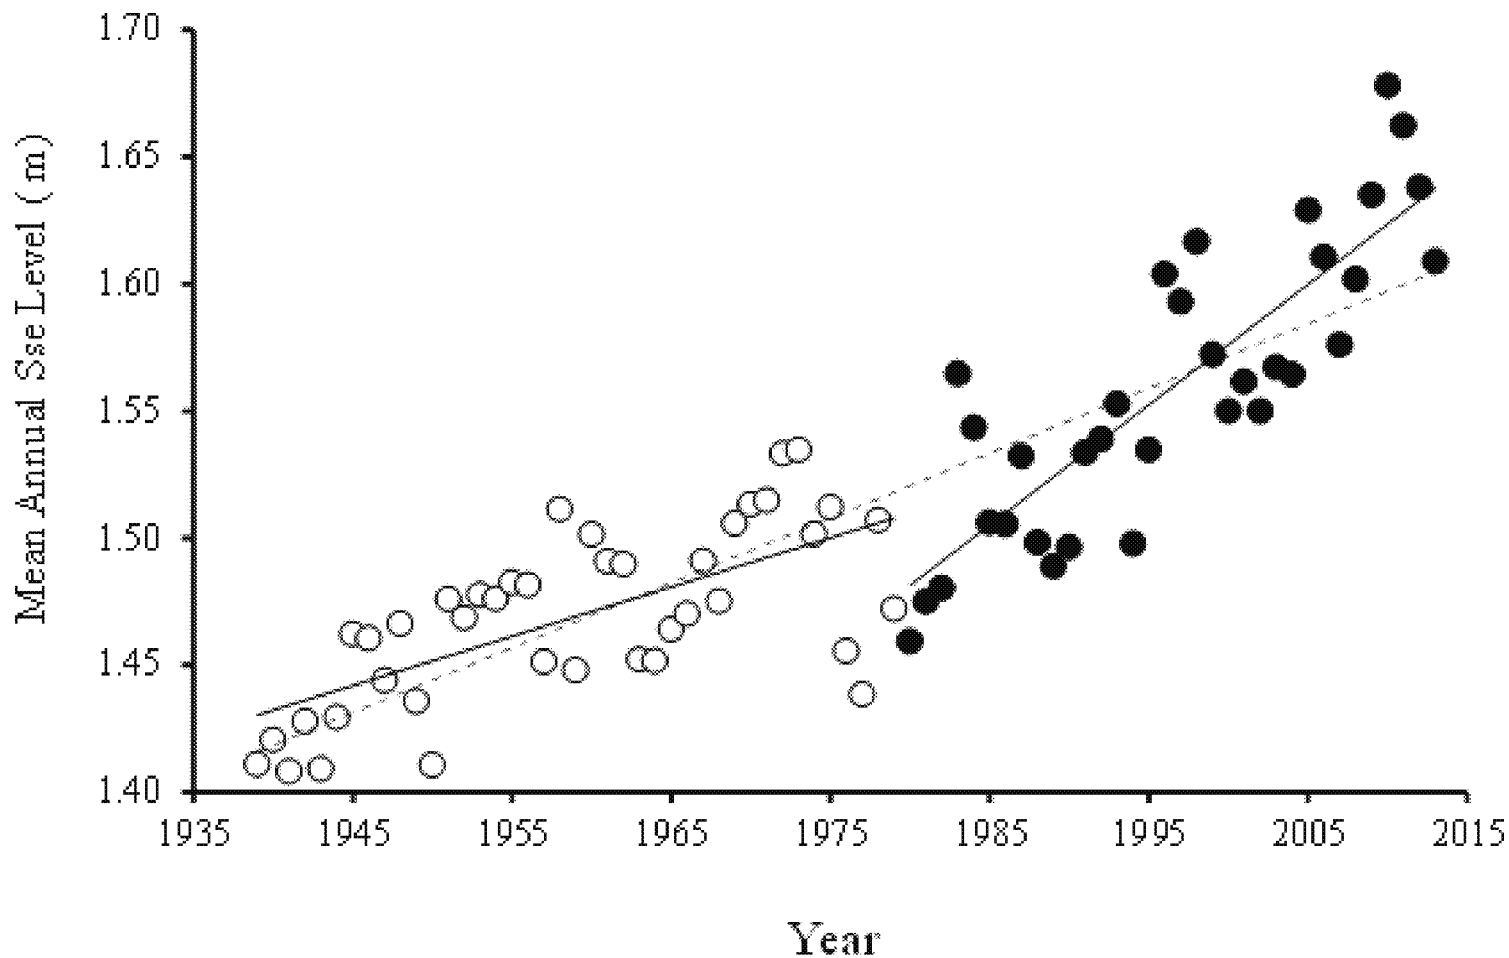
Annual average sea level at New London, CT. Open circles indicate sea levels from 1939-1979 (2 mm/y) and filled circles indicate sea levels from 1980-2013 (4.7 mm/y).

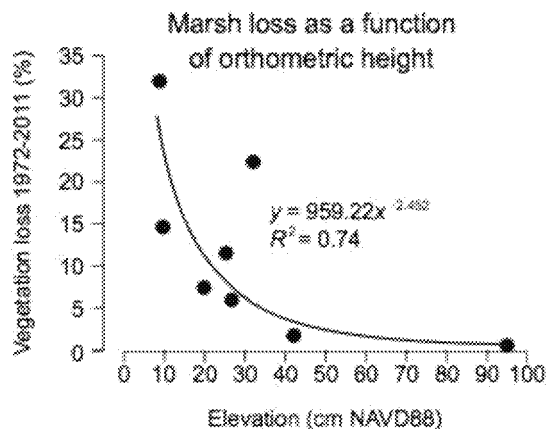
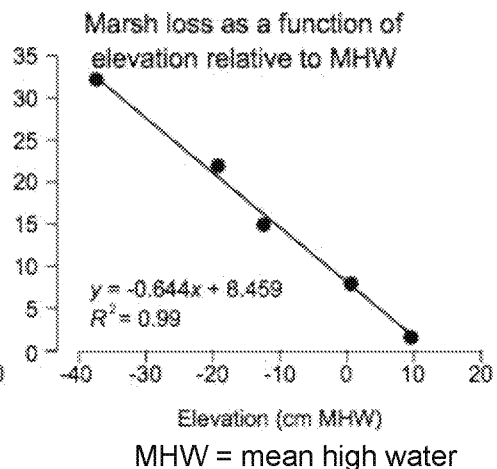
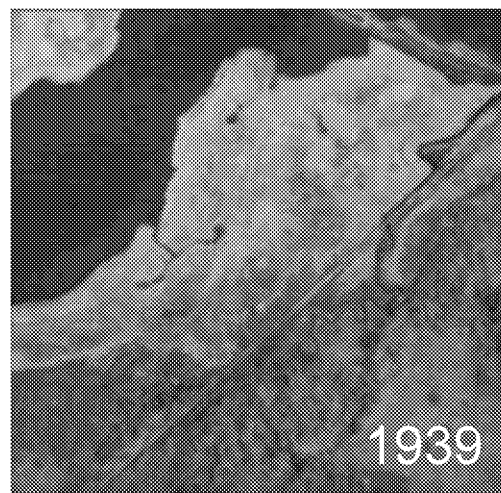
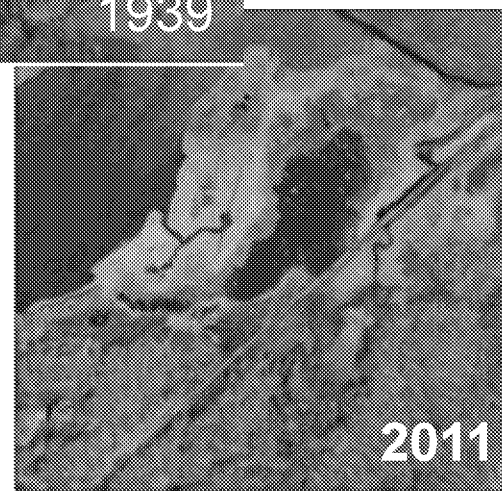
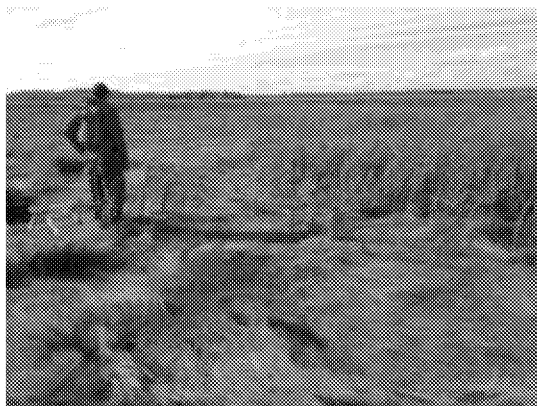
Key Observations

- Many marshes in Narragansett Bay lack “elevation capital”
- Tidal marsh vegetation changes are linked with marsh elevation

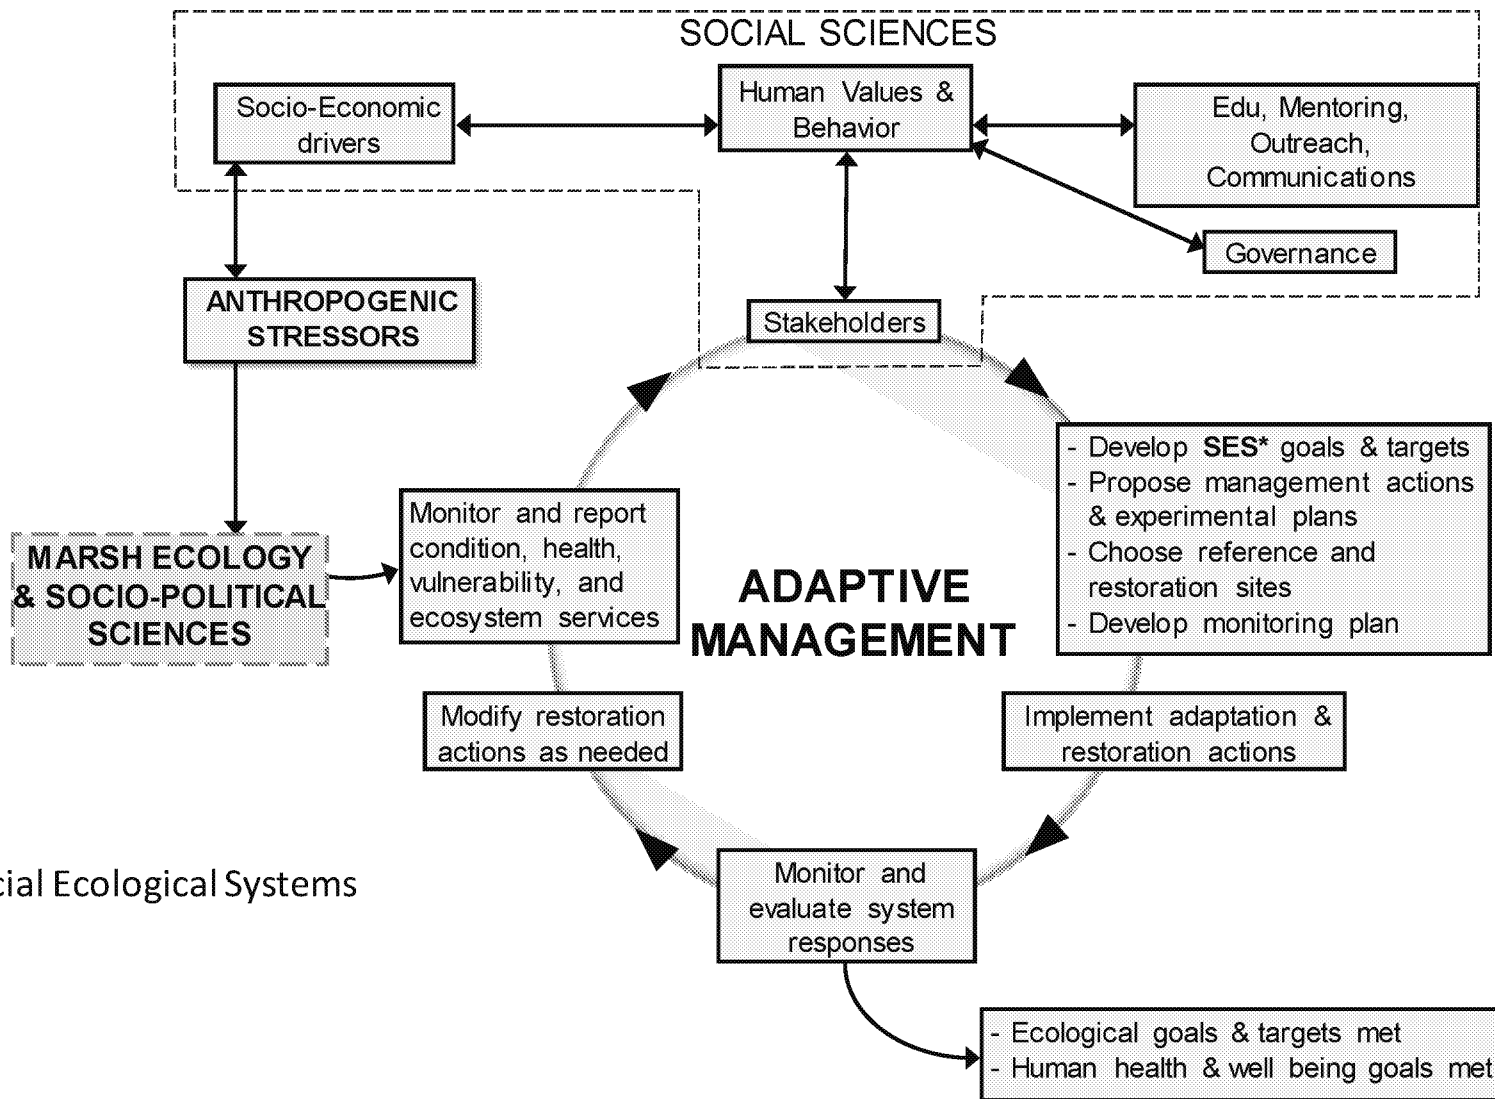
Coastal Marsh Adaptive Restoration Framework

*(SES) Social Ecological Systems

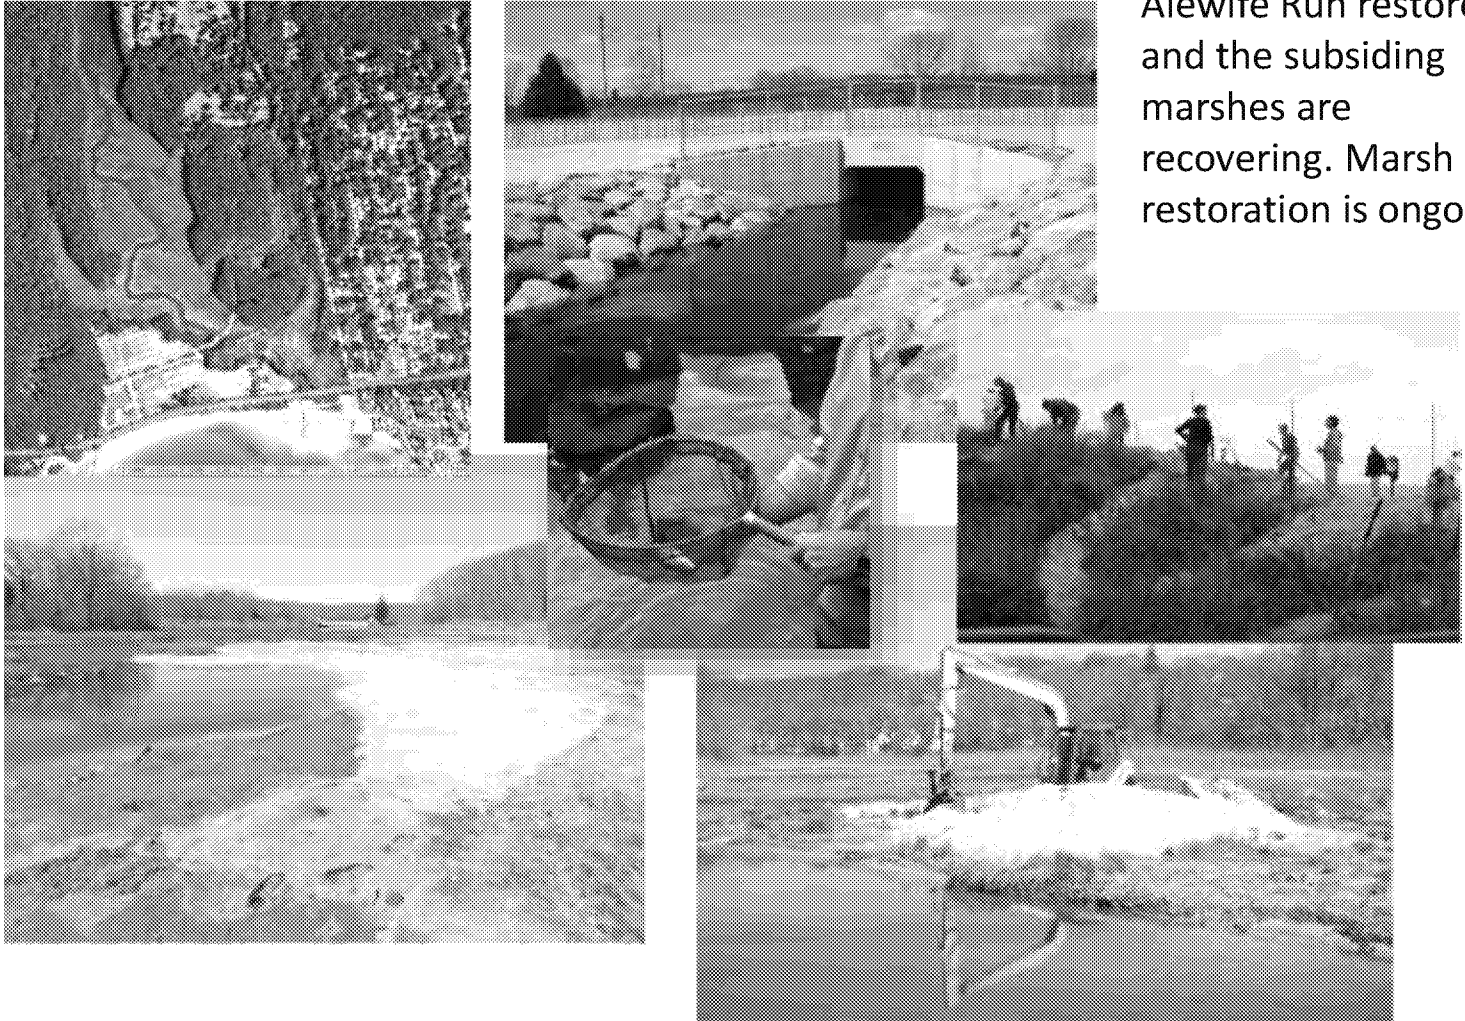
Case Study: Bride Brook, CT Restoration Project

Alewife Run restored and the subsiding marshes are recovering. Marsh restoration is ongoing.

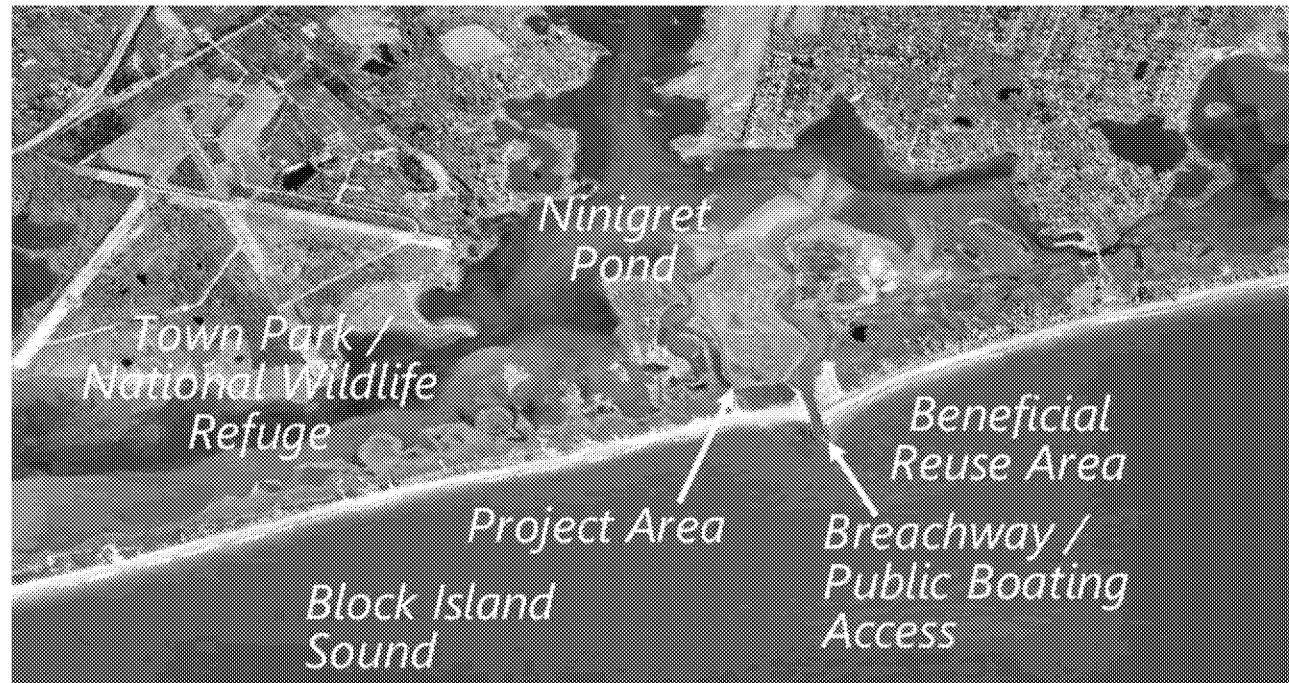
Case Study: Ninigret Pond, RI Thin Layer Placement

- Back-barrier marsh adjacent to man-made breachway, state-owned public access point, beach and campground
- Salt marsh habitat exhibiting areas of prolonged flooding, vegetative die-off, subsidence and marsh edge erosion
