## **RCRA Inspection Report**

Coty, US, LLC  
1400 Broadway Road  
Sanford, North Carolina 27332  
EPA ID No.: NCD990883175

July 19, 2022

**COMPLIANCE EVALUATION INSPECTION PICTURES**

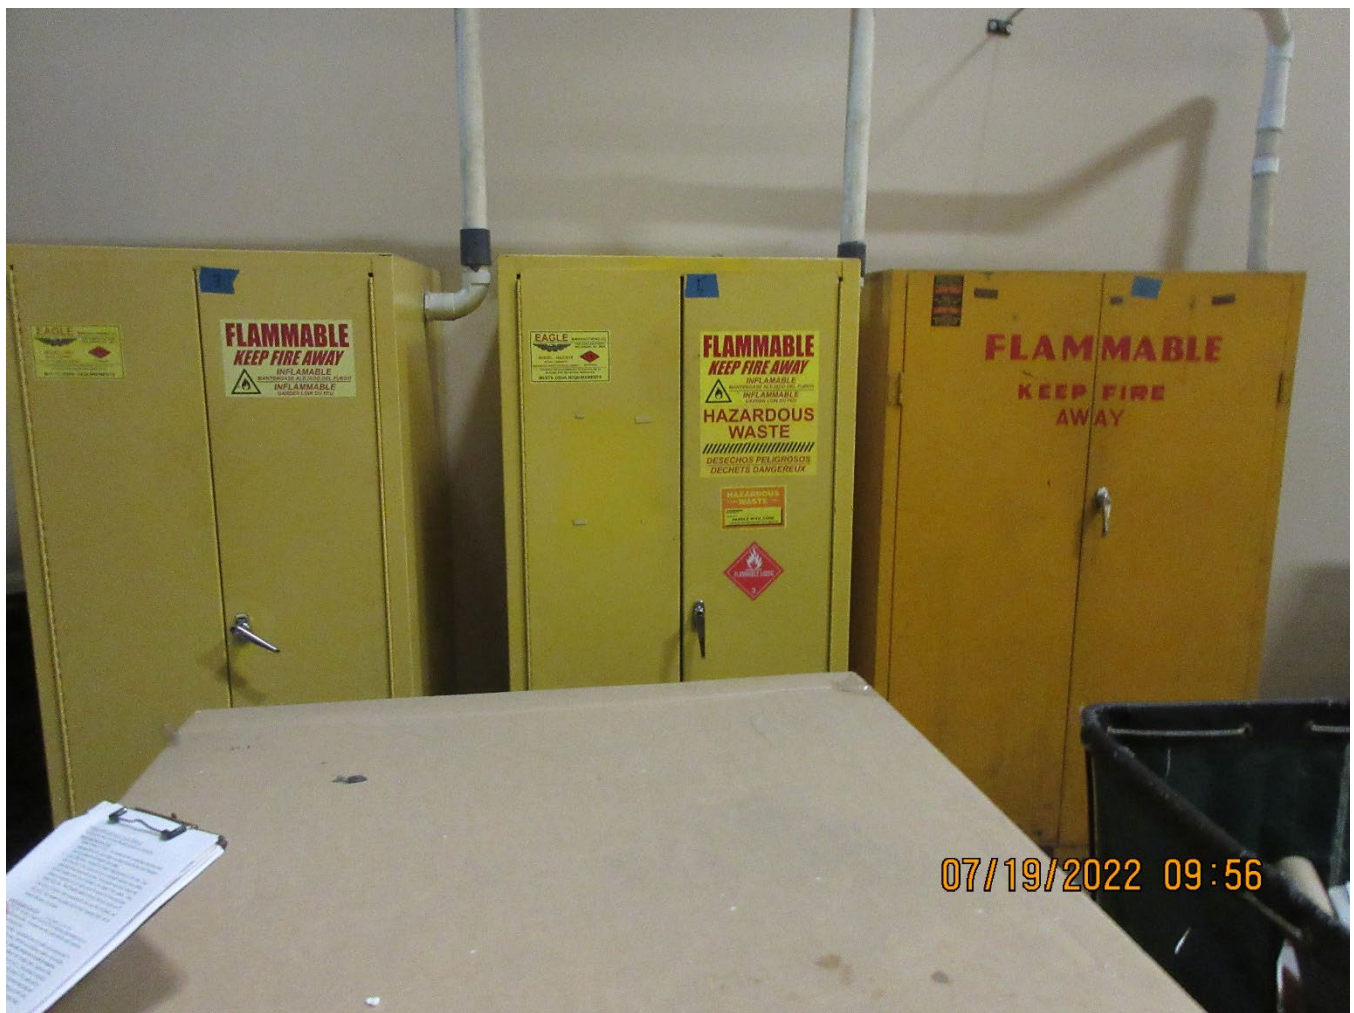
**Photo 1 – Quality Control 90-Day Accumulation Locker (Center)**

One 55-gallon drum was observed in a CAA within the center of three metal flammables cabinets. The container was empty at the time of the inspection (Photo 1).

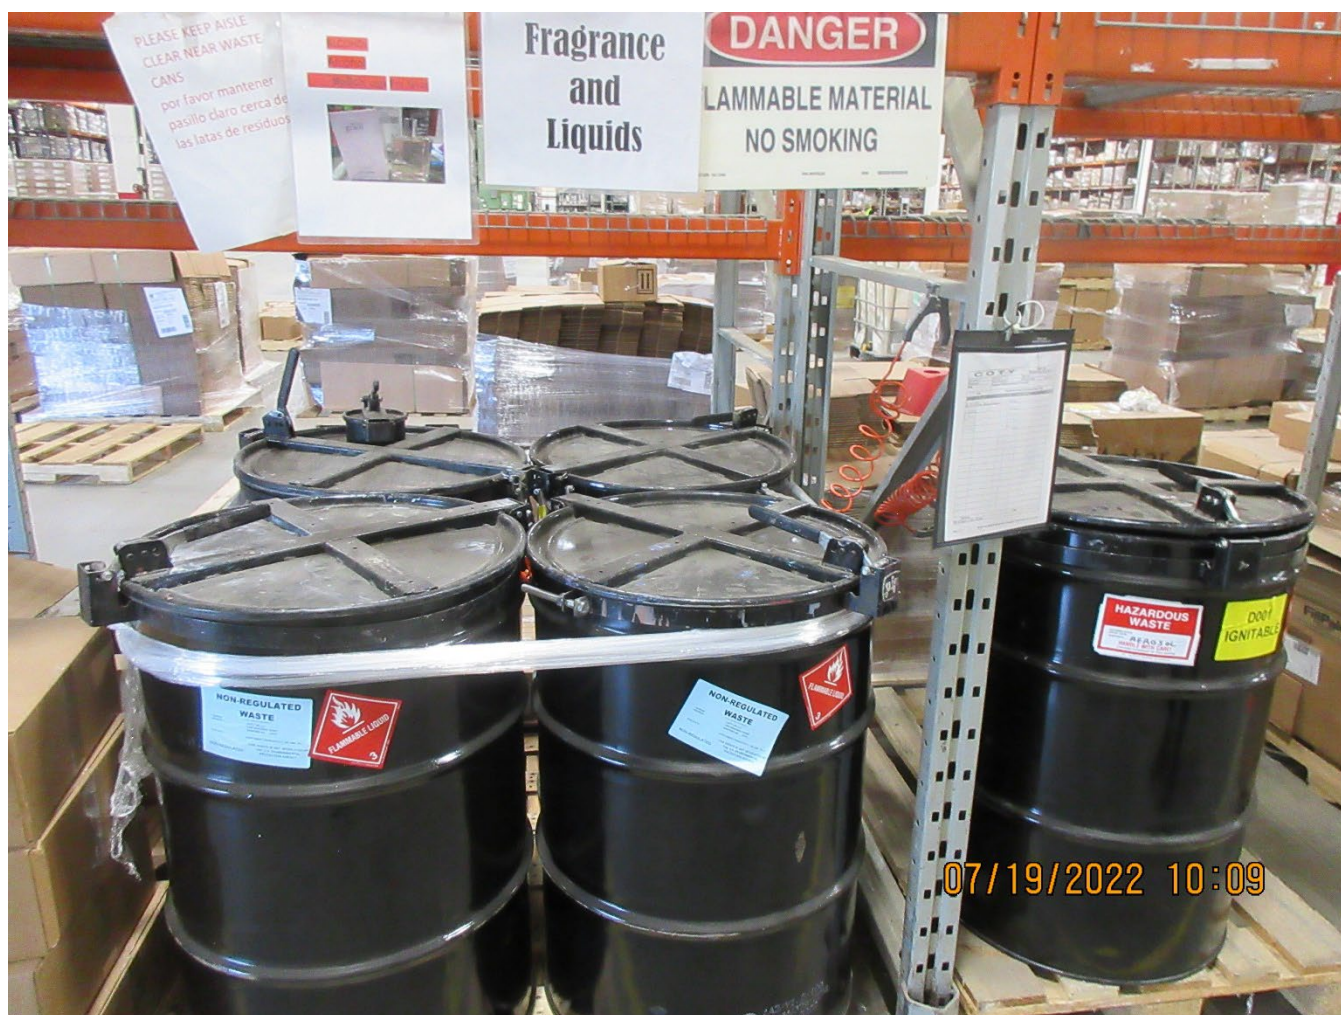
**Photo 2 – DeKitting 90-Day Accumulation Area**

the time of the inspection, one 55-gallon drum of hazardous waste aerosols (Photo 2) was observed in a CAA in this area with four 55-gallon drums of nonhazardous waste from the breaking down of kitted products which will not be used.

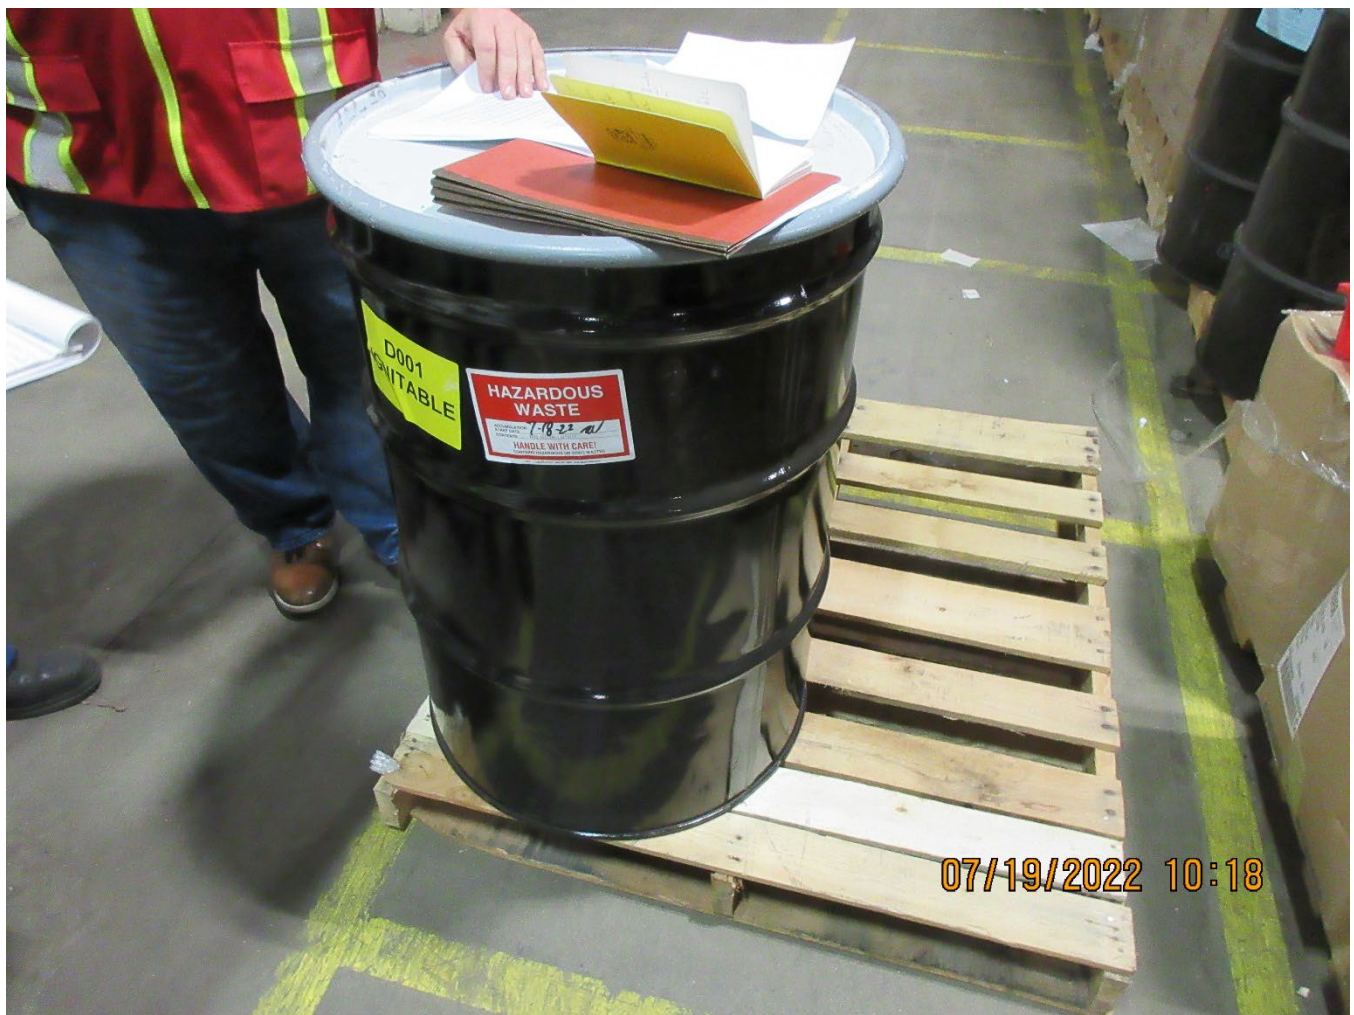
**Photo 3 – Waste Operations 90-Day Accumulation Area**

At the time of the inspection, one container of hazardous waste aerosol cans (Photo 3) had been brought to this area which was not previously designated as a CAA. Four separate containers of hazardous waste spent acetone (Photo 9) from the Lacquer Line were also observed in this area. The lid on one of the containers was not fastened (Photos 8 & 9). The oldest accumulation date on the drums was June 6, 2022. This area was not designated on the Quick Reference Guide as a CAA and was not being inspected weekly.

**Pursuant to 15A NCAC 13A .0107(a) [40 C.F.R. § 262.17], a LQG may accumulate hazardous waste on-site for 90 days or less without a permit or without having interim status, as required by Sections 130A-294(c) and (g) of the NCSWML, N.C.G.S. § 130A-294(c) and (g) [Section 3005 of RCRA, 42 U.S.C. § 6925], provided that the generator complies with the conditions listed in 15A NCAC 13A .0107(a) [40 C.F.R. § 262.17] (hereinafter referred to as the “LQG Permit Exemption”).**

**Pursuant to 15A NCAC 13A .0107(a) [40 C.F.R. § 262.17(a)(1)(iv)], which is a condition of the LQG Permit Exemption, (A) a container holding hazardous waste must always be closed during accumulation, except when it is necessary to add or remove waste; and (B) A container holding hazardous waste must not be opened, handled, or stored in a manner that may rupture the container or cause it to leak.**

**Pursuant to 15A NCAC 13A .0107(a) [40 C.F.R. § 262.17(a)(1)(v)], which is a condition of the LQG Permit Exemption, a generator is required to, at least weekly, inspect central accumulation areas looking for leaking containers and for deterioration of containers caused by corrosion or other factors.**

**Pursuant to 15A NCAC 13A .0107(a) [40 C.F.R. § 262.262(b)(4)], a generators amended contingency plan must include a Quick Reference Guide for the Facility which includes a map of the facility showing where hazardous wastes are generated, accumulated and treated and routes for accessing these wastes.**

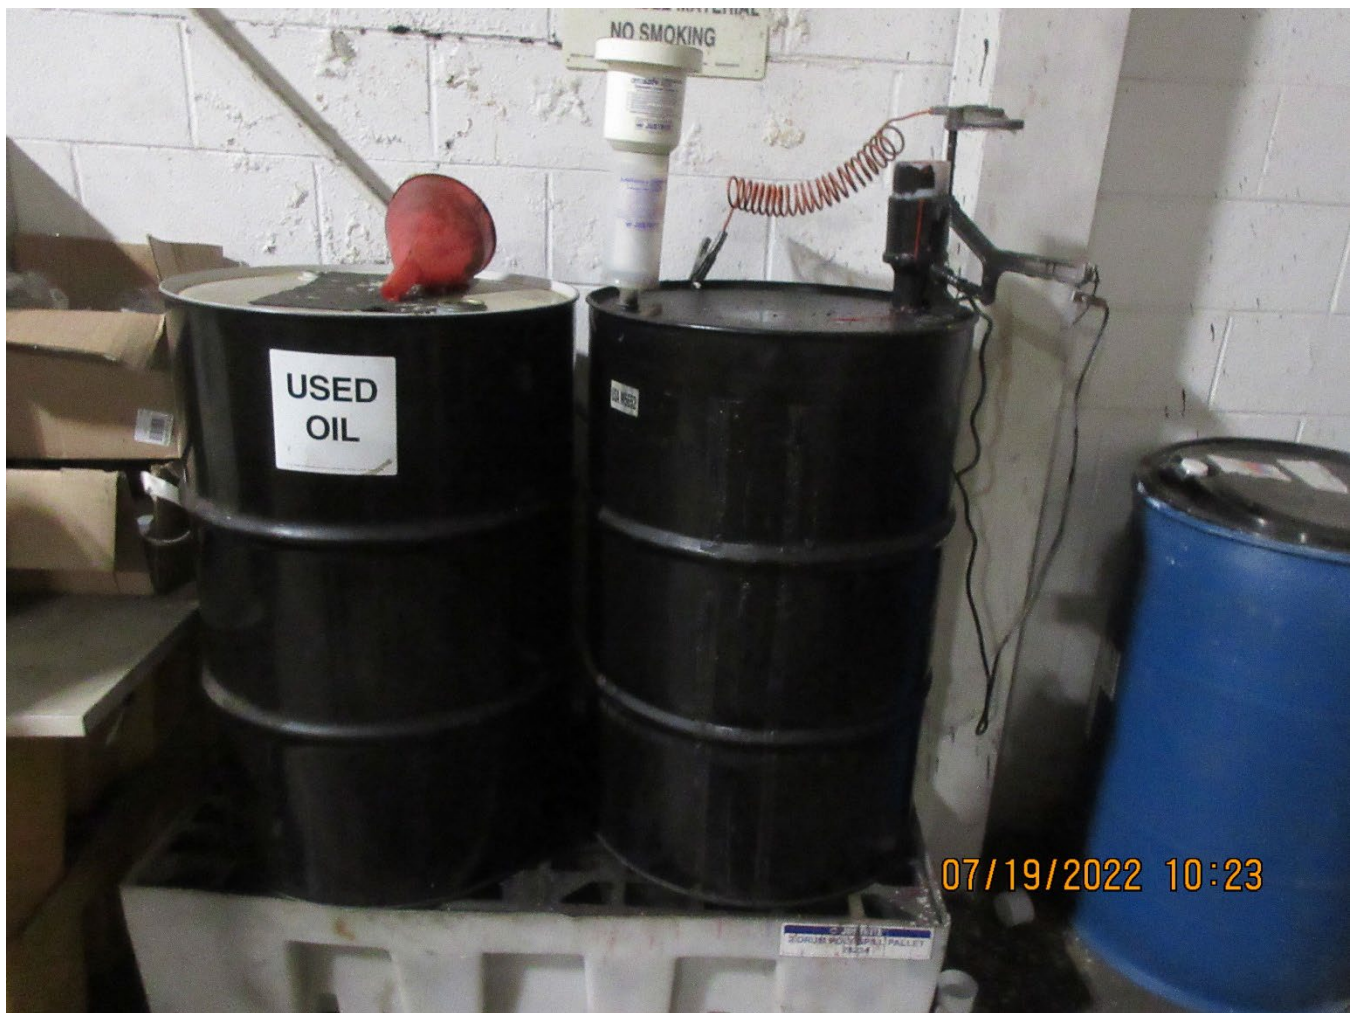
**Photo 4 – SAA Area for Aerosol Cans and Used Oil collection container**

Used oil was observed in two places in this location. All of the containers were labeled with the words “Used Oil” (Photos 4 & 7).

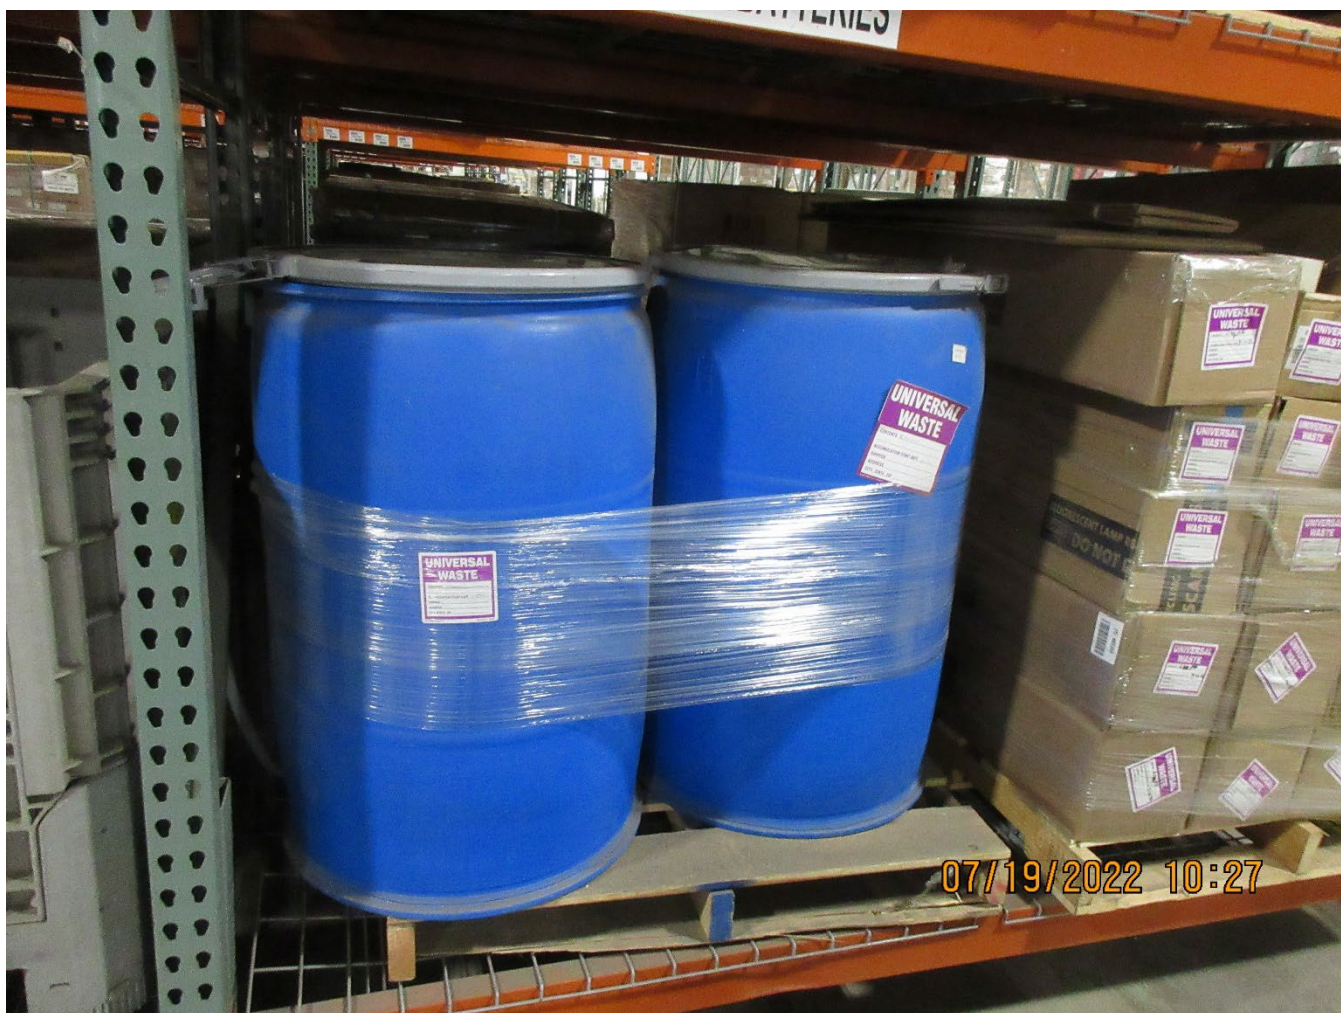
Universal wastes observed in this area included drums of universal waste batteries and boxes of universal waste fluorescent bulbs (Photos 5 & 6).

**Photo 5** – Universal Waste Batteries (left) and 4-foot boxes of Universal Waste Fluorescent Bulbs in the Waste Operations Area

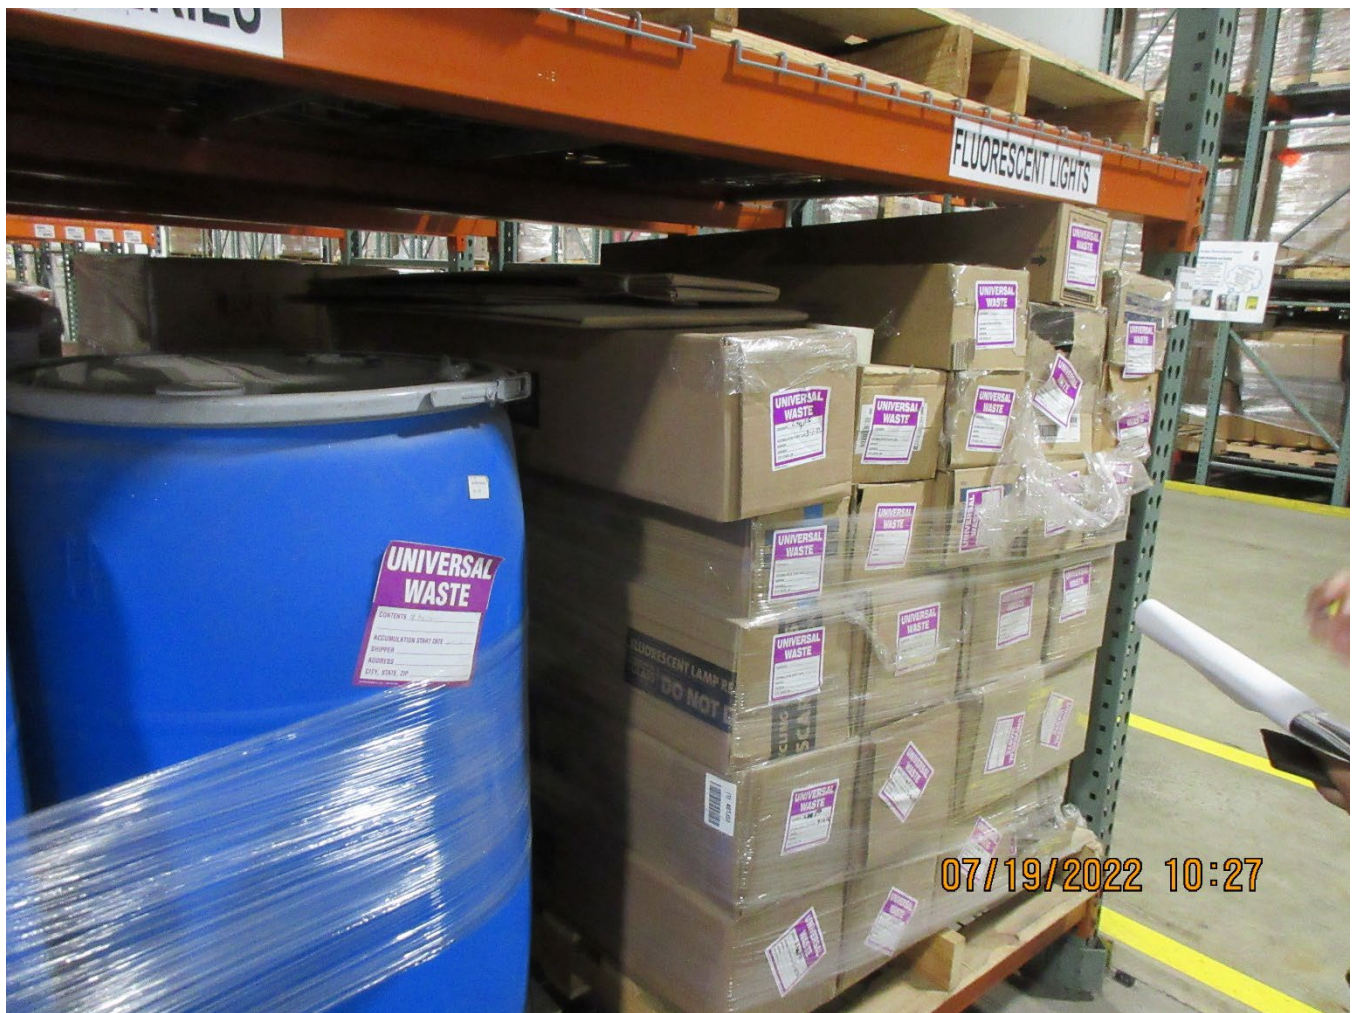
**Photo 6** - Universal Waste Fluorescent Bulbs in the Waste Operations Area

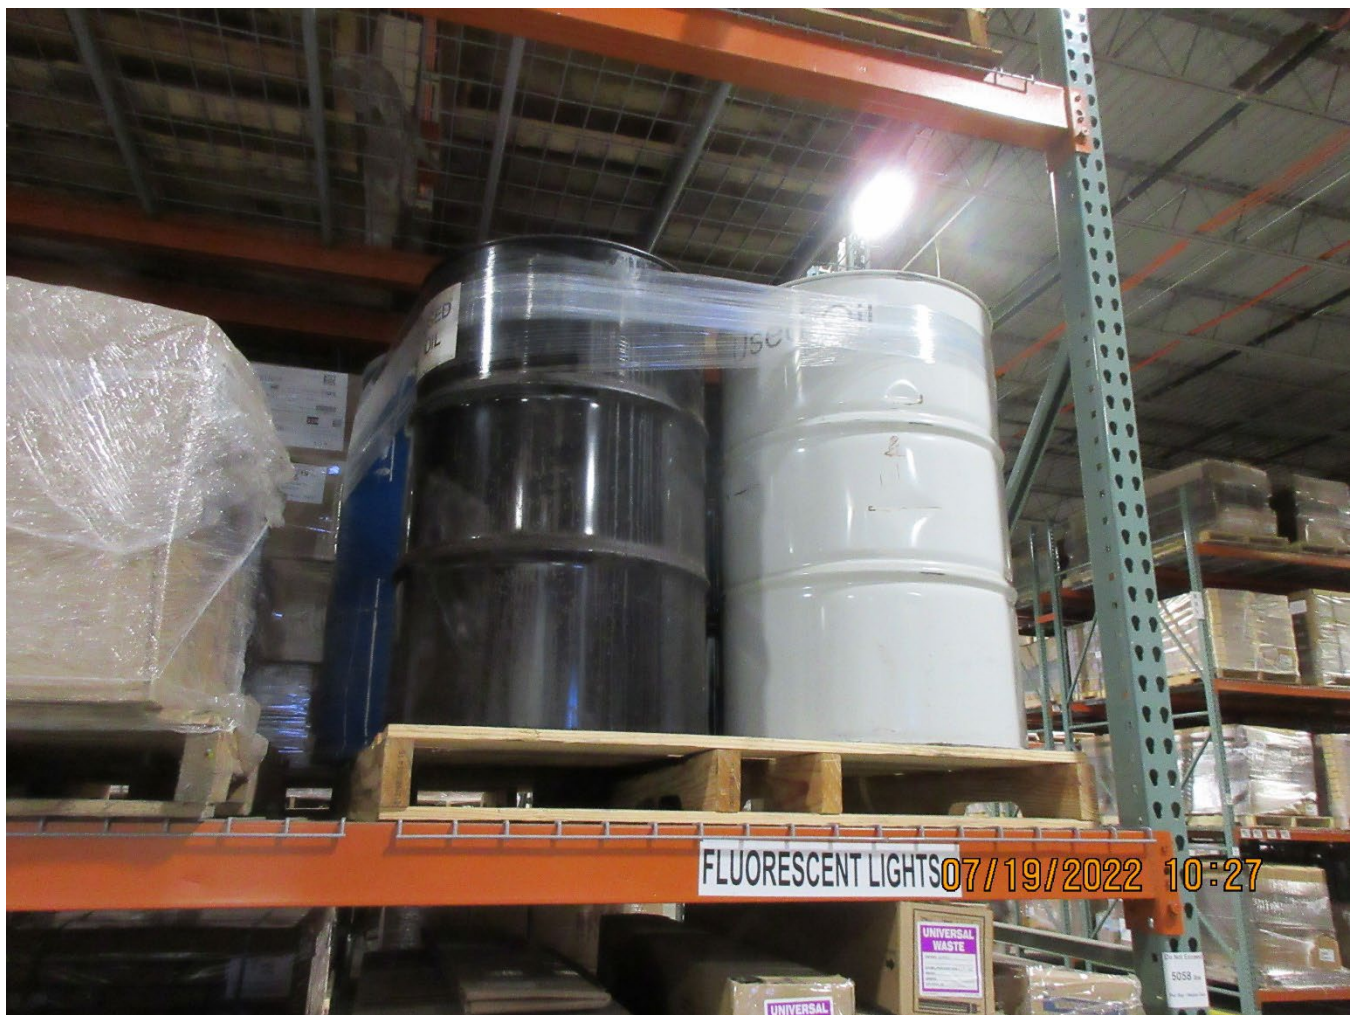
**Photo 7** – Used Oil Drums (4) in the Waste Operations Area

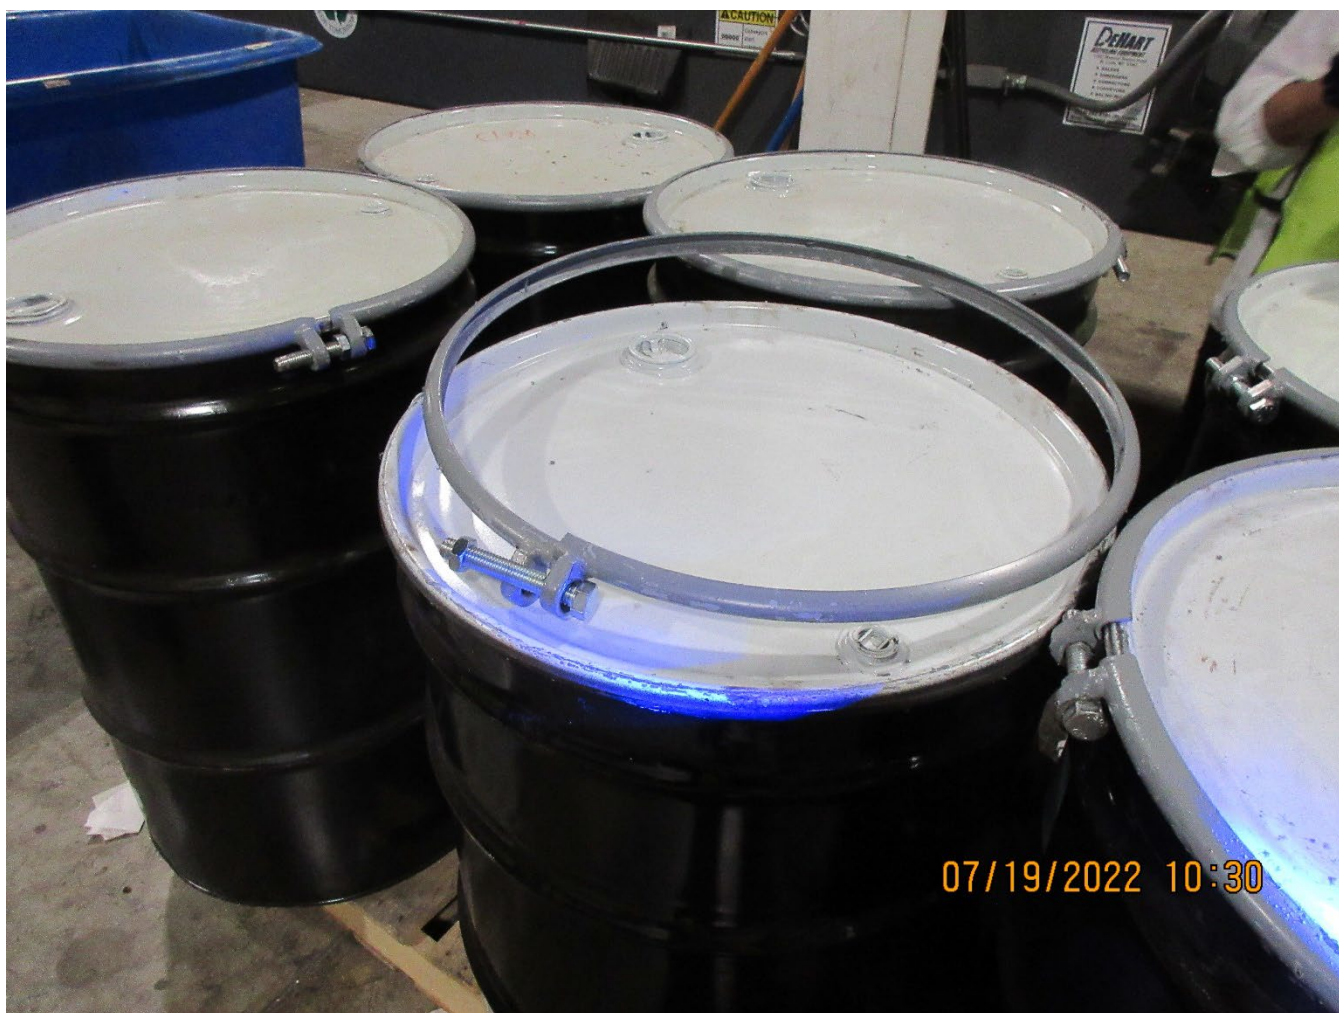
**Photo 8** – Hazardous waste containers in the Waste Operations Area

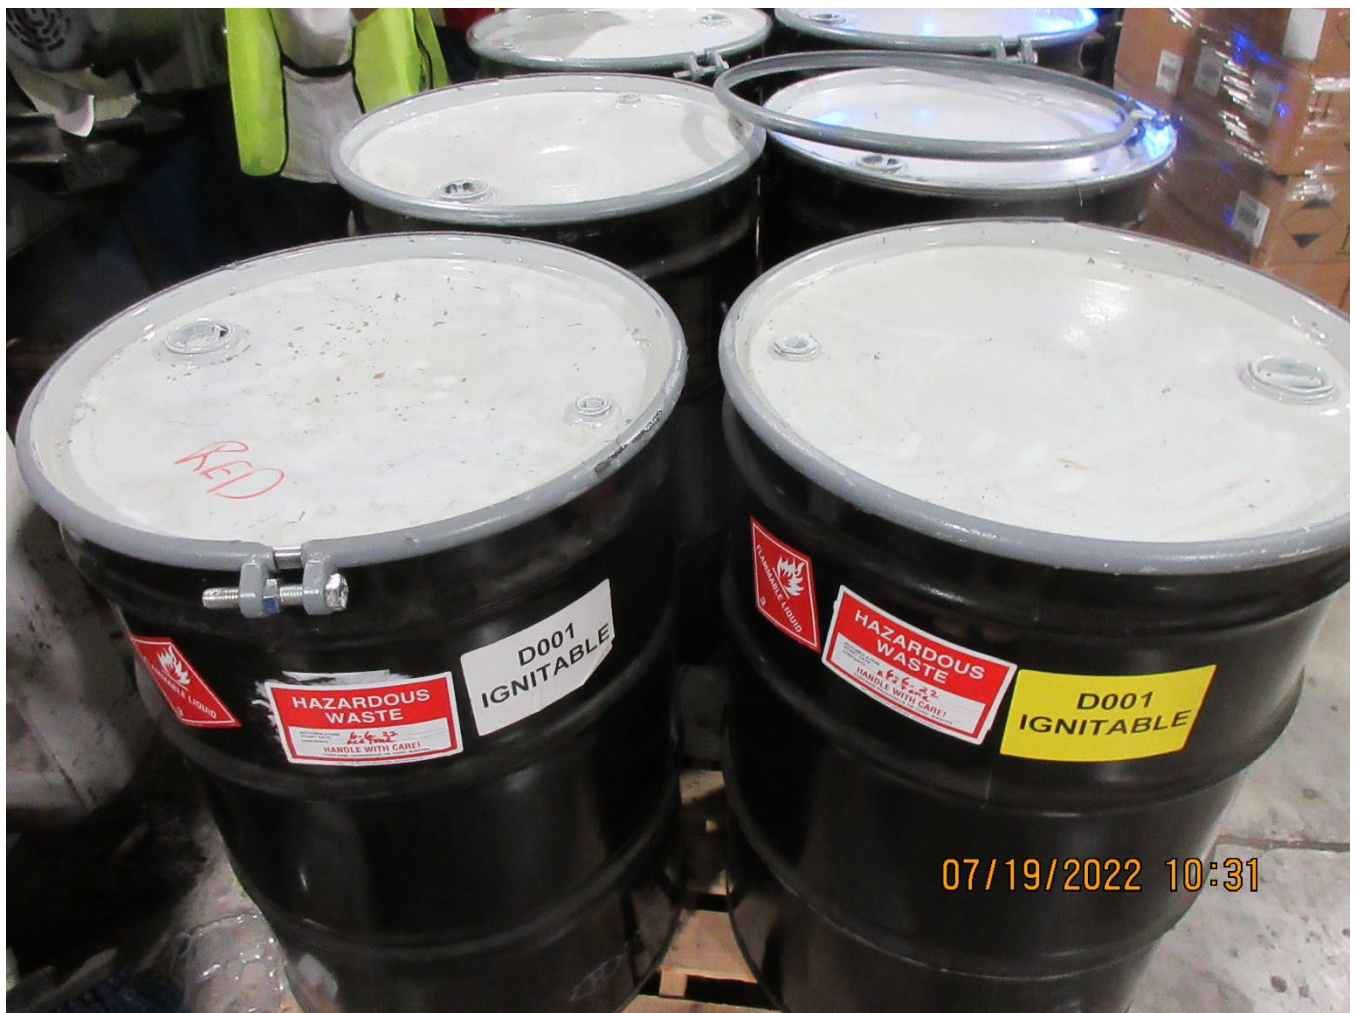
**Photo 9** - Hazardous waste containers in the Waste Operations Area

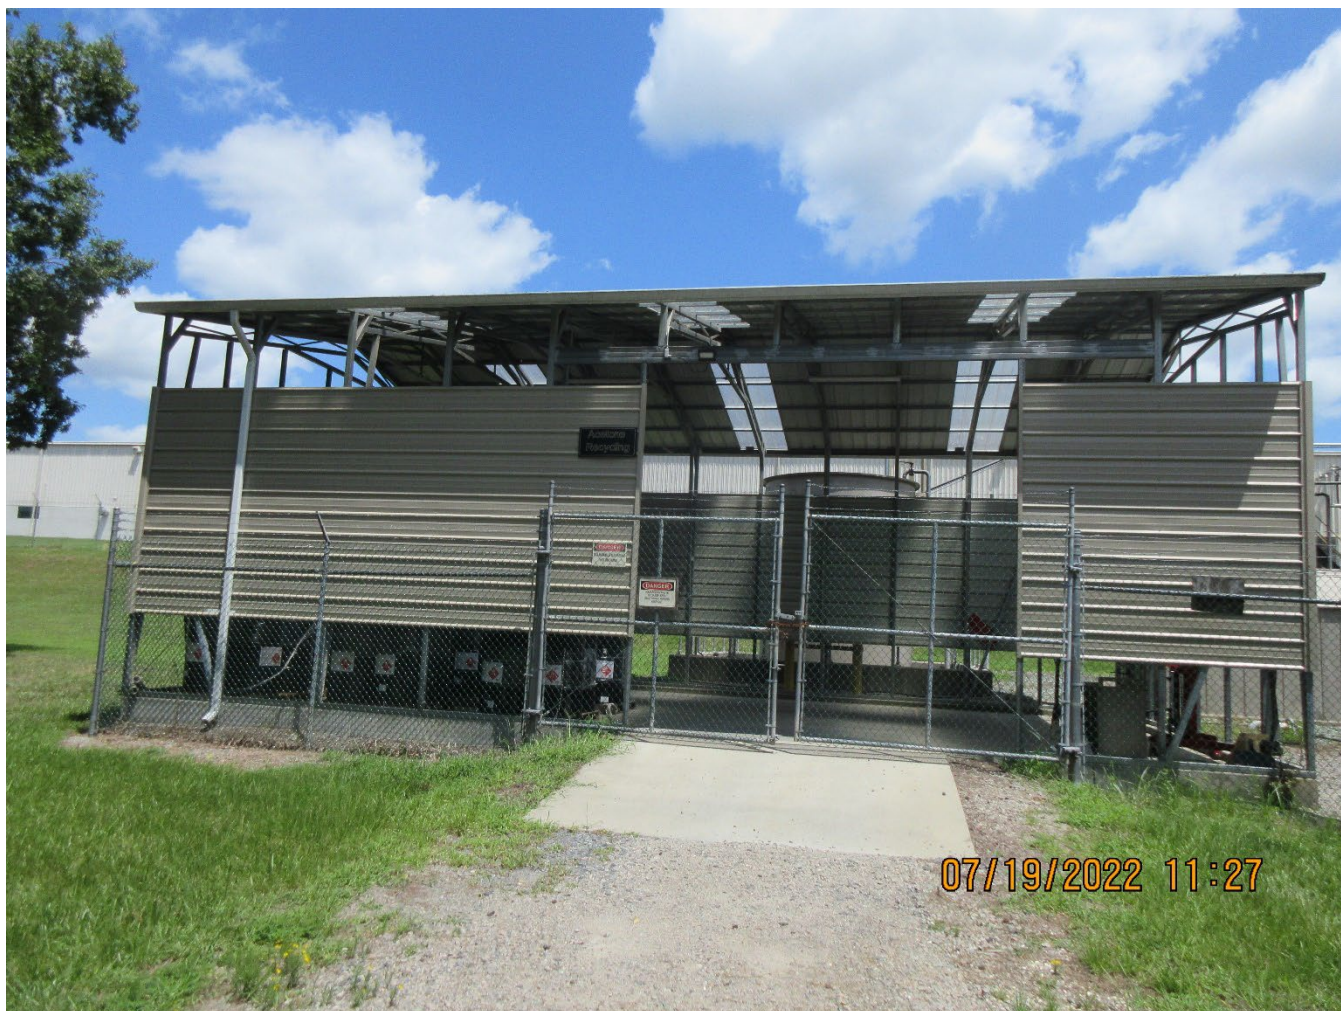
**Photo 10** – Acetone Recycling Area near WWTP

A 90-day accumulation area for drums of hazardous waste spent acetone generated from the nail polish lines is located in a structure (Photo 10) near the facility's waste water treatment plant (Photo 10) prior to being shipped off-site. Sixteen drums were observed in this area at the time of the inspection (Photo 11).

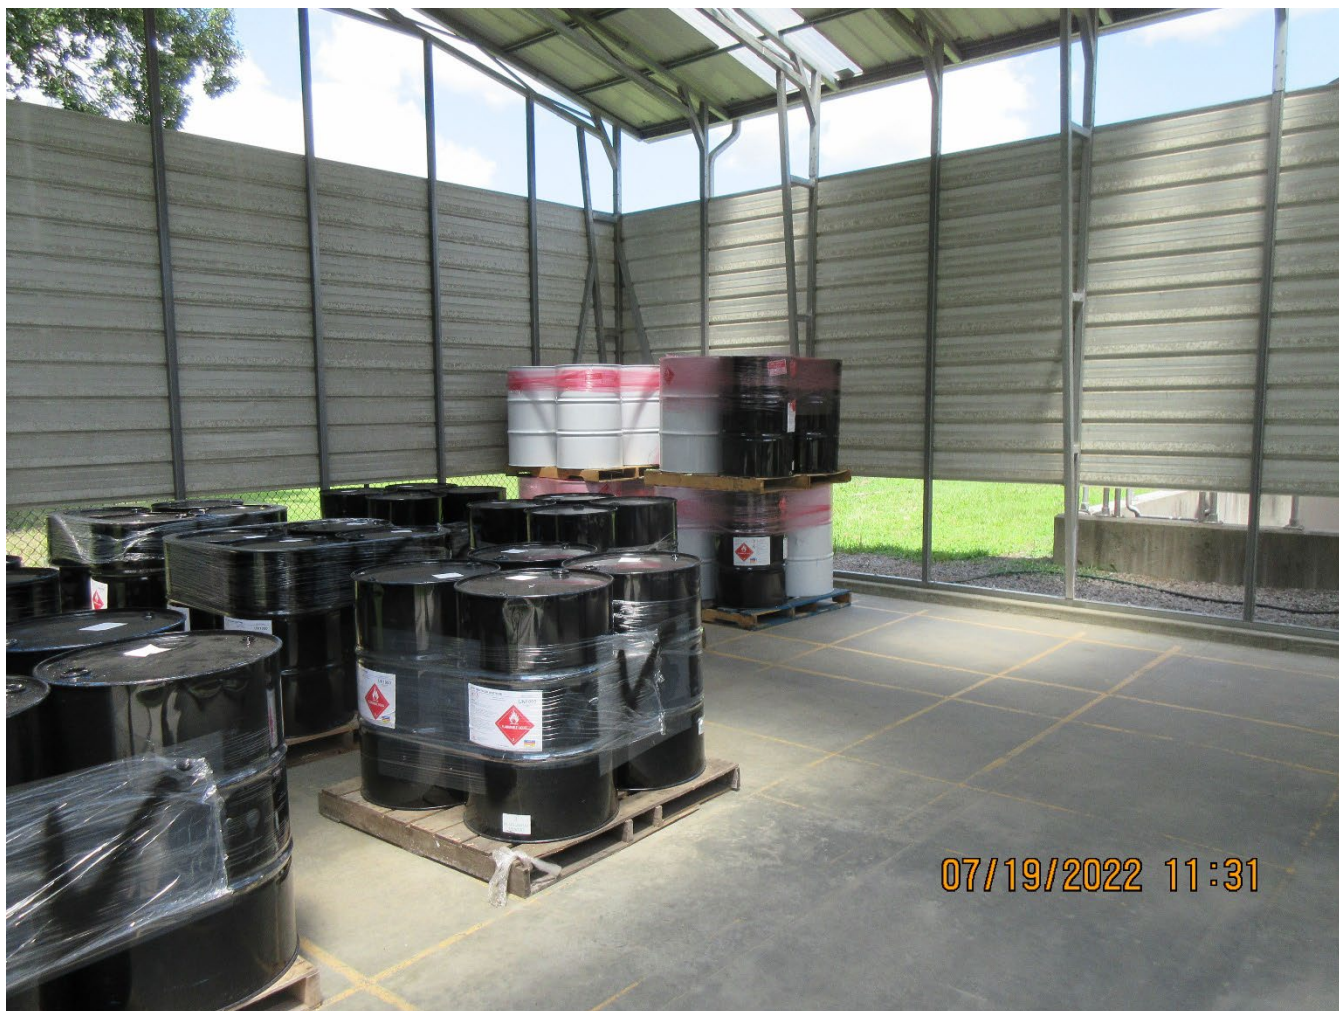
**Photo 11** – Hazardous waste (far right) observed within the Acetone Recycling Area
