## REGION 10 Enforcement Division

### INSPECTION REPORT

| <b>Company Name:</b> | Petro 49, Inc. | | |
| <b>Facility or Site Name:</b> | Petro Marine Services Ketchikan | | |

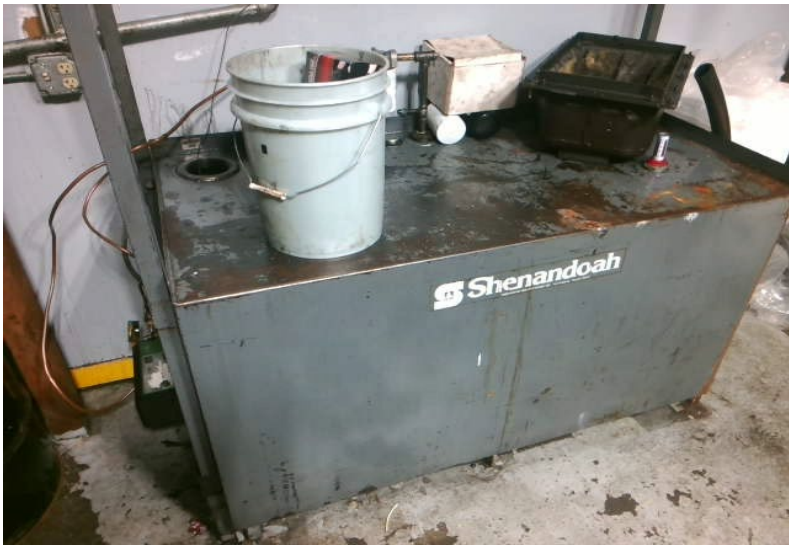
| <b>Building:</b> Warehouse | <b>Area:</b> Processing Room | <b>Sub-area:</b> |
|---|---|---|
| 300-gallon used oil storage tank, beneath the used oil burning space heater, was not labeled with the words "Used Oil." | <b>Regulation:</b><br><br>279.22(c)(1) | <b>Sections:</b> |

| <p>[Title]</p> <p>IMG-202202241349104910185730.jpg</p> <p>02/24/2022 01:49 PM (AKT)</p> <p>Jon Jones</p> <p>Warehouse/Processing Room</p> <p>No CBI</p> <p>No PII</p> <p>View of 300-gallon used oil storage tank, beneath the used oil burning space heater, that was not labeled with the words “Used Oil.”</p> | |

| Mr. Hall had facility personnel label the tank with the words "Used Oil" during the inspection. | | |

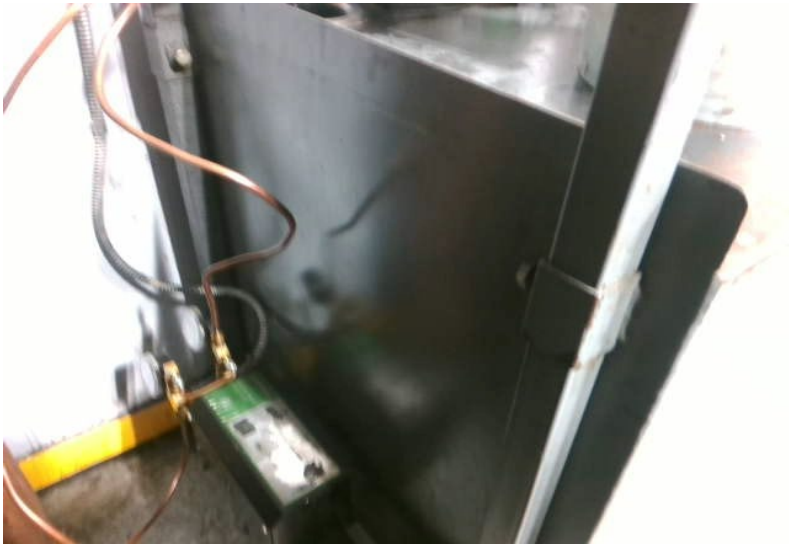
| <p>[Title]</p> <p>IMG-202202241349184918132275.jpg</p> <p>02/24/2022 01:49 PM (AKT)</p> <p>Jon Jones</p> <p>Warehouse/Processing Room</p> <p>No CBI</p> <p>No PII</p> <p>View of 300-gallon used oil storage tank, beneath the used oil burning space heater, that was not labeled with the words “Used Oil.”</p> | |

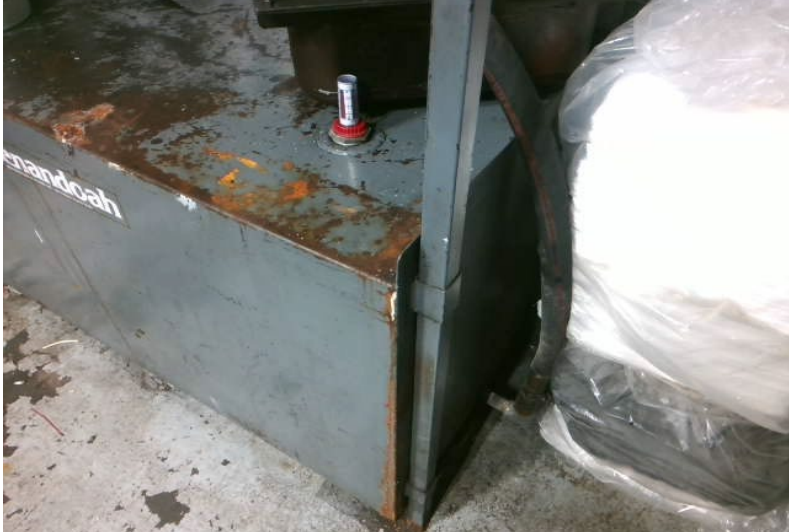
| <p>[Title]</p> <p>IMG-202202241349264926172253.jpg</p> <p>02/24/2022 01:49 PM (AKT)</p> <p>Jon Jones</p> <p>Warehouse/Processing Room</p> <p>No CBI</p> <p>No PII</p> <p>View of 300-gallon used oil storage tank, beneath the used oil burning space heater, that was not labeled with the words “Used Oil.”</p> | |

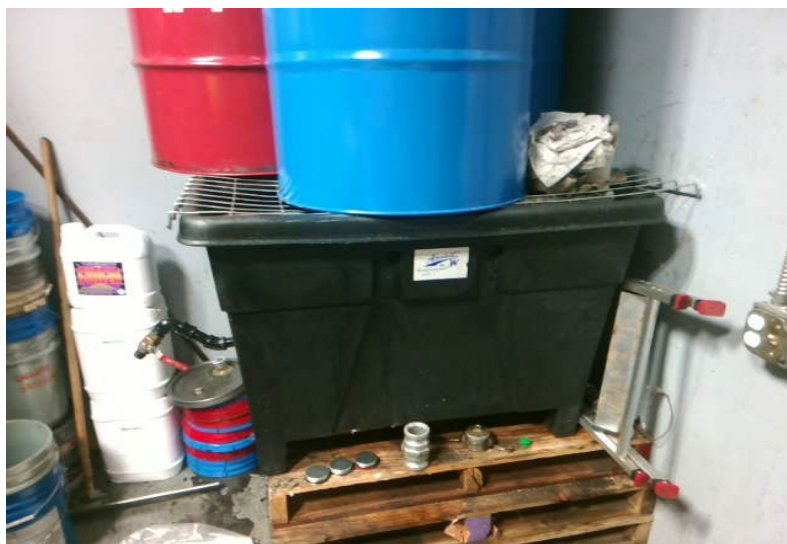
| IMG-202202241351295129186966.jpg |

| 75-gallon used oil tote was not labeled with the words "Used Oil."<br><br>Mr. Hall had facility personnel label the tote with the words "Used Oil" during the inspection. | <b>Regulation:</b><br><br>279.22(c)(1) | <b>Sections:</b> |

| View of 75-gallon used oil tote that was not labeled with the words "Used Oil." |

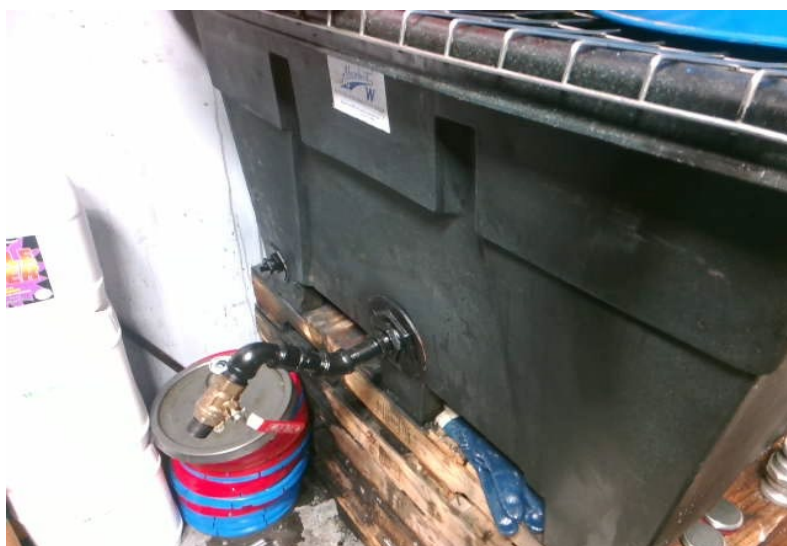
| IMG-202202241351365136175949.jpg |

| View of 75-gallon used oil tote that was not labeled with the words "Used Oil." |

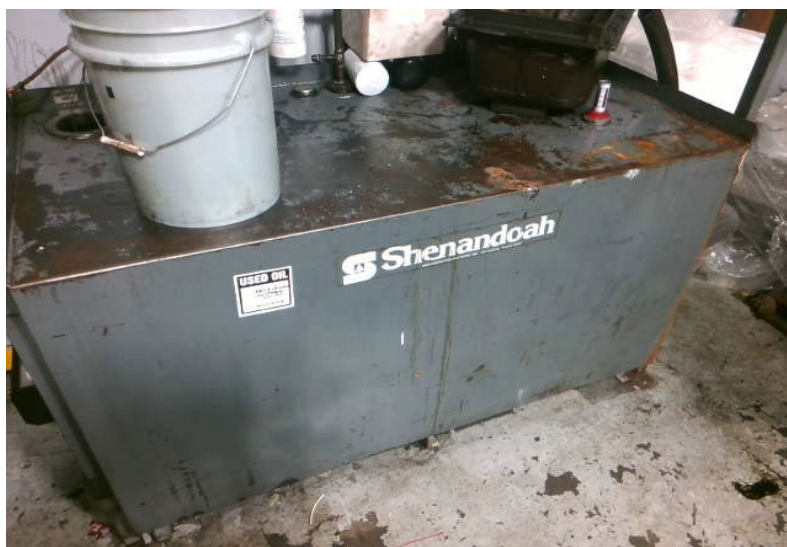
| IMG-202202241355375537187674.jpg |

| View of 300-gallon used oil storage tank, after being labeled with the words "Used Oil" during the inspection. |

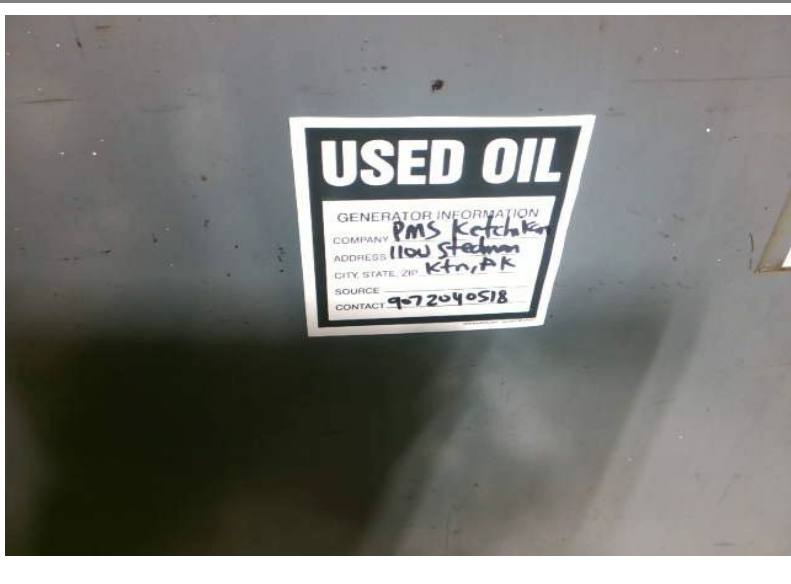
| <div>[Title]</div> <div>IMG-202202241355435543105755.jpg</div> <div>02/24/2022 01:55 PM (AKT)</div> <div>Jon Jones</div> <div>Warehouse/Processing Room</div> <div>No CBI</div> <div>No PII</div> <div>Close-up view of the label on the 300-gallon used oil storage tank.</div> | |

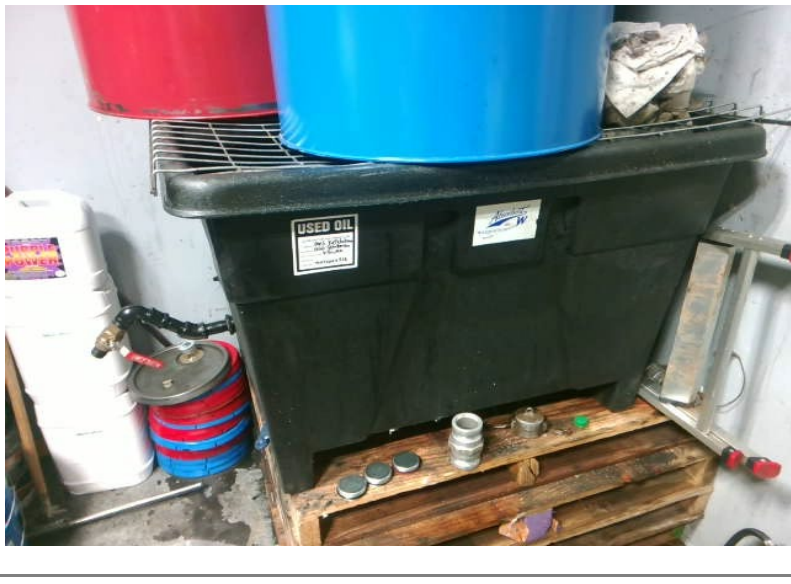
| <div>[Title]</div> <div>IMG-202202241355555555203563.jpg</div> <div>02/24/2022 01:55 PM (AKT)</div> <div>Jon Jones</div> <div>Warehouse/Processing Room</div> <div>No CBI</div> <div>No PII</div> <div>View of 75-gallon used oil tote, after being labeled with the words "Used Oil" during the inspection.</div> | |

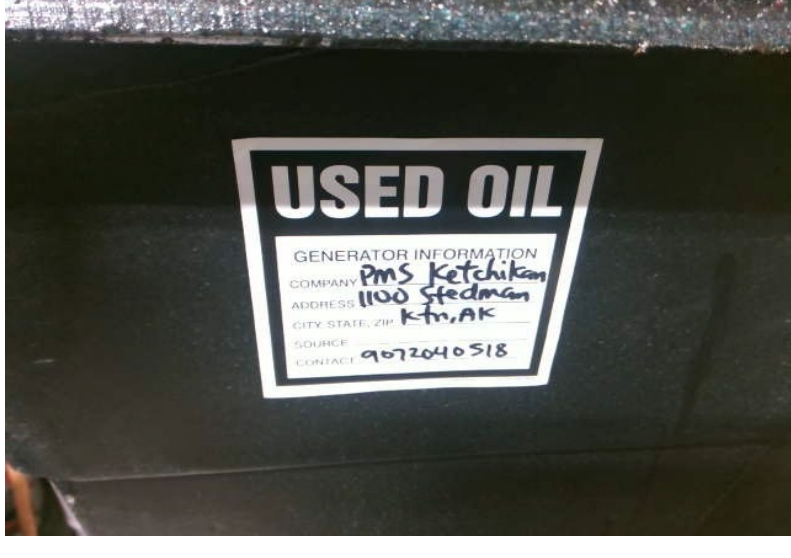
| <div>[Title]</div> <div>IMG-20220224135602562145143.jpg</div> <div>02/24/2022 01:56 PM (AKT)</div> <div>Jon Jones</div> <div>Warehouse/Processing Room</div> <div>No CBI</div> <div>No PII</div> <div>Close-up view of the label on the 75-gallon used oil tote.</div> | |
