## **RCRA Inspection Report**

Biogen U.S. Limited Partnership (Biogen)  
5000 Davis Drive  
RTP, North Carolina 27709  
EPA ID No.: NCR000005355

February 4, 2021, 8:30 a.m. – 6:00 p.m.

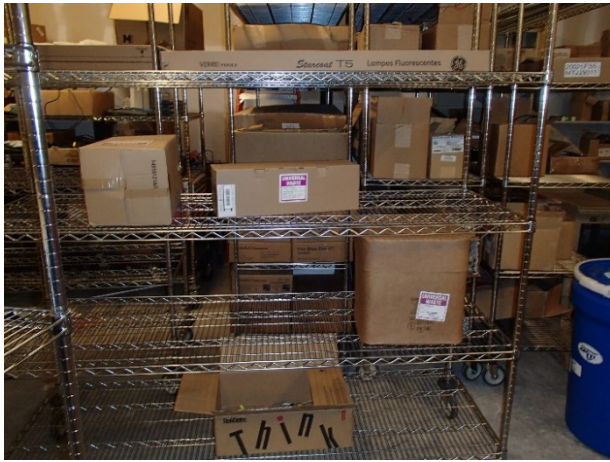
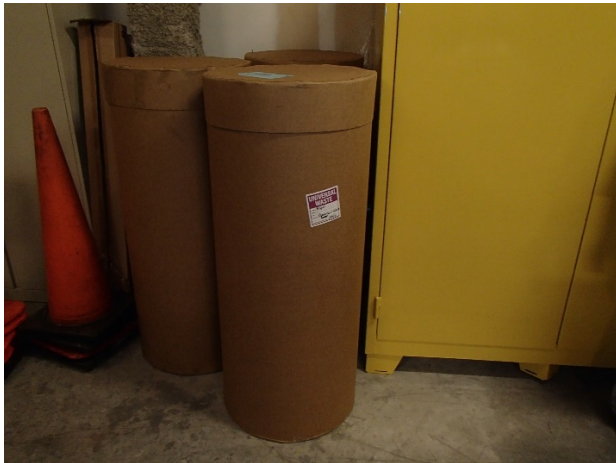
Biogen was storing universal waste in the top floor, "the penthouse", of Building 26. There were two boxes of CFLs, one box of metal halide lamps, and one cylinder storing 4-foot universal waste lamps. One box of CFLs was dated 2/3/2021 and labeled as universal waste CFL "bulbs." Facility representatives corrected the label from "bulbs" to "lamps" (Photos 1-2). Each container was closed and labeled with an accumulation start date within the last year. The oldest was dated 9/1/2020.

Photo 1: Building 2026 - universal waste lamps storage.

Photo 2: Building 2026 - universal waste lamps storage.

**Pursuant to 15A NCAC 13A .0119(b)] [40 C.F.R. § 273.14(e)], a SQHUV must label or mark each lamp or container of lamps clearly with one of the following phrases: "Universal Waste-Lamp(s)," or "Waste Lamp(s)," or "Used Lamps."**

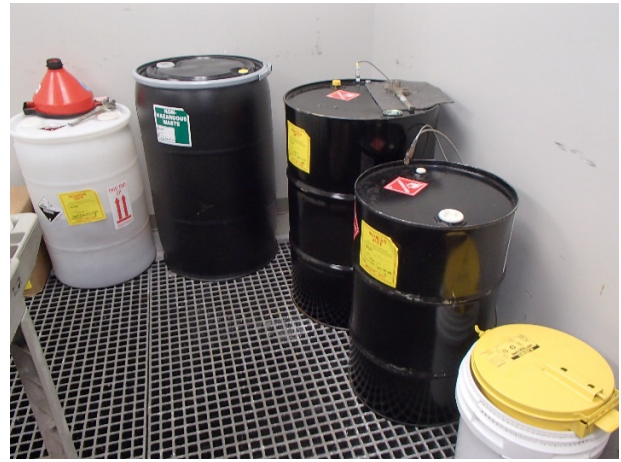
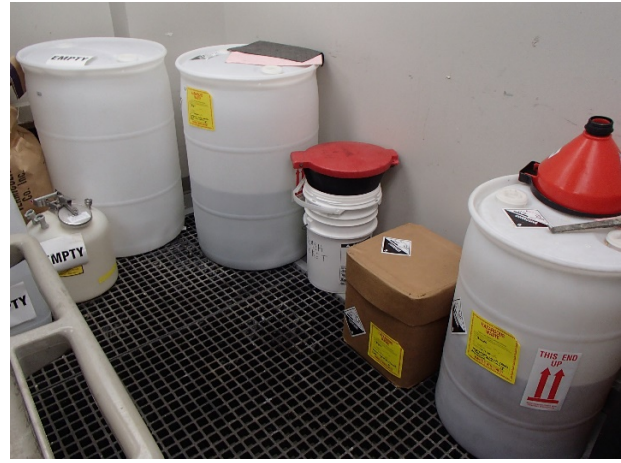
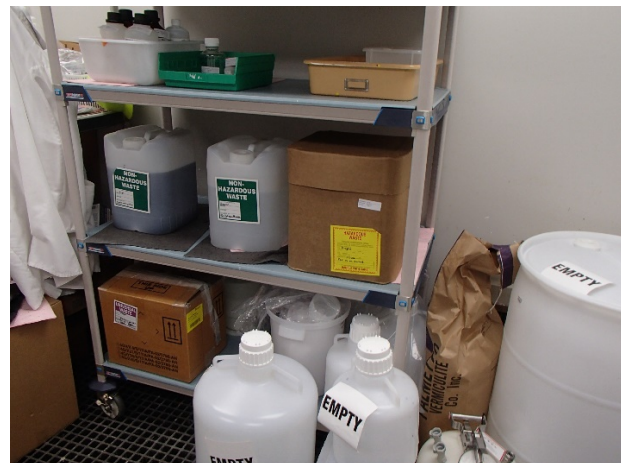
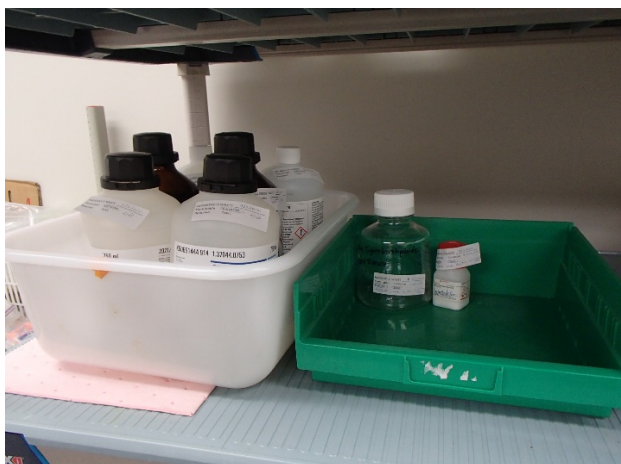
Biogen was storing approximately 215 gallons of waste in 17 containers ranging from 100 ml to 55-gallons in the Central Accumulation Area in Room 24105A. Each of the containers was labeled, dated, closed, and in good condition (Photos 4-7). The oldest accumulation start date for hazardous waste containers was 12/17/2021. The oldest date for universal waste containers was 4/14/2020. This room was supported by a grated floor. There was dirt and debris on the floor visible through the grate. Biogen had not cleaned this floor area in some time. The inspection team recommended that the floor be cleaned on a regular basis or as needed.

Photo 4: Room 24105A – Chem Waste Storage.

Photo 5: Room 24105A – Chem Waste Storage.

Photo 6: Room 24105A – Chem Waste Storage.

Photo 7: Room 24105A – Chem Waste Storage.

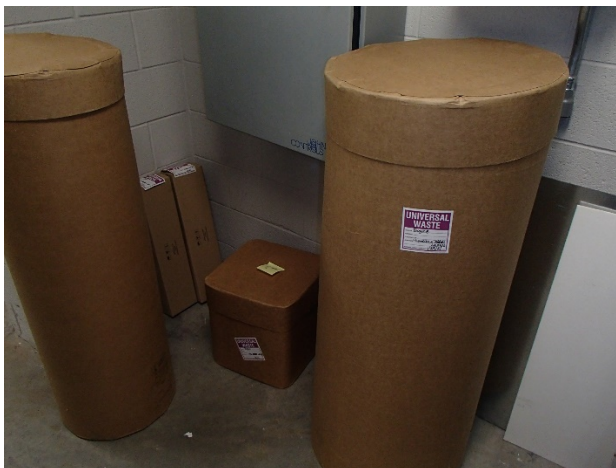
Biogen was storing universal waste lamps in one 4-foot cylinder that was in good condition, closed, and dated 1/23/2021. There was one box of HID universal waste lamps dated 1/2/2021, one box of mixed universal waste lamps dated 1/2/2021, and one box of CFL universal waste lamps dated 1/11/2021. Each

of these containers was closed and in good condition (Photo 3). The box of HID universal waste lamps was labeled as waste “bulbs.”

Photo 3: Room 24104 - Electrical – Universal Waste storage.

**Pursuant to 15A NCAC 13A .0119(b)] [40 C.F.R. § 273.14(e)], a SQHUW must label or mark each lamp or container of lamps clearly with one of the following phrases: “Universal Waste-Lamp(s),” or “Waste Lamp(s),” or “Used Lamps.”**

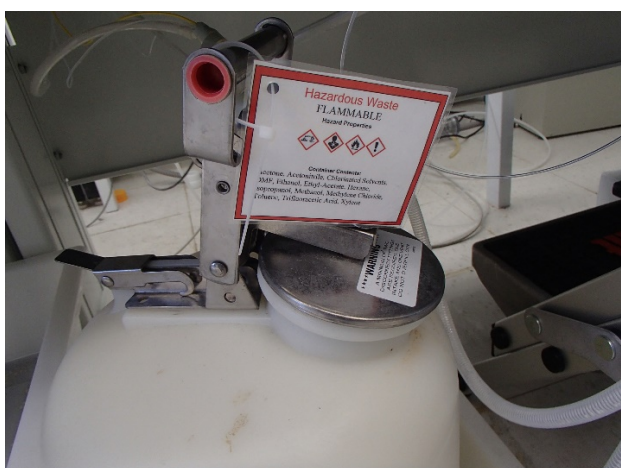
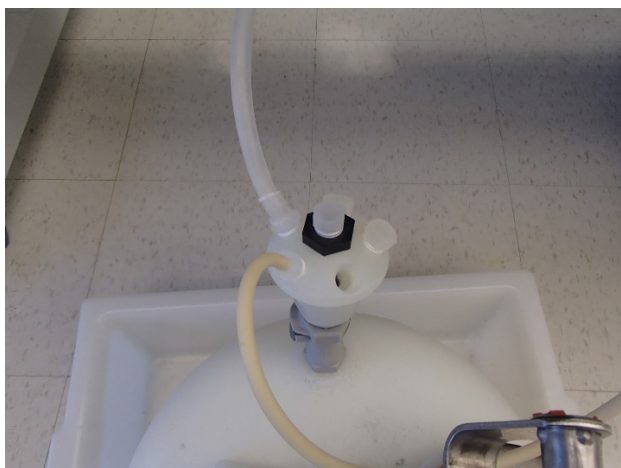
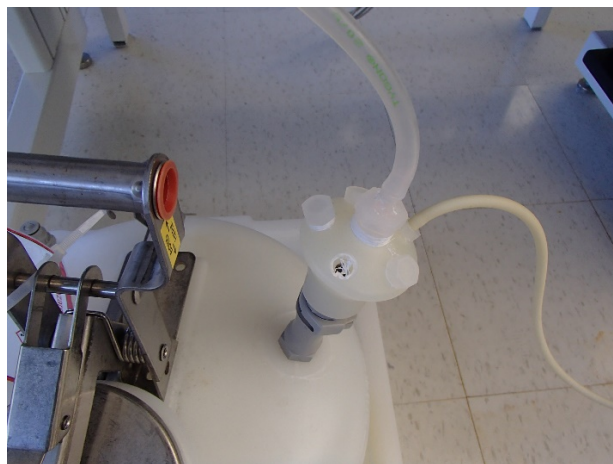
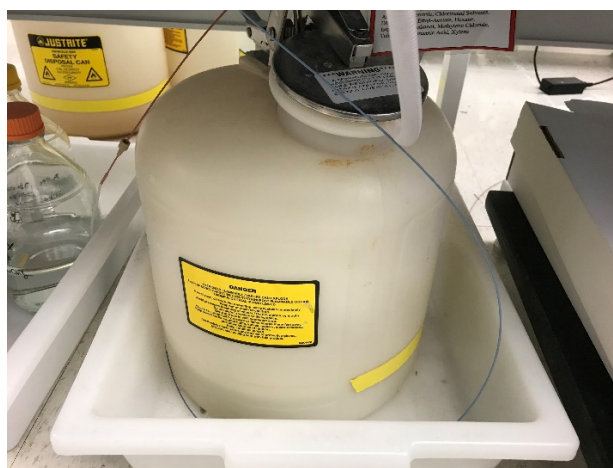
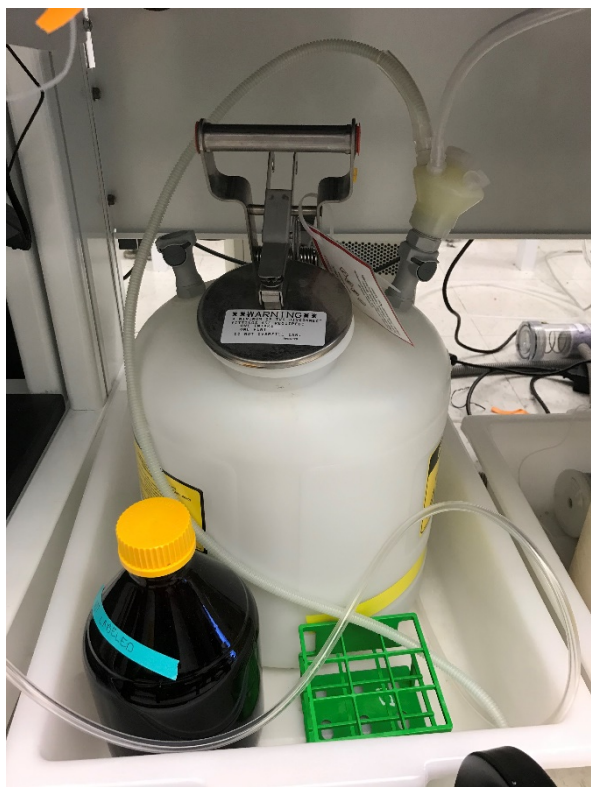
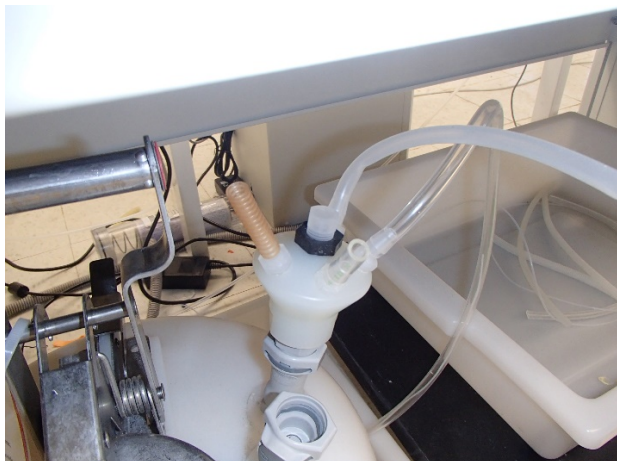
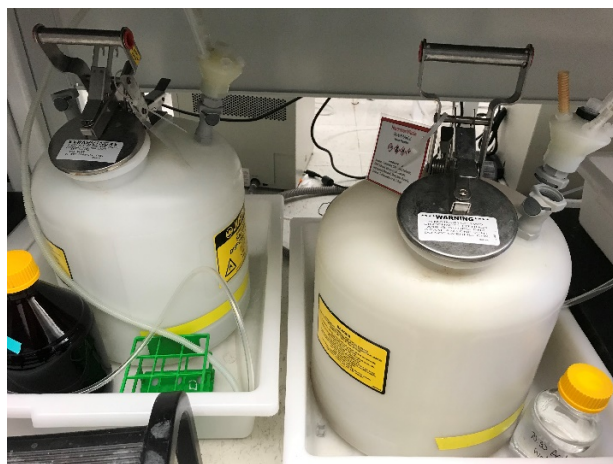
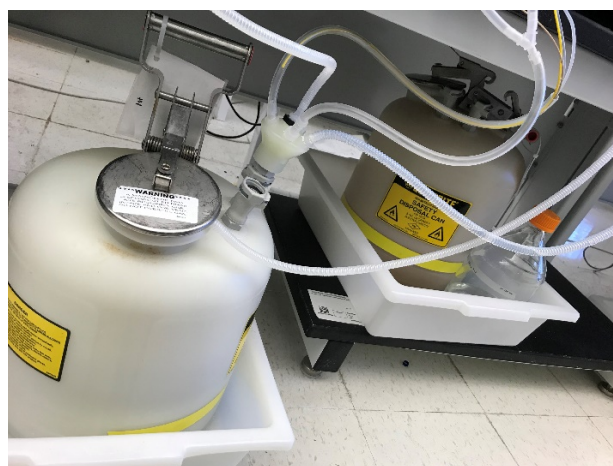
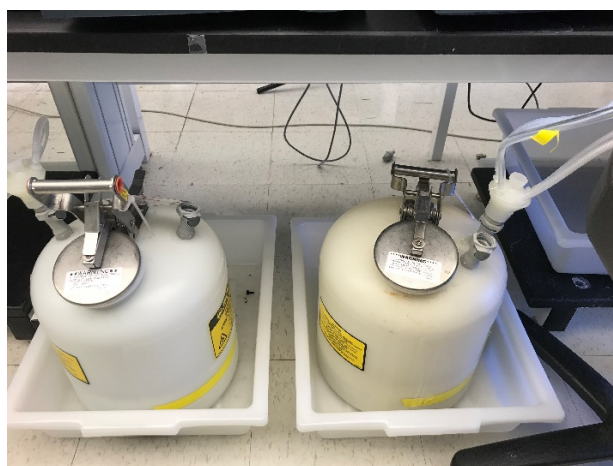
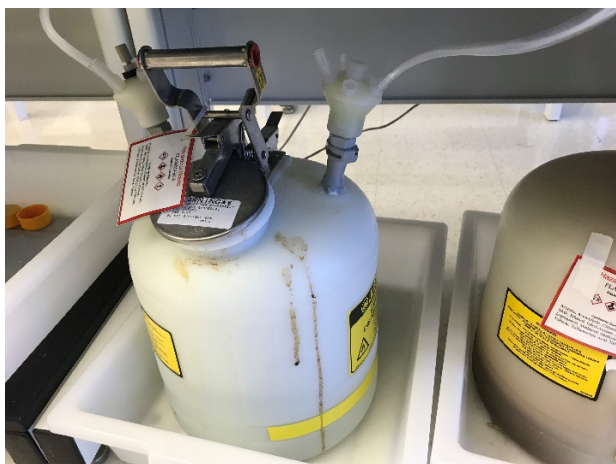
Biogen was operating twenty-two HPLCs in Room 24160 AD Lab. Each HPLC was attached to a 5-gallon accumulation container affixed with a manifold of six ports on the cap. Each of the satellite accumulation areas (SAAs) were in good condition and labeled. Twelve of twenty-two SAA containers had at least one port open (Photos 8-17). There was waste on the outside of one container (Photo 17).

**Pursuant to 15A NCAC 13A .0107(a) [40 C.F.R. § 262.15(a)(4)], which is a condition of the SAA Permit Exemption, a generator is required to keep containers of hazardous waste closed at all times during accumulation, except when adding, removing, or consolidating waste; or when temporary venting of a container is necessary for the proper operation of equipment, or to prevent dangerous situations, such as build-up of extreme pressure.**

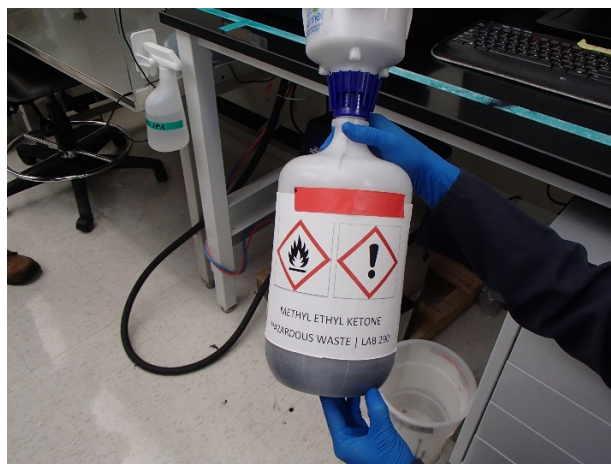
Biogen was storing methyl ethyl ketone hazardous waste in a 4-liter plastic container with a drain funnel attached at the top opening (Photo 20-21). This container was in good condition, closed, and marked as flammable liquid.

Photo 20: Room 24260.

Photo 21: Room 24260.

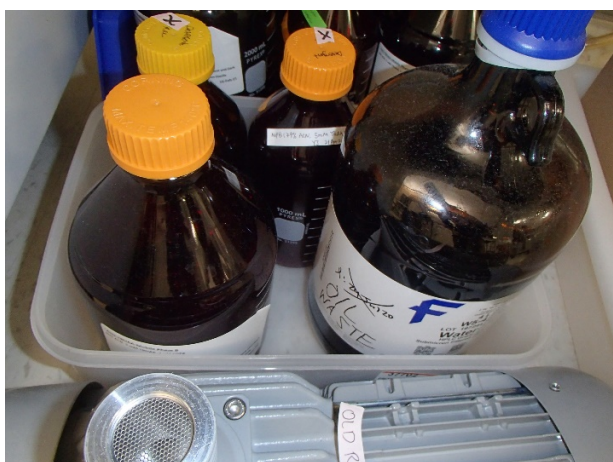
Photo 18: Room 24160.

There was one 4-liter rough pump container labeled as “Oil waste” (Photo 18). Containers of used oil are required to be labeled as “Used Oil.”

**Pursuant to 15A NCAC 13A .0118(c) [40 C.F.R. § 279.22(c)(1)], containers and aboveground tanks used to store used oil at generator facilities must be labeled or marked clearly with the words “Used Oil”.**

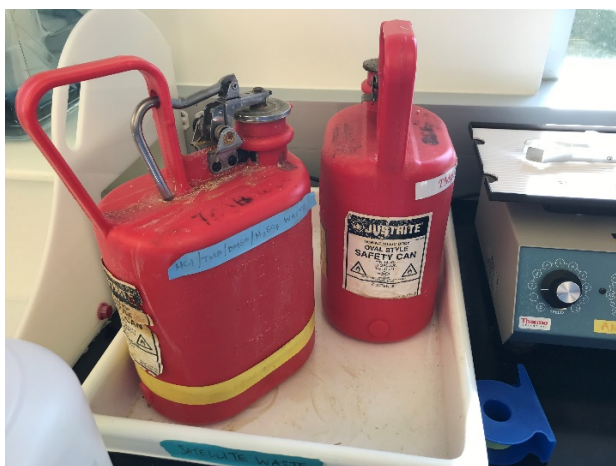
Photo 19: Room 24169.

Biogen was storing HCL/TMB/DMSO/Sulfuric acid waste in a one-gallon red flip top container in a designated SAA area (Photo 19). This container was not labeled as hazardous waste. These containers should have included an indication of corrosive hazard. Also, Biogen was storing tetra-methyl-benzene/di-methyl sulfoxide tips in a similar 1-gallon red flip top container in this waste bin.

**Pursuant to 15A NCAC 13A .0107(a) [40 C.F.R. § 262.15(a)(5)], which is a condition of the SAA Permit Exemption, a generator is required to mark or label its containers (i) with the words “Hazardous Waste” and (ii) with an indication of the hazards of the contents.**

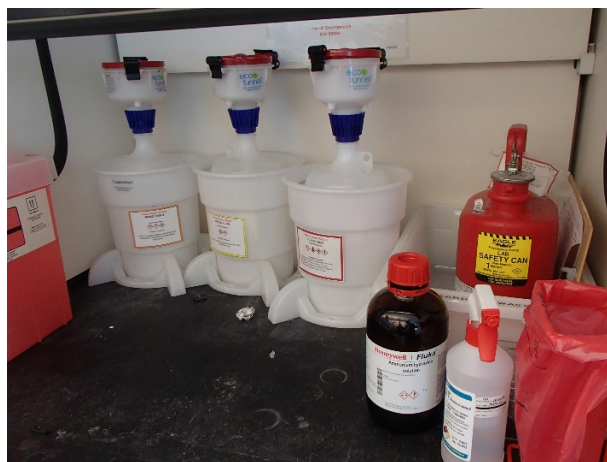
Photo 25: Room 24490.

Across the laboratory, Biogen was accumulating waste in three 4-liter bottles with eco funnels: one for mixed bases, one for mixed acids, and one for flammables (Photo 25). Under the same laboratory hood was one, 1-gallon red flip top safety canister storing flammable hazardous waste. These containers were in good condition, closed, and labeled on the day of the inspection.

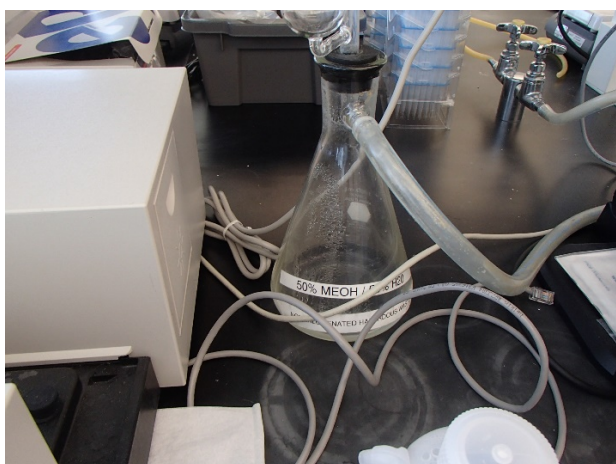
Biogen was operating four HPLCs in Room 24490. Each of these HPLC's was attached to a 5-gallon SAA container. These containers were in good condition and labeled. Three of these 5-gallon SAA containers were open on the day of the inspection. Biogen was operating one, 1-liter SAA beaker storing MECH (Photos 23-24). This SAA beaker was open and was not labeled with an indication of the hazard.

Photo 23: Room 24490.

Photo 24: Room 24490.

**Pursuant to 15A NCAC 13A .0107(a) [40 C.F.R. § 262.15(a)(4)], which is a condition of the SAA Permit Exemption, a generator is required to keep containers of hazardous waste closed at all times during accumulation, except when adding, removing, or consolidating waste; or when temporary venting of a container is necessary for the proper operation of equipment, or to prevent dangerous situations, such as build-up of extreme pressure.**

**Pursuant to 15A NCAC 13A .0107(a) [40 C.F.R. § 262.15(a)(5)], which is a condition of the SAA Permit Exemption, a generator is required to mark or label its containers (ii) with an indication of the hazards of the contents.**

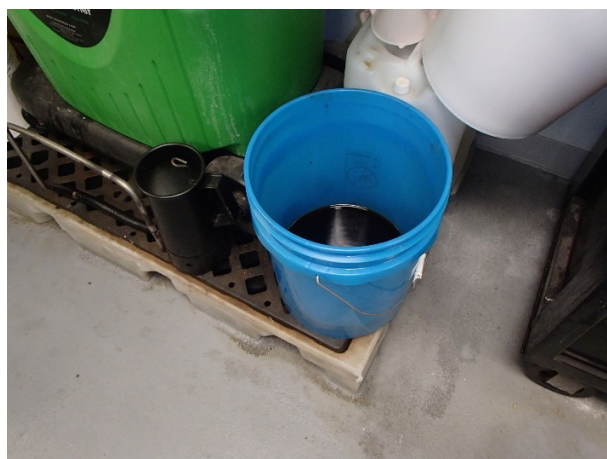
Biogen was storing one, blue 5-gallon container of used oil. This container was not labeled with the words “Used Oil” on the day of the inspection (Photos 26-27). Facility personnel added the words Used Oil to the container during the inspection.

Photo 26: Room 2101.

Photo 27: Room 2101.

**Pursuant to 15A NCAC 13A .0118(c) [40 C.F.R. § 279.22(c)(1)], containers and aboveground tanks used to store used oil at generator facilities must be labeled or marked clearly with the words “Used Oil.”**

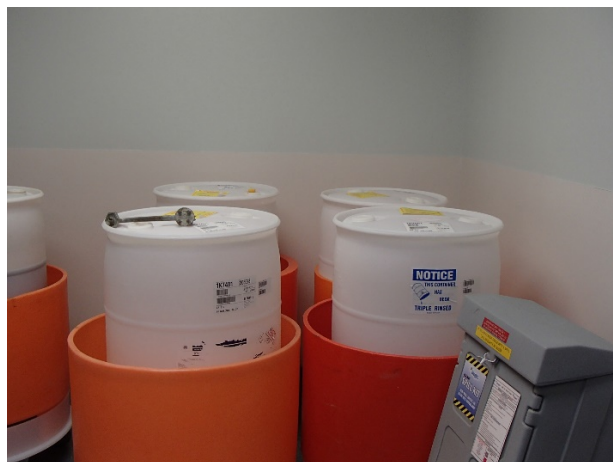
Photo 29: Room 3113.

The inspection team noted four 55-gallon poly containers in Room 3113 Media Prep Airlock on the day of the inspection (Photo 29). One container was labeled as sodium selenite but was empty. The other three containers were not empty and contained insulin with Hydrochloric acid, Tyrosine and Sodium Hydroxide, and Ethanolamine respectively. Biogen was managing these containers as SAAs. However, since these containers were not at the point of generation and the volume of waste was greater than 55-gallons it was not eligible to be managed as an SAA and should have been managed as a CAA. Additionally, there were no accumulation start dates on the three containers storing waste nor were there any indications of the hazard. Biogen employees that transfer waste to a CAA should be trained.

**Pursuant to 15A NCAC 13A .0107(a) [40 C.F.R. § 262.17(a)(5)(i)(B) and (C)], which is a condition of the LQG Permit Exemption, a generator must mark or label its containers with the following: an indication of the hazards of the contents; and the date upon which each period of accumulation begins clearly visible for inspection on each container.**

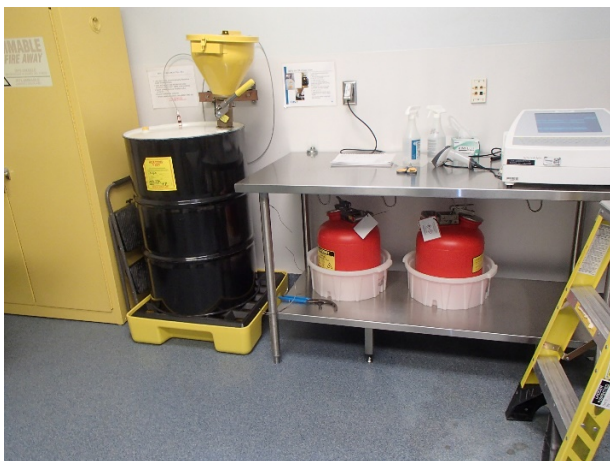
Photo 28: Room 2104.

Biogen was accumulating one, 55-gallon metal container of hazardous waste isopropyl alcohol in a SAA with a yellow funnel attached to the bung hole in room 2104 (Photo 28). This container was labeled as a hazardous waste and flammable liquid. There were also two, red 5-gallon accumulation SAA cans (D001) (Photo 28). These containers were in good condition, closed, and labeled.

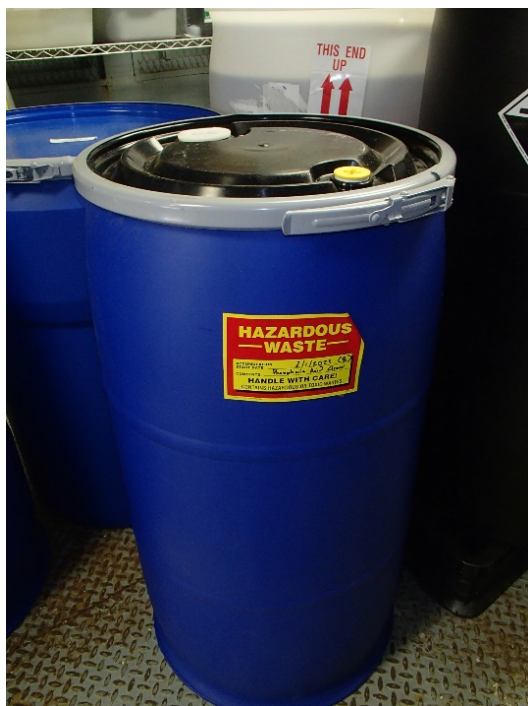
Biogen stores approximately 800 gallons of hazardous waste, universal waste, and non-hazardous waste in approximately 40 containers in waste shed 29A (Photos 30-31). These containers were in good condition, closed, and labeled with an accumulation start dates. The oldest accumulation start date for hazardous waste containers was 12/23/2020. The oldest accumulation start date for universal waste containers was 4/14/2020.

There was one 30-gallon container of phosphoric acid dated 2/1/2021. This container was not labeled with an indication of hazard (Photo 31).

Photo 30: Waste Shed 29A.

Photo 31: Waste Shed 29A.

**Pursuant to 15A NCAC 13A .0107(a) [40 C.F.R. § 262.17(a)(5)(i)(B)], which is a condition of the LQG Permit Exemption, a generator must mark or label its containers with the following: an indication of the hazards of the contents.**

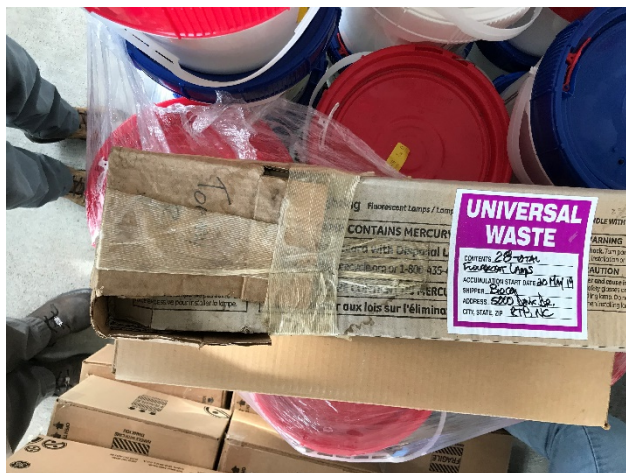
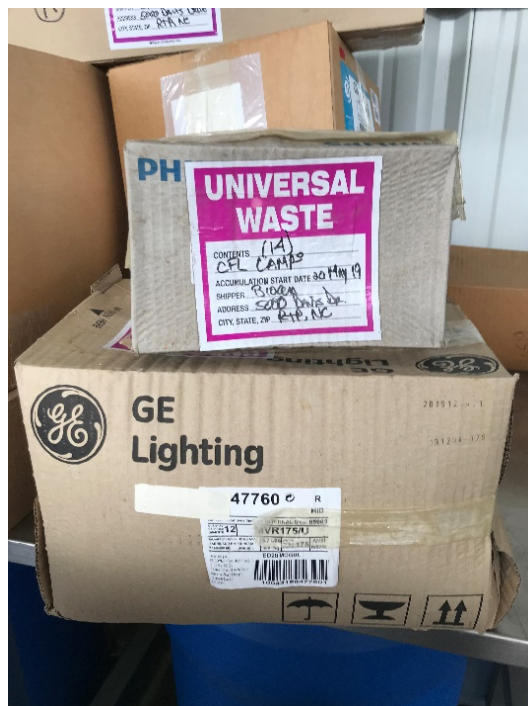
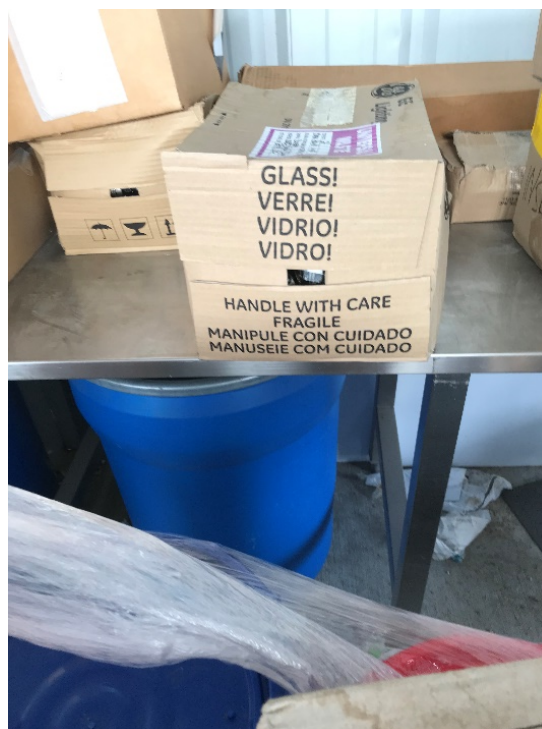
There was a total of 12 boxes storing universal waste lamps. Two of these boxes were open and three of these boxes were dated more than one year (Photos 32-34). These wastes were shipped off-site under manifest number 001088473 on 2/19/2021.

Photo 33: Non-Haz Cage.

Photo 32: Non-Haz Cage .

Photo 34: Non-Haz Cage.

**Pursuant 15A NCAC 13A .0119(b) [40 C.F.R. § 273.13(d)], a SQHUW must manage universal waste lamps in a way that prevents releases of any universal waste or component of a universal waste to the environment.**

**Pursuant to 15A NCAC 13A .0119(b) [40 C.F.R. § 273.15(a) and (c)], a SQHUW may accumulate universal waste no longer than one year and must be able to demonstrate the length of time that the universal waste has accumulated from the date that it became a waste or was received.**
