## **RCRA Inspection Report**

American Cast Iron Pipe Company (ACIPCO)  
1500 32<sup>nd</sup> Ave North  
Birmingham, AL 35207

March 22, 2023, 8:40 a.m.

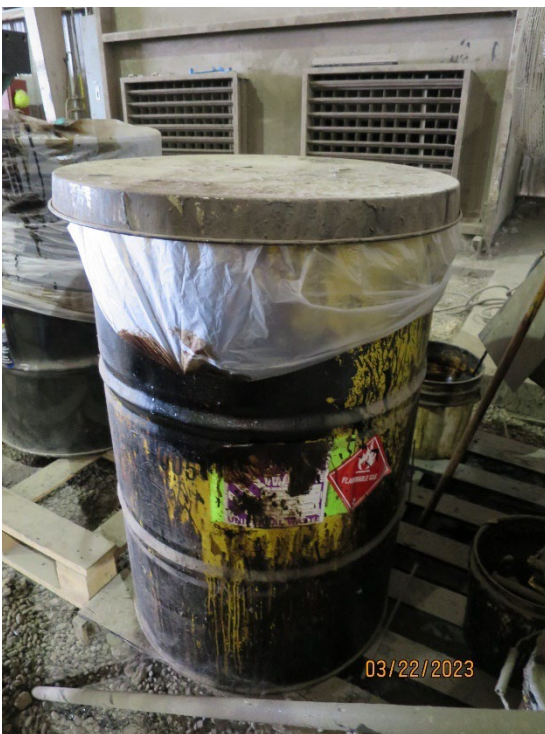
In the touch up area of the coating line, cracks and all imperfections in the cement coating, as well as scratches in the paint, are corrected by hand. ACIPCO manages a satellite accumulation area (SAA) in this area. At the time of the CEI, inspectors observed one 55-gallon drum labeled “Hazardous Waste, Cutback Paint (Pure R17, MOS 50), Ignitable (D001),” and one drum labeled “Hazardous Waste, Waste Aerosols, Ignitable (D001), Tetrachloroethylene (D039), Trichloroethylene (D040).” This waste drum was also labeled with a universal waste label that was dirty and illegible (Photos 1 & 2).

**Photo 2:** An illegible Universal Waste label on a 55-gallon drum of waste aerosol cans.

**Pursuant to ADEM Admin. Code r. 335-14-11-.02(5)(f) [40 CFR 273.14(f)] a SQHUW must label or mark each universal waste aerosol cans (i.e., each aerosol can), or a container in which the aerosol cans are contained, must be labeled or marked clearly with any of the following phrases: "Universal Waste-Aerosol Can(s)," "Waste Aerosol Can(s)," or "Used Aerosol Can(s)."**

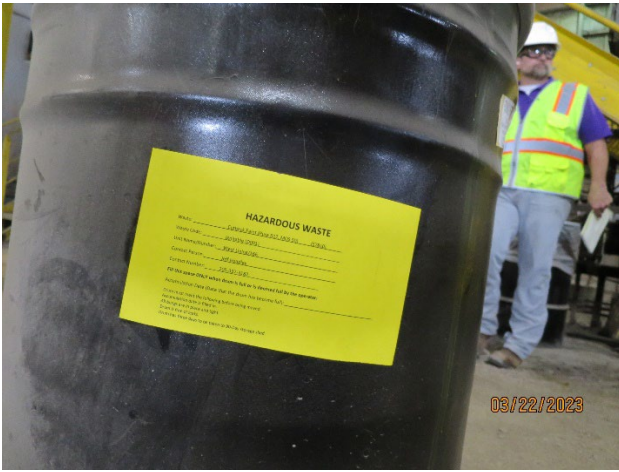
On the opposite end of the coating line warehouse, inspectors observed a second satellite accumulation area. At the time of the inspection, inspectors observed one 55-gallon drum labeled “Hazardous Waste, Cutback Paint (Pure R17, MOS 50), Ignitable (D001),” and one 55-gallon

**Photo 3:** A 55-gallon SAA drum of cutback paint missing an indication of the hazards of its contents in the West Coating Line.

**Pursuant to ADEM Admin. Code r. 335-14-3-.01(5)(a)5.(ii) [40 C.F.R. § 262.15(a)(5) (ii)], which is a condition of the SAA Permit Exemption, a LQG is required to mark or label its SAA containers with an indication of the hazards of the contents.**

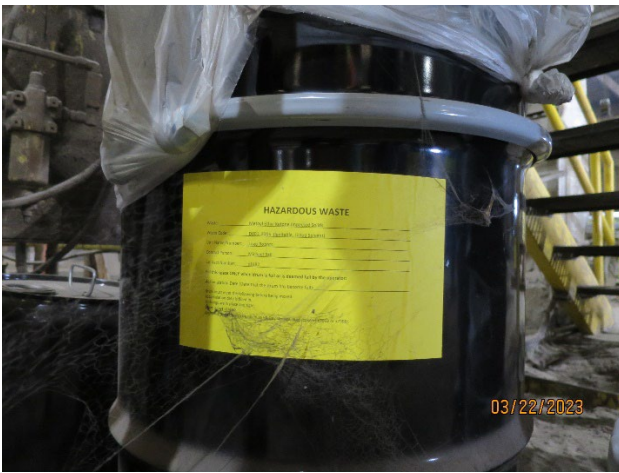
drum labeled “Hazardous Waste, MEK Methyl Ethyl Ketone Impacted Solids, D001, F005 (Ignitable, Listed Solvent)” (Photos 3 and 4). This drum did not have a ring around the lid and therefore could not be properly sealed.

**Photo 4:** A 55-gallon SAA drum of MEK missing an indication of the hazards of its contents in the West Coating Line. This drum did also not have a ring around its open top lid and therefore could not be properly sealed and closed.

**Pursuant to ADEM Admin. Code r. 335-14-3-.01(5)(a)(4) [40 CFR 262.15(a)(4)], a SAA container holding hazardous waste must always be closed during accumulation, except when it is necessary to add or remove waste and must not be opened, handled, or stored in a manner that may rupture the container or cause it to leak.**

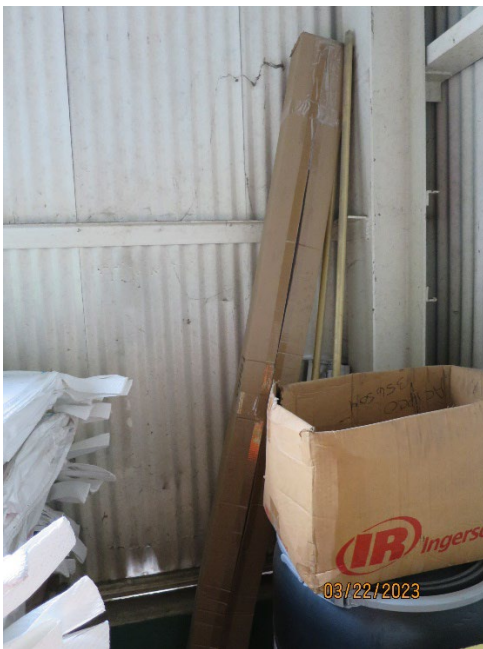
- One (1) closed container labeled “Universal Waste Lamps, 11/11/22.”
- One (1) 55-gallon container labeled as universal waste non-PCB ballasts. This container was not marked with an accumulation date.
- One (1) box of lithium batteries that was open and unlabeled at the time of the inspection (Photo 7).
- One (1) closed box of LED lights.
- Several Universal Waste lamps leaning against the wall, not in a container (Photo 5).

**Photo 5:** Unlabeled box of universal waste lamps next to universal waste lamps not stored in a container in the CAA.

**Pursuant to ADEM Admin. Code r. 335-14-11-.02(4)(d)(1) [40 CFR 273.13(d)(1)], a SQHUW must contain any lamp in containers or packages that are structurally sound, adequate to prevent breakage, and compatible with the contents of the lamps. Such containers and packages must remain closed and must lack evidence of leakage, spillage, or damage.**

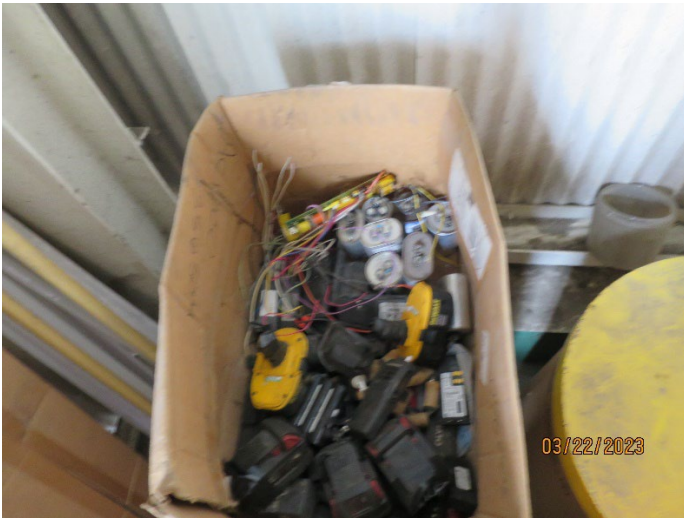
**Photo 6:** An open, unlabeled box of universal waste lithium batteries in the CAA.

**Pursuant to ADEM Admin. Code r. 335-14-11-.02(4)(a)(1) [40 CFR 273.13(a)(1)], a small quantity handler of universal waste must contain any universal waste battery that shows evidence of leakage, spillage, or damage that could cause leakage under reasonably foreseeable conditions in a container. The container must be closed, structurally sound, compatible with the contents of the battery, and must lack evidence of leakage, spillage, or damage that could cause leakage under reasonably foreseeable conditions.**

**Pursuant to ADEM Admin. Code r. 335-14-11-.02(5)(a) [40 CFR 273.14(a)] A small quantity handler of universal waste must label or mark label each Universal waste batteries (i.e., each battery), or a container in which the batteries are contained clearly with any one of the following phrases: "Universal Waste - Battery(ies)", or "Waste Battery(ies)", or "Used Battery(ies)."**

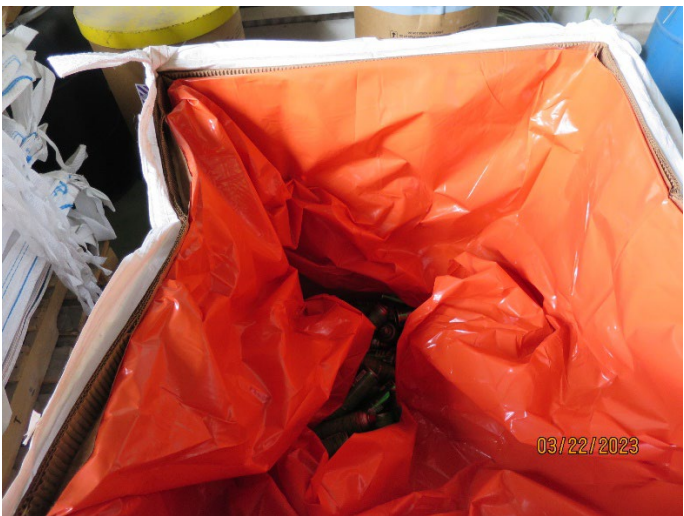
- One (1) open cubic yard box half full of aerosol cans. The box was labeled with "Universal Waste, American Cast Iron Pipe Co, Waste Aerosols," and a DOT flammable liquids placard. This container was not marked with an accumulation date (Photo 7).

**Photo 7:** An open cubic yard box of universal waste aerosol cans. This container was not marked with an accumulation date.

**Pursuant to ADEM Admin. Code r. 335-14-11-.02(6)(a) [40 C.F.R. § 273.15(a)], a SQHUW may accumulate universal waste no longer than one year and must to be able to demonstrate the length of time that the universal waste has accumulated from the date that it became a waste or was received.**

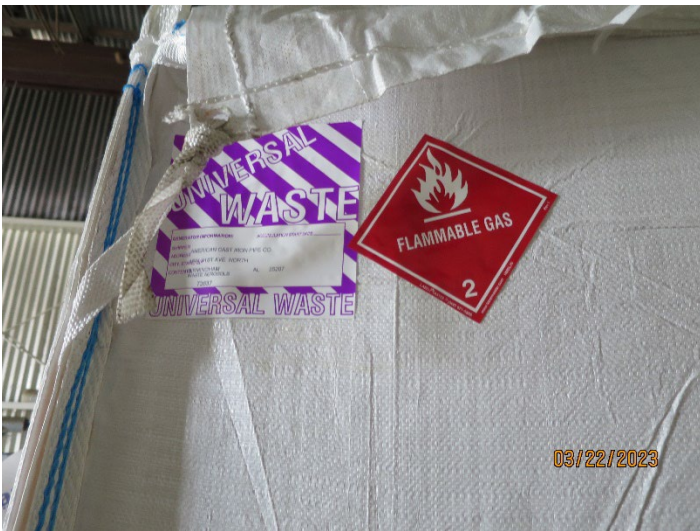
- Four (4) cubic yard boxes labeled "Universal Waste, American Cast Iron Pipe Co, Waste Aerosols," and a DOT flammable liquids placard. These boxes were not marked with an accumulation date (Photo 8)

**Photo 8:** A cubic yard box of universal waste aerosol cans not marked with an accumulation date in the CAA.

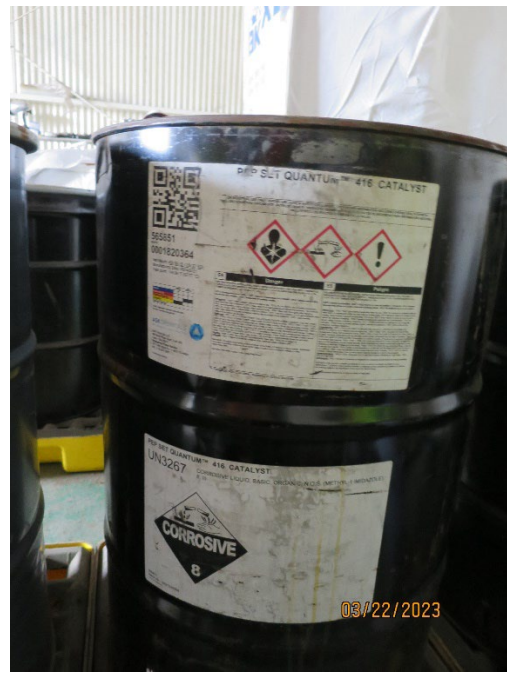
- One (1) 55-gallon drum labeled with a product label with a DOT corrosive placard. This drum was not labeled with the words "Hazardous Waste" or an accumulation date (Photo 9).

**Photo 9:** Drum in the CAA that was labeled with a product label and missing the words “Hazardous Waste” and an accumulation date.

**Pursuant to ADEM Admin. Code r. 335-14-3-.01(7)(a)5(i) [40 C.F.R. § 262.17(a)(5)(i)], which is a condition of the LQG Permit Exemption, a generator must mark or label its containers with the following: the words “Hazardous Waste”; an indication of the hazards of the contents; and the date upon which each period of accumulation begins clearly visible for inspection on each container.**

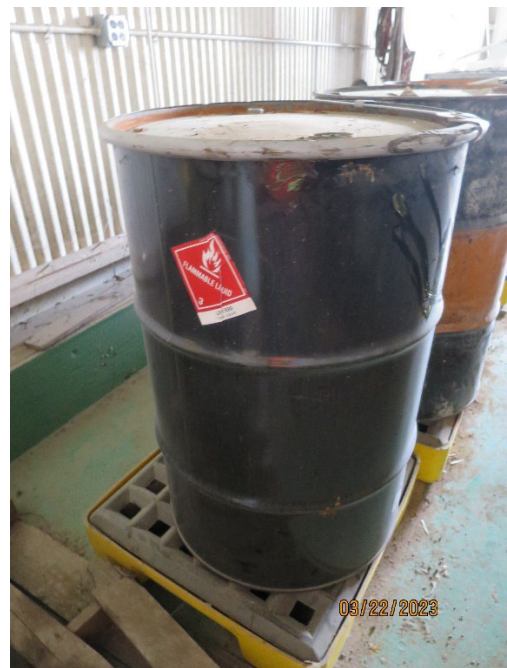
- One (1) 55-gallon drum labeled with a product label that included a DOT flammable liquid placard. This drum was not labeled with the words "Hazardous Waste" or an accumulation date (Photo 10).

**Photo 10:** Drum in the CAA that was labeled with a product label and missing the words “Hazardous Waste” and an accumulation date.

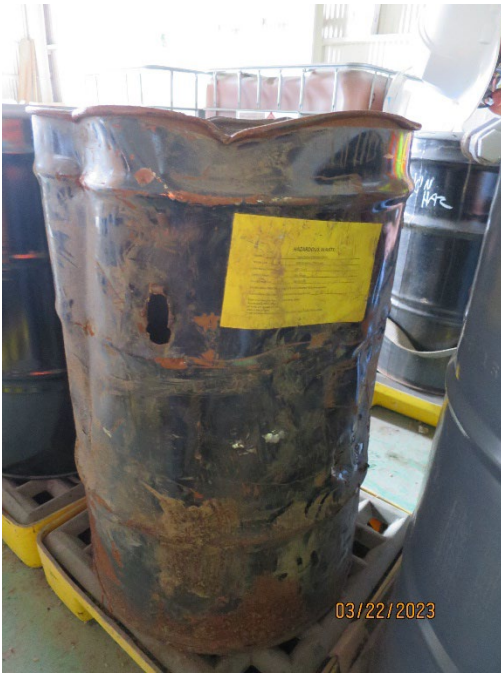
- One (1) 55-gallon drums of "Hazardous Waste, Cupola Dust, D006, D008, 9/30/2022." This drum was missing an indication of the hazards of its contents and has accumulation date

exceeding the 90-day accumulation time limit for large quantity generators. This drum was rusted, in poor condition, and open (Photo 11).

**Photo 11:** A CAA drum that was missing an indication of the hazards of its contents and has accumulation date exceeding the 90-day accumulation time limit for large quantity generators. This drum was also rusted, in poor condition, and open.

**Pursuant to ADEM Admin. Code r. 335-14-3-.01(7)(a)1.(v) [40 C.F.R. § 262.17(a)(1)(iv)], which is a condition of the LQG Permit Exemption, a container holding hazardous waste must always be closed during accumulation, except when it is necessary to add or remove waste; and a container holding hazardous waste must not be opened, handled, or stored in a manner that may rupture the container or cause it to leak.**

**Pursuant to ADEM Admin. Code r. 335-14-3-.01(7)(a) [40 C.F.R. § 262.17(a)], a LQG may accumulate hazardous waste on-site for 90 days or less without a permit or without having interim status, as required by Section 22-30-12(b) of the AHWMMA, Ala. Code § 22-30-12(b) [Section 3005 of RCRA, 42 U.S.C. § 6925], provided that the generator complies with the conditions listed in ADEM Admin. Code r. 335-14-3-.01(7) [40 C.F.R. § 262.17] (hereinafter referred to as the “LQG Permit Exemption”).**

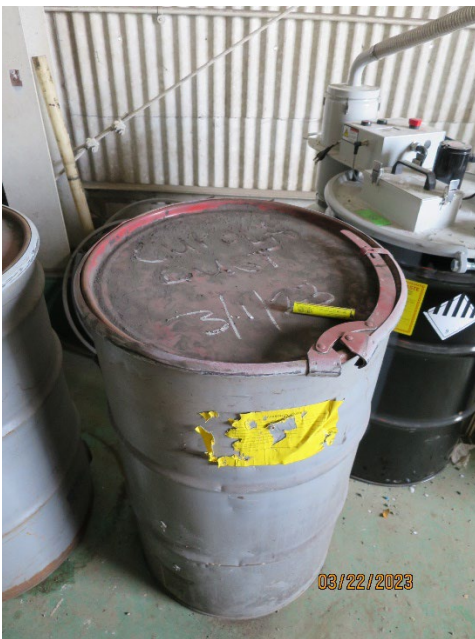
- Eight (8) 55-gallon drums labeled “Hazardous Waste, Cupola Dust, D006, D008, 3/1/2023.” This drum hazardous waste label was ripped and illegible (Photo 12).

**Photo 12:** A hazardous waste drum in the CAA with an illegible hazardous waste label. The lid of the drum was marked with an accumulation date.

**Pursuant to ADEM Admin. Code r. 335-14-3-.01(7)(a)5(i) [40 C.F.R. § 262.17(a)(5)(i)], which is a condition of the LQG Permit Exemption, a generator must mark or label its containers with the following: the words “Hazardous Waste”; an indication of the hazards of the contents; and the date upon which each period of accumulation begins clearly visible for inspection on each container.**
