## **RCRA Inspection Report**

St. Johns Packaging (USA) LLC  
2619 Phoenix Drive  
Greensboro, NC 27406

EPA ID#: NCD041747775  
NAICS #: 326112 – Plastics Packaging Film and  
Sheet (Including Laminated) Manufacturing,  
326111 – Plastics Bag and Pouch  
Manufacturing

October 17, 2023 at 8:20 AM

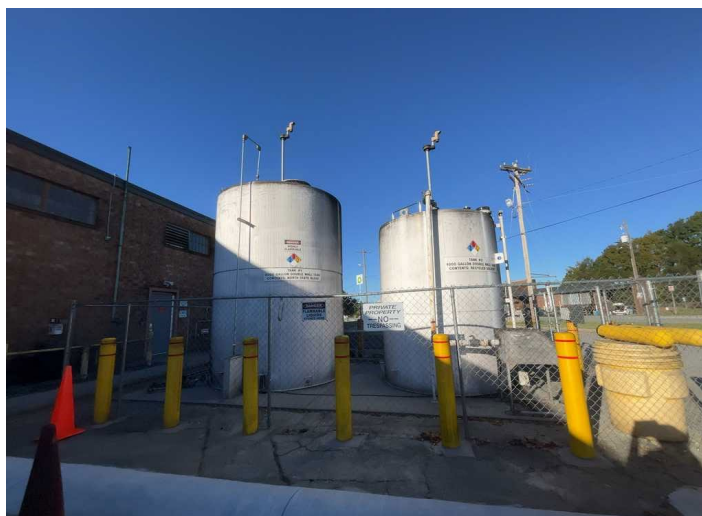
Outside the manufacturing building are two (2) double-walled above-ground storage tanks (ASTs). There is one (1) 4,000-gallon AST used to store HSM solvent labeled "Recycled Solvent" with an NFPA placard and one (1) 8,000-gallon AST used to store fresh solvent labeled "North State Blend" with an NFPA placard (Photo 1). No hazardous waste was observed in this area.

| 4,000-gallon AST labeled “Recycled Solvent” with an NFPA placard and 8,000-gallon AST labeled “North State Blend” with an NFPA placard. | | | Photo 1:<br>File: IMG-2023101708584758472078833.jpg |

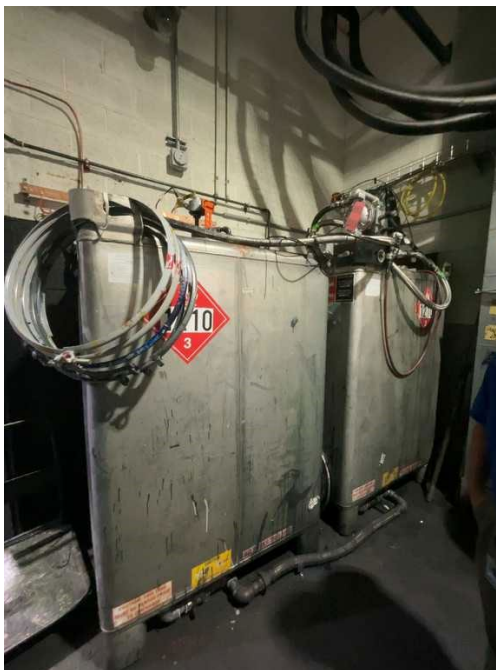
The distillation room is used to recycle spent solvent from the printing press. HSM solvent is hard-piped from the printing press area into one of two (2) 550-gallon double-walled ASTs (Photo 2). Once the HSM passes through the distillation unit, it is stored in a 550-gallon AST labeled "Clean Recycled Solvent Tote" (Photo 3). The inspectors observed two (2) 55-gallon drums of hazardous waste still-bottoms in an SAA (Photo 3). The containers were full and being prepared to be moved to the facility's 90-day central accumulation area (CAA). Both containers were closed, labeled "Hazardous Waste", and marked with an indication of the hazard of the contents.

| Two (2) 550-gallon double-walled ASTs for HSM solvent. | | | Photo 2:<br>File: IMG-20231017090602622055226.jpg |

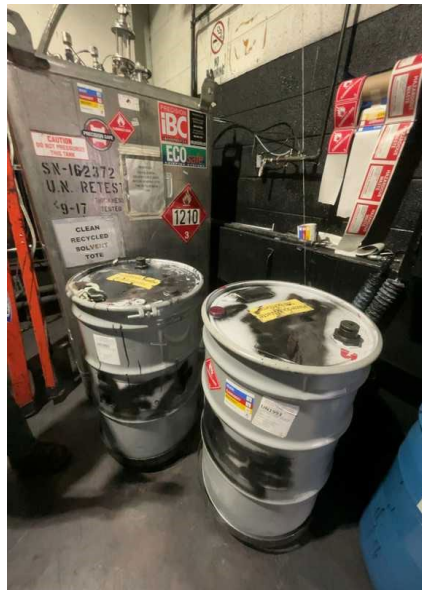
| 550-gallon AST for Clean Solvent and two (2) 55-gallon drums of hazardous waste still bottoms to be moved to CAA. | | | Photo 3<br>File: IMG-202310170908478472036448.jpg |

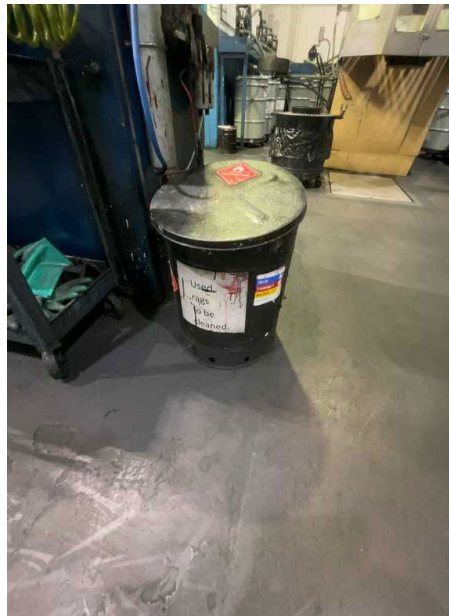
Just outside the Distillation Room was a 5-gallon container of solvent-contaminated wipes labeled "Used Rags to be Cleaned", which are laundered by the company Aramark. The container was closed and had a flammable liquid placard to indicate the hazard of the content (Photo 4).

**Pursuant to 15A NCAC 13A .0106(a) [40 C.F.R. § 261.4(a)(26)(i)], Solvent-contaminated wipes that are sent for cleaning and reuse are not solid wastes from the point of generation, provided that (i) The solvent-contaminated wipes, when accumulated, stored, and transported, are contained in non-leaking, closed containers that are labeled "Excluded Solvent-Contaminated Wipes." The containers must be able to contain free liquids, should free liquids occur. During accumulation, a container is considered closed when there is complete contact between the fitted lid and the rim, except when it is necessary to add or remove solvent-contaminated wipes. When the container is full, or when the solvent-contaminated wipes are no longer being accumulated, or when the container is being**

| 5-gallon container of solvent-contaminated wipes labeled "used rags". | | | Photo 4<br>File: IMG-2023101709121912191819016.jpg |

After the inspection, Craig Bonde submitted a photo via email showing all containers that store excluded solvent-contaminated rags were re-labeled with the words “Excluded Solvent-Contaminated Wipes”.

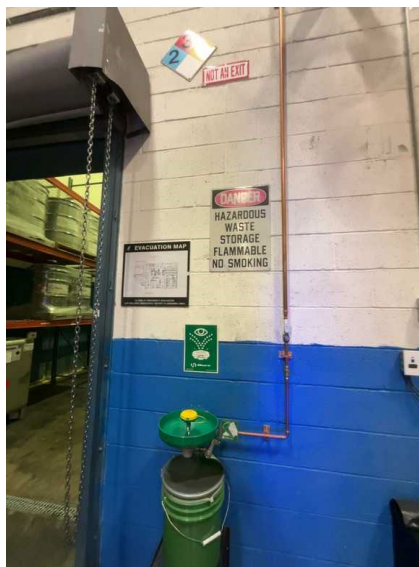
SJP manages a hazardous waste CAA inside the manufacturing building. The area was identified with a sign which read “Danger, Hazardous Waste Storage Flammable No Smoking” (Photo 5). The facility manages ignitable waste and non-hazardous waste in this CAA.

| 90-Day CAA Entrance | | | Photo 5<br>File: IMG-2023101709302030201904444.jpg |

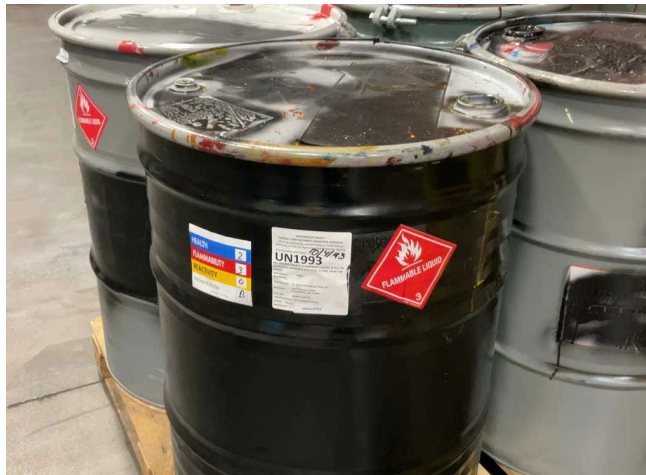
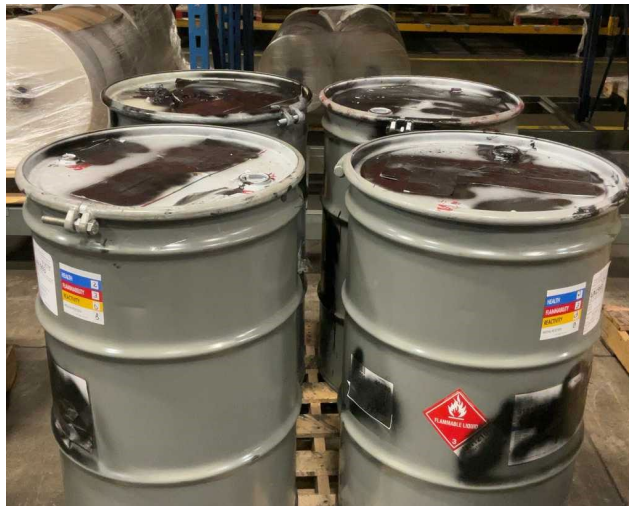
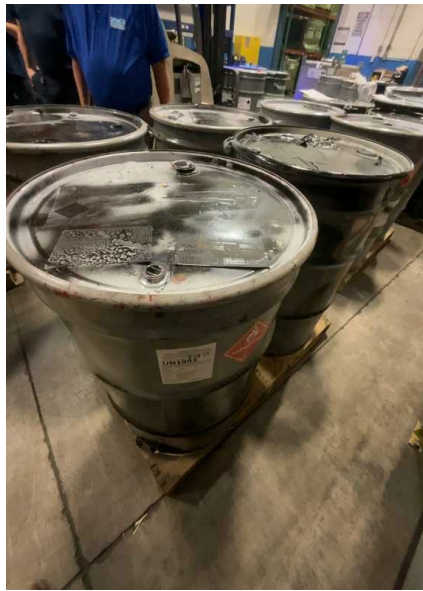
The inspectors observed the 12 55-gallon drums of hazardous waste n-propanol, n-propyl acetate (D001) being prepared to be shipped off for disposal on the same day. All containers were properly closed, labeled with the words “Hazardous Waste”, dated, and marked with a flammable liquid placard. The oldest date recorded was 09/28/2023 (Photos 7-9). Adequate aisle space was observed.

| 90-Day hazardous waste containers. | | | Photo 7<br>File: IMG-2023101709361736171815027.jpg |

| 90-Day hazardous waste containers. | | | Photo 8<br>File: IMG-2023101709363236322074378.jpg |

| 90-Day hazardous waste containers. | | | Photo 9<br>File: IMG-2023101709391139111957518.jpg |

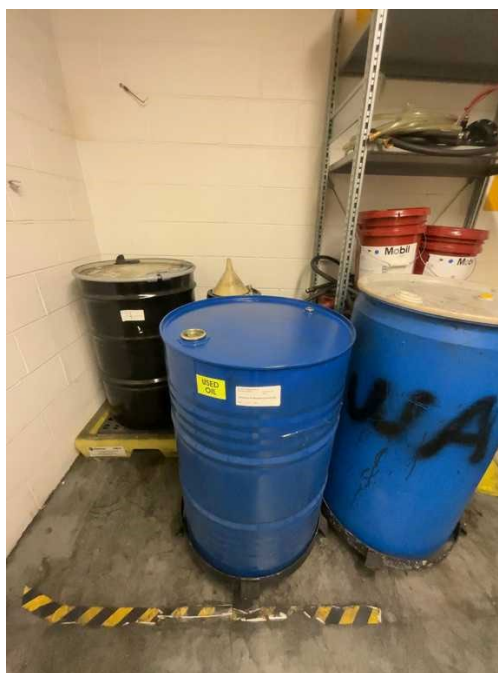
Near the maintenance shop entrance, the inspectors observed one (1) 55-gallon container storing used oil. The container was closed and labeled “Used Oil” (Photo 11).

| 55-gallon used oil container. | | | Photo 11<br>File: IMG-2023101709551955191921808.jpg |
