## **RCRA Inspection Report**

Bakelite Chemicals LLC (Bakelite)  
200 Ampac Road  
Conway, North Carolina 27820  
Northampton County

March 23, 2023, 8:30 a.m. to 4:30 p.m.

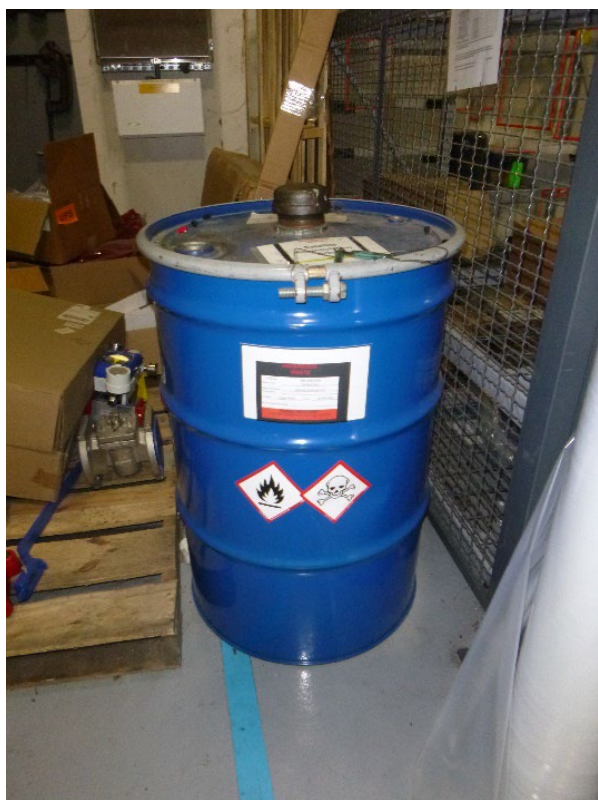
Photograph 1: Maintenance Shop SAA.

| Location | Hazardous Waste stored; EPA ID numbers; Indication of the Hazards |
|---|---|
| Maintenance Shop – Building 202 SAA (Photograph 1): | One 55-gallon blue metal container of unpunctured aerosol cans; D001/D035/D039; Ignitable and Toxic |

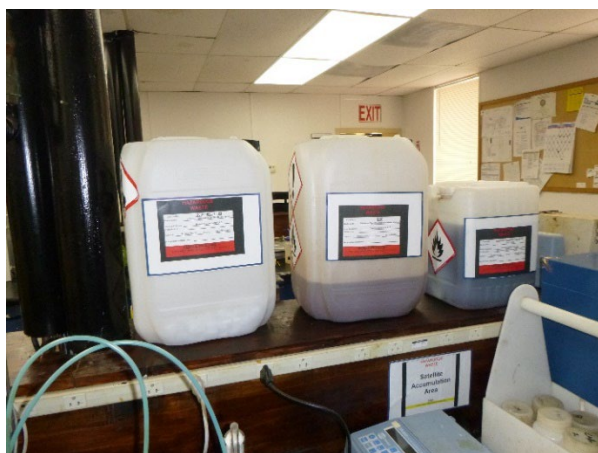
Photograph 2: Resin Plant Laboratory SAA.

| Location | Hazardous Waste stored; EPA ID numbers; Indication of the Hazards |
|---|---|
| Resin Plant Laboratory SAA (Photographs 2-3): | One 5-gallon of ethylene Glycol/isopropyl alcohol (IPA); D001; Ignitable<br>One 2.5-gallon container of hydranal; D001/D002; Ignitable and Corrosive<br>One 5-gallon container of NIR/GC; D001/U003/U122; Ignitable and Toxic<br>One 1-liter hydranal; D001; no indication of the hazards |

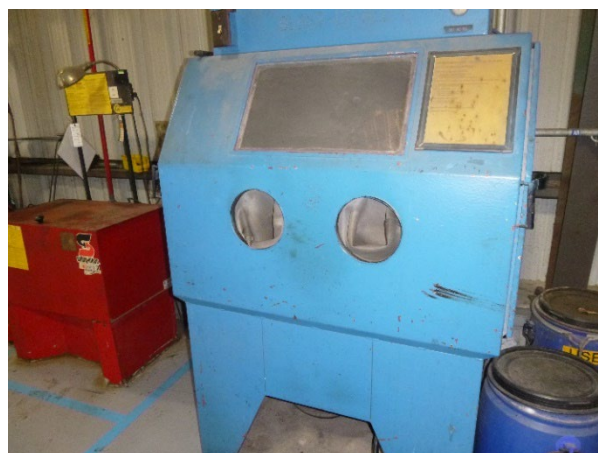
Photograph 4: Abrasive blasting unit and parts washer in the Maintenance Shop.

In addition to the waste listed above, the Maintenance Shop was operating a red parts washer which is refilled, as necessary, by Safety-Kleen (Photograph 4). Bakelite’s records show that this waste is managed as a hazardous waste for ignitability (D001). Facility personnel stated that solvent contaminated wipes are managed under the solvent-contaminated disposable wipe exclusion and disposed of in the trash.

Bakelite was operating a blue abrasive blasting unit in the maintenance area (Photograph 4). Facility personnel stated that this blasting unit was used sparingly on unpainted parts. There were no records of disposal or waste determination with the waste from this unit. Bakelite should ensure that a waste determination is conducted prior to disposal of this waste. This was an area of concern for the inspection team.

Pursuant to 15A NCAC 13A .0107(a) [40 C.F.R. § 262.11], a person who generates a solid waste, as defined in 15A NCAC 13A .0106 [40 C.F.R. § 261.2], must make an accurate determination as to whether that waste is a hazardous waste in order to ensure wastes are properly managed according to applicable RCRA regulations articulated in 15A NCAC 13A .0107(a) [40 C.F.R. § 262.11].

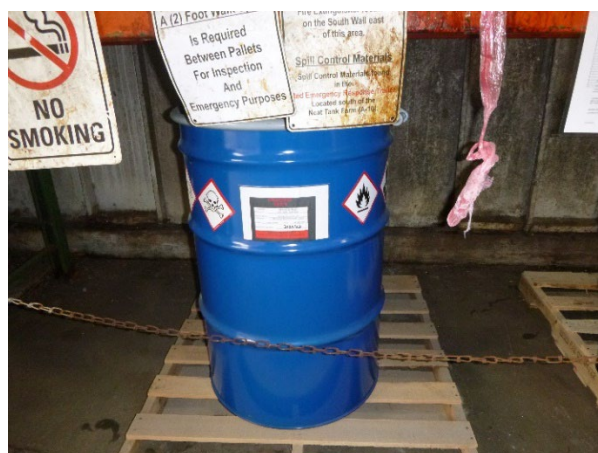
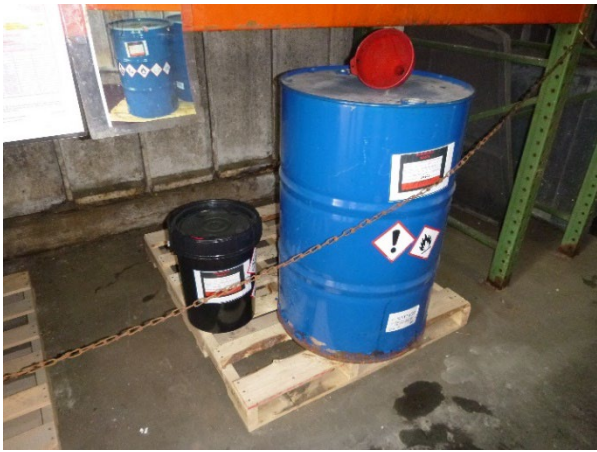
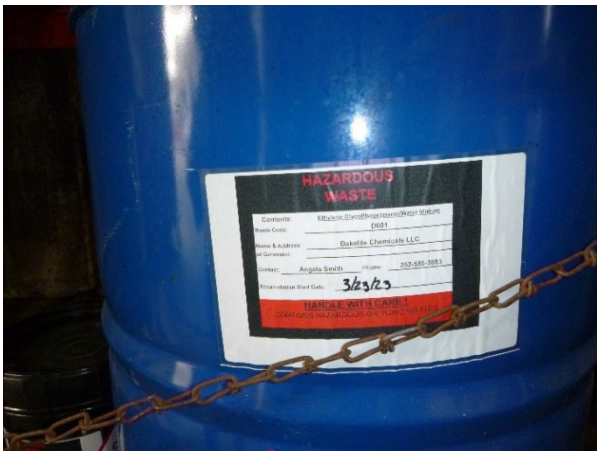
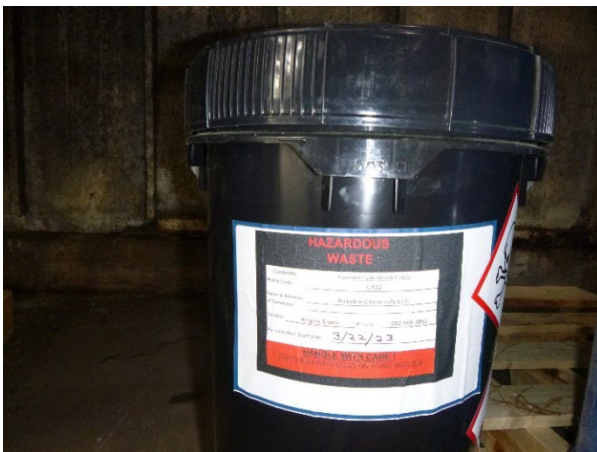
| Location | Size of Container; Hazardous Waste stored; EPA ID numbers; Indication of the Hazards; Accumulation Start Date (ASD) |
|---|---|
| K-1/K-5 CAA<br>(Photographs 5-8): | One 55-gallon blue metal container storing RPPC filter bags; D001/D005/D023/D035; Ignitable; with an ASD of March 22, 2023<br><br>One 55-gallon blue metal container storing ethylene glycol/Isopropanol/water mixture; D001; irritant and oxidizer; with an ASD of March 23, 2023:<br><br>One 5-gallon black plastic container storing formaldehyde beach filters; U122; acutely toxic; with an ASD of March 22, 2023. |

Each container in the CAAs was in good condition, closed, labeled with the words Hazardous Waste, labeled with the indication of the hazard, and marked with an ASD. Each CAA was marked with “No Smoking” and “Hazardous Waste Area” signs and had emergency spill information and emergency personnel contact information posted.

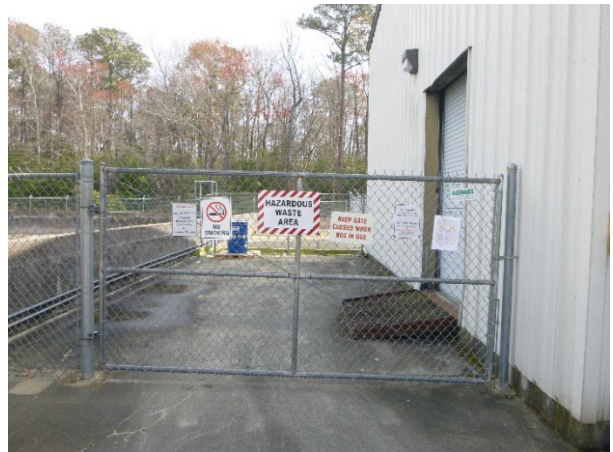
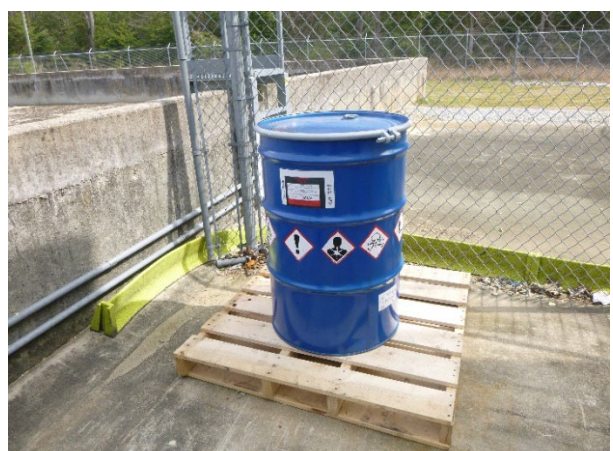
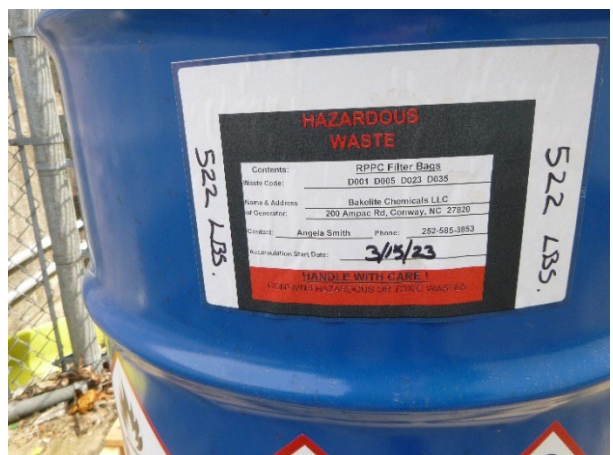
| Location | Size of Container; Hazardous Waste stored; EPA ID numbers; Indication of the Hazards; Accumulation Start Date (ASD) |
|---|---|
| MCCD<br>(Photographs 9-11): | One 55-gallon blue metal container storing RPPC filter Bags; D001/D005/D023/D035; irritant, health hazard, flammable, acutely |

| | toxic, oxidizer, and aquatic toxic indication of hazards; with an ASD of March 15, 2023. |

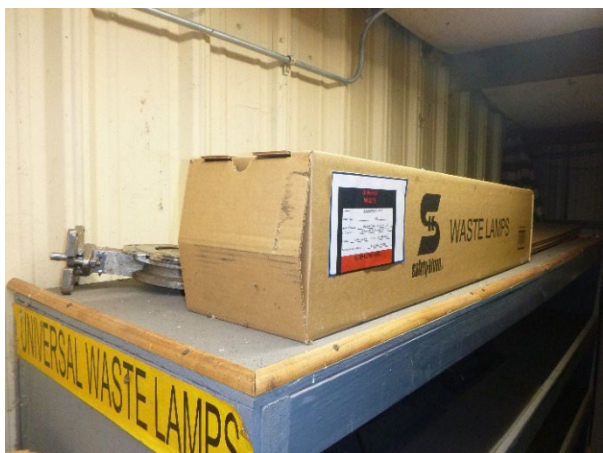
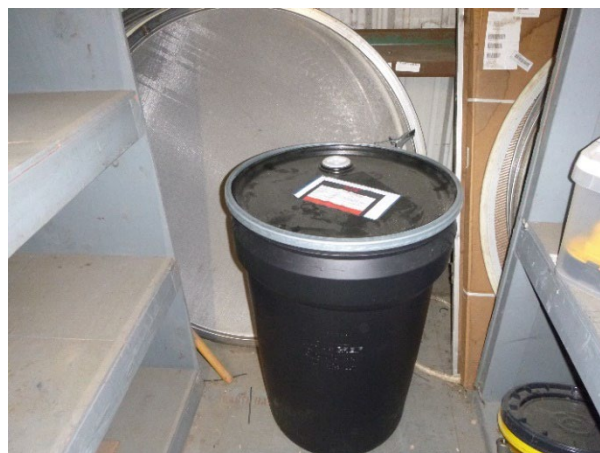
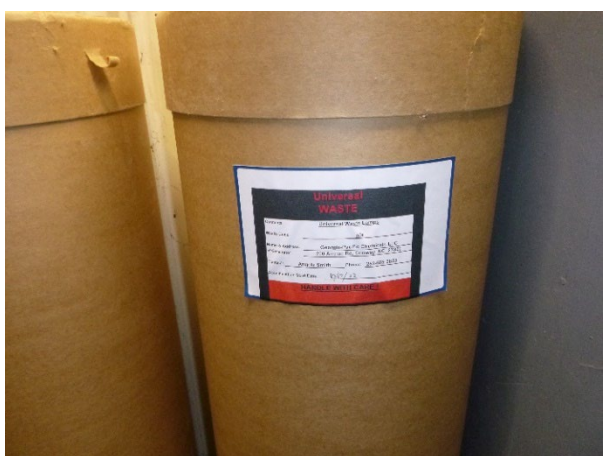
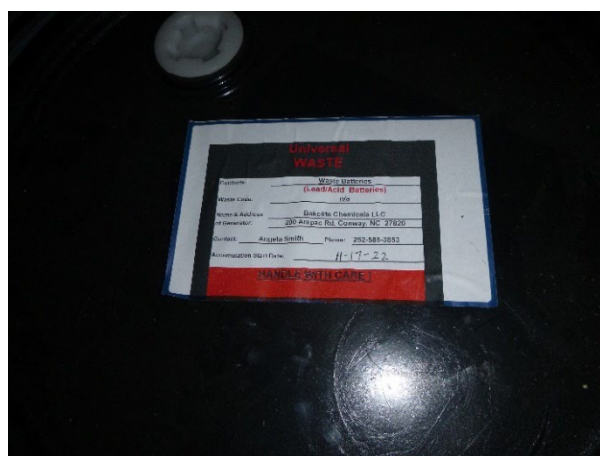
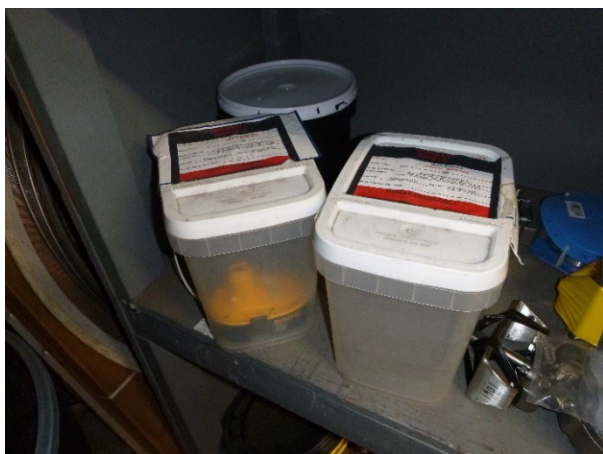
Bakelite manages universal waste (UW) batteries and lamps. Bakelite was storing its UW on the mezzanine level of the Maintenance Shop (Building 202). On the day of the inspection, Bakelite was storing one 1-gallon container of UW batteries that was labeled with an ASD of March 16, 2023; two 4-foot containers of UW lamps labeled with ASDs of September 28, 2022, and October 17, 2022, respectively; and one 30-gallon container of UW lead-acid batteries labeled with an ASD of November 17, 2022. These containers were in good condition, closed, and labeled as required (Photographs 12-16).

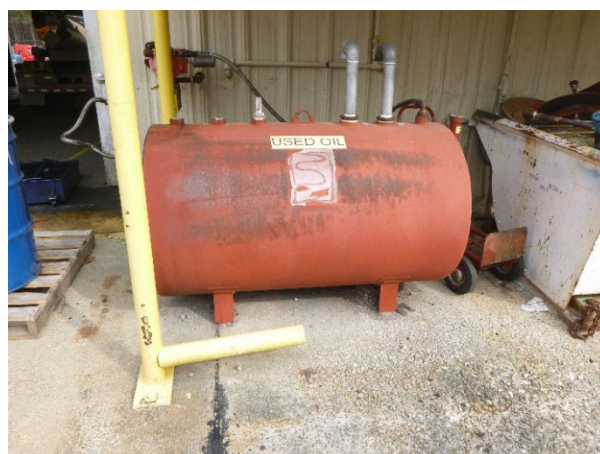
Photograph 17: Base CAA.

Bakelite was generating used oil in the Truck Shop. At the time of the inspection there was one 55-gallon container of used oil filters and one 270-gallon double-walled above-ground storage tank storing used oil. The container and tank were each labeled with the words “Used Oil” and in good condition. The inspection team observed drain pans accumulating used oil that were not labeled with the words “Used Oil”. Facility personnel labeled the drain pans during the inspection (Photograph 17).

team observed drain pans accumulating used oil that were not labeled with the words “Used Oil”. Facility personnel labeled the drain pans during the inspection (Photograph 17).

**Pursuant to 15A NCAC 13A .0118(c) [40 C.F.R. § 279.22(c)(1)], containers and aboveground tanks used to store used oil at generator facilities must be labeled or marked clearly with the words “Used Oil.”**

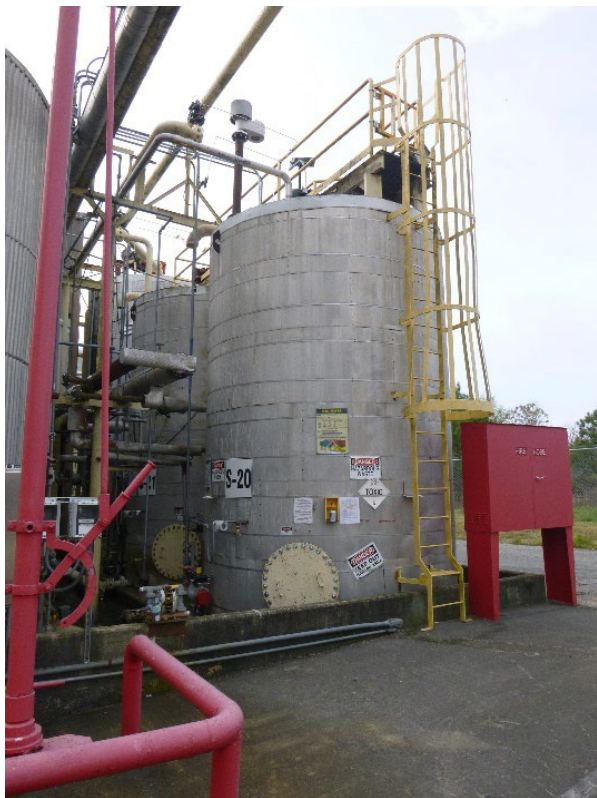
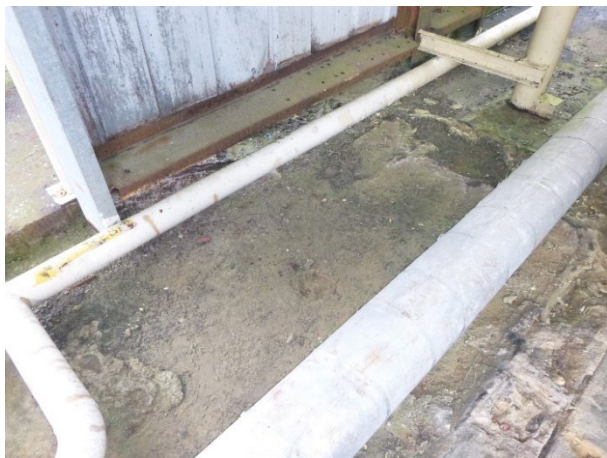
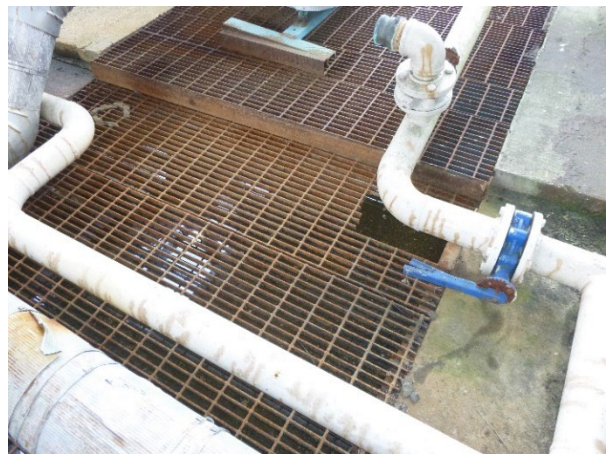
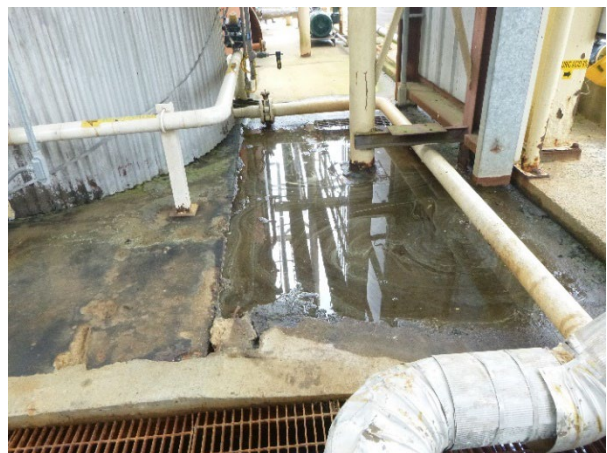
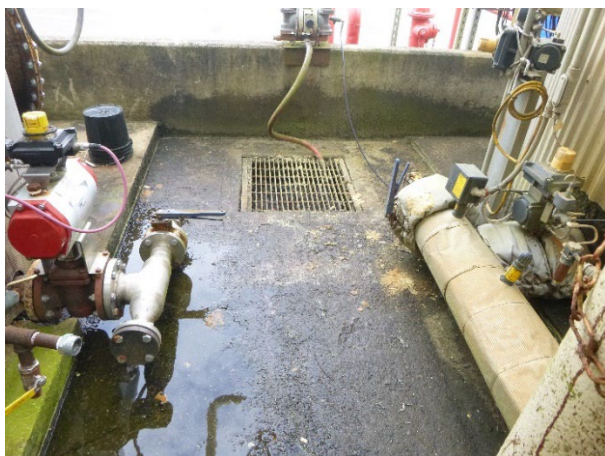
Bakelite manages hazardous waste distillate water in its A-7 tank farm, a tank system, in a hazardous waste tank labeled S-20. Bakelite began operating this hazardous waste tank with a 9,929-gallon capacity in 2010. S-20 is a vertical above-ground storage tank (Photographs 18-26). This tank has a fixed roof facility representatives stated in an inter-company memo dated November 16, 2020, that the vapor pressure when operating was 0.00636 psi and that the waste contains approximately 4.36% of Total Organics. This tank appears to be a Level 1 tank. Bakelite stated that the ancillary equipment to the tank is in secondary containment (double-walled piping). Bakelite conducts daily inspections of the tank and the piping leading to and from the tank. S-20 is marked with the words “Danger, Hazardous Waste”; with the EPA waste ID codes D005 (Barium) and D023 (o-Cresol); with a DOT placard to indicate the hazard of the contents; and with an ASD of March 21, 2023. Emergency information is posted on the tank. A fire extinguisher, spill kit, airhorn, and fire hydrant were available in the area. Bakelite employees utilize two-way radios or cell phones for communication.

The tank, S-20, is located in a tank farm with ten product tanks. These tanks share a concrete secondary containment area. The inspection team noted widespread residual spills of material and windblown debris covering the floor of the secondary containment. Facility personnel pointed out a remediated location in this secondary containment area that was identified by the NCDEQ representative during the previous inspection. This area was not located next to the hazardous waste tank, but it was within the secondary containment footprint. The secondary containment area has a central sump to collect spills and rainfall. This sump was full on the day of the inspection. The floor of the secondary containment area was obscured by pooled liquids, residual spills, and debris, so the inspection team was unable to determine if there were cracks or gaps in the secondary containment concrete. The debris and spilled material appeared to have been present for some time in the secondary containment; many areas of the concrete were green in color (Photographs 18-23). Subsequent to the inspection, Bakelite provided photos of the sump areas which appeared to be free of standing liquids but still appeared to be marred by debris and spilled material. Bakelite personnel stated that storm water from the secondary containment area is pumped into the process by using the manual pump located near the base of Tank S-20. Bakelite must demonstrate the hazardous waste determination used prior to reuse of this accumulated water in the process.

- The inspection team noted widespread residual spills of material and windblown debris covering the floor of the secondary containment of Tank S-20.

- The inspection team was unable to determine if there were cracks or gaps in the secondary containment concrete due to debris and accumulated liquids.

**Pursuant to 15A NCAC 13A .0107(a) [40 C.F.R. § 262.17(a)(2)], which incorporates Pursuant to 15A NCAC 13A .0110(j) [40 C.F.R. § 265.193(c)(4)] and is a condition of the LQG Permit Exemption, a generator accumulating hazardous waste in a tank system must at a minimum provide secondary containment systems that are sloped or otherwise designed or operated to drain and remove liquids resulting from leaks, spills, or precipitation. Spilled or leaked waste and accumulated precipitation must be removed from the secondary containment system within 24 hours, or in as timely a manner as is possible to prevent harm to human health or the environment, if removal of the released waste or accumulated precipitation cannot be accomplished within 24 hours.**

**Pursuant to 15A NCAC 13A .0107(a) [40 C.F.R. § 262.17(a)(2)], which incorporates to 15A NCAC 13A .0110(j) [40 C.F.R. § 265.193(e)(1)(iii)] and is a condition of the LQG Permit Exemption, the external liner system of a secondary containment system that is provided by a generator for a tank system that is accumulating hazardous waste must be free of cracks or gaps.**

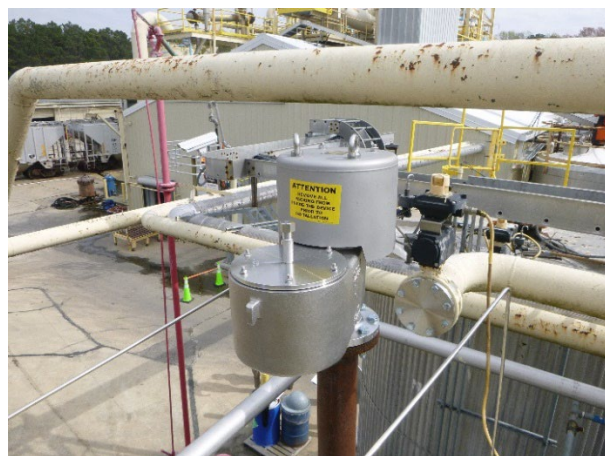
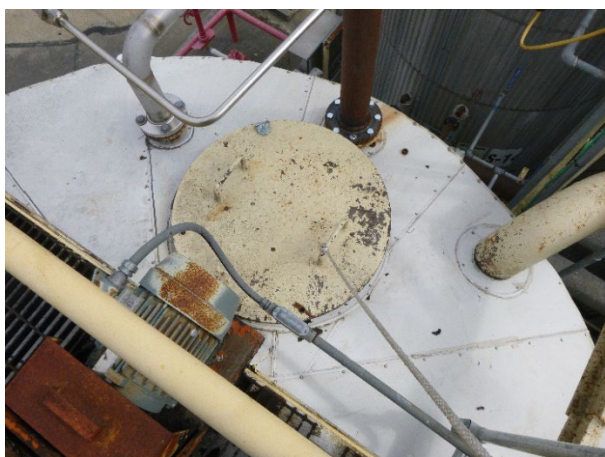
The inspection team inspected the top of Tank S-20 (Photographs 24-26). The manway on top of the tank was covered by a metal cover with two handles. Although the cover is designed to be affixed to the manway opening using four bolts, only one of the bolt holes was equipped with a bolt on the day of the inspection; the other three were not (Photographs 24-25). The inspectors observed a rope tied to one of the cover handles and to the railing on top of Tank S-20. This closure device was also not closed as designed because the metal cover was larger than the opening and did not appear to be the correct size to fit the manway (Photographs 24-25). The area on top of the tank was not inspected by the facility and the unsecured closure device was not in the closed position. In an email dated April 20, 2023, Emily Thompson provided documentation that this tank is subject to RCRA 265 Subpart CC, and stated *“The hazardous waste tank, S-20, at the Conway, NC Bakelite Chemical plant is not exempt from Subpart CC. I have attached documentation on assessments of Subparts AA, BB, and CC including how we meet the Level 1 tank control requirements for Subpart CC.”*

The area on top of Tank S-20 was not inspected by the facility and the unsecured closure device was not in the closed position. In an email dated April 20, 2023, Emily Thompson provided documentation that this tank is subject to RCRA 265 Subpart CC, and stated *"The hazardous waste tank, S-20, at the Conway, NC Bakelite Chemical plant is not exempt from Subpart CC. I have attached documentation on assessments of Subparts AA, BB, and CC including how we meet the Level 1 tank control requirements for Subpart CC."*

- The closure device on top of Tank S-20 was not closed.

**Pursuant to 15A NCAC 13A .0107(a) [40 C.F.R. § 262.17(a)(2)], which incorporates 15A NCAC 13A .0110(u) [40 C.F.R. § 265.1085(c)(2)(iii)(A)] and is a condition of the LQG Permit Exemption, a generator controlling air pollutant emissions from a tank using Tank Level 1 controls shall equip the tank with a fixed roof designed so that each opening in the fixed roof, and any manifold system associated with the fixed roof shall be equipped with a closure device designed to operate such that when the closure device is secured in the closed position there are no visible cracks, holes, gaps or other open spaces in the closure device or between the perimeter of the opening and the closure device.**

**Pursuant to 15A NCAC 13A .0107(a) [40 C.F.R. § 262.17(a)(2)], which incorporates 15A NCAC 13A .0110 [40 C.F.R. § 265.1085(c)(4)(i) and (iii)] and is a condition of the LQG Permit Exemption, the owner or operator controlling air pollutant emissions from a tank using Tank Level 1 controls shall visually inspect the fixed roof and its closure devices to check for defects that could result in air pollutant emissions. Defects include, but are not limited to, visible cracks, holes, or gaps in the roof sections or between the roof and the tank wall; broken, cracked, or otherwise damaged seals or gaskets on closure devices; and broken or missing hatches, access covers, caps, or other closure devices. In the event that a defect is detected, the owner or operator shall repair the defect in accordance with the requirements of paragraph (k) of this section.**

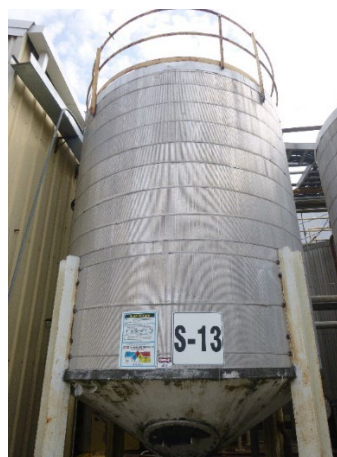
Photograph 27: Tank S-13.

Bakelite utilizes Tank 13 (Photograph 27) to store sodium hydroxide process tank cleaning solution, which is used to clean process tanks until the material is spent. When the material can no longer be used for its intended purpose, Bakelite must make a hazardous waste determination on the solid waste in this tank. Bakelite has historically determined that this waste is hazardous when generated. At that time, this tank would be subject to regulations under 40 CFR Subpart J. Bakelite most recently shipped this waste as hazardous waste D002, on January 23, 2023. In an email dated March 24, 2023, Angie Smith responded to a question from Andrea Stermer by stating that the sodium hydroxide remains in use until it is removed by the transporter. This is an area of concern for the inspection team.

Pursuant to 15A NCAC 13A .0107(a) [40 C.F.R. § 262.11], a person who generates a solid waste, as defined in 15A NCAC 13A .0106 [40 C.F.R. § 261.2], must make an accurate determination as to whether that waste is a hazardous waste in order to ensure wastes are properly managed according to applicable RCRA regulations articulated in 15A NCAC 13A .0107(a) [40 C.F.R. § 262.11].

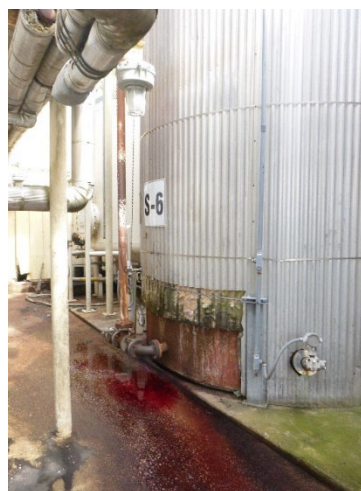
Photograph 28: Tank S-6.

The inspection team noted pooled red liquids near K-5 and Tank S-6 during the inspection (Photograph 28). Facility personnel stated that the red liquid was non-hazardous. Pursuant to 15A NCAC 13A .0107(a) [40 C.F.R. § 262.11(f)], an LQG must maintain records supporting its hazardous waste determinations. Bakelite must provide documentation on the waste determination for these liquids accumulating on the concrete near K-5 reactor and Tank S-6.
