**Compliance Evaluation Inspection Report**

Tutwiler POTW  
Highway 49 East,  
Tutwiler, MS 38963  
NPDES Permit Number: MS0025054

**Project No. CV-MS0025054-02222024**

**COMPLIANCE EVALUATION INSPECTION REPORT**  
Tutwiler MS WWTP, Project # CV-MS0025054-02222024

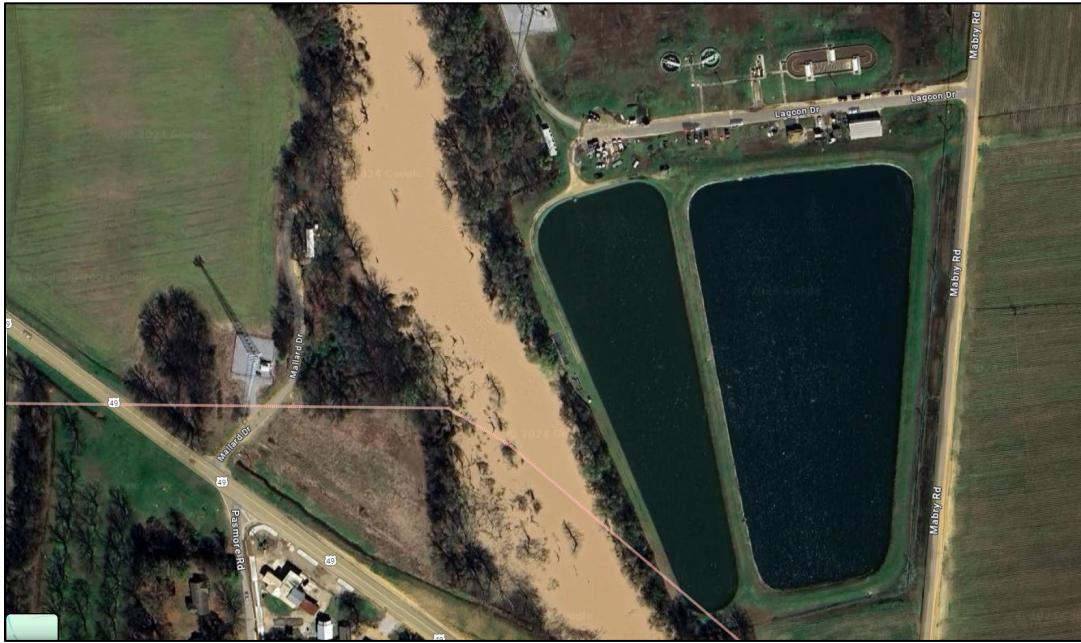
Figure 1. Aerial View of Facility (Oxidation ditch and secondary clarifiers to the north; lagoons to the south). Hopson Bayou to the west.

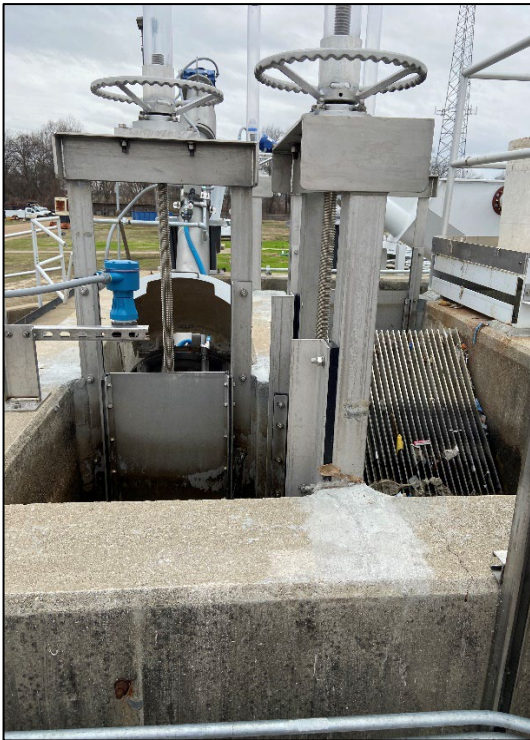
- The bar screen noted at the headworks was clean and operational (Photo 1).
- The auger grit removal system was out of service (Photo 1).
- Flow was low enough that the bypass to the lagoons was not being used at the time of inspection (Photo 2).

Photo 1: Auger (Left) and bar screen (Right).

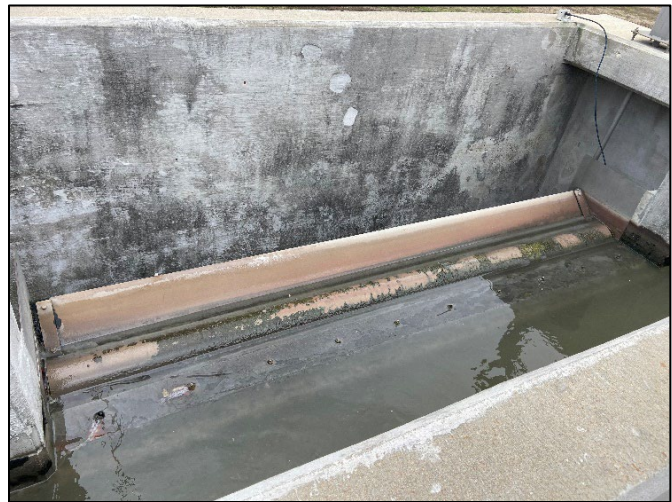
Photo 2: Bypass weir to lagoons at headworks.

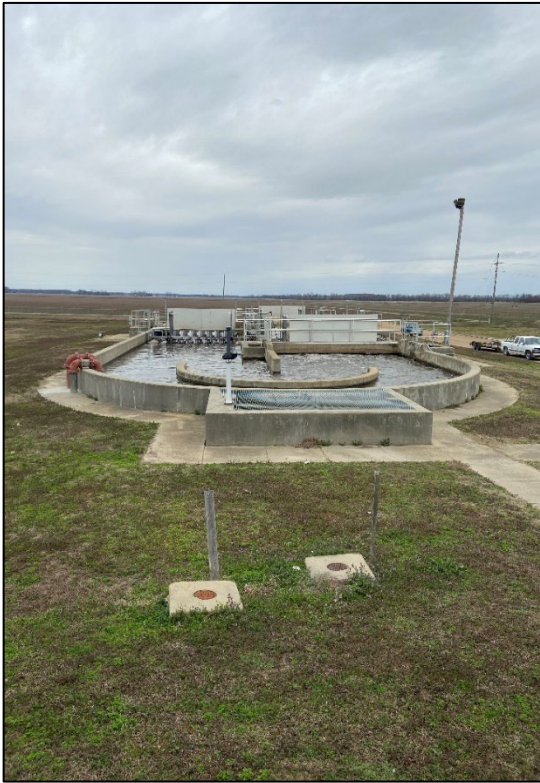
- Oxidation ditch appeared well maintained with the CWSRF rehabilitation. However, Mr. Newman noted that the brushes were now tied to a Dissolved Oxygen meter and he has concerns about solids settling when the 3<sup>rd</sup> brush is not in use (Photo 3).

Photo 3: Oxidation ditch.

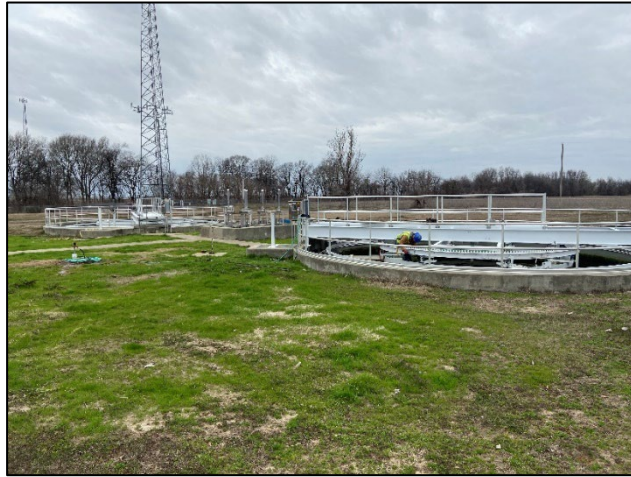
- One of the two secondary clarifiers is out of service for rehabilitation (photo 4).
- One of the return activated sludge pumps was noted to be out of service.

Photo 4: Clarifiers (clarifier on right out of service).

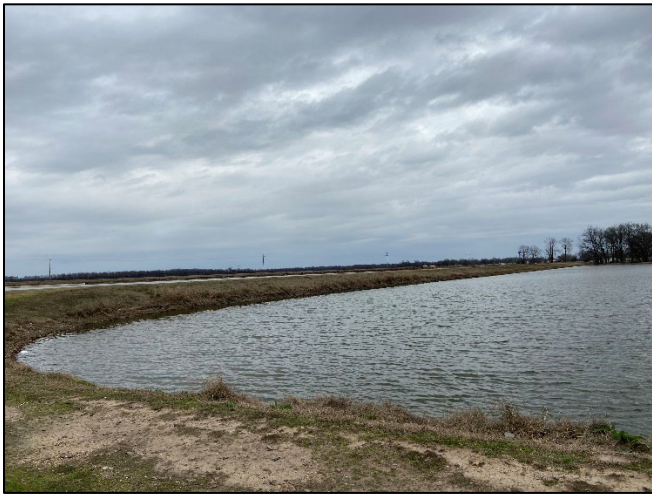
- The old lagoons were necessary to schedule and complete the construction going on in the oxidation ditch and clarifiers (Photo 5).
- The newly constructed chlorine contact chamber was in use (Photo 6). While Mr. Newman mentioned that the upgrade shortened detention time, the Chlorine and Sulfur Dioxide (de-chlorination) are now dosed based upon effluent flow.

Photo 5: Lagoons.

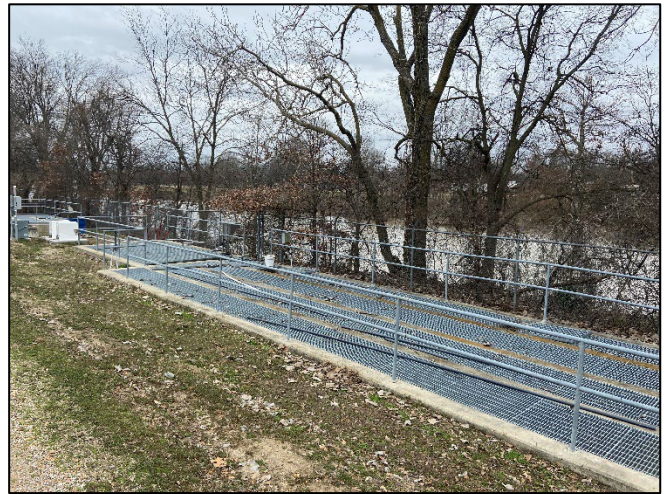
Photo 6: New chlorine contact chamber.
