E. I. DU PONT DE NEMOURS & COMPANY  
INCORPORATED  
ENGINEERING DEPARTMENT  
WILMINGTON, DELAWARE

REPORT OF  
COMPANY PROTECTIVE COATINGS  
AND THERMAL INSULATION MEETING

April 28-29, 1976  
New Castle, Delaware and Chambers Works

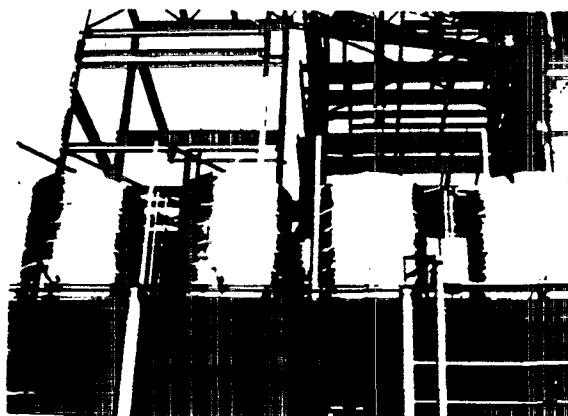
FIGURE 4 - Thermacon System - Tank Insulation Complete

Figure 4 shows the completed vessels, which the plant project engineer reports have no damage through the 32-mil weather barrier in three years of operation. There are some sizeable dents from construction work in the immediate area, but no punctures. The engineer stated he believes this insulation system will be maintenance free for the life of the vessel. We certainly can't say that about our conventional insulation systems.

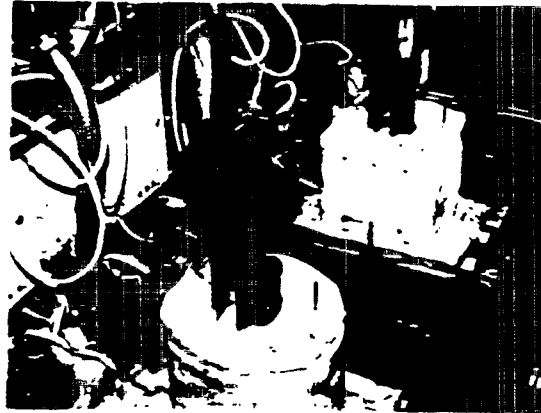
FIGURE 7 - Modified Turbine Blankets  
on Polymer Grid Units

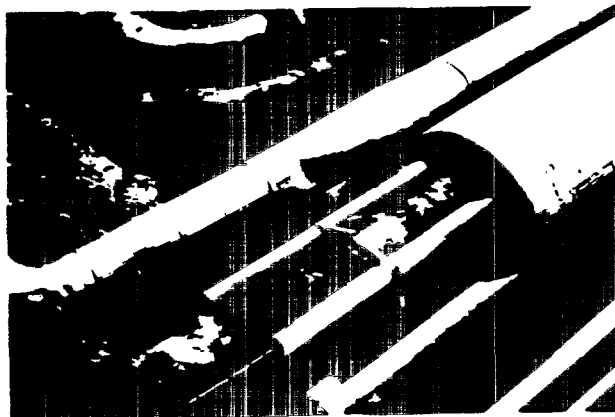
FIGURE 8 - Blocking Used to Stabilize  
Oversize Insulation
