# **RCRA Inspection Report**

Everlube Products  
100 Cooper Circle  
Peachtree City, Georgia 30269

EPA ID#: GA0002265148

Primary NAICS: 325510 – Paint and Coating Manufacturing

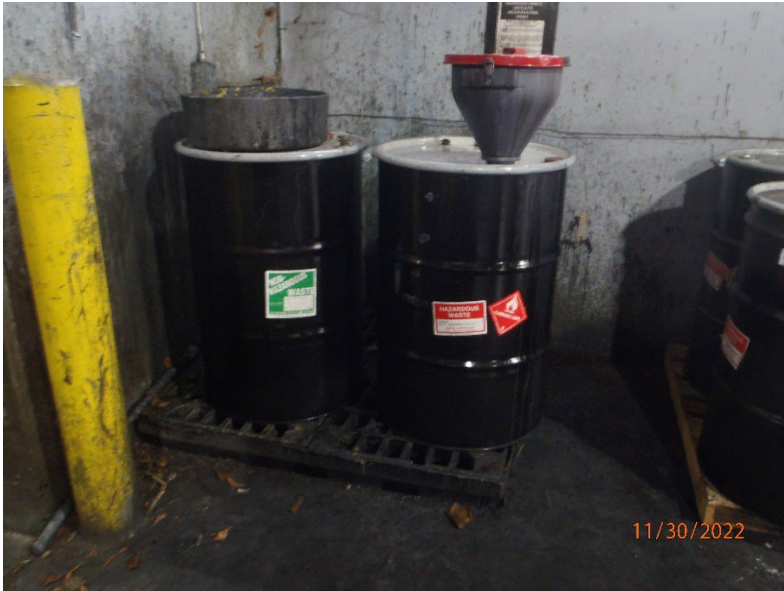
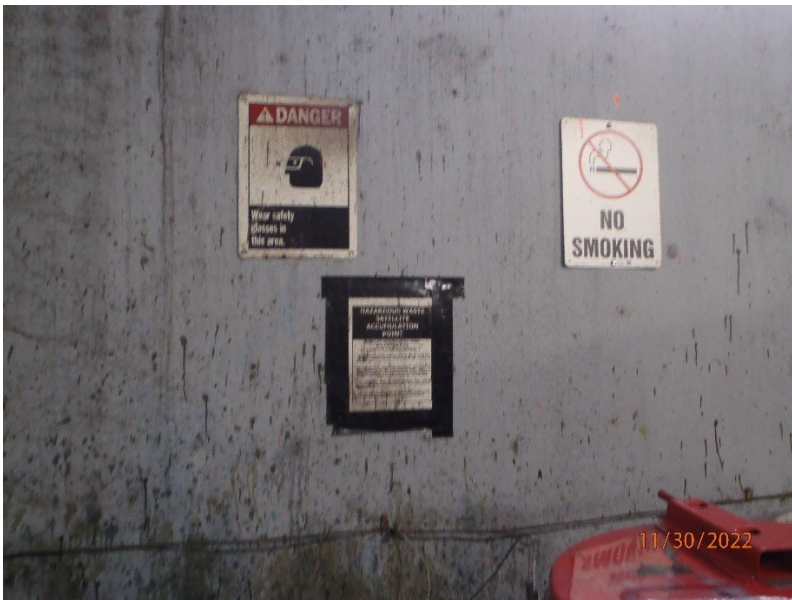
The inspection team inspected a Satellite Accumulation Area (SSA) near the Central Accumulation Area (CAA) (Figure 1 and 2). The SAA had a 55-gallon container of non-hazardous waste and one 55-gallon container of hazardous waste. The containers were closed. The HW container was labeled as hazardous waste and had the indication of hazards label. This SAA container was not at or near the point of generation and was not under the control of the operator of the process who generated the waste.

Figure 1: PB300002.JPG – Satellite Accumulation Area Near Central Accumulation Area (90-Day Area)

Figure 2: PB300005.JPG – Signage for Satellite Accumulation Area (SAA)

**Pursuant to Ga. Comp. R. and Regs. 391-3-11-.08(1) [40 C.F.R. § 262.15(a)], a container holding hazardous waste in a Satellite accumulation area must be at or**

**near the point of generation of the waste and under the control of the operator of the process generating the waste.**

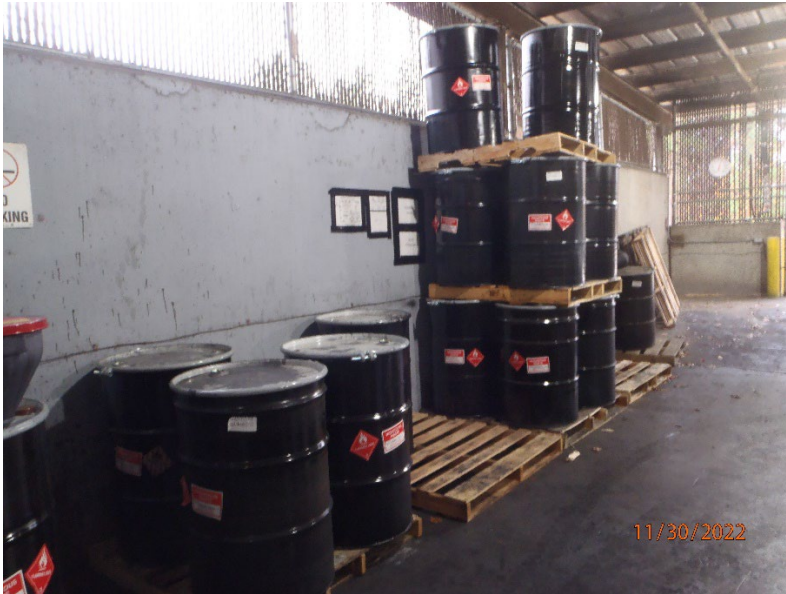
The CAA has thirteen 55-gallon containers of hazardous waste (HW), one 55-gallon container of non-hazardous waste, two 55-gallon product containers, and one 55-gallon container of used oil. In one area ten of the 55-gallon HW containers were on pallets, and the pallets were stacked three high (Figure 3). The hazardous waste containers were labeled with hazardous waste labels and hazard labeling. Some dates on the hazardous waste containers were difficult to read.

Figure 3: PB300004.JPG – Central Accumulation Area (CAA)/90-Day Area

**Pursuant to Ga. Comp. R. and Regs. 391-3-11-.08(1) [40 C.F.R. § 262.17(a)(5)(i)(C)], which is a condition of the LQG Permit Exemption, a generator must mark or label its containers with the following: the date upon which each period of accumulation begins clearly visible for inspection on each container.**

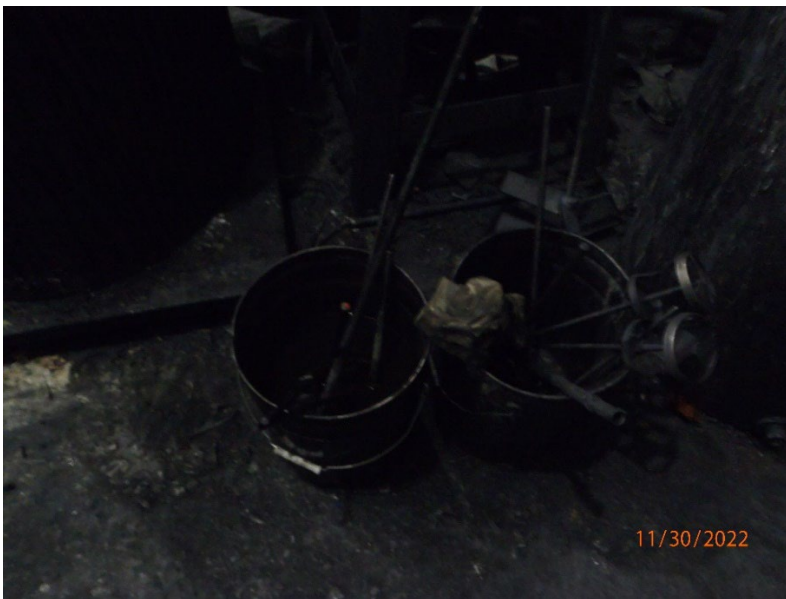
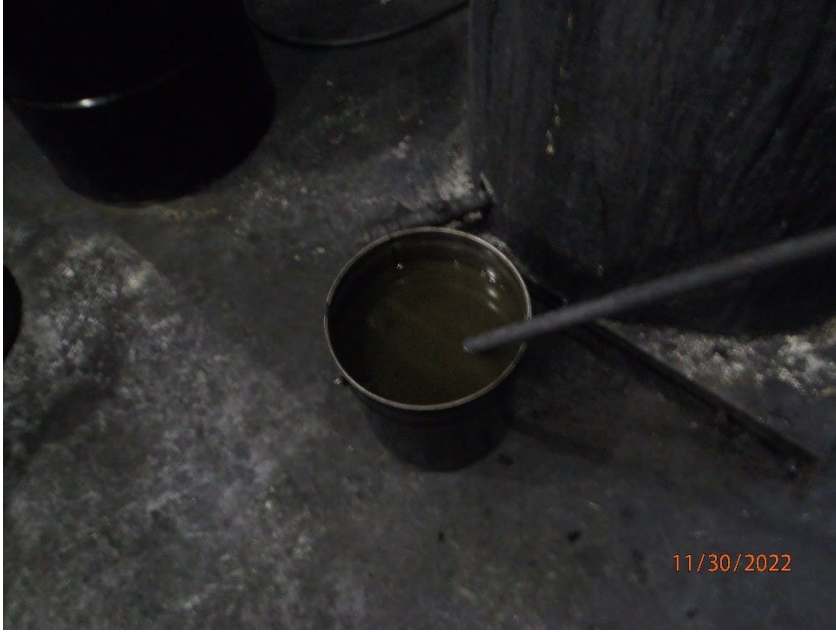
Steve Mills explained the process used for the cleaning of production containers after use. The inspection team observed three open unlabeled 5-gallon buckets with solvent with tools soaking in them for cleaning (Figures 4 and 5). The inspection team recommended considering a parts washer.

Figure 4: PB300008.JPG – 5-Gallon Buckets with Part Soaking

Figure 5: PB300009.JPG – 5-Gallon Bucket with Tool Soaking in Solvent

**Pursuant to Ga. Comp. R. and Regs. 391-3-11-.08(1) [40 C.F.R. § 262.15(a)(4)], which is a condition of the SAA Permit Exemption, a generator is required to keep containers of hazardous waste closed at all times during accumulation, except when adding, removing, or consolidating waste; or when temporary venting of a container is necessary for the proper operation of equipment, or to prevent dangerous situations, such as build-up of extreme pressure.**

**Pursuant to Ga. Comp. R. and Regs. 391-3-11-.08(1) [40 C.F.R. § 262.15(a)(5)(i) and (ii)], a container holding hazardous waste in a Satellite accumulation area must be marked or labeled with the words “Hazardous Waste” and an indication of the hazards of the contents.**

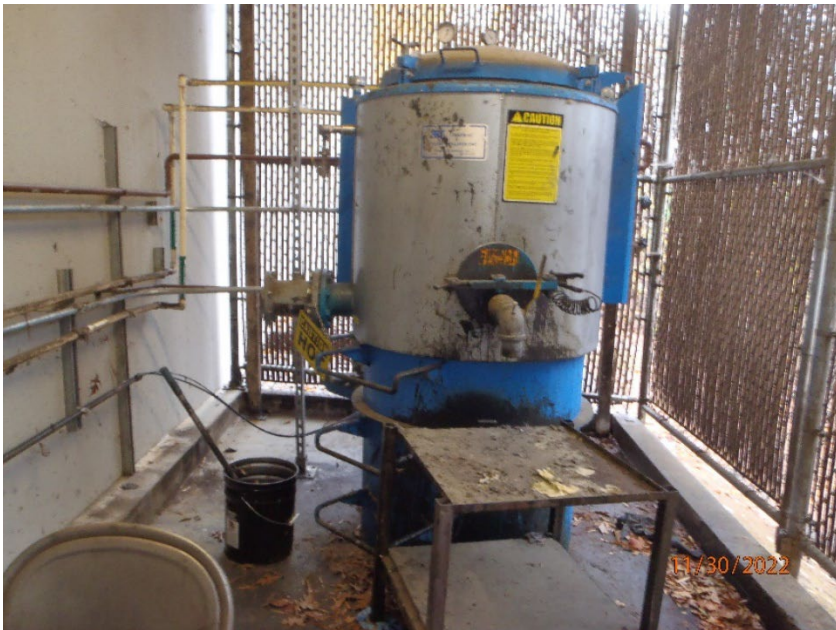
The inspection team observed the solvent recycling unit (Figure 6). The operation of the unit was explained. MEK solvent is being reclaimed. The unit is run one (1) to two (2) times per week. No leaks or spills were observed, but two open unlabeled partially full 5-gallon buckets of waste were present. One bucket was half full of trash and the other bucket was half full of sludge (Figure 7). The inspection team observed the solvent feed drums inside of the production area (Figures 8 and 9). The solvent feed drums were not closed but had a gap around the hose leaving the container. The drums of recovered solvent were not labeled.

Figure 6: PB300013.JPG – Solvent Recycling Still Unit

**Pursuant to Ga. Comp. R. and Regs. 391-3-11-.08(1) [40 C.F.R. § 262.15(a)(4)], which is a condition of the SAA Permit Exemption, a generator is required to keep containers of hazardous waste closed at all times during accumulation, except when adding, removing, or consolidating waste; or when temporary venting of a container is necessary for the proper operation of equipment, or to prevent dangerous situations, such as build-up of extreme pressure.**

**Pursuant to Ga. Comp. R. and Regs. 391-3-11-.08(1) [40 C.F.R. § 262.15(a)(5)(i) and (ii)], a container holding hazardous waste in a Satellite accumulation area must be marked or labeled with the words “Hazardous Waste” and an indication of the hazards of the contents.**

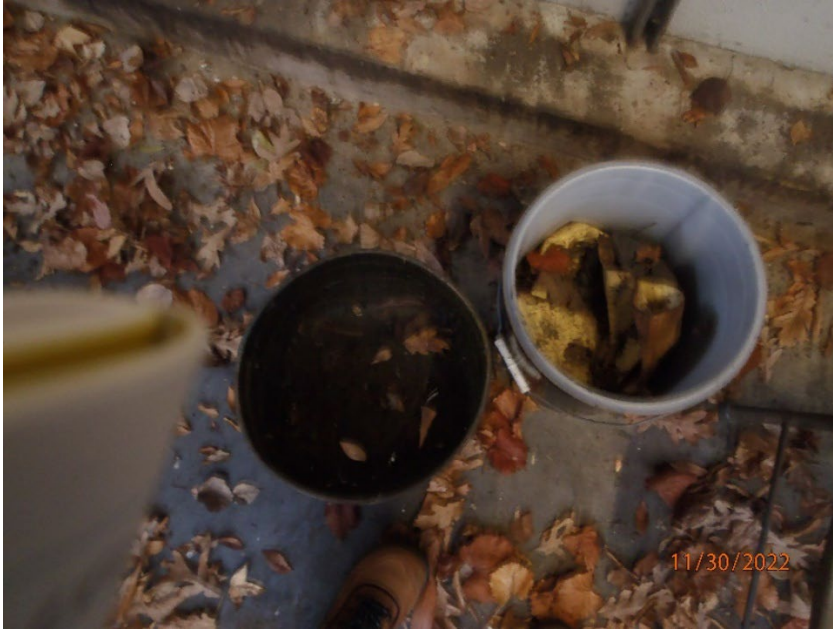
Figure 7: PB300014.JPG – Two 5-Gallon Buckets

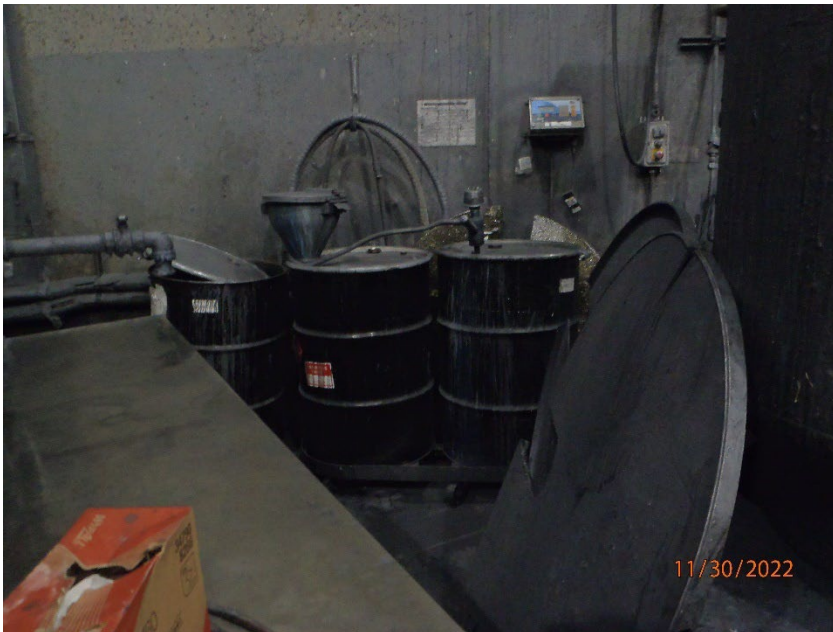
Figure 8: PB300016.JPG – Solvent Feed to Solvent Recovery Still

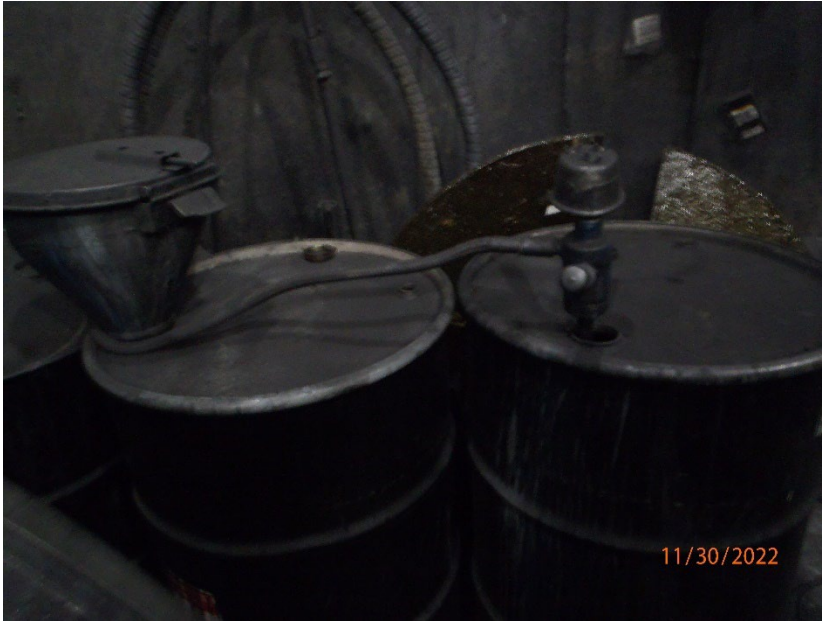
Figure 9: PB300017.JPG – 2<sup>nd</sup> Photograph of Feed to Solvent Recovery Unit

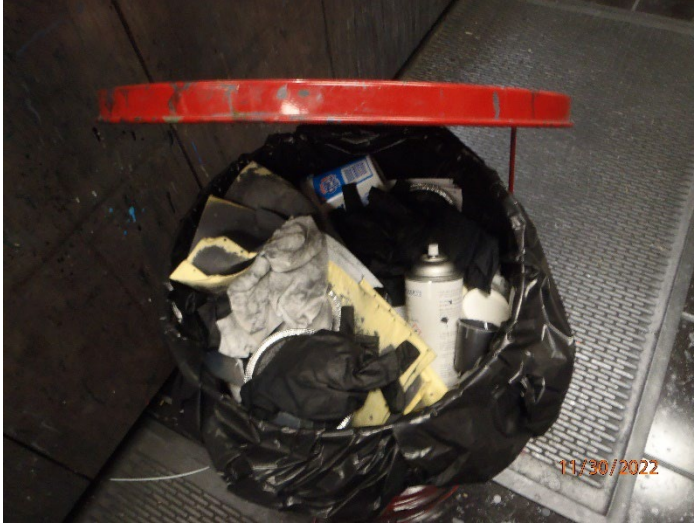
The Research and Development Lab (R&D Lab) and Quality Assurance Lab (QA Lab) were inspected. The labs were generating hazardous waste but did not have a SAA. Solvent contaminated rags and used gloves are placed in red, 30-gallon containers (Figure 11). These containers were not being managed as hazardous waste or as a contaminated solvent wipes container. The containers were not labeled as “hazardous waste” or to the hazards of the contents. The QA Lab told the inspection team that they were disposing of the contents of the container in the dumpster.

Figure 11: PB300019.JPG – Waste Materials in Laboratory

**Pursuant to Ga. Comp. R. and Regs. 391-3-11-.08(1) [40 C.F.R. § 262.11], a person who generates a solid waste, as defined in Ga. Comp. R. and Regs. 391-3-11-.07(1) [40 C.F.R. § 261.2], must make an accurate determination at the point of generation as to whether that waste is a hazardous waste in order to ensure wastes are properly managed according to applicable RCRA regulations.**

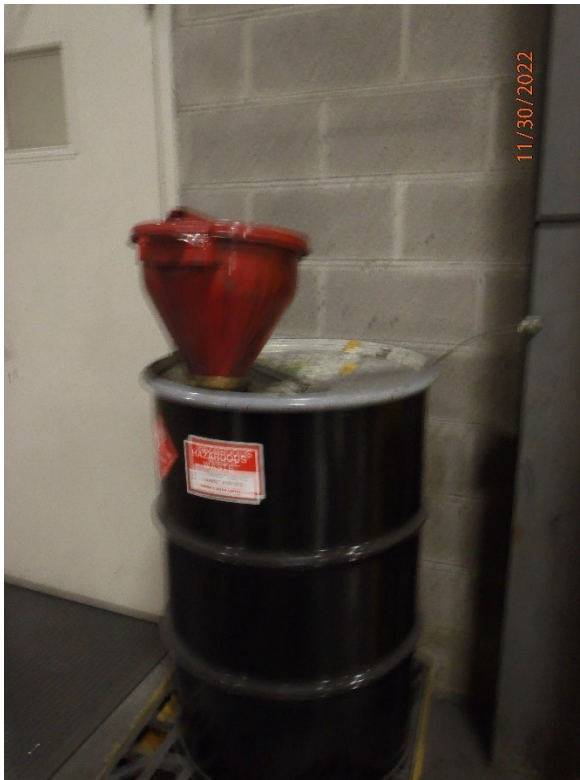
Figure 12: PB300021.JPG – Hazardous Waste SAA 55-Gallon Container

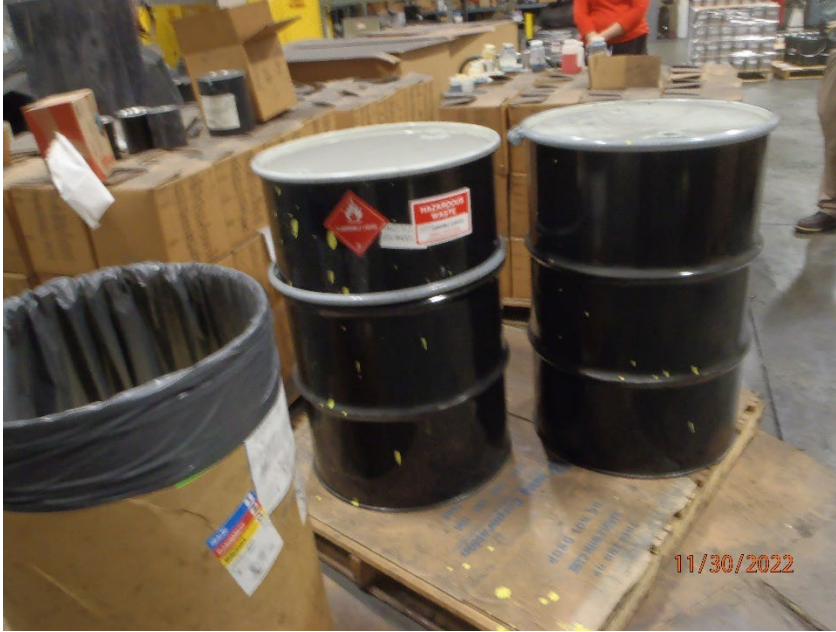
The area holding sample retains was inspected. Sample retains are retained for a minimum of two years. No releases or compromised containers were observed (Figure 14). A SAA HW container was observed in this area (Figure 13). This area of the plant is not normally staffed except when processing the old containers. This SAA was not under the control of an operator. The containers were closed and was properly labeled and marked. Some of the sample retains in this area were over three years old. Sample retains from 2017, 2018, and 2019 were observed.

Figure 13: PB300018 – 55-Gallon SAA Container Near Sample Retains

**Pursuant to Ga. Comp. R. and Regs. 391-3-11-.08(1) [40 C.F.R. § 262.15(a)], a container holding hazardous waste in a Satellite accumulation area must be at or near the point of generation of the waste and under the control of the operator of the process generating the waste.**

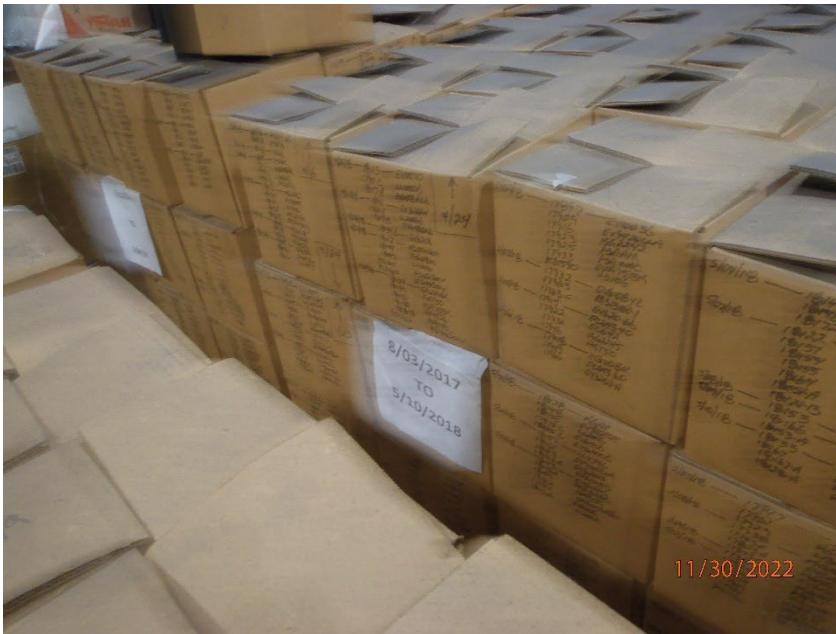
Figure 14: PB300027.JPG – Sample Retains Staged for Processing  
Containers are from 2017 and 2018

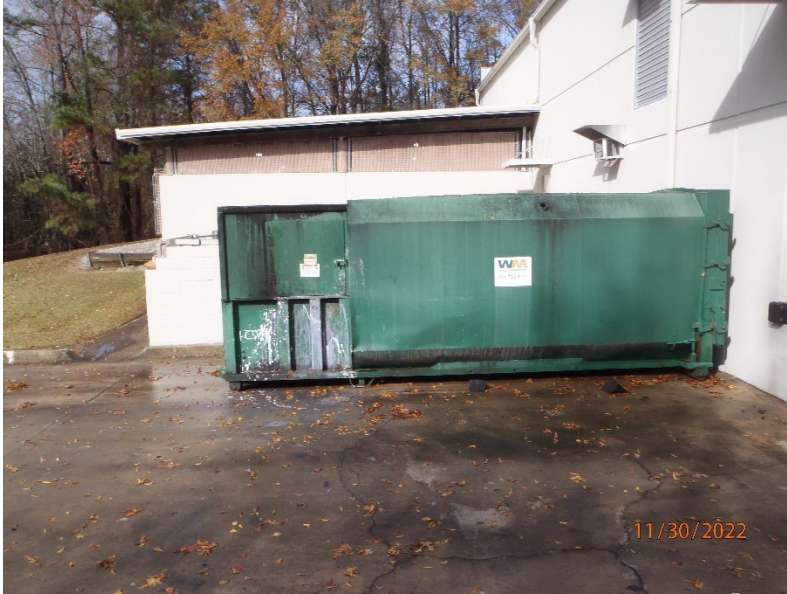
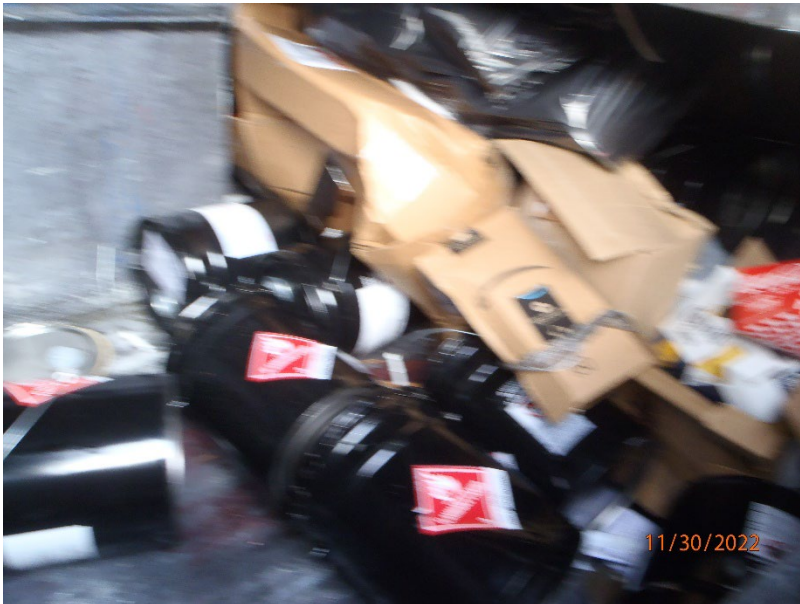
The last area inspected was the solid waste dumpster. The dumpster had paint & liquids spilled on and near it. There was a solvent odor inside the dumpster. According to the QA lab, solvent wipes and aerosol cans were being disposed of in the dumpster (Figures 15 and 16). No hazardous waste, free liquid, aerosol cans or solvent containing items should be disposed of in the dumpster.

Figure 15 – PB300030.JPG – Solid Waste Dumpster

Figure 16: PB300033.JPG – Wastes in the Solid Waste Container

**Pursuant to Ga. Comp. R. and Regs. 391-3-11-.08(1) [40 C.F.R. § 262.11], a person who generates a solid waste, as defined in Ga. Comp. R. and Regs. 391-3-11-.07(1) [40 C.F.R. § 261.2], must make an accurate determination at the point of generation as to whether that waste is a hazardous waste in order to ensure wastes are properly managed according to applicable RCRA regulations.**
