INSPECTION REPORT

| Statute(s)/Program(s) | Clean Water Act, NPDES, Stormwater – Industrial | | |
| Type of Inspection | Compliance Evaluation Inspection | | |
| Permittee Name | Cedar Poles, LLC | | |

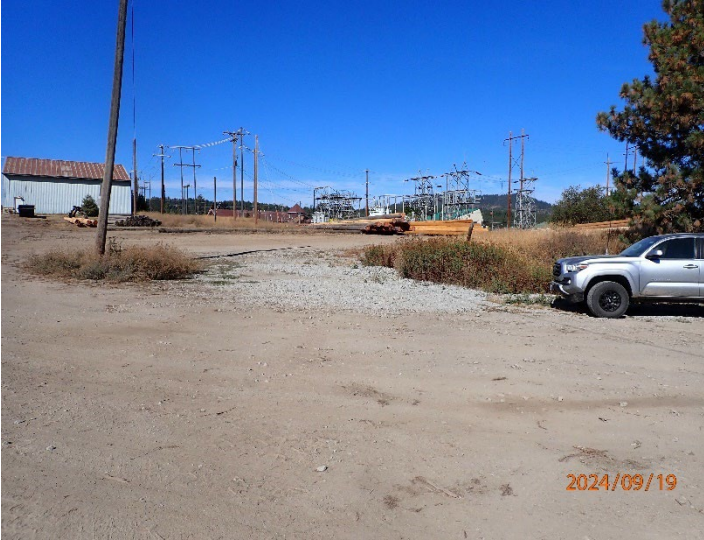
| During the site tour, I noticed that the dumpster near the shop was uncovered, and I did not observe the presence of a lid. |

| Photograph Log – Cedar Poles, LLC | |
|---|---|
| <p>Photo #:01 (P190211)</p> <p>Description: Facing west, photo of dumpster by shop without a lid, as well as gravel and vegetated buffer north of Outfall 001 in forefront of phot.</p> | <p>Photo #:02 (P190210)</p> <p>Description: Facing down, photo of the SWPPP map at the time of the inspection.</p> |

| <b>AOC:</b><br>At the time of the inspection, the facility had one dumpster without a lid. Post-inspection, the facility submitted a photo showing the dumpster with the lid closed. See Appendix II. |

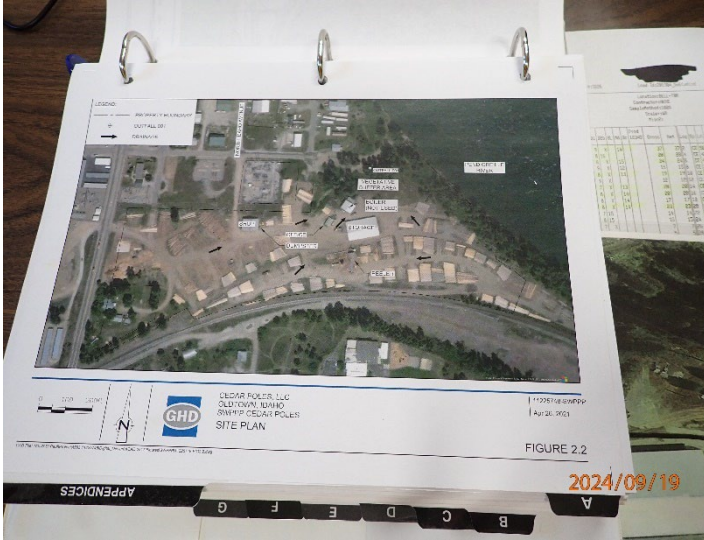
discharge evaluation were not in the Stormwater Pollution Prevention Plan (SWPPP). Additionally, the following items were missing from the SWPPP map: 1) size of the property in acres, 2) location of all stormwater control measures, 3) indication of whether the receiving water is impaired, 4) location of potential pollutant sources, 5) areas of Endangered Species Act- designated critical habitat for endangered or threatened species, and 6) locations of the following activities: loading/unloading areas, processing and storage areas, and immediate access roads and rail lines used or traveled by carriers of raw materials. I also observed that the SWPPP was not signed and dated. During the closing conference of the inspection, the Authorized Representative signed and dated the SWPPP. Post-inspection, the Facility provided documentation regarding employee training, as well as documentation on gravel delivery and installation/maintenance. See Appendix II.

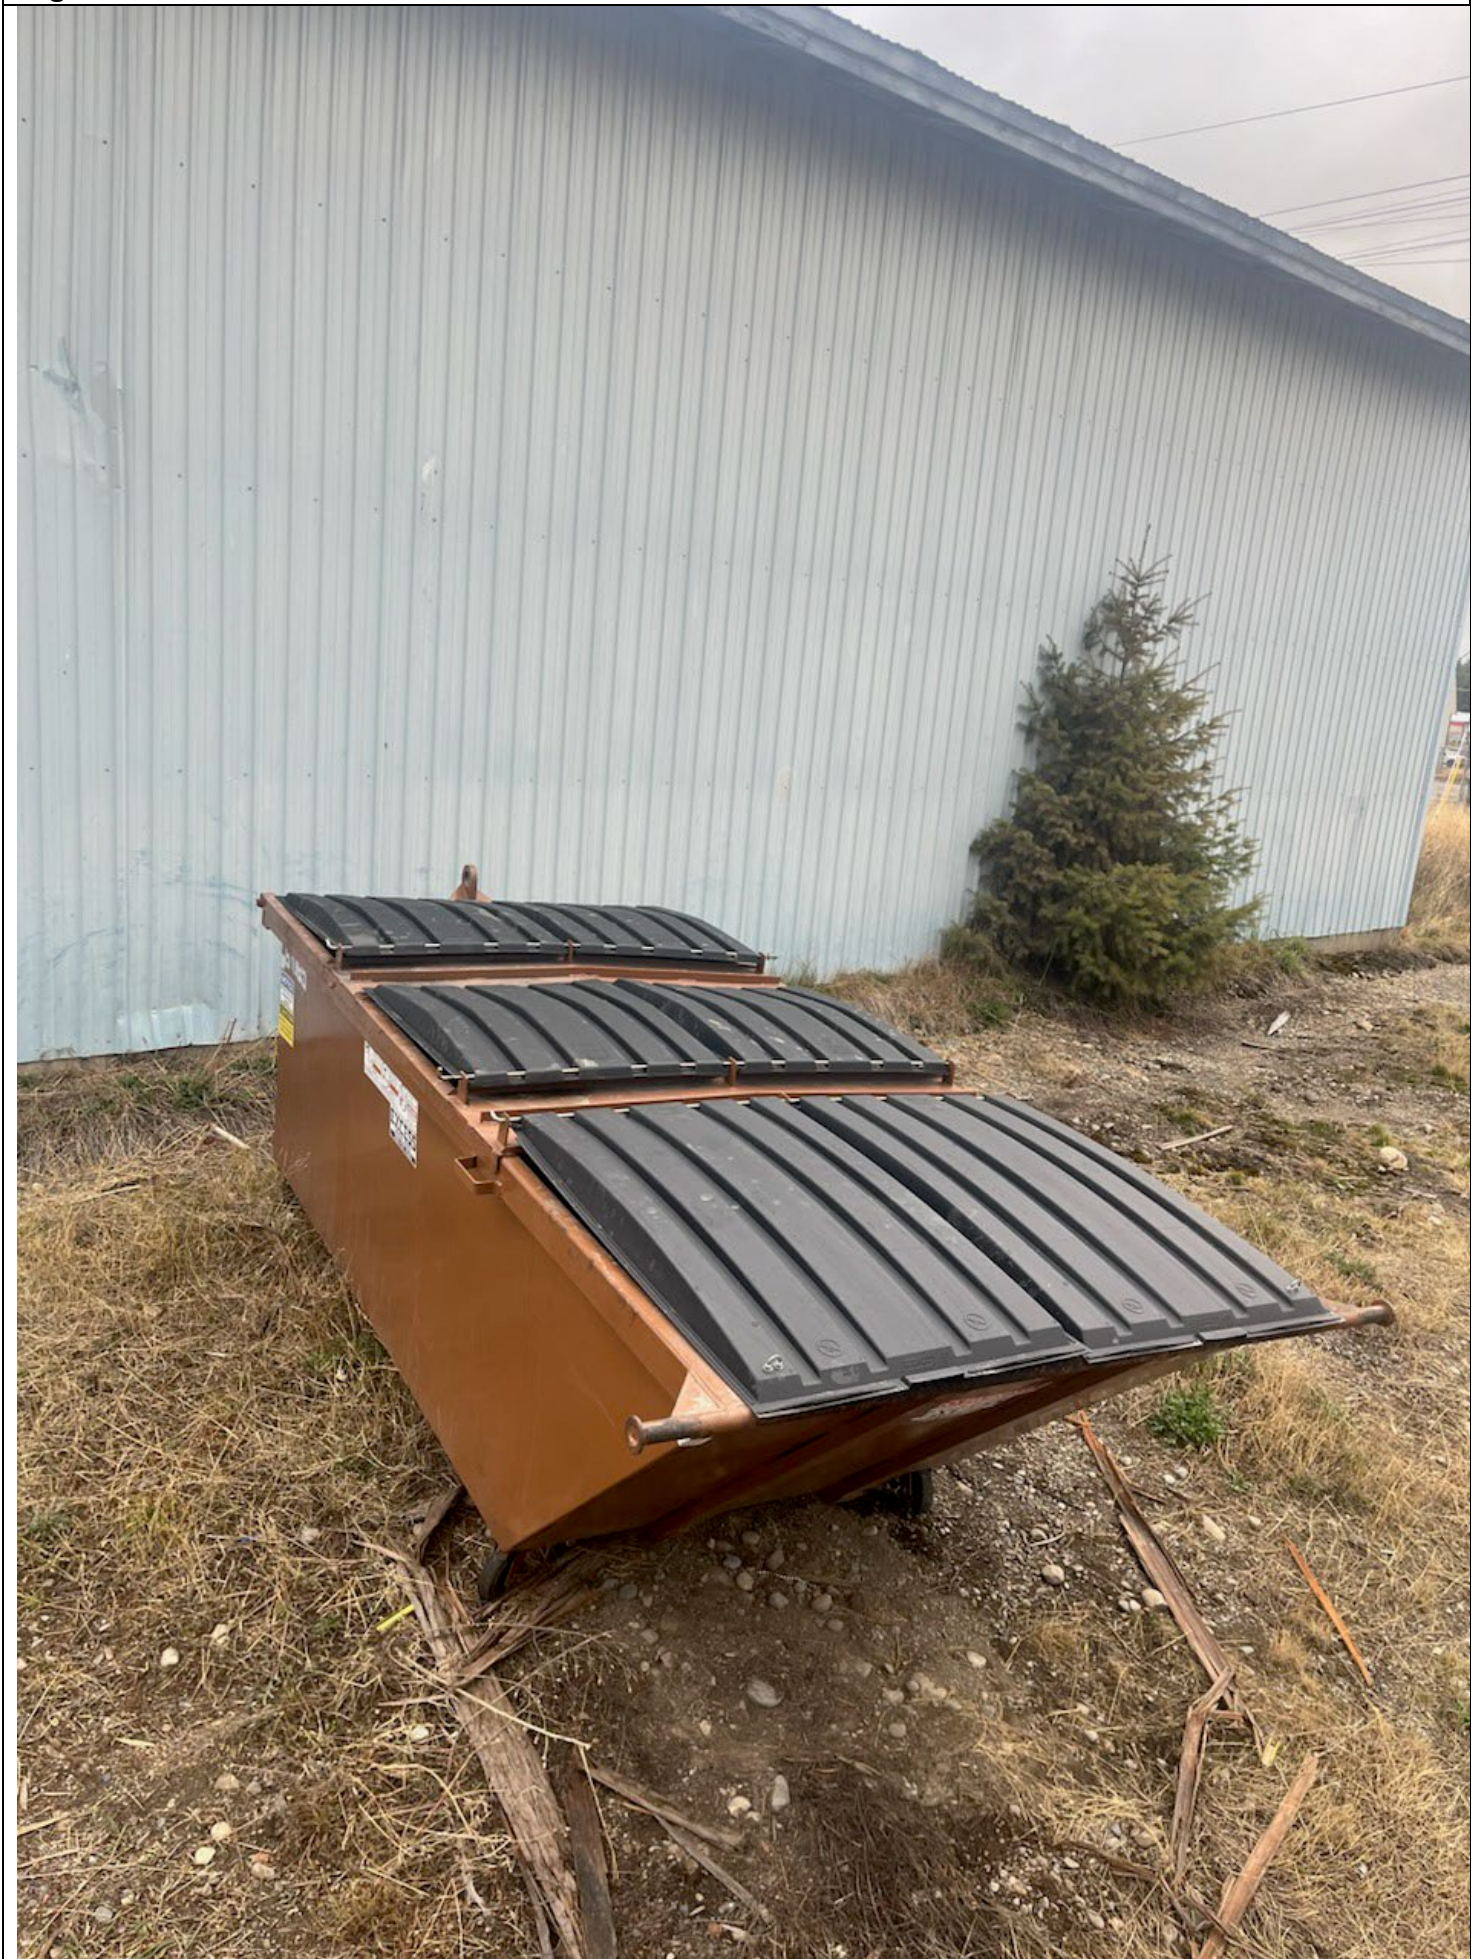
**Page 1 of 1**

**AOC Reference #: OBS-001 – Dumpster Lid near Shop.**
