Clean Water Act Section 404: Site Visit/Case Development

CWA 404 Inspection

Loubuildco, LLC

Tax parcel numbers 065-000-010-01-000 and 065-000-005-14-901 in the Municipality of Loíza, Puerto Rico

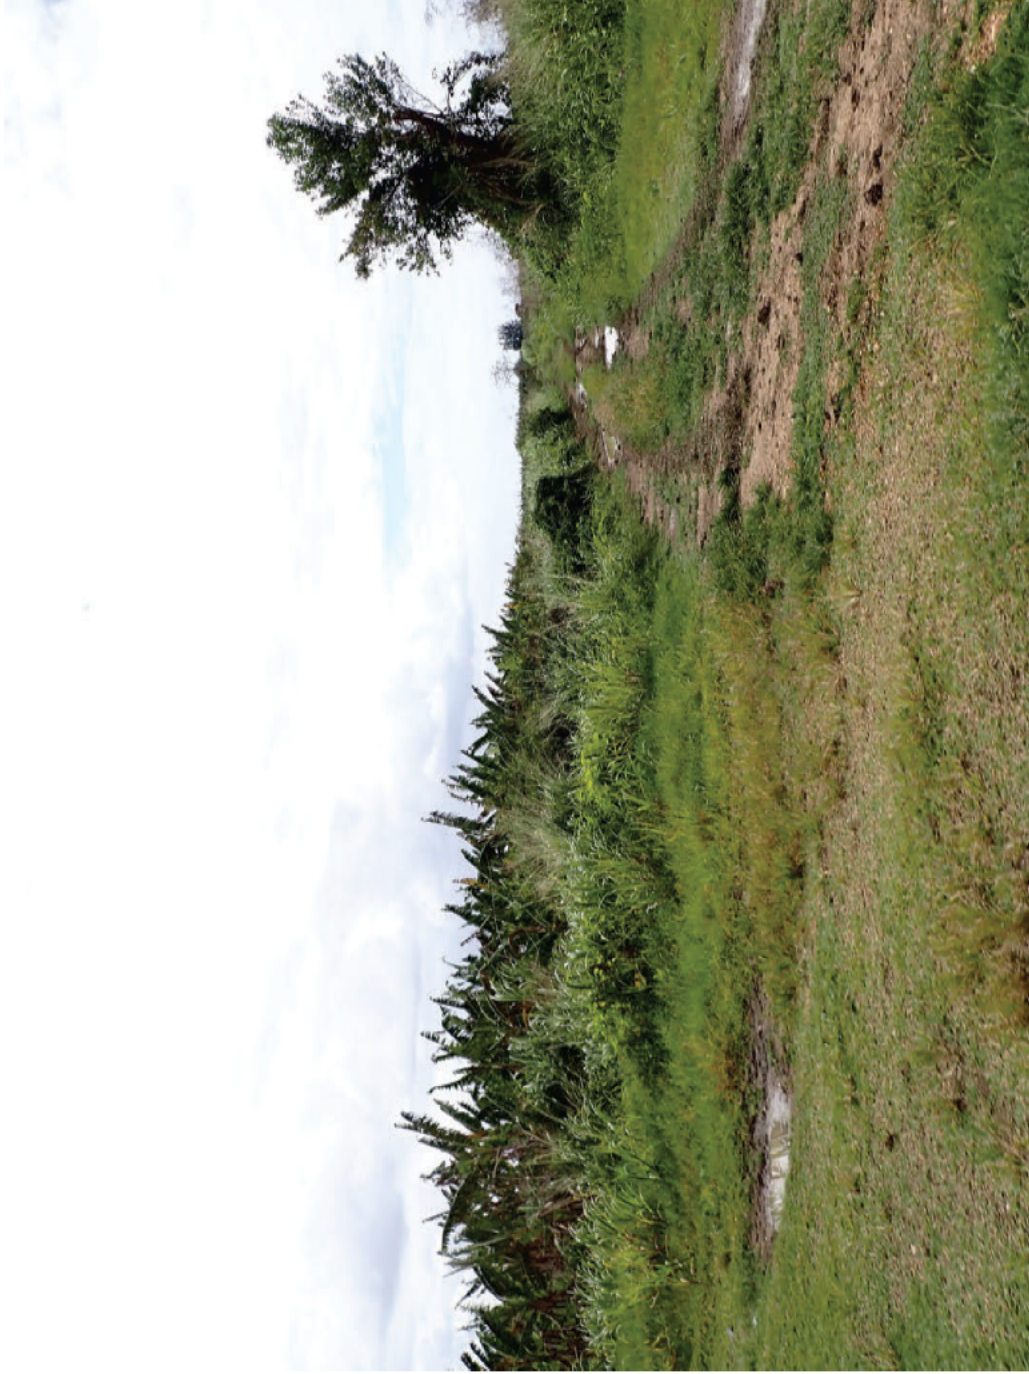
Date: April 6, 2022
Time: 2:26 PM
Photographer: Seika Robinson
Photo ID: P4060099

Description: Entrance of the site where EPA had met with Loubuildco, LLC.

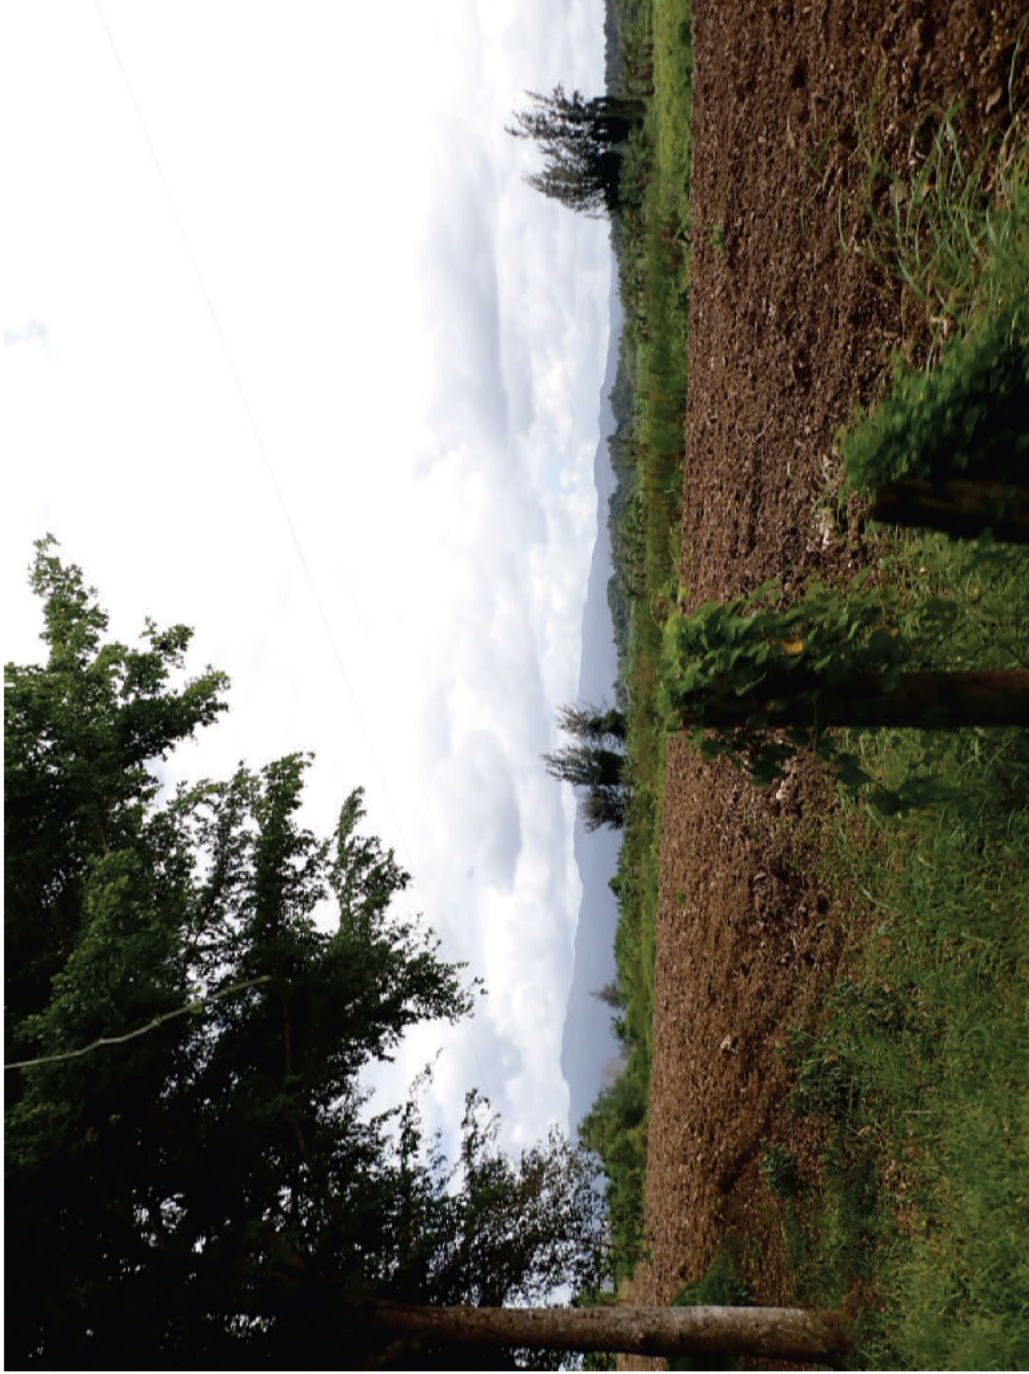
Photo ID: P4060092

Description: Vegetative land clearing alongside the entrance road.

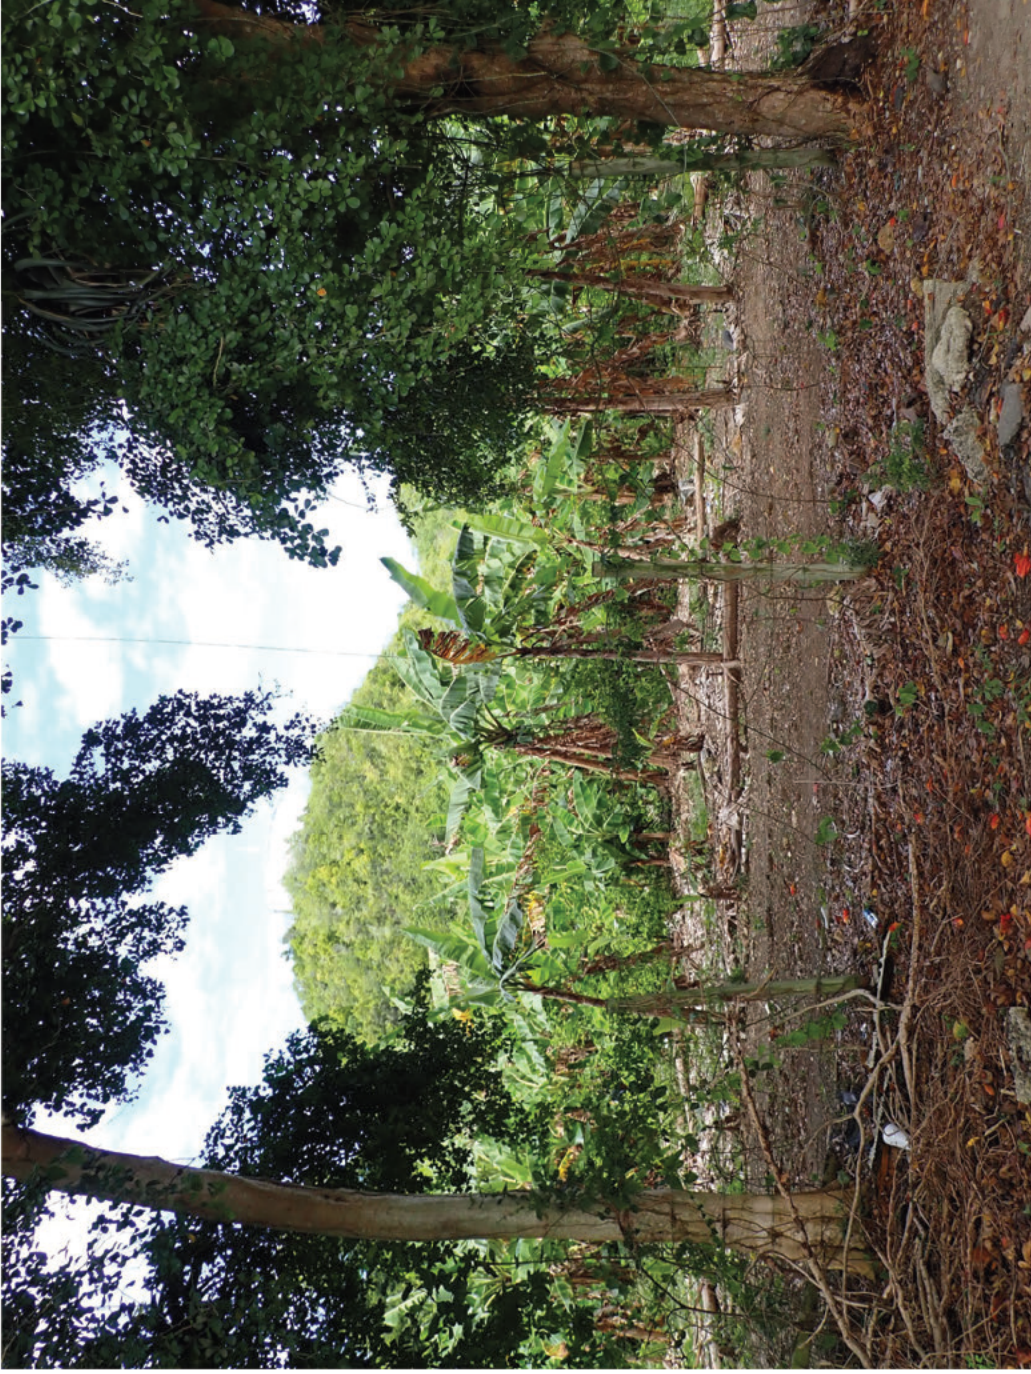
Photo ID: P4060094

Description: Mature plantain trees for agricultural farming.

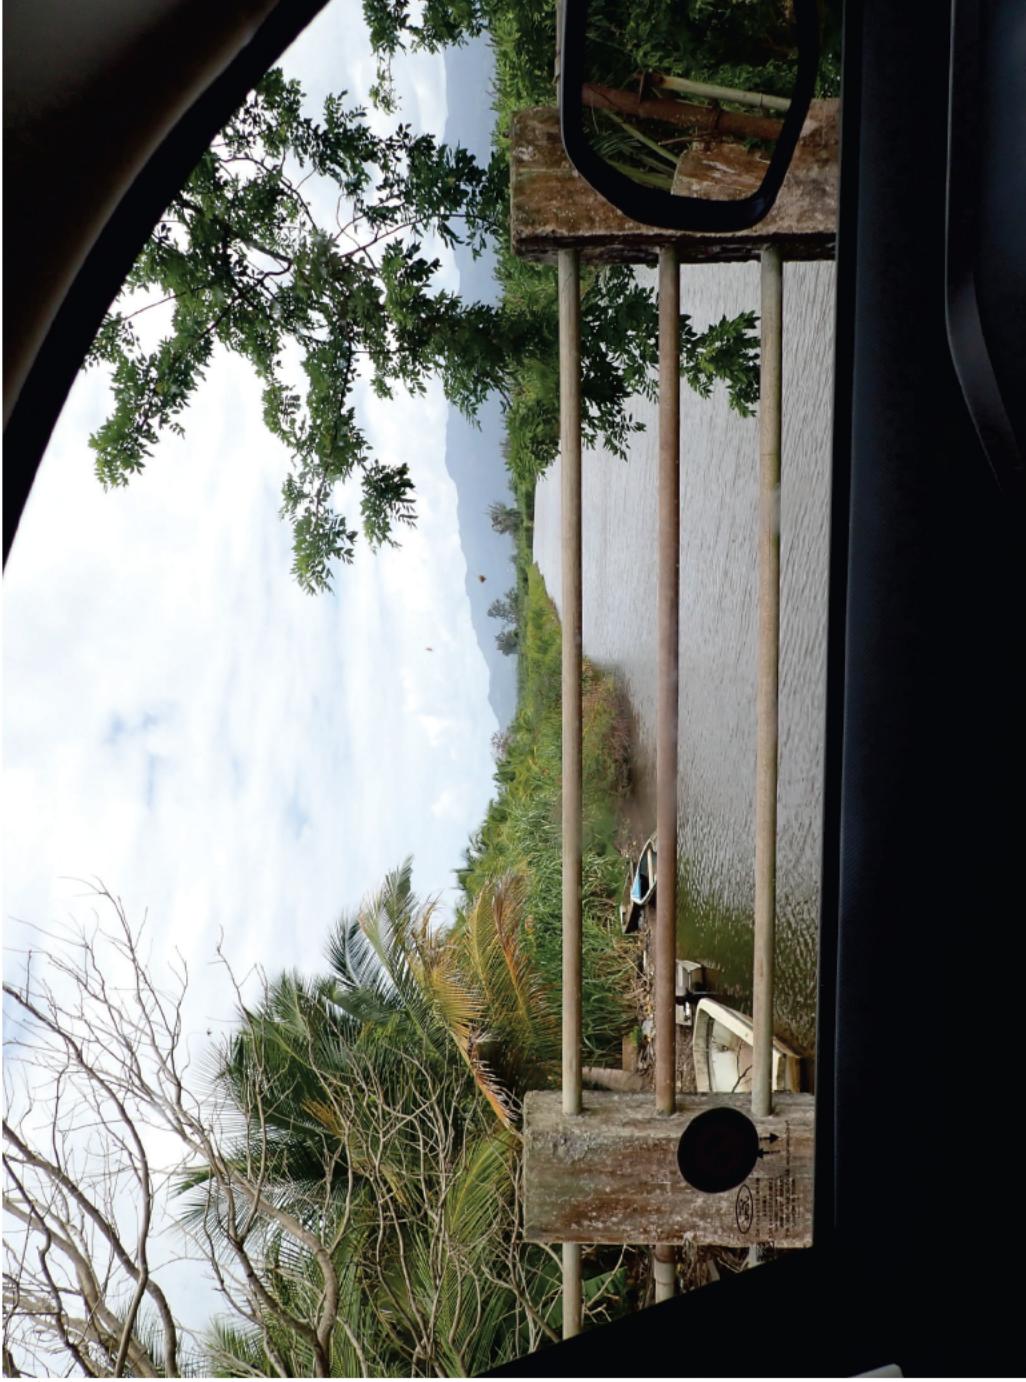
Photo ID: P4060097

Description: The Caño Gallardo, a traditional navigable water location on the property.

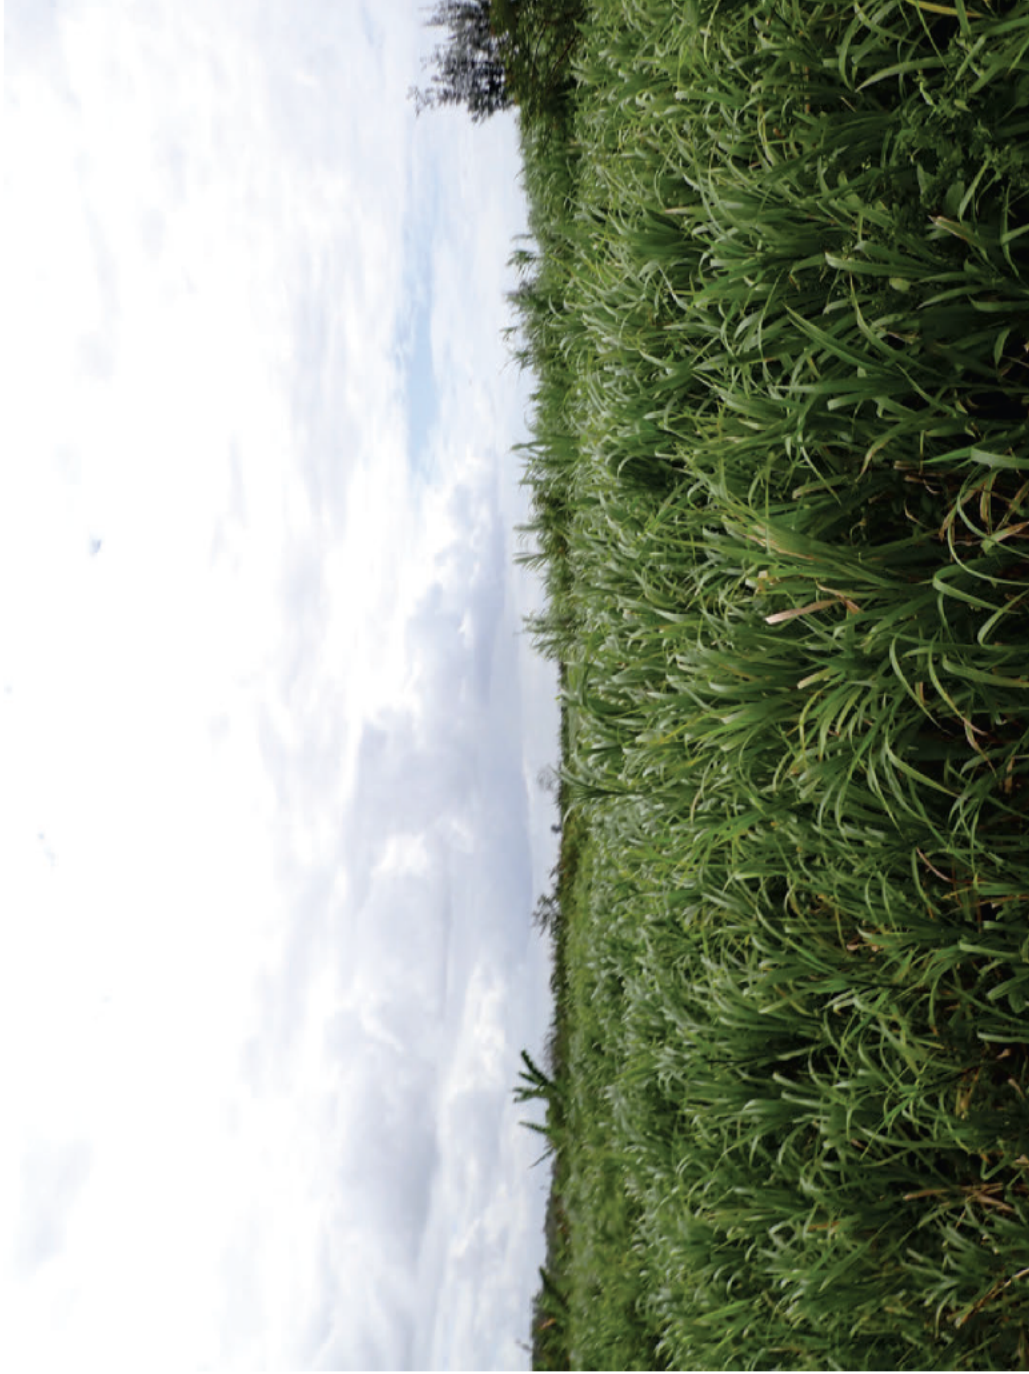
Date: April 6, 2022
Time: 2:25 PM
Photographer: Seika Robinson
Photo ID: P4060098

Description: Panorama of potential wetland area.

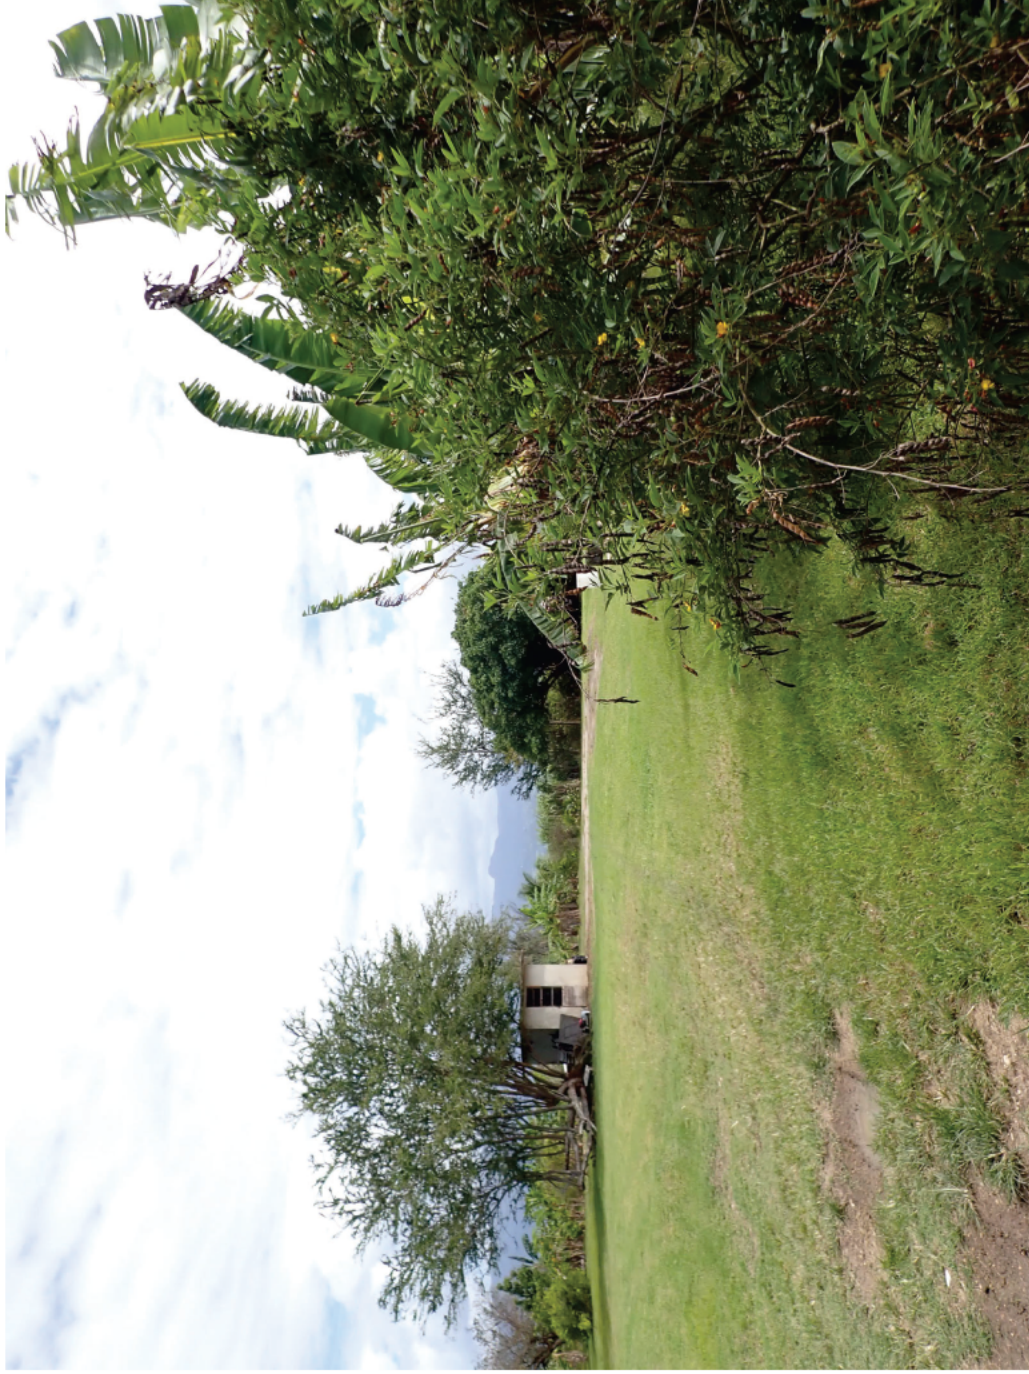
Photo ID: P4060103

Description: An abandoned building located on the site. Other residential buildings were observed on site but were not photographed.

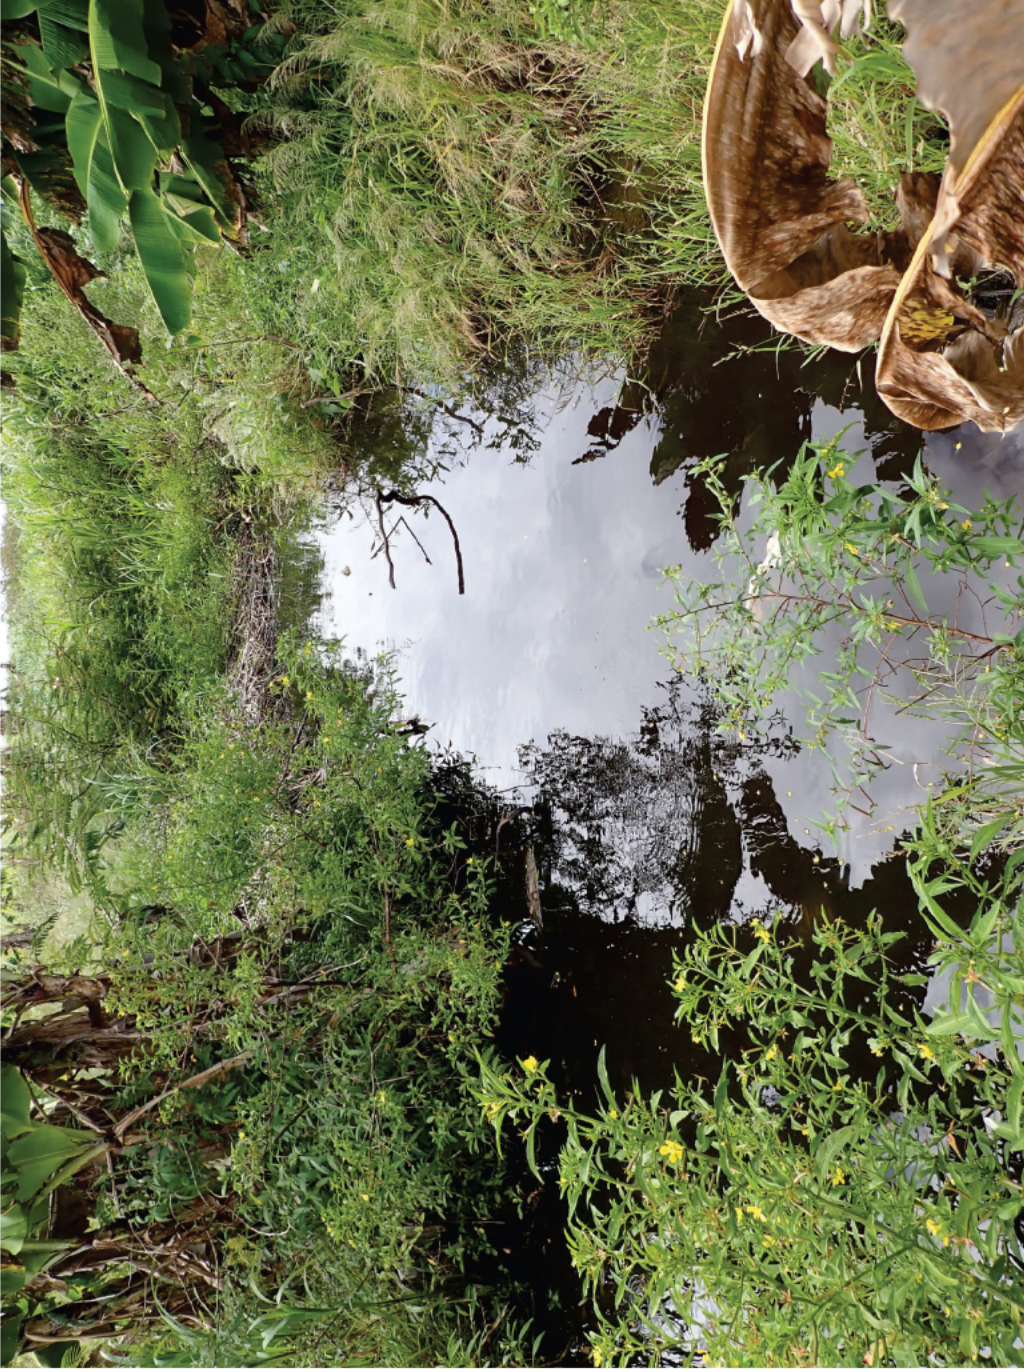
Date: April 6, 2022
Time: 2:42 PM
Photographer: Seika Robinson
Photo ID: P4060107

Description: Unnamed tributary on the site.

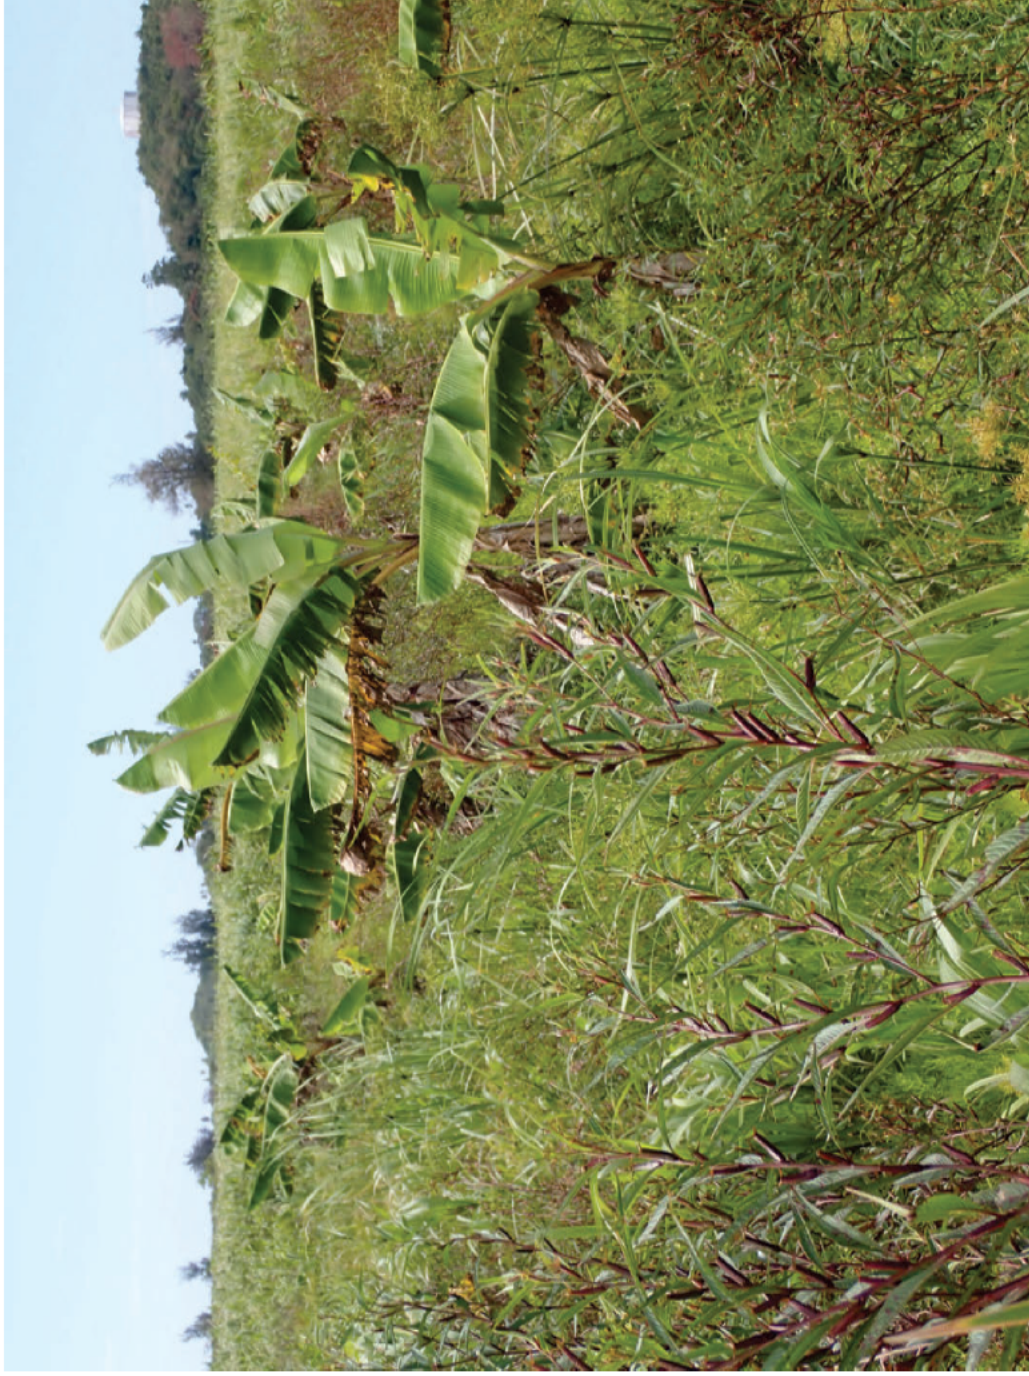
Photo ID: P4060118

Description: Panorama of the site located near the second soil pit.

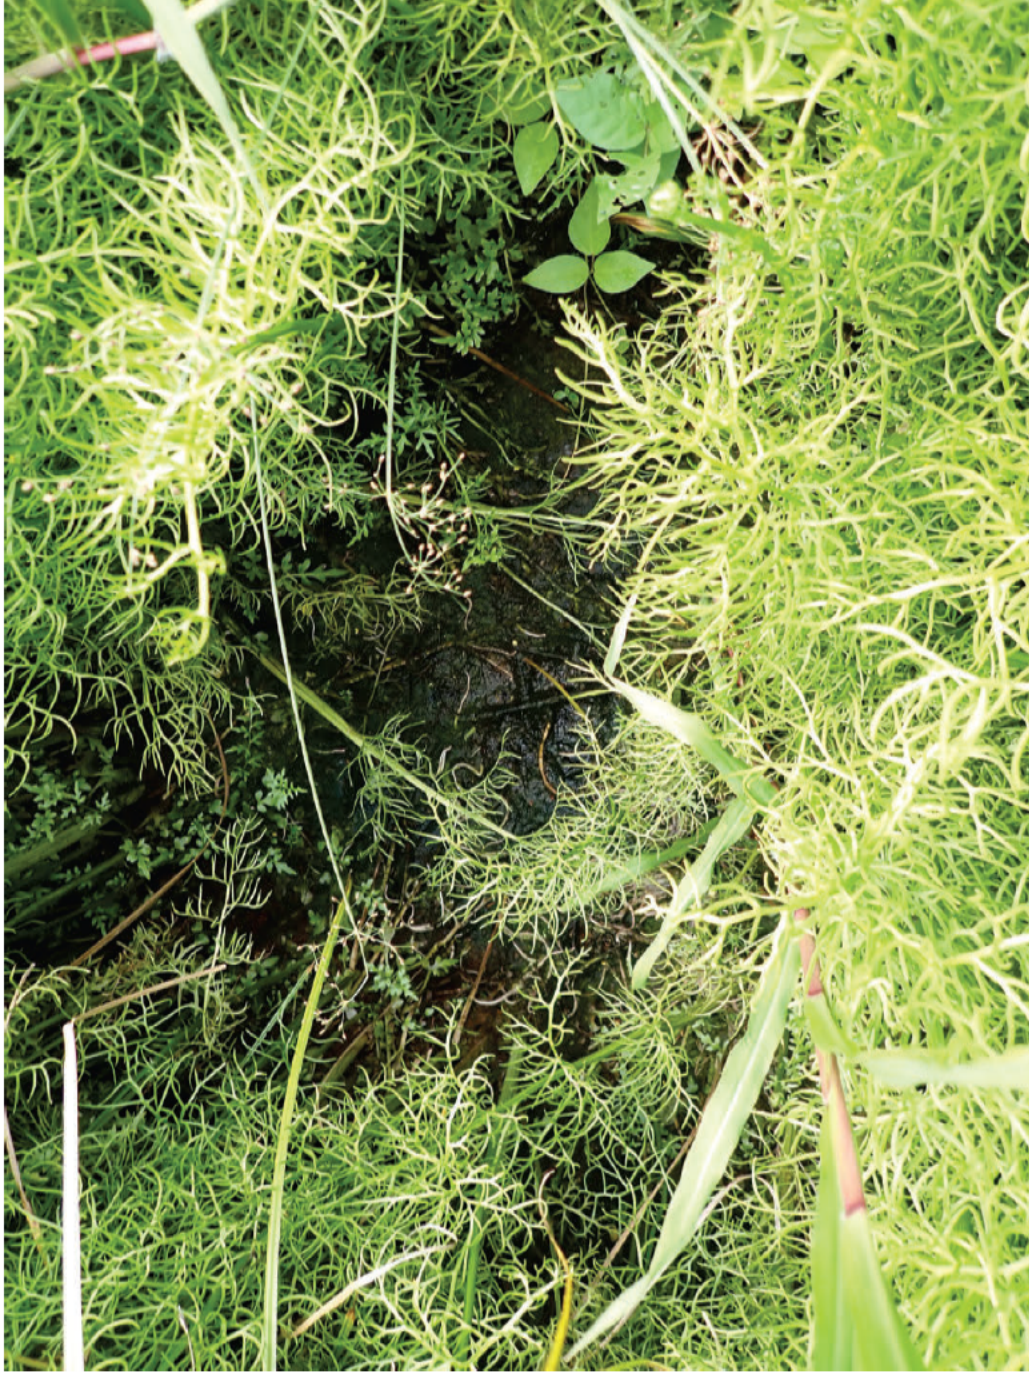
Date: April 6, 2022
Time: 2:45 PM
Photographer: Seika Robinson
Photo ID: P4060113

Description: Saturated soils interspersed throughout the site.

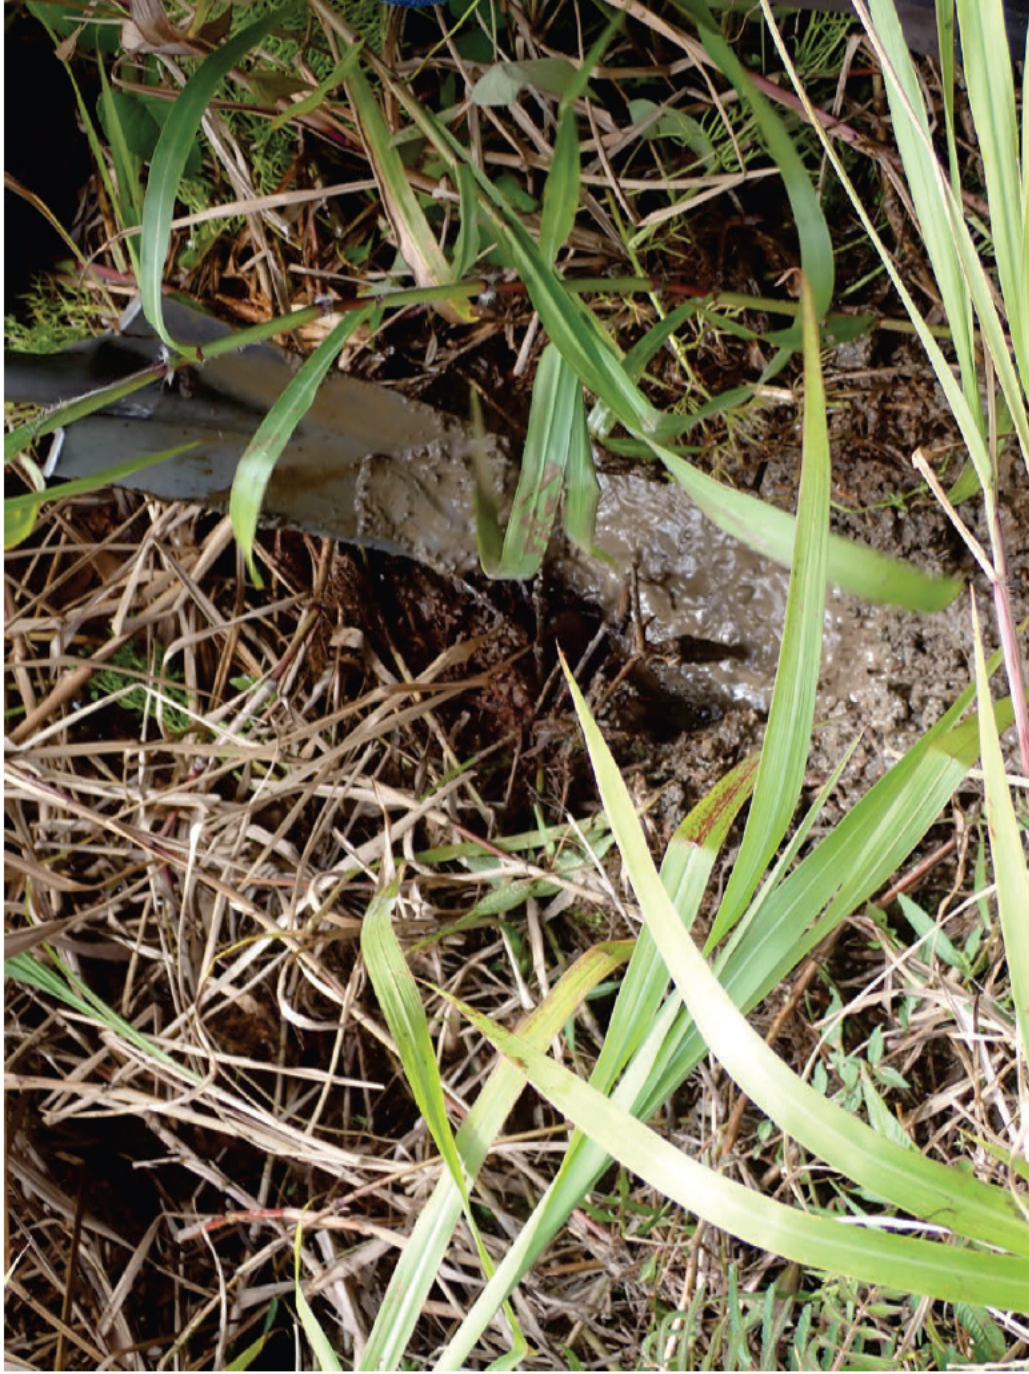
Photo ID: P4060115

Description: First soil pit dug to test for field indicators of hydraulic soils.

Saturated soils and a high water table was observed.

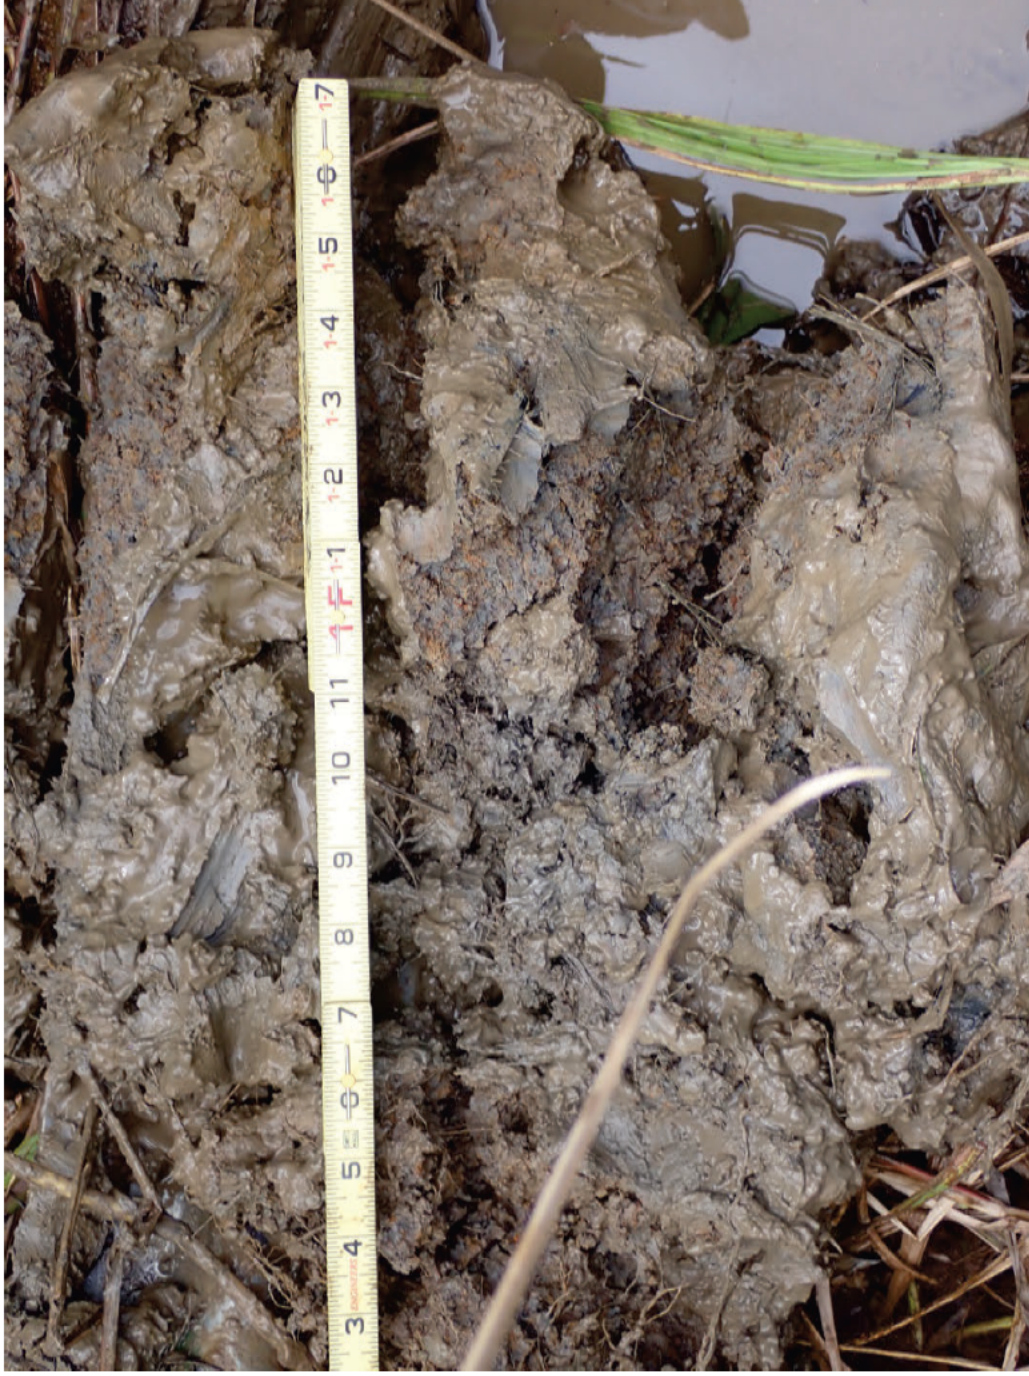
Photo ID: P4060124

Description: First soil pit dug to test for field indicators of hydraulic soils.

Saturated soils, high water table, depleted soils and redox reactions were observed.

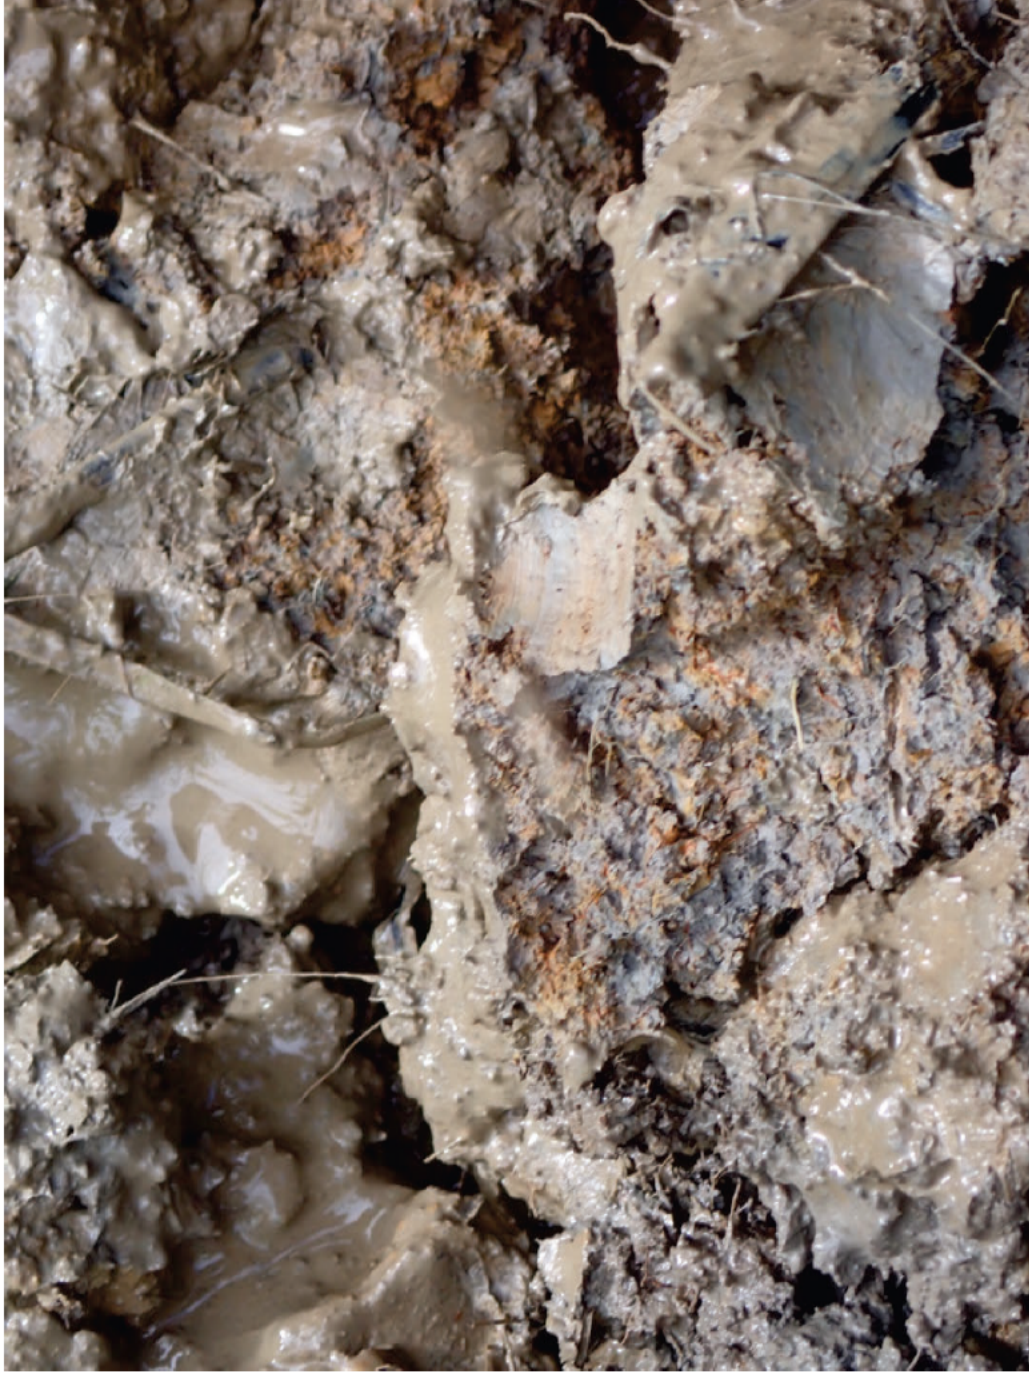
Photo ID: P4060123

Description: First soil pit dug to test for field indicators of hydraulic soils.

Depleted soils and redox reactions were observed.

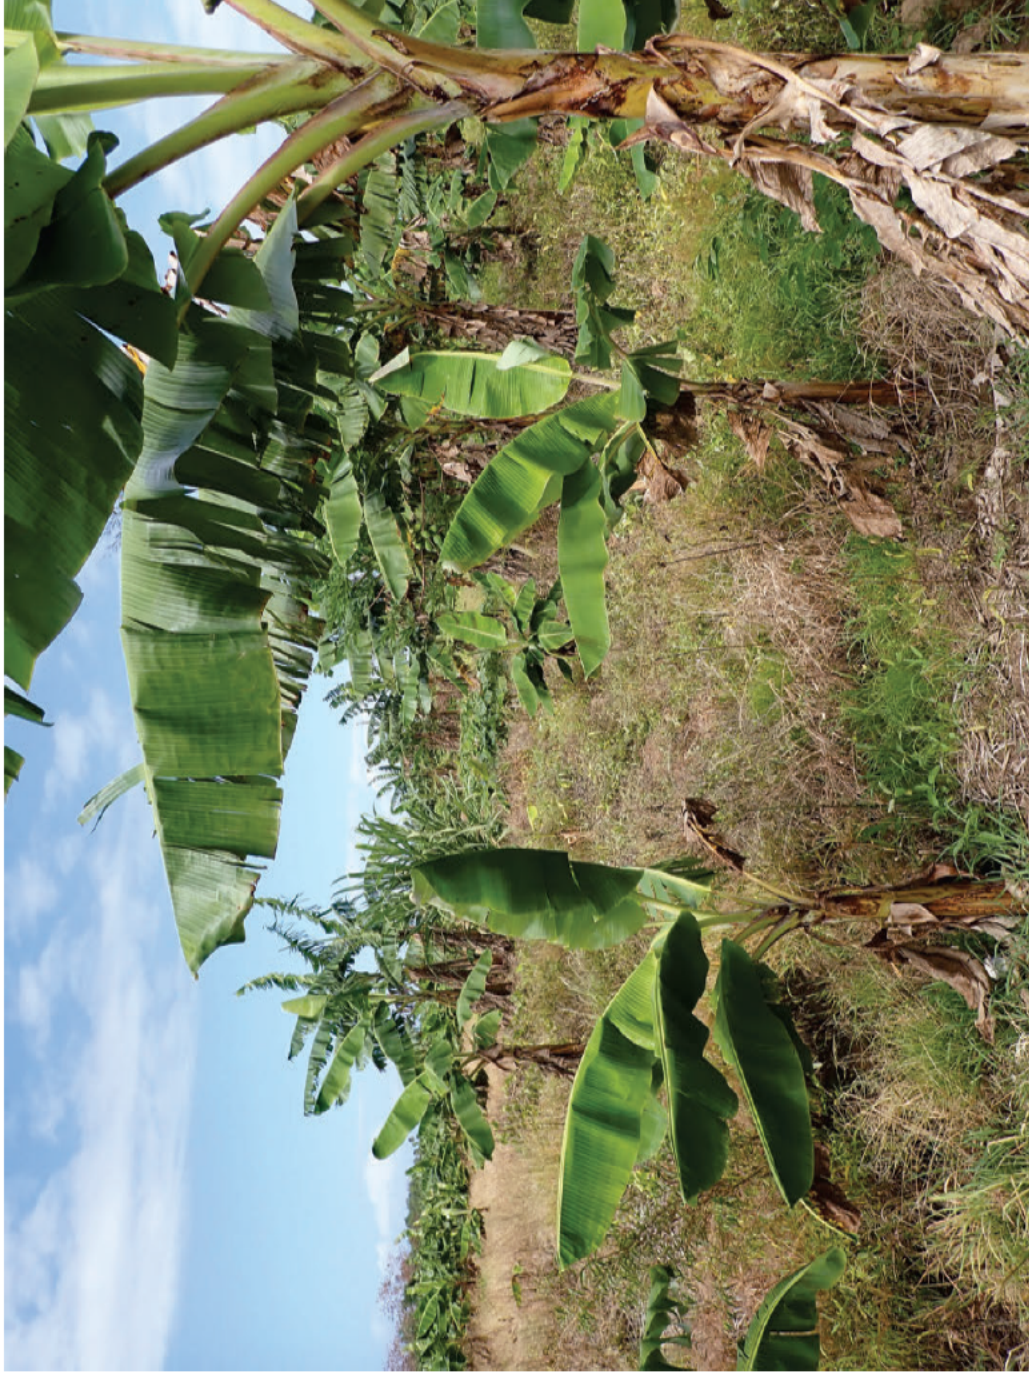
Photo ID: P4060102

Description: Panorama of the site conditions near second soil pit.

Potential wetland boundary area.

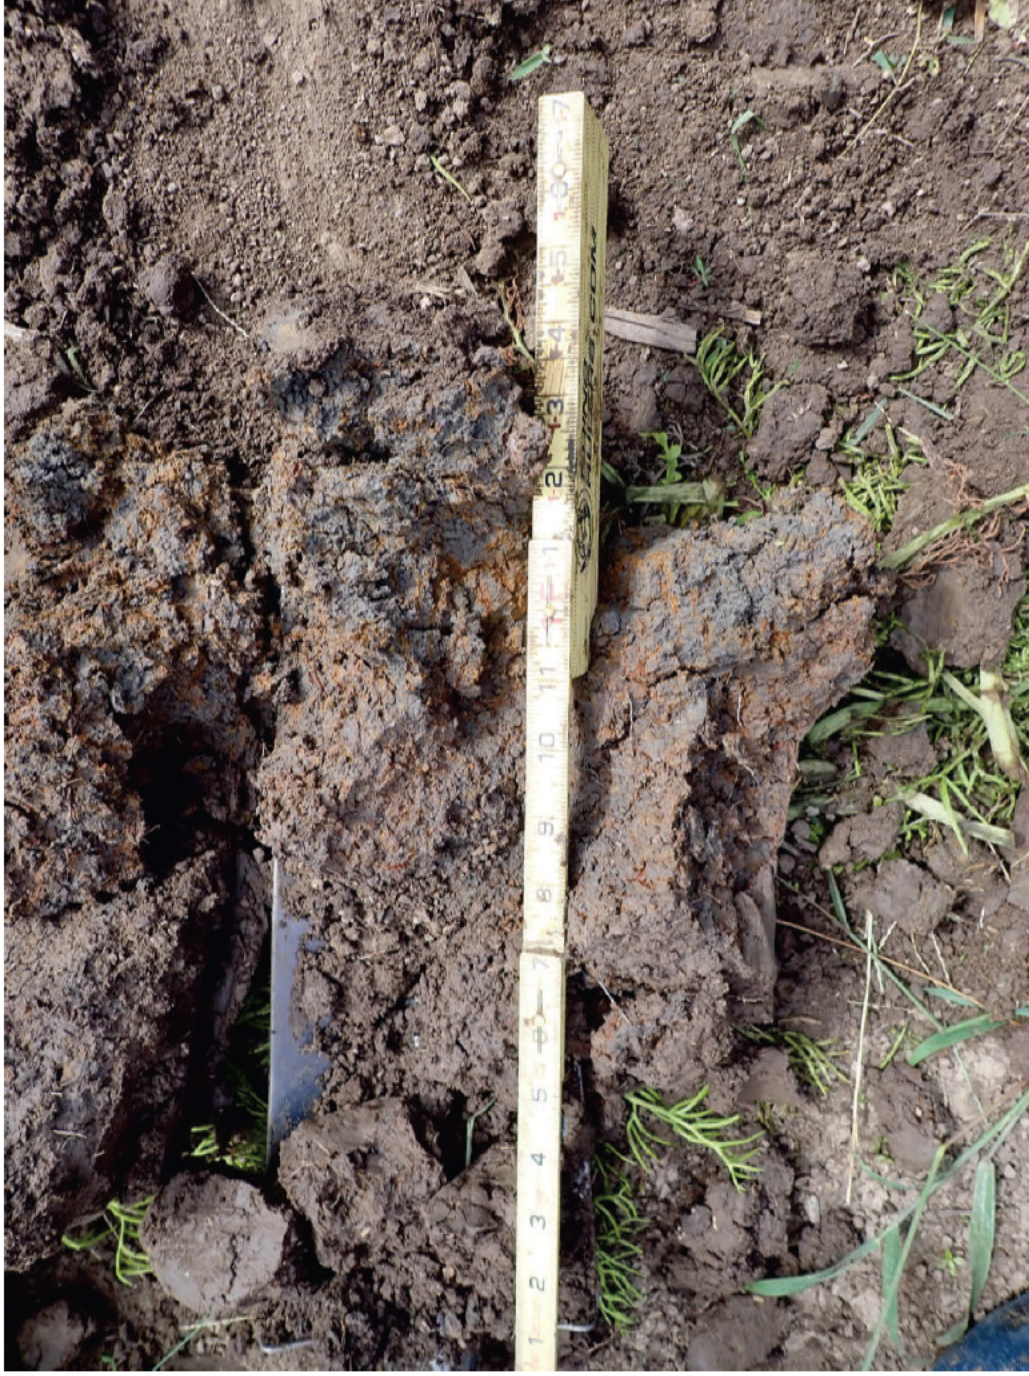
Photo ID: P4060127

Description: Second soil pit dug to test for field indicators of hydraulic soils.

Depleted soils and redox reactions were observed.

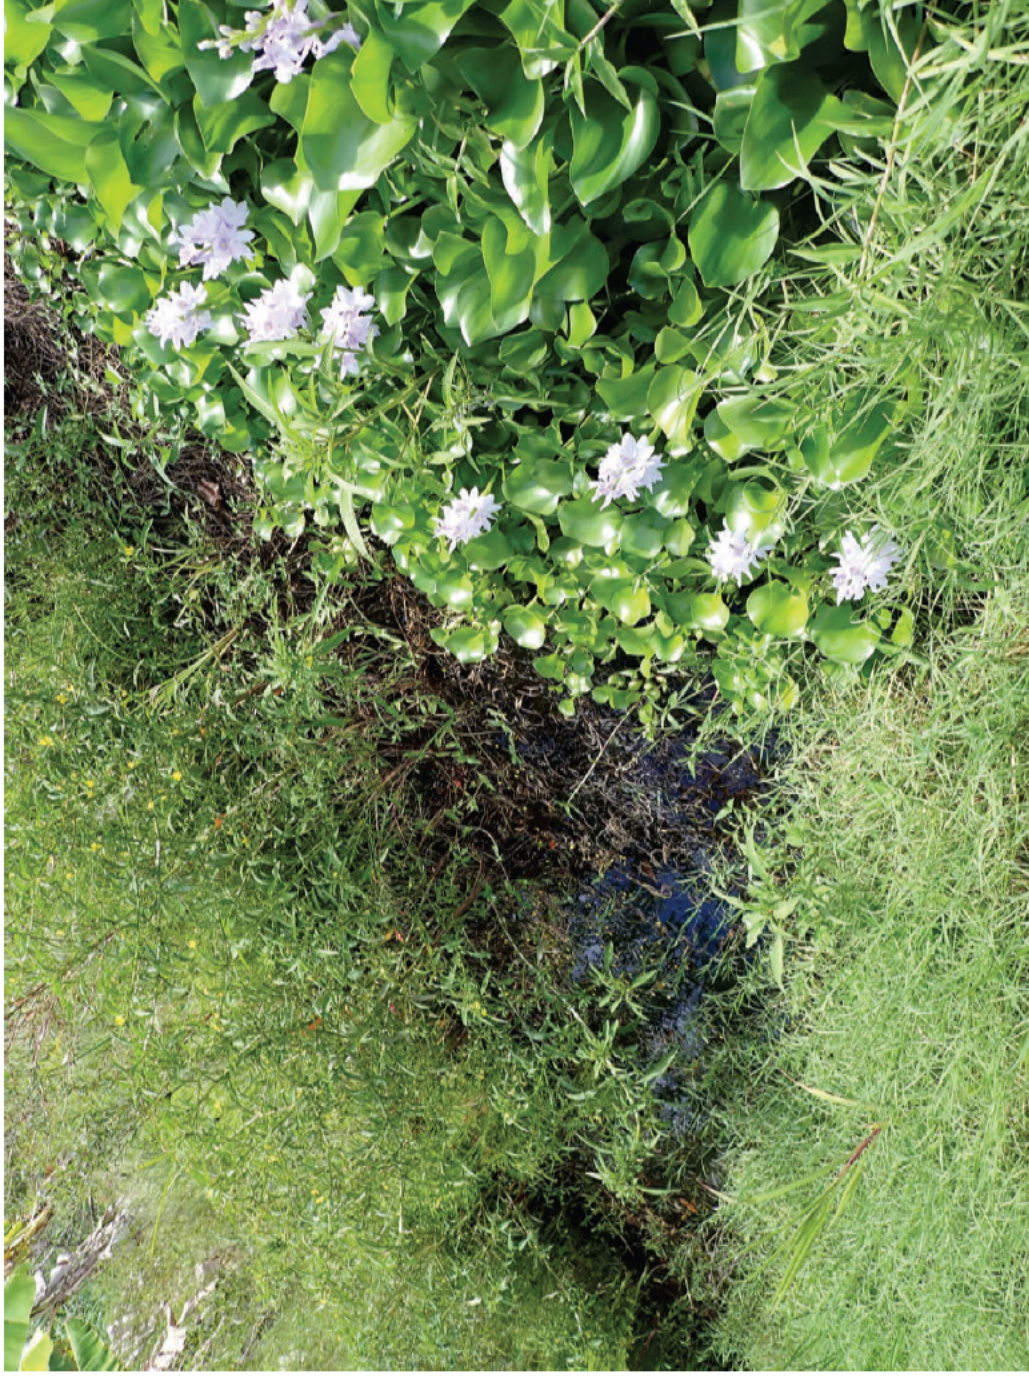
Photo ID: P4060139

Description: A flowing stream containing aquatic vegetation.

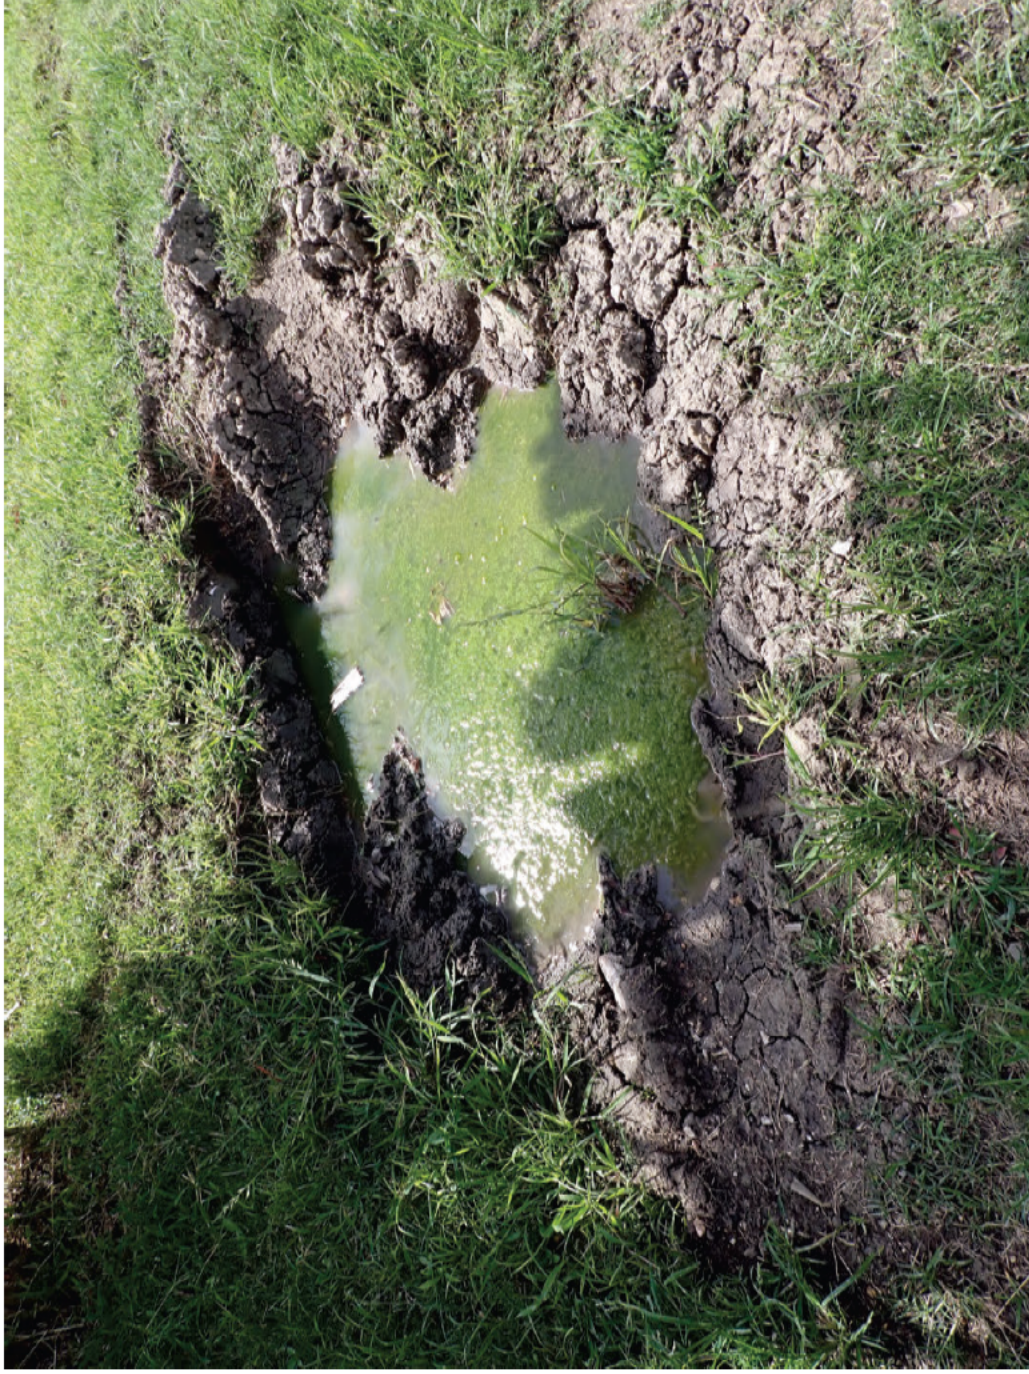
Photo ID: P4060142

Description: Standing water containing algae.
