Clean Water Act Section 404: Site Visit/Case Development

CWA 404 Inspection

Loubuildco, LLC

Tax parcel numbers 065-000-010-01-000 and 065-000-005-14-901 in the Municipality of Loíza, Puerto Rico

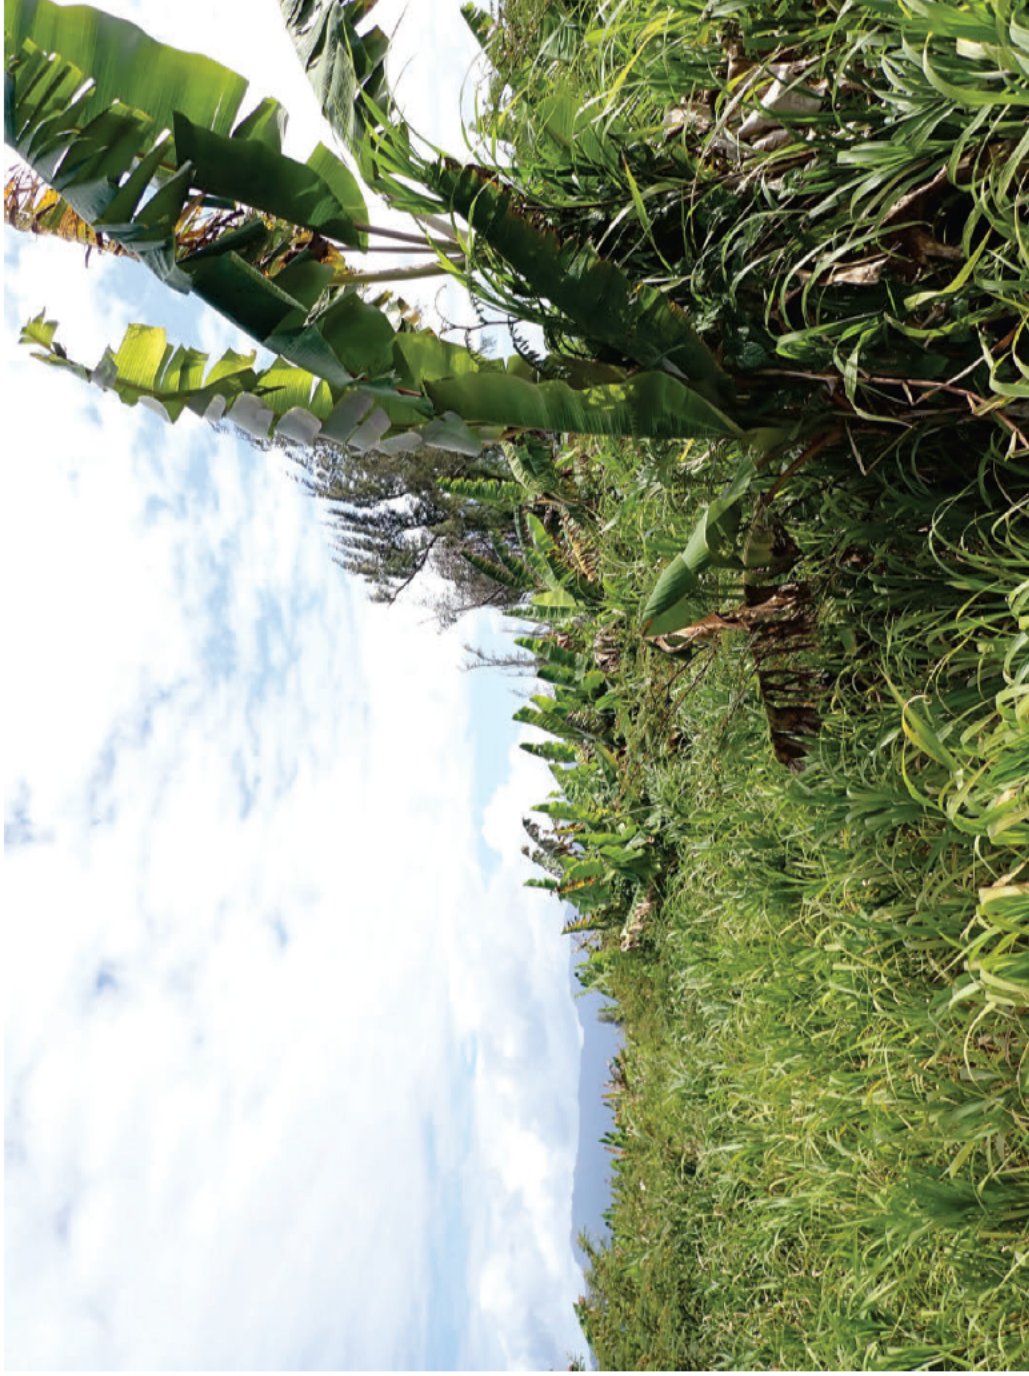
Photo ID: P4060146

Description: Panorama of the site between second and third soil pit.

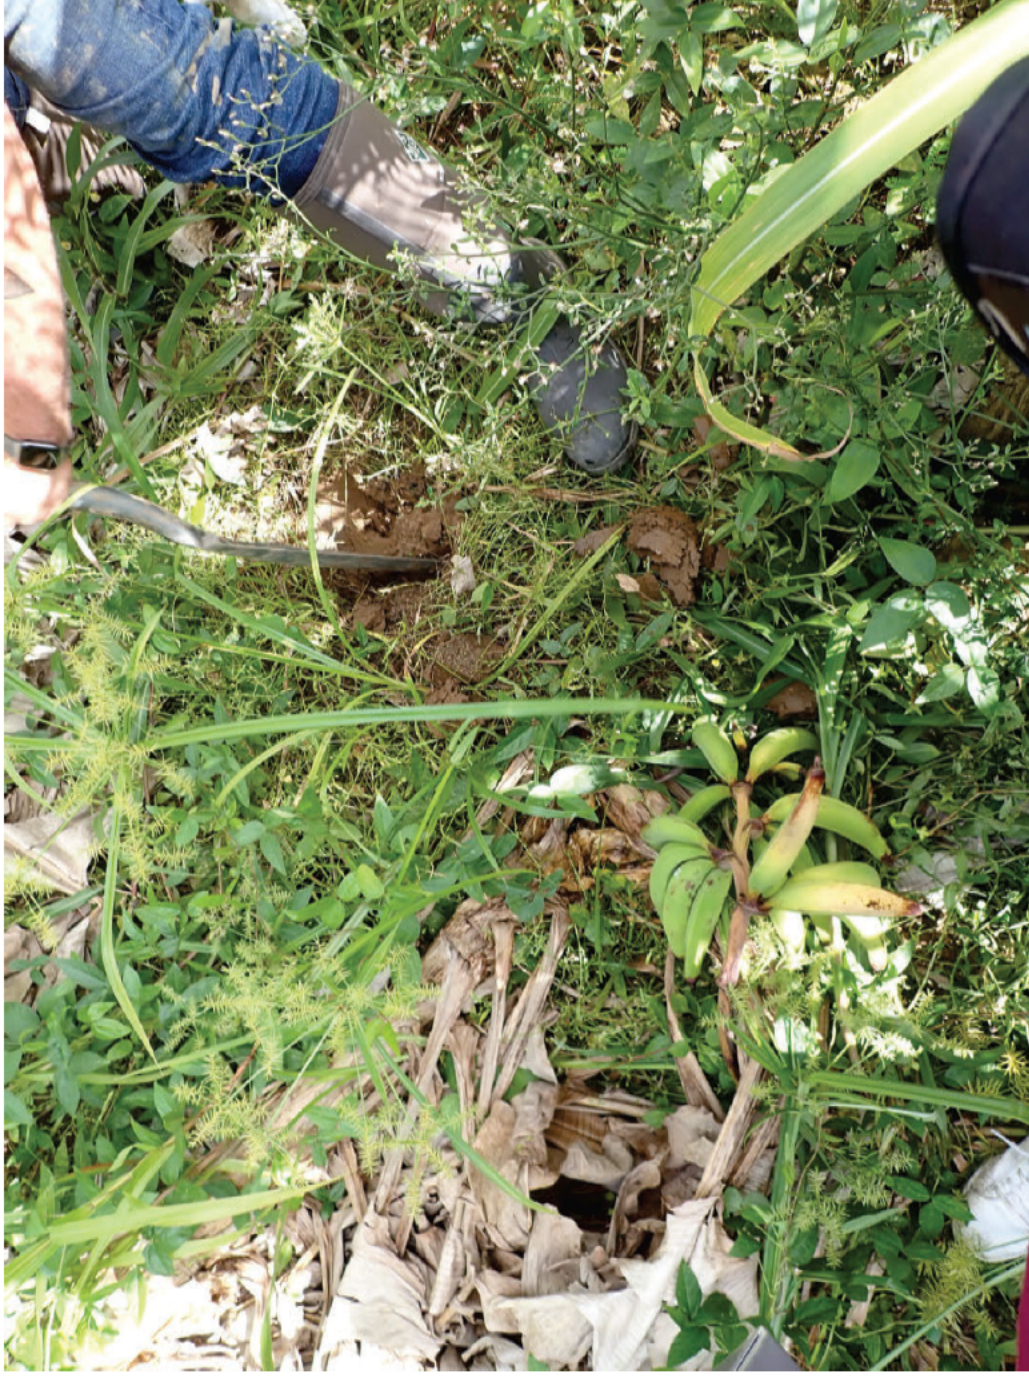
Date: April 6, 2022
Time: 3:48 PM
Photographer: Seika Robinson
Photo ID: P4060150

Description: Third soil pit dug to test for field indicators of hydraulic soils.

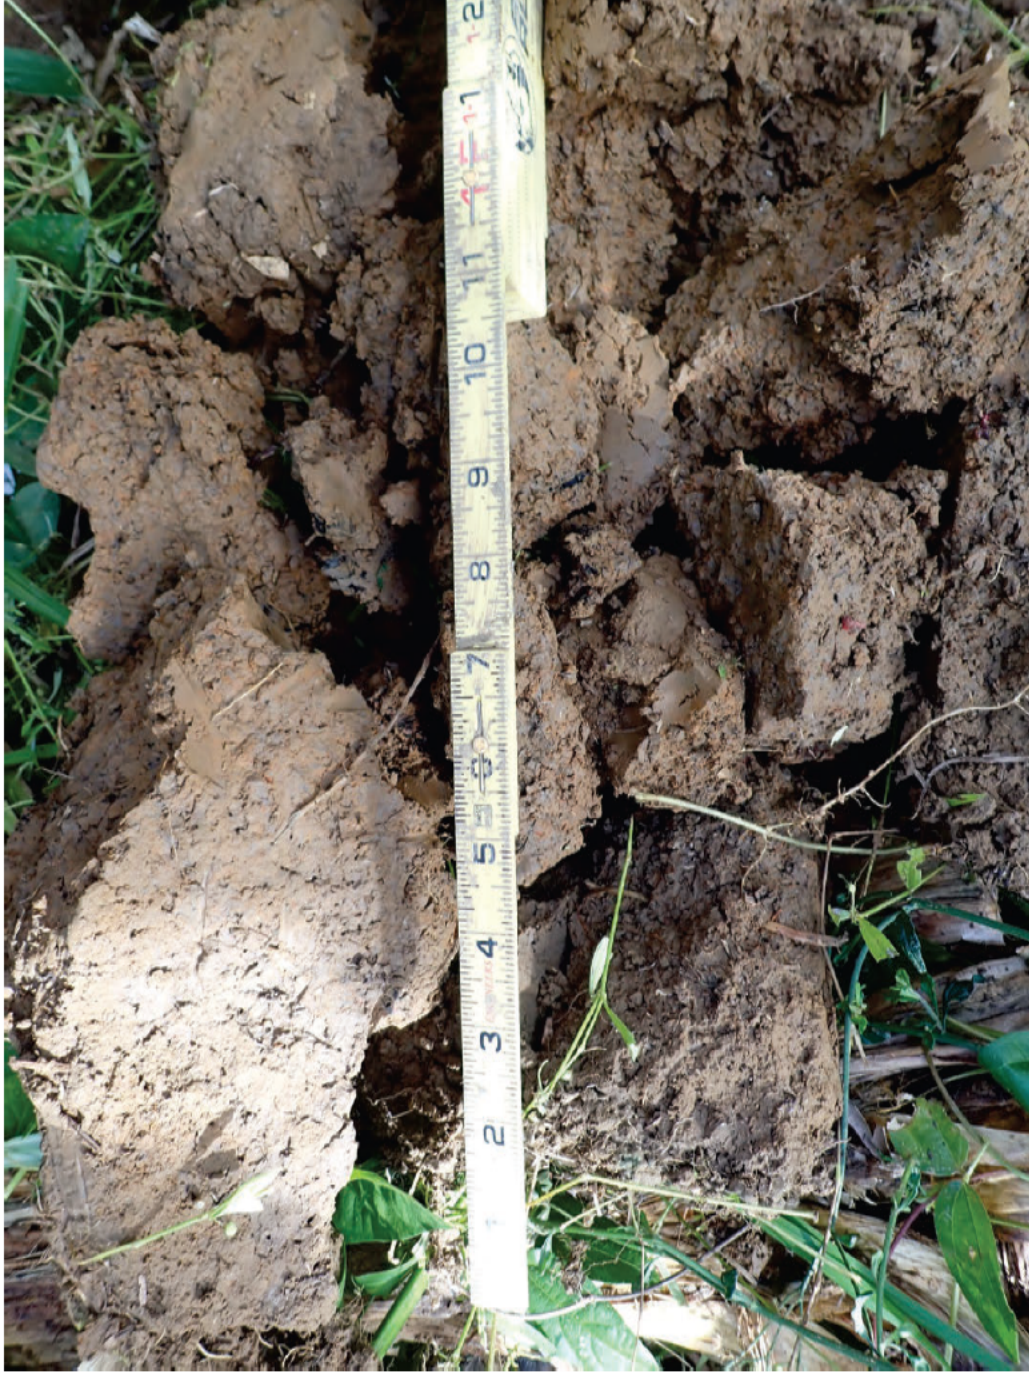
Photo ID: P4060155

Description: Third soil pit dug to test for field indicators of hydraulic soils. No indicators were found.

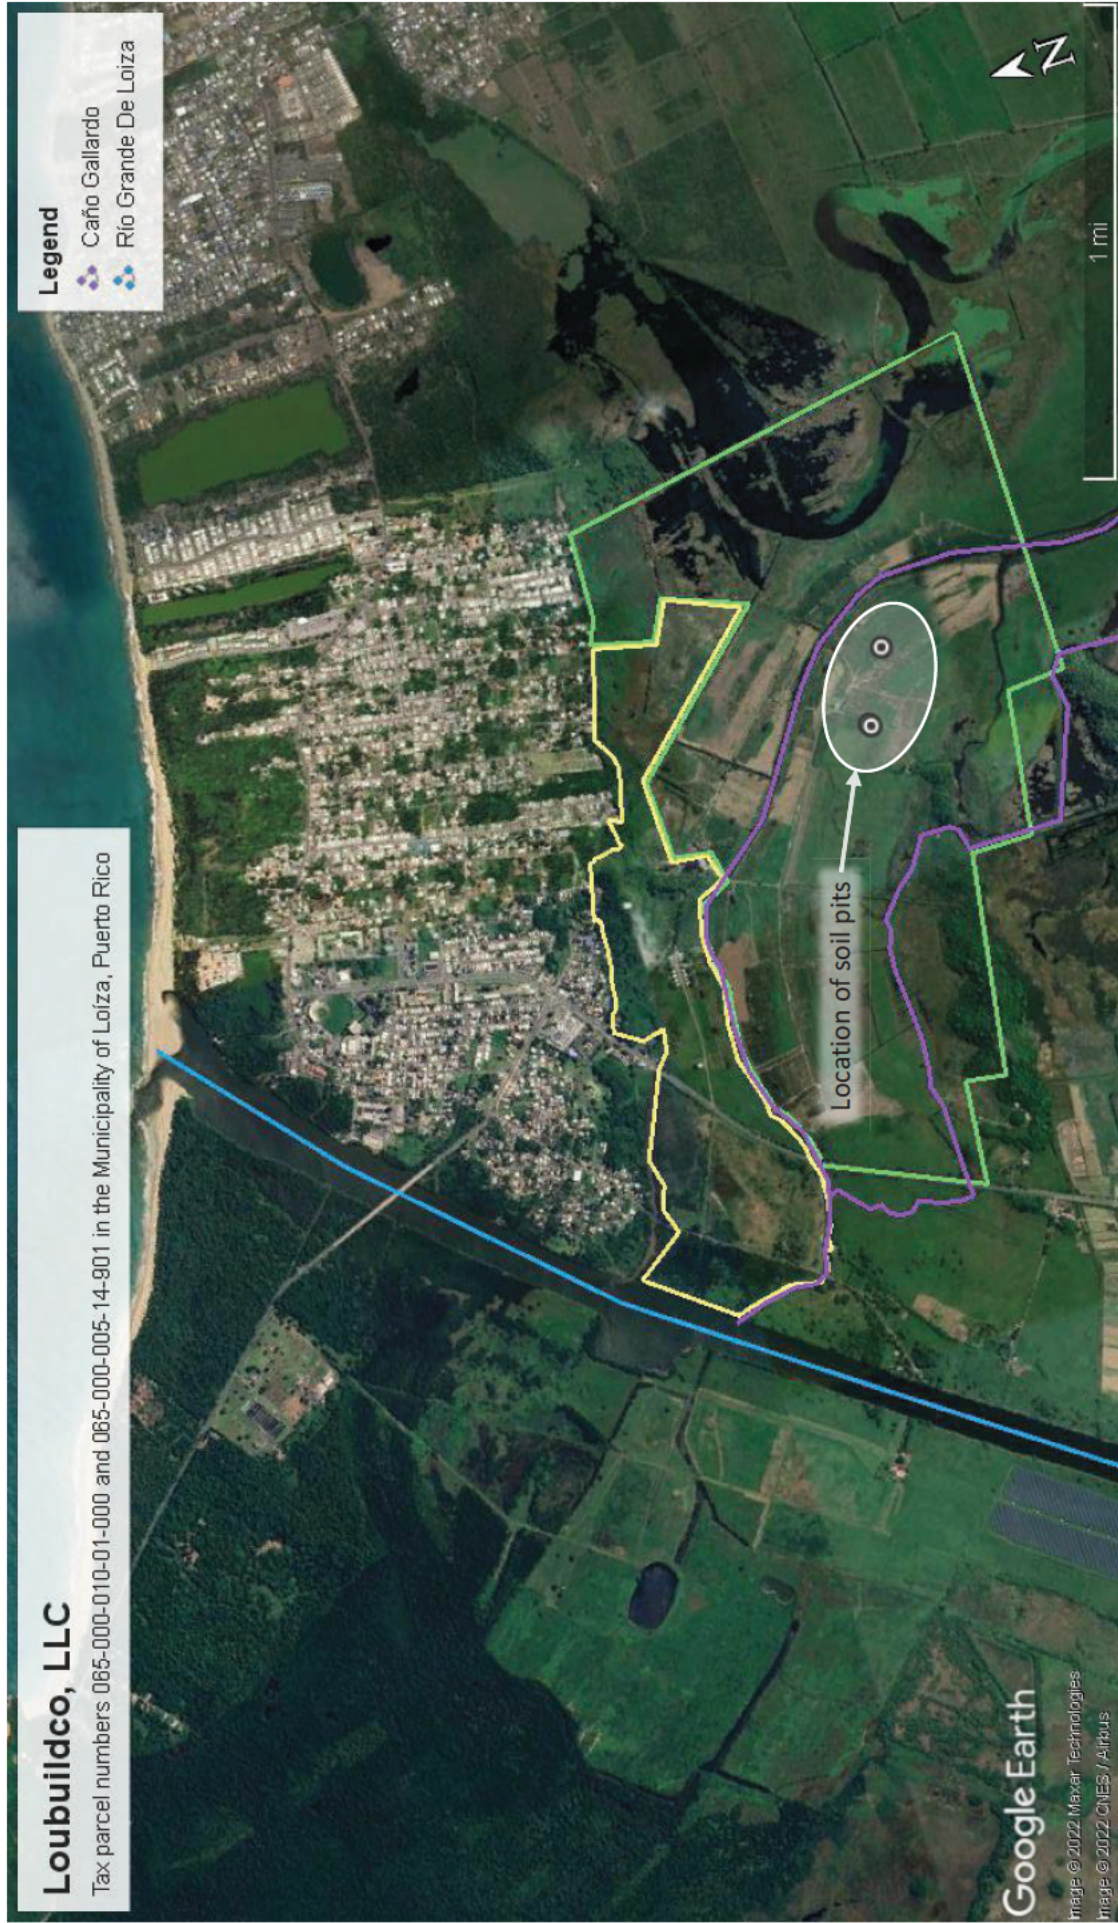
Figure 1 Site map with locations of the soil pits highlighted.

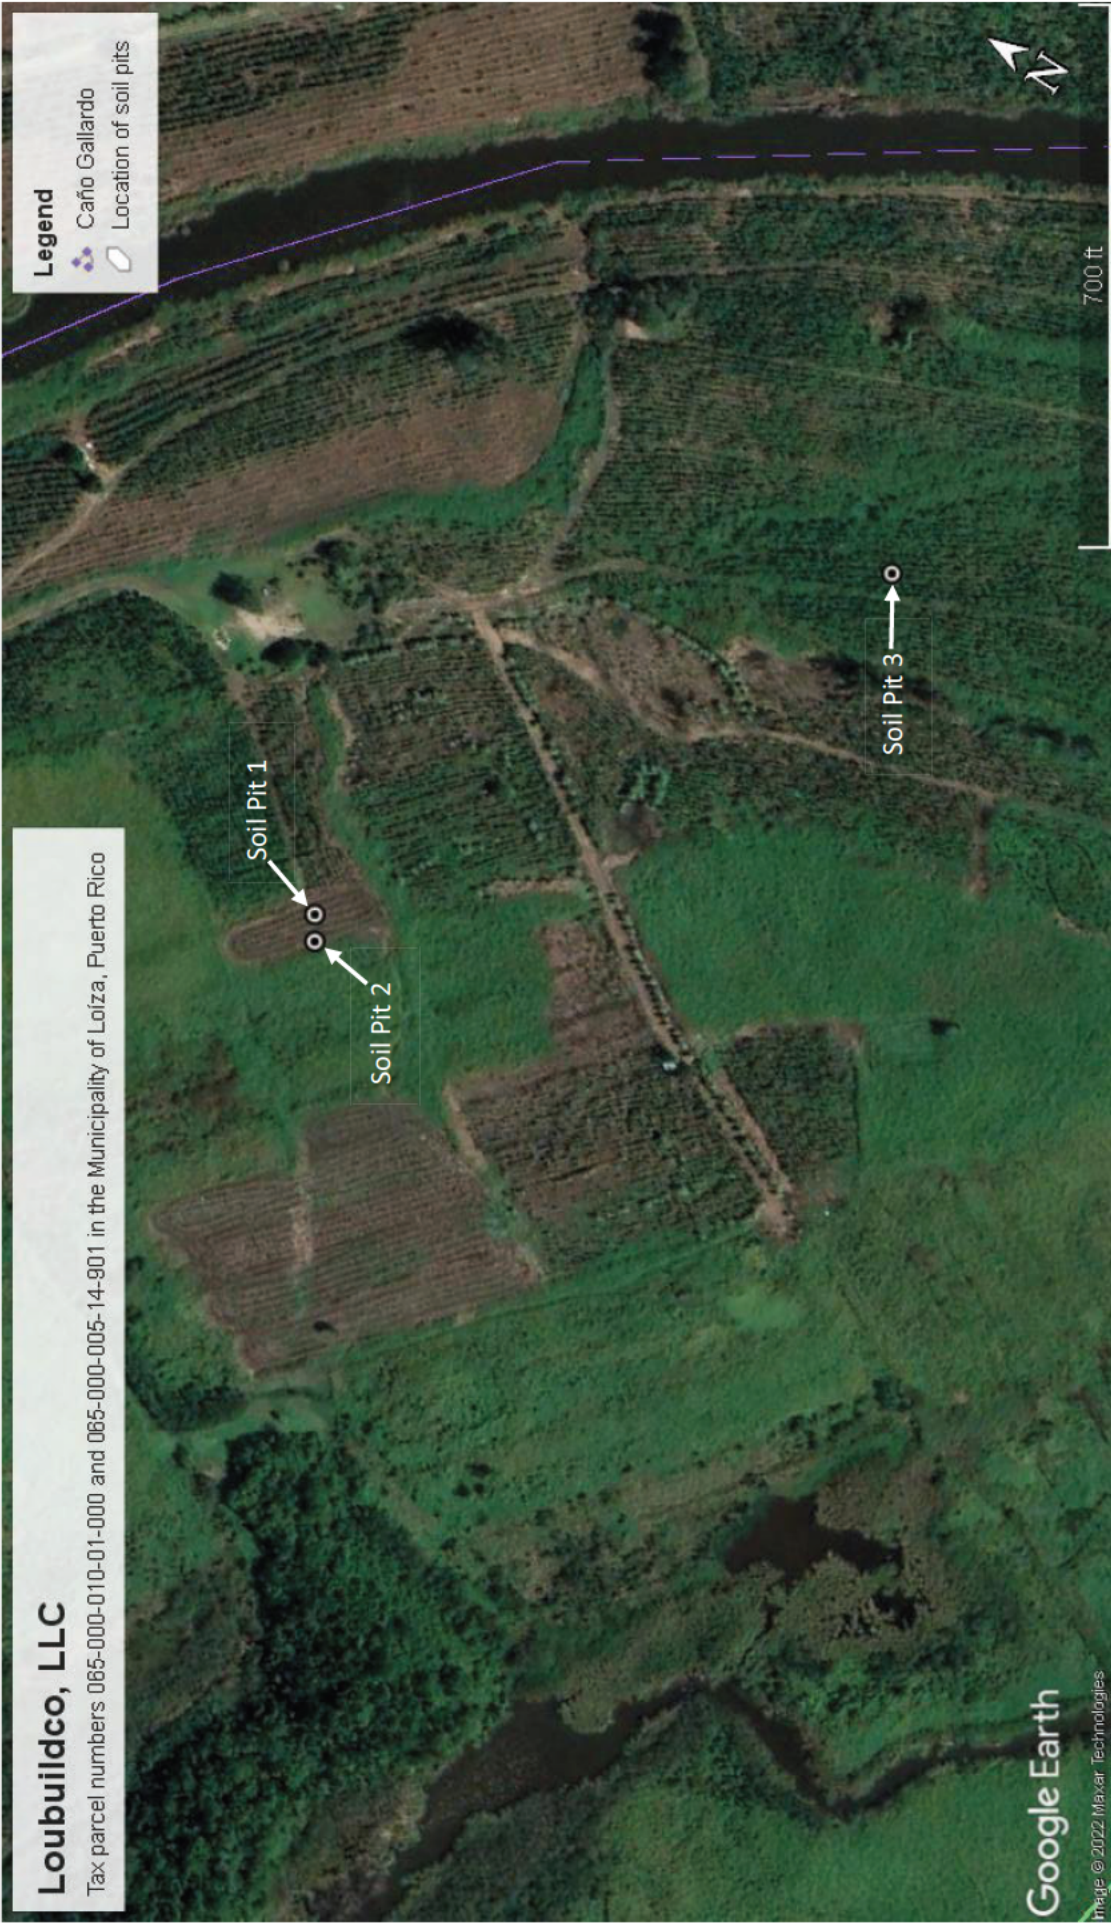
Figure 2 GPS Coordinate points taken of the soil pit locations.
