## **RCRA Inspection Report**

Heraeus Precious Metals North  
America, LLC (Heraeus)  
1975 Knoxville Highway  
Wartburg, Tennessee 37887

November 28, 2023, 9:30 am-2:30 pm

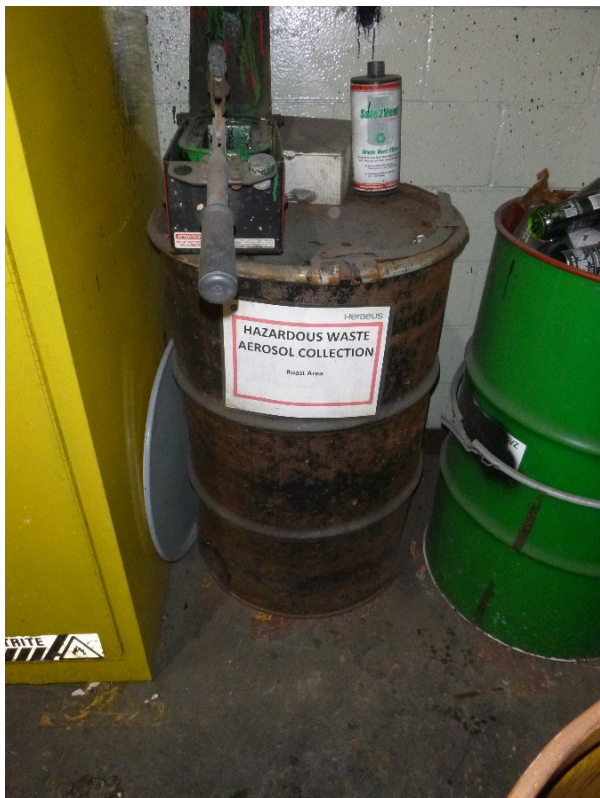
Heraeus representatives stated that the process waste generated in the roast/incineration area is collected and sent back through the process. The inspection team noted one 55-gallon black waste collection container in this area (Photograph 1). The collection container was accumulating aerosol can residues. Typically, when Heraeus generates a spent aerosol can, it is punctured draining the liquid portion into a collection container which is managed as hazardous waste and the punctured cans are accumulated as scrap metal. This container was labeled "Hazardous Waste Aerosol Collection". The container was affixed with a puncture device that was open on the day of the inspection. The inspection team recommends that this container be closed when not adding or removing waste and that the indication of the hazard be added as part of the container labeling.

Photograph 1: Aerosol SAA Container with puncture device.

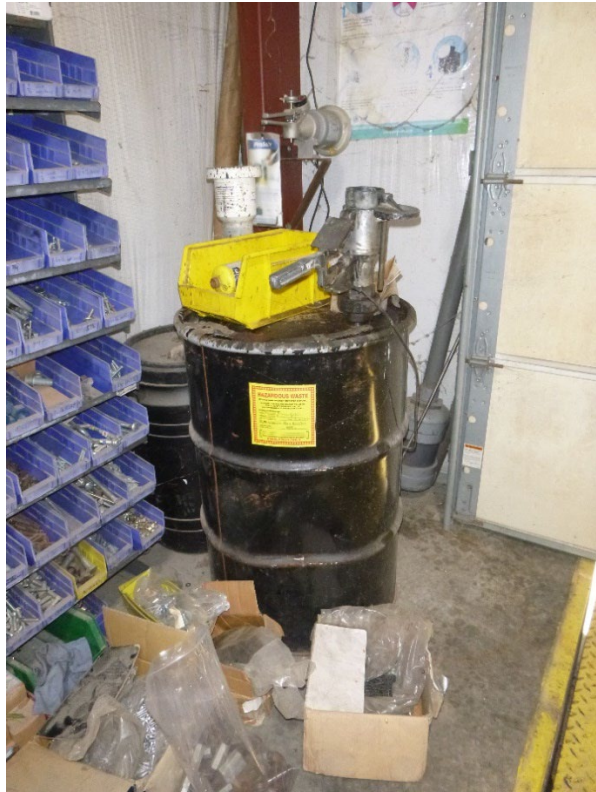
The inspection team toured the maintenance area which was in an adjacent building. Heraeus stores aerosol can waste and universal waste batteries in this building. The facility has been converted to LED lights in 2022 so that no universal waste lamps are generated. The aerosol can residues were stored in a 55-gallon container. This container was labeled with a hazardous waste label (Photograph 2) and affixed with a can puncturing device which was open on the day of the inspection. The inspection team recommends that this container be closed when not adding or removing waste and that the indication of the hazard be labeled on the exterior of the container. Heraeus representatives pointed out cardboard boxes that are used to store and accumulate universal waste lamps (Photograph 3). There were no lamps on site on the day of the inspection. The inspection team noted three spent batteries on top of a 5-gallon plastic pail. The Heraeus representative stated that batteries in this area were spent. None of the batteries were marked as universal waste nor did they have an accumulation start date marked on the exterior of the batteries (Photograph 3). The Heraeus representative was unable to determine how long these batteries had been stored in this area.

Photograph 2: Aerosol SAA Container with puncture device.
