## Before and after view of Reynolds

## Cutting pollution is costly game

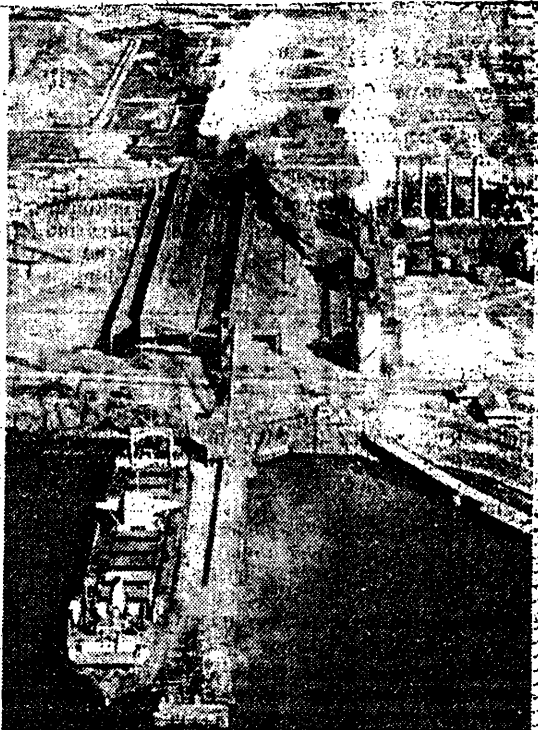
The photo above shows Reynolds Metals plant after installation of pollution curbs and below is how it looked before the equipment was installed. However, neither of these photos shows the San Patricia plant, the major source of pollution at the Reynolds

site. It was operating at the time of the photo below but was out of the picture. It was not operating when the top photo was made. The white plumes in the lower photo are water vapor, not pollutants.

First is that the San Patricio plant, always the primary source of emission, is operating in the earlier photo and not in the second. It is pictured in the upper right of the "before" photo. Secondly, cooling tower water vapor creates varying plumes depending on atmospheric conditions and is not a pollution problem.

The harmless vapor plumes are much larger in the earlier photo.

Improvements at the Sherwin plant have included installation of a scrubber for dust control at the bauxite unloading dock. Dust can be seen rising from ship side in the earlier picture. A bag-type dust collector has been installed at the alumina loading dock at the lower right.

New electrostatic precipitators have been added to the soda recovery kiln which is almost at the center of the lower picture and similar equipment has been put on all nine of the kilns used to dehydrate alumina as it moved through the final stage of processing.

The two accompanying photos reflect some of the change in air quality near the plant. One was taken in the mid-1960s; the second on April 1 of this year.

Along with addition of expensive dust collection and emission control equipment, there are two other important factors affecting the appearance of the plant in the before-and-after photos.
