## **RCRA Inspection Report**

United States Coast Guard Base  
Elizabeth City (USCG – EC)  
1664 Weeksville Road  
Elizabeth City, North Carolina 27909  
Pasquotank County

March 21, 2023, 8:20 a.m. – 7:05 p.m.

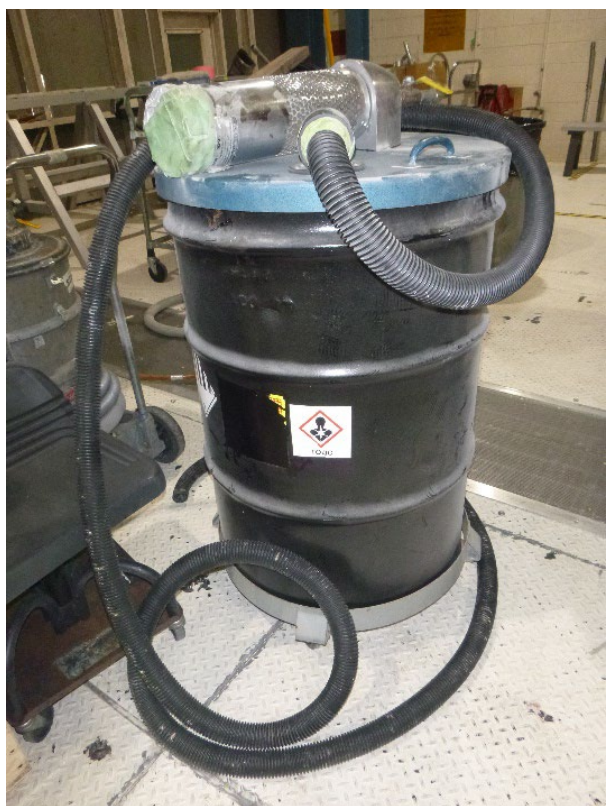
In Hanger 77, the inspection team noted three 55-gallons of cornstarch blast media (D007) that were not labeled with the words hazardous waste and two of these containers were not labeled with an indication of the hazard (Photographs 10-11). Facility personnel stated that these containers were moved throughout the hanger to vacuum up waste from the nearby CAAs (Filter Bank CAA and Control Room CAA) and on the work area of the hanger floor after blasting off metal parts during maintenance operations. The volume of the combined containers was greater than 55 gallons (1/3 full, 1/3 full, and 2/3 full respectively) on the day of the inspection. Two of these containers were affixed with vacuum attachments to the lid. One container was labeled during the inspection with the words hazardous waste (Photograph 11).

Photograph 10: Building 77 Hanger SAA.

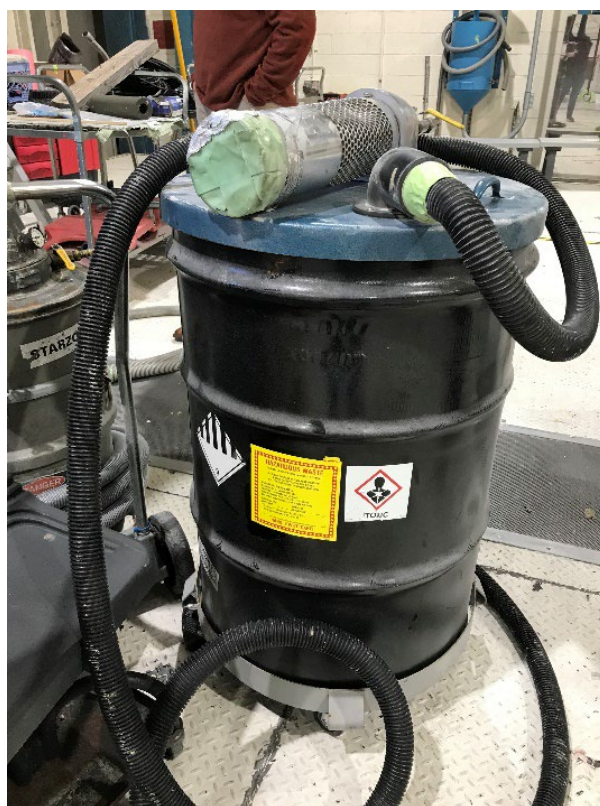
Photograph 11: Building 77 Hanger SAA.

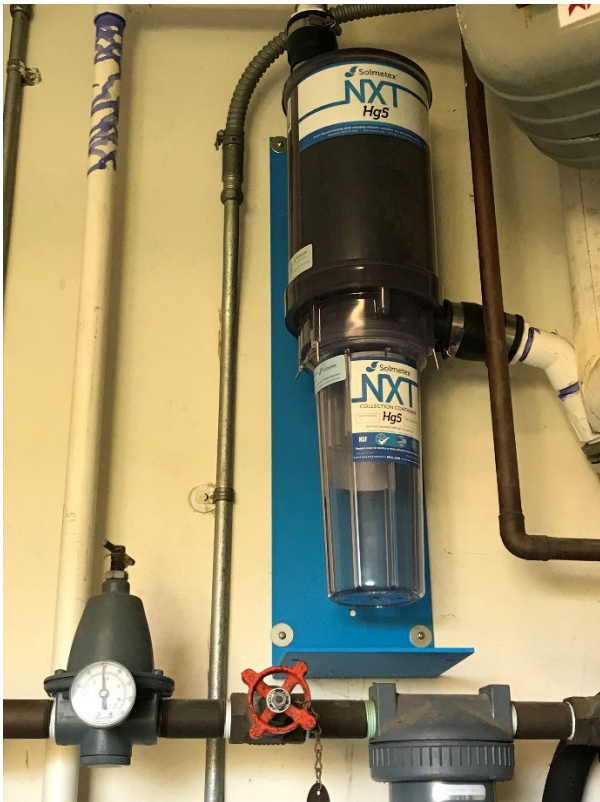
Photograph 17: Amalgam recovery system.

USCG-EC operates an amalgam recovery system to intercept bits of waste from entering the solid waste or liquid waste streams from the dental clinic. The filter operates on waste amalgam removed through suction from all dental chairs and collected in a Solmetex Machine (Photograph 17). The most recent shipment of this waste was on May 21, 2021.

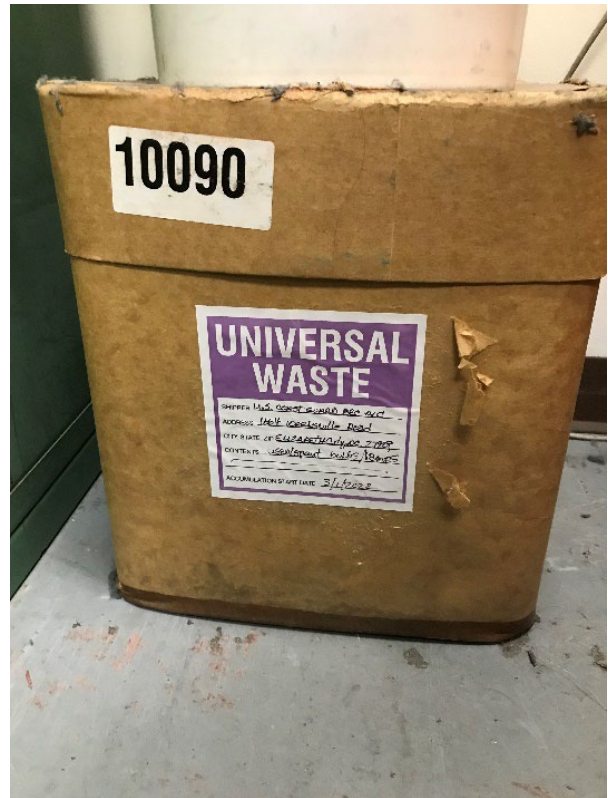
Photograph 19: Building 1 Container dated 3/30/2022.

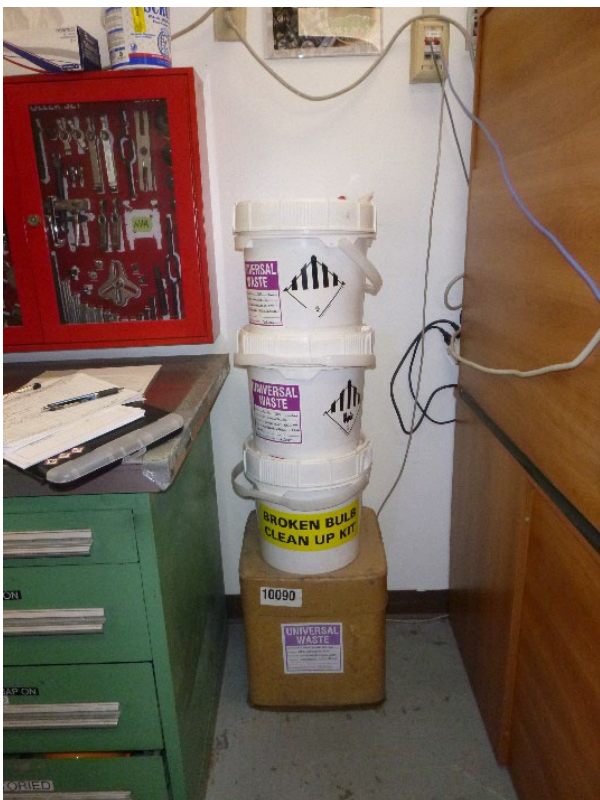
The inspection team noted universal wastes in the Tool Room of Building 75. There were two 5-gallon containers of universal waste batteries: one for alkaline batteries and one for lithium, NiCad, and Ni Metal Halide batteries (Photograph 18). These containers were in good condition, closed, and marked with an accumulation start date of March 1, 2023. Underneath these two containers was an 18-inch cube for storage of universal waste lamps. The container was labeled as universal waste and in good condition (Photograph 19). The accumulation start date on the container was March 1, 2022. This was documented as an error in the year (should have been marked 2023) through universal waste shipping documents. This is an area of concern for the inspection team.

Photograph 18: Universal Waste Lamps.

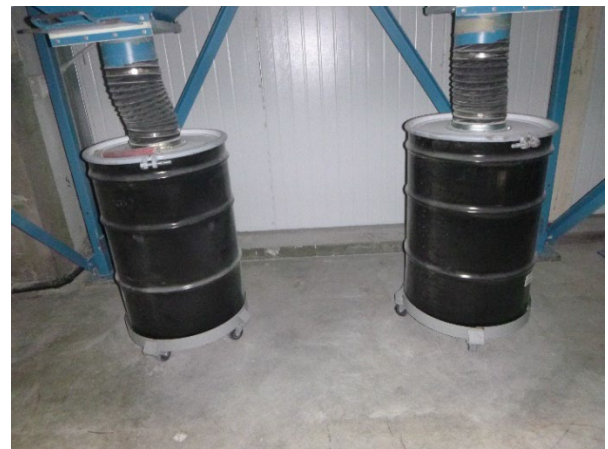
There were four unlabeled containers in this area that were recently replaced underneath four of the eight the blast media baghouses. These containers were empty (Photographs 20-21). Facility personnel labeled the containers during the inspection and dated them with the current date. There other four containers were labeled and were dated March 20, 2023 (D007) (Photographs 22-23). In the corner of this room was a container with vacuum affixed to the lid (Photograph 24). This SAA container was empty on the day of the inspection. The inspection team and the facility representatives discussed whether this vacuum system would be considered an SAA. The conclusion of the inspection team was that since it was a

Photograph 20: Building 77 Filter Bank Room

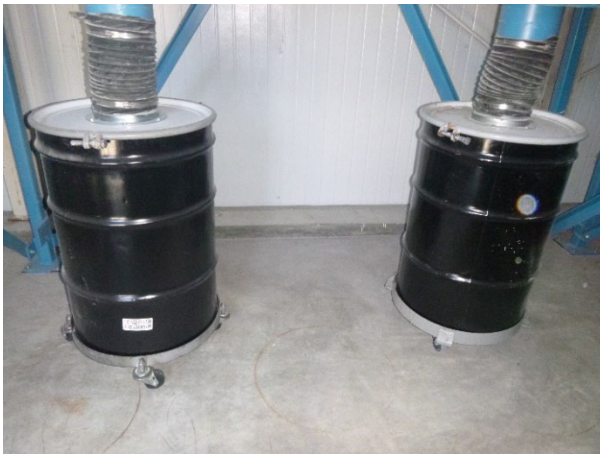
Photograph 21: Building 77 Filter Bank Room.

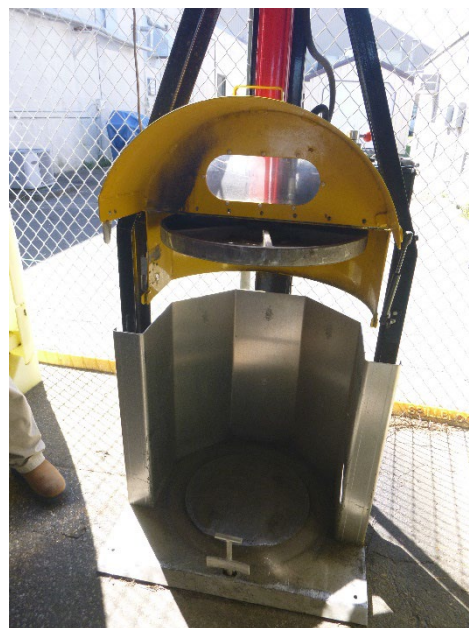
The inspection team noted an area of concern. A compactor was observed in this area that used to compact waste solvent wipes for the purpose of reducing the number of containers shipped (Photographs 31-32). There was no active compaction occurring during the inspection. Activity of this nature, treatment of hazardous waste, is required to be conducted in compliance with a 40 CFR 262.17 exemption or under a RCRA hazardous waste permit. Specifically, this compaction unit operates with as an open container in the current orientation. The inspection team anticipates that some VOC containing emissions would occur during treatment. Capture of these emissions would be necessary to meet an exemption in 262.17.

Photograph 31: HazMart CAA Compactor.

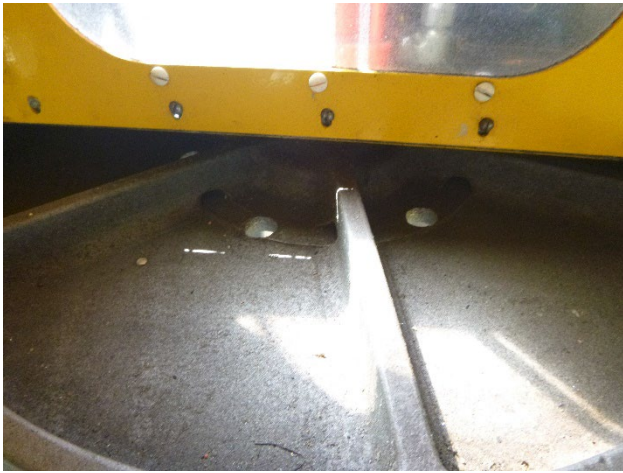
Photograph 32: HazMart CAA Compactor.

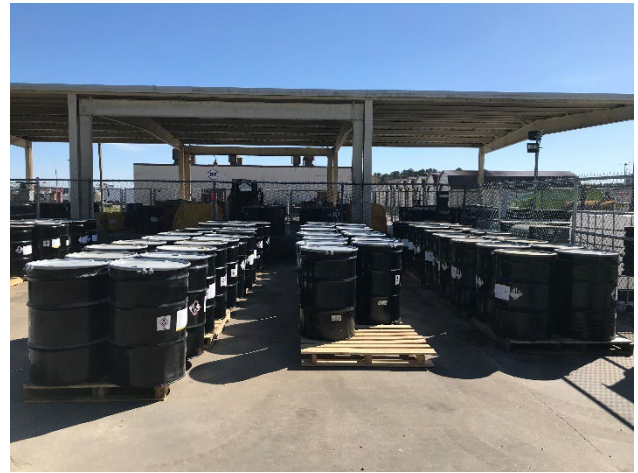
USCG – EC stores full containers of cornstarch blast media on an uncovered concrete pad adjacent to the site hazardous waste permitted container storage area (Photograph 35). This

area is surrounded by fencing and access is through a locked gate. On the day of the inspection there were eighty (80) containers of cornstarch waste (D007). These containers were labeled, in good condition, closed, and stored with adequate aisle space. The oldest accumulation start date observed was February 3, 2023.

Photograph 35: Building 185 Annex CAA.

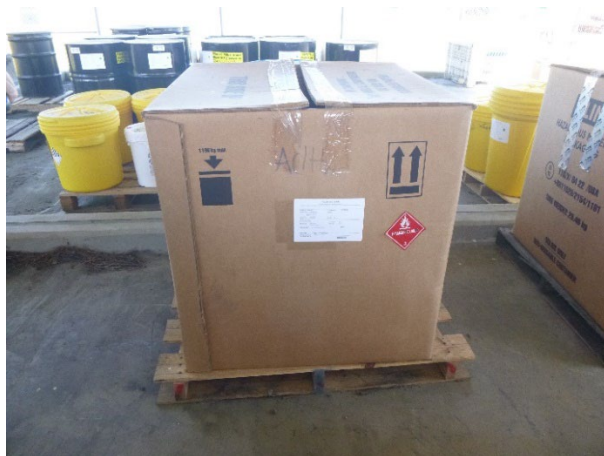
The inspection team noted one label did not include an accumulation start date (ASD) (Photographs 36-38). Facility personnel added the ASD while the inspectors looked on. This was an area of concern for the inspection team.

Photograph 38: Permitted Storage Area.

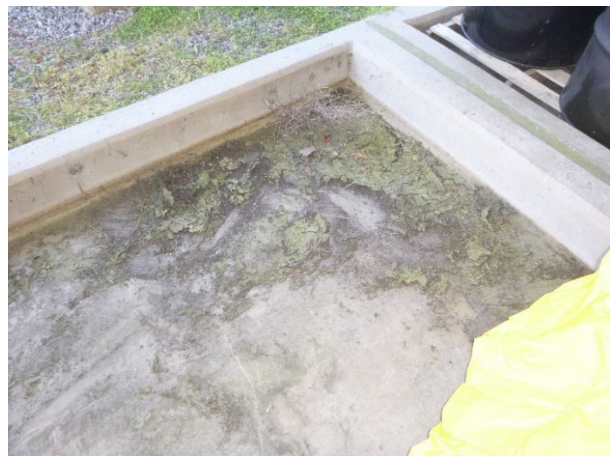
The inspection team noted dirt and grass clippings in the secondary containment of the permitted area. This is an area of concern for the inspection team. Debris in the secondary containment

could inhibit the Base staff from detecting a leak from one of the stored containers. Regular cleaning, when necessary, of the cells should be conducted (Photograph 39).

Photograph 39: Permitted Storage Area.

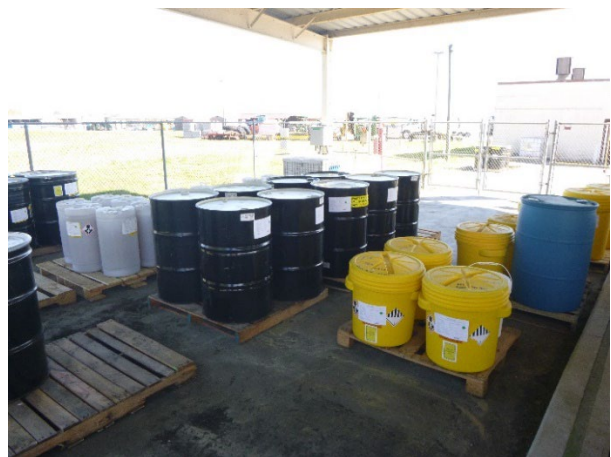
Photograph 40: Permitted Storage Area.

The waste types observed on the day of inspection included: waste sealants and adhesives (D001/D007/D011/D018/D035), waste debris (cups, sticks, wipes, etc.) (D007/D035/F005), waste paint related materials (D001/D007/F003), waste aerosols (D001), alodine wipes (D007), waste filters (D007), shop vacuum dust (D006/D007), abrasive blast media (D007), methylene chloride paint stripper (D007/F002), and soldering waste (D008/D011) (Photographs 36 – 54).

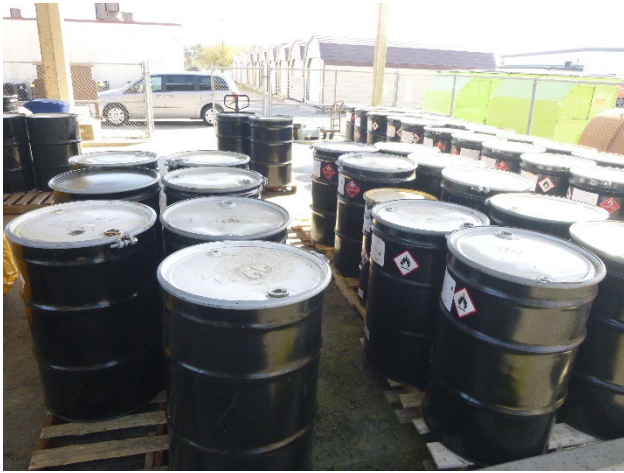
The inspection team toured the permitted container storage area. On the day of the inspection, the inspection team noted that Cell 1 had exceeded its permitted storage capacity for this cell. There were 44 55-gallon containers and one 30-gallon container of waste present on the day of the inspection. This total volume is calculated as 2,450 gallons which exceeds the permitted amount for Cell 1 (Photograph 42).

Photograph 42: Permitted Storage Area.

**Pursuant to Permit Condition Part III, the maximum storage capacity allowed is 2,250 per cell.**

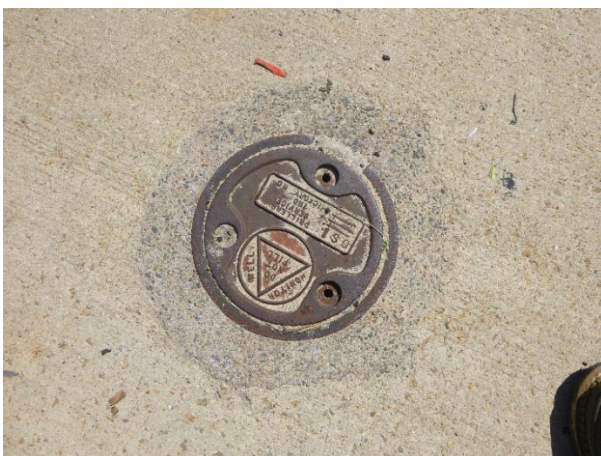
The inspection team inspected the monitoring wells near Building 77, the Aircraft Stripping Area, including well locations 12MW6, 12MW21, 12MW27, and 12MW26. The outer plate on monitoring well 12MW21 was not secure in that the bolts were missing (Photograph 56). The inspection team did not inspect the actual well during the inspection. This was an area of concern. USCG – EC should regularly inspect each monitoring well to ensure security.

Photograph 56: Monitoring Well.
