**Region 6 - Enforcement & Compliance Assurance Division**  
**INSPECTION REPORT**

| Company Name: | <b>Magnolia Water Utility Operating Company LLC</b> | |

### **Site 1: Shadowwood STP- Mechanical (LA0075281) - 09:38 AM (CT) on 05/20/2024**

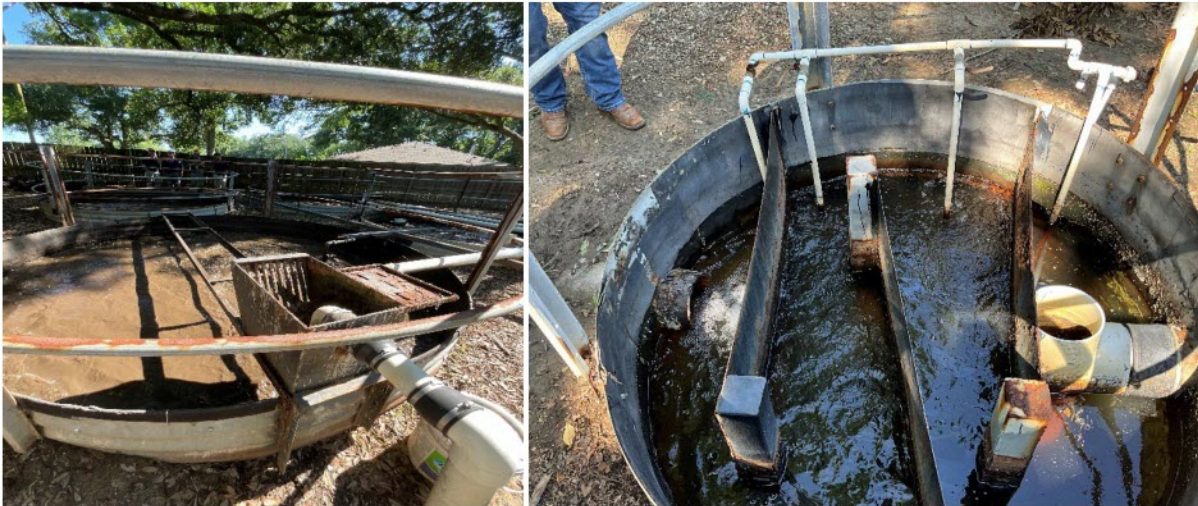
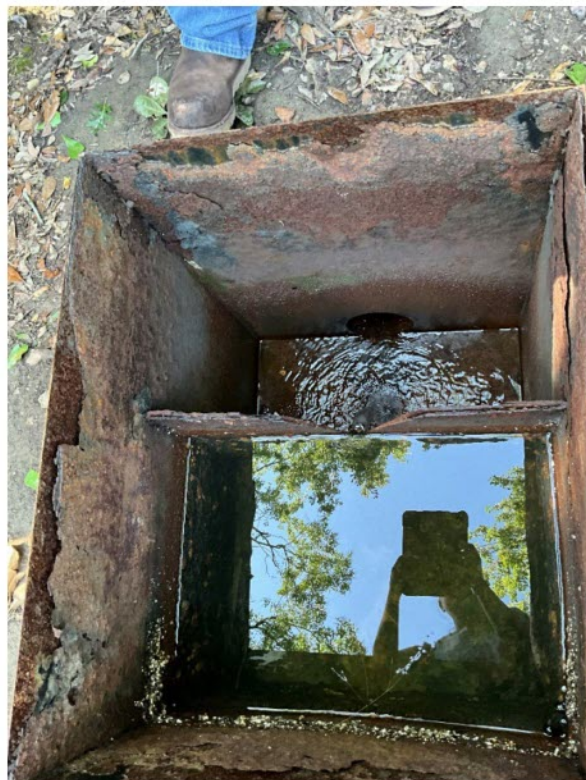
At the time of this inspection, heavy rust and corrosion was visible on the bar screen support bracing, clarifiers, chlorine contact chamber, and the v-notch weir box (see pictures below). Protective coating on the interior walls of the tanks also showed extensive wear and peeling.

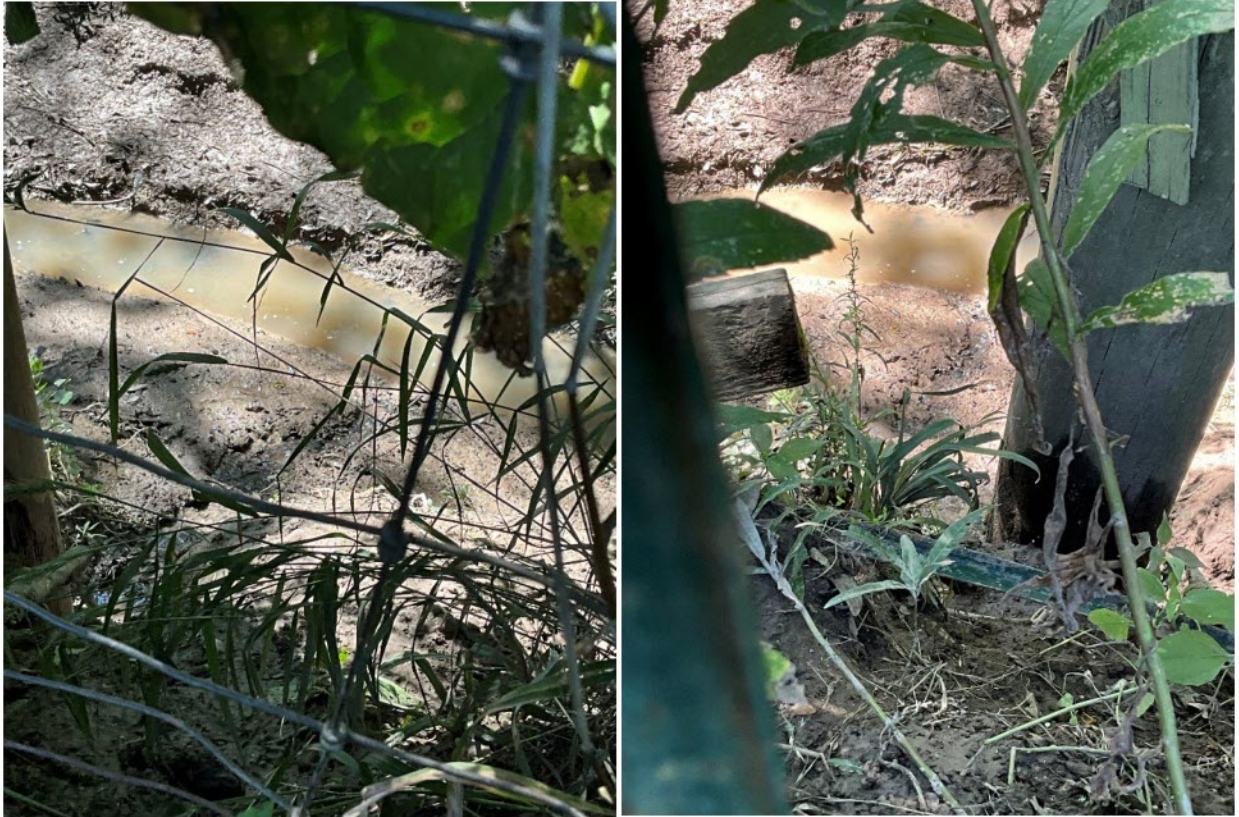
At the time of the inspection, a breach in the primary cell's levee, which was creating an unpermitted discharge, was observed. The bypass location is marked on the following diagram. Pictures of the discharge are also included on the following page.

The required initial notification and the written report for this unpermitted discharge was not provided and could not be located in EDMS. The STP's MOM "Spill/Upset report" was not provided at the time of this report.

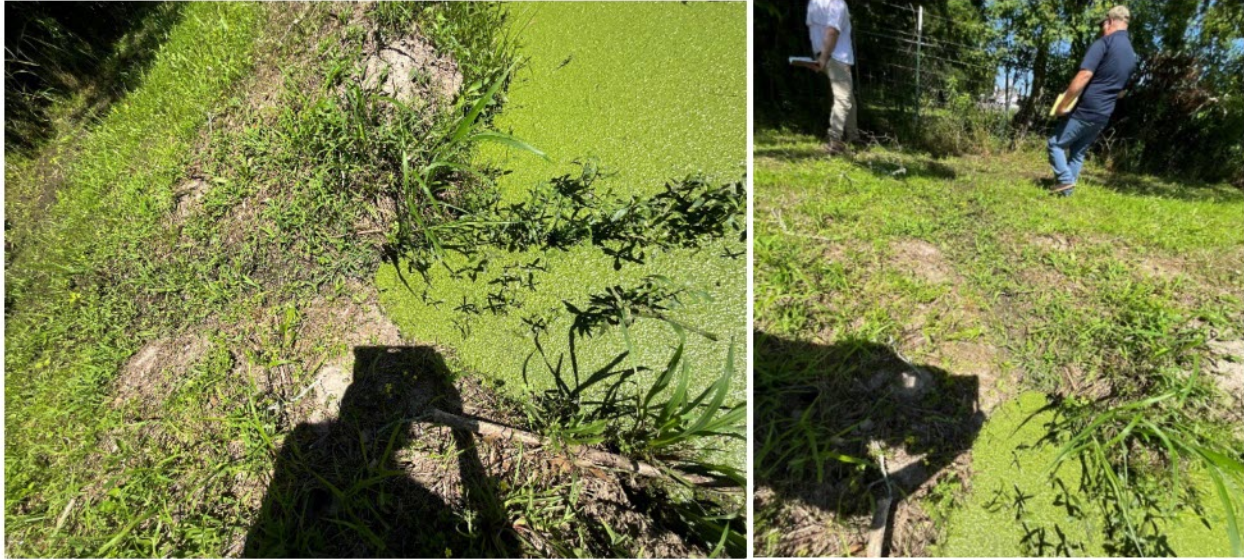
At the time of the inspection, surface water was observed flowing from the neighboring community directly into the primary cell. The inflow location is marked on the following diagram. Pictures of the discharge are also included on the following page.

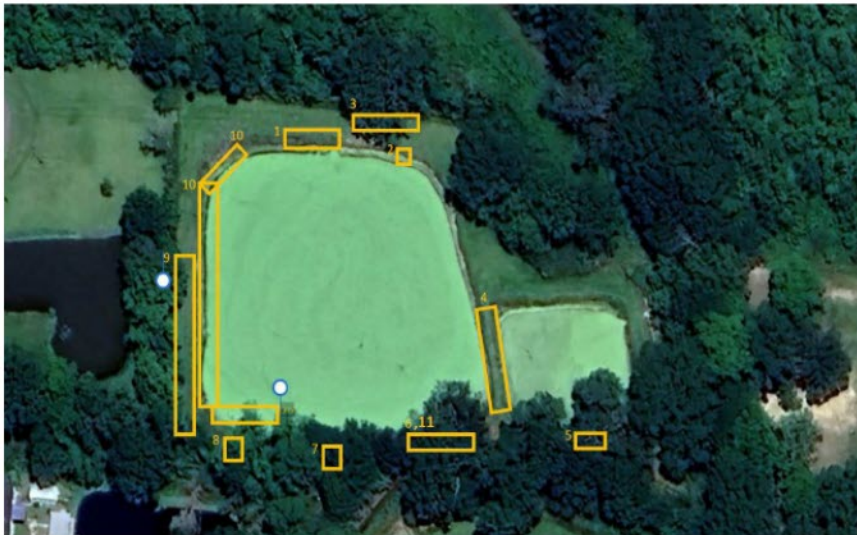
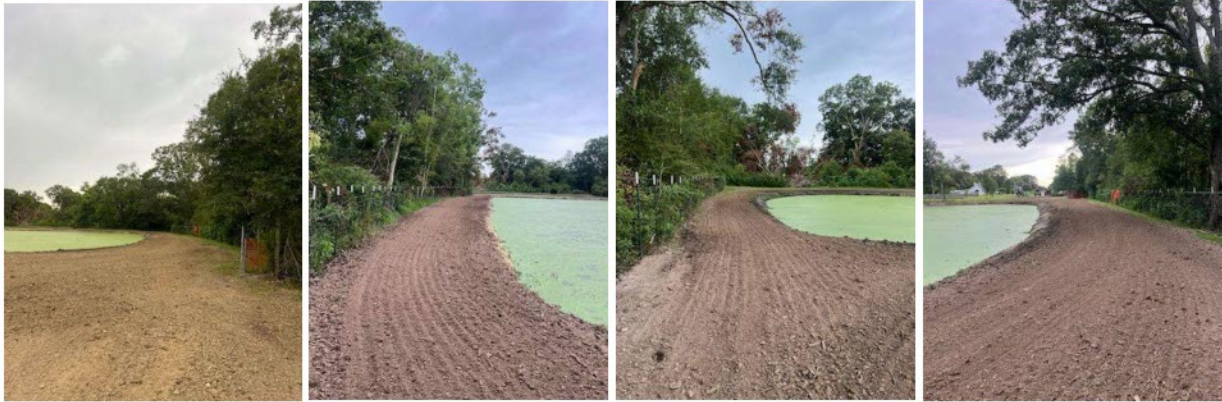
In an e-mail from Mr. Graman dated 7/27/2024 he explains that “berm repairs have been completed in July 2024 to stop the leaking which was observed from Cell 1.” The scope of work preformed and the pictures of completed work were provided on 7/29/2024. See below.

## SCOPE OF WORK

1. Excavate and backfill existing rodent holes.
2. Increase berm elevation 2ft, in area ~6ft x 6ft.
3. Increase berm elevation 2ft, in area ~10ft x 30ft.

4. Widen berm to 6ft, and increase elevation 3ft. Excavate and backfill existing rodent holes.
5. Increase berm elevation 2ft, in area ~6ft x 6ft.
6. Increase berm elevation 2ft, in area ~7ft x 50ft.

7. Increase berm elevation 2ft, in area ~7ft x 12ft.
8. Increase berm elevation 2ft, in area ~4ft x 4ft.
9. Increase berm elevation 2ft, in area ~10ft x 150ft.

10. Remove existing debris from lagoon bank.
11. Emergency Ber Repair:
  - Install Silt Fence along all perimeters of area of work.
  - Widen 100 LF of unstable berm ~4 FT with imported select fill.

- Drive approximately 100 Linear Feet of non-coated, 14 foot long steel sheet piles along edge of unstable berm to provide berm stabilization while excavating.

- Excavate approximately 100-feet of trench, 3 foot wide and 6 foot to 9 foot deep in order to remove existing top soil, root systems and associated growth from existing berm.

- Backfill trench with imported select fill with 12" loose lifts compacted to a minimum of 95% compaction.
  - Remove sheet piles.
  - Remove silt fence.

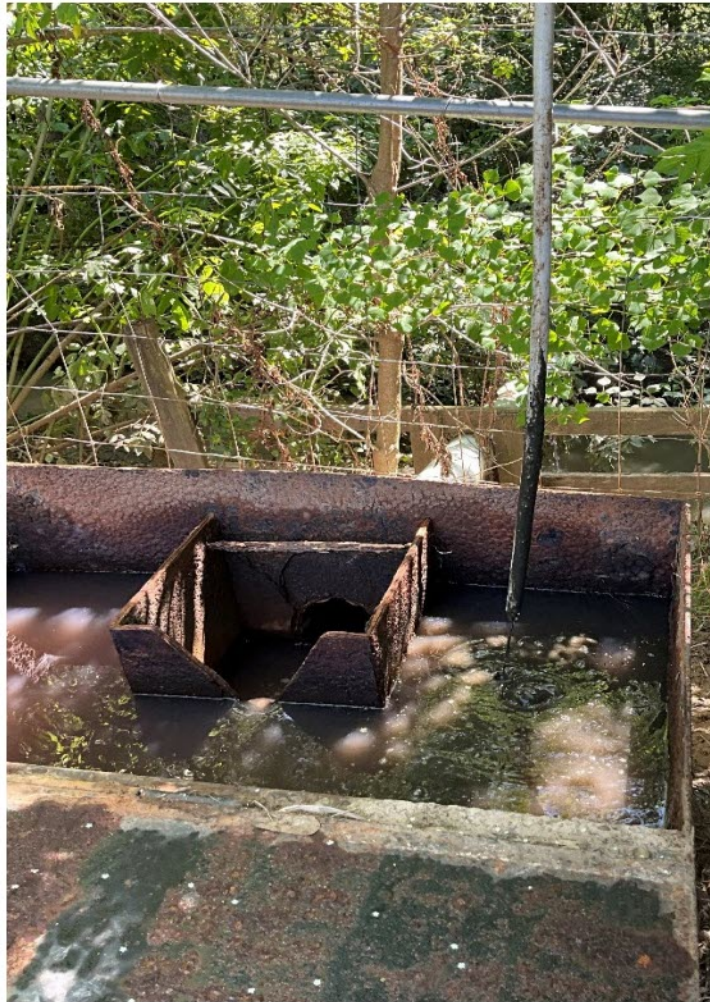
At the time of the inspection, approximately 2.5 foot of sludge was observed in the chlorine contact chamber (see picture below). The sites' MOM states, "During each site visit, Magnolia Water UOCs personnel shall inspect each chlorine contact chamber for the presence of floatable and settled solids. Any floatable solids in the chlorine contact chamber shall be removed by skimming on the same day the problem is identified. If settled solids are present in the chlorine contact chamber, they shall be removed if, at any location within the chlorine contact chamber, the settled solids are deep enough to register when measured with a Sludge Judge sampling device. Removal of floatable and settled solids within the chlorine contact chamber shall be documented by Magnolia Water UOCs personnel on the applicable plant's Operation and Maintenance Report ("O&M Report")."

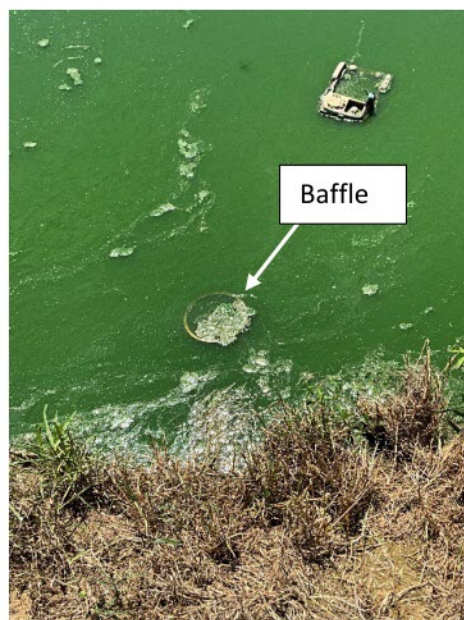
At the time of the inspection, the baffle from the final pond to chlorine contact chamber was not installed to prevent solids from entering the chlorine contact chamber and being discharged. See the picture below.

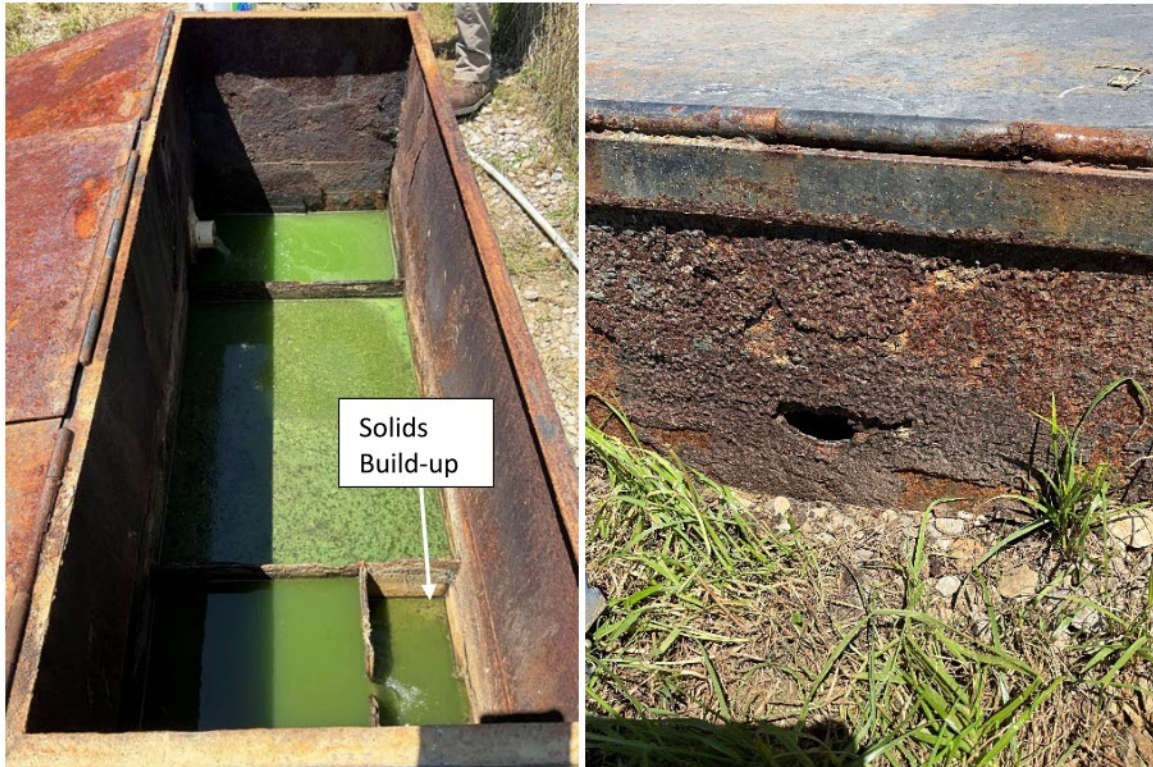
At the time of the inspection, solids were observed built up in the discharge vault and after the v-notch weir. Rust deterioration was observed on the chlorine contact vault and v-notch weir. See the pictures below.

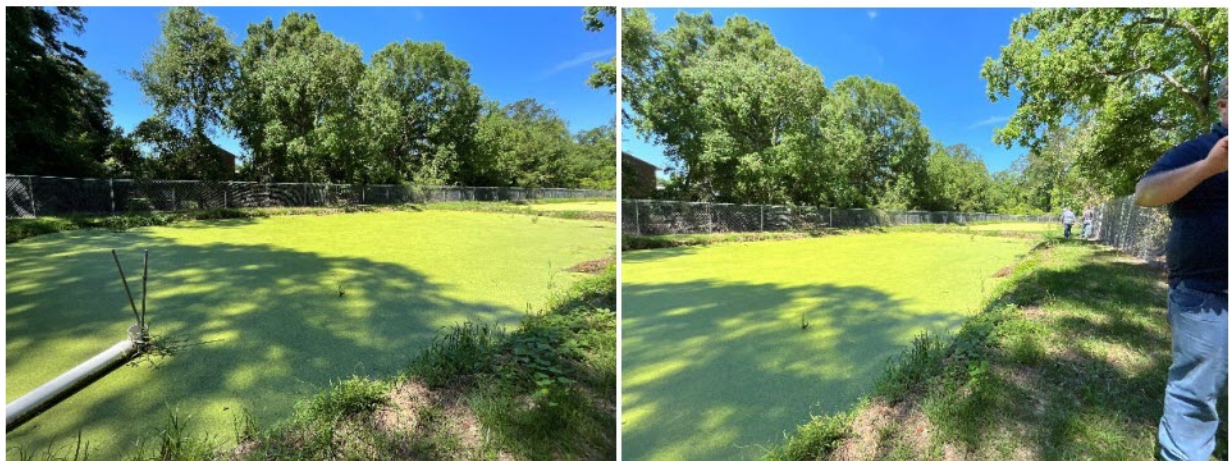
At the time of the inspection, the abandoned lagoons were full and appeared to be discharging. Information was requested on the closure and elimination of the unpermitted discharge from the lagoons. In an e-mail from Mr. Graman, dated 7/29/2024, he explained that "Magnolia Water UOC is working with a licensed Engineer to coordinate the needed improvements and permitting with LDH (Louisiana Department of Health). The Lagoon effluent is planned to be plugged and the Lagoon cells brought into use as a flow equalization structure to buffer the peak flows from the system."

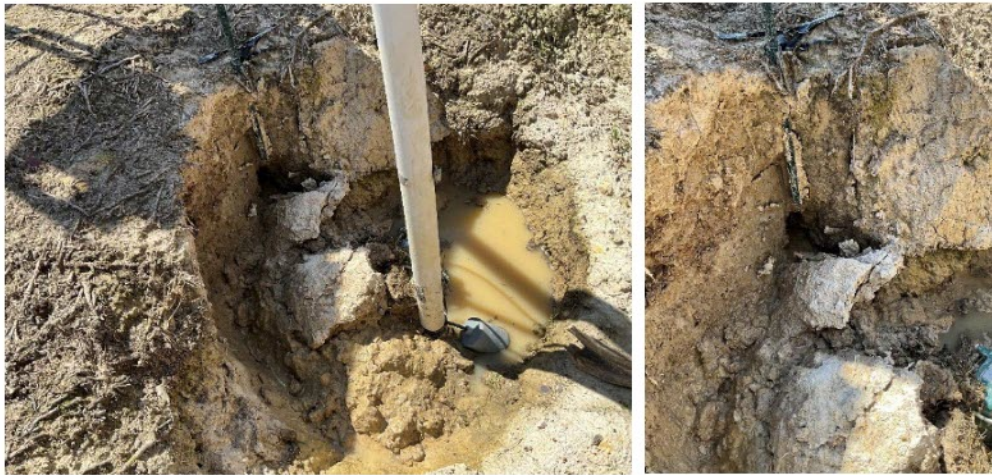
At the time of the inspection, the pre-cast concrete 8,500-gallon aeration chamber was observed leaking (see pictures below). Information was requested related to the repairs required to fix the leaking concrete aeration chamber. In an e-mail from Mr. Graman, dated 7/29/2024, he explained that he is “working with Operations group to confirm the install data of the sump pump to control the leaking water.” And is “working with the Operations group to confirm the next steps for investigating and planning repair to address the leaking tankage.”

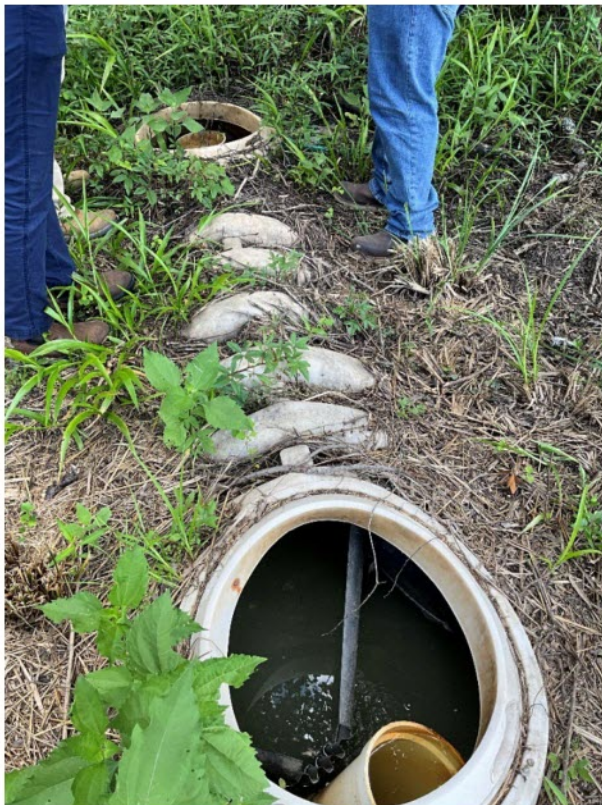
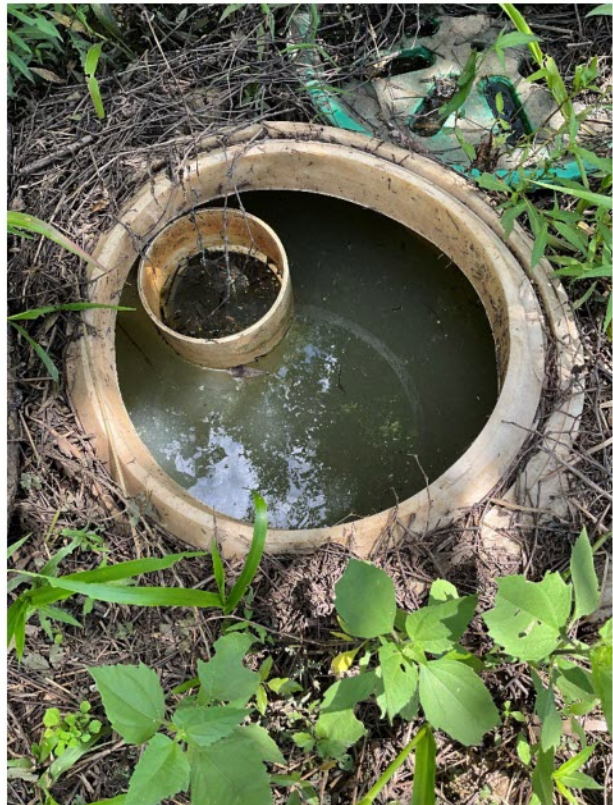
At the time of the inspection, the chlorine contact chamber (CCC) was located in a flooded area of the receiving stream (see picture below). The STP’s discharge sampling location appeared to be full and influenced by the river’s backflow. When the river water level rises it inundates the CCC and influences the discharge samples and floods the discharge sampling location. In an e-mail from Mr. Graman, dated 7/29/2024, he explained that “Magnolia Water UOC is working with a licensed Engineer to plan the needed repairs to modify the CCC effluent piping to prevent backflows in this manner.”

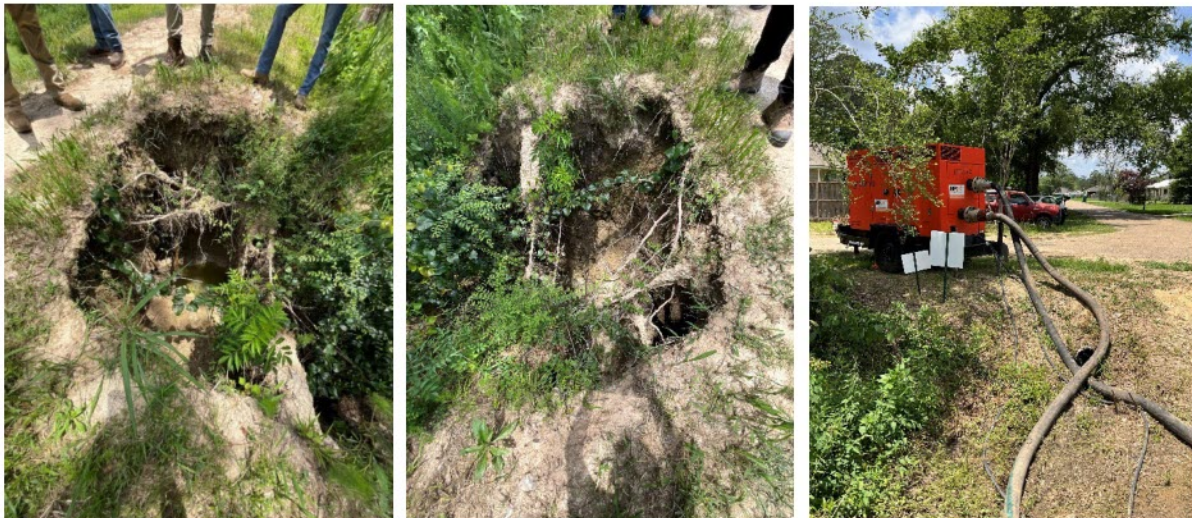
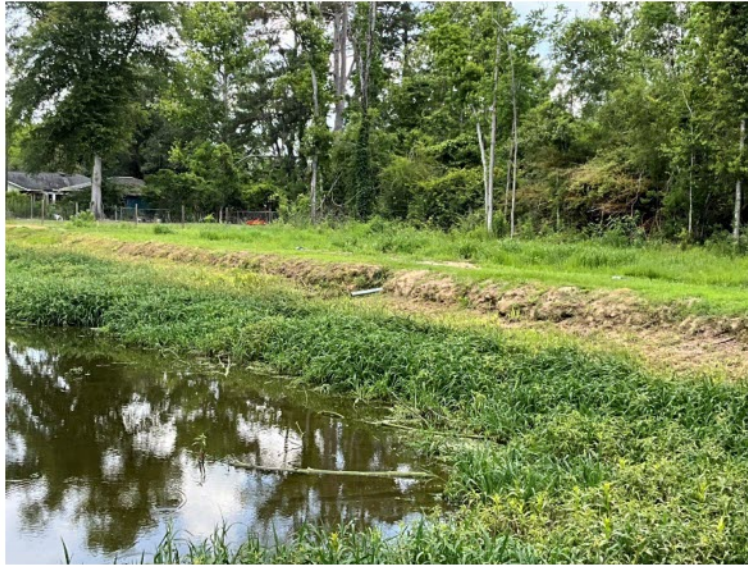
At the time of the inspection a large breach in the main pond's levee was observed (see pictures below). A large pump was being used to pump effluent from the main cell into the second smaller cell in order to lower the main pond's level. This was done in an attempt to prevent discharge through the levee breach. Mr. Graman explained that due to boundary disputes with the local parish, heavy equipment was unable to be brought in to conduct the required repairs to the levee.

In a supplemental letter addressing the reported “No Discharge” conditions at the Albany Heights STP dated 02/09/2024, Mr. Graman details that “since the submittal of the Final STP Reports, damage to the berms has been discovered which has resulted in leaking from that location. This damage was previously unobserved as the damage was in an area that was unable to be cleared of vegetation due to the property line. Coordination is underway to repair this damaged section and stop the leaking from the berm. It is possible that an effluent discharge will be re-established when the berm repairs are performed to the leaking area.”

At the time of the inspection, a path forward for the berm breach was requested. In an e-mail from Mr. Graman, dated 7/29/2024, he explained that “Magnolia Water UOC is working to get parish approval for the addition of a culvert to the drainage ditch which will facilitate the install of an Access Road to the facility. This Access Road will allow the needed equipment and dirt material to be brought on site to perform the berm repairs to the leaking area.”

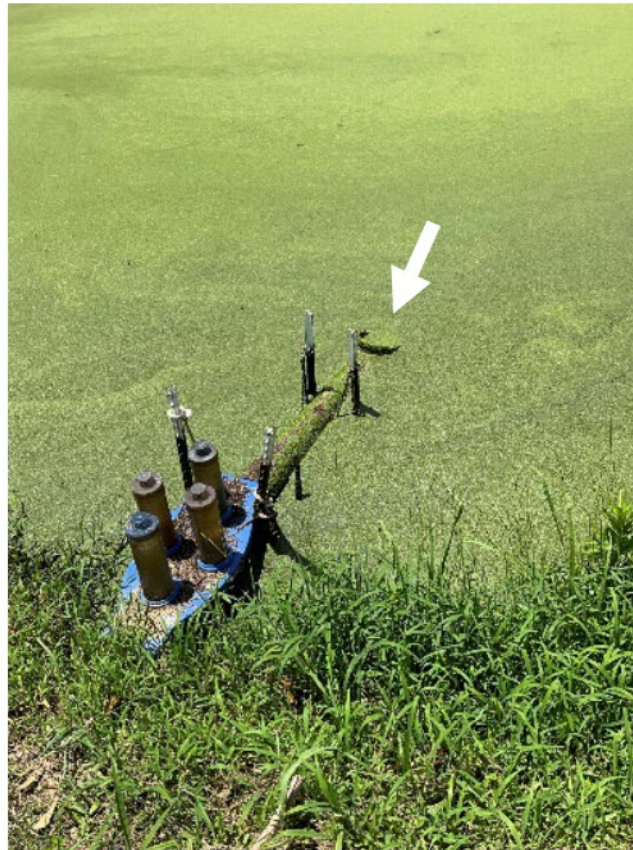
At the time of the inspection, the baffle from the final pond to chlorine contact chamber was not installed properly and was therefore unable to prevent solids from entering the chlorine contact chamber and being discharged. See the picture below.
