**Class I and II Well Inspection Form**  
**US Environmental Protection Agency – Region 4**  
**Underground Injection Control Program**  
61 Forsyth Street SW, MC 9T25, Atlanta, Georgia, 30303  
Phone: (404)562-9424

Facility Name: *Blackjack Plant* \_\_\_\_\_  
Street Address: *4940 Blackjack Plant Road* \_\_\_\_\_  
City: *Jay* \_\_\_\_\_ County: *Santa Rosa* \_\_\_\_\_ State: *FL* \_\_\_\_\_ Zip: *32535* \_\_\_\_\_  
Nature of Business: *Oil and gas production* \_\_\_\_\_  
Facility Owner/Operator: *Black Creek Energy, LLC* \_\_\_\_\_ Phone: *(601) 431-5386* \_\_\_\_\_  
Email: *harris.butler@butlerroyals.com* \_\_\_\_\_  
Facility Contact (if different): *Michael Wetzel* \_\_\_\_\_ Phone: *(850) 324-6271* \_\_\_\_\_  
O/O Mailing Address: *140 Virginia Street, Suite 402* \_\_\_\_\_  
City: *Richmond* \_\_\_\_\_ County: *NA* \_\_\_\_\_ State: *VA* \_\_\_\_\_ Zip: *23209* \_\_\_\_\_

Well Name & #: *St. Regis Paper Company #13-3* \_\_\_\_\_  
Well Type (see table): *Enhanced Recovery (EOR)* \_\_\_\_\_ State Permit: API # *0911320041* \_\_\_\_\_  
Latitude (°N): *30.8545 °N* \_\_\_\_\_ Longitude (°W): *-87.102597 °W* \_\_\_\_\_ Elevation (ft): *NA* \_\_\_\_\_  
Injection Method (c

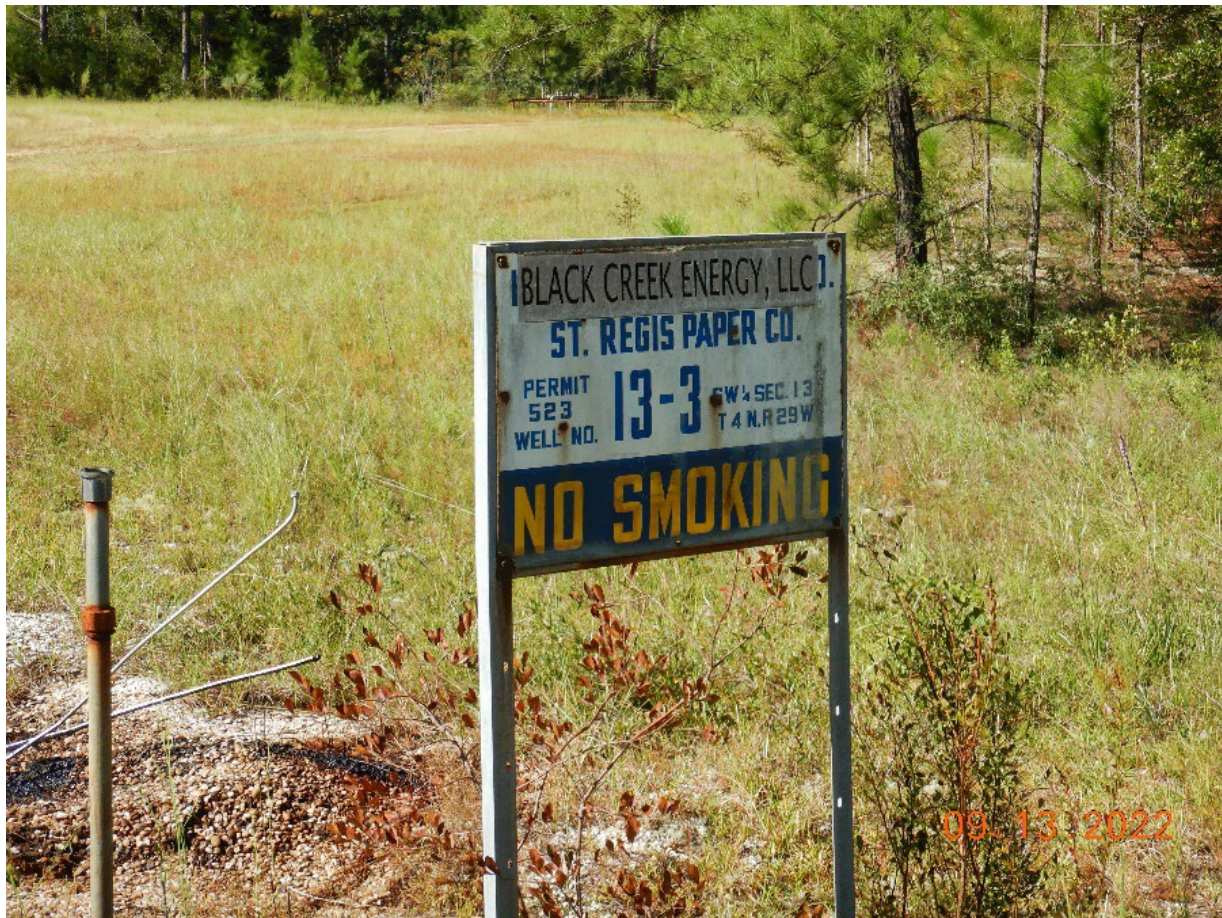
Description: *Looking south, St. Regis Paper Company #13-3 sign alongside access road.* \_\_\_\_\_

**Photograph 1:** Looking south, St. Regis Paper Company #13-3 sign alongside access road.

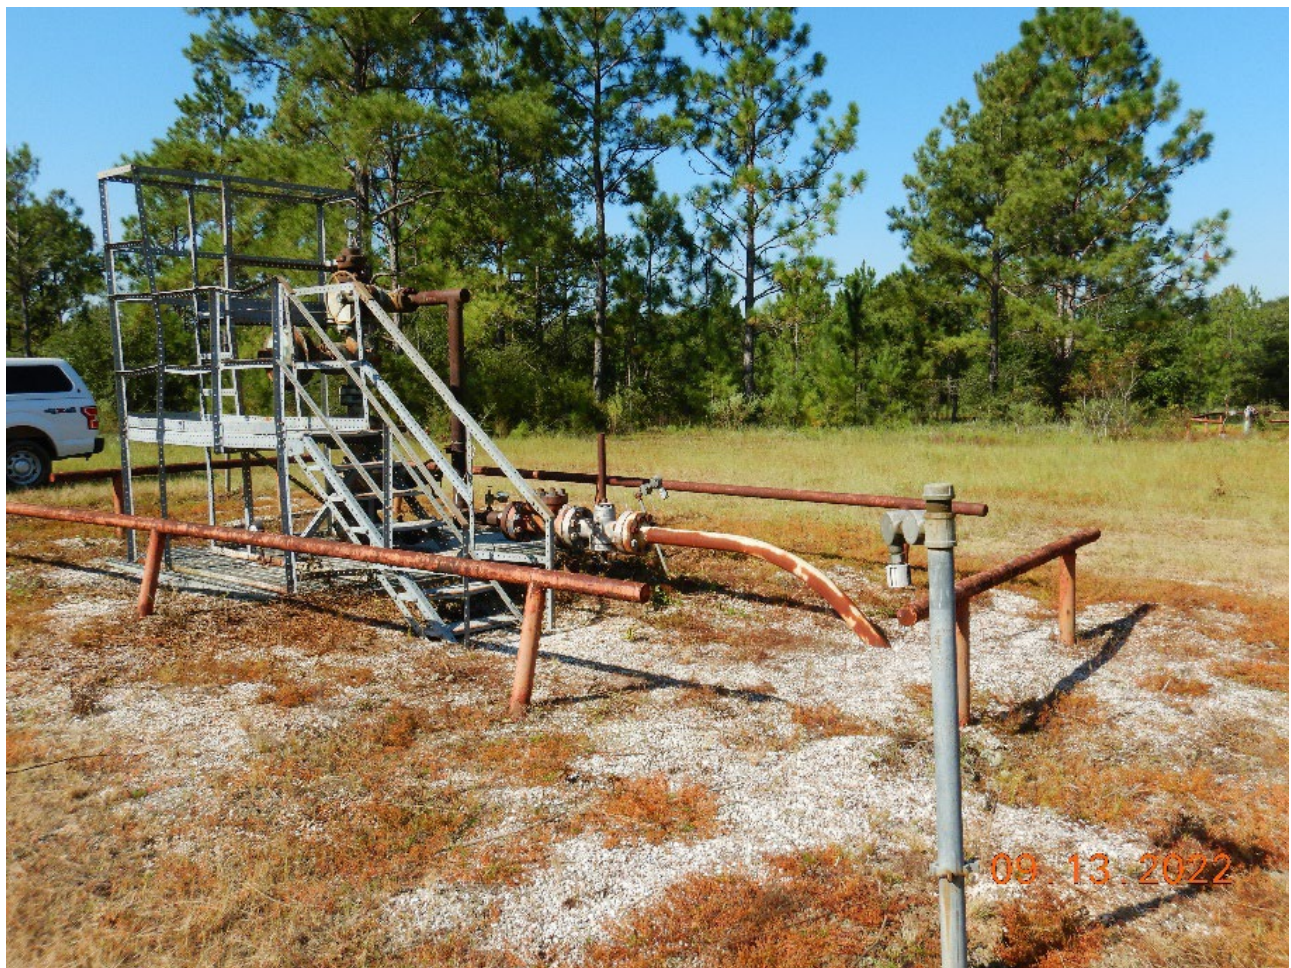
Description: *Looking southwest, site overview showing well head, pressure gauges, valves, and access stairs.* \_\_\_\_\_

**Photograph 2:** Looking southwest, site overview showing well head, pressure gauges, valves, and access stairs.

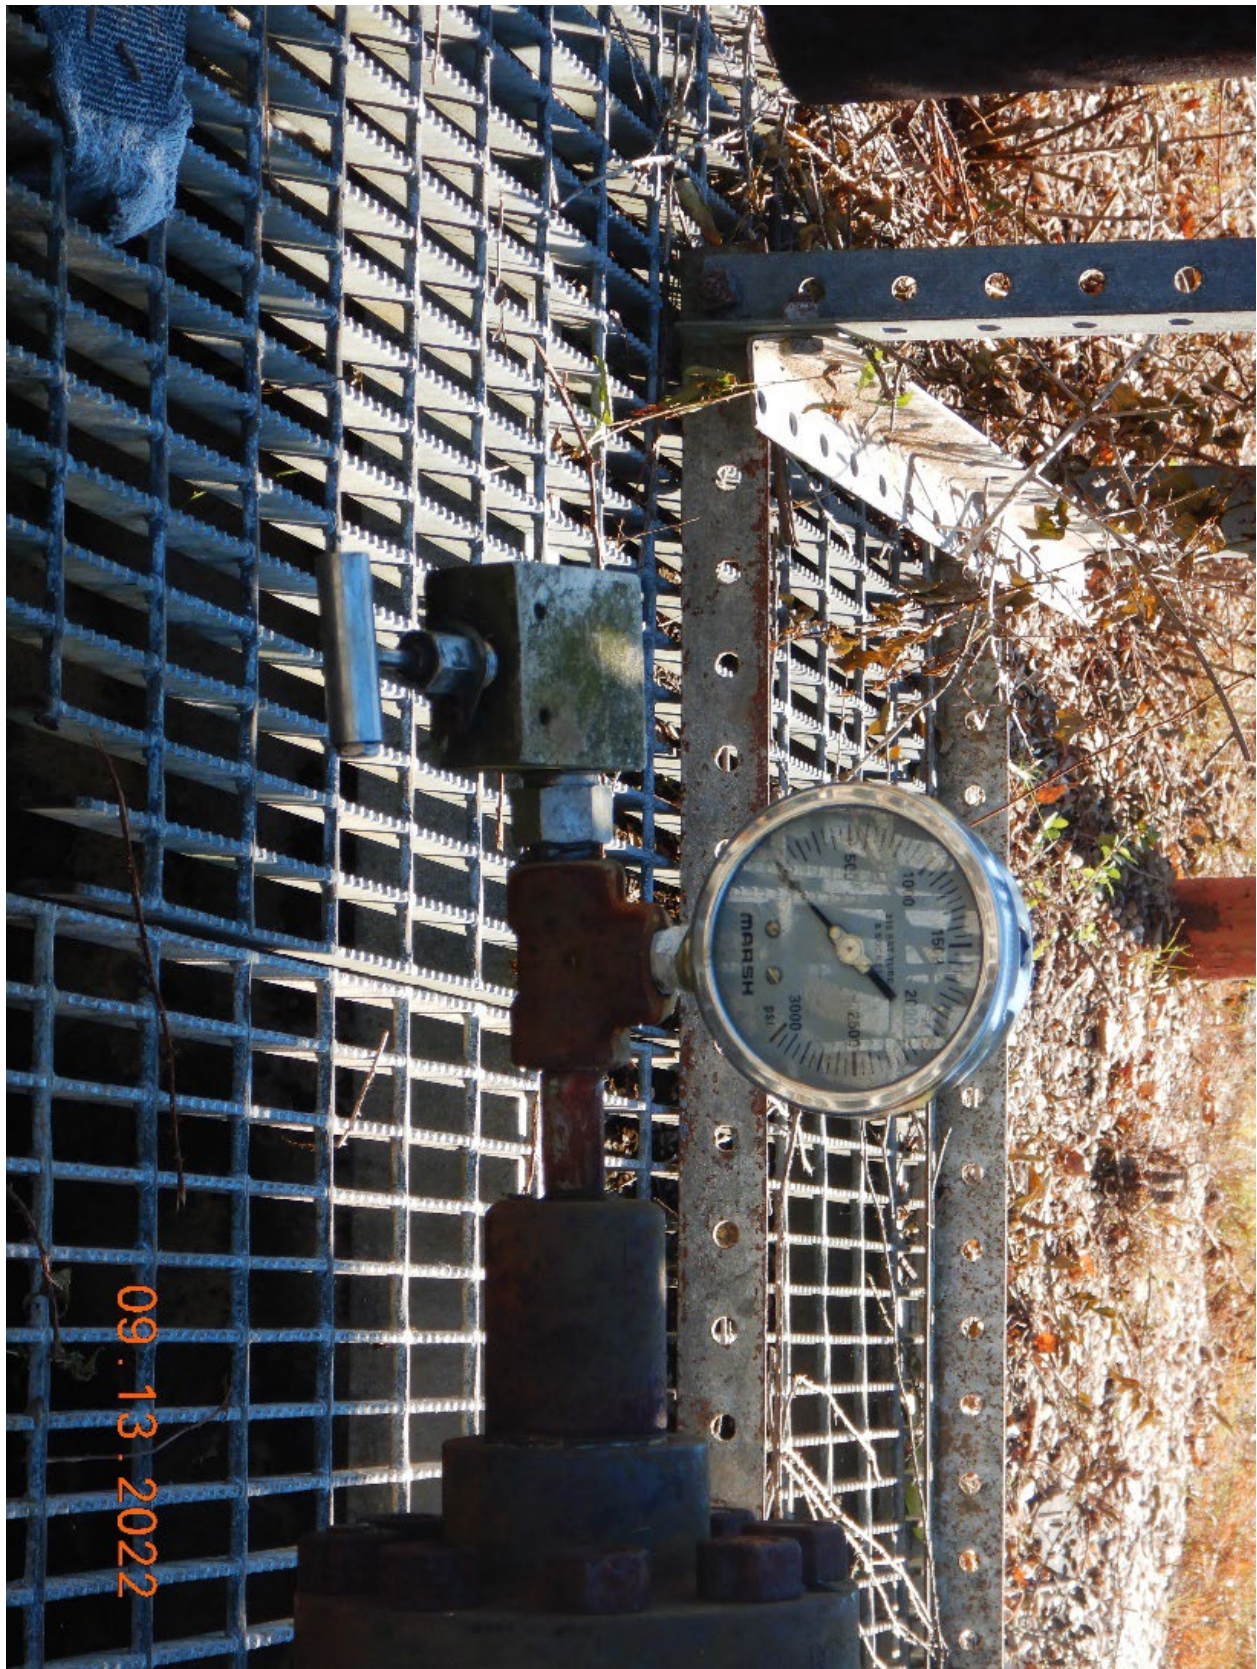
Description: *Looking east, closeup view of production casing pressure gauge reading 0 psi.* \_\_\_\_\_

**Photograph 4:** Looking east, closeup view of production casing pressure gauge reading 0 psi.

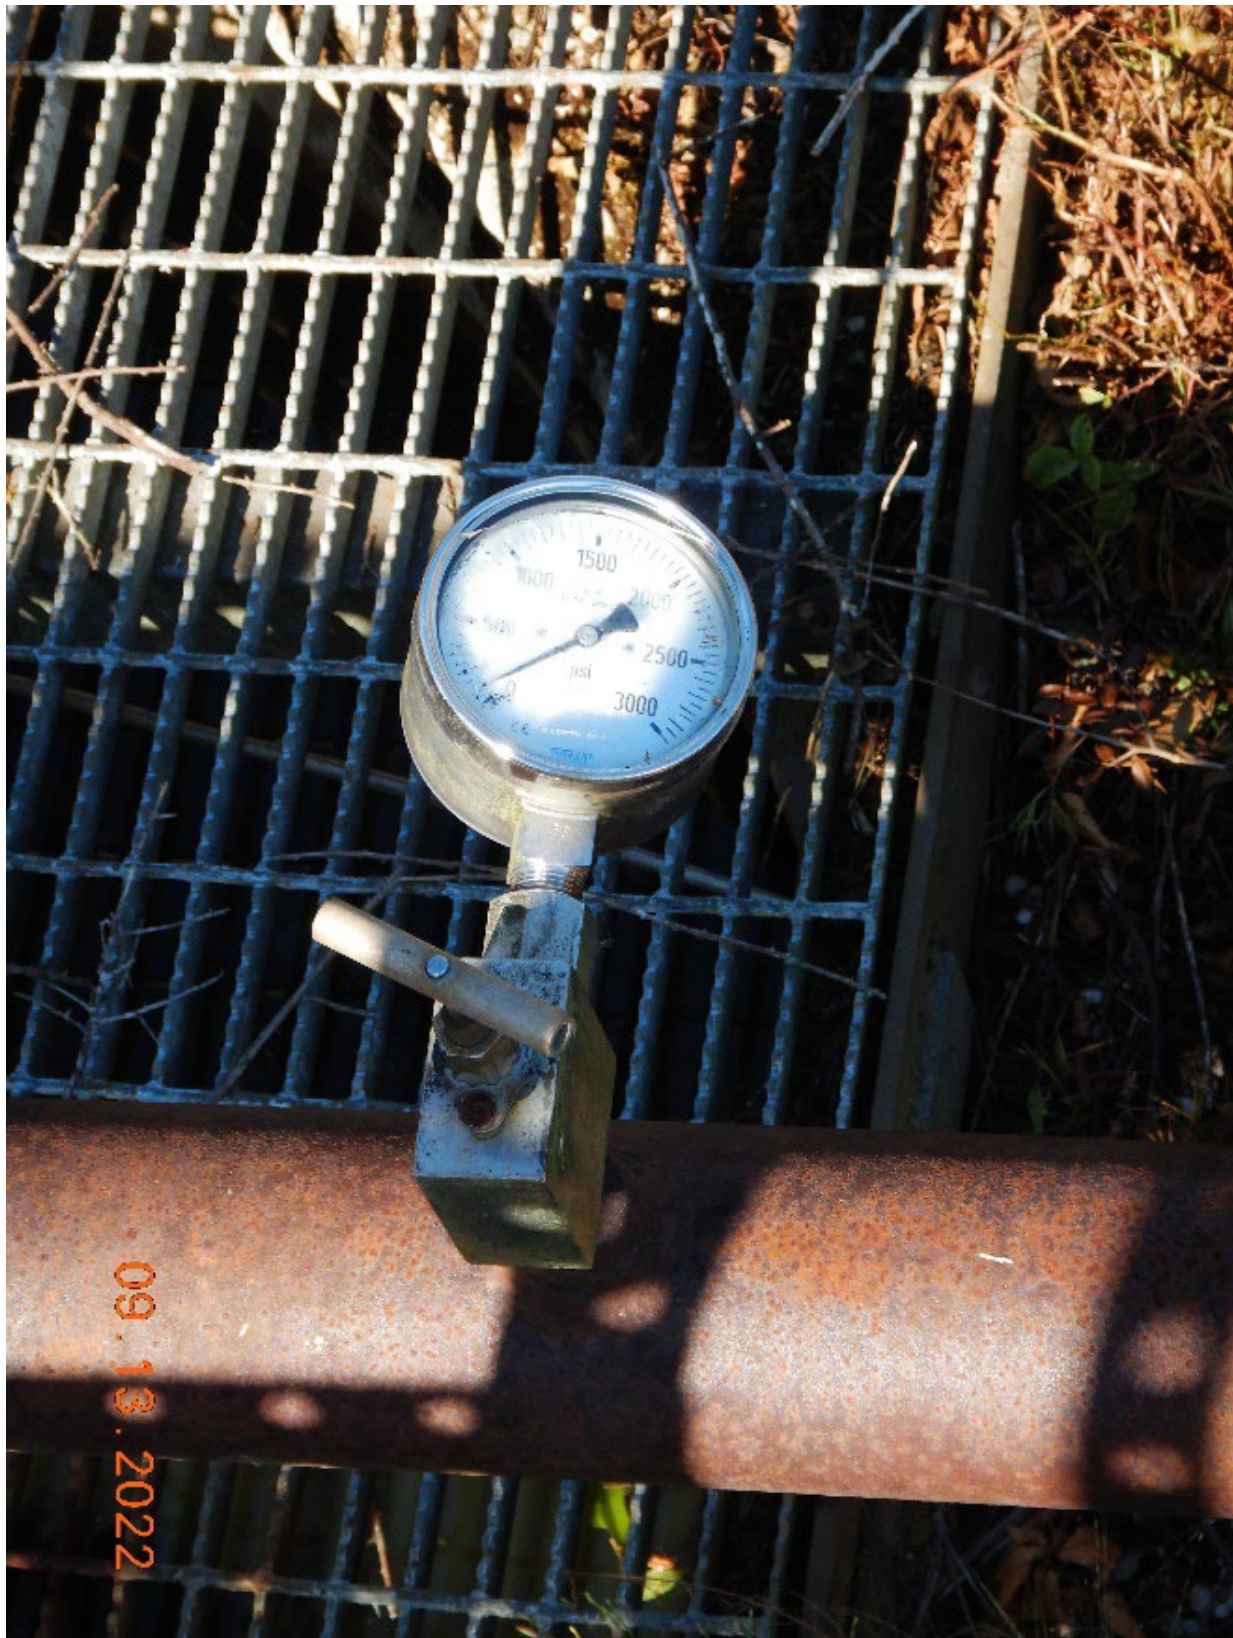
Description: *Looking down, closeup view of line pressure gauge reading 0 psi.* \_\_\_\_\_

**Photograph 5:** Looking down, closeup view of line pressure gauge reading 0 psi.

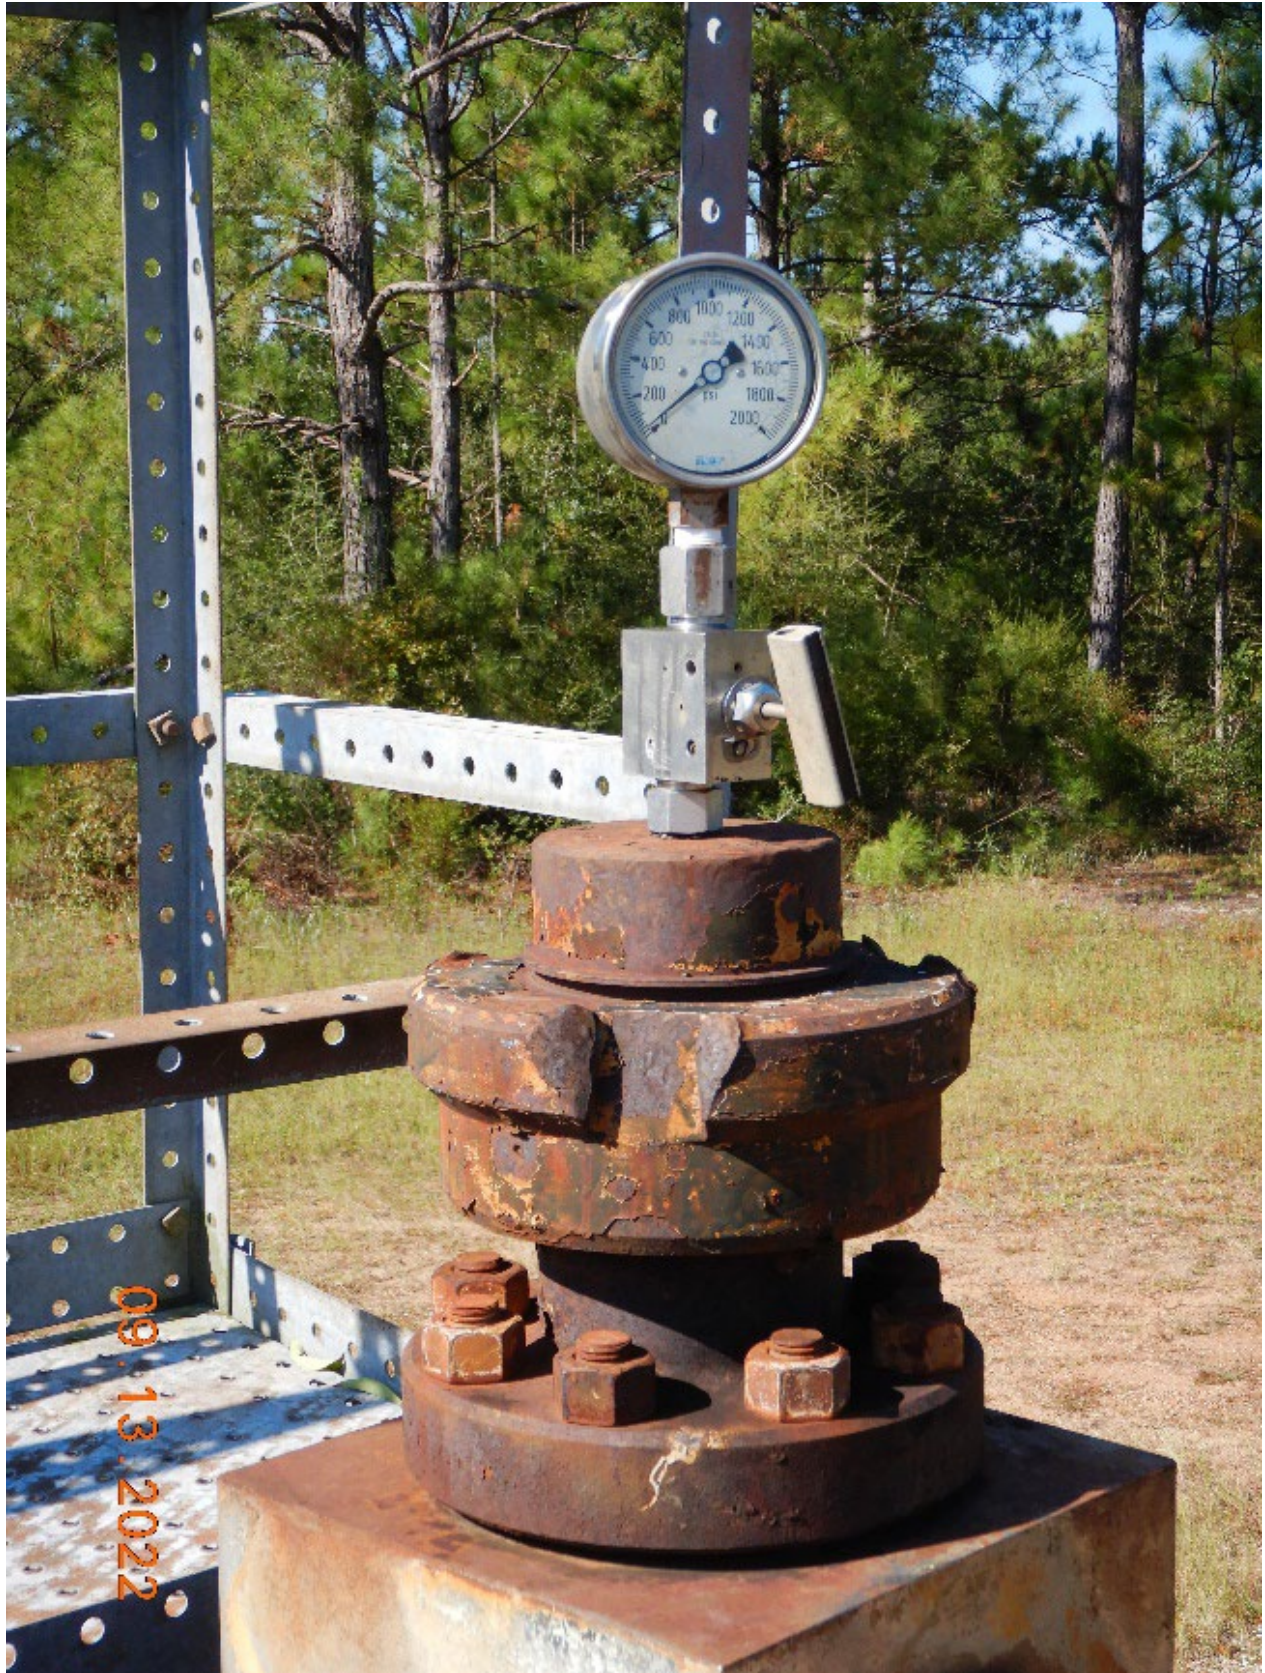
Description: *Looking south, closeup view of internal pressure gauge reading 0 psi.* \_\_\_\_\_

**Photograph 6:** Looking south, closeup view of internal pressure gauge reading 0 psi.
