## **RCRA Inspection Report**

Wacker Chemical Corporation  
854 N Main Street  
Calvert City, Kentucky 42029  
Marshall County

EPA ID# KYR000047274  
NAICS# 325510 – Paint and Coating  
Manufacturing

December 10, 2024, 9:00 a.m.

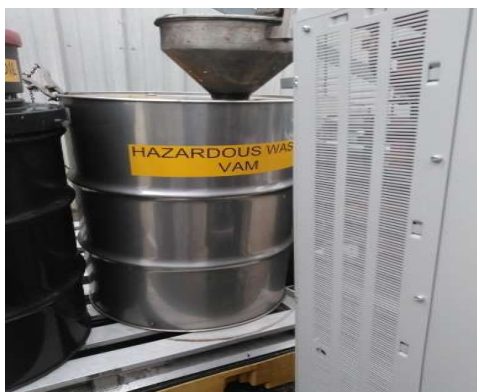
The inspectors observed one 55-gallon satellite container with a latched funnel accumulating VAM waste stored behind the maintenance shop (Photo-1). The container was observed to be closed and labeled with the words "Hazardous Waste". There was no indication of hazards of the content.

Photo-1 SAA Container (Missing Indication of Hazard Label (IOH))

**Pursuant to 401 KAR 39:080 Section 1(1) [40 C.F.R. § 262.15(a)(5)], which is a condition of the SAA Permit Exemption, a generator is required to mark or label its containers with an indication of the hazards of the contents.**

On 12/13/2024, the facility sent a photo of the satellite container with a label indicating the hazards of the contents.

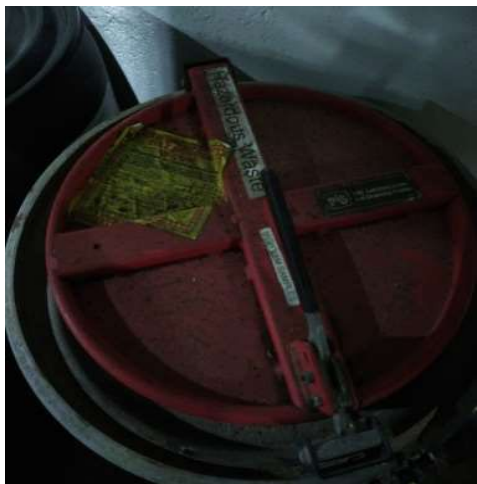
The analytical lab provides quality control testing for inbound samples from the production area and final outbound samples from the finished product. There was one 55-gallon satellite container staged outside the lab accumulating waste VAM samples. The container was observed to be closed and labeled with the words "Hazardous Waste". The label was on the lid of the satellite container (Photo-2). The label was observed to be dirty and not clearly visible. There was no indication of hazards of the contents.

Photo-2 SAA Container-lab (Missing IOH)

**Pursuant to 401 KAR 39:080 Section 1(1) [40 C.F.R. § 262.15(a)(5)], which is a condition of the SAA Permit Exemption, a generator is required to mark or label its containers with an indication of the hazards of the contents.**

On 12/13/2024, the facility sent photo of the satellite container with a label indicating the hazards of the contents. The inspectors also observed nitrile gloves in a 3-gallon container. On 12/13/24, the facility personnel sent an email regarding the lab glove recycle program. Wacker sends approximately 200 pounds of nitrile gloves for recycling every year.

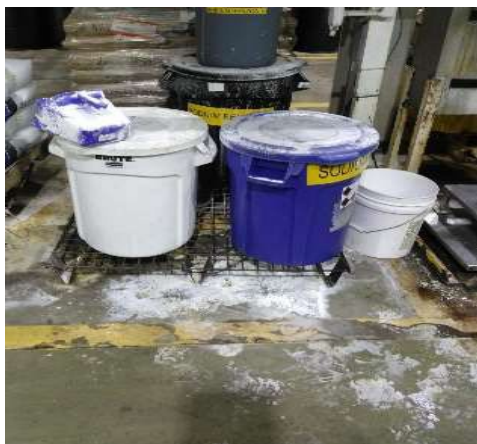
Adjacent to the Lab SAA container, the inspectors observed few containers and several tanks of 500-gallons capacity containing products (Photo-3 and Photo-4). According to the facility personnel, they were in various stages of processing. Although there was no activity in this area during the inspection, the inspectors observed leaks and spills on the floor near the tanks as well as near the containers. The facility should make a proper waste determination and dispose of the spilled material accordingly. In addition, the facility shall take steps to ensure to prevent and/or minimize the release of hazardous substance to the environment.

Photo-3 Waste Products on the Floor  
Adjacent to the Lab

**Pursuant to 401 KAR 39:080, Section 1(1) [40 C.F.R. § 262.17(a)(6)], which incorporates 401 KAR 39:080, Section 1(1) [40 C.F.R. § 262.251], and is a condition of the LQG Permit Exemption, a generator is required to maintain and operate its facility to minimize the possibility of a fire, explosion, or any unplanned sudden or non-sudden release of hazardous waste or hazardous waste constituents to air, soil, or surface water which could threaten human health or the environment.**

**Pursuant to 401 KAR 39:080, Section 1(1) [40 C.F.R. § 262.11], a person who generates a solid waste, as defined in 401 KAR 39:080, Section 1(1) [40 C.F.R. § 261.2], must make an accurate determination as to whether that waste is a hazardous waste in order to ensure wastes are properly managed according to applicable RCRA regulations articulated in 401 KAR 39:080, Section 1(1) [40 C.F.R. § 262.11].**

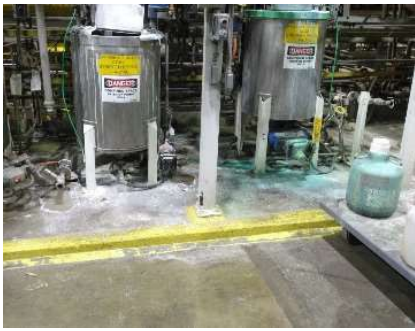
Photo-4 Leaks and Spills of Products near the Process tanks adjacent to the Lab.

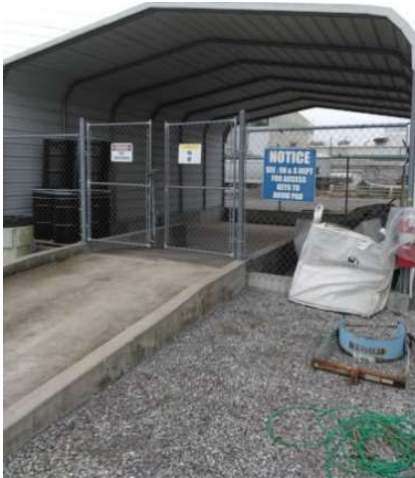
The hazardous wastes are stored in a covered concrete pad enclosed by a chain link fence and a concrete berm (Photo-5). The inspectors observed a sign indicating the storage area and “No Smoking”. The storage area was equipped with a fire extinguisher and a spill kit. There was no hazardous waste in the storage at the time of inspection. According to the records, the last shipment was on 11/11/2024. There were no leaks or spills observed in the accumulation area.

Photo-5 Central Accumulation Area

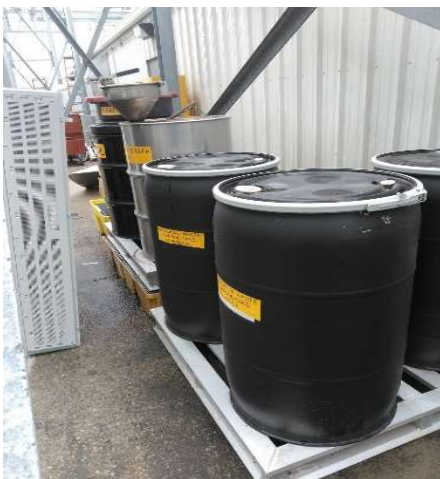
The inspectors observed three universal waste 55-gallon containers on a spill pallet. One contained Aerosol Cans-Lubricant; Aerosol Cans-Paint; and Aerosol Cans-Pesticides (Photo-6). All the containers were observed to be closed and labeled. According to the facility personnel, universal waste is picked up by Clean Harbors, Deer Park and La Porte Texas and Clean Harbors Baton Rouge, Louisiana and Eldorado Arkansas once a year and the length of time for storage is tracked using nonhazardous manifests.

Photo-6 Universal Waste Staging Area
