# RCRA Compliance Inspection Report

## W.R. Grace & Co.

Albany, Oregon

August 2, 2021 – August 3, 2021

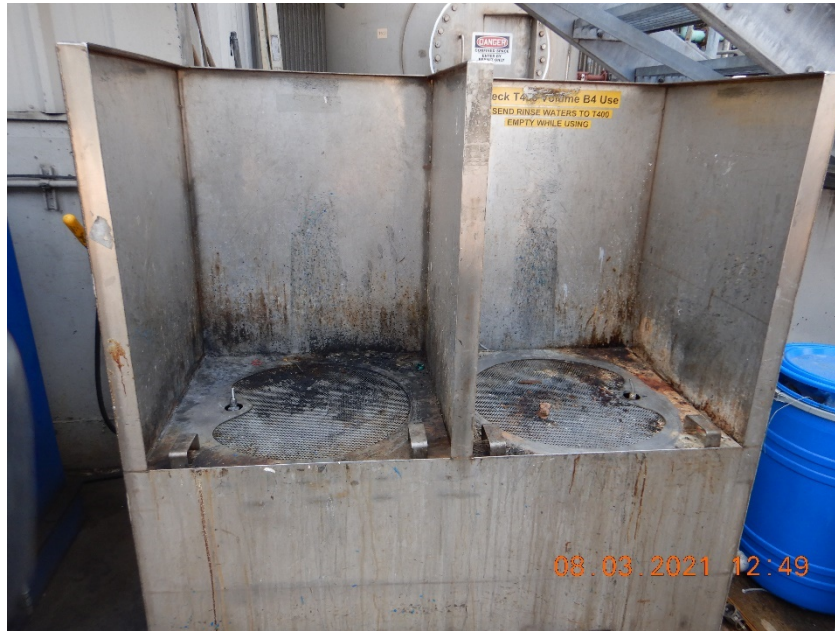
{Photograph 2, Attachment 08}

The inspection team then moved to the drum washing station at approximately 10:30. Mr. Wolters observed a reading of 697 ppm from the grate on the drum washing station. Specifically, the right-hand grate as shown in Photo 2 in Attachment 08. Ms. Chavez asked the facility where the material from the drum rinsing station is discharged to. Mr. Bradshaw explained the material is sent to the Tank T-400 hazardous waste tank. Mr. Bradshaw also explained that the facility procedure is to line up RCRA empty drums, triple rinse the drums in the station while simultaneously pumping the rinse water to Tank T-400 to ensure that the bottom of the rinse station does not accumulate hazardous waste. The facility then crushes the drum within the drum crusher next to the triple rinse station. Ms. Chavez noted it appeared that material was left in the right-hand containment section of the triple rinse station. This is the same area where Mr. Wolters observed the 697-ppm reading from the TVA 2020. Mr. Bradshaw explained it is uncommon for any material to be left inside the drum washing station and all material should have been pumped into the Tank T-400 hazardous waste tank.

1. The TVA 2020 measured a concentration of 697 parts per million (ppm) coming from the top of the right-hand side grate of the drum washing station.

Mr. Wolters observed a reading of 697 ppm from above the right-side grate on the "drum wash" station/sump (see Attachment 08, Photo 2). Mr. Bradshaw explained that the materials collected in this unit are ultimately sent to Tank T-400, the hazardous waste tank. At the time of this inspection, inspectors observed a layer of materials/sludge accumulated below the grate of this unit and emissions were detected by the TVA 2020 with a concentration reading of 697 ppm on one side.

For the areas of concern regarding the facility's triple rinse station (area of concern #6), the sump was emptied of its non-hazardous liquid wash waster on the same day it was observed. In addition, the facility has reinforced training on procedures for timely emptying of the sump.

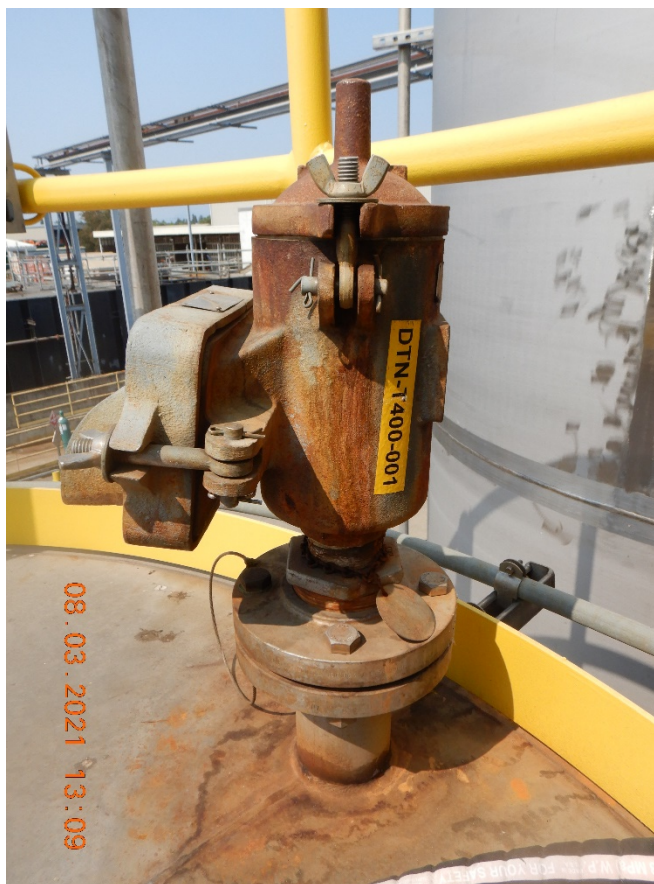
{Photograph 3, Attachment 08}

At approximately 11:00, the inspection team went on top of Tank T-400. Mr. Wolters completed LDAR monitoring on all connections, valves, manways, and flanges on top of Tank T-400. The background reading observed from the TVA 2020 was 1.5 ppm. During the monitoring event, Mr. Wolters observed a reading of 1.13 percent, or approximately 11,300 ppm coming from the conservation vent (DTN-T400-001) on Tank T-400. Mr. Wolters then began monitoring Tank T-401. Mr. Wolters observed a reading of 297 ppm from the manway cover and a reading of 415 ppm from the conservation vent (DTN-T401-003).

2. Conservation vent from the top of T400 tank located in the tank farm with an observed reading of 11,300 ppm from the TVA 2020.

1. 40 C.F.R. § 265.1085(k) explains the requirements for owners or operators if a defect is detected during an inspection. During the inspection, Mr. Wolters noted a net reading of 11,300 ppm coming from the conservation vent on Tank T-400 (see Attachment 08, Photo 3). This exceeds the detectable emission threshold of 500 ppm. WRG would be required to repair the defect found on the conservation vent in accordance with 40 C.F.R. § 265.1085(k). In addition, Mr. Wolters observed a net reading of 415 ppm on the conservation vent on Tank T-401. Although it is not considered a detectable emission, the facility was notified of the reading.

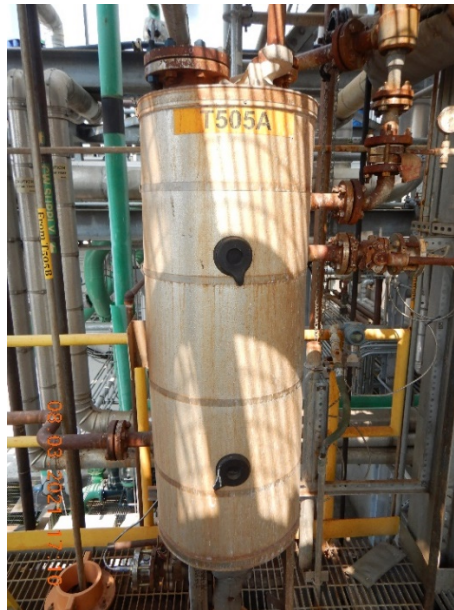
{Photograph 4, Attachment 08}

The inspection team then observed Tank T-505A at approximately 15:10. Tank T-505A is the receiving unit for the middle cut from the DBE distillation column, and it is intended to collect the reclaimed DBE solvent. The material collected in Tank T-505A is reused on-site in various processes, and the tank is shown as a receiving tank in the distillation process depicted in Attachment 09. The inspection team then observed Tank T-505B, which is a receiving unit for the facility's DBE distillation process, Tank T-505B holds the distillates/lights from the DBE column.

3. Tank T-505A is used as a receiving unit for reclaimed DBE from the DBE distillation column.

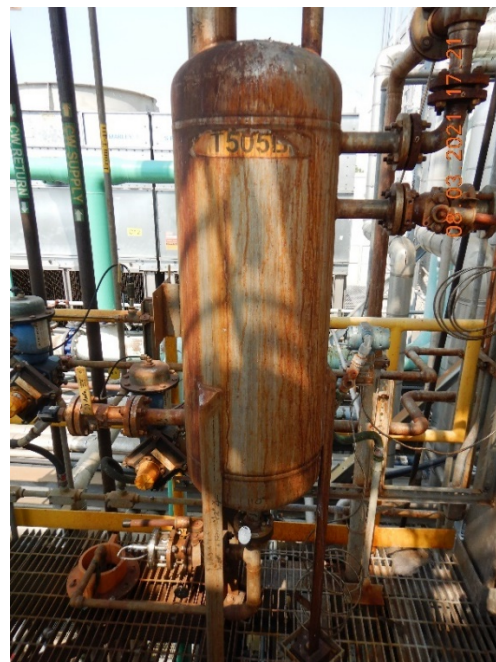
{Photograph 5, Attachment 08}

According to the facility, Tank T-505B is managed as a process unit and operates under a vacuum. The materials collected in Tank T-505B are ultimately discharged to the facility's hazardous waste tank when the Tank T-505B reaches 30 percent capacity. The total capacity is approximately 40 gallons.

4. Tank T-505B is a receiving unit for distillates/lights from the facility's DBE distillation column.

Tank T-501 and Tank T-505B are both directly hard piped to hazardous waste Tanks T-400 and T-401. Tank T-501 is used to recirculate spent solvent into the DBE distillation column during operations for the solvents cooling properties. Once the DBE distillation column is no longer in use, the solvent is no longer recirculated and discharges directly to the hazardous waste tanks. Tank T-505B is a knockout pot that is used to collect distillate from condensers. The condensers are hard piped directly into Tank T-505B when the DBE distillation column is

operating, and the system is under vacuum. When the DBE distillation column is not in operation or Tank T-505B accumulates approximately 30 percent of its 40-gallon capacity, it is discharged via hard piping to hazardous waste tank T-400. Photographs of Tank T-505B and Tank T-501 are provided in Attachment 08 (Photos 7 and 8, respectively).

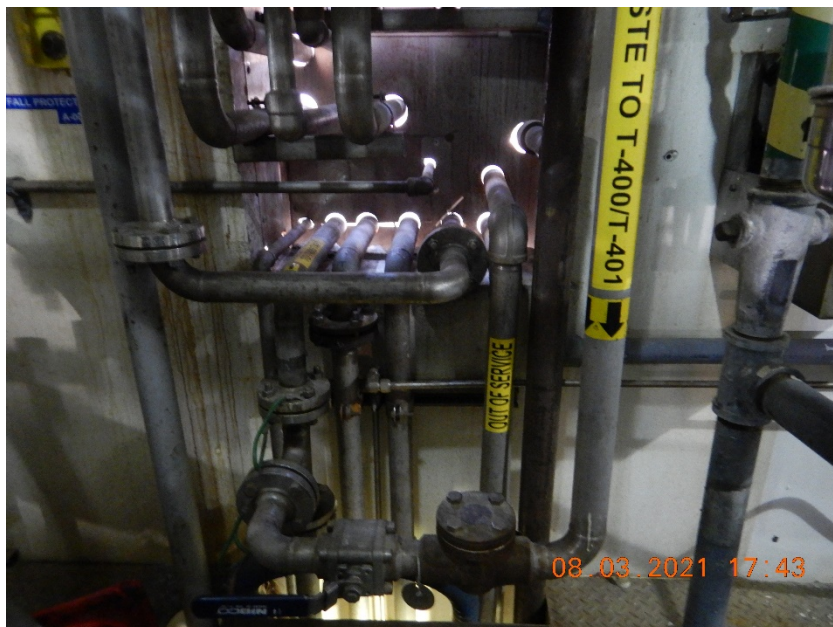
{Photograph 6, Attachment 08}

The inspection team then entered Building 2 at approximately 15:40. All lines that were labeled as part of the facility's LDAR monitoring program or contained hazardous waste at any point were monitored. During the monitoring event, the inspection team observed points B-79 (flange), B-80 (flange), B-81 (isolation valve), and B-82 (check valve) in the facility's LDAR monitoring program to be missing tags.

5. Lines containing points B-79, B-80, B-81, and B-82 inside Building 2 that were not tagged.

During the monitoring event, the inspection team observed that LDAR monitoring points B-79 (flange), B-80 (flange), B-81 (isolation valve), and B-82 (check valve) located inside the western wall of Building 2 were missing tags (see Attachment 08, Photos 6 and 7). Mr. Wolters also observed that during the monitoring event of the DBE distillation column that tag B-33 was missing. In addition, components that are not monitored regularly are still required to be marked as applicable to Subpart BB.

For the areas of concern regarding the missing tags (area of concern #5) on B-33, B-79, B-80, B-81, and B-82; the facility stated the points are readily identifiable testing points based on the description on the inspection form and were immediately identified during the inspection. The facility has also installed new LDAR tags at all of the points listed above.

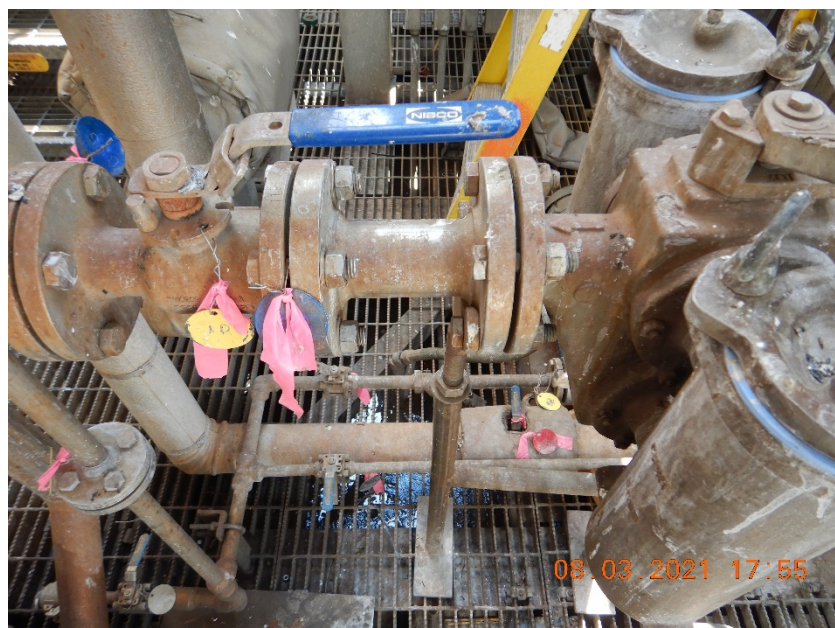
{Photograph 7, Attachment 08}

In addition to the points missing tags inside Building 2, Mr. Wolters observed that during the comparative monitoring of the DBE distillation column that tag B-33 appeared to be missing. The inspection team moved back to the DBE distillation column to confirm.

6. Photograph of point B-33 as documented in the facility's LDAR program. The point was located on the flange in the center of the photograph that is unlabeled.

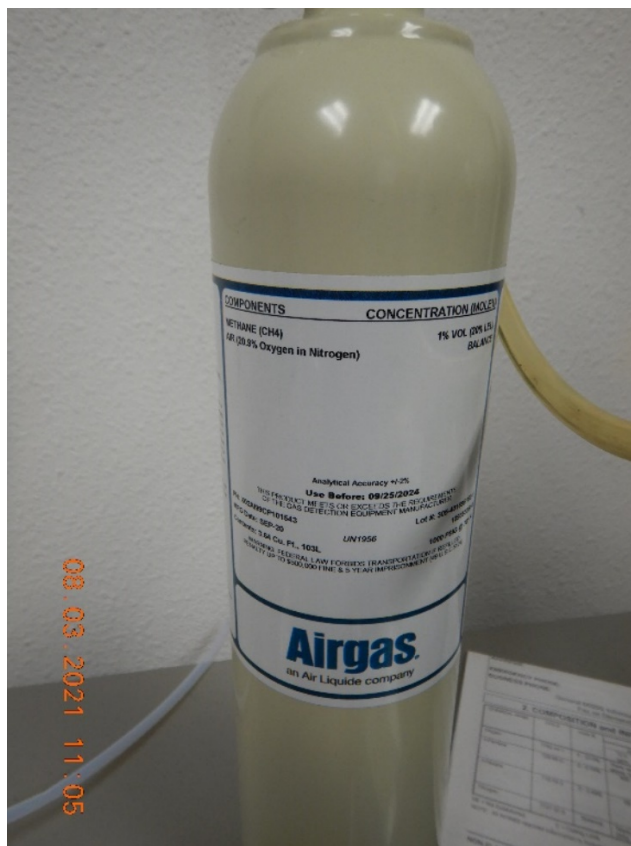
{Photograph 1, Attachment 08}

WRG uses one ThermoScientific TVA 2020 maintained by WRG on site for conducting LDAR monitoring. The TVA 2020 was last serviced in January 2021 which was sent to the manufacturer for maintenance and multi-point calibration per the manufactures SOP. Mr. Bradshaw explained that the TVA 2020 is serviced on an annual basis. The TVA 2020 is calibrated before each monitoring event following the facility's SOP as shown in Attachment 17. The inspection team noted the SOP states the facility uses a calibration gas of 100-ppm isobutylene. Before the walkthrough on August 03, 2021; Mr. Bradshaw demonstrated to the inspection team how the facility calibrates their TVA 2020. Mr. Wolters observed Mr. Bradshaw using ambient air as the zero-air and one-span point calibration gas with a concentration of 10,000 ppm methane. This is also documented in the facility's "TVA 2020 FID Quick Start Procedure" shown in Attachment 17. Ms. Chavez asked Mr. Bradshaw if the facility uses methane or isobutylene. Mr. Bradshaw explained the facility began using methane in August 2017 but that the SOP for WRG must not have been updated. Mr. Bradshaw provided the certificate of analysis for the 10,000-ppm methane container used to calibrate the facility's TVA 2020 on the morning of August 03, 2021. The certificate of analysis is provided in Attachment 18.

7. Methane calibration gas was used for calibration of the facility's TVA 2020.

WRG uses a ThermoScientific TVA 2020 as its detection instrument for LDAR monitoring, and calibration is performed using 10,000 ppm methane gas monthly on the morning before the monitoring event begins (see Attachment 08, Photo 1). Mr. Bradshaw demonstrated how the facility calibrates their TVA 2020 to Mr. Wolters. Mr. Wolters observed Mr. Bradshaw conducting a two-point calibration: the zero-calibration point was based on ambient air, and the span point was based on a 10,000-ppm methane calibration gas. However, calibration at 500 ppm is not part of the facility's calibration procedure.

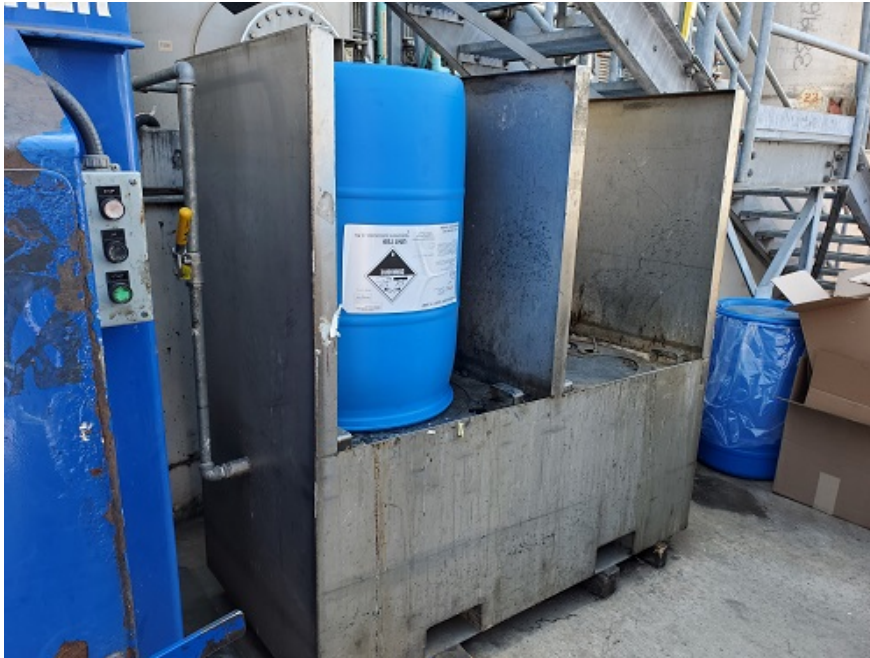
RCRA CEI performed by the state also observed and photographed this drum wash station. According to the state inspector, the drum wash station was found to contain approximately 1" of sludge and liquids at the time of that inspection. In addition, when monitoring the unit, the facility's monitoring equipment alarmed to indicate fugitive volatile emissions were detected from this unit. The following pictures were provided via email to Ms. Chavez:

8. Photograph taken of the drum wash station from an Oregon DEQ RCRA inspector.

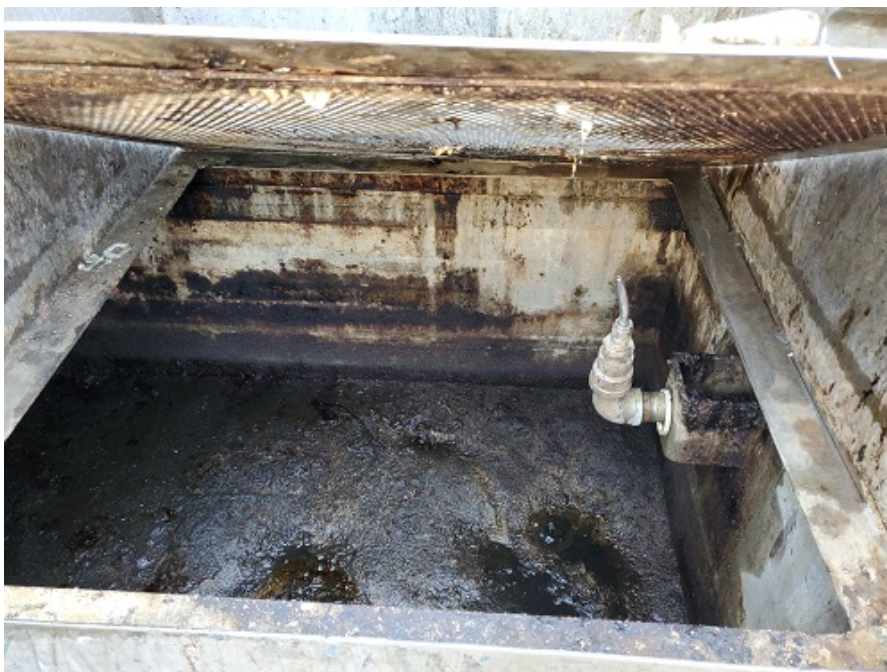
9. Photograph of sludge present inside the drum washing containment.
