## **RCRA Inspection Report**

Eastman Chemical Company  
Eastman Road  
Kingsport, Tennessee 37662  
EPA ID No: TND 003 376 928  
Sullivan County

Opening conference April 26, 2021 via phone. Onsite inspection conducted May 4-6, 2021, 7:30 am – 4:30 PM

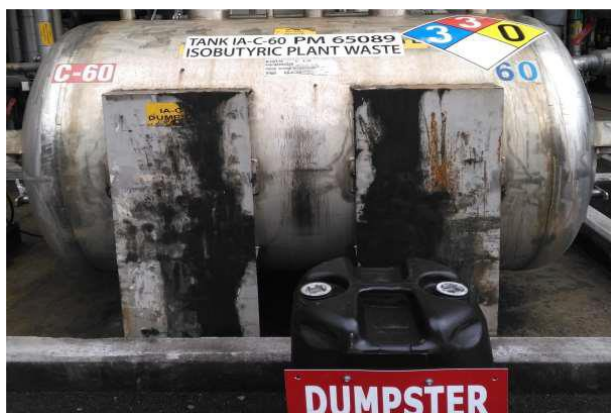
a. I-AC-60 dumpster (750 gallons): At the time of the inspection the dumpster was closed and marked with an accumulation start date of 5-4-2021. Building 646 dumpster I-AC-60 was not marked “Hazardous Waste” (Photo 1). April 19, 2021 subpart CC monitoring results for this dumpster were reviewed. Eastman provided a photograph of the corrected labeling for this container on May 19, 2021.

Photo 1: Building 646 I-AC-60 dumpster – was not labeled with words “Hazardous waste.”

**Pursuant to Tenn. Comp. R. & Regs. 0400-12-01-.03(4)(e)2(iii) [40 C.F.R. § 262.34(a)(3)], which is a condition of the LQG Permit Exemption, a generator is required to label or clearly mark each container and tank accumulating hazardous waste on-site with the words: “Hazardous Waste.”**

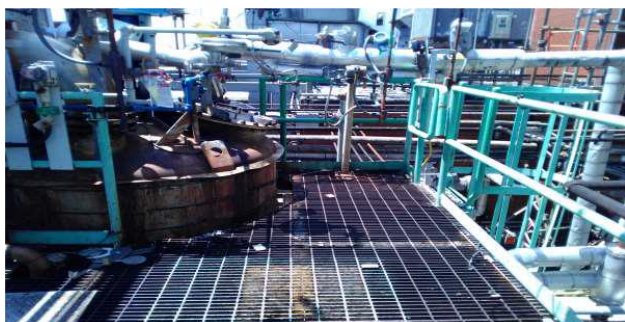
1. Tank 15: 1,771-gallon level 1 tank: Tank 15 has been decommissioned. The tank was previously designated for D003 diketene sludge from the reclamation of acetic acid. The sludge was pumped to dumpsters at Building 244 dumpster pads 1, 2, and 3 then managed at Building 248. Equipment associated with tank 15 has been decommissioned. The equipment (one pump and 46 valves) was previously subject to MON LDAR and 0400-12-01-.05(28) air emission standards. The most recent subpart BB air monitoring for equipment associated with Tank 15 was reviewed. The inspection team noted two 1-gallon, unlabeled, containers on the Tank 15 and Tank 14 catwalk. These containers were initially suspected of being used oil. Photos provided by Eastman on May 25, 2021, show that the 1-gallon containers had been removed from the catwalk and the contents were determined to be “New Oil” and not “Used Oil” (Photos 2-3).

Photo 2: Picture provided May 25, 2021. The two 1-gallon containers observed during the inspection had been removed from the Tank 14/15 catwalk.

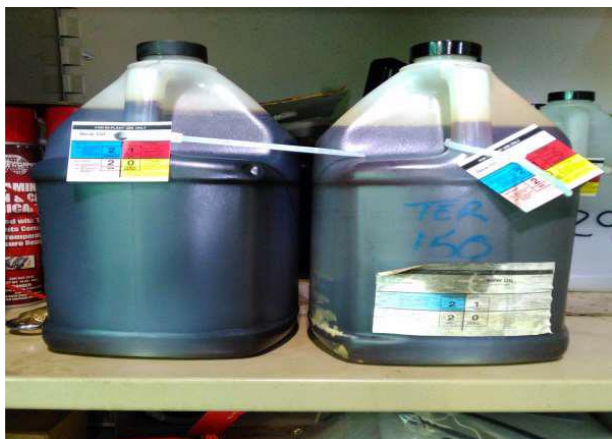
Photo 3: Picture provided May 25, 2021. The two 1-gallon containers observed on the Tank 14/15 catwalk during the inspection labeled “New Oil”.

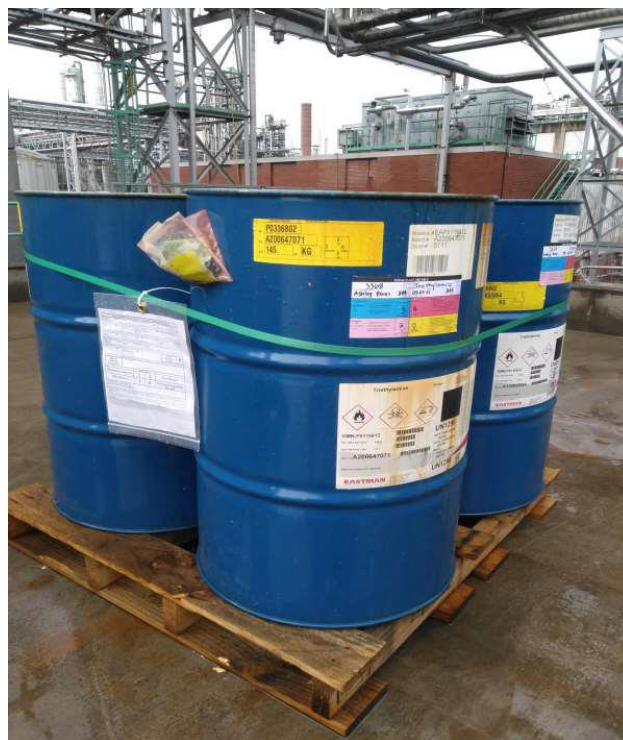
4. Courtyard: 90-day container accumulation area: Containers awaiting transportation to Building 248 are stored in the courtyard on the north side of Building 244. At the time of the inspection, four (4) 55-gallon metal containers of triethylamine stored in the courtyard were closed and marked with an accumulation start date of 5-3-2021. None of these four containers were labeled with the words, "Hazardous Waste" (Photos 4-5). The waste ticket attached to the tie around the drums was marked as "Hazardous Waste".

Photo 4: Building 244 Courtyard: Four drums of hazardous waste were not labeled “Hazardous Waste” at the time of the inspection.

**Pursuant to Tenn. Comp. R. & Regs. 0400-12-01-.03(4)(e)2(iii) [40 C.F.R. § 262.34(a)(3)], which is a condition of the LQG Permit Exemption, a generator is required to label or clearly mark each container and tank accumulating hazardous waste on-site with the words: "Hazardous Waste."**

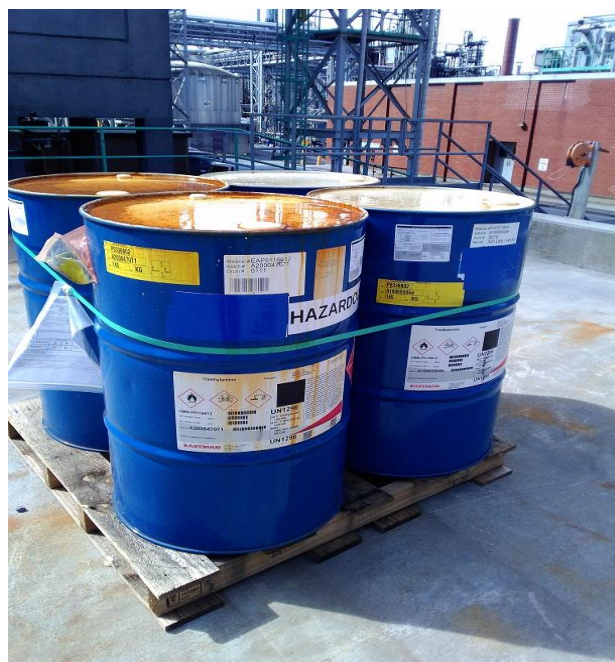
Photo 5: Building 244 – four drums of waste triethylamine labeled as “Hazardous Waste”

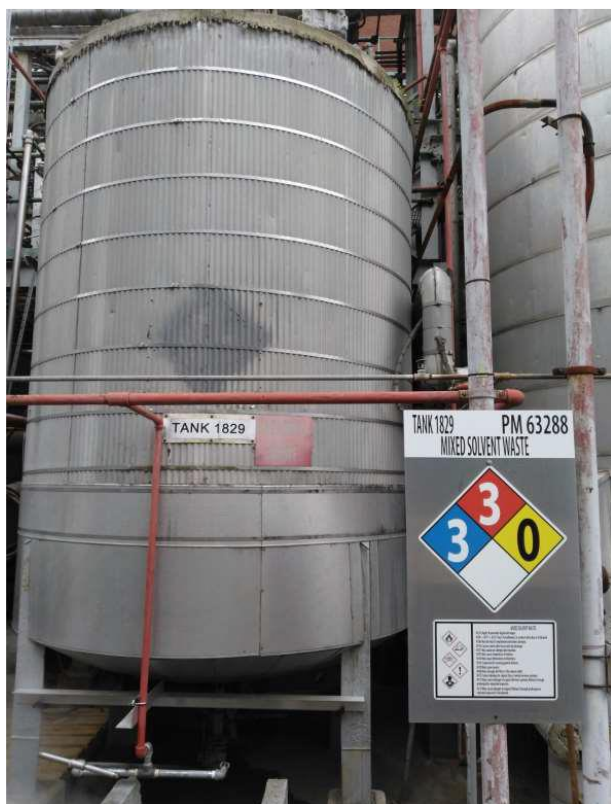
Vegetation was observed growing in the tank insulation on the top of Building 267 tank 1829 (Photos 6-7). Eastman should continue to monitor this tank to ensure the integrity is not compromised.

Photo 6: Building 267 tank 1829.

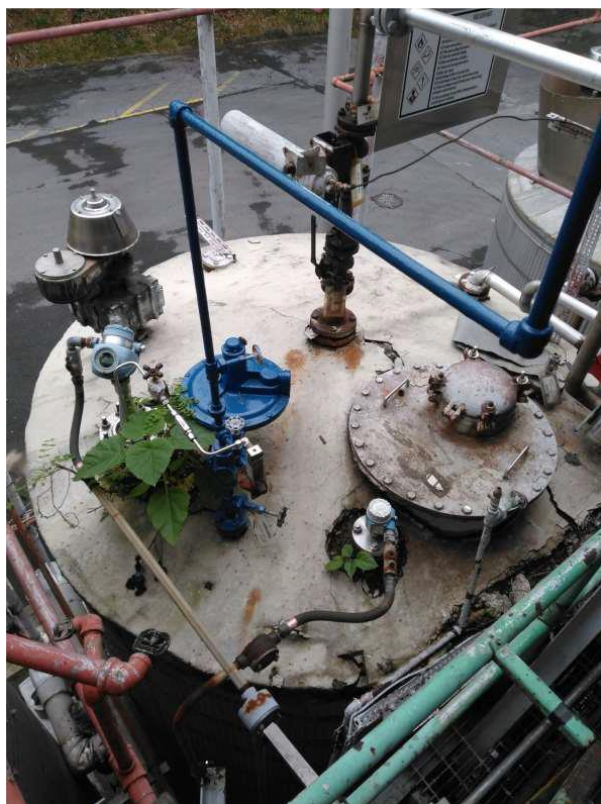
Photo 7: Bldg. 267 tank 1829: Vegetation observed growing on top of the tank.

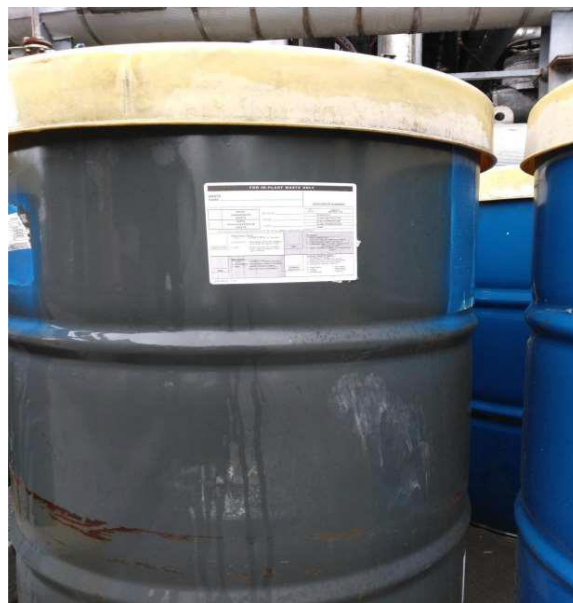
3. Building 335 Used Oil collection area: Used oil and used oil filters are collected in an area located adjacent to Building 335. Filters are transported to Building 248 and the used oil is burned at B-83 and B- 325 for energy recovery. Seven containers of used oil were present at the time of the inspection. One container of used oil was not labeled "Used Oil". Facility personnel labeled the container during the inspection (Photos 8-9).

Photo 8: Building 335 Used oil storage area. One 55-gallon container of used oil was not labeled "Used Oil".

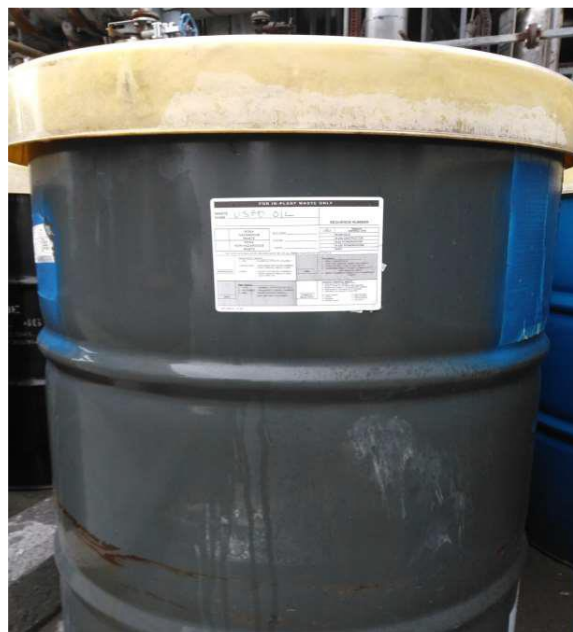
Photo 9: Building 335 Used oil storage area. Container marked used oil

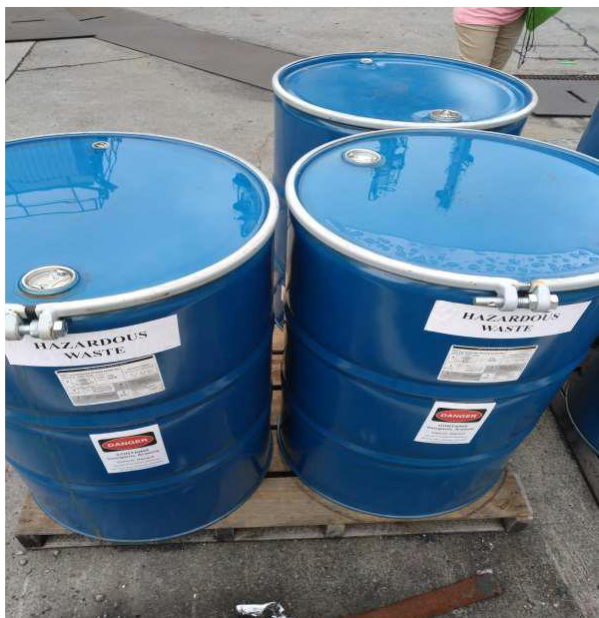
1. South Wall: 90-day container accumulation area: D004 Arsenic and catalyst wastes from Building 332 satellite accumulation areas (SAAs) are accumulated in 55-gallon drums. Thirty-five (35) 55-gallon drums of contaminated items and cooler arsenic were present at the time of the inspection. All the containers were closed and labeled “Hazardous Waste”. Thirty-two (32) of the containers were marked with an accumulation start date. The oldest accumulation start date was 3-17- 21. Three (3) of the 55-gallon containers of hazardous waste cooler arsenic were not marked with accumulation start dates (Photo 10). When the inspection team pointed this out, Eastman marked each container with the accumulation start date. The inspection team noted one 55-gallon drum of outdated and unused Criterion 534 Co-Moly Catalyst product in the non-hazardous waste accumulation area located next to the Building 332 South Wall hazardous waste 90-day central accumulation area. The container had a hazardous waste label and was marked with two different dates in two different locations on the container. The year on the hazardous waste label was illegible. The other date noted on the container was 3-17-1983 (Photos 11-13). The product label indicated the catalyst was composed of 31 non-RCRA metals. The MSDS, provided after the inspection of the area, documented that the outdated catalyst was non-hazardous.

Photo 10: Building 332 South wall 90-day accumulation area. Three (3) containers of hazardous waste cooler arsenic were not marked with an accumulation start date.

**Pursuant to [Tenn. Comp. R. & Regs. 0400-12-01-.03(4)(e)2(ii) [40 C.F.R. § 262.34(a)(2)], which is a condition of the LQG Permit Exemption, a generator must mark or label its containers with the date upon which each period of accumulation begins clearly visible for inspection on each container.**

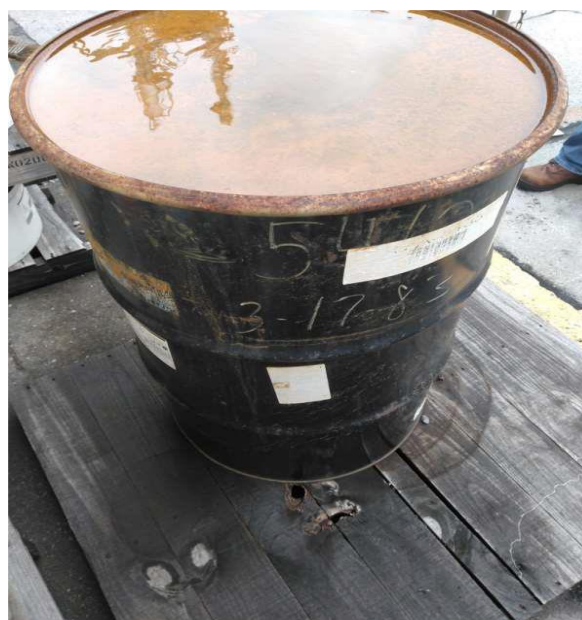
Photo 12: Building 332 South wall container of Criterion 534 Co-Moly Catalyst dated 3-17-83.

**Pursuant to [Tenn. Comp. R. & Regs. 0400-12-01-.03(1)(b) [40 C.F.R. § 262.11], a person who generates a solid waste, as defined in Rule 0400-12-01-.02(1)(b), must determine if that waste is a hazardous waste.**

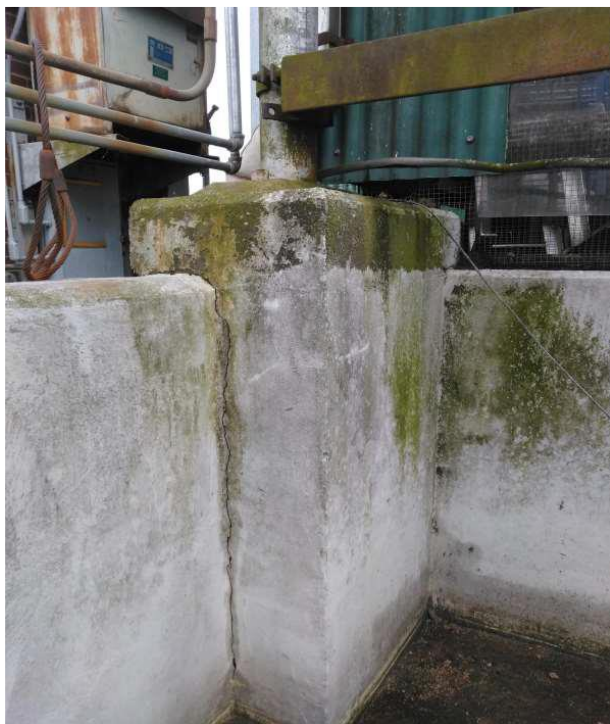
4. Permitted Container Storage (SO1) Area Building 285 HWSU-30 (and 90-day accumulation area) Trailer Pad: HWSU-30 is permitted under Permit TNHW-137. Hazardous waste generated on-site and received from off-site may be managed in this unit. The trailer pad is also used for loading and unloading products and raw materials. Waste is pumped from 55-gallon drums into a tank trailer and transported to B-248 for disposal. Hazardous waste was not present at the time of the inspection. At the time of the inspection, a crack was observed in the wall of the trailer pad (Photo 14). The slab (base) of the unit appeared to be free of cracks. Repairs to the wall of the concrete pad were completed on May 14, 2021 (Photo 15).

Photo 14: Building 285 HWDU-30. Crack in the wall of the secondary containment at the time of the inspection.

**Pursuant to Permit Condition III.F.1 of Permit number TNHW-137: The permittee shall ensure that the container storage areas have a containment system that is designed and operated in accordance with 12 Paragraph III.F.2 below and is constructed and maintained as specified in the plans and specification found in Attachment 8.**

**Pursuant to Attachment 8, Section 10 of Permit number TNHW-137, concerning HWSU-30: Building 285 Trailer Pad, the concrete base and walls are sufficiently impervious to contain leaks, spills, and accumulated precipitation until the collected material is detected and removed.**

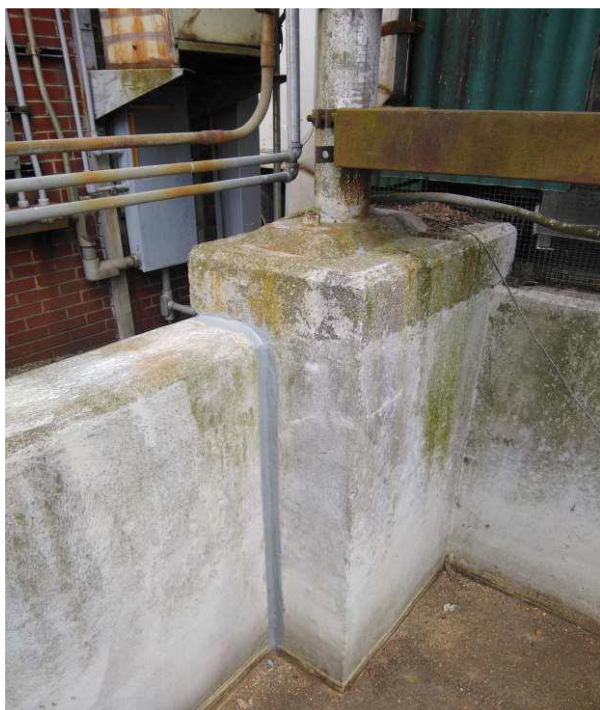
Photo 15: Bldg. 285 HWDU-30. Photograph provided by the facility on May 20, 2021. Repairs have been completed.

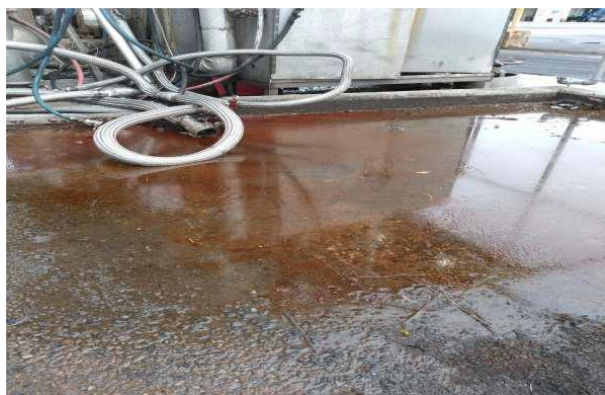
a. Dumpsters DD-2 & DD-3 90-day container accumulation area: These dumpsters contain hazardous and non-hazardous wastes from heels from transport trailers, rail yard storage tanks, line flushing due to repairs, and raw material samples. This U-listed waste is disposed of at Building 83 Boiler. Hazardous waste containers were not present at the time of the inspection. The most recent subpart BB air monitoring results for equipment associated with Building 201 dumpster DD-2 and DD-3 were reviewed. The inspection team noted red liquid in the dumpster area secondary containment (Photo 16). Eastman later identified the red liquid as a non-hazardous KD3 and KD4.

Photo 16: Bldg. 201 dumpster pad. Red tinted water in secondary containment.

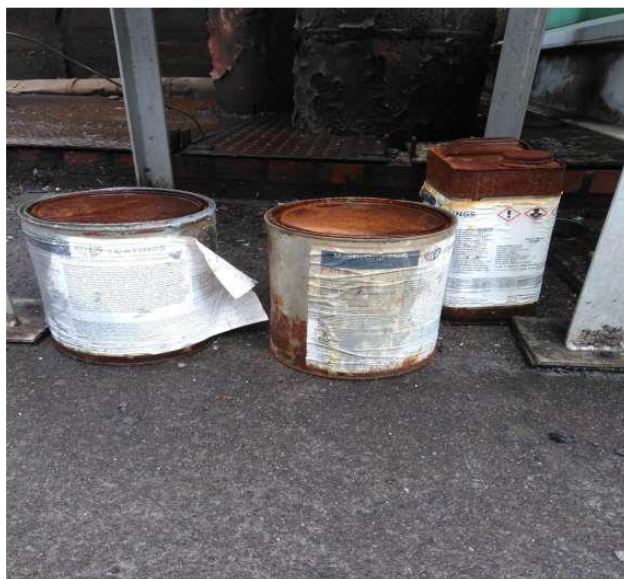
Photo 17: Outside of Building 137. Three containers of hazardous waste coating.

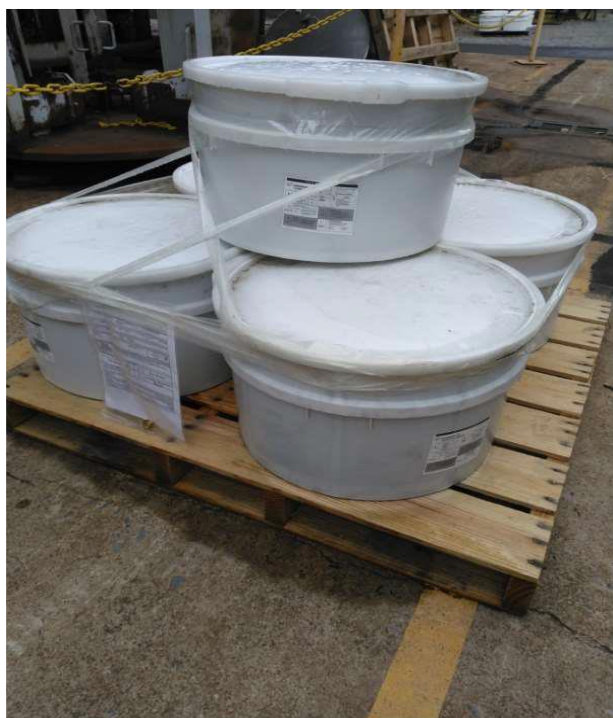
Photo 18: Building. 221 North accumulation area: Five (5) containers of hazardous waste

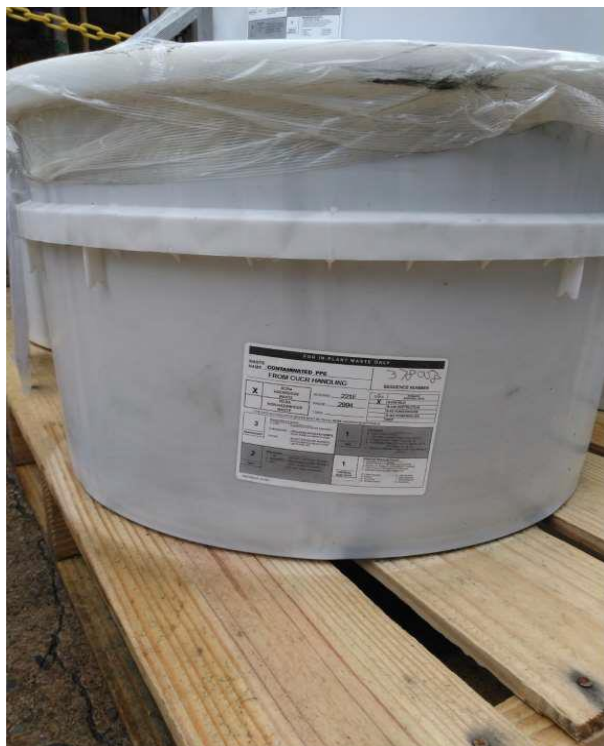
Photo 19: Bldg. 221 North accumulation area: Five (5) containers of hazardous waste were not marked with the accumulation start date at the time of the inspection.

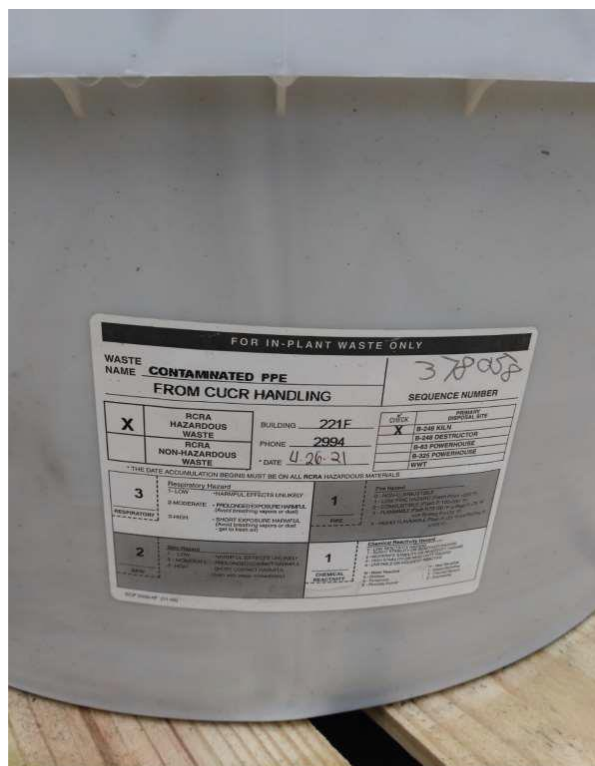
Photo 20: Building 221 North accumulation area: Facility personnel wrote the accumulation start date on the five (5) containers.

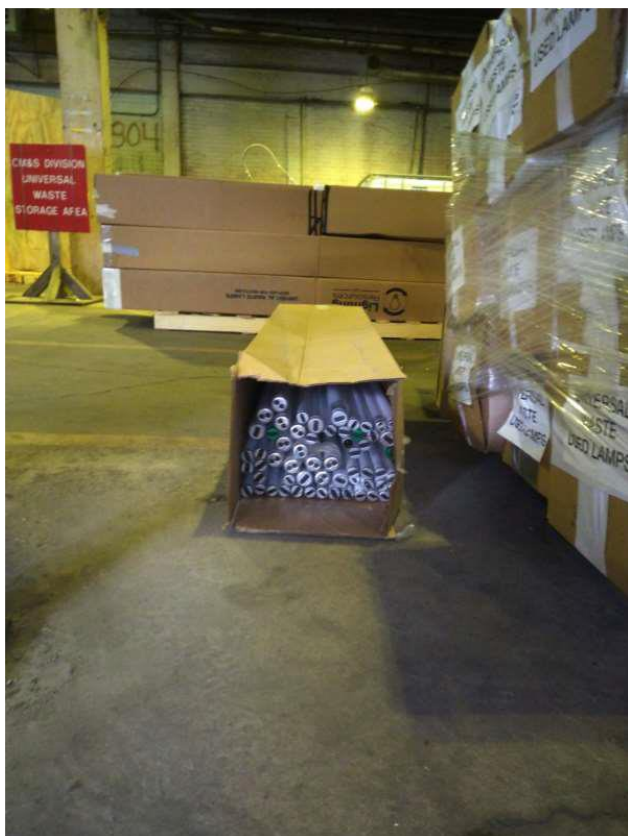
Photo 21: Building 8 universal waste accumulation area. One container of spent bulbs was not closed or labeled at the time of the inspection.

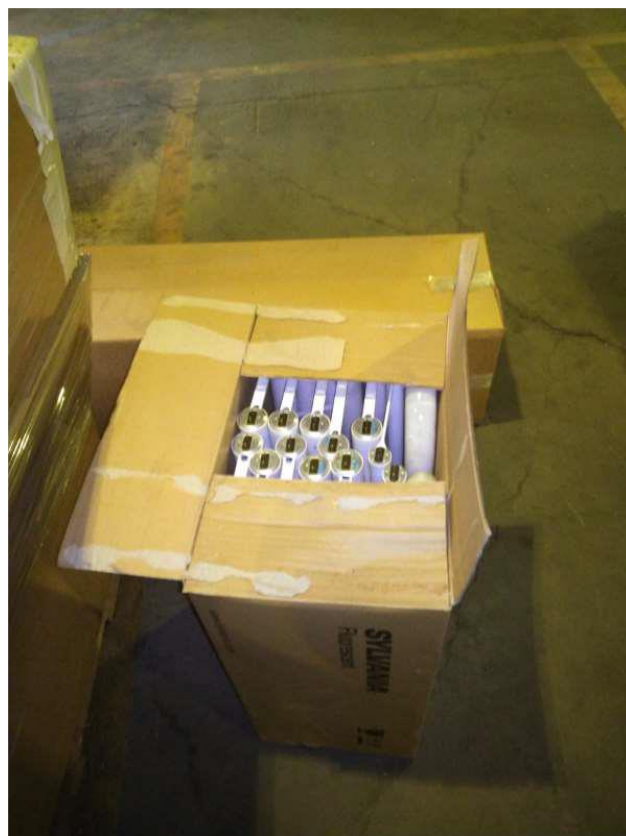
Photo 22: Building 8 universal waste accumulation area. A second container of spent bulbs was not closed or labeled at the time of the inspection.

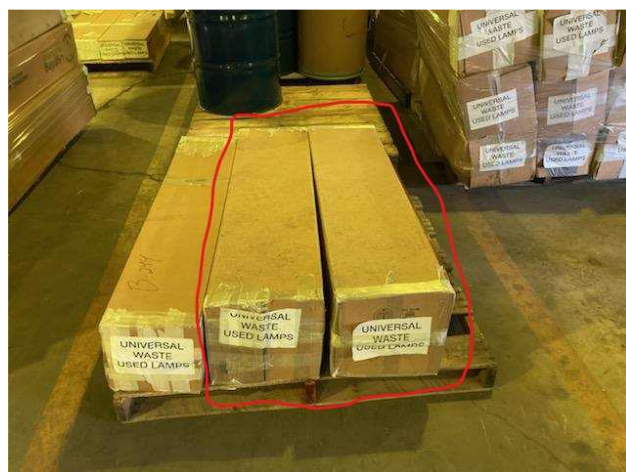
Photo 23: May 19, 2021 photo of Building 8 universal waste bulbs closed and labeled. Violation adequately addressed.

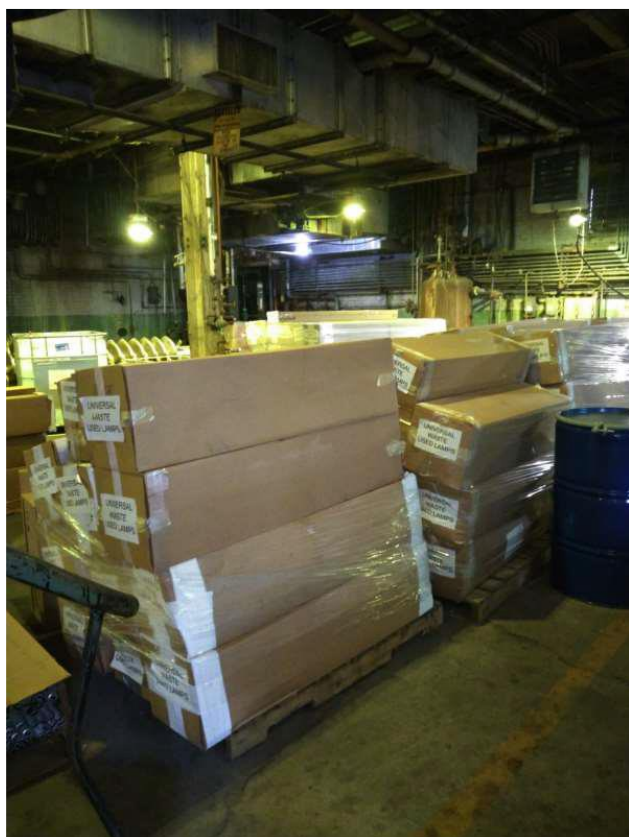
Photo 24: Building 8 universal waste accumulation area. Pallets of boxes of universal waste lamps.
