## OECA – Air Enforcement Division INSPECTION REPORT

| Regulatory Program(s) | Title V/NESHAP | |
| Company Name: | <b>Pemex – Deer Park Refining LP</b> | |
| Facility Name: | <b>Deer Park Refinery</b> | |

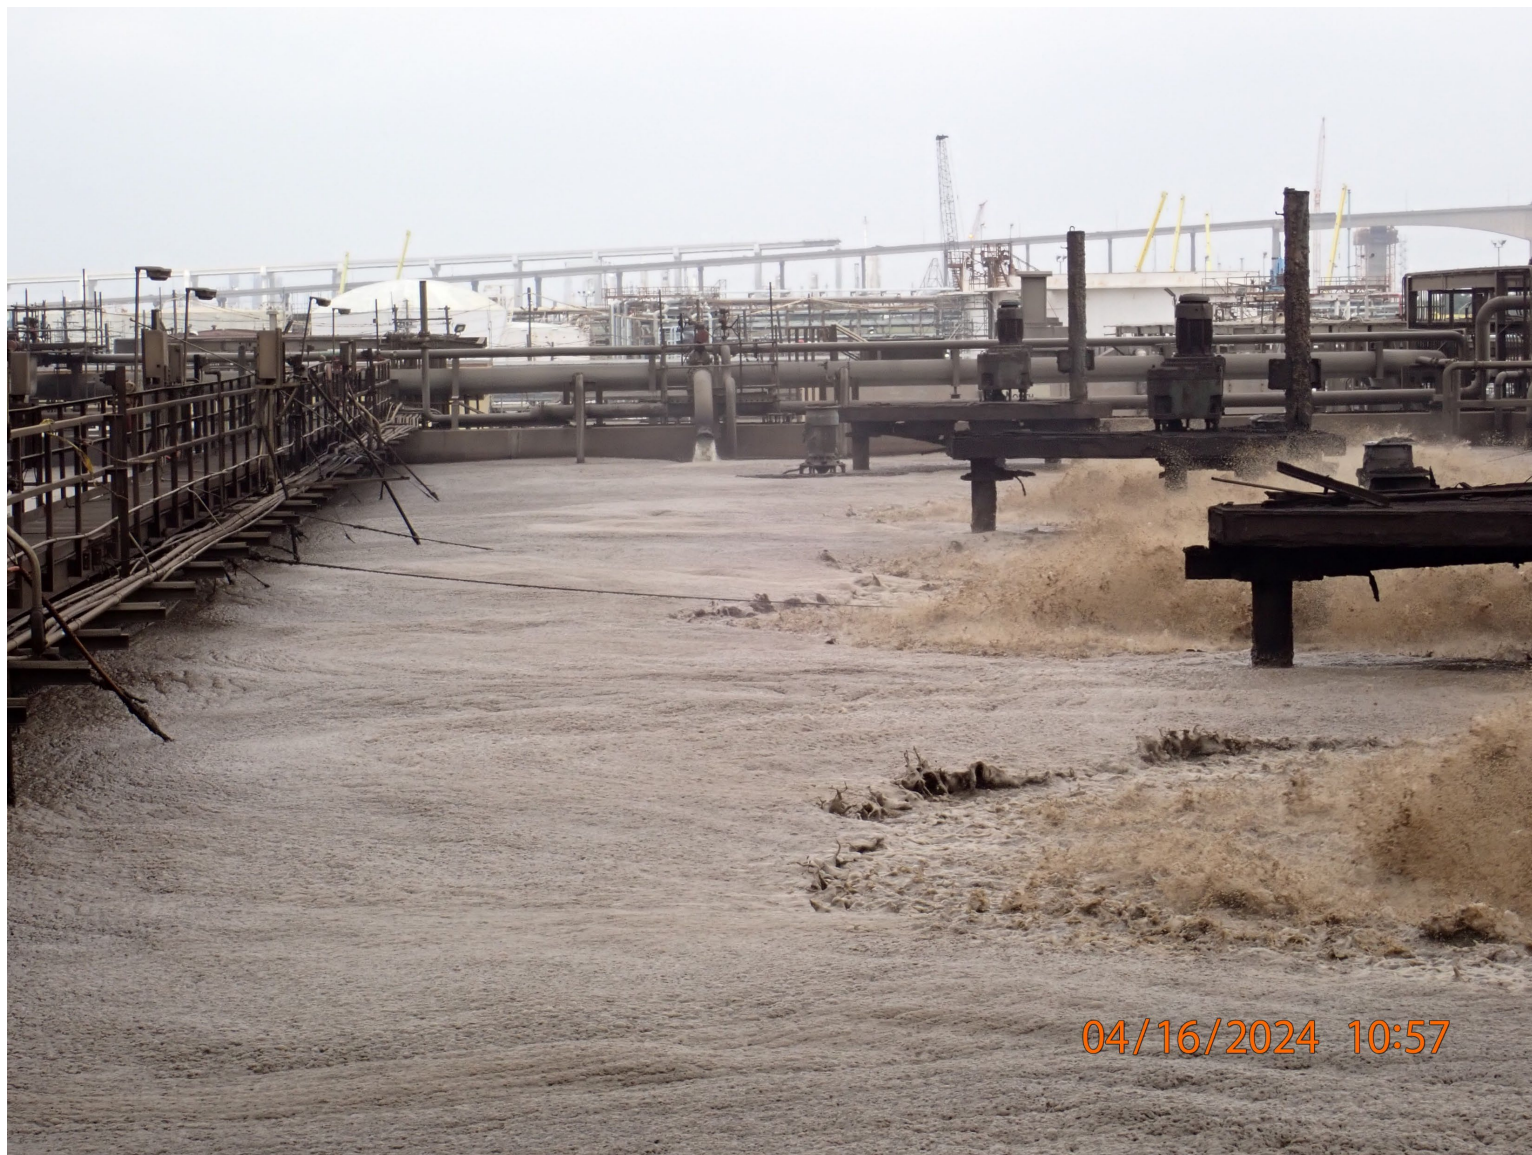
Photo 002: NET Aeration Basin and “Pour” Inlet, North Section  
4/16/2024 09:57 P4160002.jpg

Prior to the inspection, I reviewed the root cause analysis (“RCA”) and corrective action plan (“CAP”) documents submitted by DPR. There had been several exceedances of the benzene action level at Monitor #13, starting on July 21, 2020 and continuing sporadically up until the time of the inspection. The root cause analyses for these exceedances point to the NET aeration basin as the cause, specifically because the inlet to the aeration basin is positioned above the liquid level as a “pour” fill, as opposed to a “submerged” fill. [AOC 3] [AOC 4]

The corrective action plan for the exceedances at Monitor #13 focus solely on the aeration basin, extending the inlet pipe downward so there is a submerged fill instead of the current splash fill. However, our inspection found many other sources in the NET that may be contributing to the Monitor #13 exceedances. Additionally, from our conversations with the facility there seem to be issues with the wastewater upstream of the aeration basin which are causing high benzene concentrations, and it is unclear if the submerged fill corrective action will solve the issue.

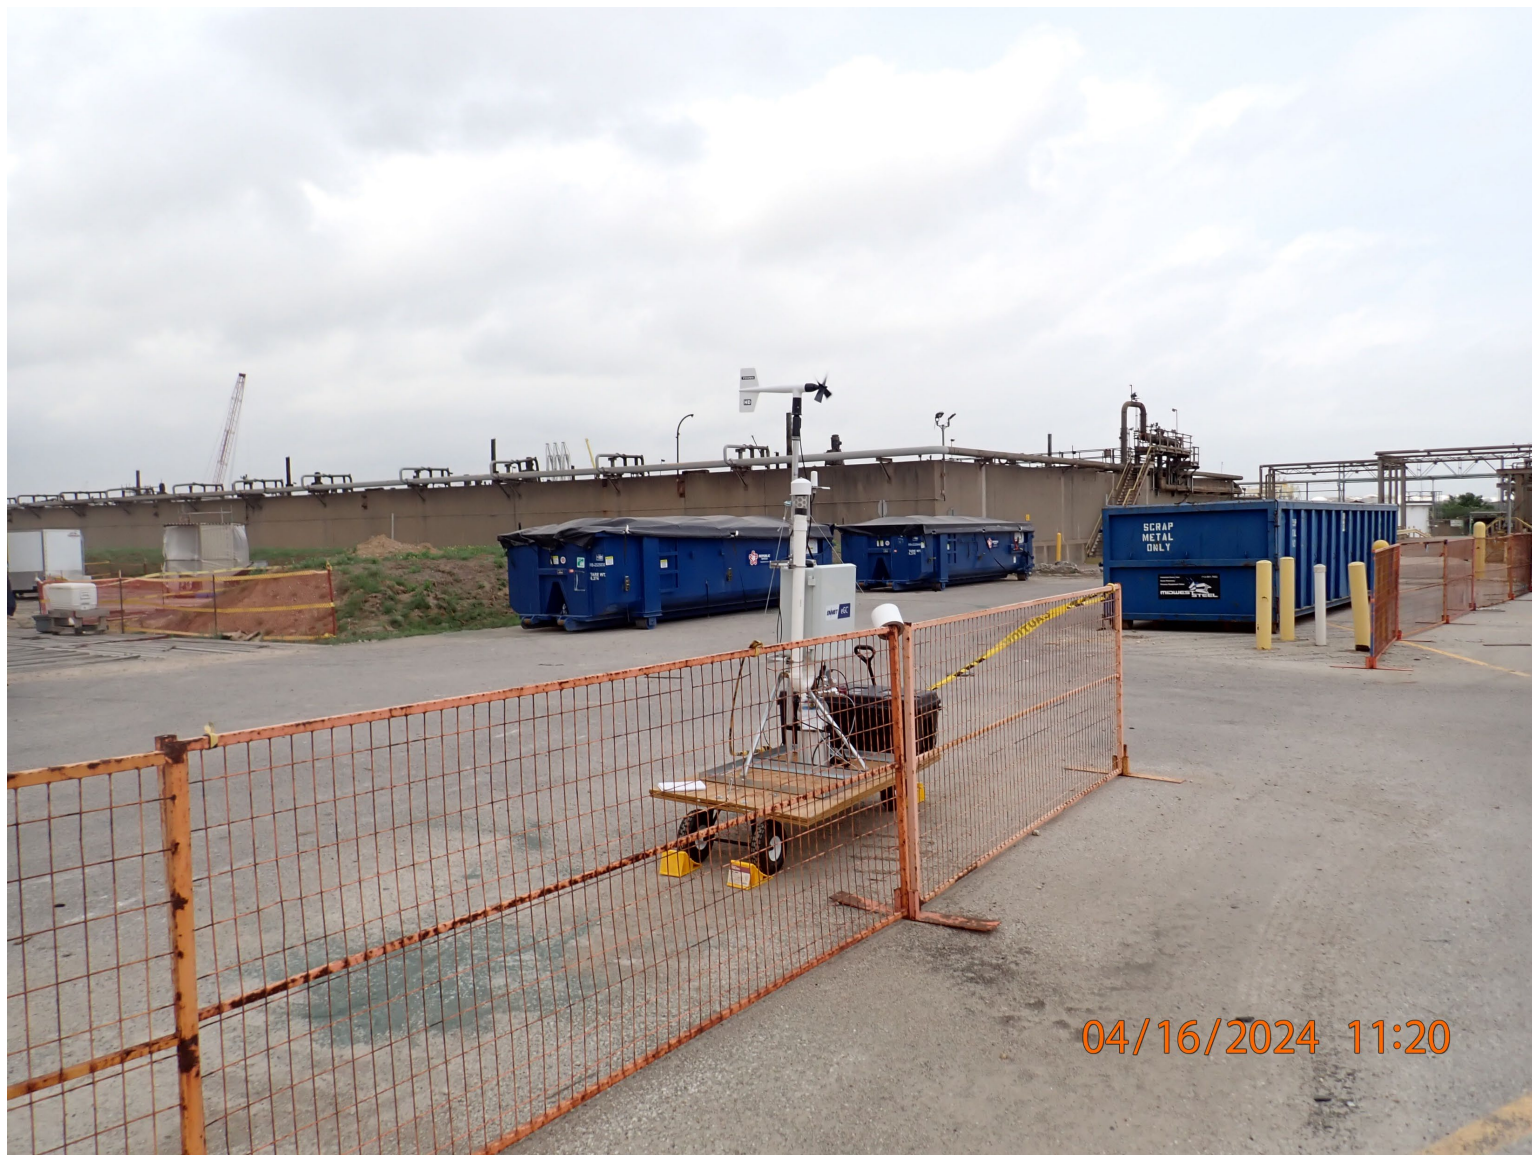
Photo 004: EPA-1A Location - 4/16/2024 10:20 P4160004.jpg

At around 12:30, The ERG contractors set up eGC EPA-1 southeast of the NET aeration basin. (Site code EPA 1A in eGC report) (Photos 004 and 05)

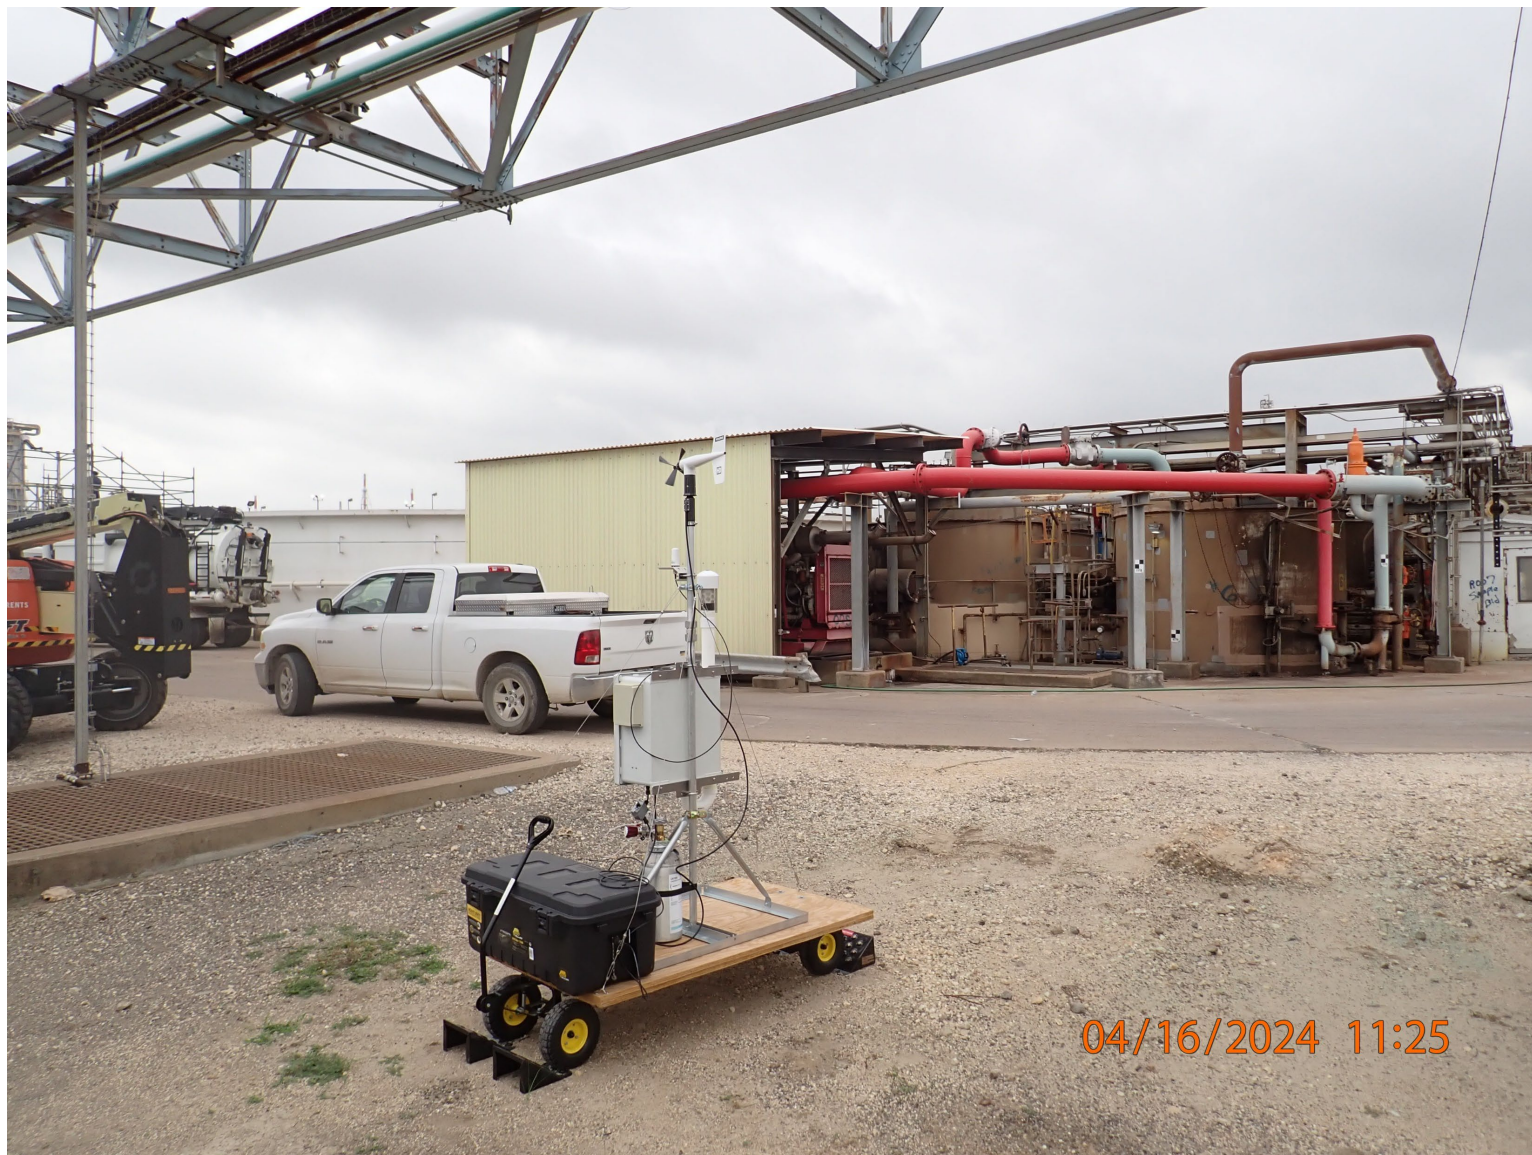
Photo 006: EPA-2A Location - 4/16/2024 10:25 P4160006.jpg

The ERG contractors set up the eGC EPA-2 next to Monitor #13 and northwest of the NET aeration basin. (Site code EPA 2A in eGC report) (Photos 006 and 007)

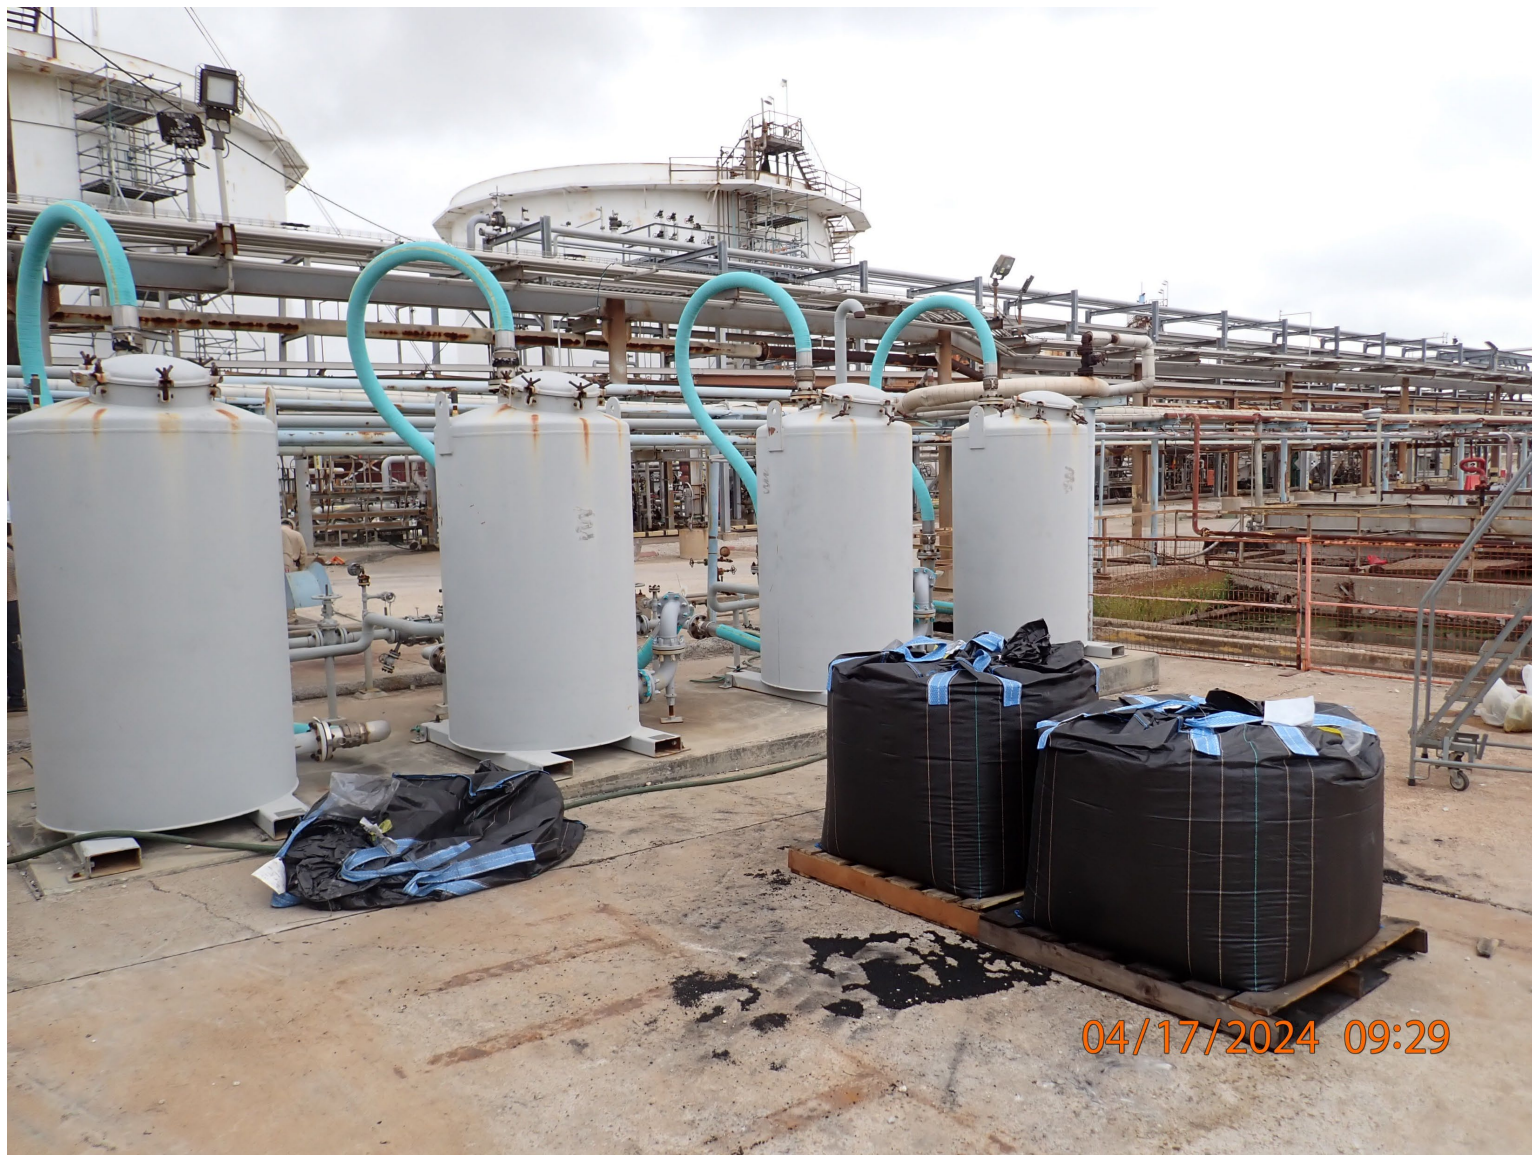
Photo 008: MH-4 Carbon Beds - 4/17/2024 09:27 P4170008.jpg

The carbon beds controlling VOC emissions from MH-4, as required by the consent decree with EPA, have gone from having breakthrough once every 8 to 10 months to having breakthrough weekly. DPR staff said this drastic increase in breakthrough frequency is due to alkylate leaking into the wastewater; an issue they were working to address. The frequent breakthrough of the carbon beds, which was still occurring at the time of the inspection, has caused significant VOC emissions.

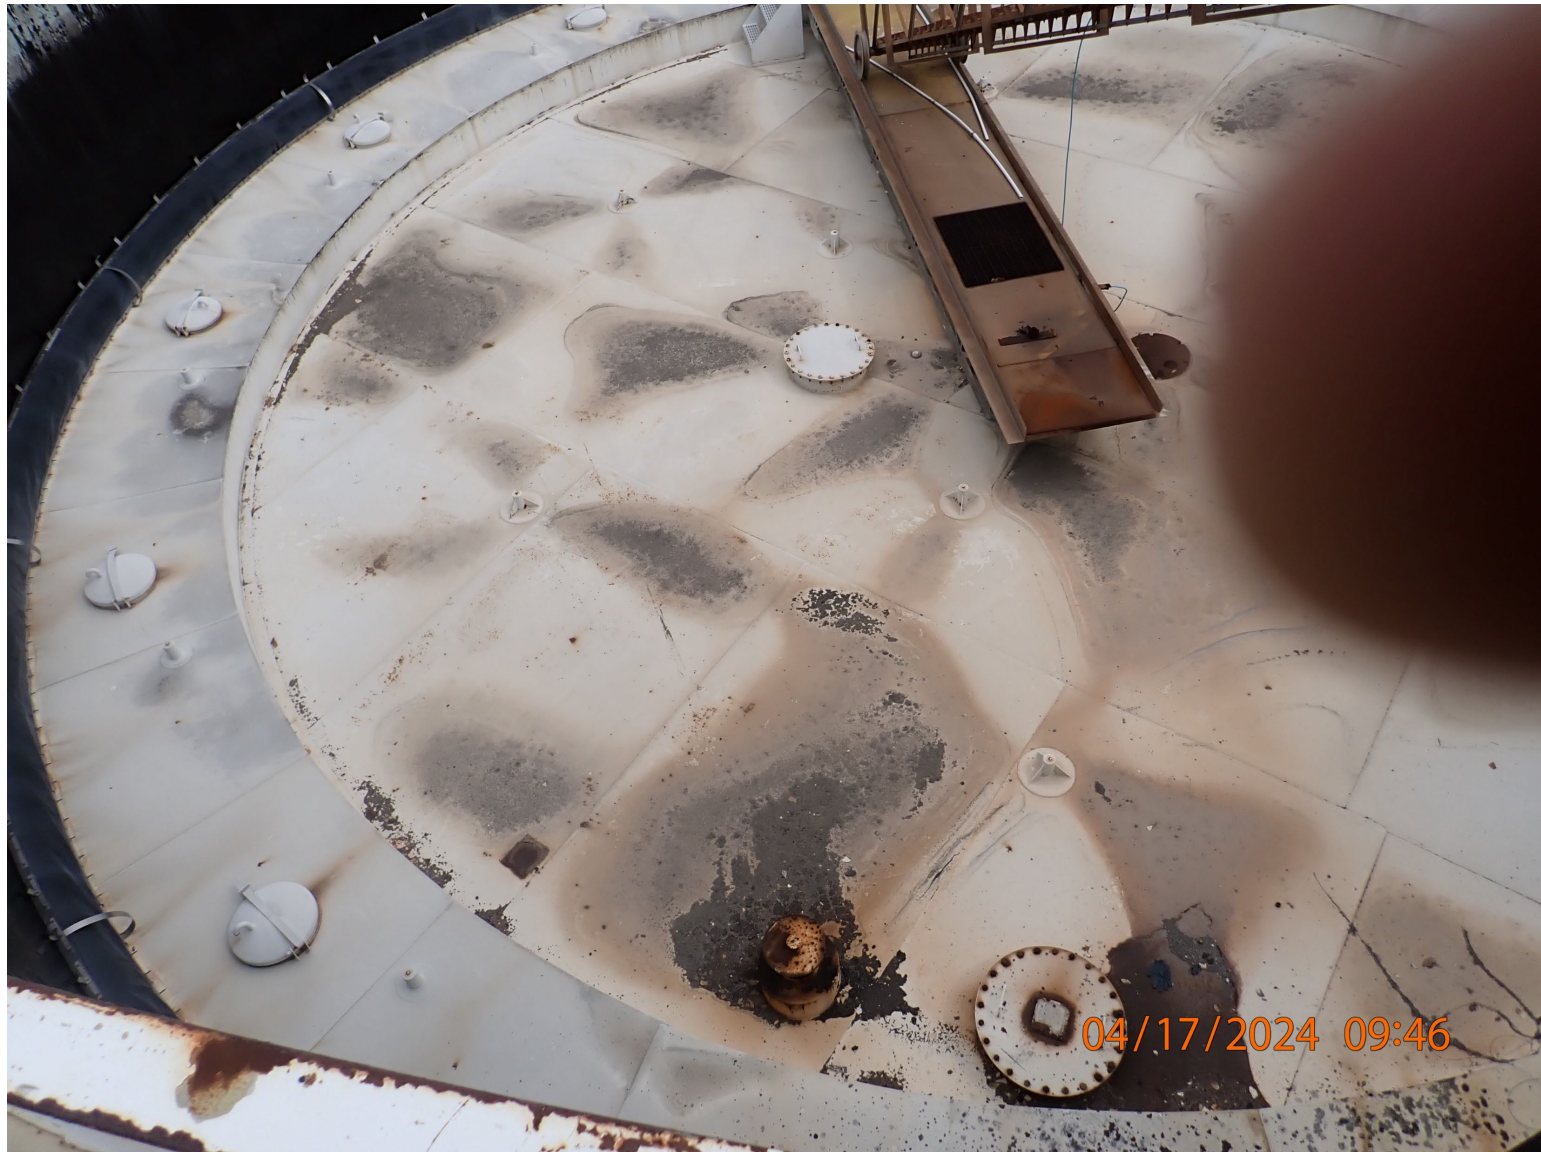
Photo 010: Equalization Tank T-302 Pop-up vent - 4/17/2024 09:46 P4170010.jpg

At approximately 10:40, I went to the top of Tank T-302, one of the BWON equalization and diversion tanks in the NET. I observed a heavy VOC plume with the FLIR camera coming from a vent on the external floating roof. (FLIR0027, Photo 010) I then went to the top of Tank T-301, the other BWON equalization and diversion tank, and observed another heavy VOC plume coming from a similar vent on the external floating roof. (FLIR0028, Photo 011) [AOC 21]

I asked about the leaks on the external floating roofs of tanks T-301 and T-302. Mr. Stanley told me that the facility identified pop-up vents leaking on both tanks. **[AOC 21]** Normally, the pop-up vents activate when the tank is landed to prevent a vacuum forming under the roof, and they should not be open unless the roof is landed. They said the tank roofs have not been landed recently. They also told me that the tank levels at the time I observed emissions (10:50) were 26.4 feet for T-302 and 22.4 feet for T-301.

DPR staff updated us on the equalization and diversion tanks T-301 and T-302. They said that investigation revealed that the pop-up vents were not activated, and that the cause of the leak was a seal issue on the pop-up vents. They said that they were in the process of replacing the seals and making a release calculation for the leaks. [AOC 21]

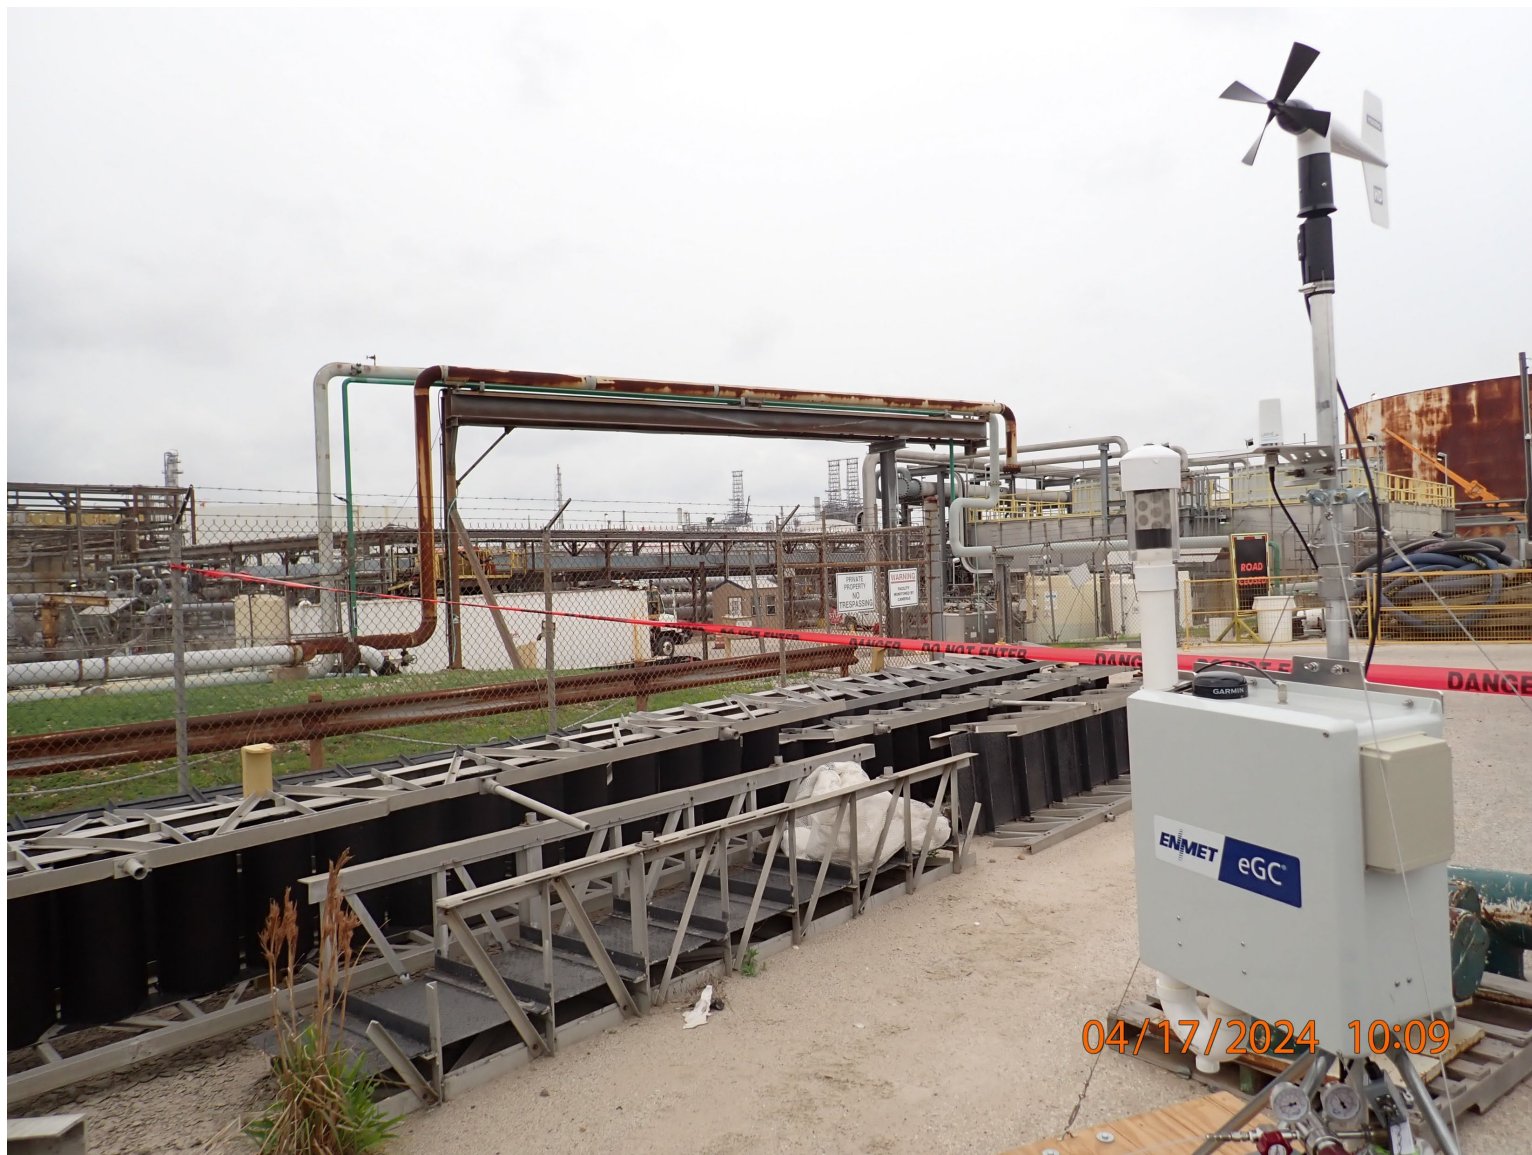
Photo 012: EPA-1B Location - 4/17/2024 10:08 P4170012.jpg

The ERG contractors moved the eGC EPA-1 to a new location north of the DNFs, NE of the BWON CPIs and tanks T-301 and T-302, and NW of the aeration basin. (Site EPA 1B in the attached eGC report. Photos 012 and 013)

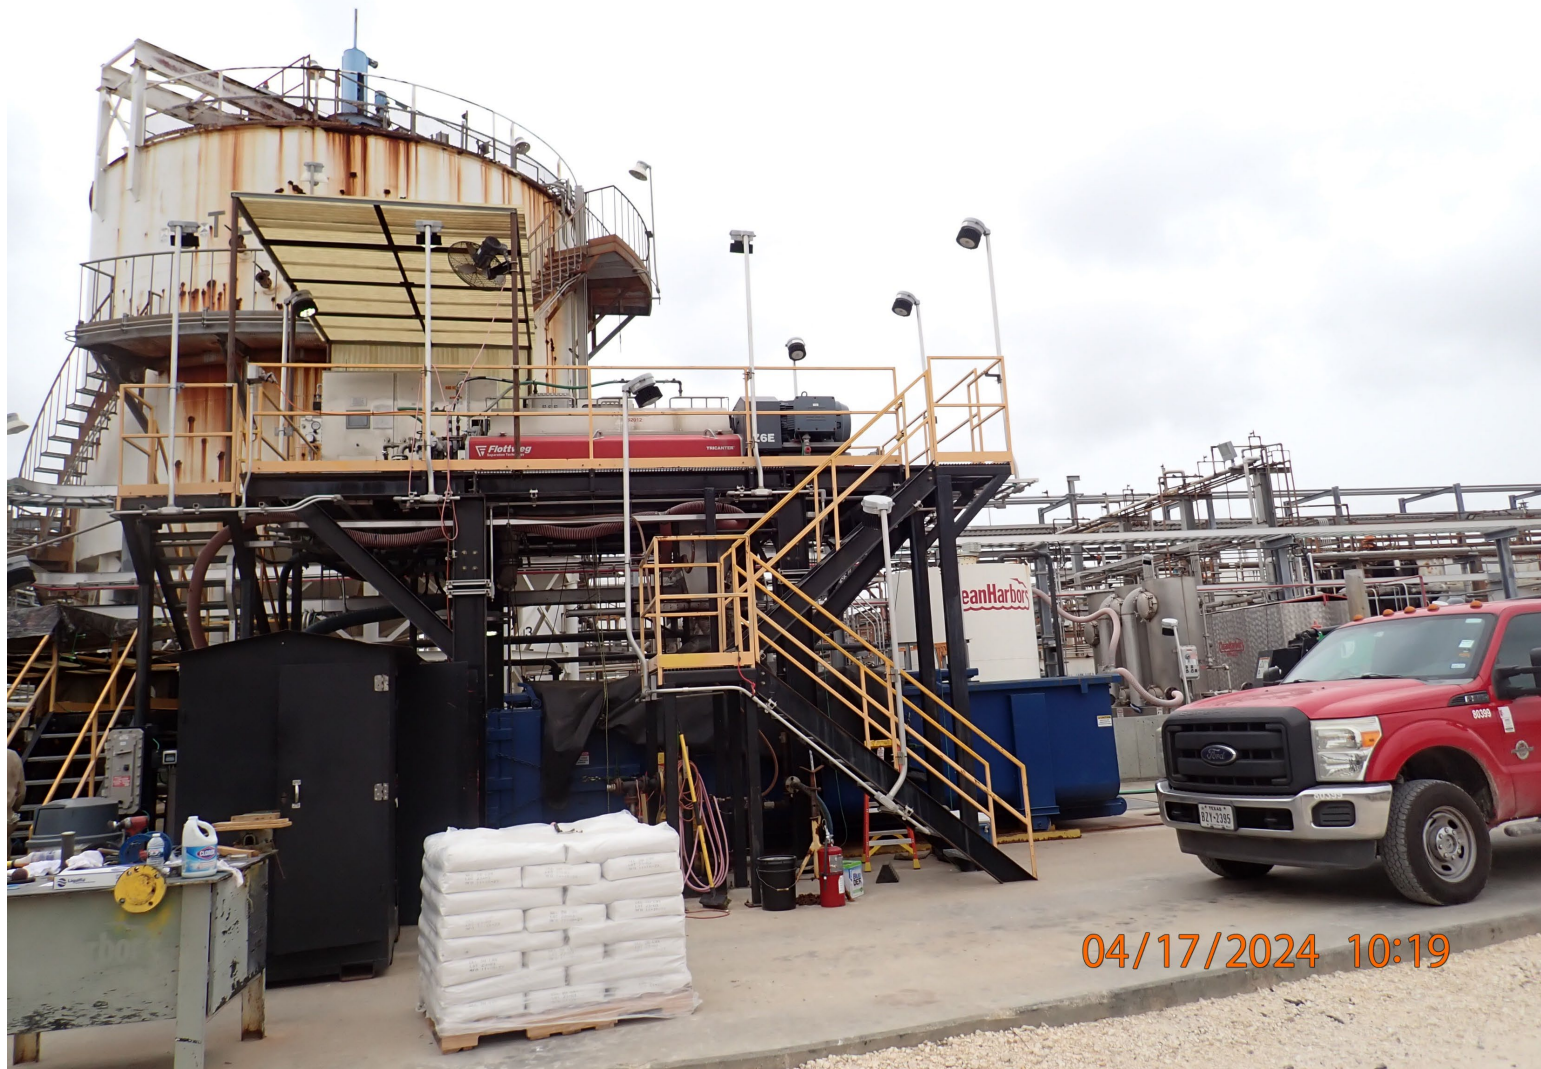
Photo 014: Clean Harbors sludge removal centrifuge  
4/17/2024 10:19 P4170014.jpg

Mr. Studebaker and I observed the Clean Harbors sludge removal centrifuge, a "Flottweg separation technology tricanter". (Photo 014) We recorded benzene concentrations of up to 1800 ppm using the UltraRae at the seal gap on the motor side of the centrifuge. **[AOC 18]** I used the FLIR infrared camera to observe emissions from the centrifuge. (FLIR0029) We observed Clean Harbors employees sitting in the area close to the centrifuge, and told the facility our concerns about their potential exposure to benzene.

We observed benzene from the centrifuge used by Clean Harbors to dewater sludge taken from the diversion tank in the BWON stream. We detected up to 1800 ppm benzene with the handheld monitor, and around 9 ppm benzene from the summa cannister sample.

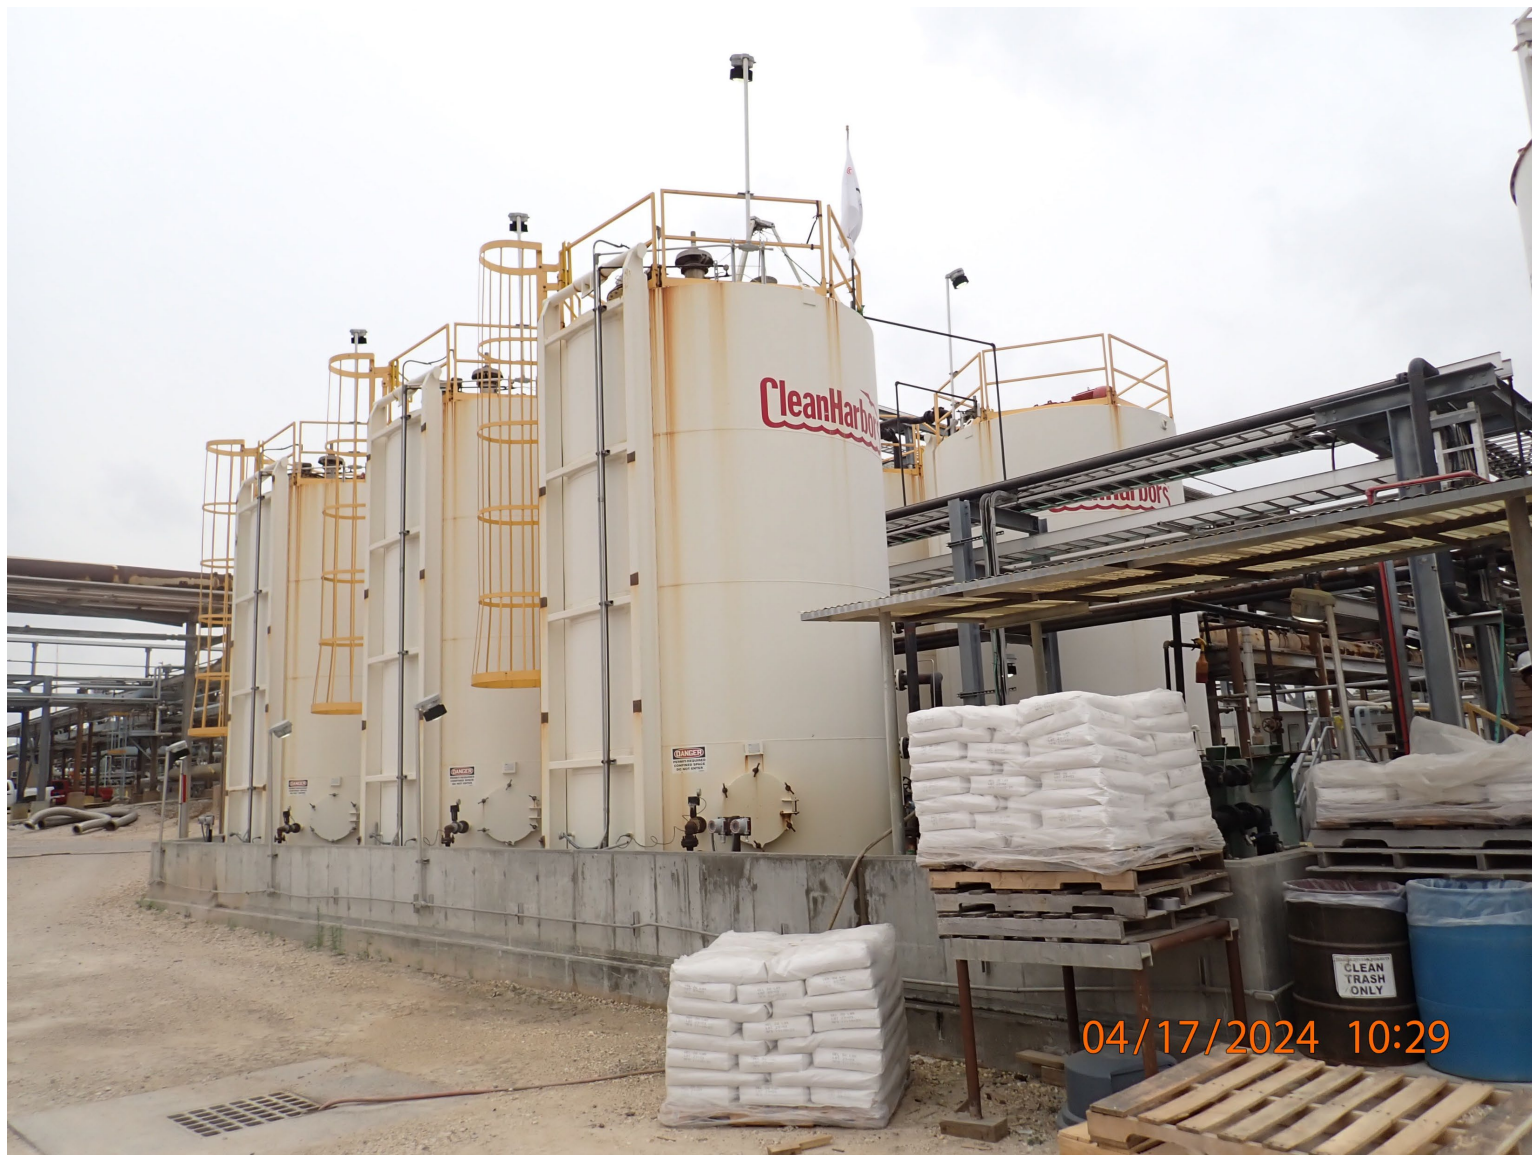
Photo 017: Clean Harbors sludge holding tanks  
4/17/2024 10:29 P4170017.jpg

I observed VOC emissions from the top of several of the six fixed roof tanks in the sludge removal process. (FLIR0030) **[AOC 19]**

DPR staff updated us on the Clean Harbors sludge fixed roof tanks. They said that there was corrosion on the weighted manway emergency pressure relief vents, as well as leaks in the rubber gasket seals that they were working to replace.

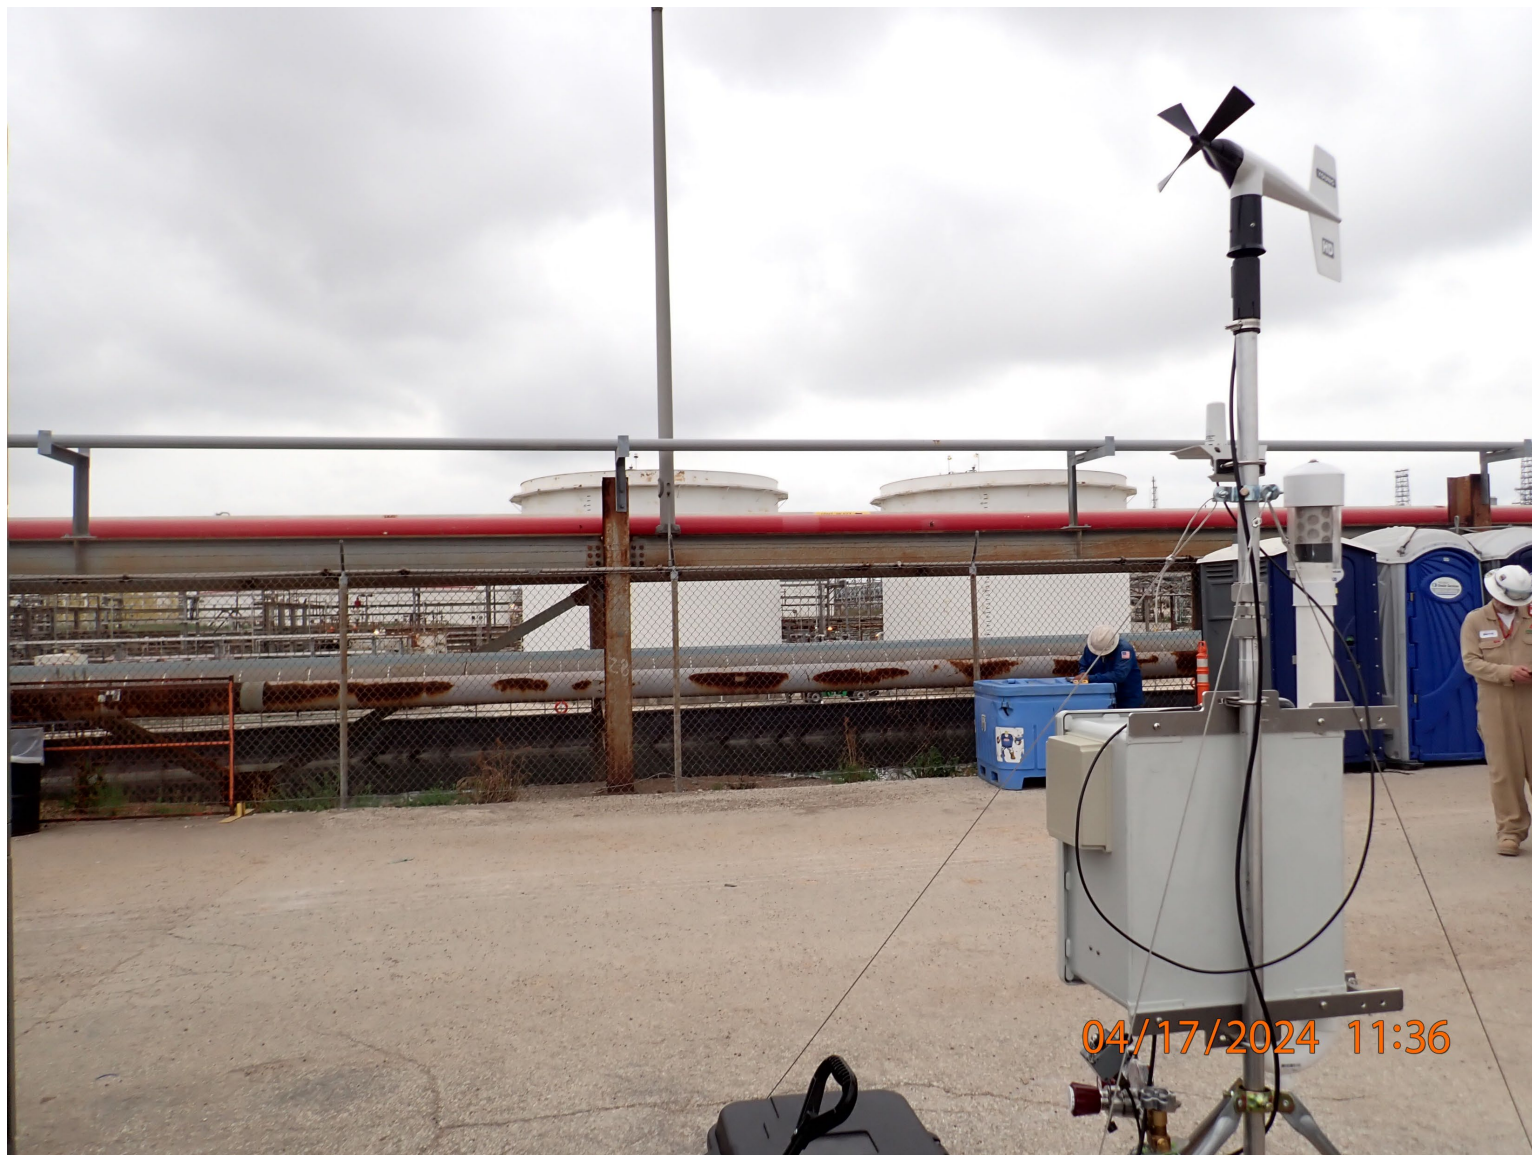
Photo 018: EPA 2B Location - 4/17/2024 11:36 P4170018.jpg

At approximately 12:30, ERG contractors moved eGC EPA-2 to a new location on Upper Dock Rd. (Site EPA 2B in the eGC report. Photos 018, 019, and 020) This location is NNW of the NET, CPIS, and Clean Harbors sludge removal operation.

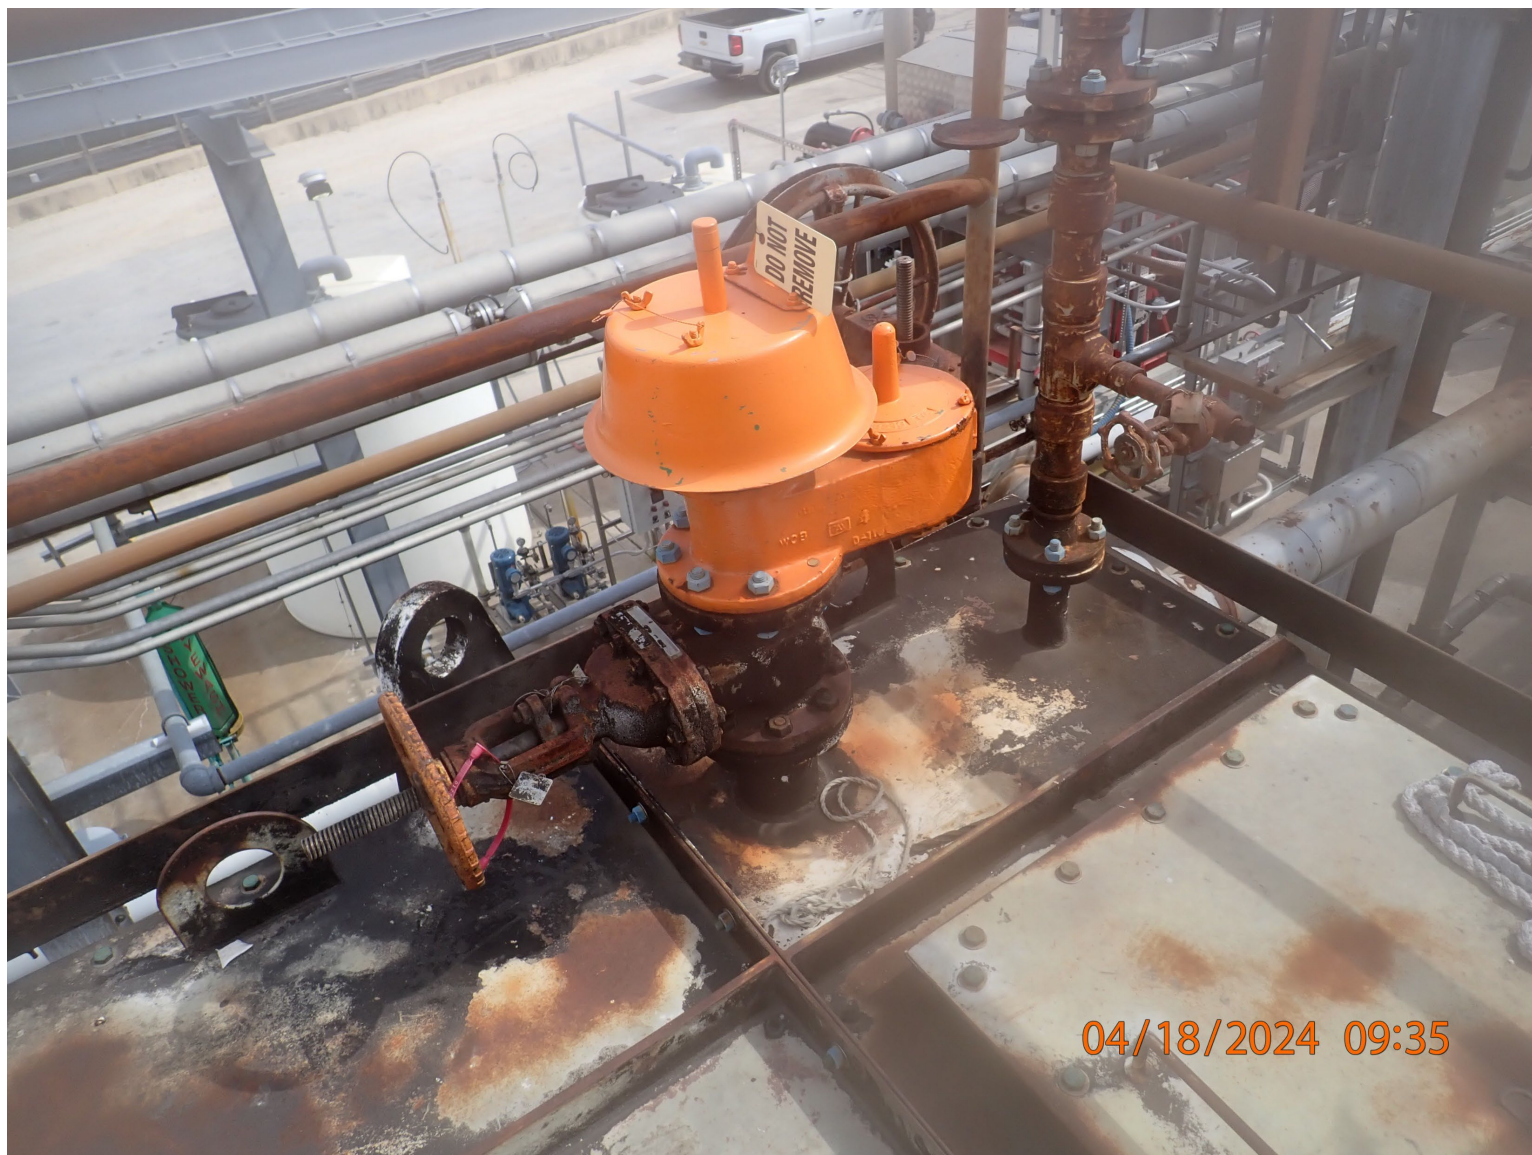
Photo 022: CPI #2 Vacuum Breaker - 4/18/2024 P4180022.jpg

I went on top of the BWON corrugated plate interceptors ("CPIs") within the NET. On the north CPI #2 (T-307), I monitored the pressure-vacuum relief vent ("PVRV") and recorded up to 10 ppm benzene from the vacuum breaker using the UltraRae. (Photo 022.) I also observed emissions from the vacuum breaker using the FLIR camera. (FLIR0031) Mr. Brown recorded up to 450 ppm tVOCs from the vacuum breaker, and up to 120 ppm from the pressure relief vent. I noted that the PVRV had an LDAR tag #90298 and component ID PVN-01412. (Photo 025) [AOC 16]

We observed benzene emissions from the North CPI orange Pressure/vacuum relief valve, with concentrations of 10 ppm benzene and about 450 ppm VOCs.

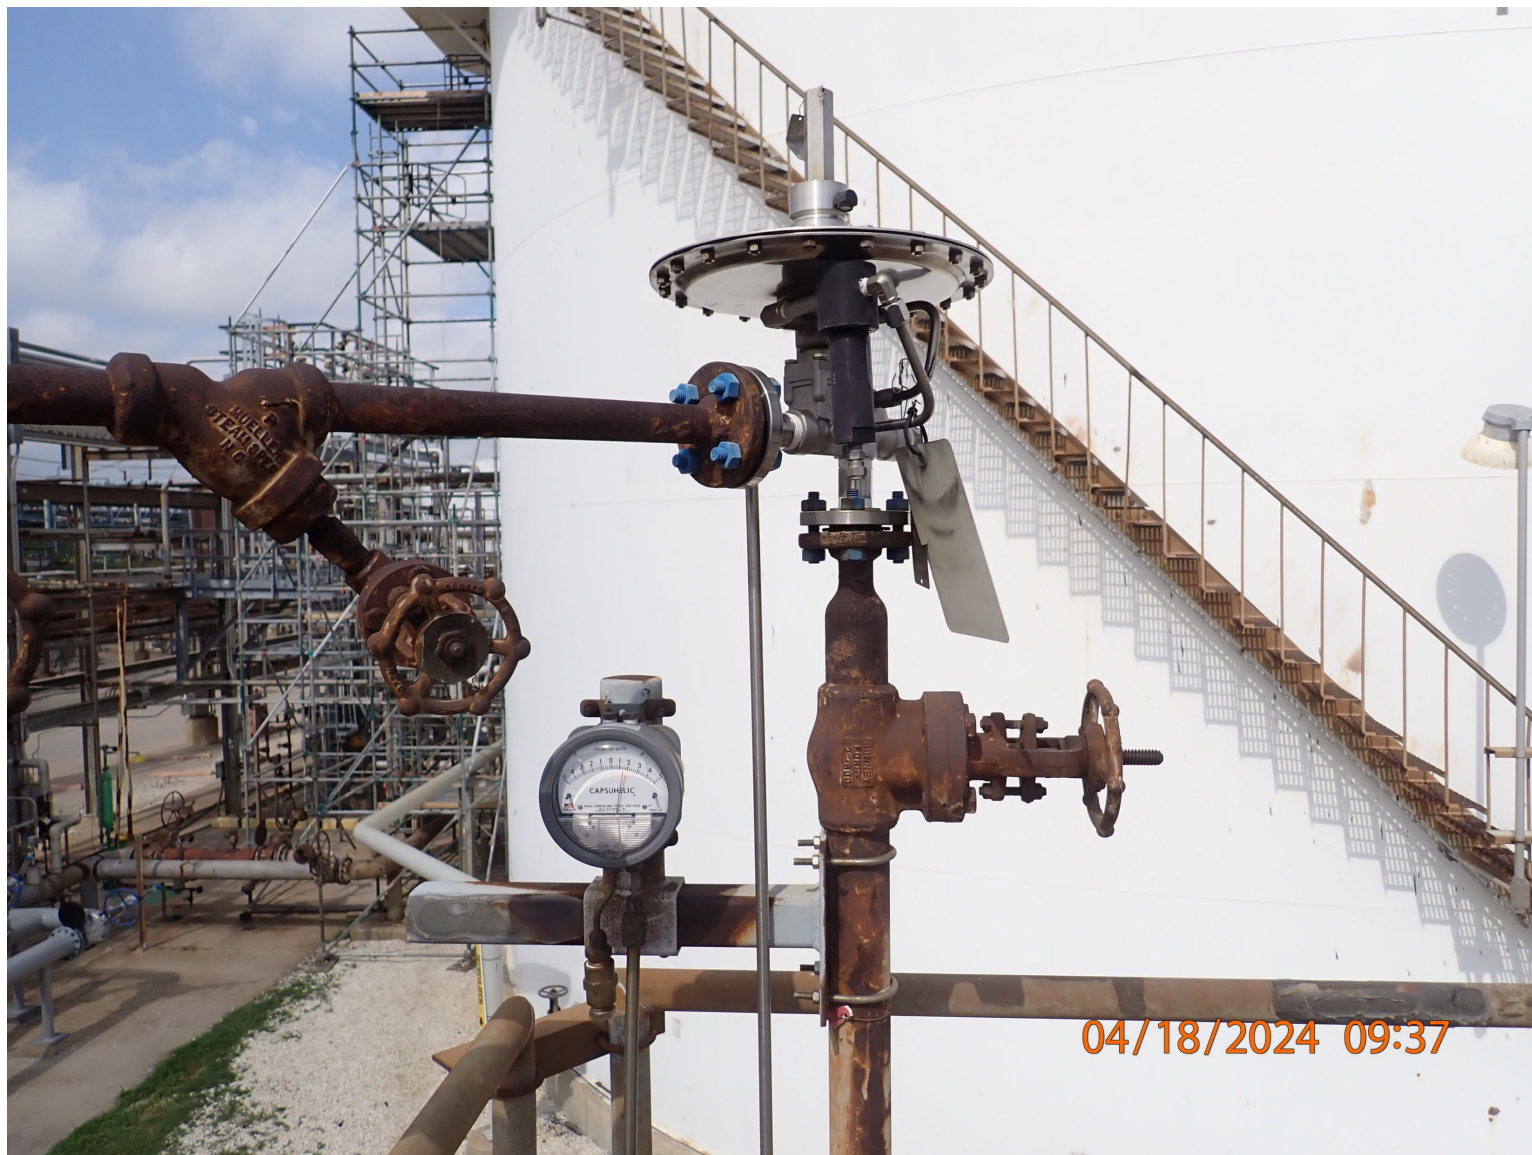
Photo 023: CPI#2 nitrogen blanket pressure gauge  
4/18/2024 09:37 P4180023.jpg

I noted the manual pressure gauge for the nitrogen blanket on the north CPI #2 was reading 1.8 inches of water column (1.8" WC). (Photo 023) I then went on top of the south CPI #1 (T-306) and observed that the pressure gauge for the nitrogen blanket for that unit was reading -0.2" WC. (Photos 026, 027) I asked Mr. Villanueva why the pressure was slightly negative on the south CPI #1. He indicated that both CPI's nitrogen blankets were interconnected and that the pressures should be identical on both, and that there may be a problem with the manual gauge on the South CPI #1. **[AOC 15]**
