## OECA – Air Enforcement Division INSPECTION REPORT

| Regulatory Program(s) | Title V/NESHAP | |
| Company Name: | <b>Pemex – Deer Park Refining LP</b> | |
| Facility Name: | <b>Deer Park Refinery</b> | |

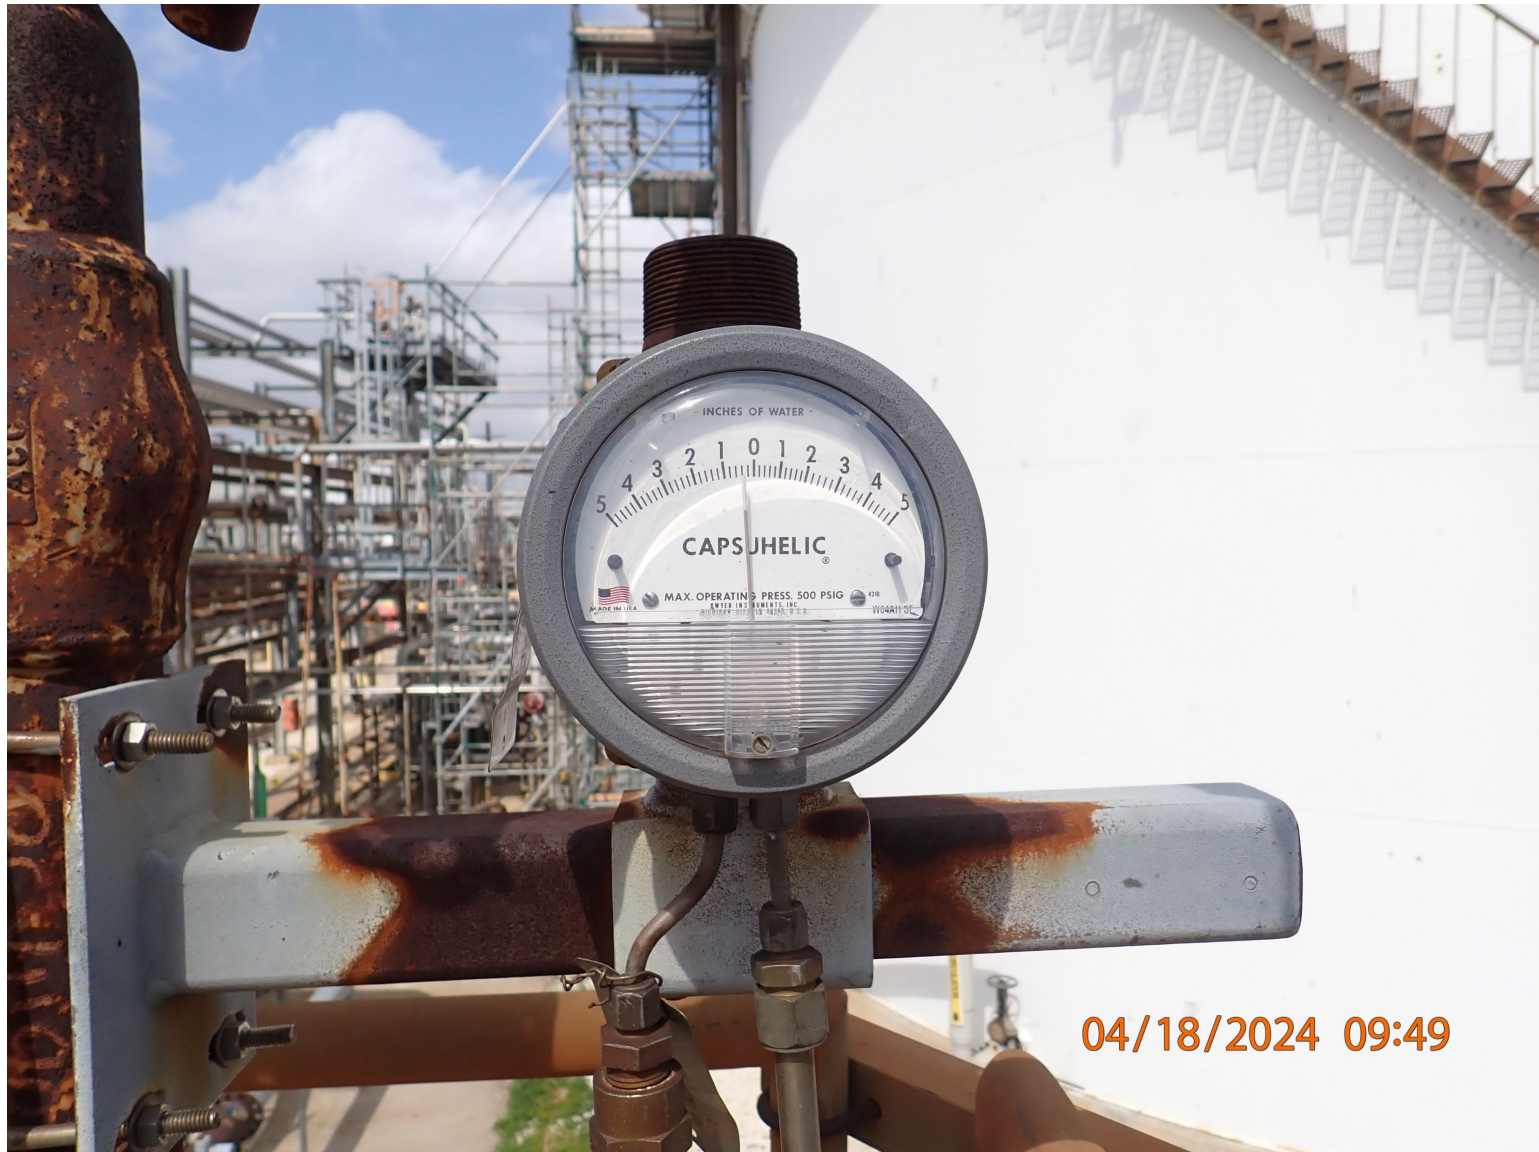
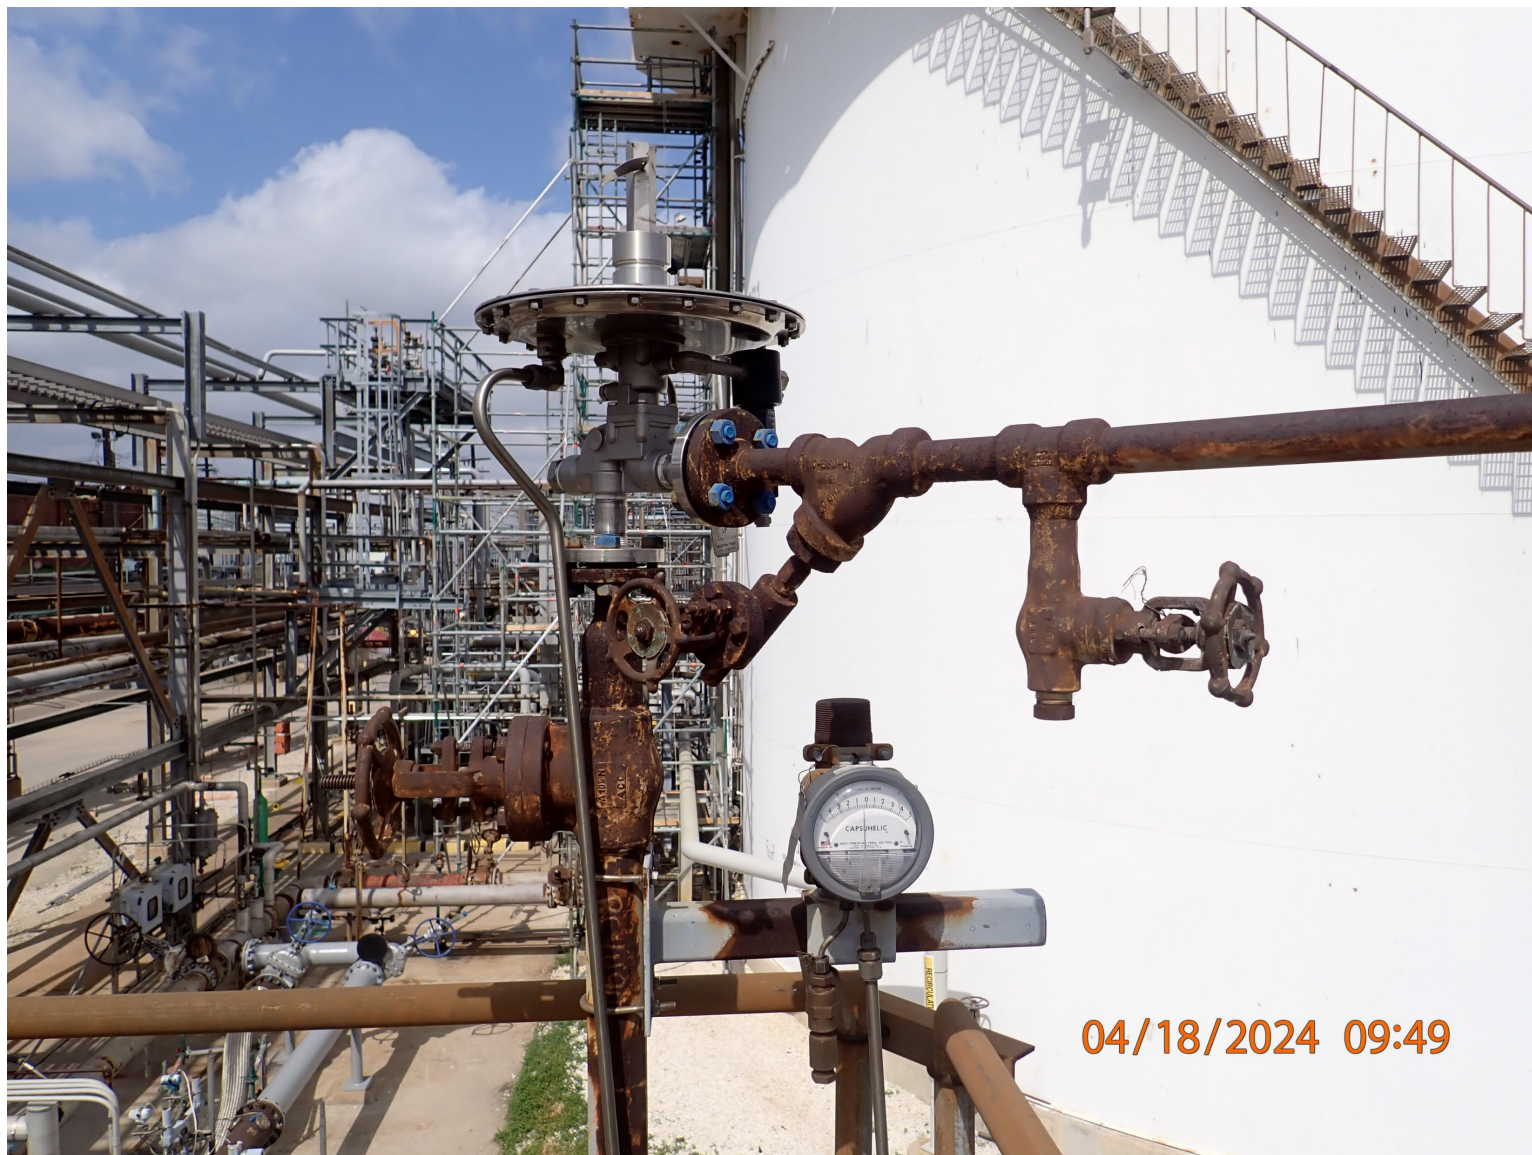
Photo 026: CPI #1 nitrogen blanket pressure gauge - 4/18/2024 09:49 P4180026.jpg

I noted the manual pressure gauge for the nitrogen blanket on the north CPI #2 was reading 1.8 inches of water column (1.8" WC). (Photo 023) I then went on top of the south CPI #1 (T-306) and observed that the pressure gauge for the nitrogen blanket for that unit was reading -0.2" WC. (Photos 026, 027) I asked Mr. Villanueva why the pressure was slightly negative on the south CPI #1. He indicated that both CPI's nitrogen blankets were interconnected and that the pressures should be identical on both, and that there may be a problem with the manual gauge on the South CPI #1. **[AOC 15]**

We observed that the manual pressure gauge for the nitrogen blanket on NESHAP CPI #1 T-306 was malfunctioning and stuck at -0.2" WC.

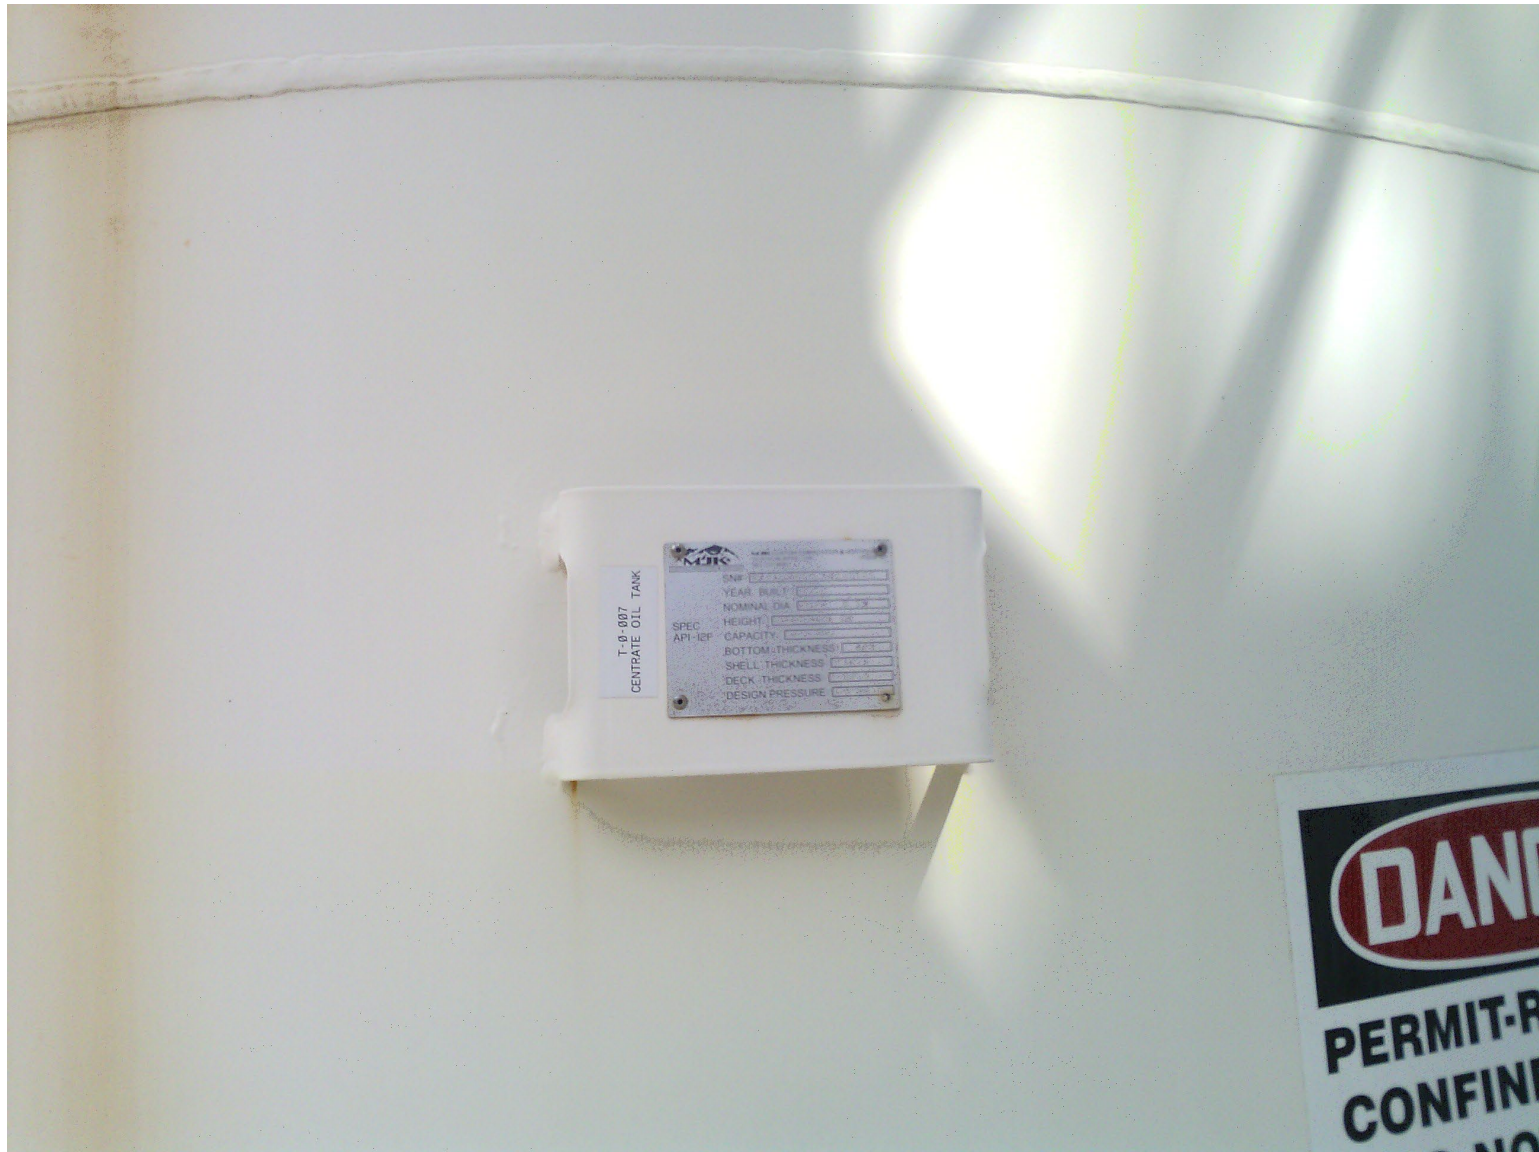
Photo 033: Centrate oil tank T-0-007 nameplate - 4/18/2024 09:58 FLIR0033.jpg

I observed VOC emissions with the FLIR camera from the centrate oil tank T-0-007. (FLIR0032 and FLIR0034. Photo 033) The emissions were coming from a weighted manway on top of the tank. Mr. Villanueva said that the weighted manway had been replaced 4 years ago, and that the seal may need to be replaced. **[AOC 20]**

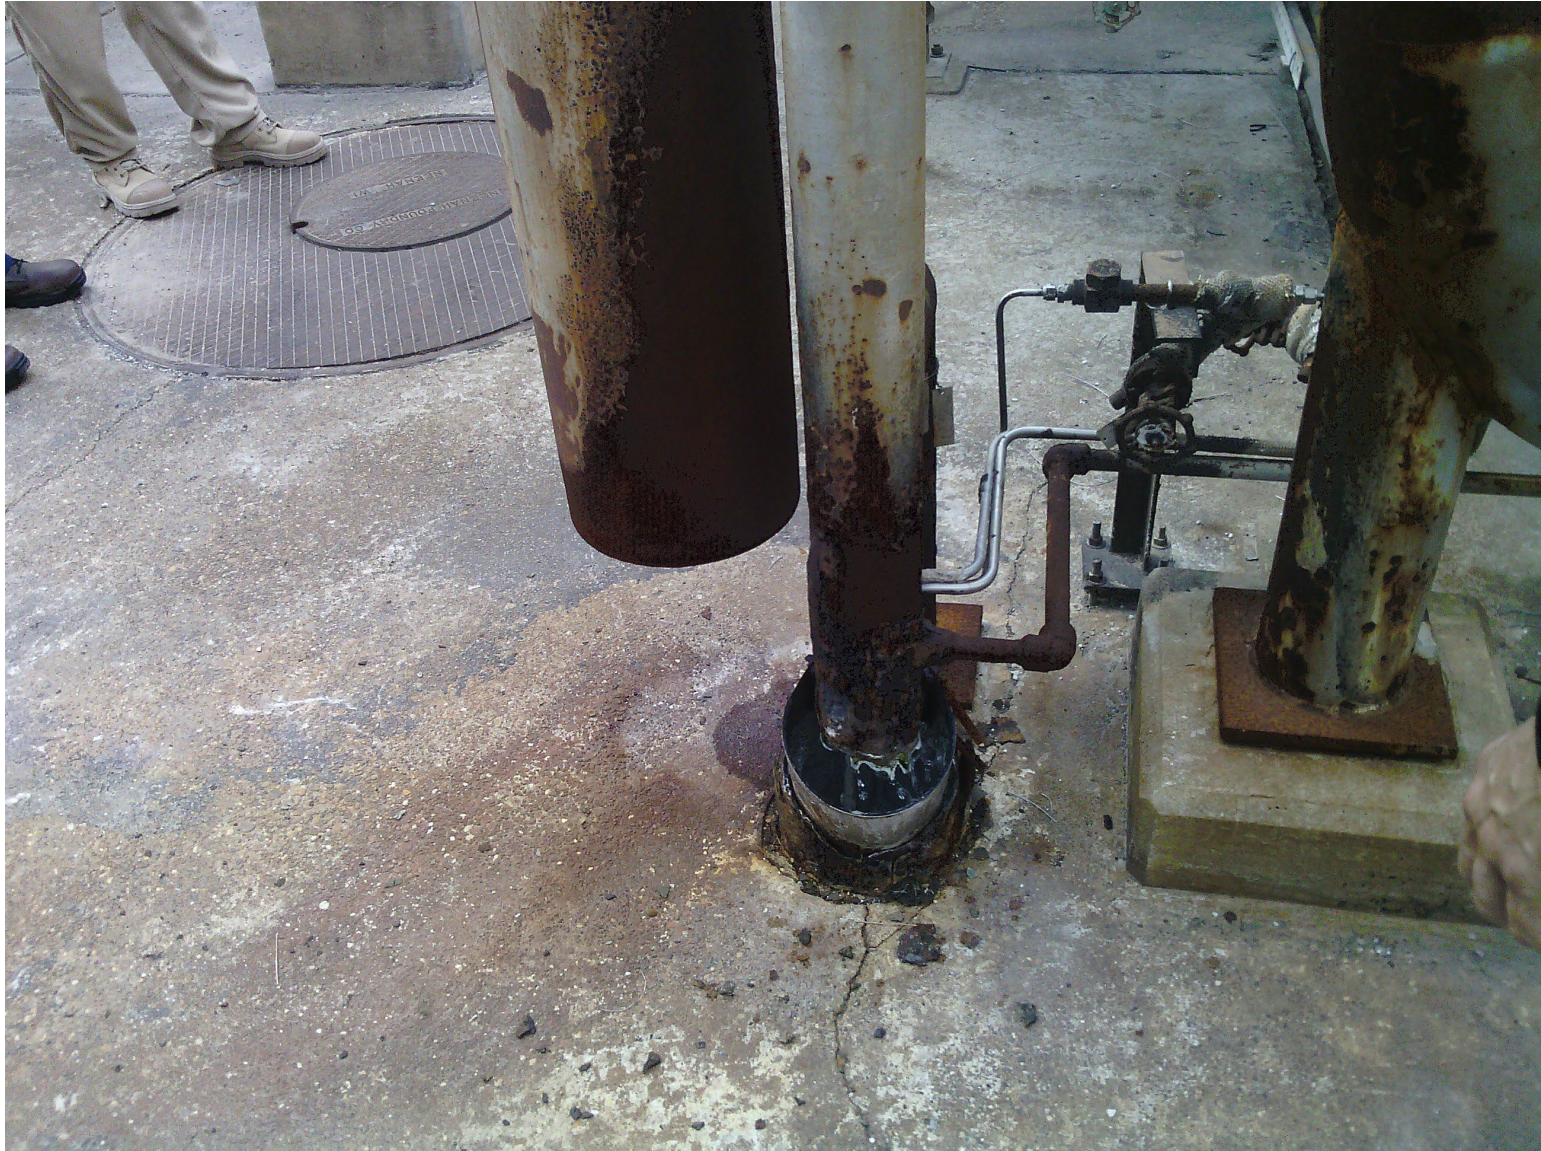
Photo 036: IGF #2 water seal drain - 4/18/2024 10:09 FLIR0036.jpg

I observed the Induced Gas Floatation ("IGF") Units, which receive BWON regulated wastewater from the CPIs. I first observed emissions from the north IGF #2 (T-309) water seal drain, where I recorded up to 30 ppm benzene with the UltraRae and 315 ppm tVOCs with the Neo PID. (Digital video FLIR0035, Photo 036) I also detected benzene concentrations up to 14.75 ppm from the water seal drain on the south IGF #1. (Photo 046) **[AOC 10]**

We observed benzene concentrations, 15 to 30 ppm, at water seal drains on the Induced Gas Floatation Units #1 and #2, T-308 and T-309, respectively.

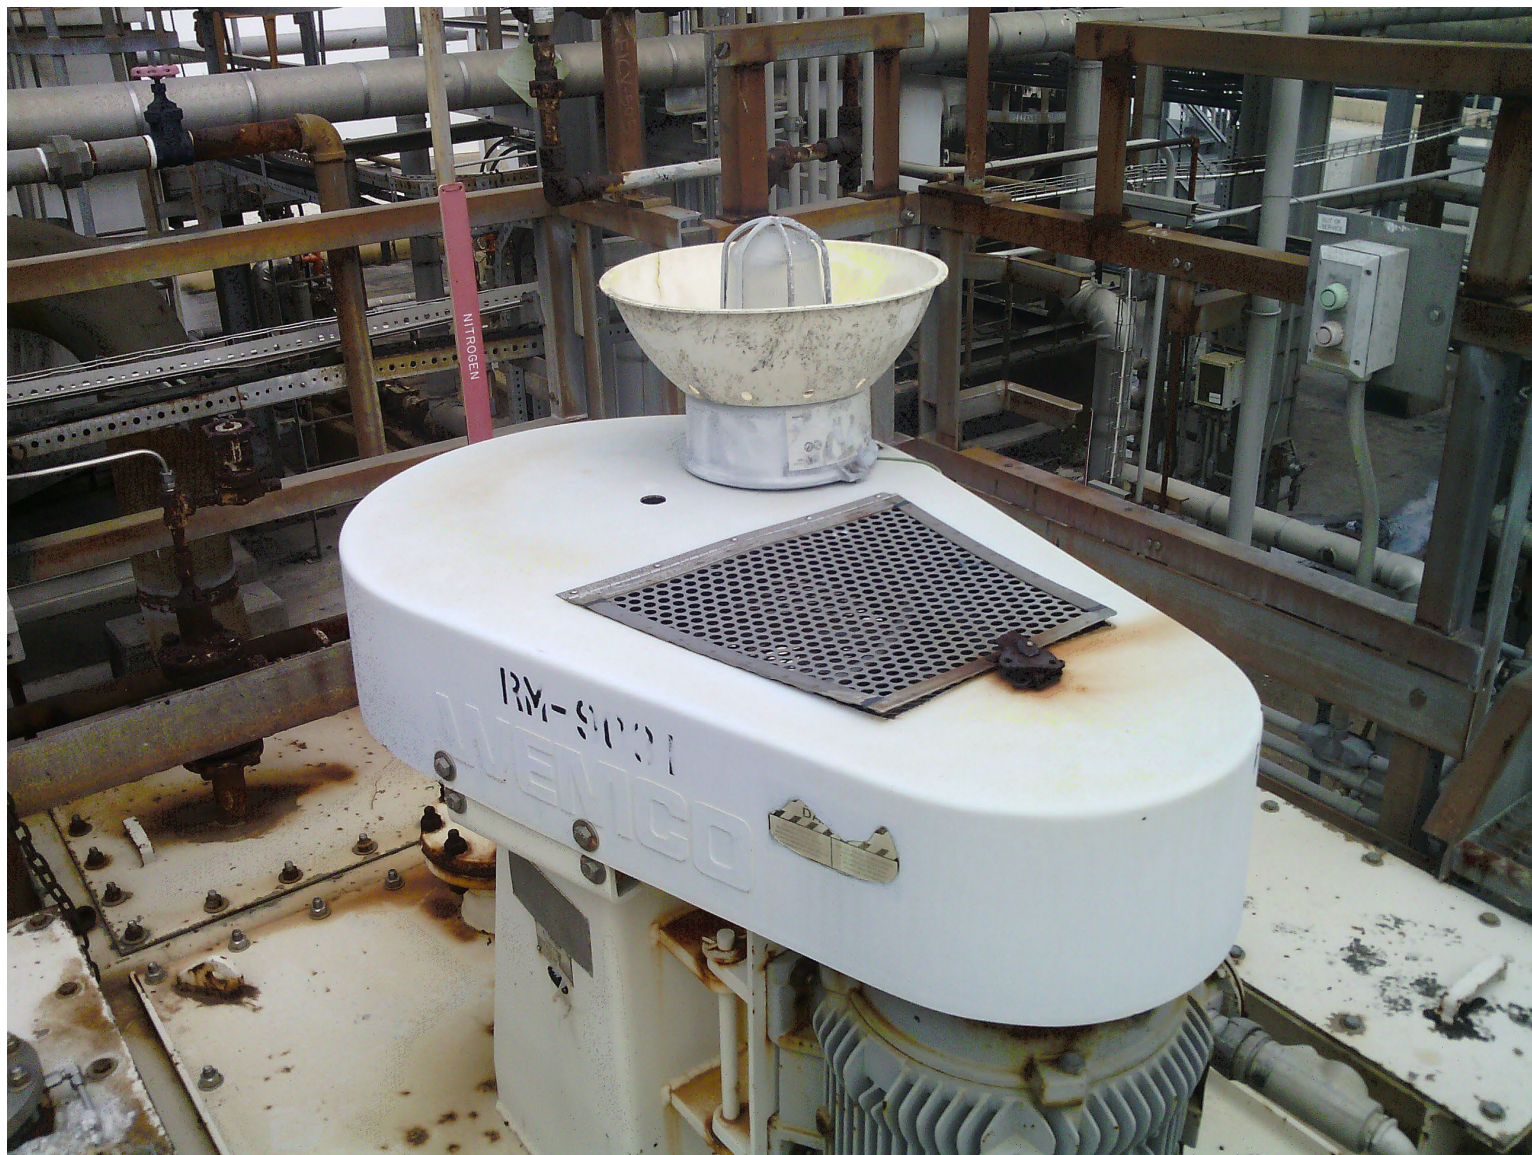
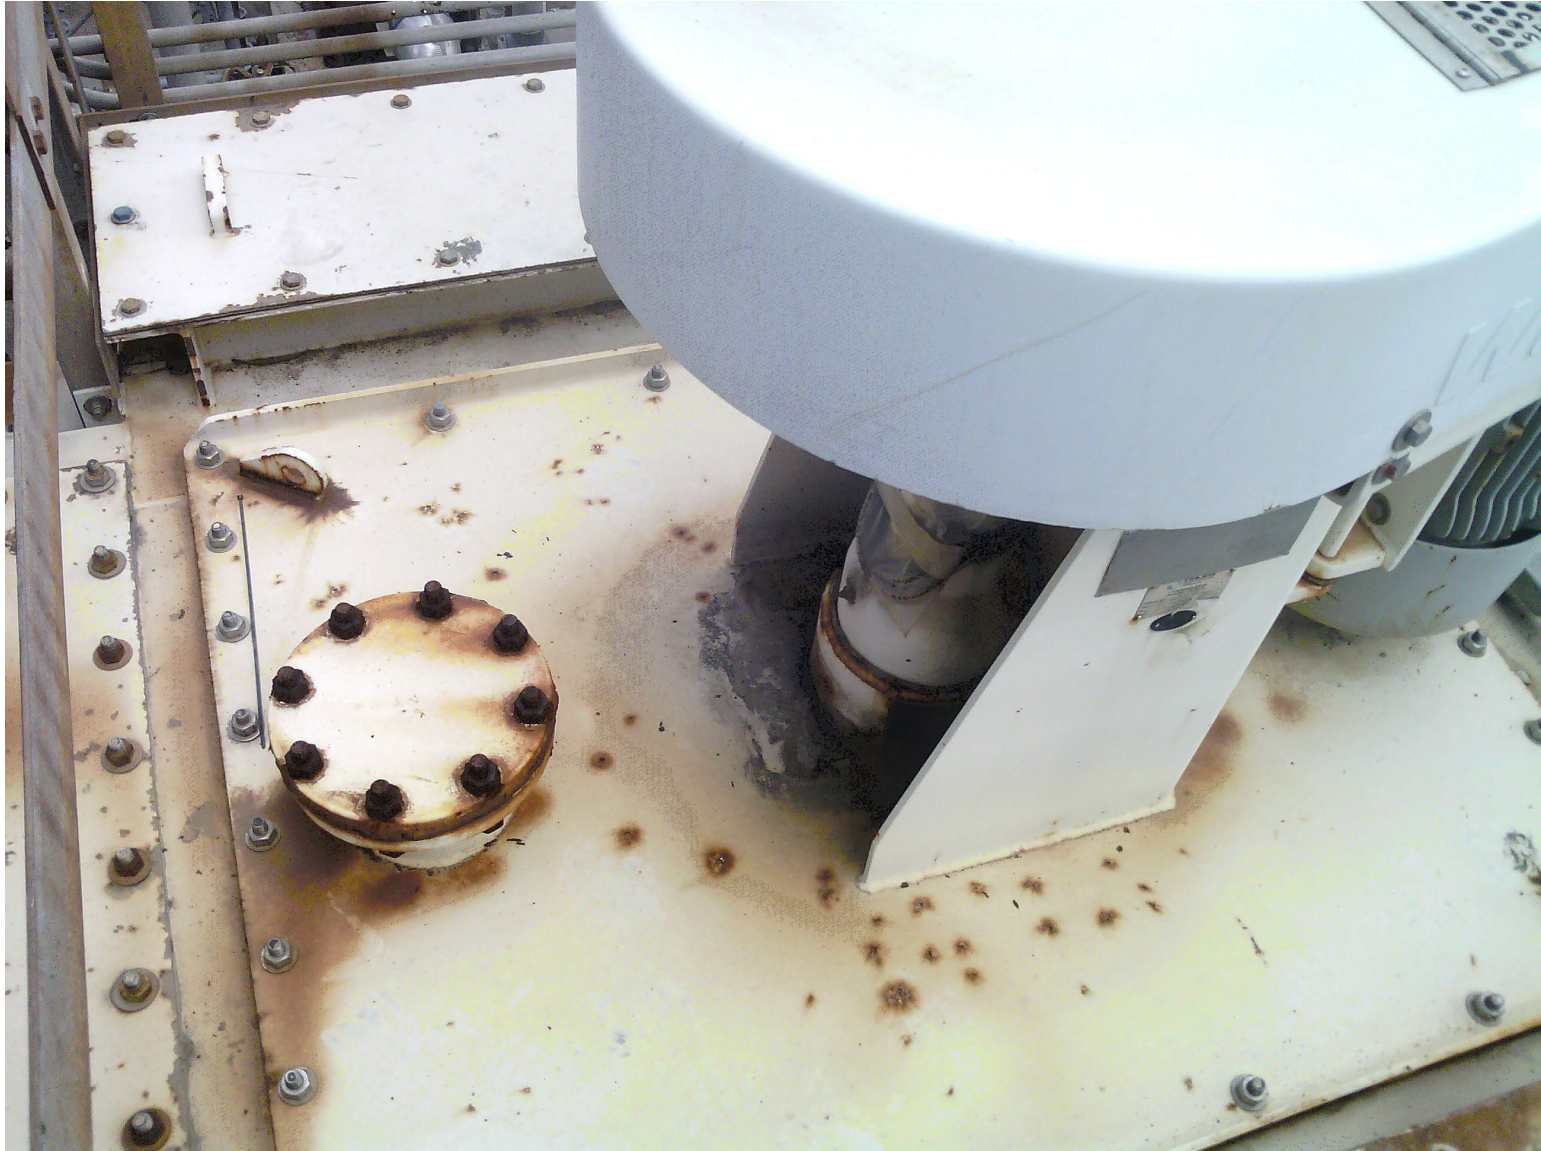
Photo 041: IGF #1 agitator RM-9031 - IGF 4/18/2024 11:25 FLIR0041

We then observed a leak from agitator RM-9031 on the south IGF #1, T-308. (FLIR0039, Photo 041 and 042) We detected benzene concentrations of at least 100 ppm, the maximum the UltraRae can detect, and tVOC concentration up to 8,092 ppm from the agitator leak. **[AOC 12]** We also observed visible corrosion and gaps where the agitator shaft entered the IGF. **[AOC 14]**

We observed benzene emissions from a leak in agitator RM-9031 on the South IGF unit. Over 8,000 ppm VOCs and over 100 ppm benzene concentration was detected with the handheld monitors.

We observed that the general condition of the IGFs had several spots of severe rust and some corrosion. The leak from AOC 11 was from a rusty flange connection, and the leak from AOC 12 was from a section of the agitator that had visible corrosion gaps.

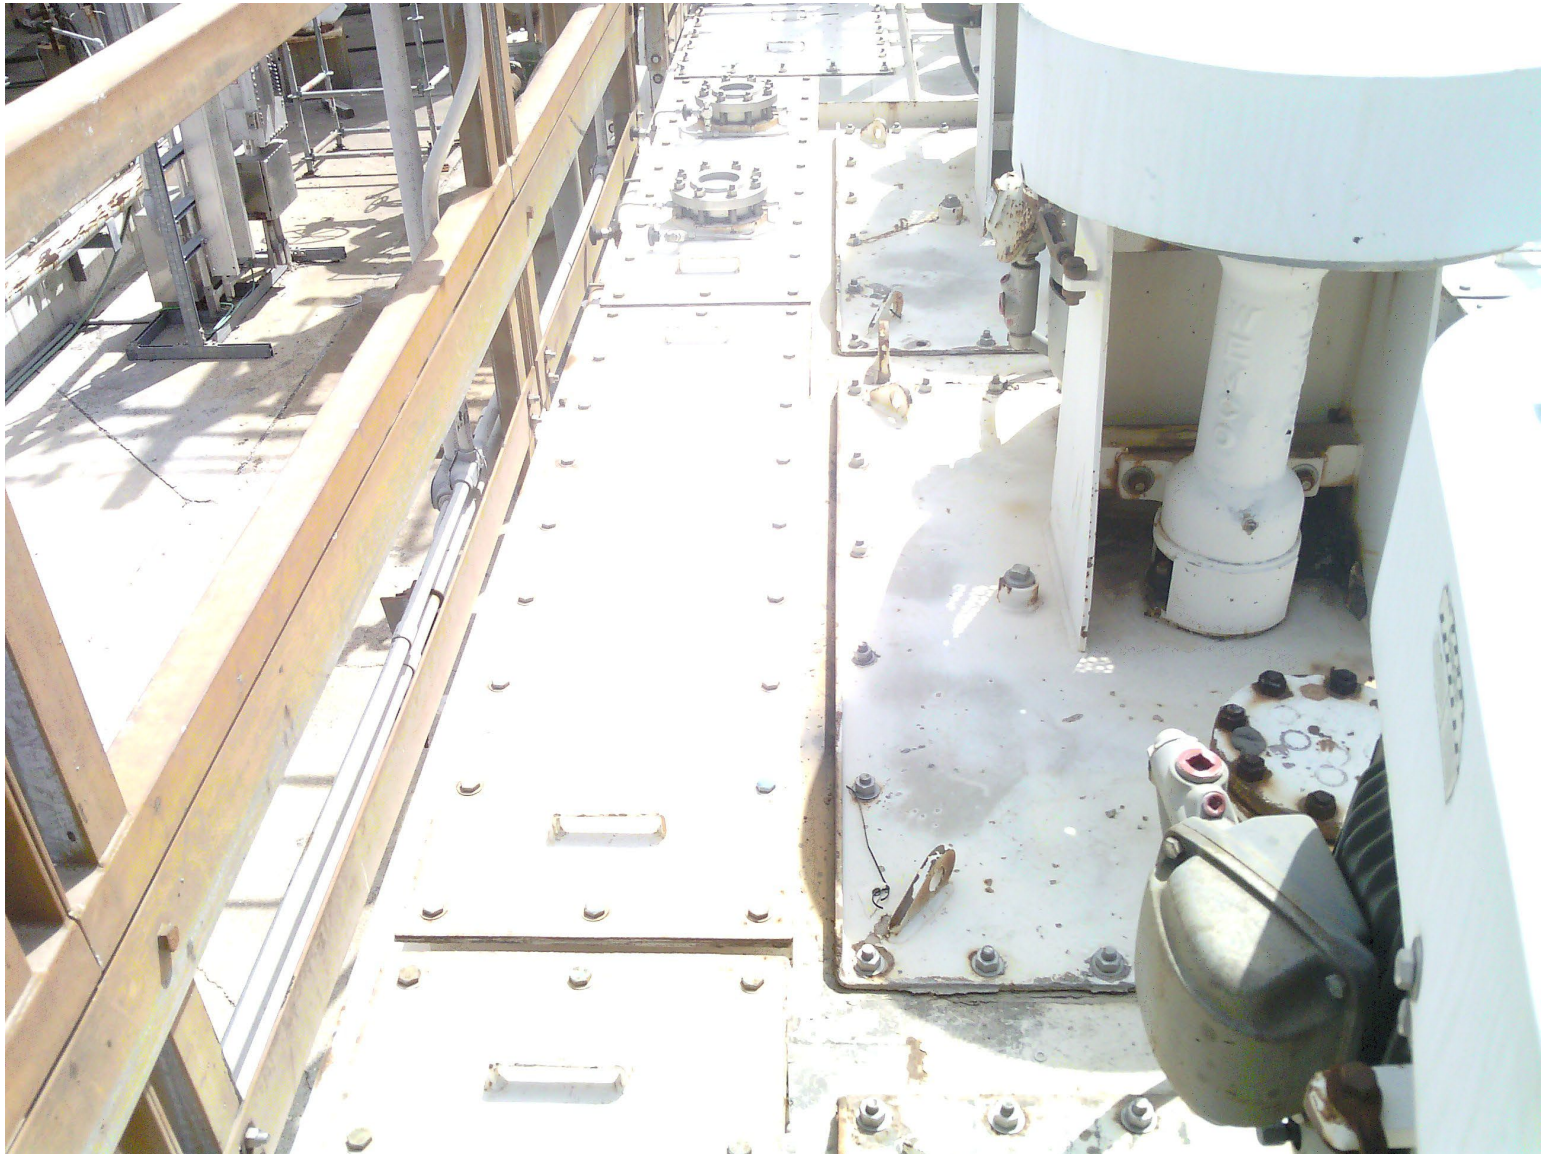
Photo 043: IGF #2 flange leak; 4/18/2024 11:27 FLIR0043.jpg

Mr. Studebaker and I then went on top of the IGFs. I detected emissions using the FLIR camera from a flange on the north IGF #2. (FLIR0038, Photo 043). The flange was adjacent to agitator RM-9039 on the north IGF #2. We detected concentrations up to 195 ppm benzene and 4,000 ppm tVOCs from the flange leak. **[AOC 11]**

We observed benzene concentrations from a flange leak on North IGF unit T-309. The emissions were observed from the flange on the north side of agitator RM-9039. We observed concentrations of 4,000 ppm VOCs and 195 ppm benzene.

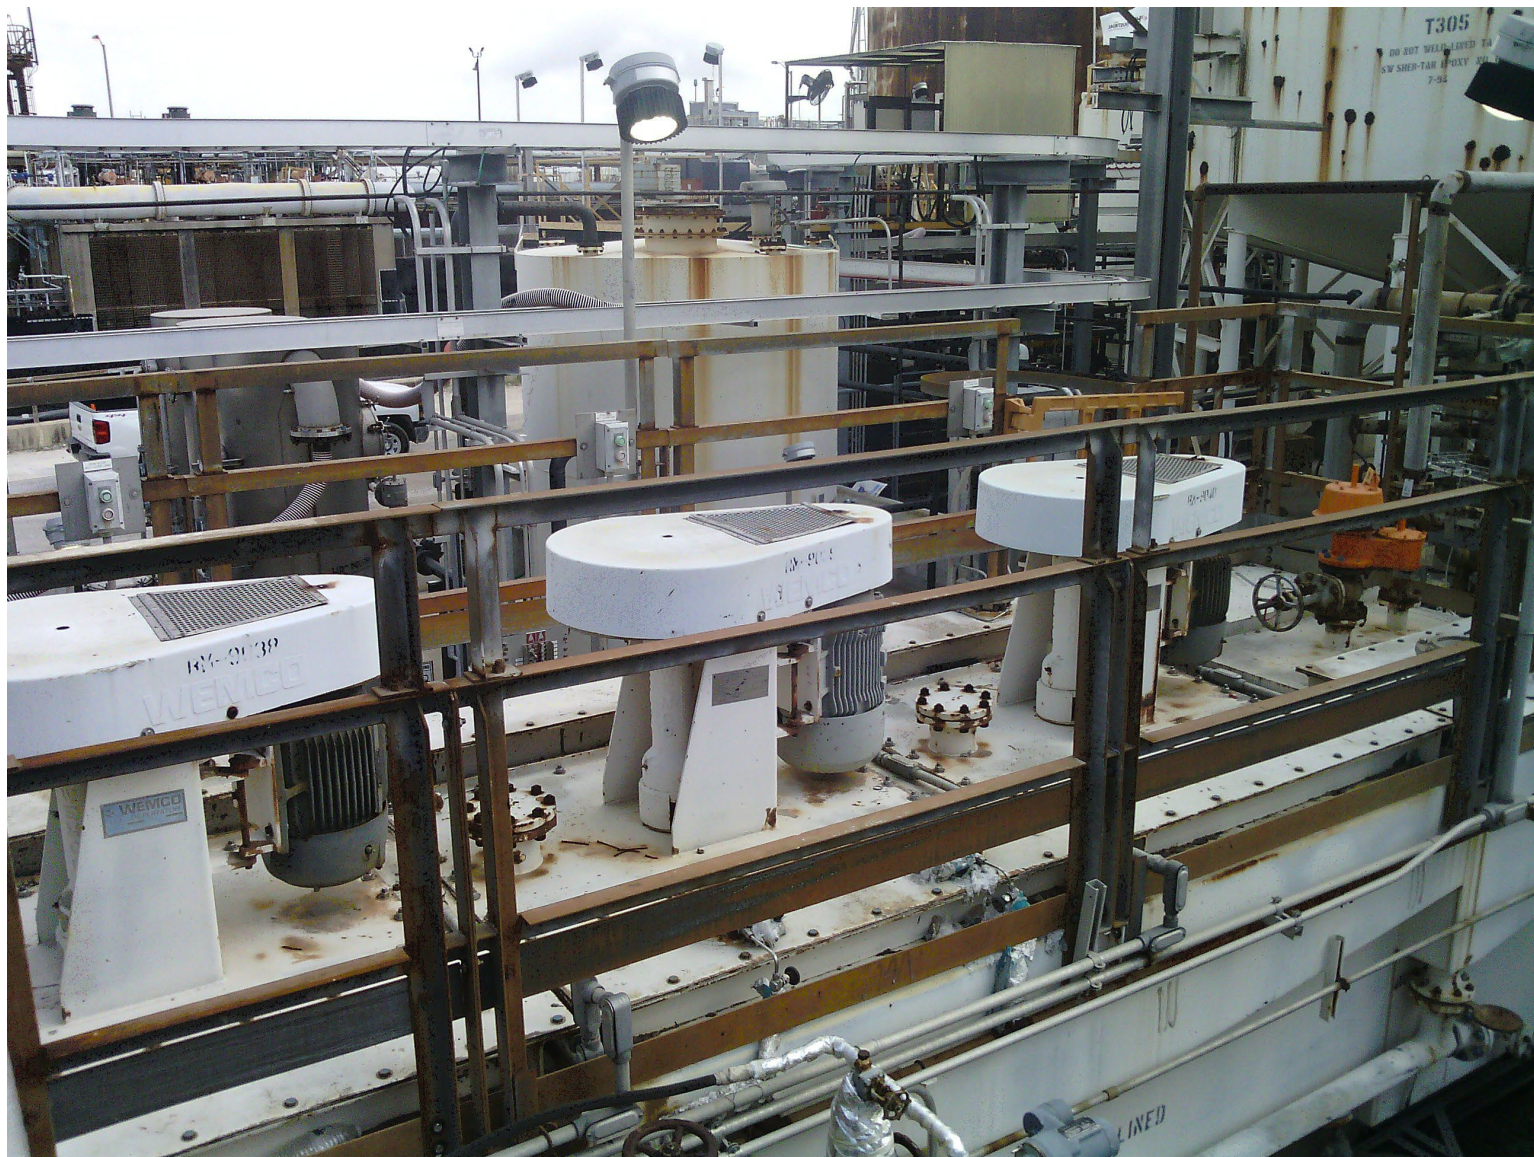
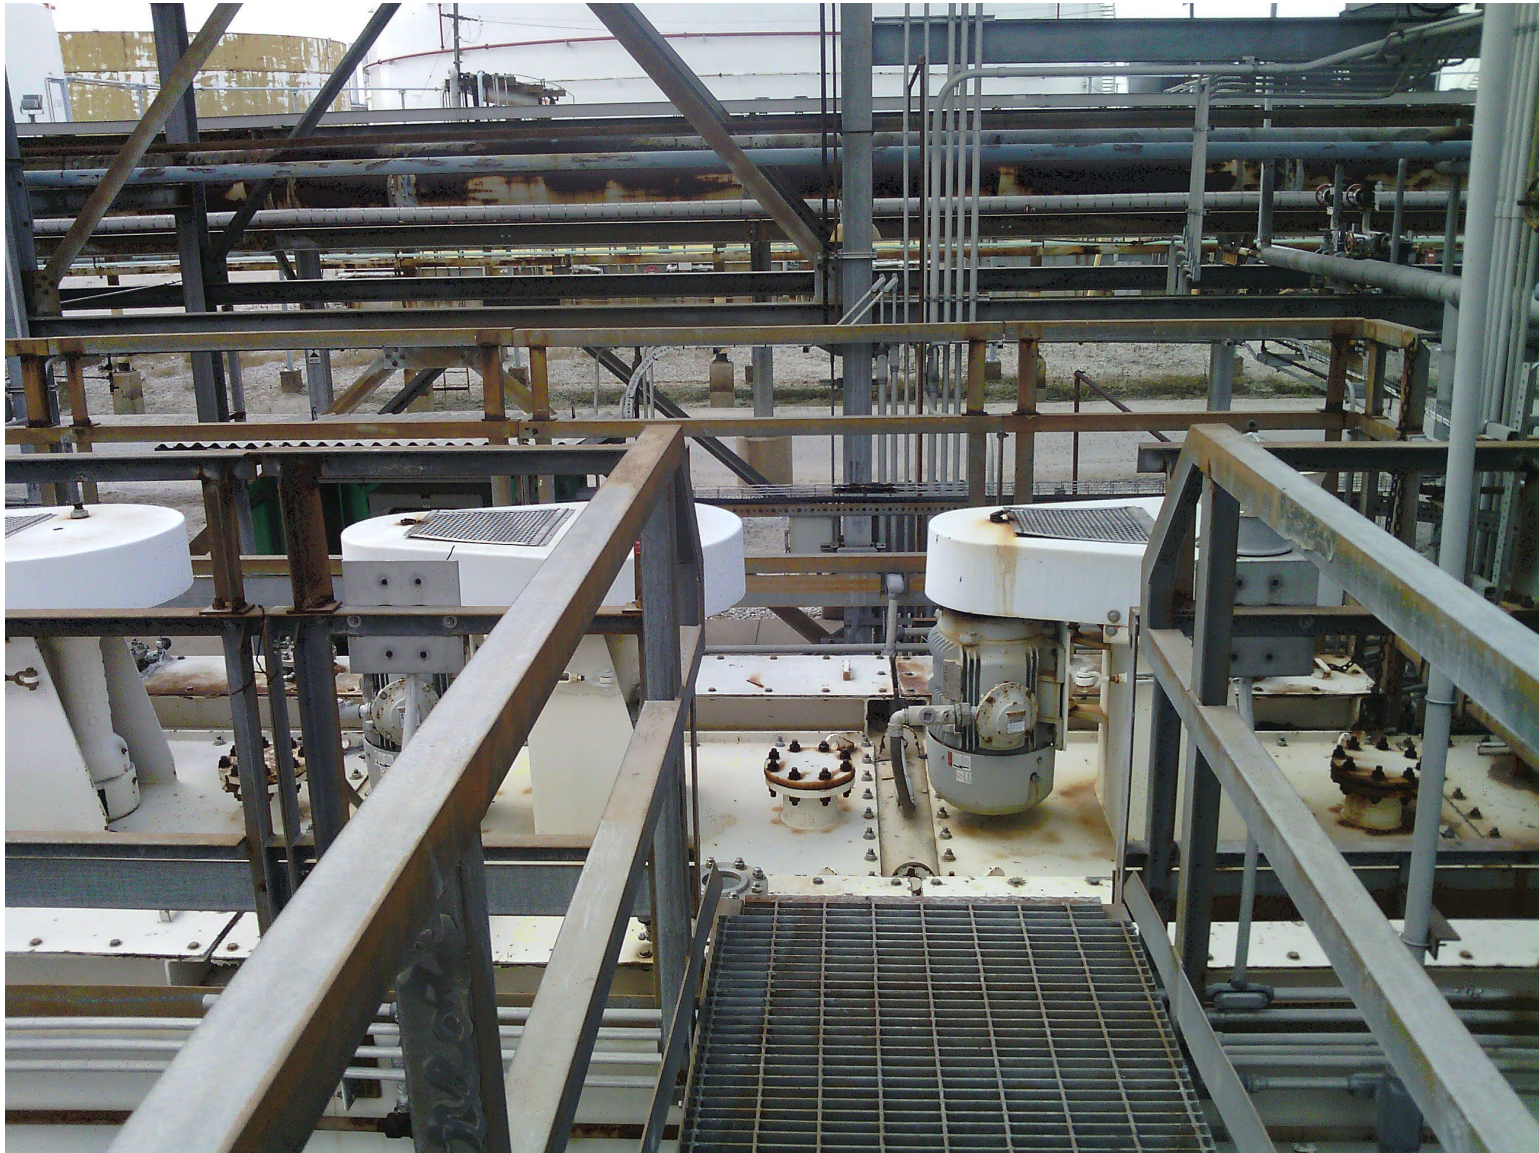
Photo 044: IGF #2 - 4/18/2024 11:28 FLIR0044.jpg

We then observed emissions from the pressure relief valve on the south IGF #1. (FLIR0040) We detected up to 10 ppm benzene and 20 ppm tVOCs from the pressure hood vent. **[AOC 13]** I took photos of north IGF #2 (Photo 044) and south IGF #1 (Photo 045), along with the associated agitators, from the catwalk between the IGFs.

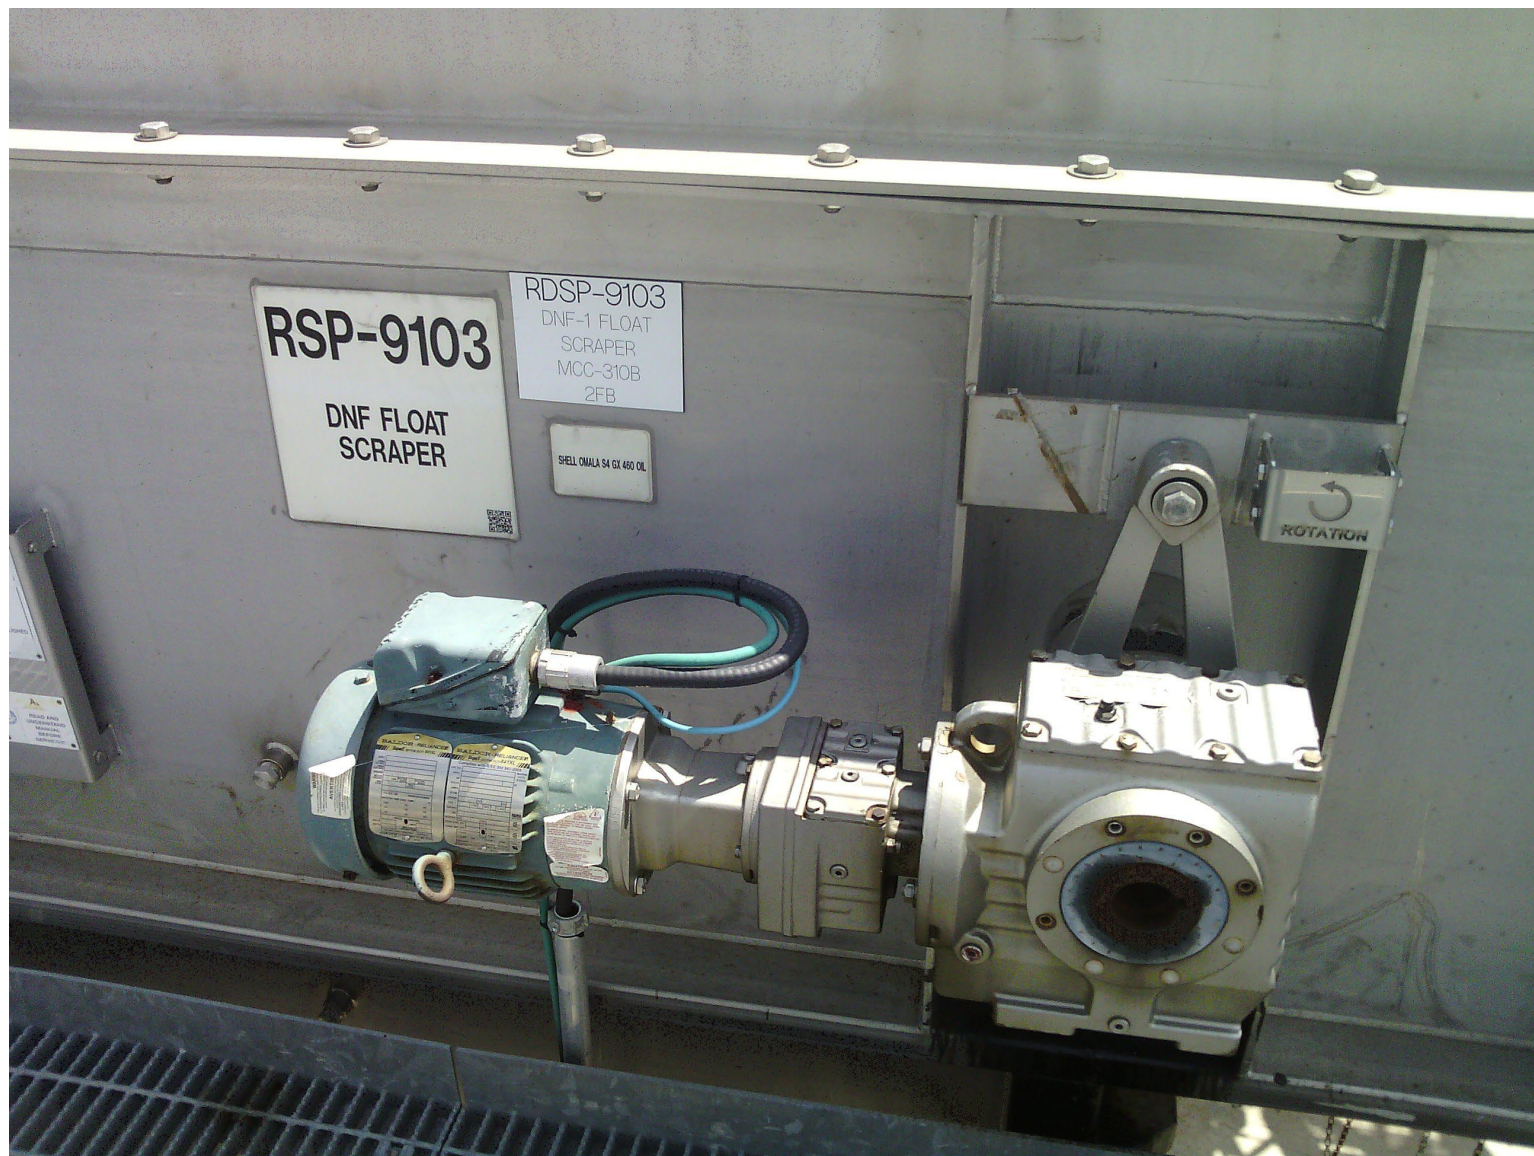
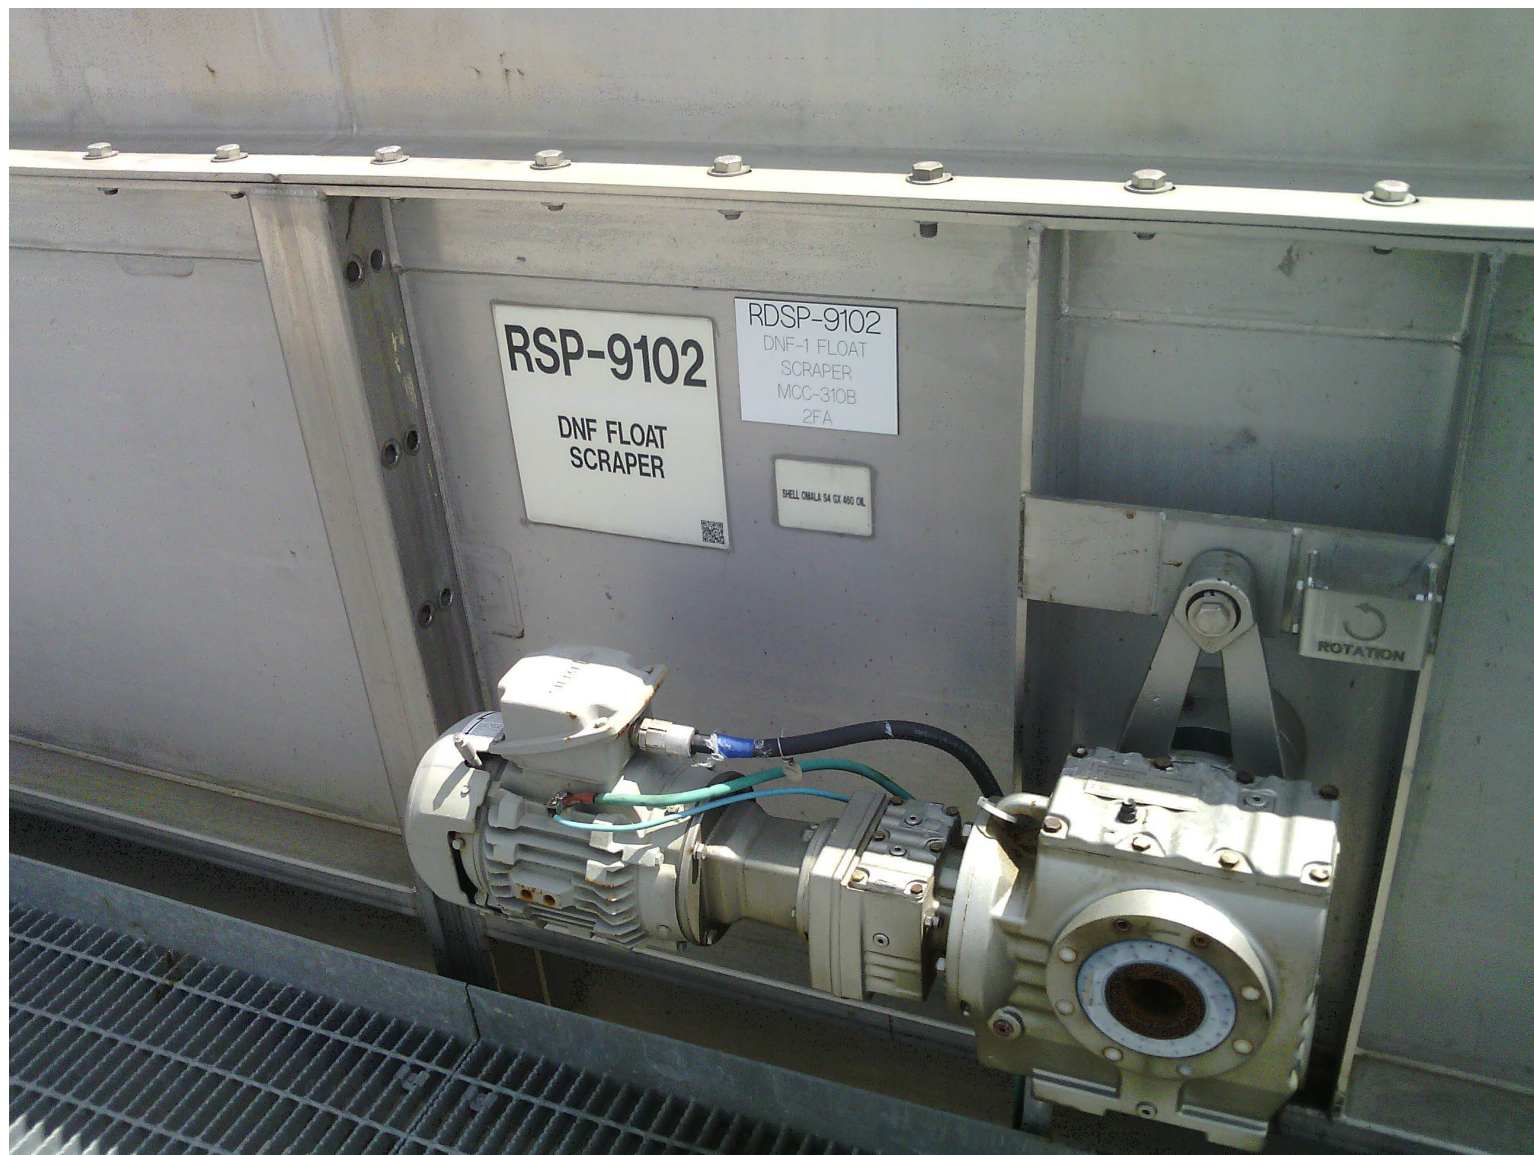
Photo 050: DNF TN-80010 float scraper RSP-9103 - 4/18/2024 12:03 FLIR0050.jpg

At approximately 8:00, EPA Inspector Knodl and the ERG contractors arrived at the site and demobilized the two EPA eGCs. They also collected summa cannister #SAT140 from the DNF TN-80010 Float Scraper RSP 9103 where high VOC and benzene concentrations had been observed the previous day. The summa cannister analysis showed 436 ppb benzene and 305 ppb toluene. **[AOC 17]** See attached eGC report for the full summa cannister analysis.

We observed benzene and VOC emissions at the TN-80010 DNF Float Scrapers from four points where the scrapers enter the unit, at RSP 9100, 9101, 9102, and 9103. We observed VOC concentrations up to 10,500 ppm VOCs, and summa cannister sampling the next day showed at least 400 ppb benzene.
