## OECA – Air Enforcement Division INSPECTION REPORT

| Regulatory Program(s) | Title V/NESHAP | |
| Company Name: | <b>Pemex – Deer Park Refining LP</b> | |
| Facility Name: | <b>Deer Park Refinery</b> | |

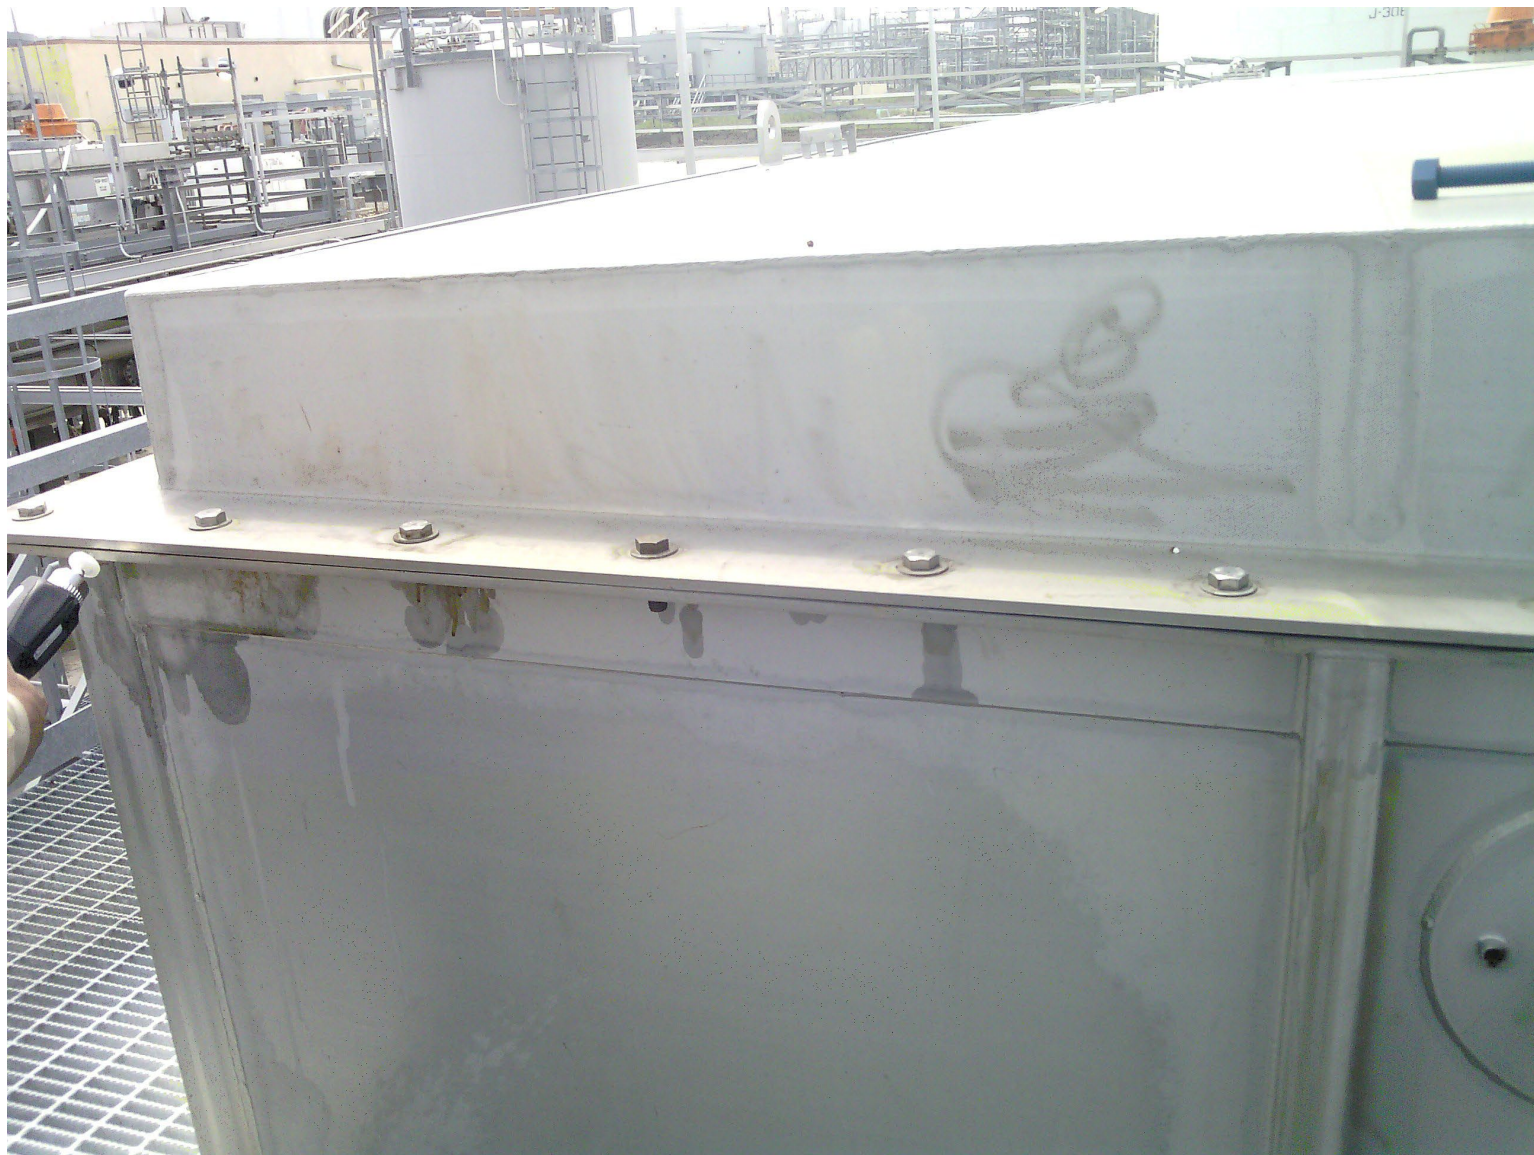
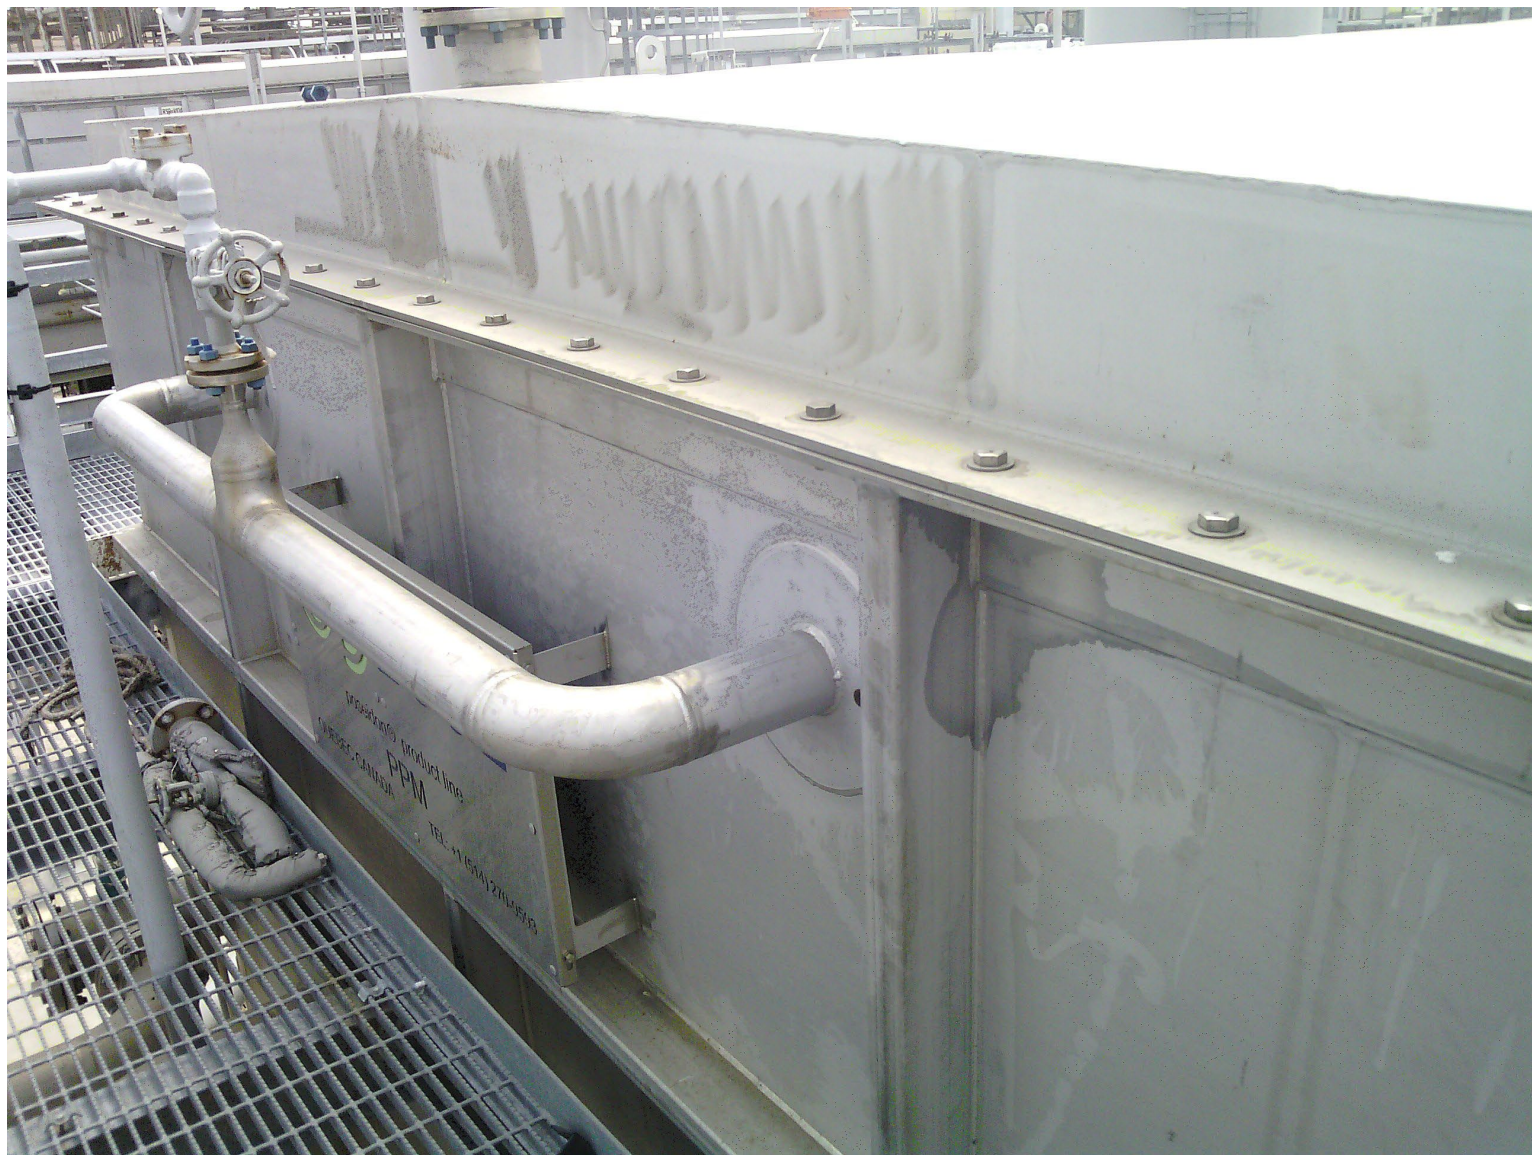
Photo 053: DNF TN-80010 flange - 4/18/2024 12:11 FLIR0053.jpg

I observed VOC emissions from a pressure vent hood on top of the DNF TN-80010. (FLIR0052) We also observed some condensation forming from small leaks in the flange on the DNF. (Photos 053 and 054) I took photo 055 of the nameplate for the DNF TN-80010.

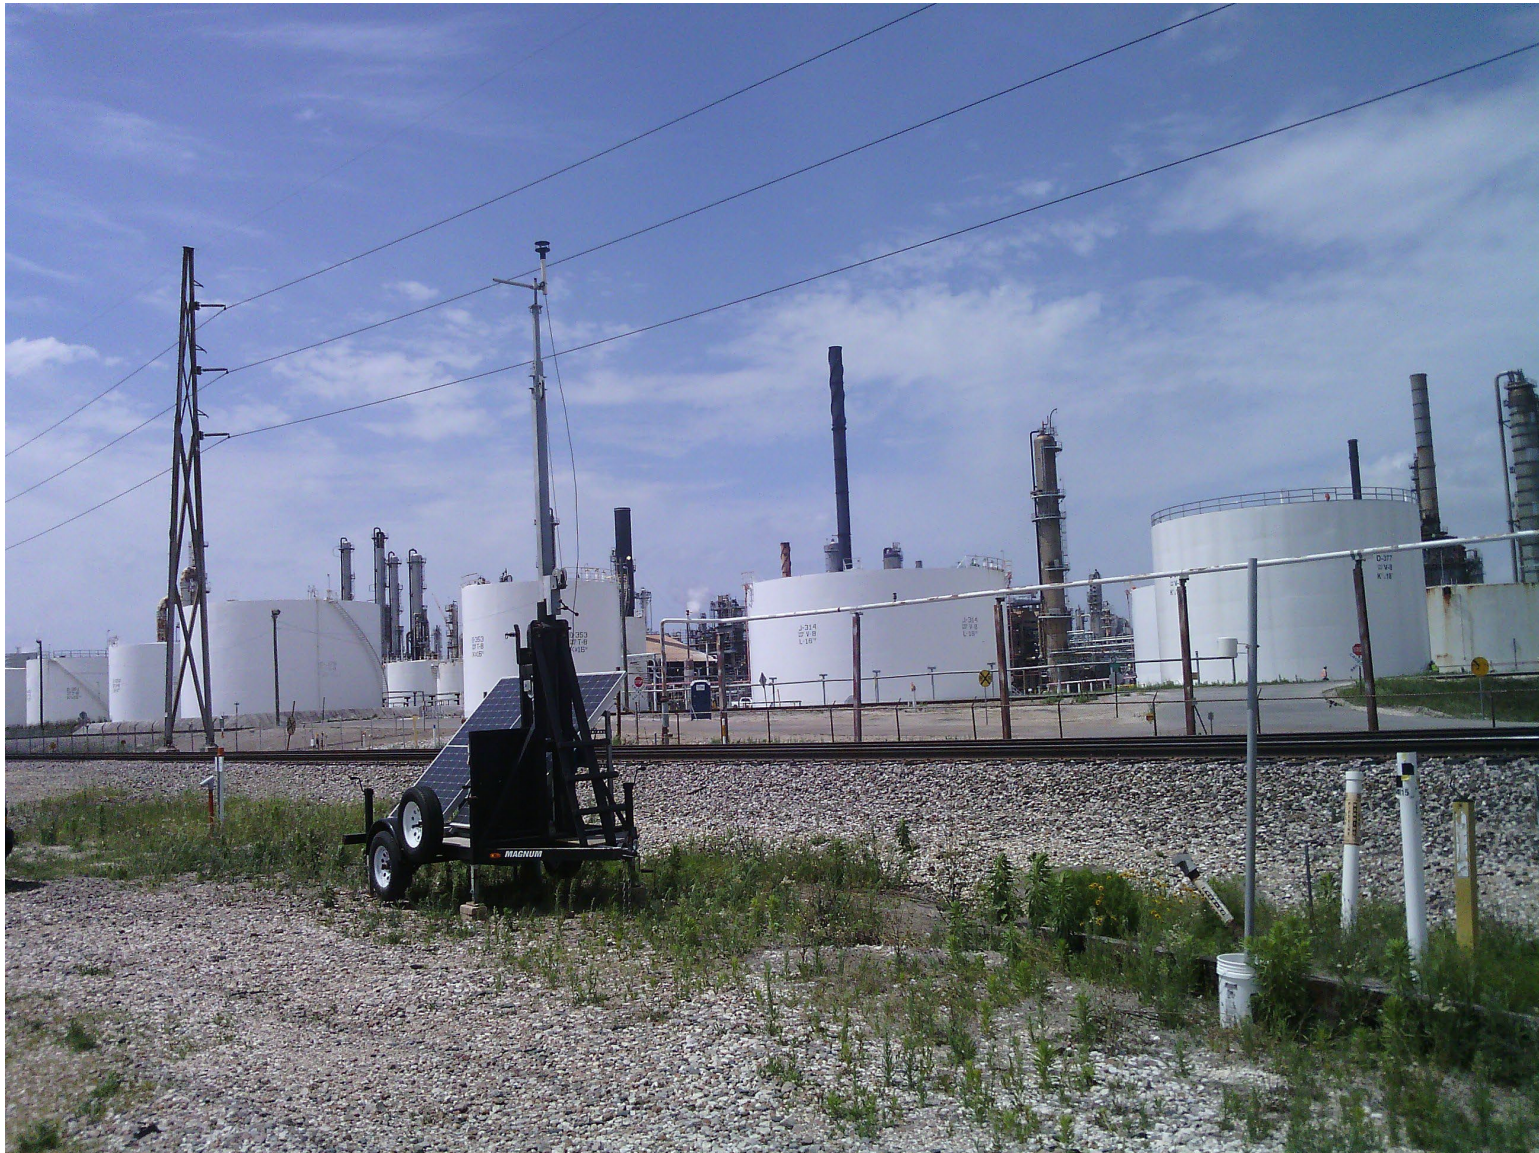
Photo 056: Aecom eGC near tank G-313 - 4/18/2024 14:09 FLIR0056.jpg

The Aecom eGCs were moved to new locations starting April 2024. One eGC was placed on the southeast corner of the refinery, near Monitor #5 and Shell Chemical's wastewater treatment plan known as the South Effluent Treater ("SET"). (Photo 056) This location is also near DPR's aromatics plant, subject to the Hazardous Organic NESHAPs ("HON"). The other eGC was placed on the SW corner of the facility, near tank G-313. (Photo 057)

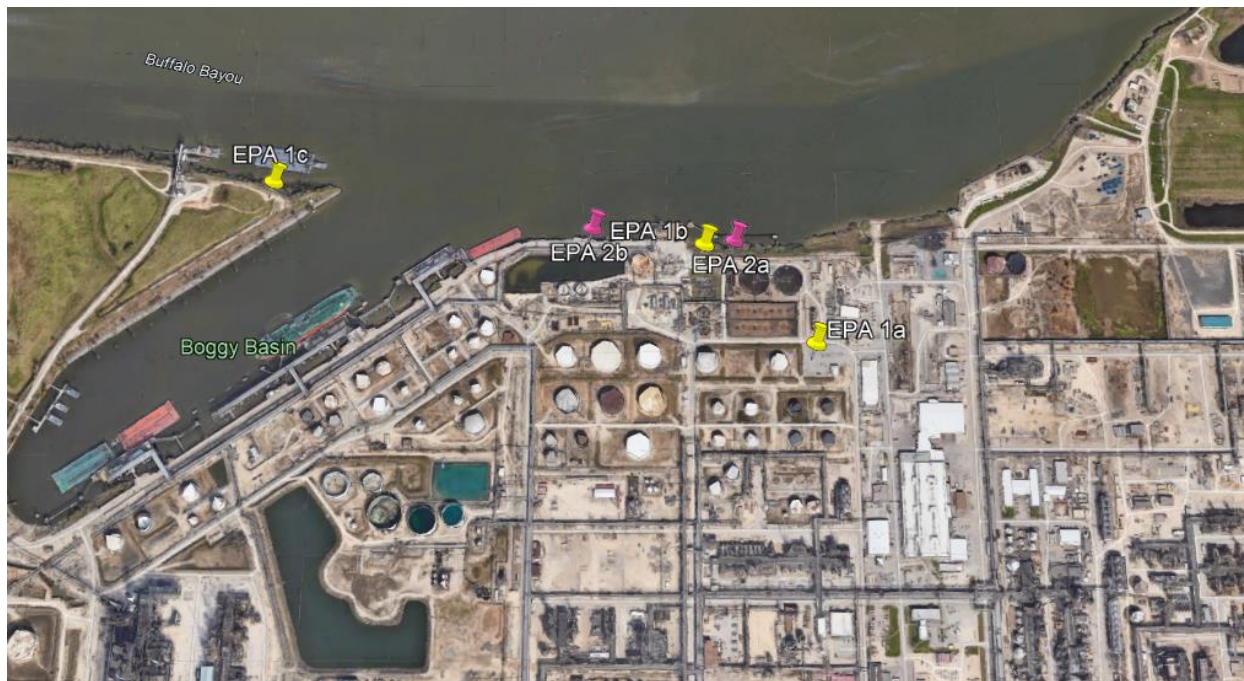
Figure 1. Pemex Deer Park Refinery eGC Sites

The eGCs are also equipped with wind sensors, and these sensors must be directionally oriented to provide accurate data. The wind sensors were appropriately oriented at the initial eGC sites and reoriented whenever the eGCs were moved.

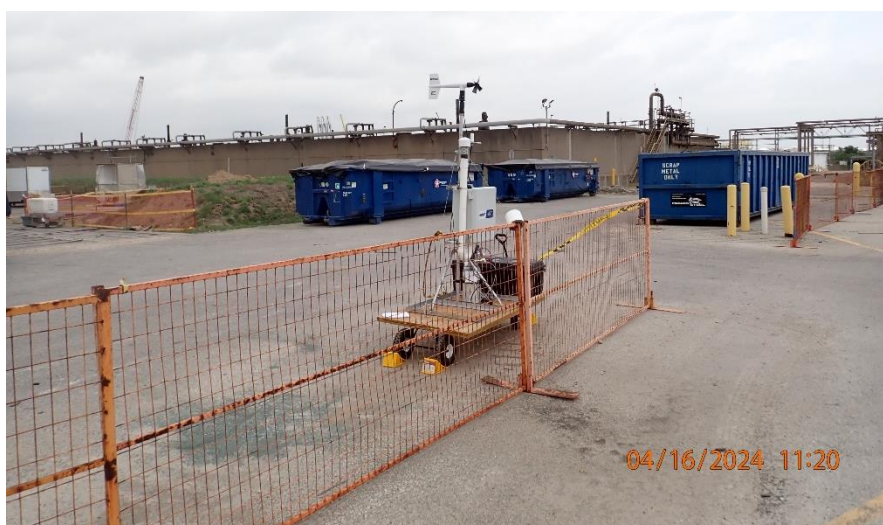
Figure 3. Site of EPA 1A

Site EPA 1A was the first site that EPA 1 was positioned at; the site is located upwind of the wastewater aerators. EPA 1 was set up at approximately 12:20 PM on April 16, 2024, and ran at site EPA 1A until 10:06 AM on April 17, 2024. The wind during this time frame came predominantly from the southeast and south southeast and varied from 1 mph to 3 mph.

- There were no eGC readings over 5.0 ppb.

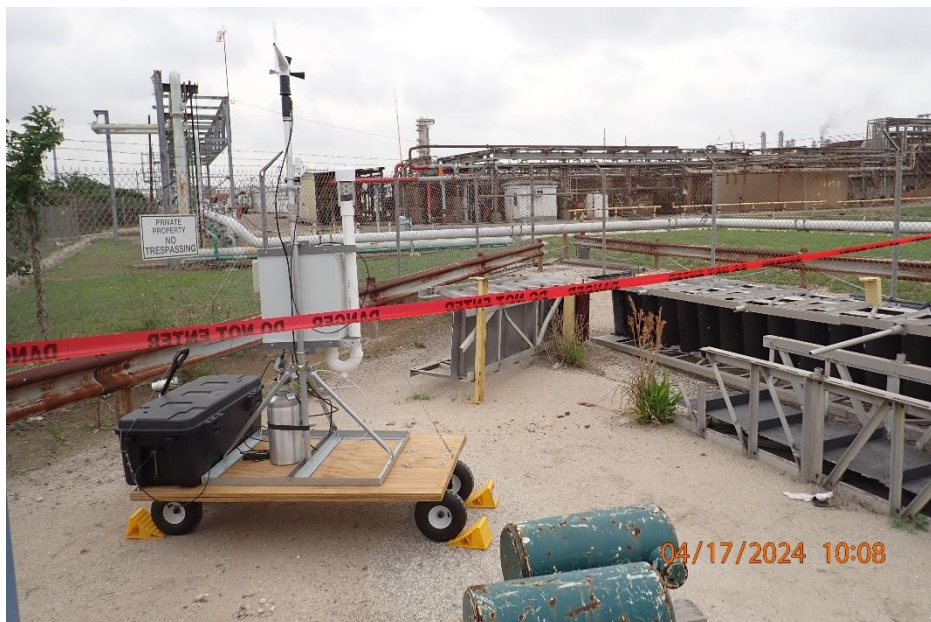
Figure 4. Site of EPA 1B

Site EPA 1B was the second site of EPA 1, this site was northwest of EPA 1A and immediately west of fenceline monitor 13 and northwest of the wastewater treatment process area. EPA 1 was set up at this site at approximately 10:15 AM on April 17, 2024 and stayed there until 10:46 AM on April 18<sup>th</sup>, 2024. The wind during this time was predominantly from the east and south, the wind speed was between 2 mph and 3 mph.

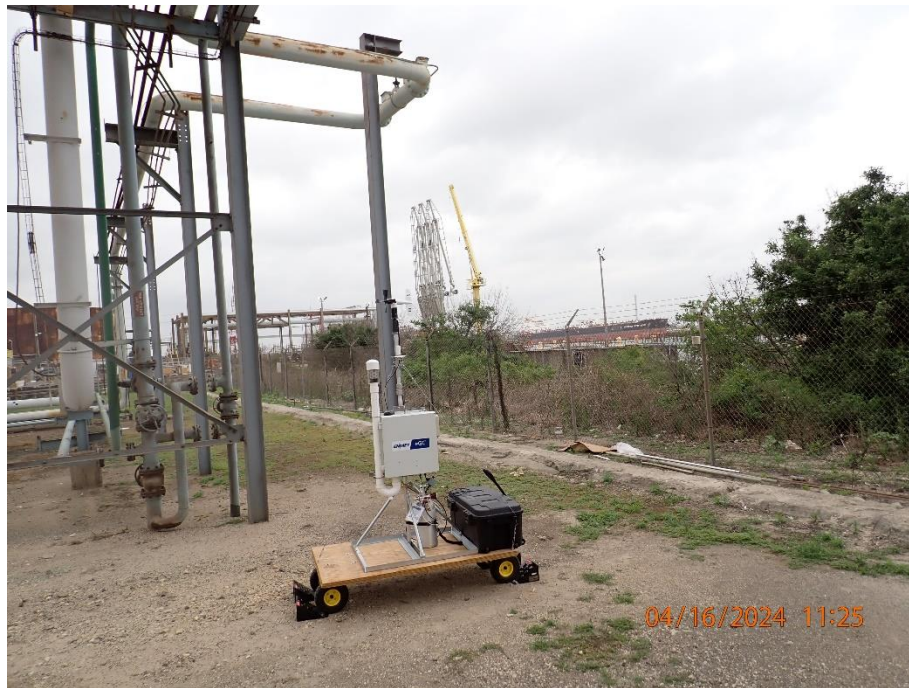
Figure 6. Site of EPA 2A

Site EPA 2A is the first location EPA 2 was deployed at during the inspection. The site was located north of the wastewater basin and directly next to fenceline monitor 13. EPA 2 was set up at approximately 11:45 AM on April 16, 2024 and stayed at this site until approximately 11:46 AM on April 17, 2024. The wind was coming from the east, southeast at a speed of approximately 1.0 – 3.0 mph on April 16<sup>th</sup> and then changed to the south at a speed of approximately 1.0 – 3.0 mph on April 17<sup>th</sup>.

- Significant benzene readings were reported from EPA 2 between 10:26 PM – 10:16 AM from April 16<sup>th</sup> to April 17<sup>th</sup>, 2024. The highest reading during this window was 25.47 ppb at 11:06 PM. Wind during this period was predominantly coming from the south with wind speed at approximately 1.5 – 2.0 mph.

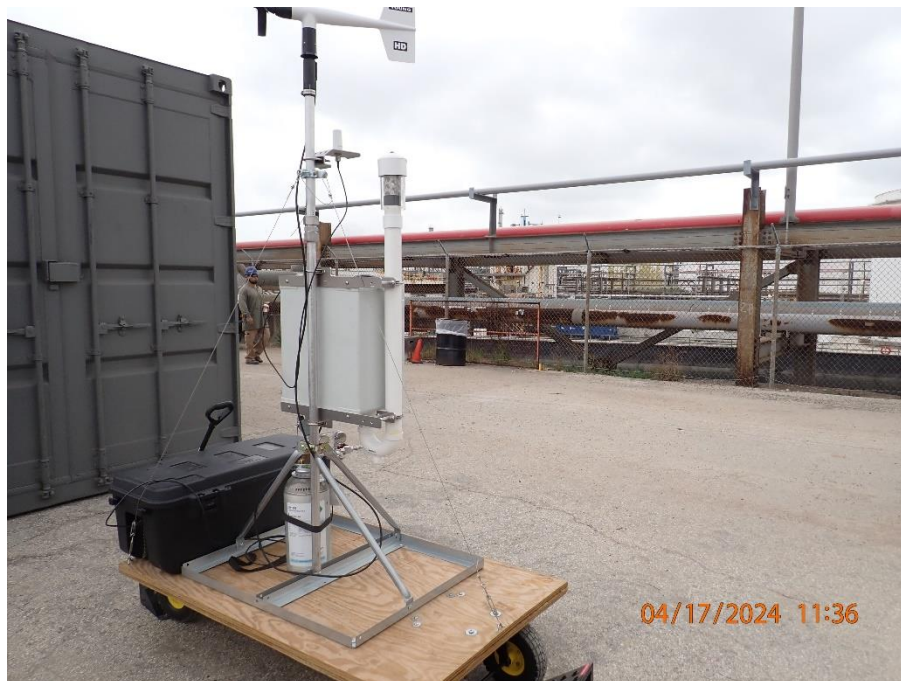
Figure 7. Site of EPA 2B

Site EPA 2B is the second location EPA 2 was deployed at during the inspection. The site was located north of the wastewater centrifuge and NESHAP wastewater tanks. EPA 2 was set up at approximately 11:56 AM on April 17<sup>th</sup>, 2024 and remained there until approximately 9:56 AM on April 19<sup>th</sup>, 2024. The wind during this period was coming from the east and south southeast at a speed of 0.5 – 2.5 mph.
