## **RCRA Inspection Report**

TVA Watts Bar Nuclear Plant  
6868-B Watts Bar Highway  
Spring City, Tennessee 37381  
Rhea County

**COMPLIANCE EVALUATION INSPECTION PHOTOGRAPHS**

**MAY 8, 2024**

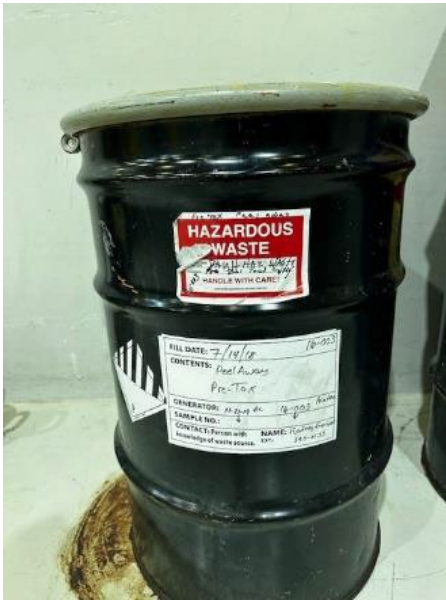
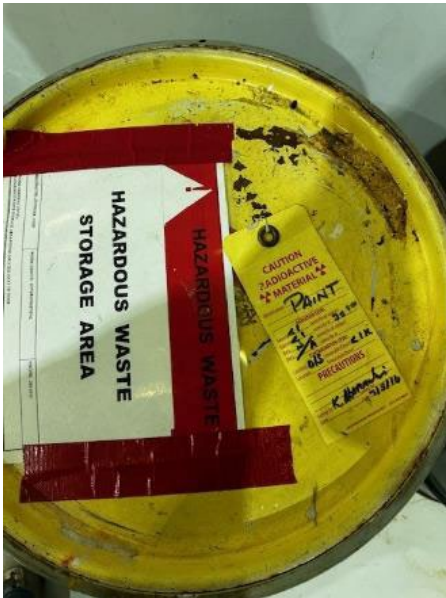
The inspectors were not able to access the radiological controlled area due to limited security clearance. However, Ms. Grubb explained that this area contained the radiological contaminated mixed waste of peel away paint and chips. At the time of the inspection, Ms. Grubb stated that a 55-gallon container of mixed waste had been stored on site over 270 days. The facility did not have a mixed waste disposal vendor to send the container, and the radiological department was not releasing the container for disposal.

Ms. Grubb provided photographs of the container via email on May 9<sup>th</sup> (Pictures 1-2). As the follow up, the EPA inspector requested the radiological half-life of the isotope. Ms. Grubb provided on May 14<sup>th</sup> via email the radiological count analysis for the mixed waste container. The document stated that the isotope Cobalt-60 has a half-life of 1,930 days and the container contents became a mixed waste on March 30, 2016. This puts the isotope half-life on July 12, 2021. However, on May 13, 2024, when the mixed waste was analyzed, the result determined that the contents were still contaminated, and thus not ready to be released to the central accumulation area (CAA) as hazardous waste.

Picture 1 – Mixed Waste container

Picture 2 – Mixed Waste container (top)

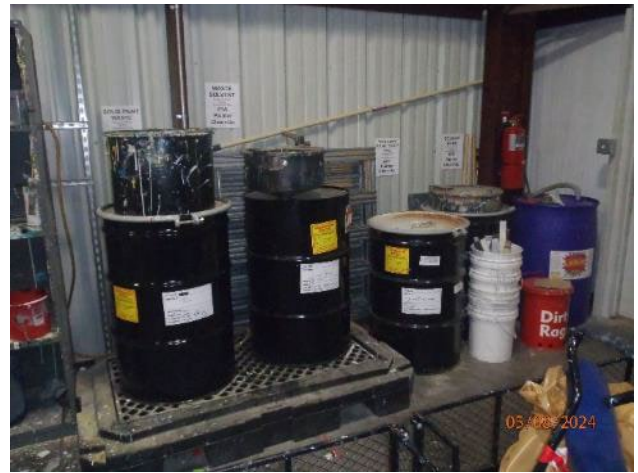
The inspectors started the inspection inside the Protective Area where security clearance and visitor passes are required. The Painter Clean Up area is outside of the main facility and is a shared paint storage room for the facility employees and contractors. The inspectors observed an SAA with a 55-gallon container of used paint, a 55-gallon container of used thinner, a 55-gallon container of used paint stripper, and a 55-gallon container of used solvent rags (Pictures 3, 5-8). The containers were observed closed and labeled but did not have hazard indicators on the containers.

Picture 3 – Painter Cleanup SAA

**Pursuant to Tenn. Comp. R. & Regs. 0400-12-01-.03(1)(f)1.(v) [40 C.F.R. § 262.15(a)(5)], which is a condition of the SAA Permit Exemption, a generator is required to mark or label its containers (ii) with an indication of the hazards of the contents.**

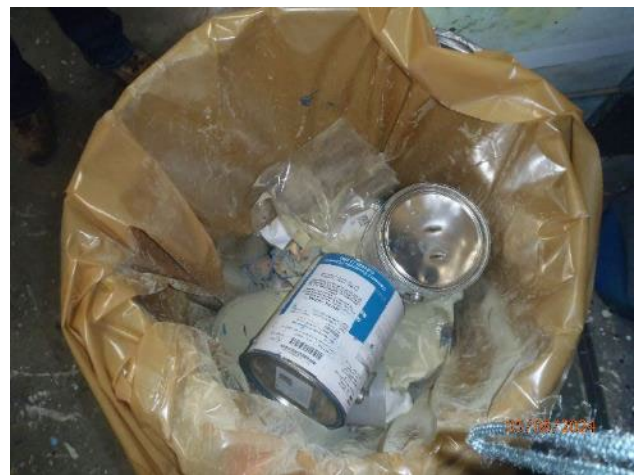
explained that storing empty paint containers in this area and allowing them to dry was the standard practice. However, the inspectors observed that several discarded containers were not empty and allowed to dry (Pictures 4, 9-11). These discarded containers held a two-part epoxy paint. The inspectors also observed some containers disposed of in the trash can that were not empty and were releasing their contents into the trash. The technician stated that these containers were generated by the contractor, Williams Specialty Energy Solutions.

Picture 4 – Painter Cleanup SAA trash w/discard HW paint containers

**Pursuant to Tenn. Comp. R. & Regs. 0400-12-01-.03(1)(b) [40 C.F.R. § 262.11], a person who generates a solid waste, as defined in Tenn. Comp. R. & Regs. 0400-12-01-.02(1)(b) (2021) [40 C.F.R. § 261.2], must make an accurate determination as to whether that waste is a hazardous waste in order to ensure wastes are properly managed according to applicable RCRA regulations articulated in Tenn. Comp. R. & Regs. 0400-12-01-.03(1)(b) [40 C.F.R. § 262.11].**

**Pursuant to Tenn. Comp. R. & Regs. 0400-12-01-.03(1)(g)2.(vii) [40 C.F.R. § 262.16(b)(7)], which incorporates Tenn. Comp. R. & Regs. 0400-12-01-.10 [40 C.F.R. Part 268], and is a condition of the SQG Permit Exemption, a generator is required to comply with land disposal restrictions (LDR) for hazardous waste.**

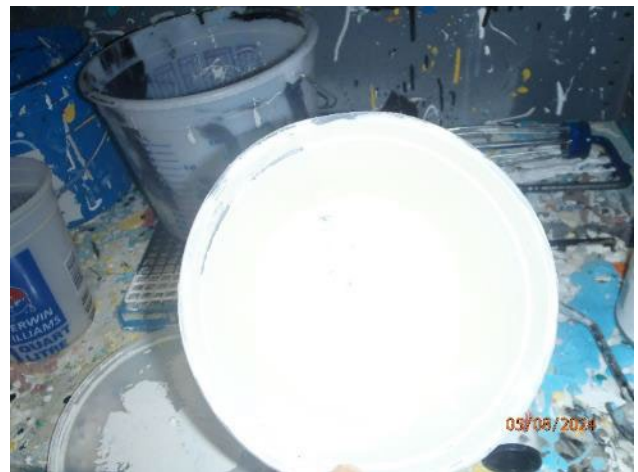
Picture 9 – Painter Cleanup SAA discarded epoxy paint in trash can

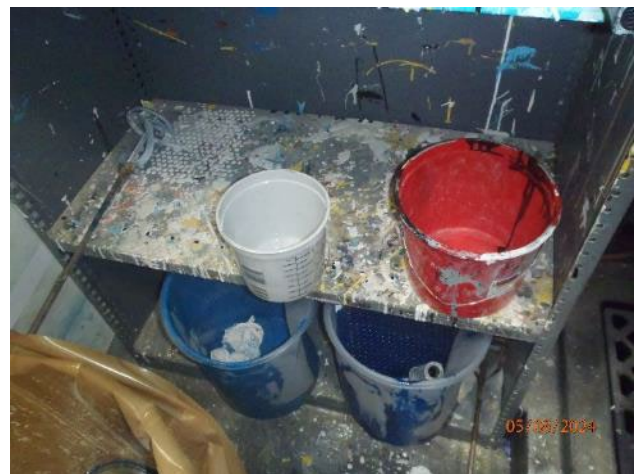
Picture 10 – Painter Cleanup SAA epoxy paint allowed to dry

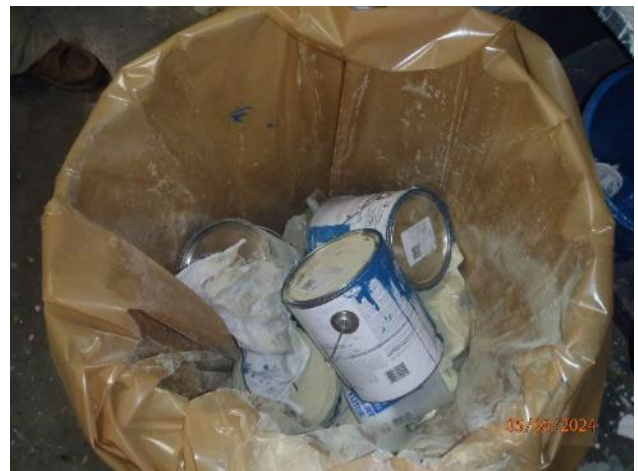
Picture 11 – Painter Cleanup SAA discarded epoxy paint cans in trash can

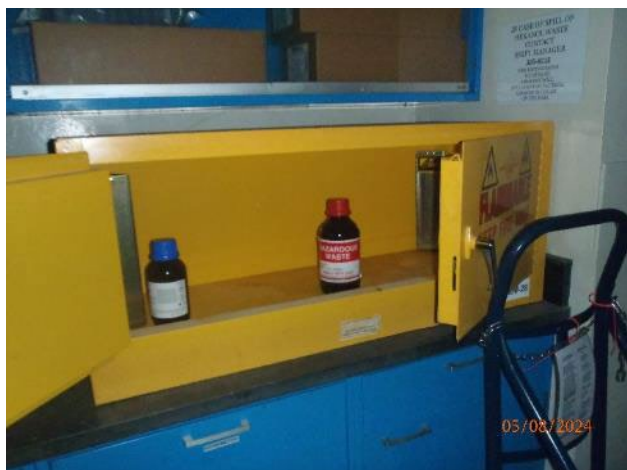
The inspectors returned to the main facility and entered the Second Chemistry Lab. At the time, the lab was unoccupied, but had a SAA container underneath the fumehood. The inspectors observed a one-liter bottle of waste hexanol. The container was closed and labeled. The inspectors also observed a green sharps container sitting on the front counter (Pictures 13-14). At the time, the container held ampules with a pinkish liquid inside. No labeling was found on the container. Ms. Grubb contacted the lab personnel who confirmed that the discarded ampules were dissolved oxygen CHEMets test kits.

Picture 12 – Secondary Chemistry Lab SAA

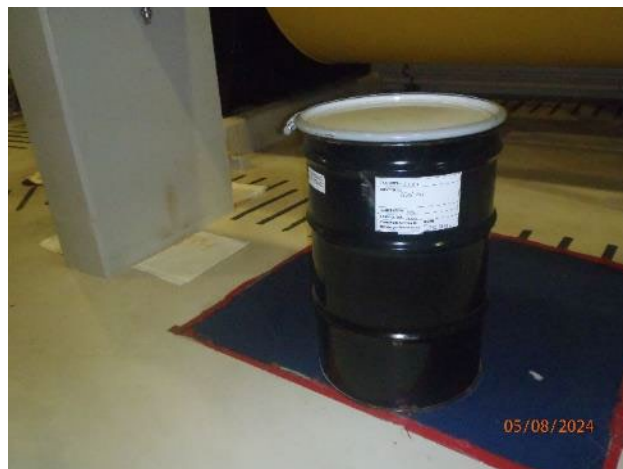
Ms. Grubb continued touring the inspectors around the main facility. The inspectors observed a 55-gallon container of used oil on an absorbent pad beside the main turbine oil tank (Picture 15). The container was closed and labeled.

Picture 15 – Main Turbine Oil Tank used oil container

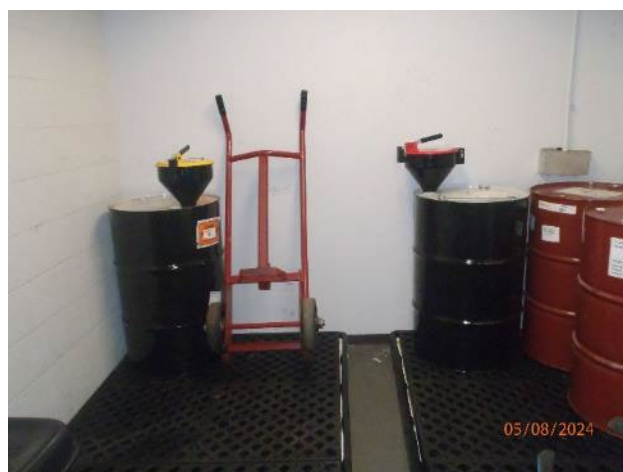
Ms. Grubb then took the inspectors to the used oil storage room. The inspectors observed two 55-gallon containers of used oil on secondary containment pallets (Pictures 16-18). The containers were labeled and closed. The container with the yellow topped funnel had used oil on the top of the container, and inside the funnel. The used oil container had been overfilled, and oil had flowed out of the full funnel onto the top of the container into the secondary containment.

Picture 16 – Storage Room for Used Oil Pads, Drums & Batteries used oil containers

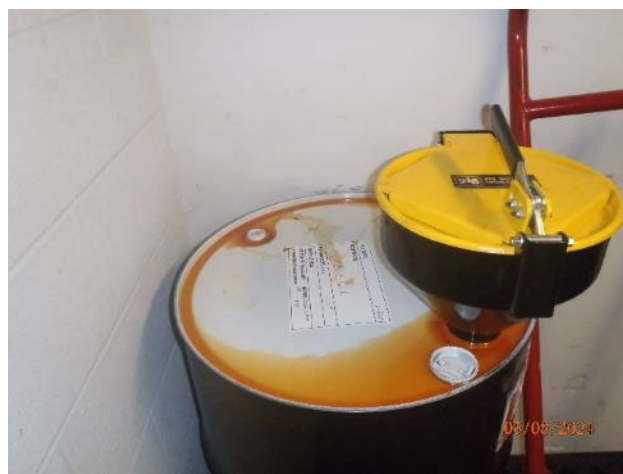
Picture 17 – Storage Room for Used Oil Pads, Drums & Batteries used oil container overfill spill

**Pursuant to Tenn. Comp. R. & Regs. 0400-12-01-.11(3)(c)4. [40 C.F.R. § 279.22(d)], upon detection of a release of used oil to the environment, the facility must clean up and manage properly the released used oil and other materials.**

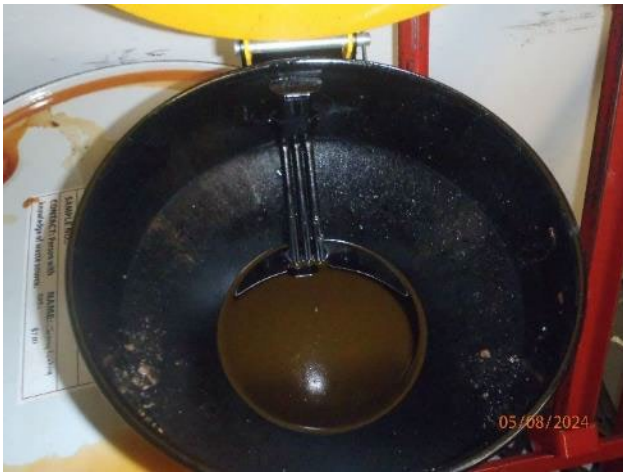
Picture 18 – Storage Room for Used Oil Pads, Drums & Batteries used oil container overfill in funnel

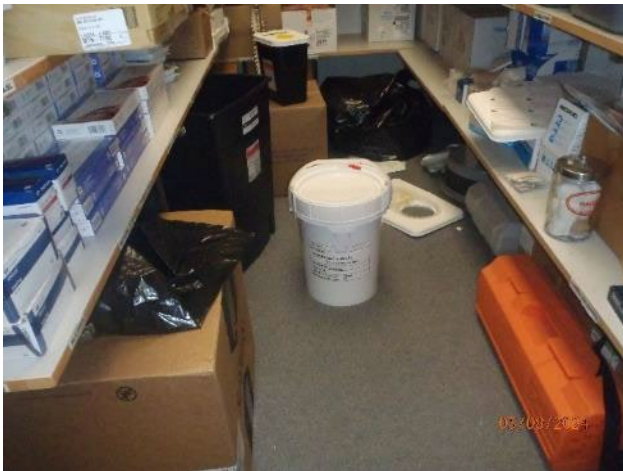
The Watts Bar Medical clinic is an outpatient clinic that provides over the counter pharmaceuticals and general first aid. No prescription medicines were kept on site. The inspectors did observe one 5-gallon container of non-creditable hazardous waste pharmaceuticals that was closed, labeled, and dated June 13, 2023 (Pictures 19-20). The staff included a doctor, nurse practitioner, and a medical technician.

Picture 19 – Watts Bar Medical HW Pharmaceutical SAA

Picture 20 – Watts Bar Medical HW Pharmaceutical SAA

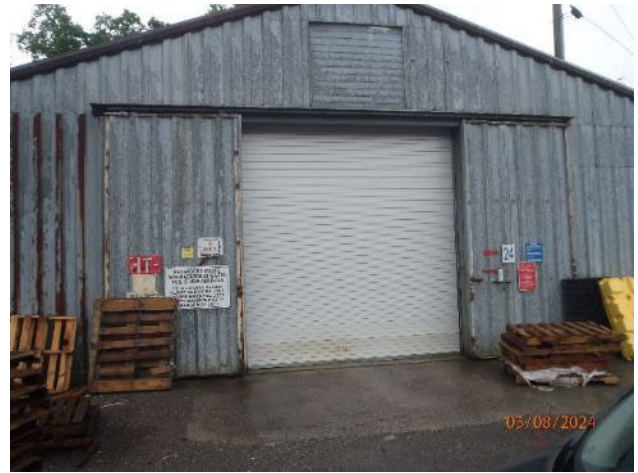
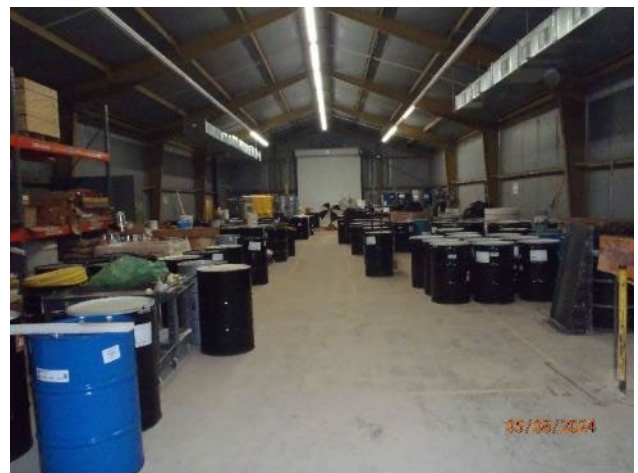
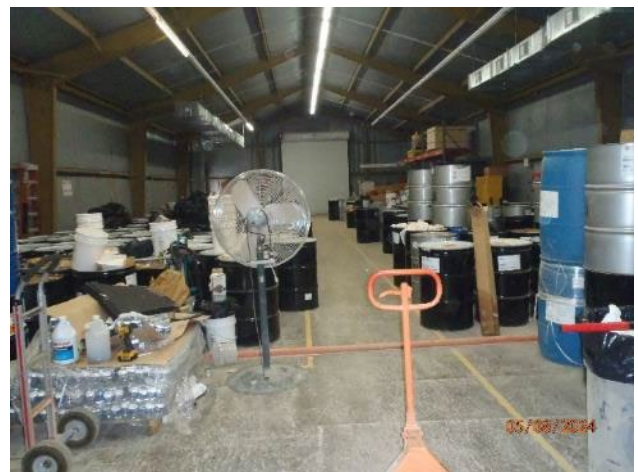
Hut 24 is the less than 180-day hazardous waste central accumulation area (CAA) (Pictures 27-29). The inspectors observed the following:

- **Area of Concern:** The 180-day CAA did not have signs for “No Smoking”, “Danger” and marked as “Hazardous Waste.”
- The 180-day CAA did not have the name and phone number of the emergency coordinator posted where the hazardous waste was being generated or stored.

Picture 27 – Hut 24 CAA

Picture 28 – Hut 24 CAA

Picture 29 – Hut 24 CAA

Pursuant to Tenn. Comp. R. & Regs. 0400-12-01-.03(1)(g)2.(ix)(II) [40 C.F.R. § 262.16(b)(9)(ii)] which is a condition of the SQG Permit Exemption, a generator is required to post next to telephones, or in areas directly involved in the generation and accumulation of hazardous waste, the name and phone number of the emergency coordinator, the location of fire extinguishers and spill control material, and the phone number of the fire department (unless the facility has a direct alarm).

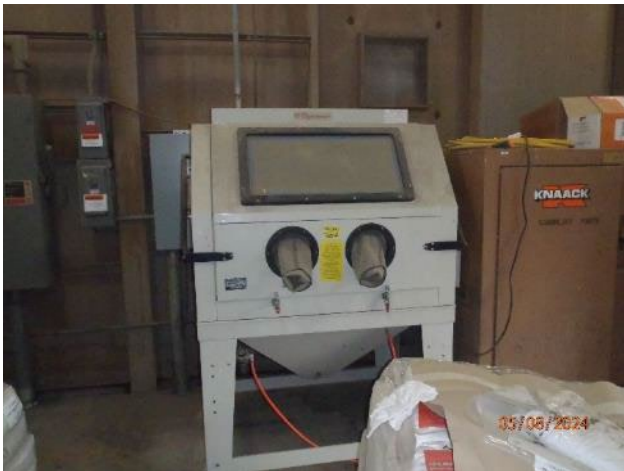
Inside the paint shop was a blast media booth (Picture 25). Ms. Grubb stated that the spent media was non-hazardous and was disposed of at the Rhea County Landfill. In addition, the spent media waste profile was on file with TDEC and certified to be sent to the landfill. The inspectors then went inside the paint booth and observed painting was in progress. Paint filters were observed in the ceiling vents. The inspectors inquired if the spent paint filters had been tested recently and Ms. Grubb said they had not. The spent paint booth filters need to have a hazardous waste determination due to the changes in paint product.

Picture 25 – Blast Shop Painter Cleanup Sand media blaster

Pursuant to Tenn. Comp. R. & Regs. 0400-12-01-.03(1)(b) [40 C.F.R. § 262.11], a person who generates a solid waste, as defined in Tenn. Comp. R. & Regs. 0400-12-01-.02(1)(b) (2021) [40 C.F.R. § 261.2], must make an accurate determination as to whether that waste is a hazardous waste in order to ensure wastes are properly managed according to applicable RCRA regulations articulated in Tenn. Comp. R. & Regs. 0400-12-01-.03(1)(b) [40 C.F.R. § 262.11].

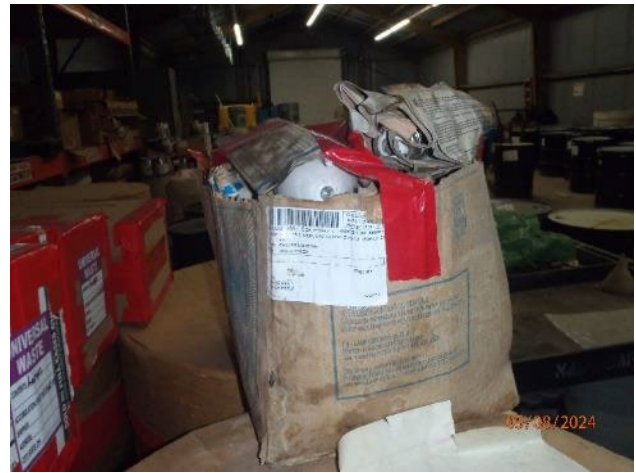
- One 55-gallon container of used paint, closed, labeled, and dated April 23, 2024 (Pictures 30-31);
- One 5-gallon container of burnishing compound, closed, labeled, and dated April 4, 2024;
- One 7.5-gallon container of burnishing compound, closed, labeled, and dated February 26, 2024;
- Five 4-foot cartons of universal waste lamps (Picture 32);
- Six cardboard boxes of universal waste lamps;
- Six 4-foot fiberboard boxes of universal waste lamps; and
- One box of universal waste mercury lamps was not closed and secured, not labeled, and not dated (Picture 33).

At the time of the inspection, the 7.5-gallon container exceeded the one-year storage date for universal waste. In addition, the inspectors observed several batteries were not contained, not labeled, and not dated. On May 17, 2024, Ms. Grubb emailed and provided the manifest to the inspectors that all universal waste at the facility during the inspection had been shipped.

Picture 33 – Hut 24 CAA UW container not secured

Pursuant to Tenn. Comp. R. & Regs. 0400-12-01-.12(2)(f)1 [40 C.F.R. § 273.15(a) and (c)], a SQHUW may accumulate universal waste no longer than one year and must be able to demonstrate the length of time that the universal waste has accumulated from the date that it became a waste or was received.

**Pursuant Tenn. Comp. R. & Regs. 0400-12-01-.12(2)(d)4. [40 C.F.R. § 273.13(d)], a SQHUW must manage universal waste lamps in a way that prevents releases of any universal waste or component of a universal waste to the environment.**

**Pursuant to Tenn. Comp. R. & Regs. 0400-12-01-.12(2)(e)5. [40 C.F.R. § 273.14(e)], a SQHUW must label or mark each lamp or container of lamps clearly with one of the following phrases: “Universal Waste-Lamp(s),” or “Waste Lamp(s),” or “Used Lamps.”**

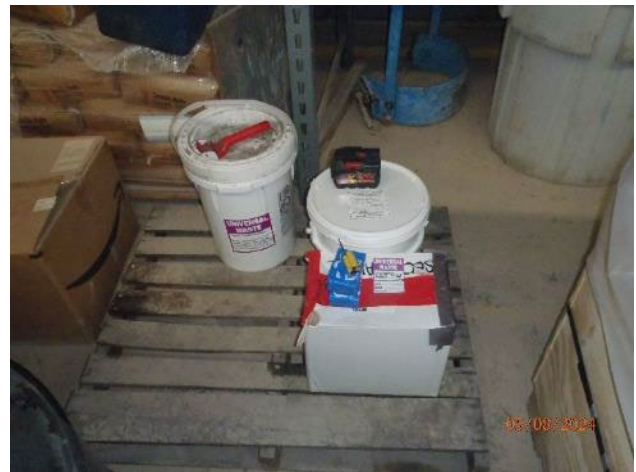
- Eight 55-gallon containers of used EHC fluid being disposed of as used oil, closed and dated November 12, 2023;
- One box of spent lead acid batteries, covered with clear plastic and dated September 1, 2023 (Pictures 36-37); and
- A pallet with one 5-gallon container of universal waste Ni-Cad batteries, closed, labeled, and dated January 13, 2024; one 7.5-gallon container of universal waste batteries, closed, labeled, and dated March 30, 2023, and one cardboard box of universal waste Ni-Cad batteries, closed, labeled, and dated August 2, 2023 (Picture 35).

Picture 35 – Hut 24 CAA UW batteries

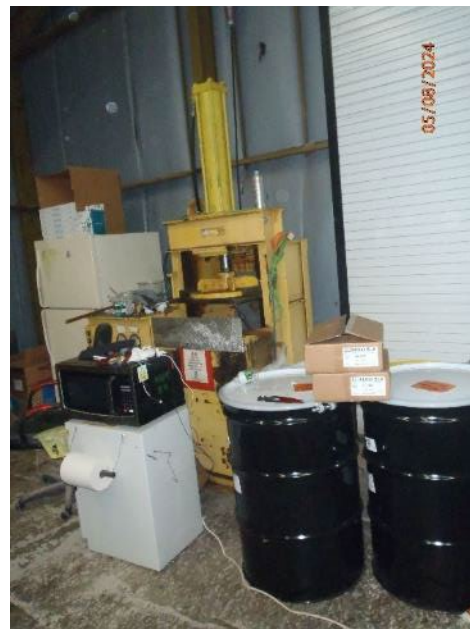
The inspectors expressed concern that a break area with refrigerator, microwave, chairs, table, and a blind spot mirror were set up in the hazardous waste storage area (Picture 50). Due to the nature of the waste generated and handled, personnel should not be allowed to establish break areas in or around hazardous waste storage areas.

Picture 50 – Hut 24 CAA compactor

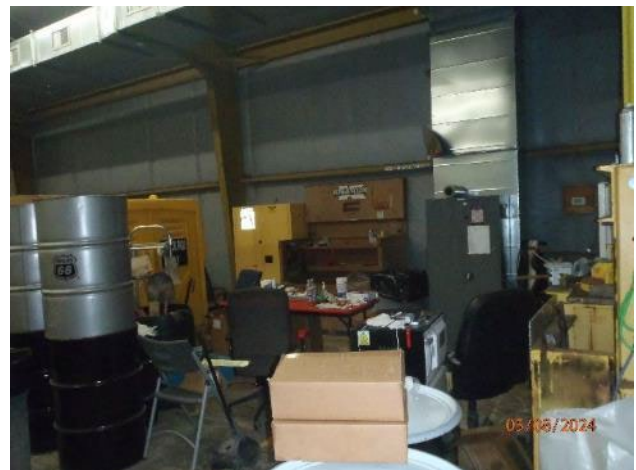
Picture 51 – Hut 24 Man Cave
