INSPECTION REPORT

| Type of inspection: | CEI - Compliance Evaluation Inspection | | | | |
| Meigs County Commissioners - Meigs County Landfill | | | | | |

A CWA inspection at the closed landfill of Meigs County.

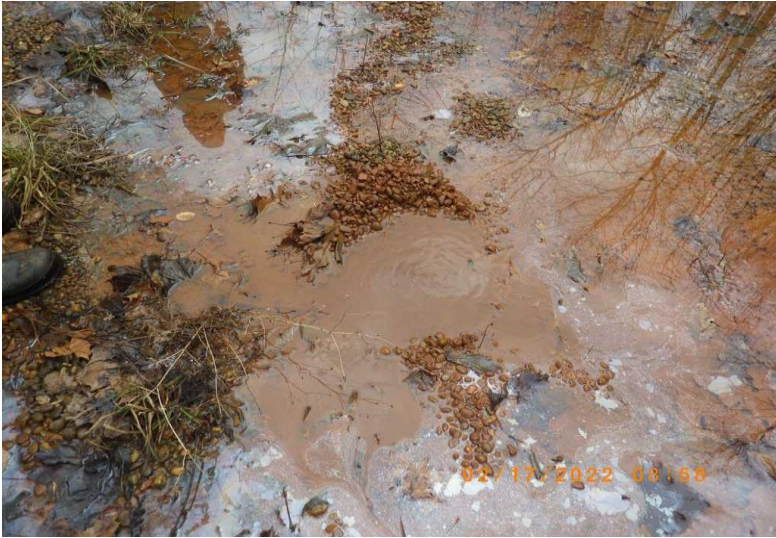
| <p>RIMG2476.JPG</p> | |

| <p>BioDiffuser</p> | |
| <p>No PII Bubbling on the surface of Cell Two where the BioDiffuser was installed. EPA also observed an oil sheen on the pooling water at Cell Two. Camera looking down.</p> | |

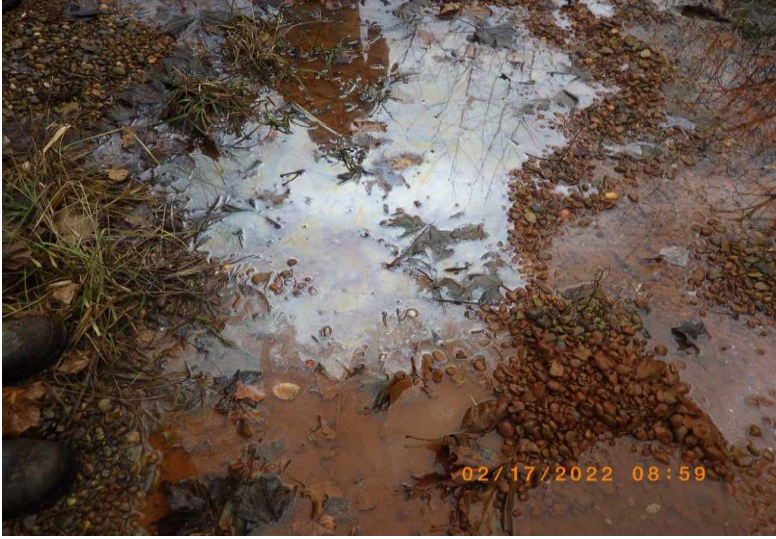
| <p>RIMG2477.JPG</p> | |

| <p>Oil sheen</p> | |
| <p>No PII EPA also observed an oil sheen on the pooling water at Cell Two. Camera looking down.</p> | |

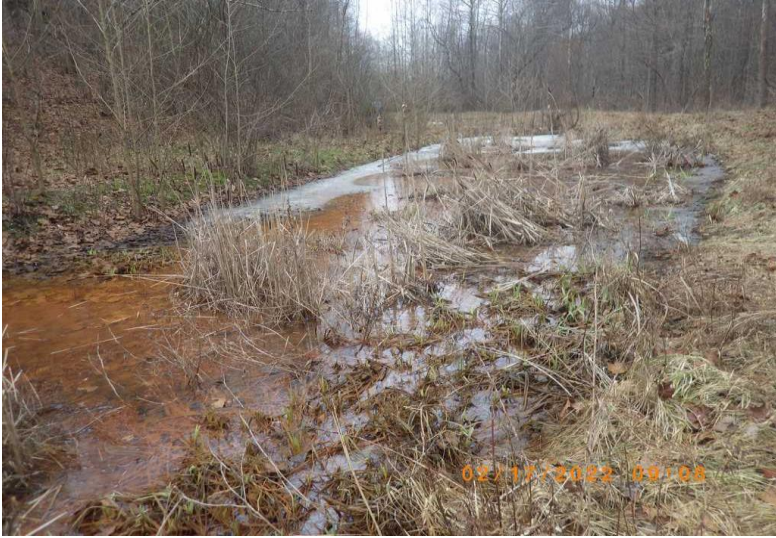
| <p>RIMG2479.JPG</p> | |

| <p>Wetland Cell One</p> | |
| <p>No PII Water pooling and vegetation are visible in Cell One. Camera looking West.</p> | |

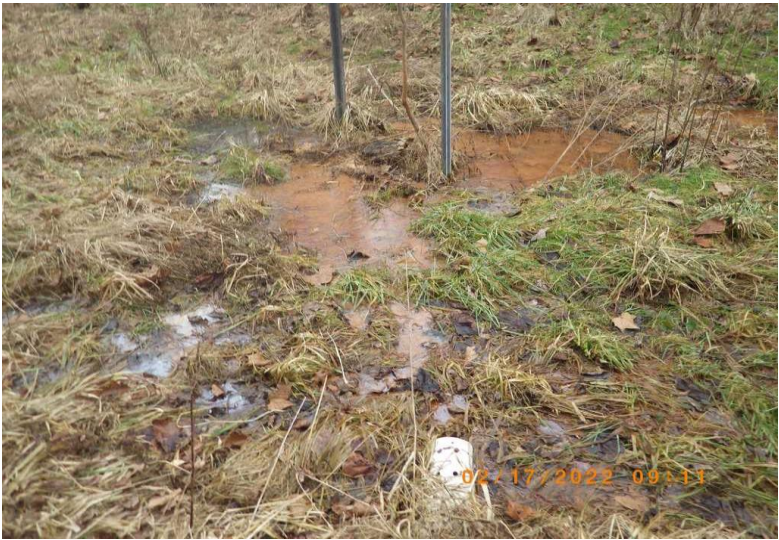
| RIMG2480.JPG | |

| <p>The AgriDrain water level control structure at the start of Cell One was flooded at the time of the inspection and there was water pooling around it.</p> | |

| Flooded water level control structure | |
| The AgriDrain water level control structure where the landfill leachate enters the wetland, was flooded at the time of the inspection. Camera looking South. | |

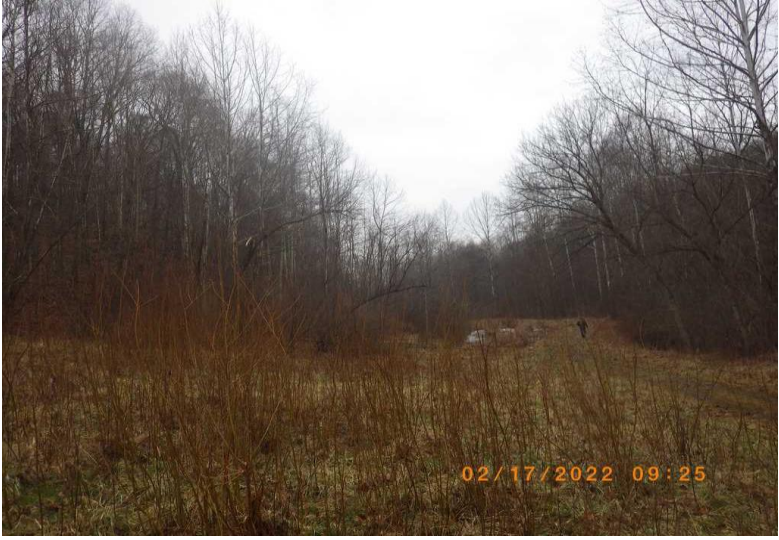
| RIMG2482.JPG | |

| Wetlands Cell One and Two | |
| View of the wetland from the landfill area. Camera looking west. | |
