## Region 6 - Enforcement & Compliance Assurance Division

### INSPECTION REPORT

| Company Name: | <b>Rebel Producing, LLC</b> | |
| Facility Name: | <b>Exxon Lease Tank Battery</b> | |

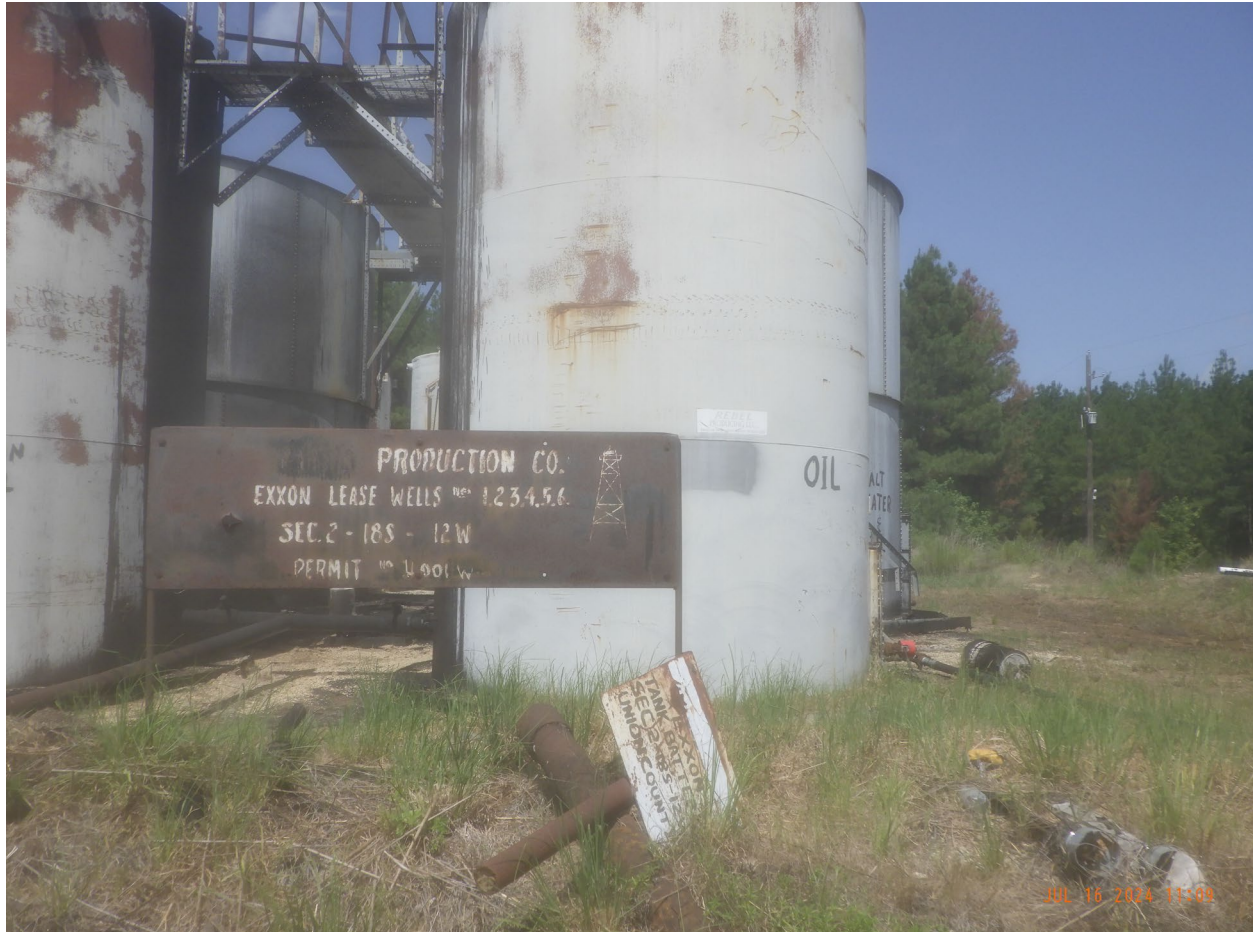
Photo No. 1

I observed the facility sign, secondary containment, oil-water separators, pipes and valves, and storage tanks located at the facility; see Appendix 1 (Photograph Log), Photo No. 1. For additional GPS location and photo metadata, see Appendix 1.

Description: Looking W, overview of facility and signage.

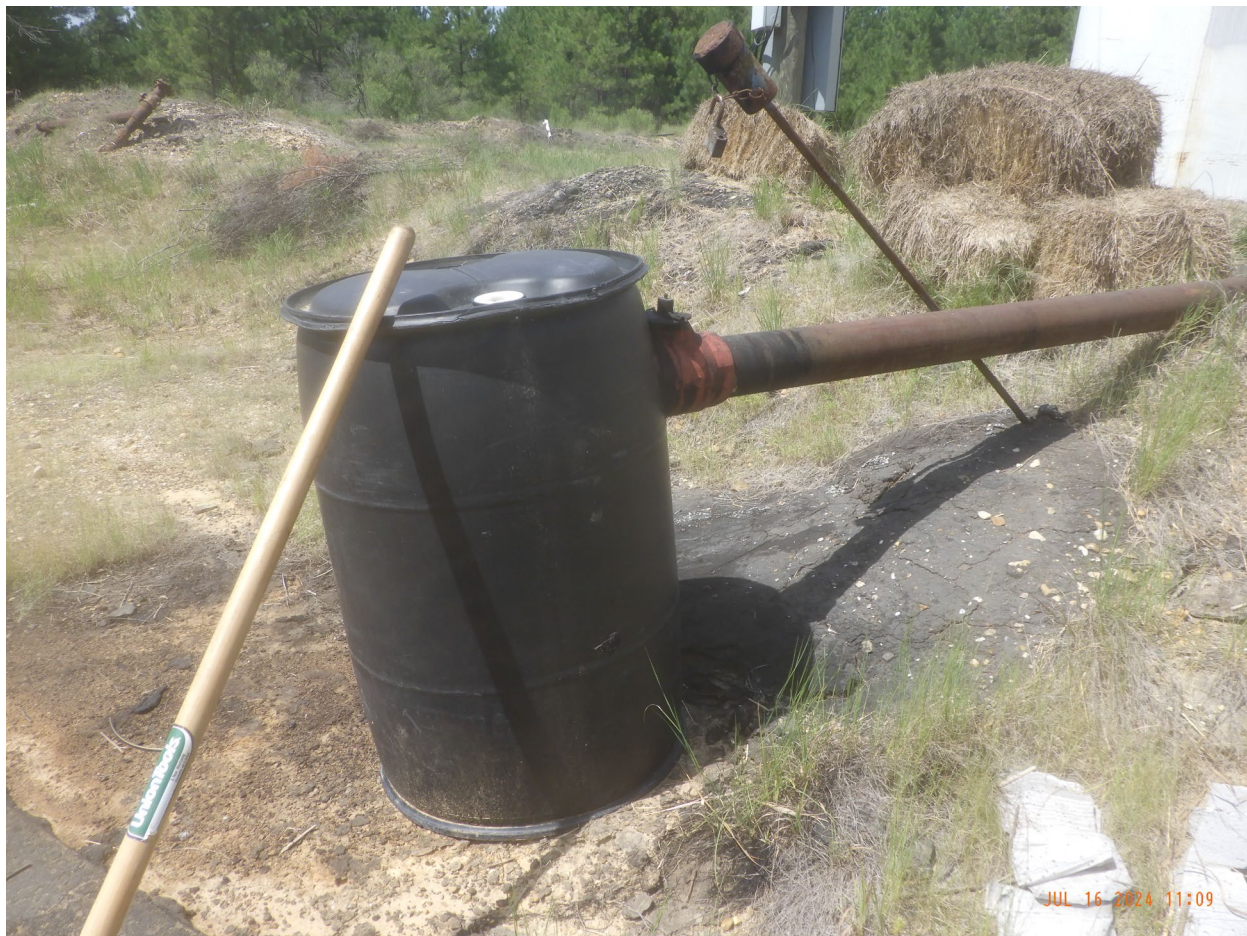
Photo No. 2

I observed an attempt to remove residual, solidified oil from the secondary containment berm, and a 55-gallon barrel used as a catch bucket for the transfer pipe, see Photo No. 2.

- A 55-gallon barrel used for the transfer pipe outside secondary containment was not stabilized,
- Woody vegetation observed inside secondary containment and a low area in the secondary containment, and
- An active leak of crude oil at a valve inside secondary containment.

**Description:** Looking SW, 55-gal barrel installed at transfer pipe to catch oil during transport. Straw bales in photo were used to absorb loose oil inside secondary containment.

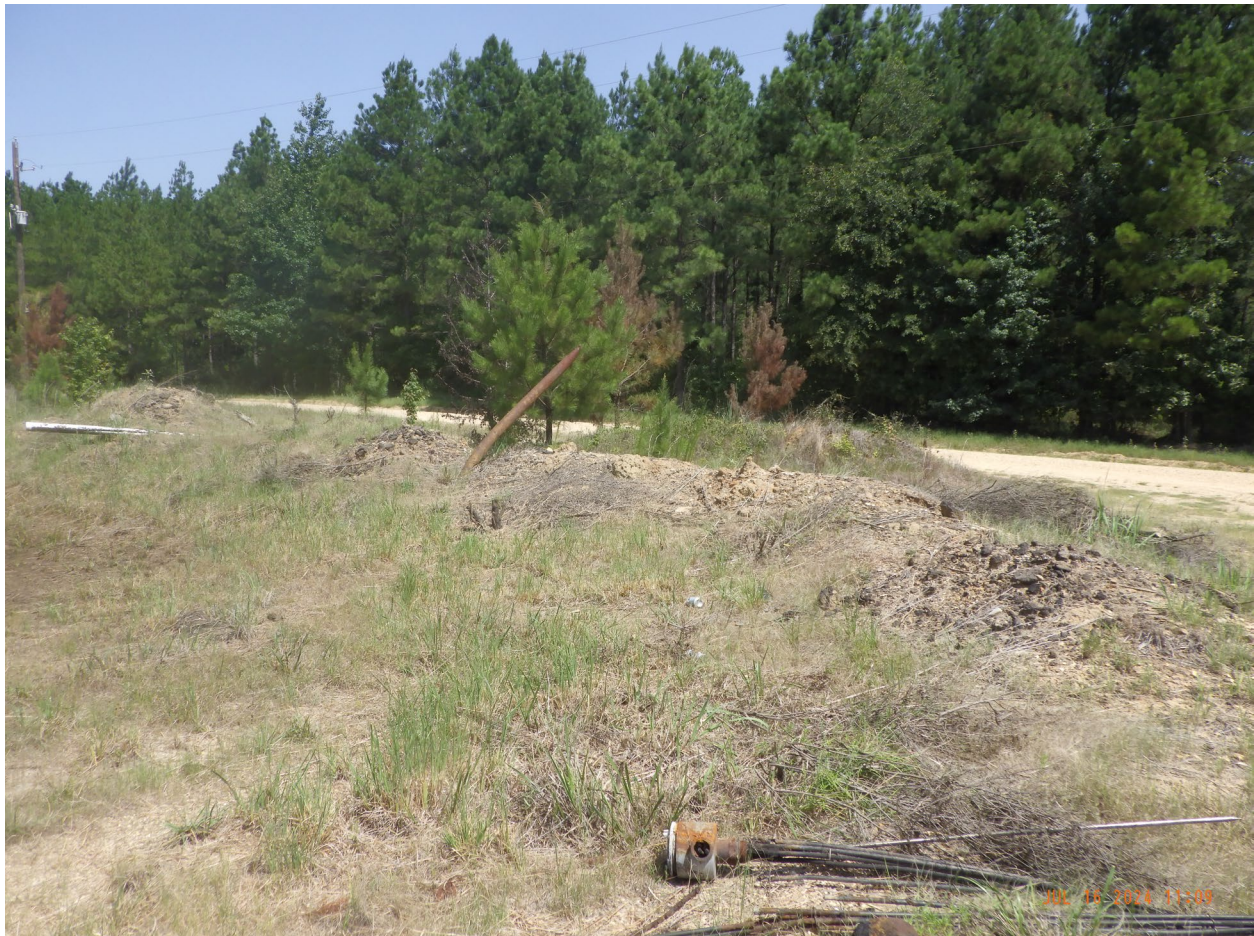
Photo No. 3

I observed the removal of woody vegetation from the secondary containment berm, see Photo No. 3.

**Description:** Looking NW, woody vegetation removed from secondary containment berm.

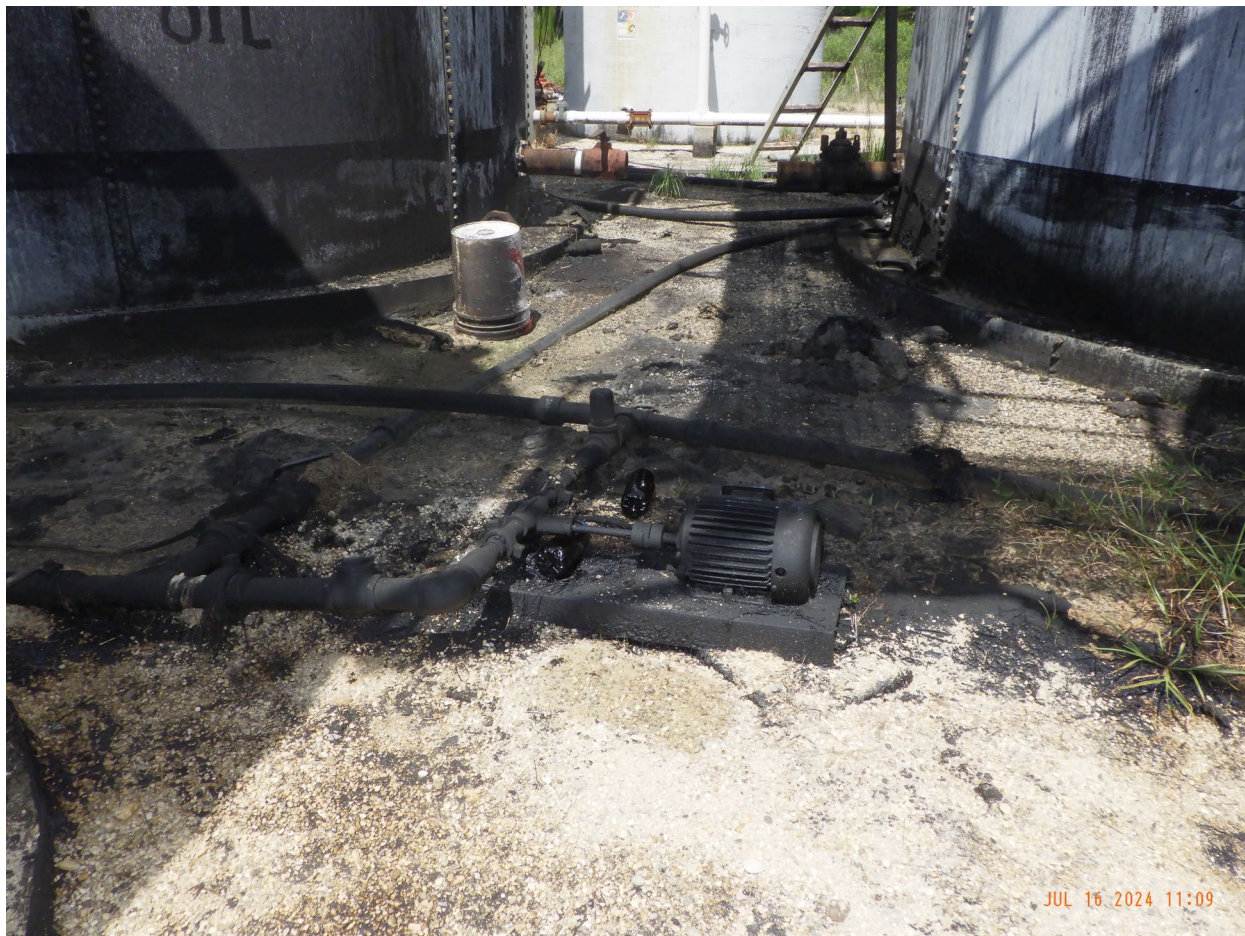
Photo No. 4

I observed a small container placed under the leaking valve inside secondary containment, see Photo No. 4.

**Description:** Looking W, loose oil from a leaking valve inside secondary containment. Mr. Burnside has placed a small catch bucket under the leaking valve.

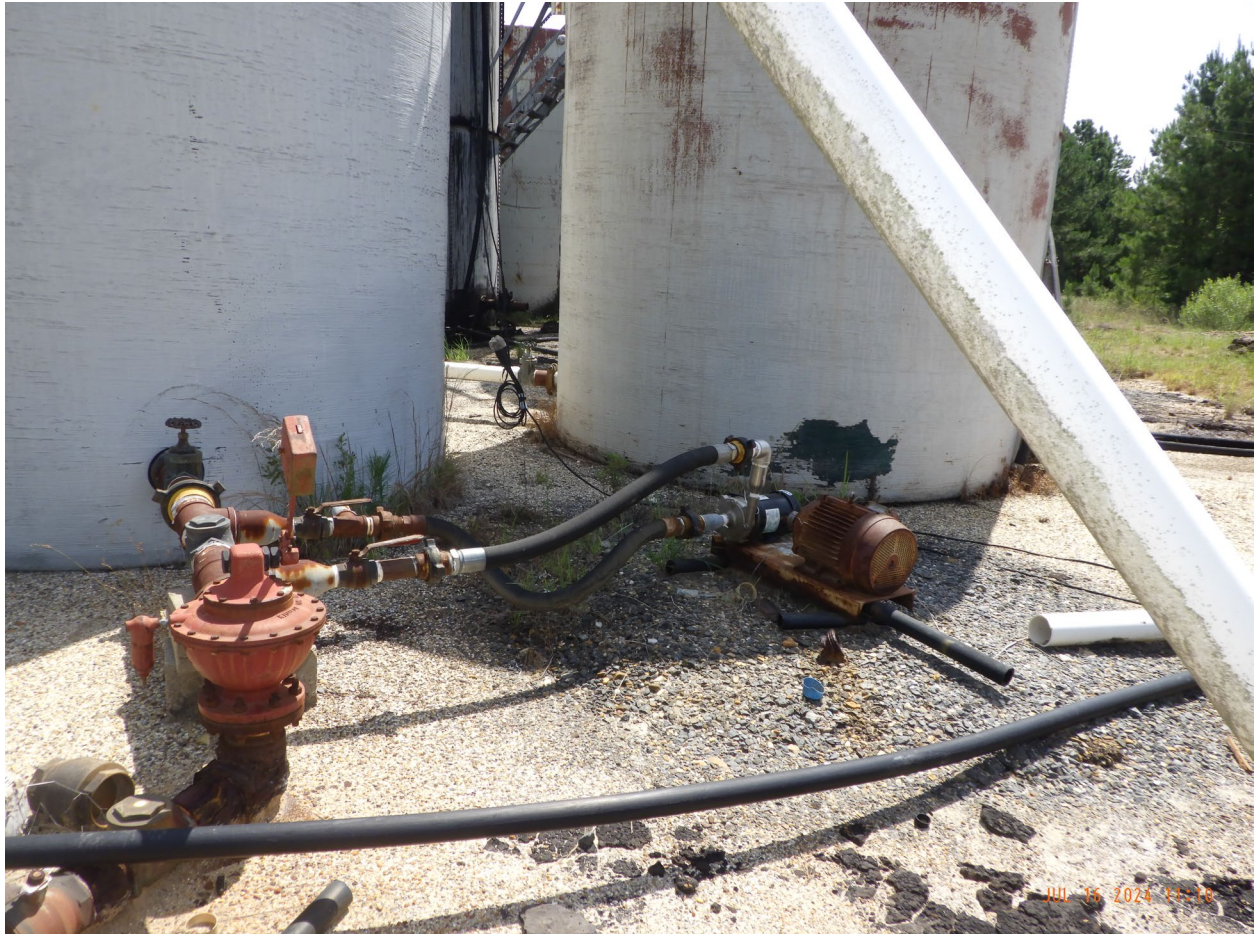
Photo No. 5

I observed a repair to a saltwater tank that had been leaking during the 04/04/2024 inspection, see Photo No. 5.

**Description:** Looking ESE, area of a previous saltwater leak, which has been repaired by Mr. Burnside.

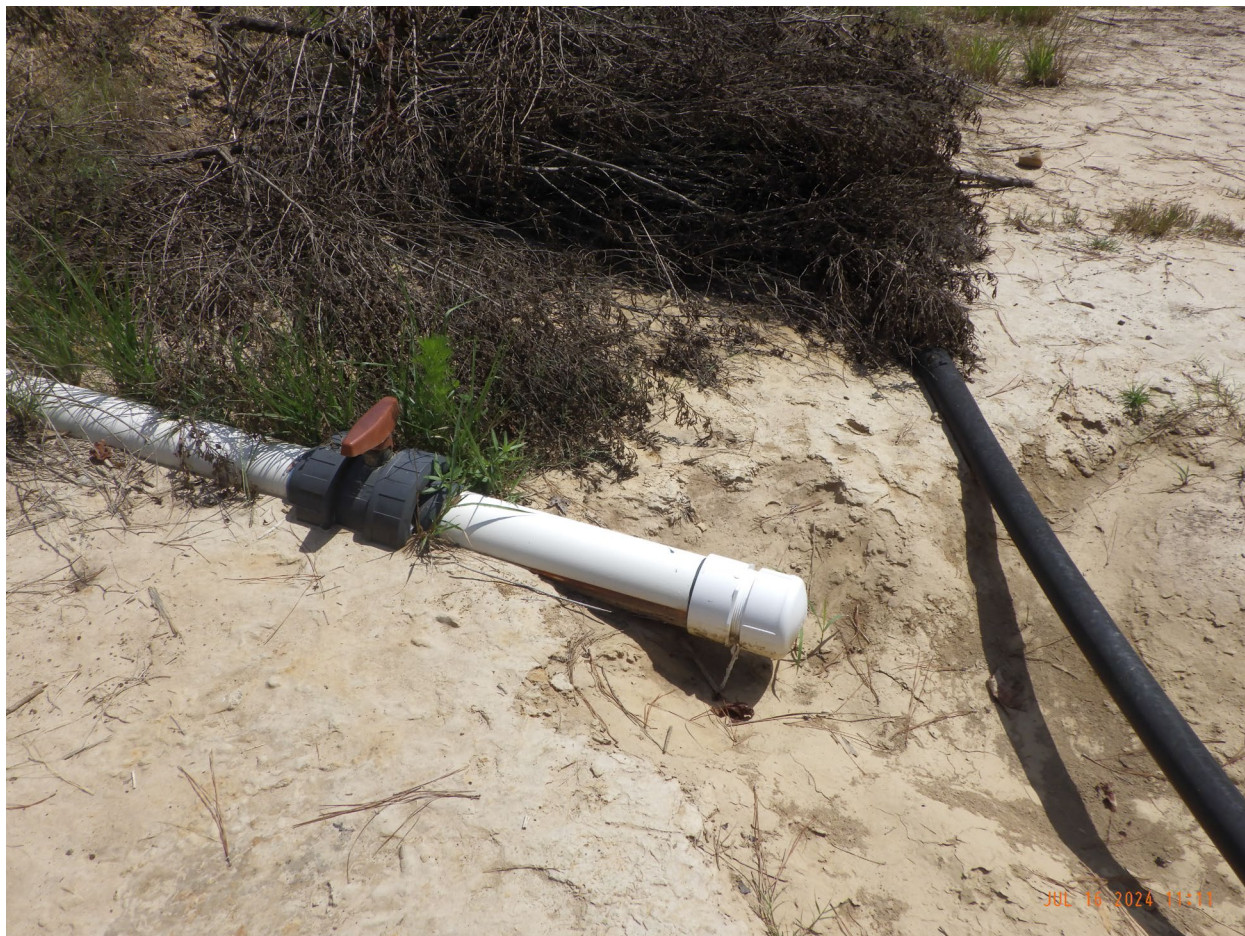
Photo No. 6

I observed the drainpipe for secondary containment with a cap and a closed shutoff valve, see Photo No. 6.

**Description:** Looking NE, the drainpipe for secondary containment with a cap and a closed shutoff valve.
