## RCRA Compliance Evaluation Inspection Report

Maxwell Air Force Base  
400 Cannon Street Winton  
Montgomery, Alabama 36112  
Montgomery County  
(334) 244-7533

EPA ID No.: ALR0570024182

April 21, 2021, 10:00 a.m.

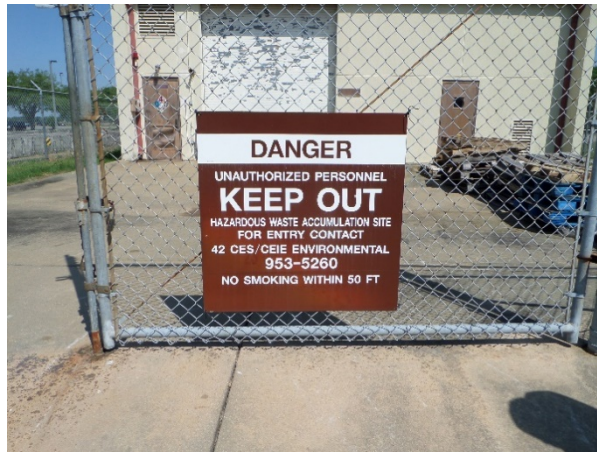
The less than 90-day hazardous waste storage area is in Building 1057. It is a separate building with a sign at the entrance indicating the building use (Picture-1). The storage area was equipped with fire protection equipment, spill control equipment, safety shower, phones for communication, and a sprinkler system. The storage area inside the building is separated into various designated areas. Each area is designated for segregating several types of waste streams that are generated on a normal basis. The waste streams stored in the less than 90-day storage area includes flammables, corrosives, universal waste, nonregulated waste, containers containing waste pending analysis, universal waste and used oil.

*Picture 1: Building 261, Less than 90-day Hazardous Waste Storage Area*

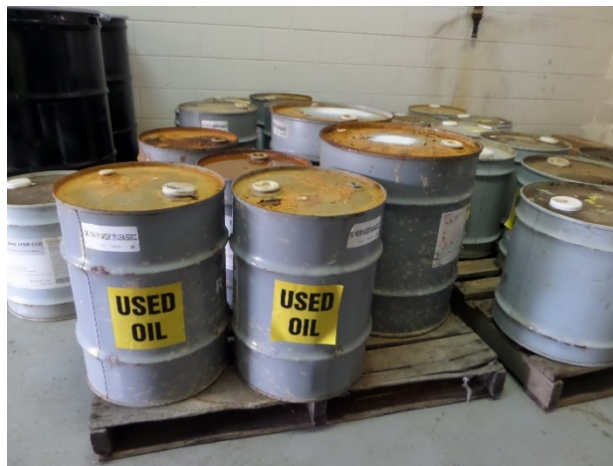
The inspectors observed 24 used oil containers stored on pallets (Picture-2). The used oil was observed to be stored in 30-gallon and 55-gallon containers. All the containers were observed to be closed and labeled. There were no leaks or spills observed on the floor. The inspectors observed five 4-foot and one 6-foot spent fluorescent lamp boxes stored on pallets in the universal waste bay (Picture-3). One 4-foot spent fluorescent box was observed to be labeled as universal waste. The other spent fluorescent boxes were handwritten as universal waste. All the boxes were observed to be closed. The oldest accumulation start date on the universal waste box was observed to be 06/09/2020.

*Picture 2: Used Oil Containers on Pallets*

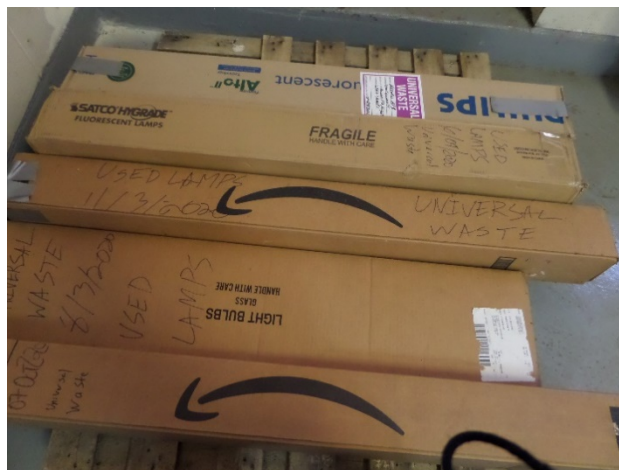
*Picture 3: Spent Fluorescent lamps (Universal Waste)*

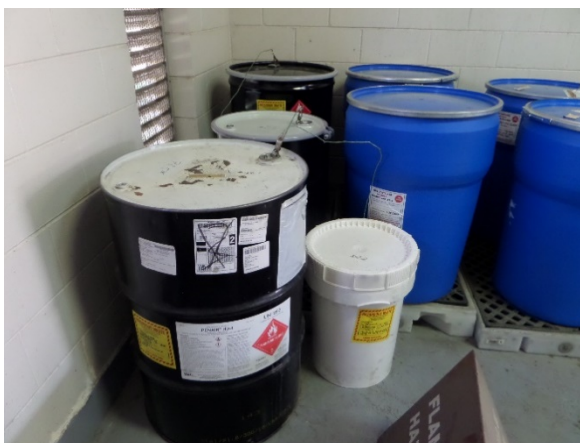
In the hazardous waste designated storage area, the inspectors observed two 55-gallon container, one 30-gallon container and one 10-gallon overpack containers (Picture-4). In the same area, the inspectors observed nine 47-gallon containers and two 125-gallon overpack containers (Picture-5). All nine containers including the overpack containers had a label indicating "Container on Hold Pending Analysis".

*Picture 4: Hazardous Waste in Storage*

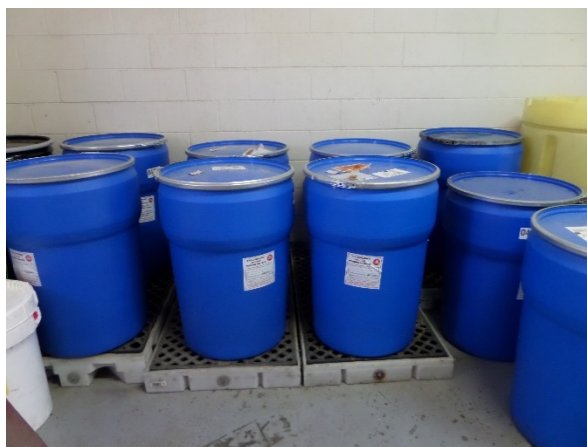
*Picture 5: Containers on Hold Pending Analysis*

Mr. Sawyer provided information via email on May 21, 2021, indicating that the nine 47-gallon poly drums and the two 125-gallon overpacks contained fuel contact water. According to Mr. Sawyer, MAFB had analyzed the fuel contact water and determined it to be nonhazardous. Mr. Sawyer also confirmed that they had received approval from ADEM to recycle the fuel contact water. Mr. Sawyer mentioned that the source of the fuel contact water was from a crash site involving two military aircrafts near the Alabama State line that MAFB Emergency Response Team were requested to respond from Washington DC.

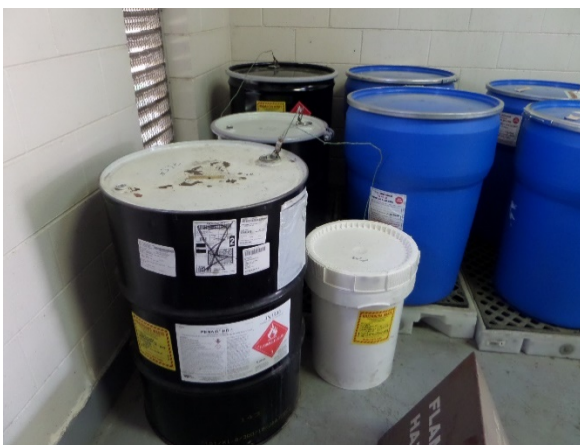
The inspectors observed that there was no aisle space in the area where the hazardous waste was stored including the containers marked as pending analysis (Picture-6). The inspectors had

difficulty accessing hazardous waste containers stored at the rear of the storage area. However, the containers were observed to be closed and labeled. The oldest accumulation start date on the container was observed to be 01/20/2021. The hazard indication on the drums were observed to be “Flammable”. Pictures showing adequate aisle space in the storage building was sent via email on May 21, 2021 to the inspectors indicating that the facility had returned to compliance.

**Pursuant to 40 C.F.R. § 262.16(b)(8)(v)], which incorporates [ADEM Admin. Code r. 335-14-6-.03(6)] [40 C.F.R. § 265.35], and is a condition of the LQG Permit Exemption, a generator is required to maintain aisle space to allow the unobstructed movement of personnel, fire protection equipment, spill control equipment, and decontamination equipment to any area of facility operation in an emergency, *unless* aisle space is not needed for any of these purposes.**

*Picture 6: Lack of Aisle Space in Storage*

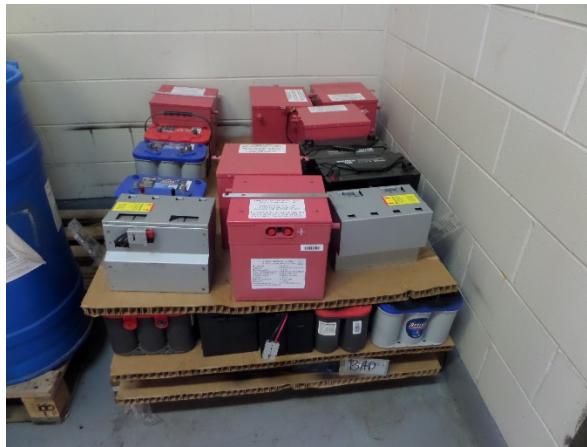
Adjacent to the poly drums and the overpacks, the inspectors observed spent lead-acid batteries (aircraft batteries, automotive batteries) stored on pallets for recycling (Picture-7). The inspectors did not observe any leaks, spills or damage to the batteries that could cause leakage to the environment. The inspectors observed five 10-gallon and two 30-gallon containers of universal waste (spent lithium batteries, spent alkaline batteries and oxide batteries). The containers were observed to be dated and closed. The oldest accumulation start date on the container was observed to be 07/15/2020. The containers were observed to be intact and non-leaking.

*Picture 7: Spent Batteries stored for Recycling*

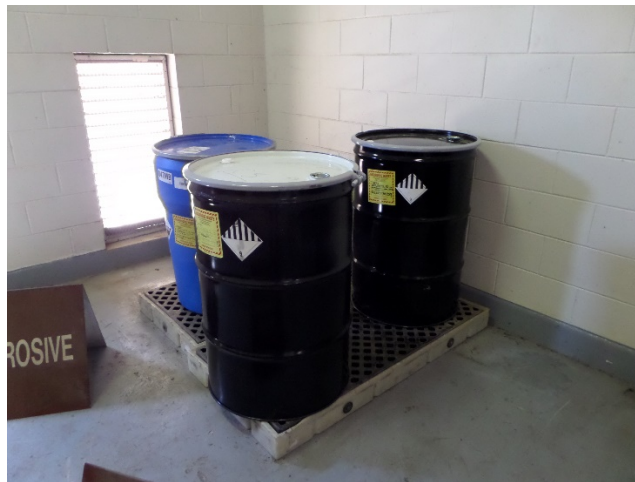
The next area inspected was the corrosive room (Picture-8). The inspectors observed three 55-gallon hazardous waste drums containing corrosive waste (D002) stored in this area. The drums

were observed to be closed, labeled with hazard indication and dated. The oldest accumulation start date on the drum was observed to be 01/22/2021. There was no evidence of leaks or spills observed in this area. Adjacent to the corrosive area, the inspectors observed an area designated for storing non-regulated waste. The inspectors observed seven containers containing non-regulated waste on pallets. All the containers were observed to be closed and labeled as non-regulated waste. No deficiencies were observed in this area.

*Picture 8: Corrosive Waste in Storage*

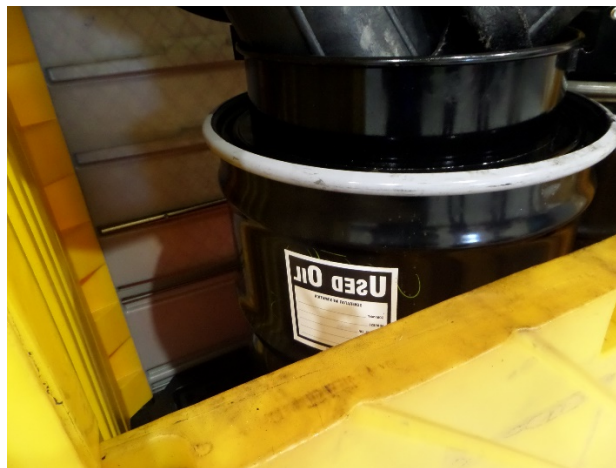
The inspectors observed a small, yellow, roll-top station that contained two 55-gallon drums used for storing used oil in the Prop shop (Picture-9). Both the drums were observed to be closed and labeled as “used oil”. The inspectors inspected the aircraft painting area. There was no painting nor blasting activity in the building at the time of inspection. The inspectors observed one SAA drum inside the blast media room. The drum was observed to be closed, labeled and with a hazard indication. The other SAA drum was located outside the building connected to a baghouse collecting the spent blast media. The drum was observed to be labeled with a hazard indication. There was no evidence of leaks and spills near the drum. The inspectors observed that the building was equipped with fire extinguishers, eye wash station and spill kits.

*Picture 9: Used Oil Storage in Prop Shop*

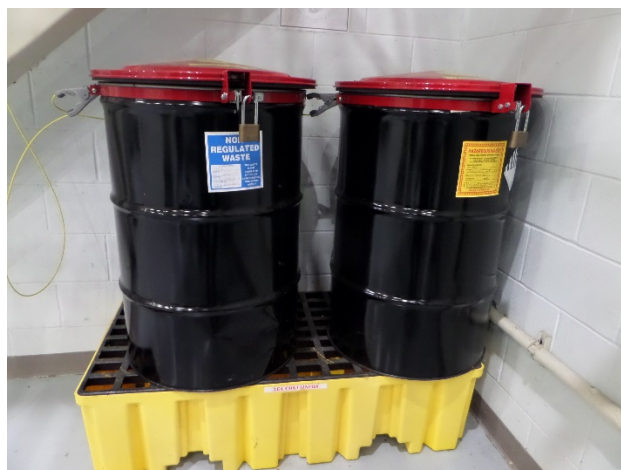
Building 1454 houses a fuel shop where hazardous waste is generated. The inspectors observed two 55-gallon drums on a spill pallet (Picture-10). One of the drums was observed to be labeled as “Hazardous Waste”, the other drum was labeled as non-regulated waste. Both the drums were observed to be closed, intact and non-leaking. The hazard identification on the hazardous waste drum was observed to be Class 9 Miscellaneous. The waste codes on the hazardous waste drum were observed to be D001 and D007. The inspectors observed that the building was equipped with fire extinguishers, eye wash station, and spill kits.

*Picture 10: SAA in Building 1454*
