## **RCRA Inspection Report**

Auburn University  
971 Camp Auburn Road  
Auburn, AL 36849

EPA ID#: ALD000826958  
NAICS #: 61131 – Colleges, Universities, and  
Professional Schools  
54171 – Research and Development in the  
Physical, Engineering, and Life Sciences  
54194 – Veterinary Services  
92614 – Regulation of Agricultural Marketing  
and Commodities

9:48 AM, June 14, 2023

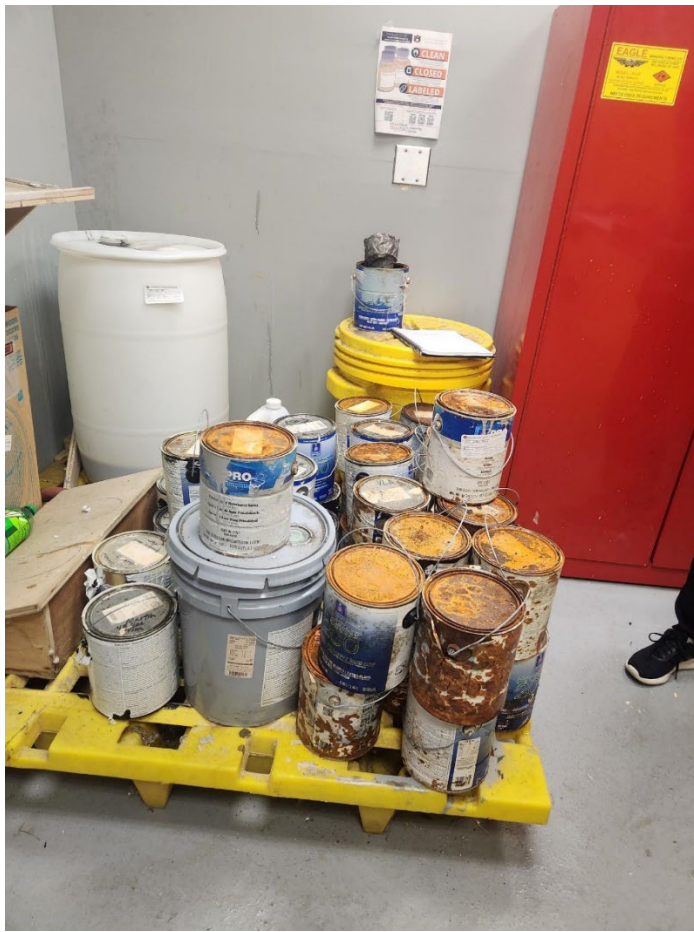
At the time of the inspection, inspectors observed one closed, unlabeled 30-gallon drum of waste paint thinner. This drum was marked with a proper hazardous waste label on-site. Inspectors also observed a pallet of 34 spent paint cans, 3-5 gallons each (Photo #1). Facility representatives informed inspectors that the paint was latex and nonhazardous; however, after separating the paint cans inspectors observed one unlabeled can of waste acrylic paint. Facility personnel

corrected this on site and marked the can with the words “Hazardous Waste, flammable liquid” and an accumulation date.

Photo #1 – waste paint cans and unlabeled 30-gallon container of paint thinner consolidated in Building 4. Inspectors observed one acrylic waste paint can was not marked with a hazardous waste label.

**Pursuant to ADEM Admin. Code r. 335-14-3-.01(7)(a)5(i) [40 C.F.R. § 262.17(a)(5)(i)], which is a condition of the LQG Permit Exemption, a generator must mark or label its containers with the following: (A) the words “Hazardous Waste”; (B) an indication of the hazards of the contents; (C) and the date upon which each period of accumulation begins clearly visible for inspection on each container.**

**Pursuant to [ADEM Admin. Code r. 335-14-3-.01(2)] [40 C.F.R. § 262.11], a person who generates a solid waste, as defined in [ADEM Admin. Code r. 335-14-2-.01(2)] [40 C.F.R. § 261.2], must make an accurate determination as to whether that waste is a hazardous waste in order to ensure wastes are properly managed according to applicable RCRA regulations articulated in [ADEM Admin. Code r. 335-14-3-.01(2)] [40 C.F.R. § 262.11].**

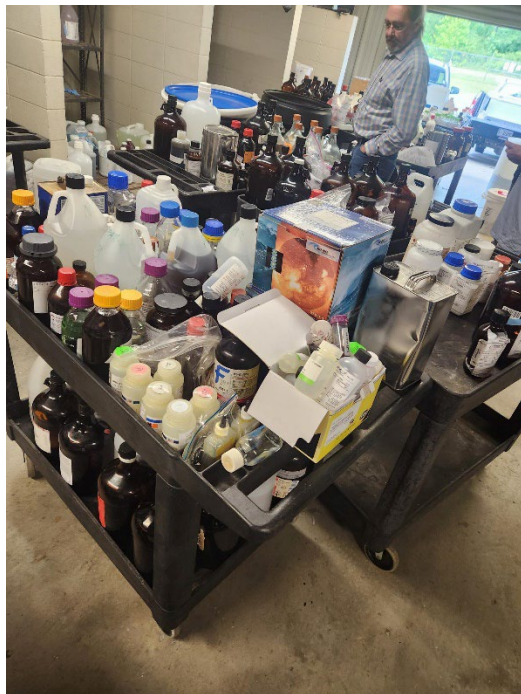
Containers were staged in this area for US Ecology to lab pack and ship for disposal. Inspectors observed shelves marked with a "Corrosive," "Toxic," "Oxidizer," "Flammable Solid," or "Class 9 Miscellaneous" DOT placards. Waste containers brought to this area are staged on the shelf with its corresponding hazard awaiting lab packs. All containers, including the Class 9 shelf, were individually marked with the words "hazardous waste," the appropriate indication of the hazards of the contents, and an accumulation date.

At the time of the inspection, the facility's hazardous waste transporter was on-site in the 90-Day or less accumulation area performing a lab pack to be shipped for disposal. Inspectors observed over 3200 small containers awaiting lab packs. The containers of waste laboratory chemicals ranging from 2L to 1ml in capacity were staged on carts to be consolidated in larger labeled drums during the lab pack (Photo #2). The transporter removed the paper labels on the containers just before consolidation.

Photo #2 – Waste in the Main 90-Day or less central accumulation area staged on carts during a lab pack.

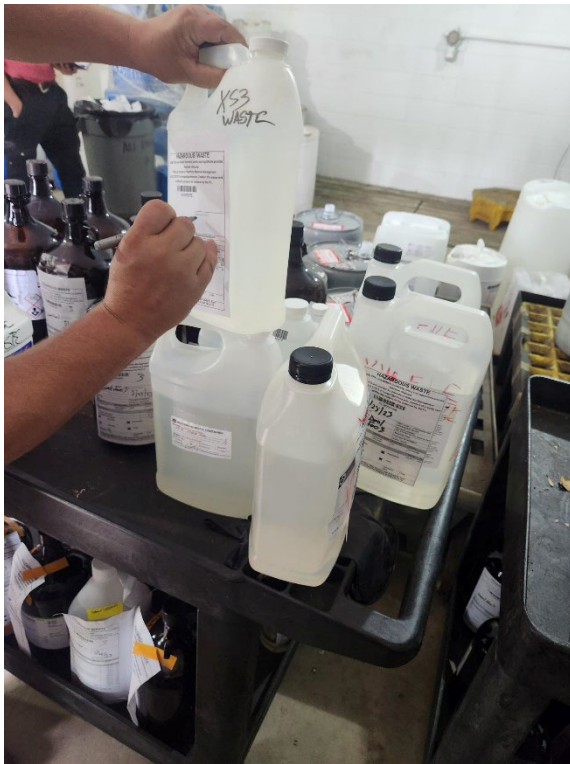
Containers in the flammable 90-Day or less area ranged from 1L to 30-gallons. Facility representatives informed inspectors that SAA's on campus are no more than 30-gallons to comply with the 55-gallon accumulation limit for SAA's. Inspectors observed a 30-gallon container marked with the words hazardous waste, flammable and toxic, TCE (Trichloroethylene.) This container was not marked with an accumulation date. Inspectors also observed three 1-gallon containers labeled "Hazardous Waste, Xylaene Substitute, t x-limonene, flammable." These containers were also missing an accumulation date. Facility representatives informed inspectors that all containers were consolidated in the 90-Day or less accumulation area on Friday, and this date was added to the labels on site (Photo #3).

Photo #3 – Date being added to hazardous waste container in the Flammable CAA.

**Pursuant to ADEM Admin. Code r. 335-14-3-.01(7)(a)5(i) [40 C.F.R. § 262.17(a)(5)(i)], which is a condition of the LQG Permit Exemption, a generator must mark or label its containers with the date upon which each period of accumulation begins clearly visible for inspection on each container.**

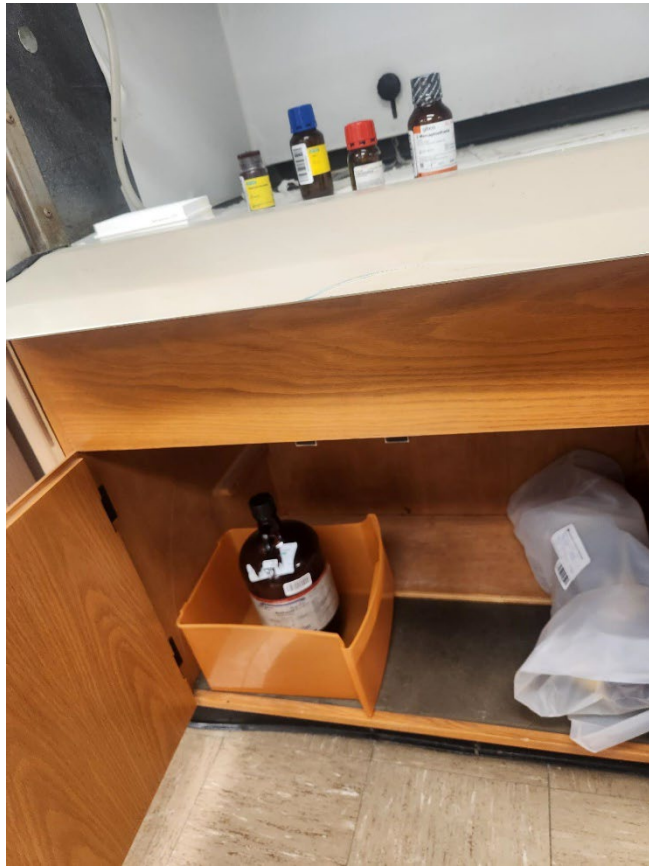
Photo #5 – Container with torn and partially illegible label observed in the Mitra Lab located in room 4202 of the of the Pharmacy College.
