**Region 6 Compliance Assurance and Enforcement Division**  
**INSPECTION REPORT**

| Regulatory Program(s) | NPDES - Oil and Gas, Produced/Brine Water | | |
| Company Name: | <b>EOG Resources, INC.</b> | | |
| Facility Name: | <b>Allen Pit</b> | | |

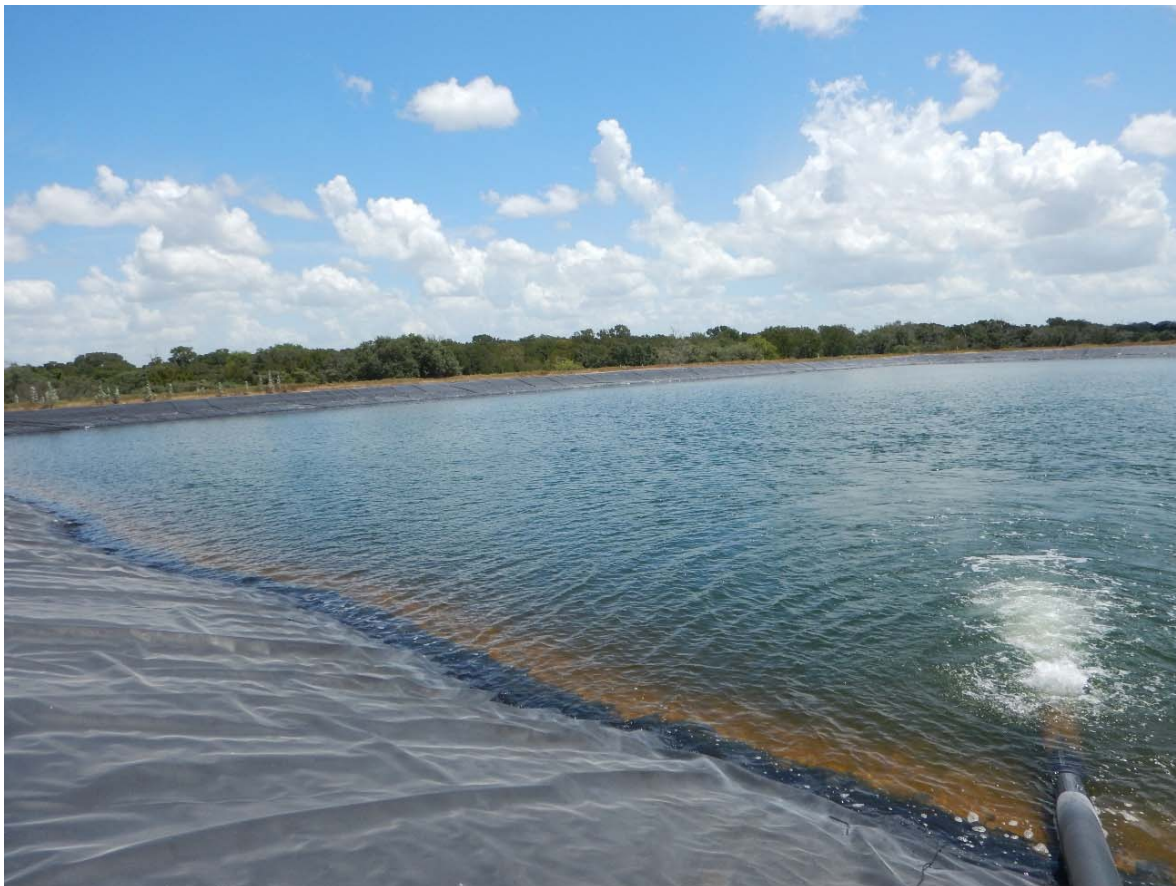
Photo No. 3

**Allen pit** is located at latitude 29.250968 N and longitude -97.547761 W. It has the capacity to enclosed approximately 240,000 barrels of water. We observed that multiples produced flow lines with indeterminate source and destination where going in and out of the pit. One of the large produced

flowline, going inside the pit, showed an active and continuous discharge of water. See Photo Nos. 3 – 4 in Appendix 1. Apparently the flow line collects and stores water from wells nearby the pit. At the same time we observed that the produced water pit had some sheens on the surface of water in pit. The open pit did not have a net system over it to prevent wildlife, like birds from coming into contact with the produced fluids. Calibrated YSI 30 Salinity Conductivity Meter was used to measure the Total Soluble Salt (TSS). We obtained a Total Soluble Salts (TSS) reading of 2,000 parts-per-million (ppm) taken at the point of release into the pit of produced water at latitude 29.251617 N and longitude -97.549370 W. See Photo No. 4 in Appendix 1. We followed a potential flowpath and monitored the surrounding areas around the pit and found that the produced water reached the tributary of Sandies Creek. We observed a marshland area with produced fluids potentially seeping below the North West corner of the pit above the surface of the ground and entering the tributary of the Sandies Creek. This is considered as the point of entry (POE), where fluids reached the tributary of Sandies Creek and it is located at latitude 29.253539 N and longitude -97.549849 W. We obtained a TSS reading of 1,900 ppm at the POE point. See Photo Nos. 5- 6 in Appendix 1. At this location, the tributary of Sandies Creek that look like a marshland area showed a flowpath of fluids and dead vegetation. It was approximately 1 foot deep and approximately 50 feet wide. We obtained another TSS reading of 1,800 ppm 90 feet down to this point. See Photo Nos. 7, 8, and 9 in Appendix 1. Additionally during the inspection we noticed a direct flowpath coming directly from the Floy Unit Lease located next to the pit. The flowpath showed water marks, sediments and debris towards the tributary of Sandies Creek. See Photo Nos. 10, 11, and 12 in Appendix 1. We followed the discharge to Sandies creek and obtained a TSS reading of 900 ppm approximately 4,659 feet downstream along Sandies Creek from the POE at latitude 29.251447 N and longitude -97.538721 W. Sandies Creek showed a defined bed and bank and evidence of riparian plants growing along the creek, sediments, debris and water marks. Tributary was approximately 35 feet in width and 4 feet deep. See Photo No. 13 in Appendix 1.

Description: This image shows the EOG Resources, INC. – Allen Pit.

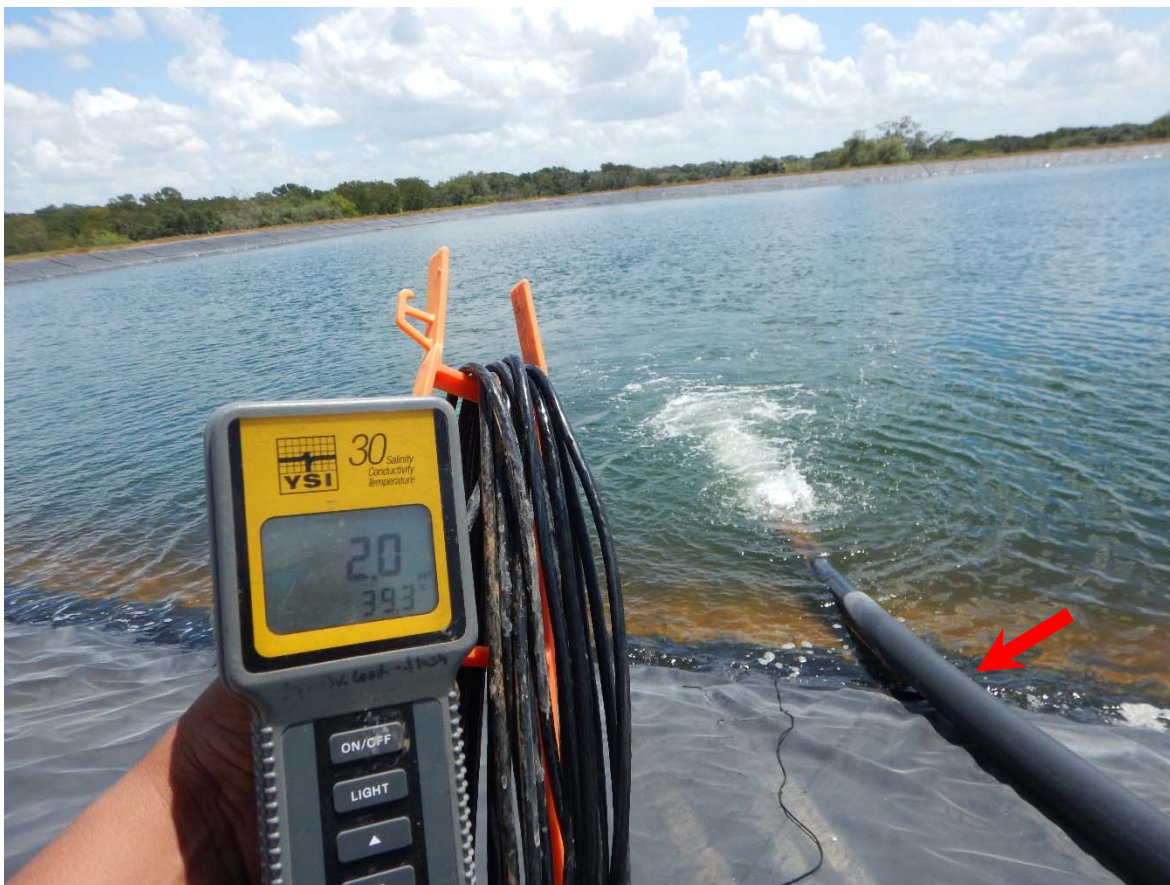
Photo No. 4

- A TSS reading of 2,000 ppm from fluids inside the pit structure
- A TSS reading of 1,900 ppm from fluids at the point of entry of tributary of Sandies Creek
- Potential seepage of produced fluids from the collection pit into the tributary of the Sandies Creek
- Flow paths next to Floy Unit Lease and Pit connected to the tributary of the Sandies Creek

Description: This image shows a measurement of Total Soluble Salts (TSS) reading of 2,000 parts-per-million in the open produced water collection pit. Also it shows an overview of a large flowline discharging produced water into the pit.

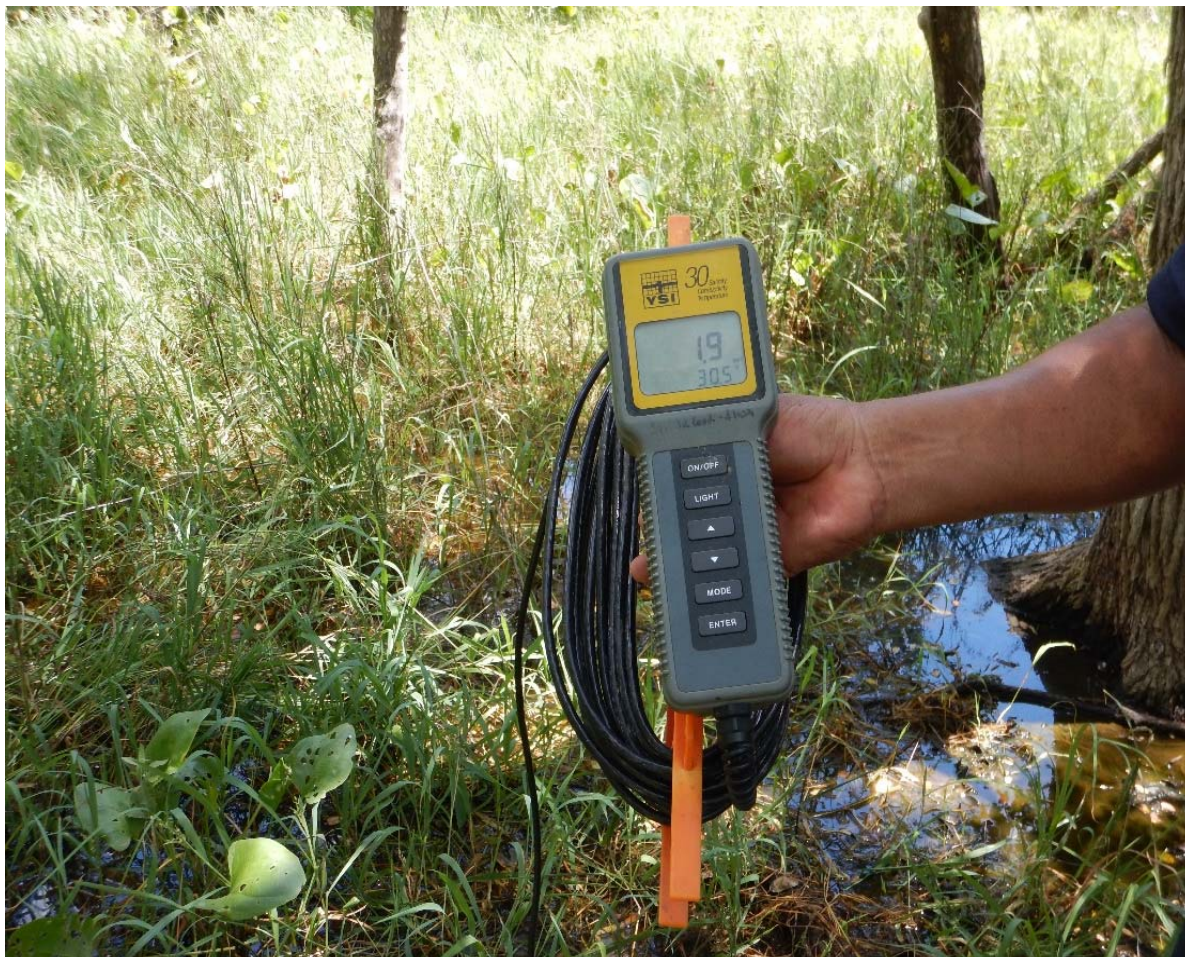
Photo No. 5

Description: This image shows the point of Entry (POE) to tributary of Sandies Creek, where a measurement of Total Soluble Salts (TSS) reading of 1,900 parts-per-million was taken.

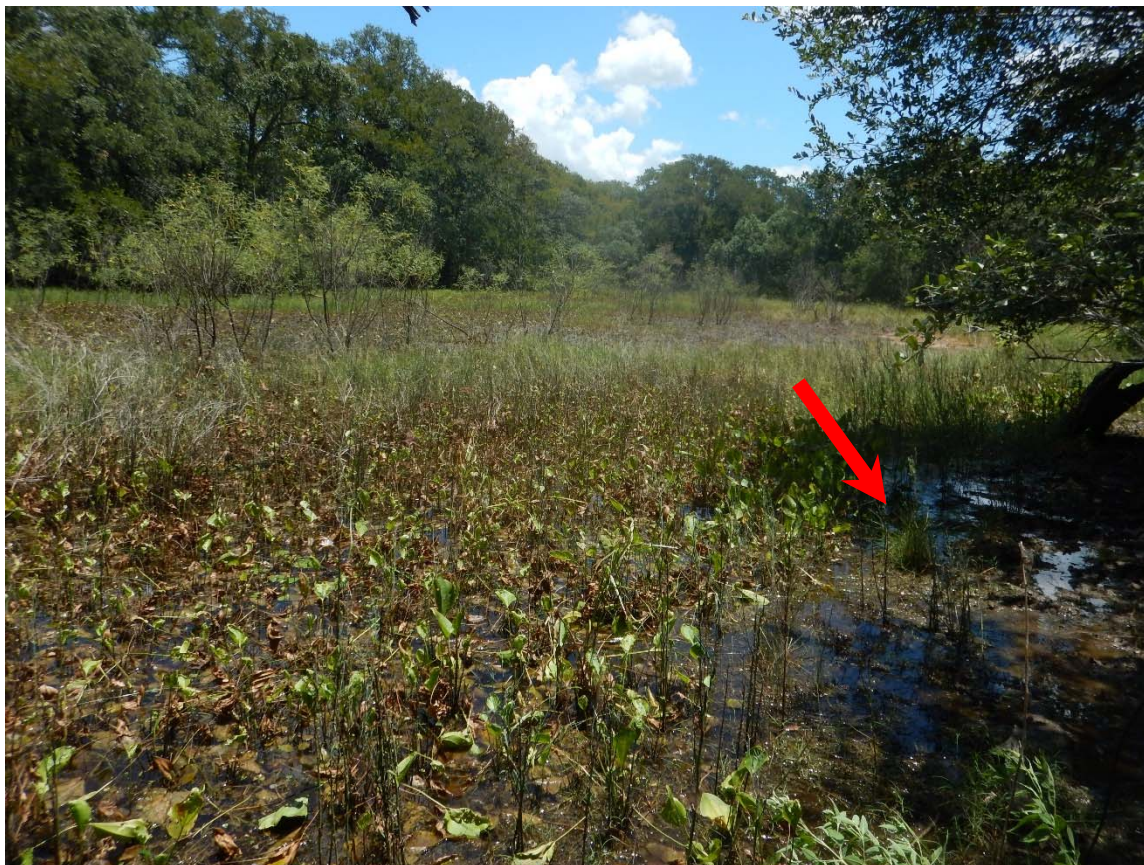
Photo No. 6

Description: This image shows the marshland area with produced fluids potentially seeping below the North West corner of the pit above the surface of the ground and entering the tributary of the Sandies Creek.

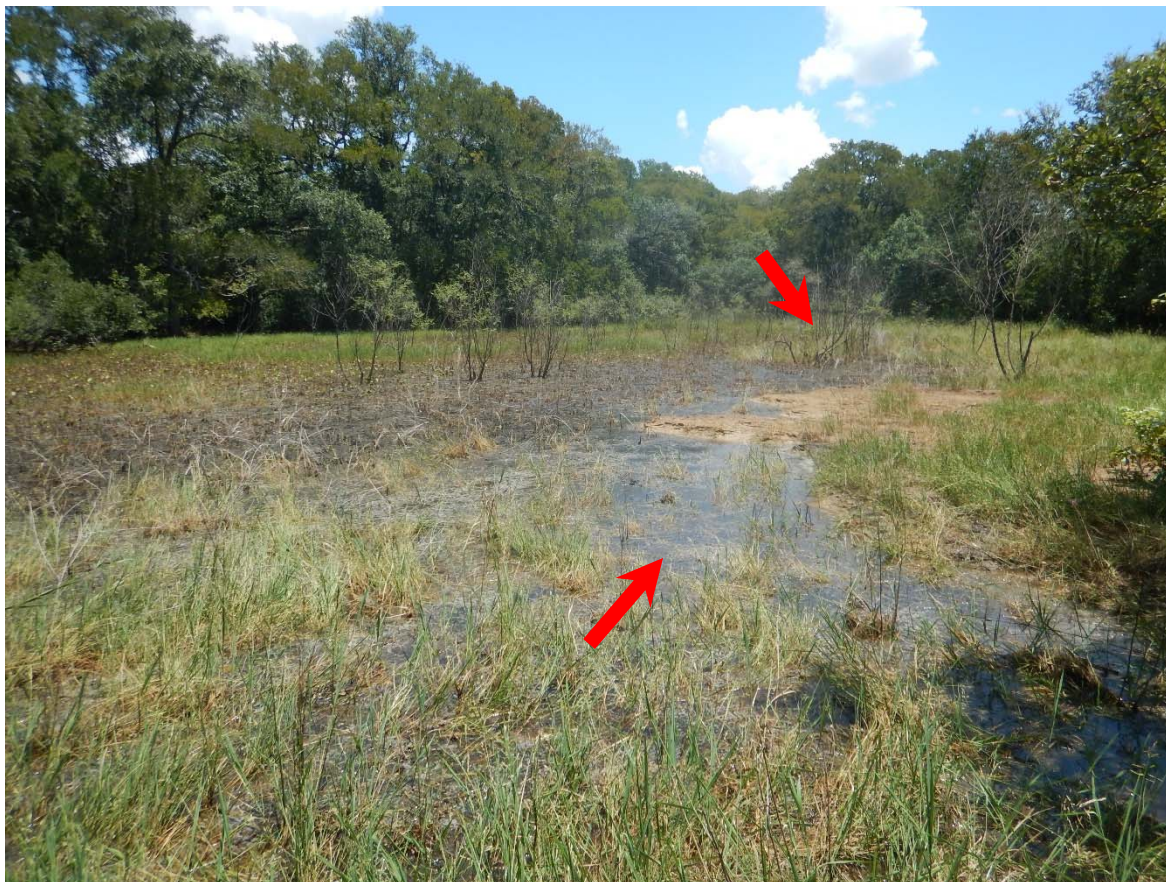
Photo No. 7

Description: This image shows a flowpath of fluids and dead vegetation downstream from the POE to the creek.

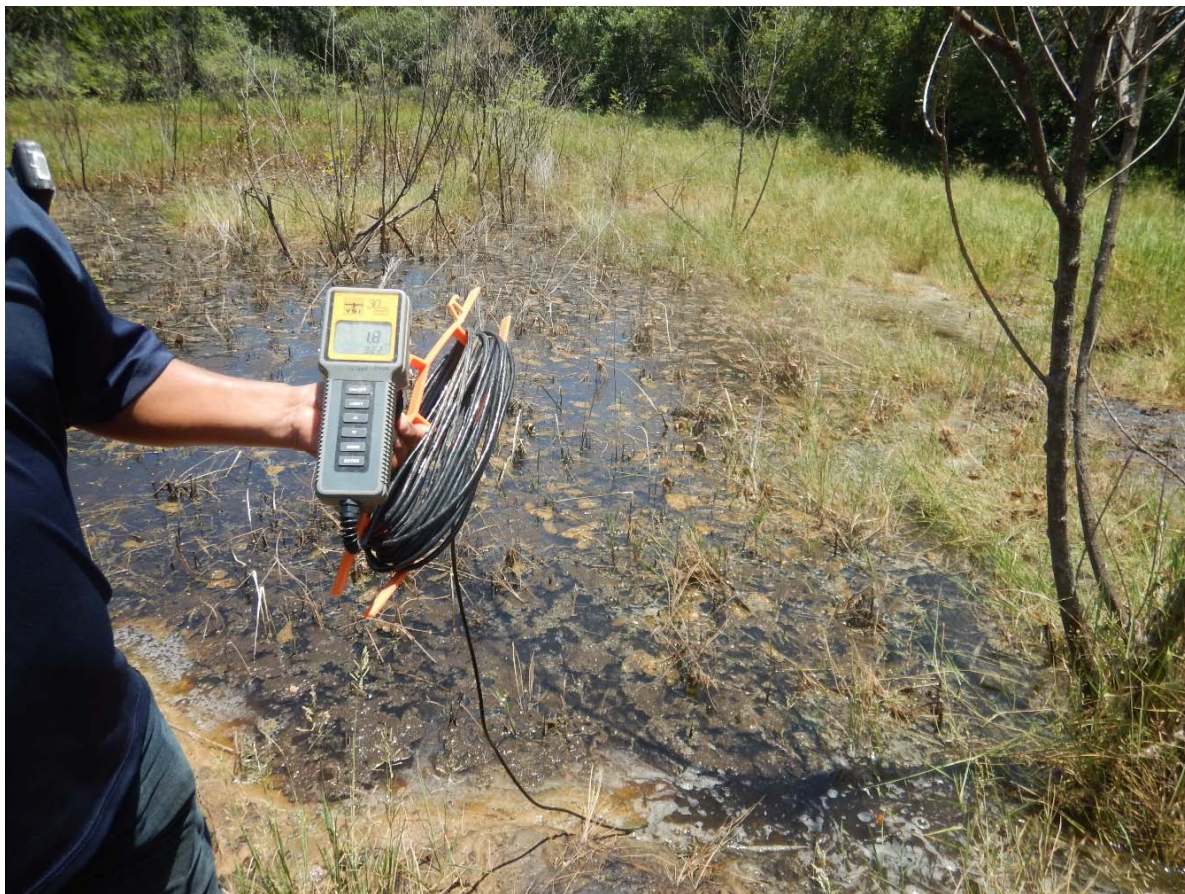
Photo No. 8

Description: This image shows a pool of fluids approximately 100 downstream of POE, where a TSS reading of 1,800 ppm was taken. This image also shows a flowpath of dead vegetation.

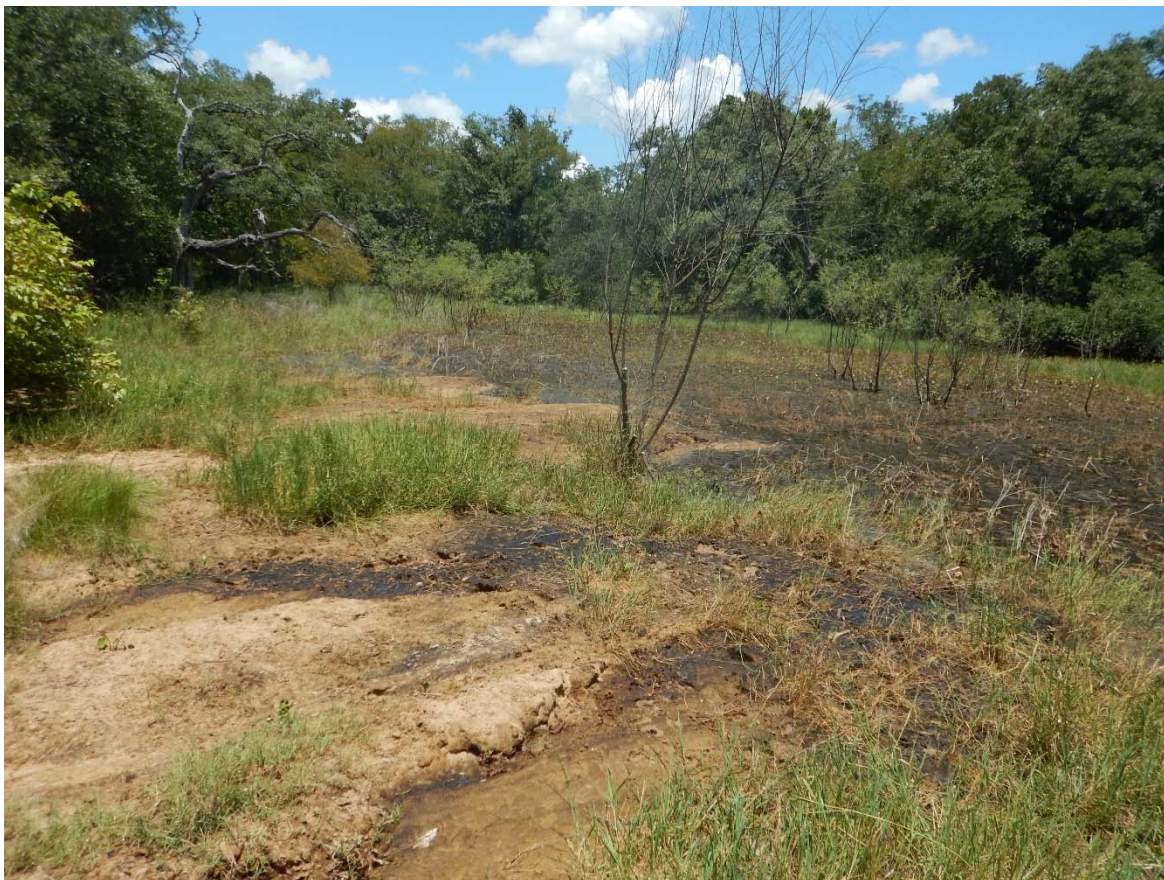
Photo No. 9

Description: This image shows a flowpath of fluids and dead vegetation going downstream to Sandies Creek.

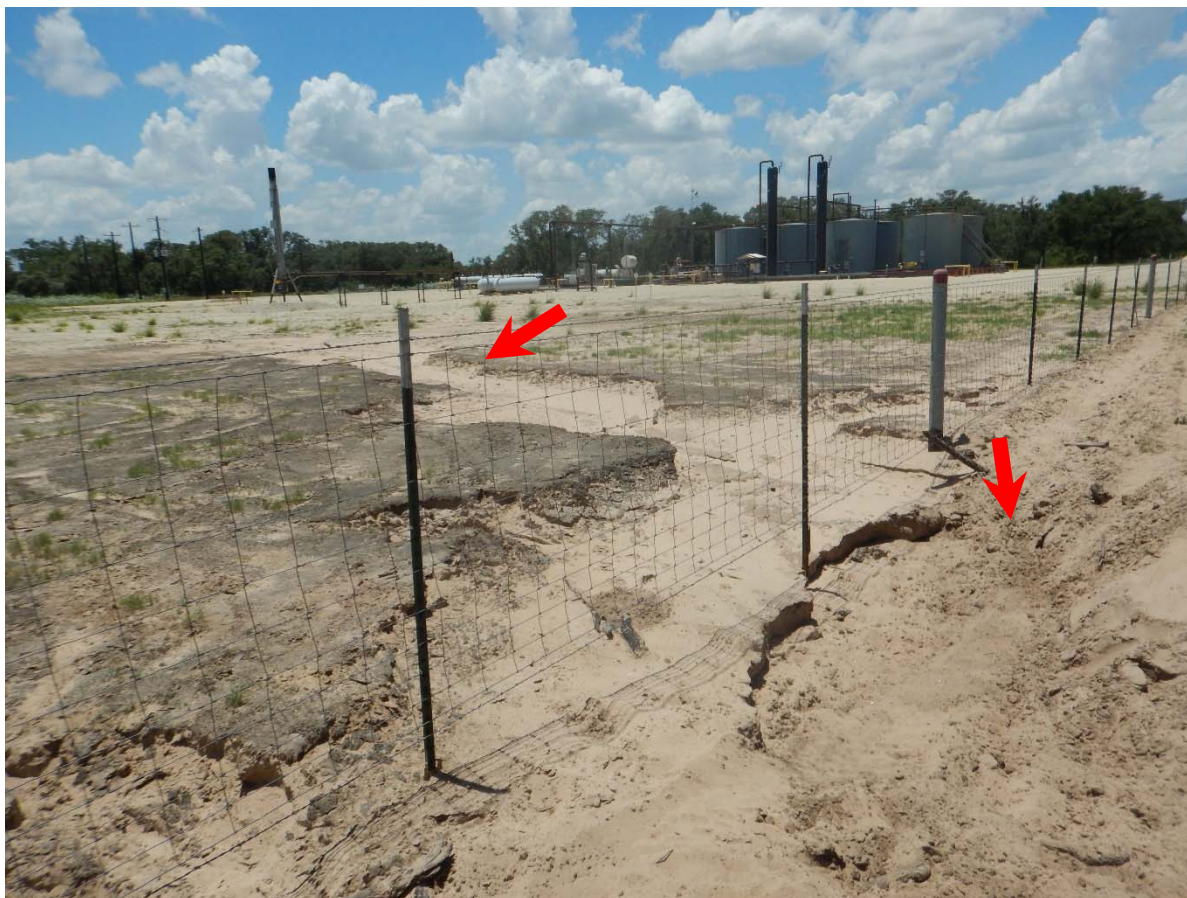
Photo No. 11

Description: This image shows the EOG Resources, INC. – Floyd Unit Lease and a flowpath leaving lease to tributary of Sandies Creek.

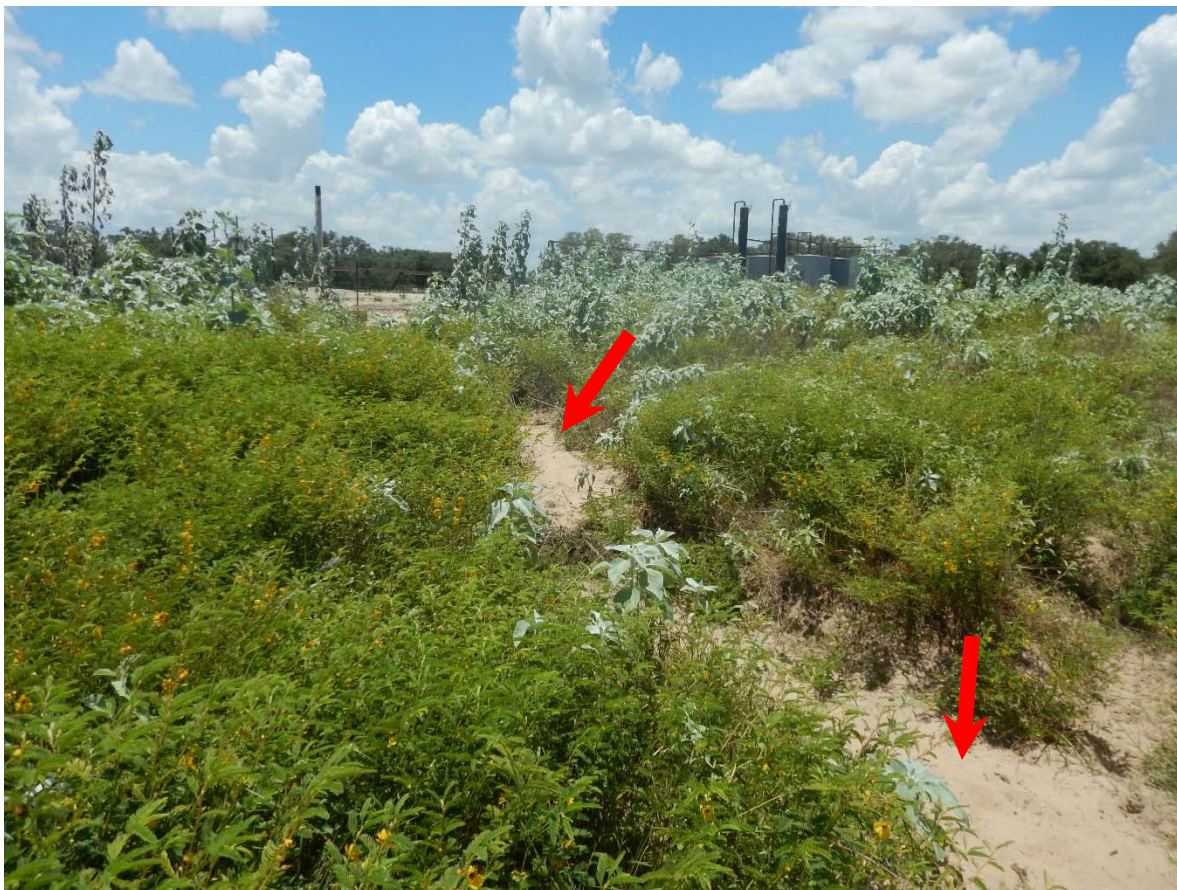
Photo No. 12

Description: This image shows the back of EOG Resources, INC. – Floyd Unit Lease and a flowpath.

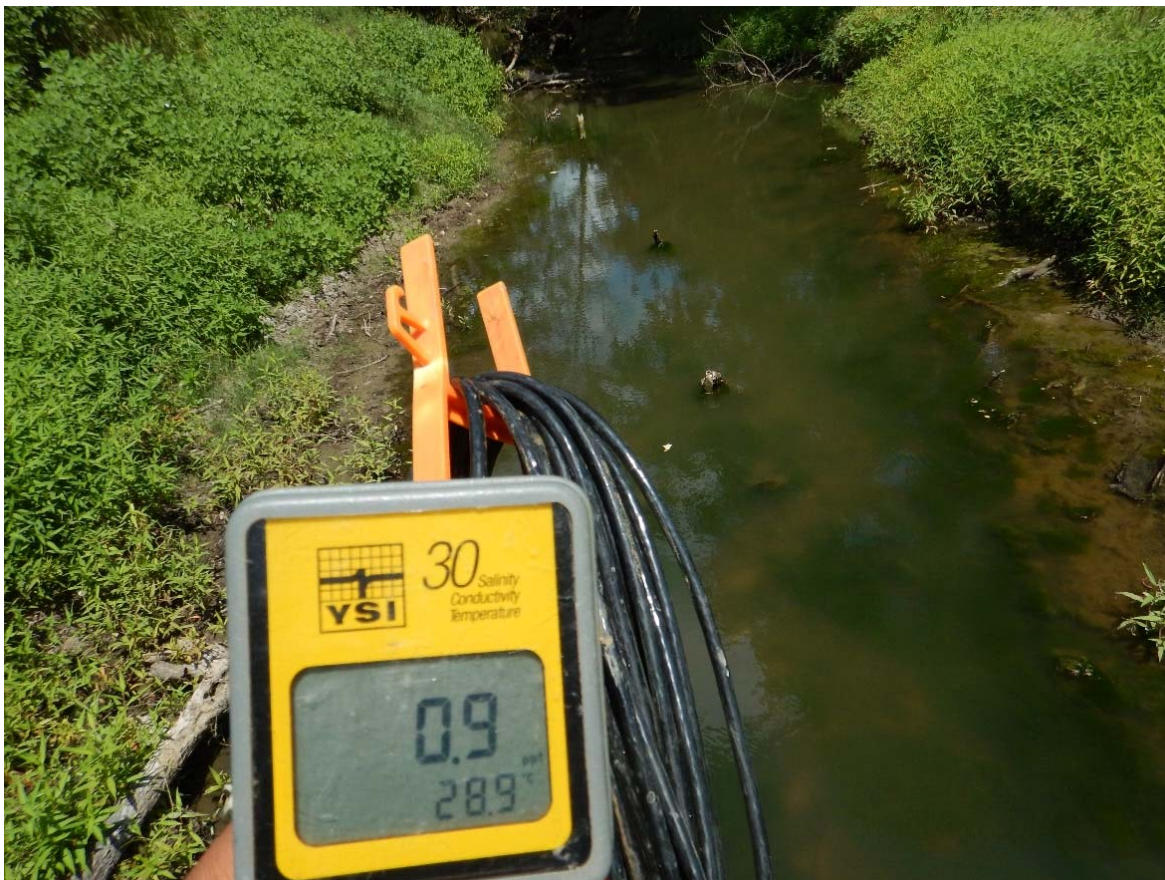
Photo No. 13

Description: This image shows a downstream TSS reading of 900 ppm along the tributary of the Sandies creek. This location was approximately 4,659 feet downstream from the Point Source of Contamination.

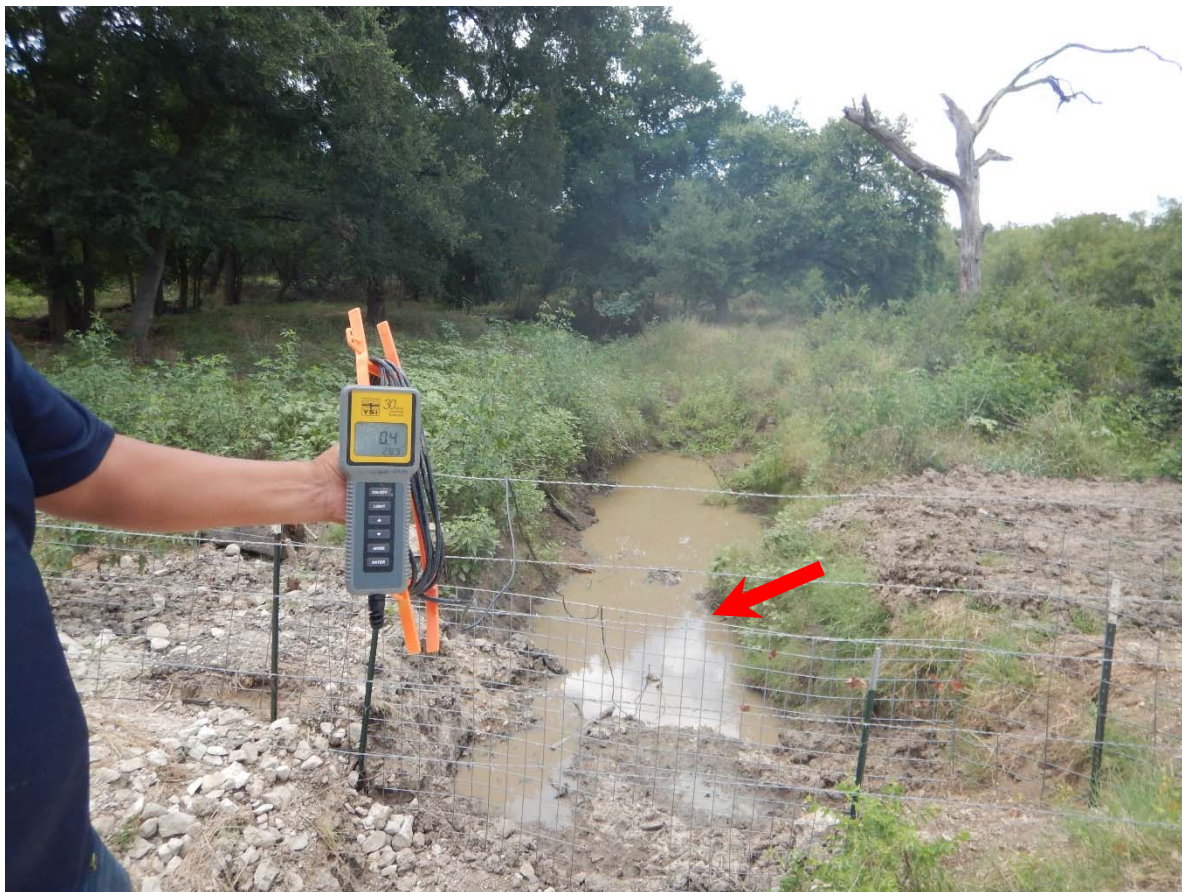
We went approximately 11 Miles upstream of the POE to the tributary of the Sandies Creek and measured the TSS to determine water quality data, such as water quality in the area. We obtained at approximately 11.29 Miles a TSS reading of 400 ppm at Latitude 29.282821 N and Longitude -97.655582 W. See Photo No. 14 in Appendix 1. Additionally we obtained at approximately 11.41 Miles a TSS reading of 700 ppm at Latitude 29.281059 N and Longitude -97.655716 W. See Photo No. 15 in Appendix 1.

Description: This image shows an upstream TSS reading of 400 ppm along the tributary of the Sandies creek. This location was approximately 11.29 miles upstream from the Point Source of Contamination.

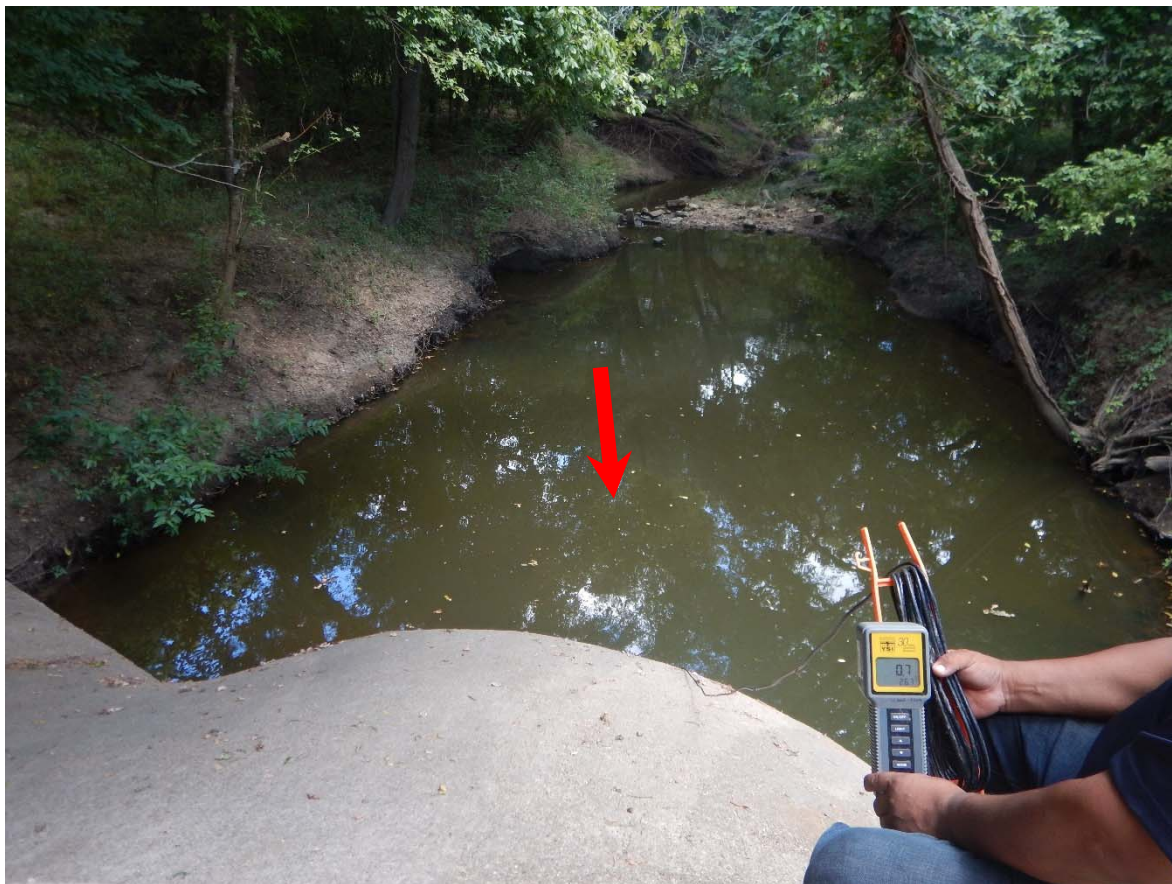
Photo No. 15

Description: This image shows an upstream TSS reading of 700 ppm along the tributary of the Sandies creek. This location was approximately 11.41 miles upstream from the Point Source of Contamination.
