## **RCRA Inspection Report**

PG Technologies  
135 Technology Blvd  
Ellisville Mississippi 39437

EPA ID # MSR000106203  
NAICS # 332811 – Metal Heat Treating

November 16, 2023

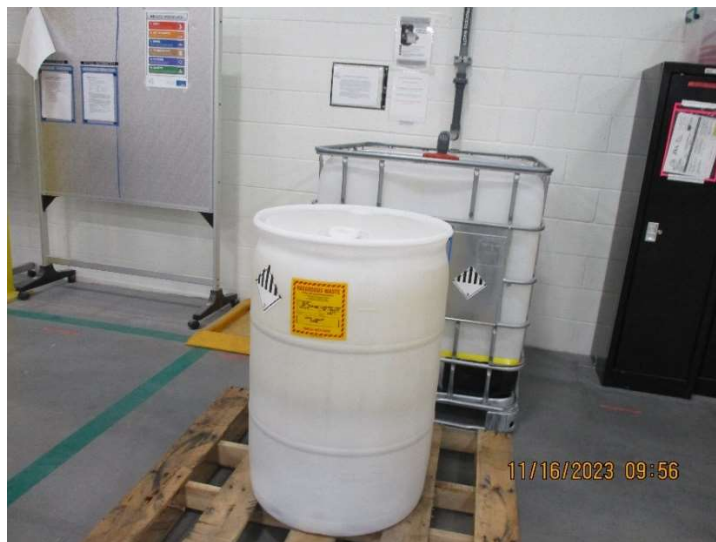
The inspectors began the walk-through in the slurry coating areas (Slurry Area #1, Slurry Area #2, and Slurry Area#3). Three SAAs are managed in this area. We were joined by Mr. Al Keller, PGT, Team Leader, during the walk through. In this area, the engine parts received the final coating (with chrome) and are washed with water in a sink (#1, #2, and #3) to clean the parts. The sinks were labeled with the words “hazardous waste.” The Waste stream D007 is generated in this area. The sink is connected to a 250-gallon tote. The totes have a yellow line to mark the 55-gallon. Once the liquid reaches this line, it is manually pumped out into a 55-gallon container (located next to the tote) and moved to the 90 days hazardous waste storage area. Photos #1, #2, and #3. The totes and the 55-gallon containers were labeled as slurry liquid waste, were observed to be closed, and labeled with the words “Hazardous Waste.”

Photo #1 Containers with slurry liquid waste

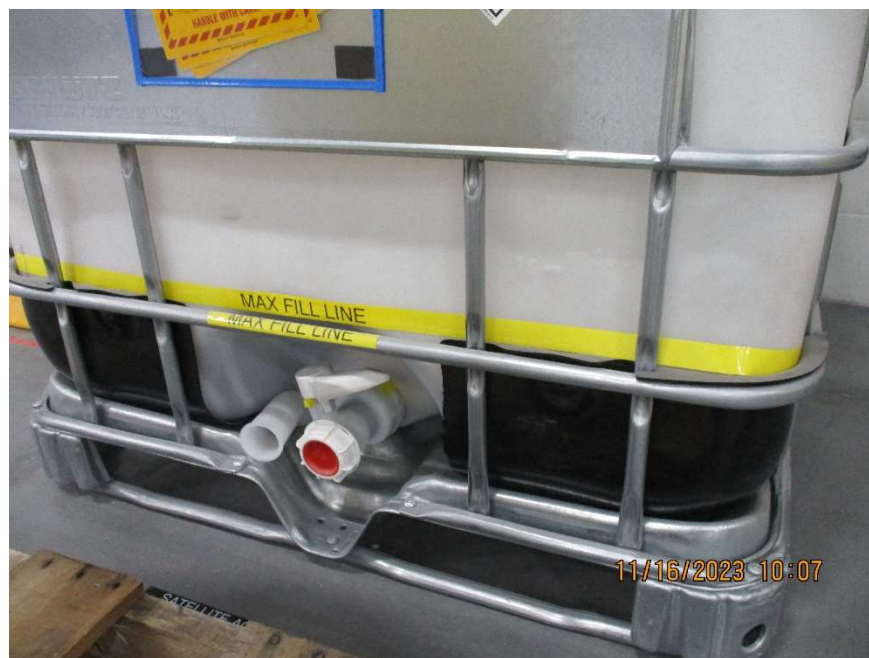
Photo #2 Tote with the yellow line mark

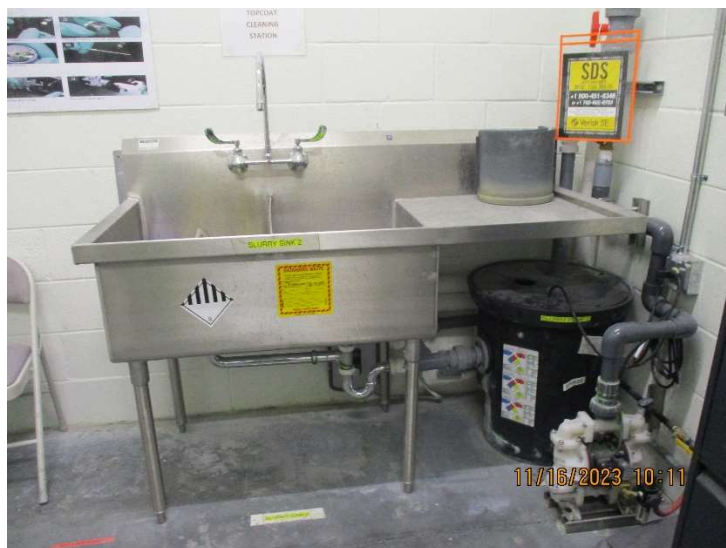
Photo #3 Sink in the slurry area to wash the parts

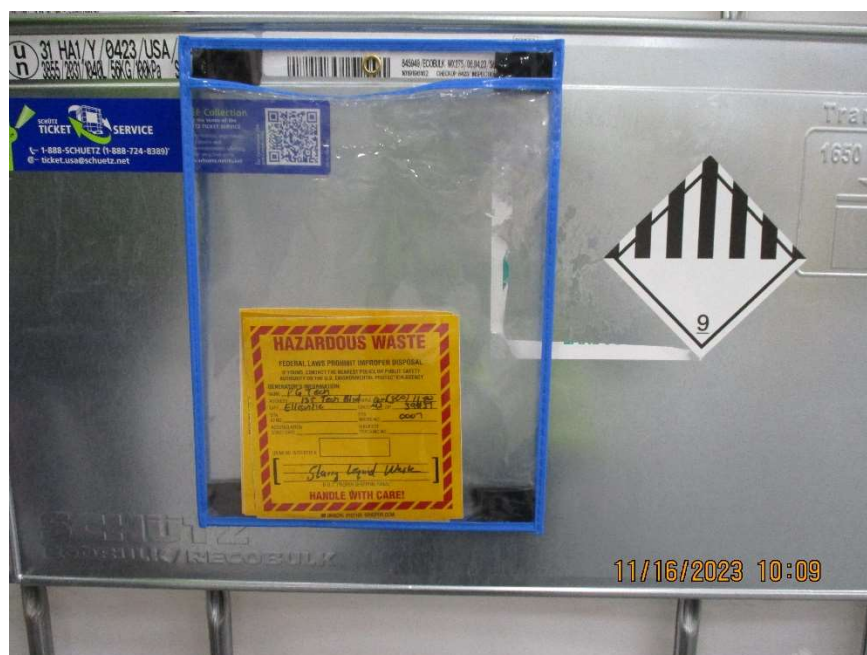
However, it was observed that the containers in the slurry area were not labeled or marked with the appropriate hazard indicator. Instead of having the “toxic” label, they were labeled with the Class 9 (miscellaneous) Department of Transportation (DOT) label. Recent guidance from the EPA (February 2023), states that the Class 9 DOT label, by itself, does not adequately indicate the hazard associated with the container’s content. Photos #4 and Photo #5.

Photo #4 Class 9 Label

**Pursuant to 11 Miss. Admin. Code Pt. 3, R. 1.3 [40 C.F.R. § 262.15(a)(5)], A generator must mark or label its container with the following: (ii) An indication of the hazards of the contents (examples include, but are not limited to, the applicable hazardous waste characteristic(s) (i.e., ignitable, corrosive, reactive, toxic); hazard communication consistent with the Department of Transportation requirements at 49 CFR part 172 subpart E (labeling) or subpart F (placarding); a hazard statement or pictogram consistent with the Occupational Safety and Health Administration Hazard Communication Standard at 29 CFR 1910.1200; or a chemical hazard label consistent with the National Fire Protection Association code 704).**

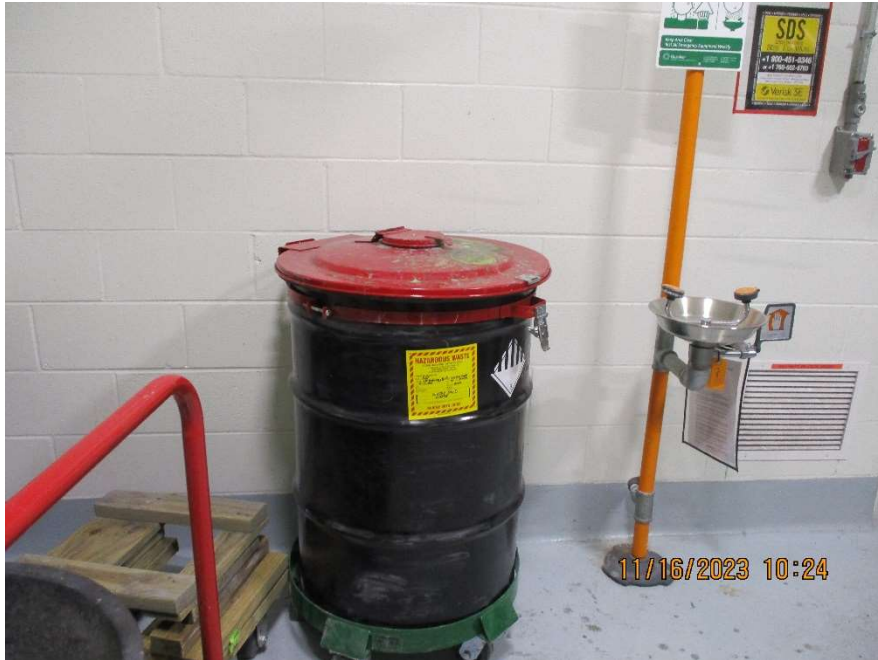
One 55-gallon container with solid (gloves, towels, etc.) was observed to be closed and labeled with the words “Hazardous Waste.”

Photo # 5 (Slurry Area) Container with gloves, towels, etc.

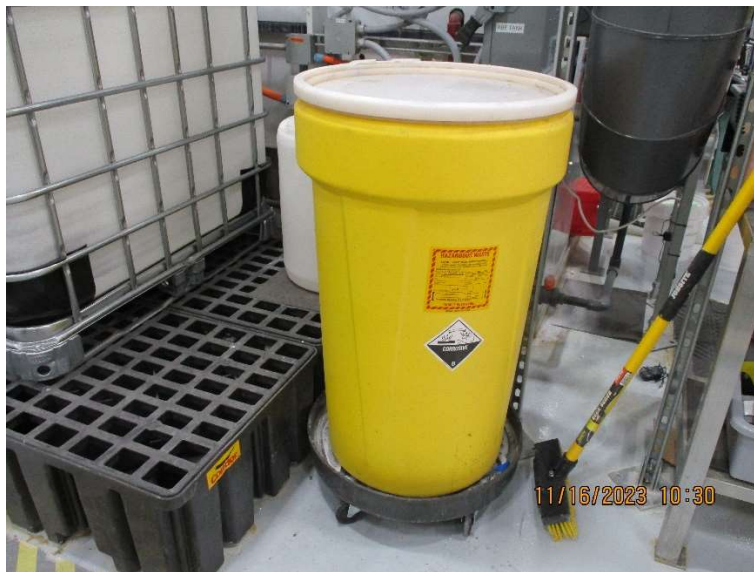
One 55-gallon container with solid (filters, ammonium hydrogen difluoride) was observed to be closed and labeled with the words “Hazardous Waste” and with an indication of the hazards of the contents. Photos #6.

Photo # 6 (ABF Stripping) Container solid waste filters

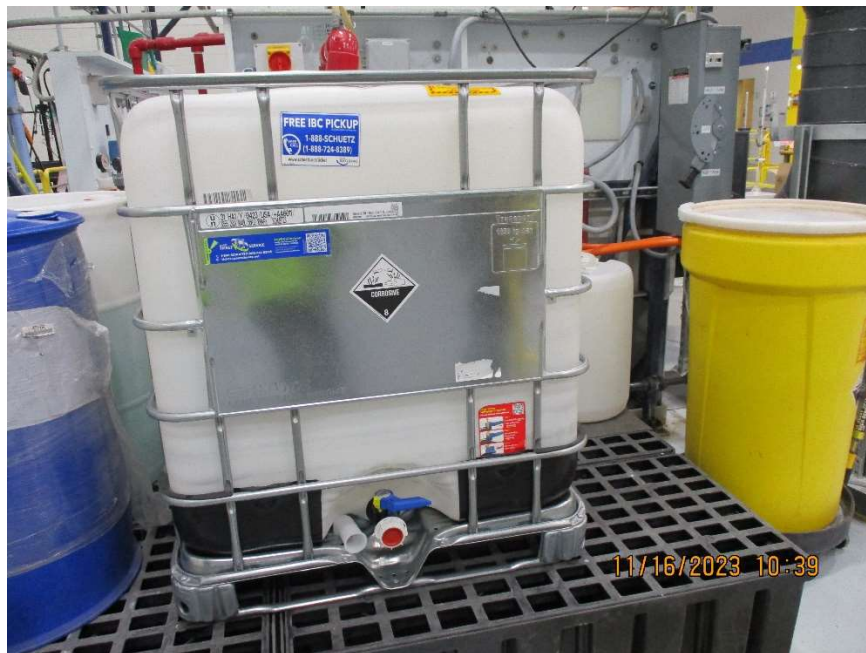
One 250-gallon tote is used to store aluminum fluoride. The tote has a line to mark the 55-gallon. Once the liquid reaches this line, it is pump out into a 55-gallon container (located next to the tote) and moved to the 90 days hazardous waste storage area. The tote was empty at time of the inspection, closed and labeled with the words “Hazardous Waste,” and with an indication of the hazards of the contents. Photo #7.

Photo # 7 (ABF Stripping) Empty tote

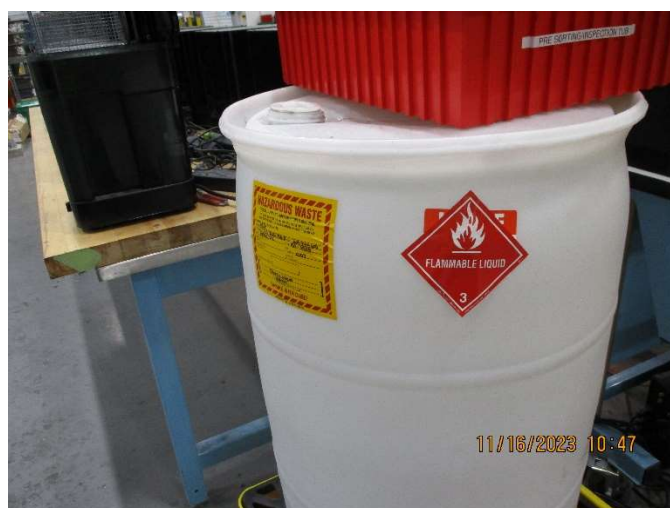
Small 3D engine parts are produced in this area and wash with alcohol for cleanliness. One 55-gallon container labeled as slurry liquid waste, was observed to be closed and labeled with the words “Hazardous Waste” and with an indication of the hazards of the contents. The container was located on a secondary containment. Photo #8.

Photo # 8 (3D Printing) container labeled as slurry liquid waste

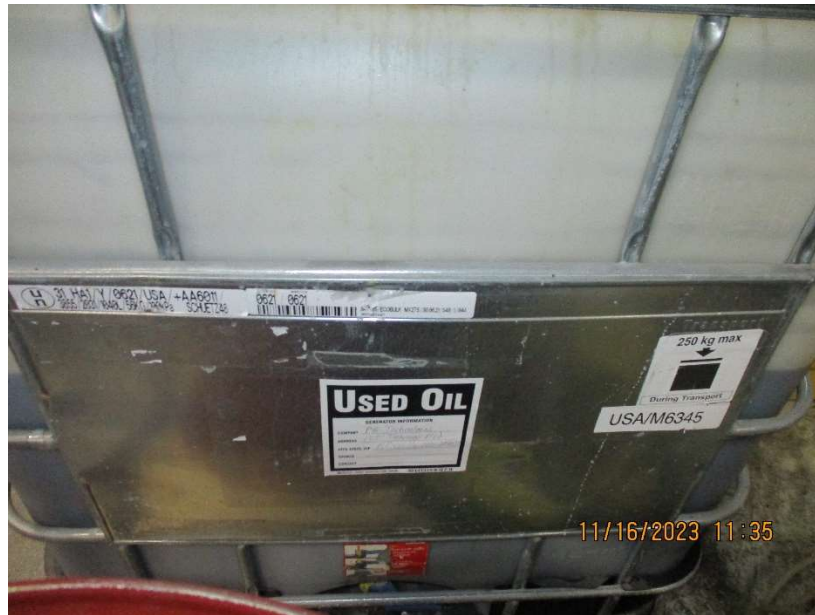
One 55-gallon container and 250-gallon tote with a funnel with lid, were observed closed and label with the words “Used Oil” in a secondary containment. Photo # 9.

Photo # 9 Container with "Used Oil"

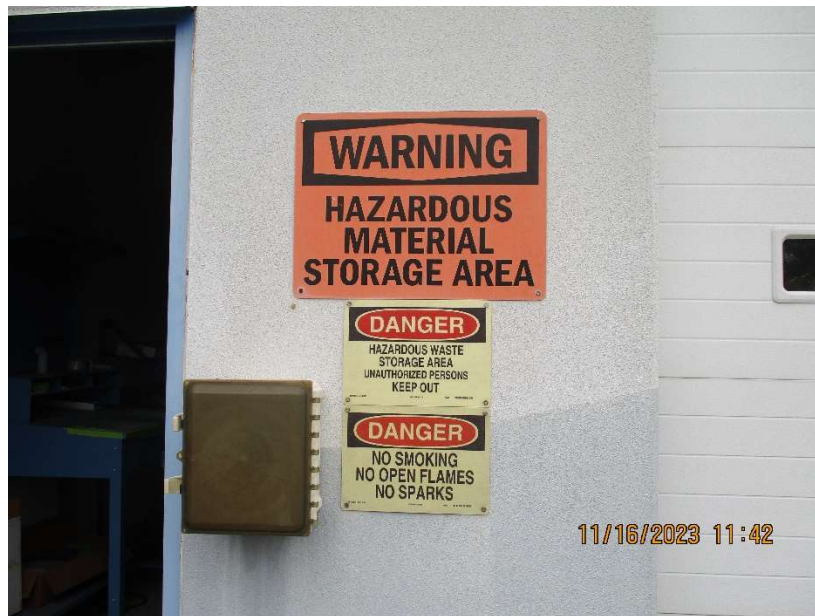
The CAA is located inside a building with labels that read “Warning Hazardous Material Storage Area,” “Danger Hazardous Waste Storage Area Unauthorized Persons Keep Out,” and “Danger No Smoking, No Open Flames, No Sparks.” Photo #10.

Photo # 10 Signage outside CAA building

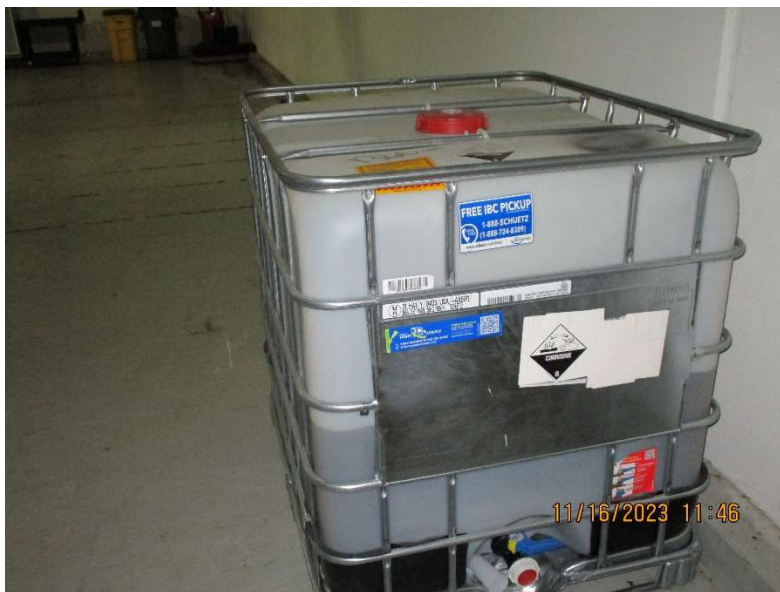
One 250-gallon tote with ABF process solution (ammonium hydrogen difluoride) was observed to be closed and labeled with the words “Hazardous Waste,” with an indication of the hazards of the contents, and dated October 26, 2023. Photo #11

Photo # 11 Tote in CAA building

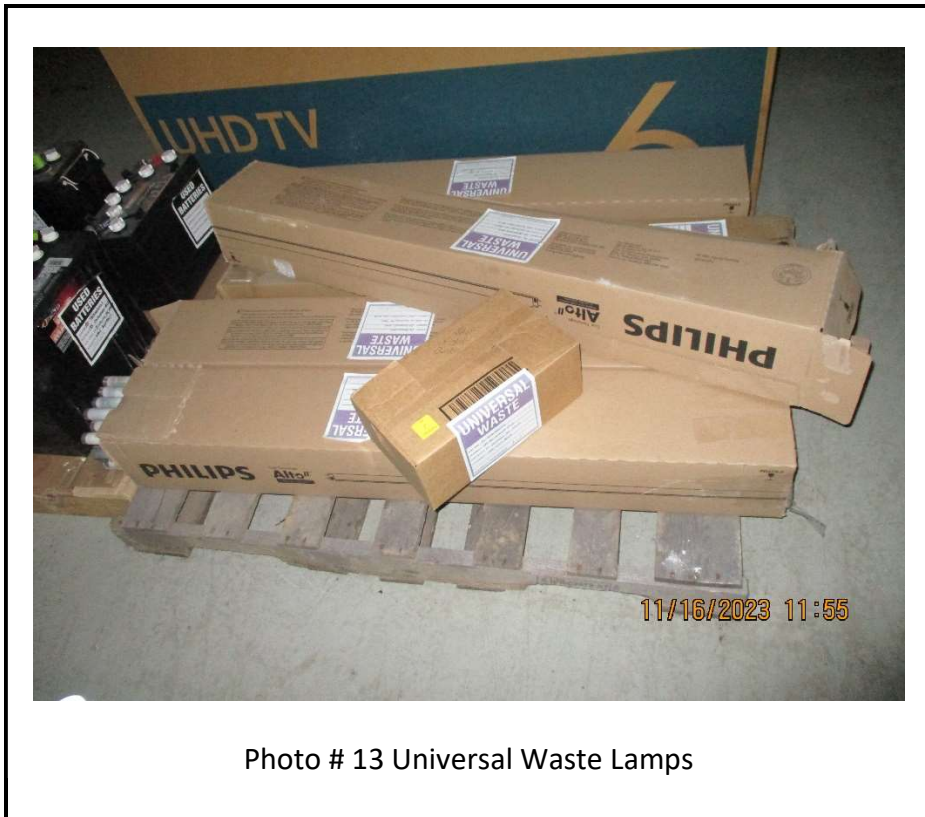
Five boxes with 4-foot lamps and one box with bulbs were observed opened. The boxes were labeled “Universal Waste Lamps” and marked with the accumulation starting date. The oldest date observed was November 21, 2022. Photo #13.

Photo # 13 Universal Waste Lamps

**Pursuant to 11 Miss. Admin. Code Pt. 3, R. 1.21 [40 C.F.R. § 273.3 (d)(1)], A SQHUW must contain any lamp in containers or packages that are structurally sound, adequate to prevent breakage, and compatible with the contents of the lamps. Such containers and packages must remain closed and must lack evidence of leakage, spillage or damage that could cause leakage under reasonably foreseeable conditions.**
