**Report Title:** Clean Air Act Inspection of Montgomery Scrap Corporation  
**Inspection Date(s):** March 17, 2022  
**Regulatory Program(s):** NESHAP and SIP  
**Company Name:** Montgomery Scrap Corporation  
**Facility Name:** Montgomery Scrap Corporation  
**Facility Location:** 15000 Southlawn Lane  
Rockville, MD 20850  
**Latitude:** 39.1029 **Longitude:** -77.13553  
**County/Parish:** Montgomery County  
**AFS Number:** MD0000002403100933  
**Permit Number:** 031-0933  
**NAICS Code:** 423930 **SIC:** 5093  
**Unique Project #:** 3E22CA074A

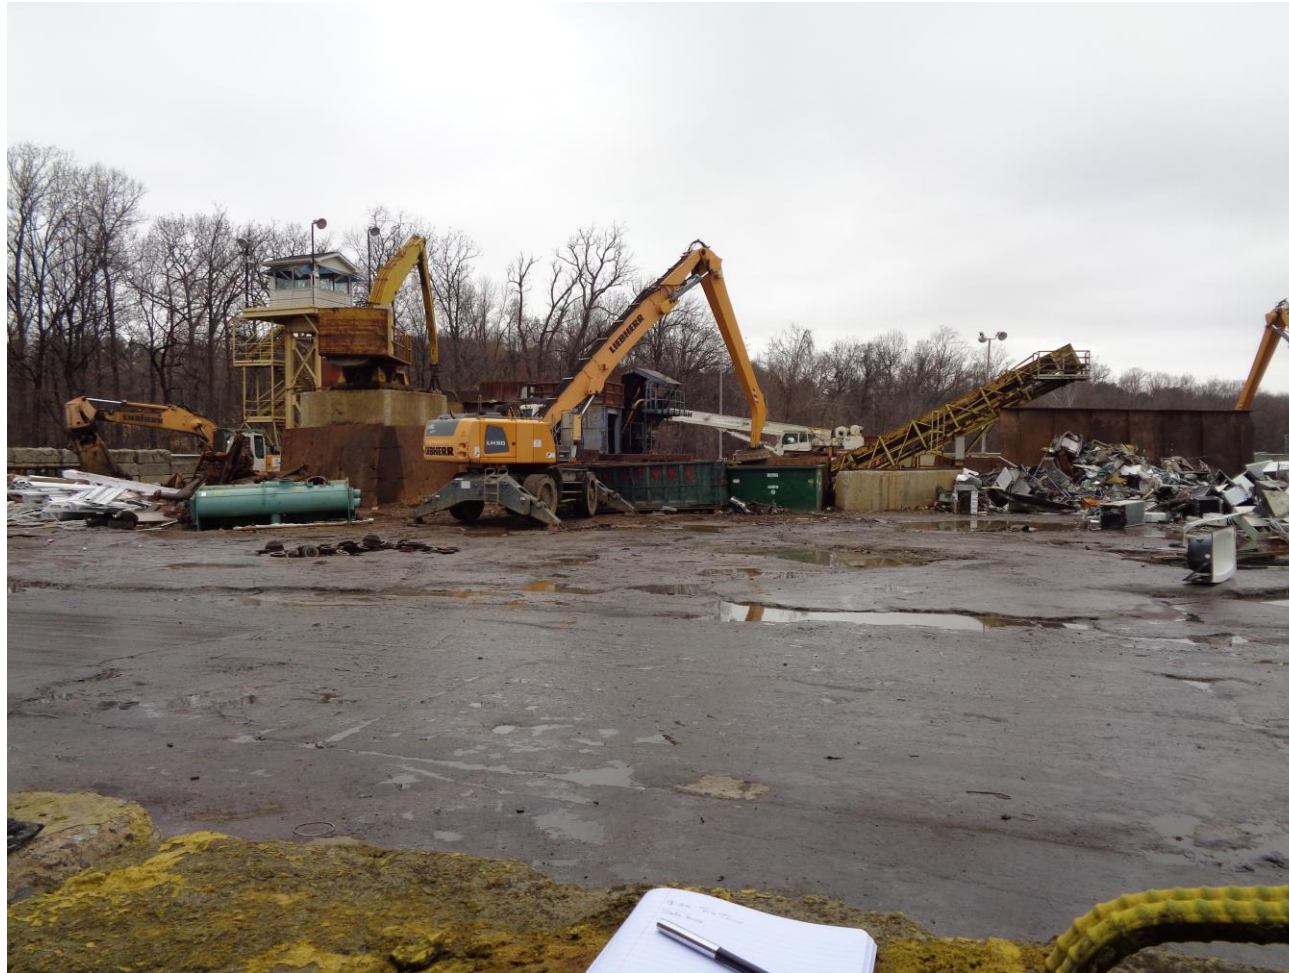
Photo Number: 1

Photo Description: Sorting and Shear Area

The inspection team began their walkthrough by exiting the conference room and walking to the back of the Facility where a scale house and shear was observed. The shears were not in operation during the time of the inspection. Mr. Hill indicated that the shears do not operate for months at a time but are used to cut larger pieces of steel into smaller pieces for further processing off site. Adjacent to the shearing area, the team observed a sorting area, where various pieces of post-consumer metal objects (refrigerators, stove parts, tire rims, shelving, and more) were being unloaded and sorted into piles by material type. The team continued towards the back of the Facility to another sorting area that consisted of aluminum and stainless-steel materials, located under a roofed concrete pad. This sorting area is feed stock for the sweat furnace, and as discussed above mostly consists of engine blocks and other engine components that contain aluminum. Sandbags were observed surrounding feed stock, and Montgomery Scrap staff indicated that the sandbags prevented water from running under the feed stock.

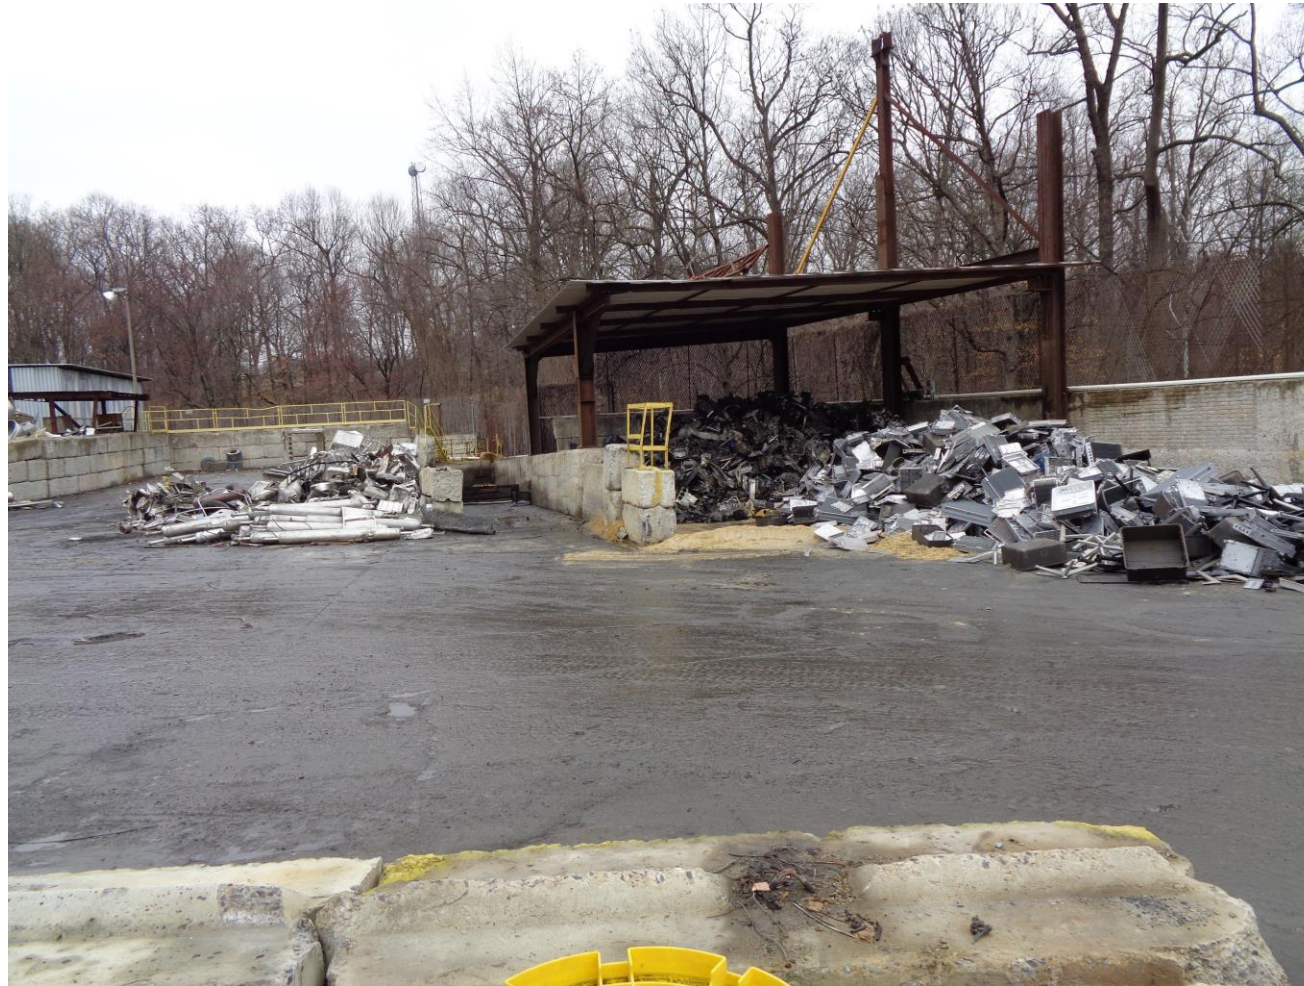
Photo Number: 2

Photo Description: Feed for Furnace

The primary/charging chamber of the aluminum sweat furnace is located at a higher gradient than the secondary/holding chamber creating a positive slope. Raw materials are hand sorted and closely inspected before being charged to the sweat furnace. The Facility uses acid test and x-ray fluoroscopy to determine what metals are present in the raw materials. Raw materials are closely inspected before charging in order to ensure that the finished product meets customer specifications. Contaminants such as magnesium can create unsafe conditions if they enter the furnace.

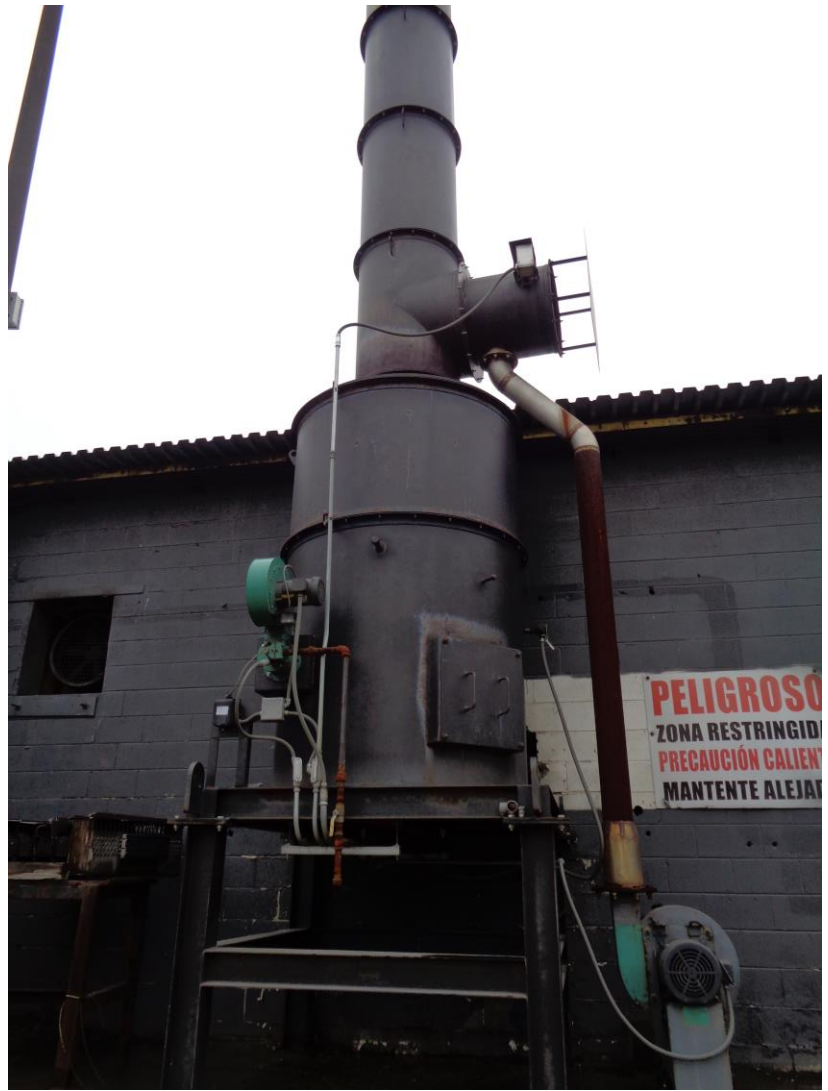
Photo Number: 3

Photo Description: afterburner for furnace

The air emissions controls on the sweat furnace include a natural gas fired afterburner and induced draft fan. The afterburner temperature is set at 1650°F to maintain a minimum temperature of 1600°F. Temperatures of the furnace and afterburner are hand recorded by operator and digitally recorded by a data logger in the stack. All gases from the furnace during a heat cycle are vented into the afterburner, with a required residence time of 0.8 seconds, in order to fully destruct the dioxin/furans (D/F) generated during the aluminum melting process.

Next the team observed the afterburner for the sweat furnace. The after burner was installed at the same time as the sweat furnace. Mr. Hill indicated that during regular operation of the furnace, the after burner operates using negative pressure and the damper operates on demand from the Programmable Logic Controller (PLC). When the doors of the sweat furnace open, the fan in the after burner pulls pollutants through the furnace creating a negative pressure. The after burner is the control device to destroy D/F and is required by 40 C.F.R Part 63, Subpart RRR.

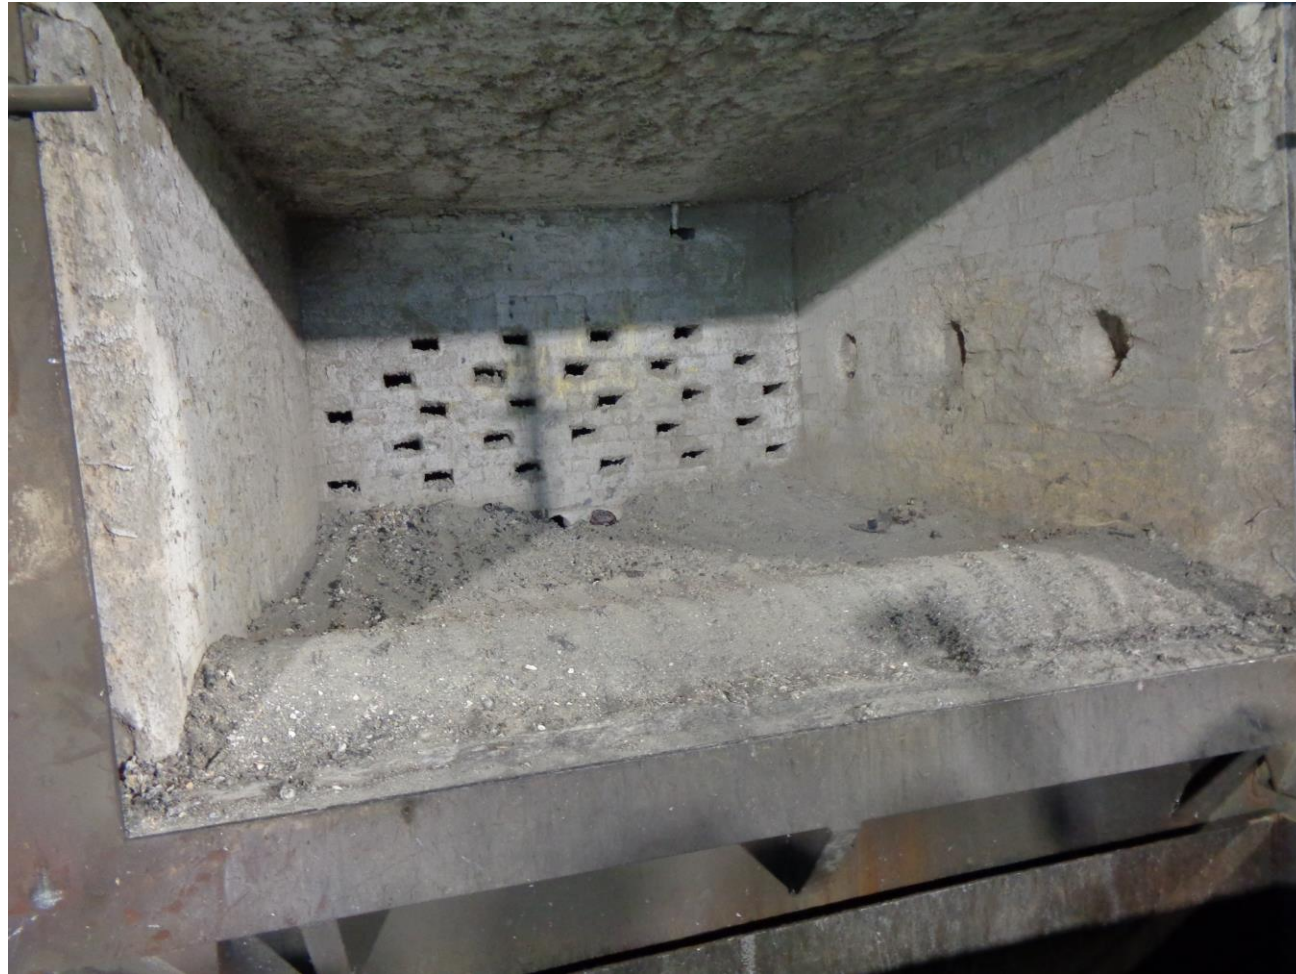
Photo Number: 5

Photo Description: inside aluminum furnace

burners in the primary chamber heating the feedstock material to 1400°F; this process causes the molten aluminum to “sweat” in droplets off the iron substrate. The melted aluminum drips down through holes and runs to the secondary chamber due to the primary chamber being constructed at a slight angle above the secondary chamber. The secondary chamber or “bath” consists of two burners to maintain the melted aluminum at its melting point. The melted aluminum sits in the bath until there is enough weight to tap the furnace directly into the ingot molds. The molds are slid along rails and lined up with the tapping spout for filling. Sows are stored inside the furnace building until they are cool enough to unmold and sell to customers. Mr. Hill opened the door of the furnace to allow team to view the inside; this door operates hydraulically and reportedly was having seal maintenance performed on the day of the inspection.

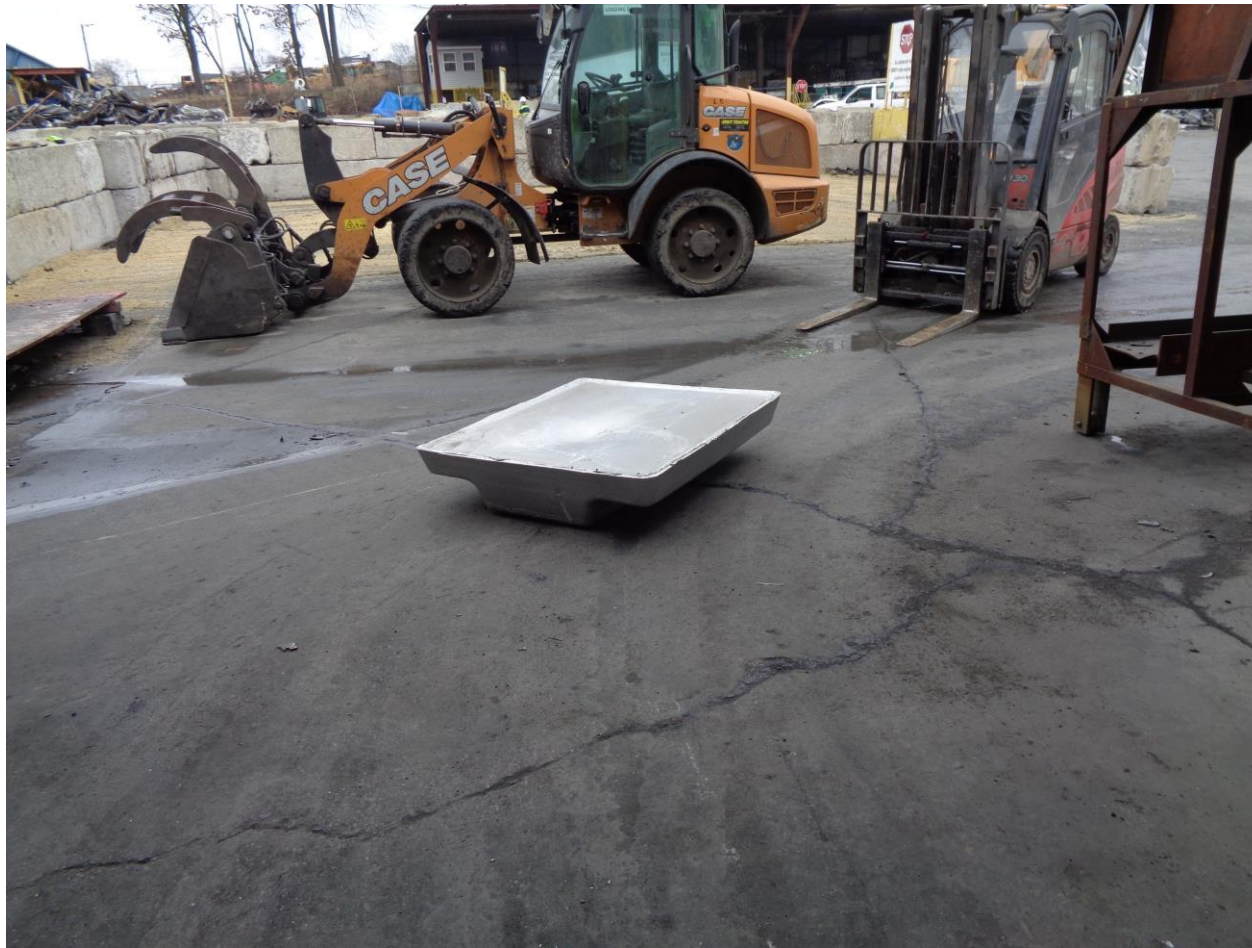
Photo Number: 6

Photo Description: aluminum sow

Next, the melted aluminum enters the secondary/holding chamber which can hold up to 3,000 pounds of molten aluminum. When the operator taps the furnace, molten aluminum is poured into a 1500 pound capacity mold. These ingots are called “sows” and after cooling (which takes a day or two) the molds are flipped with a forklift, releasing the ingot. Once all the aluminum has been melted, the remaining iron parts are raked out of the receiving chamber of the furnace and transported to the Baltimore location for shredding. The ingots are sold back to engine manufacturers.

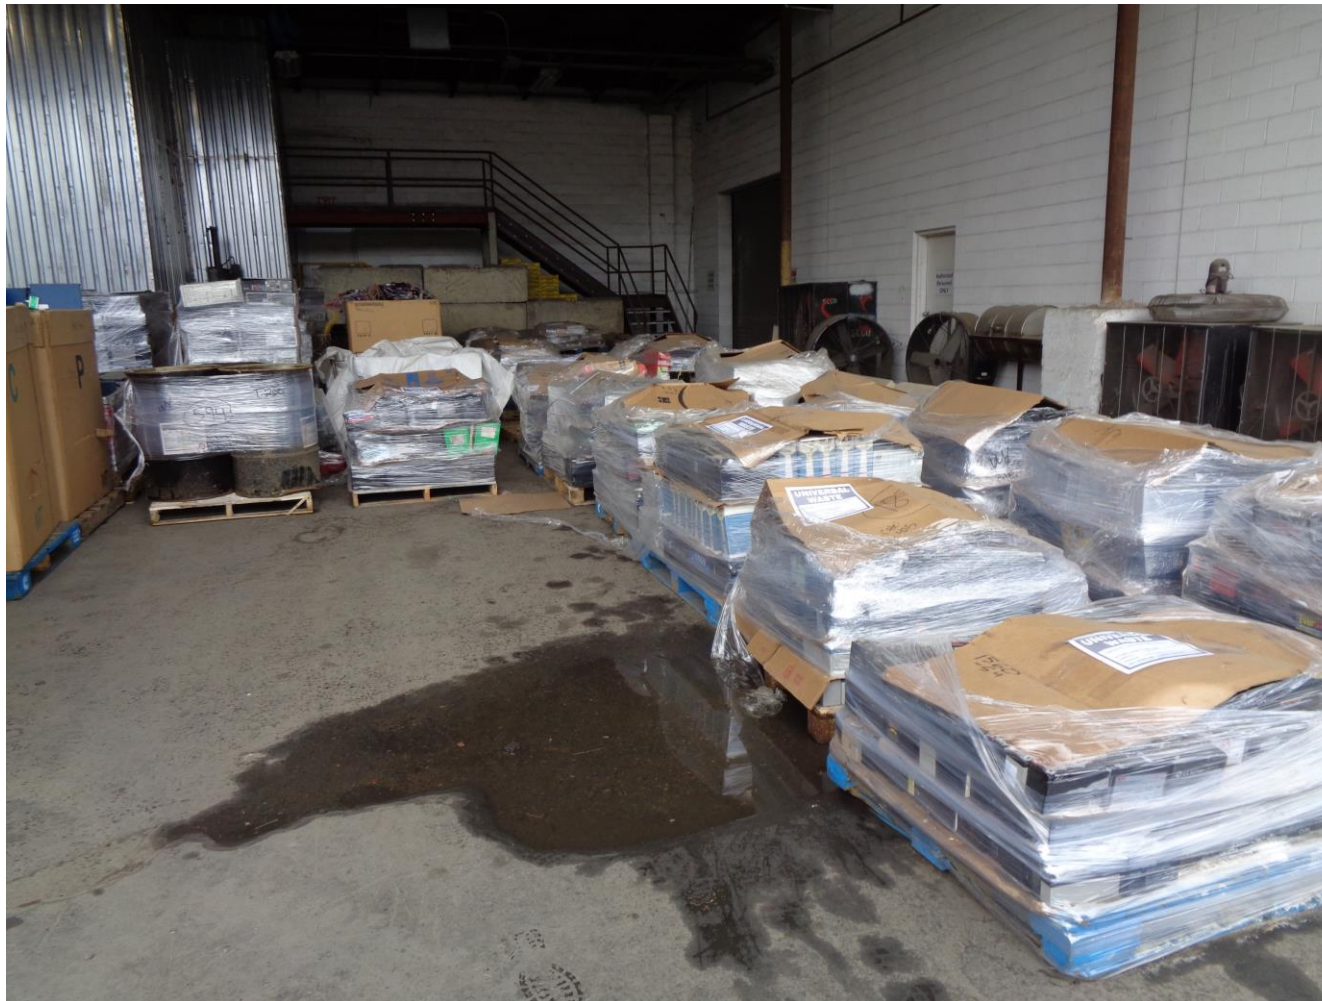
Photo Number: 8

Photo Description: universal waste storage

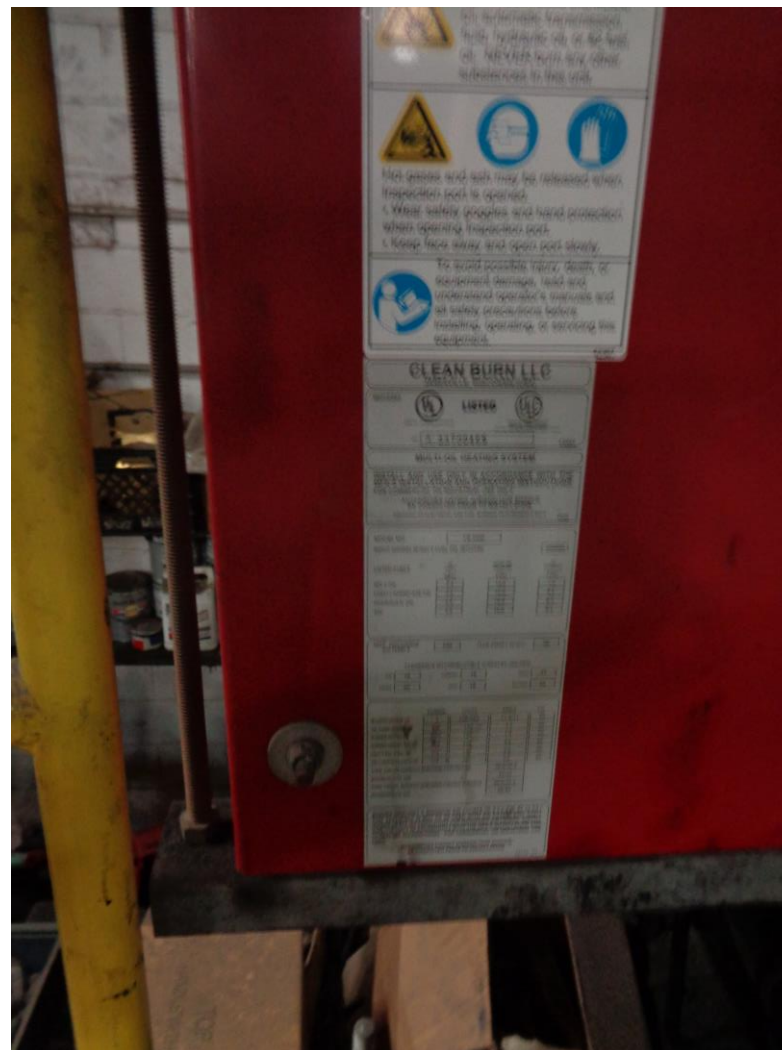
Photo Number: 9

Photo Description: waste oil burner
