**Region 10 Enforcement and Compliance Assurance Division**  
**1200 6th Avenue**  
**Seattle, WA 98101**  
**INSPECTION REPORT**

| <b>Site Name:</b> | Sterling Ranch | |

Construction Stormwater Inspection Report

*Inspection Date: February 25, 2021*

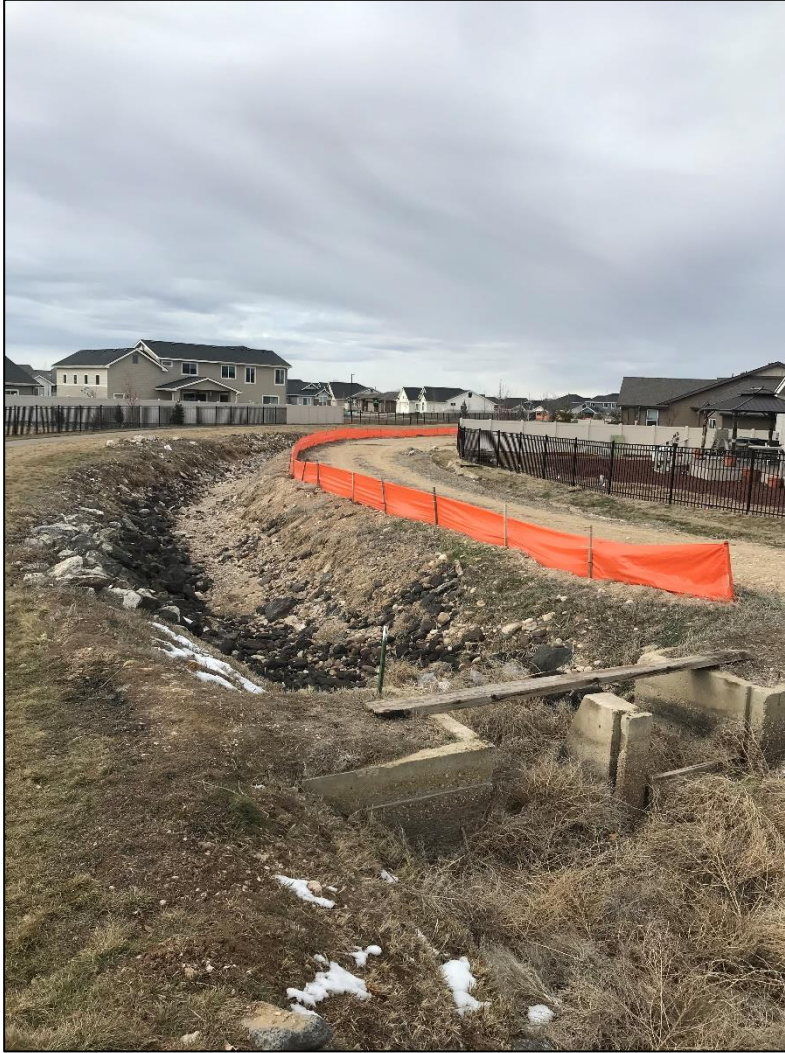
**Photograph 1.** View, facing west, of the Kuna Canal as seen from North Sailer Way. Note the silt fence located north of the Kuna Canal.

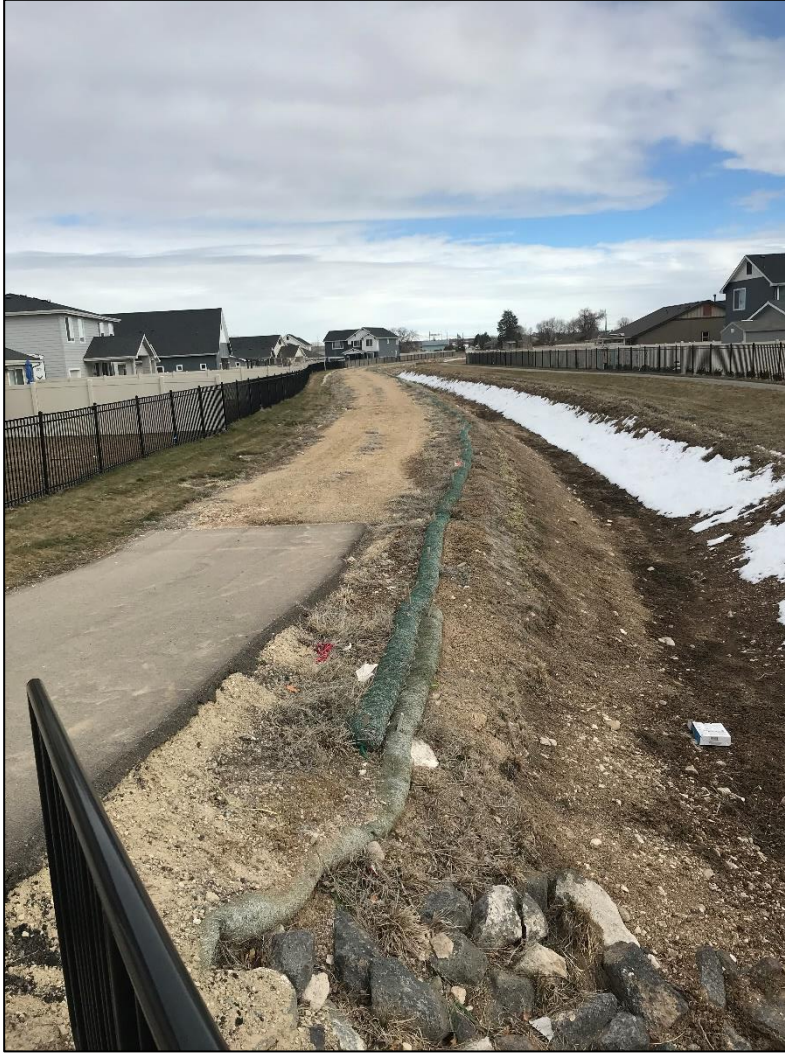
**Photograph 2.** View, facing east, of the Kuna Canal as seen from North Sailer Way. Note the fiber roll located north of the Kuna Canal.

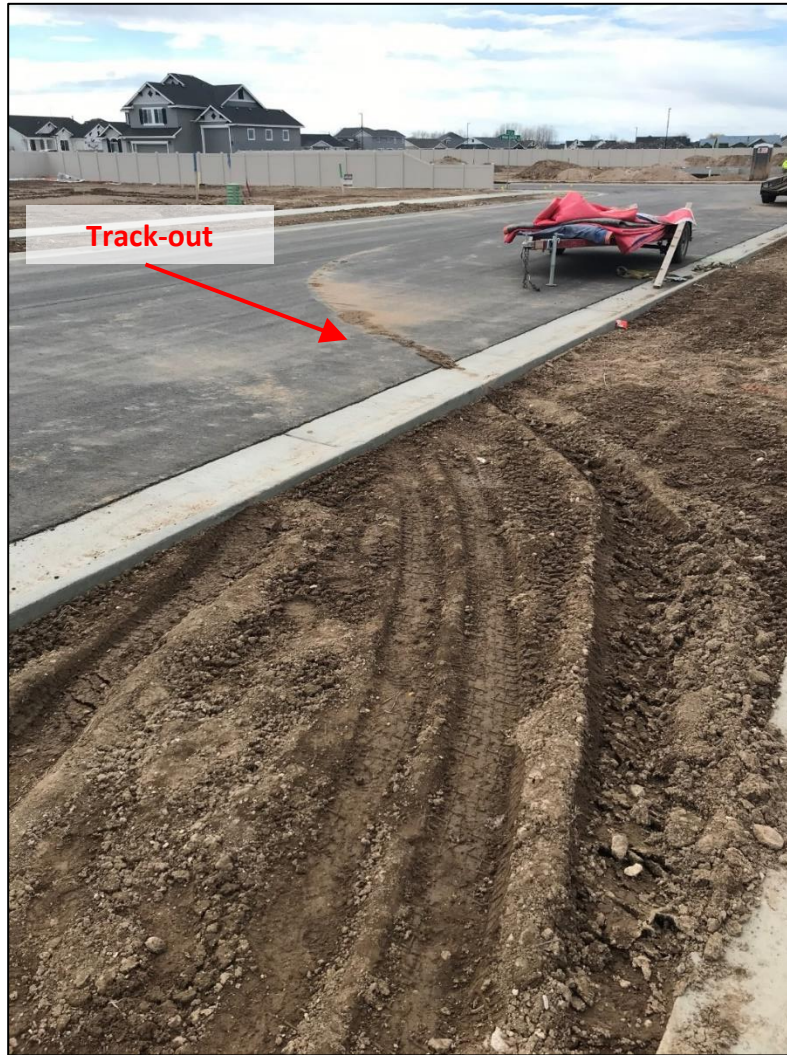
We observed that construction vehicle access had not been restricted to properly designated exit points. We observed one location on the southern area of North Hose Gulch Avenue where the Site had been accessed by vehicles or construction equipment at non-designated entrance/exits, causing sediment track-out on North Hose Gulch Avenue (refer to Attachment A, Photograph 3). Stabilization techniques had not been installed at the point where vehicle traffic entered on to paved roadway.

**Photograph 3.** View, facing southeast, of sediment track out onto North Hose Gulch Avenue due to access by vehicles or construction equipment at non-designated entrance/exits.

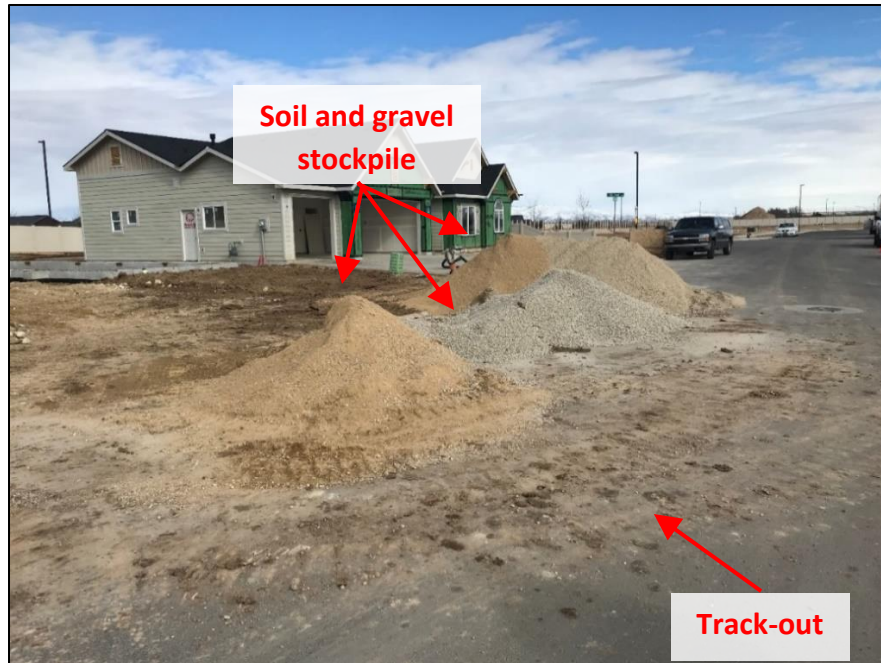
at the intersection of North Destiny Avenue and East Sweet Pearl Street (refer to Attachment A, Photograph 6).

We observed three unstabilized soil and gravel stockpiles located at the intersection of North Destiny Avenue and East Sweet Pearl Street. The stockpiles did not have sediment barriers along the downgradient perimeter areas in the roadway. The stockpiles also appeared to contribute to the sediment track-out around the stockpiles on the roadway (refer to [Attachment A, Photograph 4](#)).

**Photograph 6.** View, facing southwest, of a location of three unstabilized soil and gravel stockpiles located at the intersection of North Destiny Avenue and East Sweet Pearl Street. Note the sediment track-out on East Sweet Pearl Street.

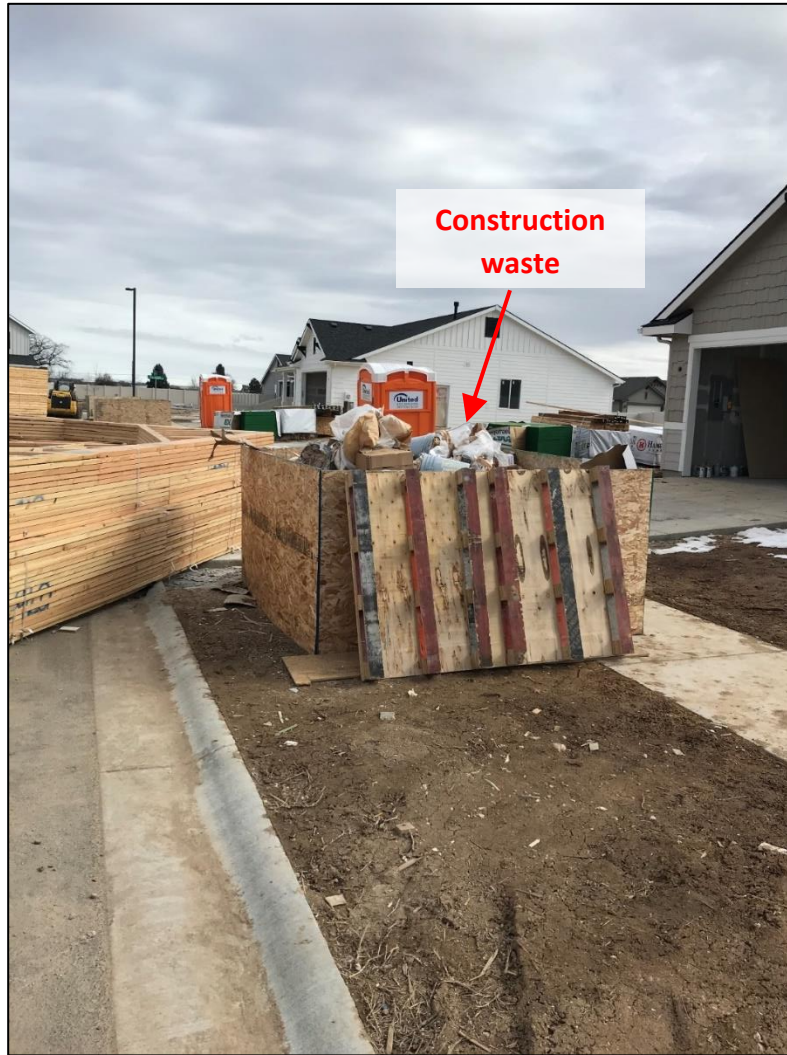
We observed six uncontained and/or uncovered piles of construction waste and debris throughout the Site. We observed two piles on East Whig Drive, two on North Windmill Way (house lot 2009), one on the western end of East Sweet Pearl Street, and one at the southern end of North Elk Creek Avenue (refer to Attachment A, Photographs 4, 5, and 7 through 11).

**Photograph 8.** View, facing east, of uncovered construction plywood container holding waste and debris at the eastern end of East Whig Drive.

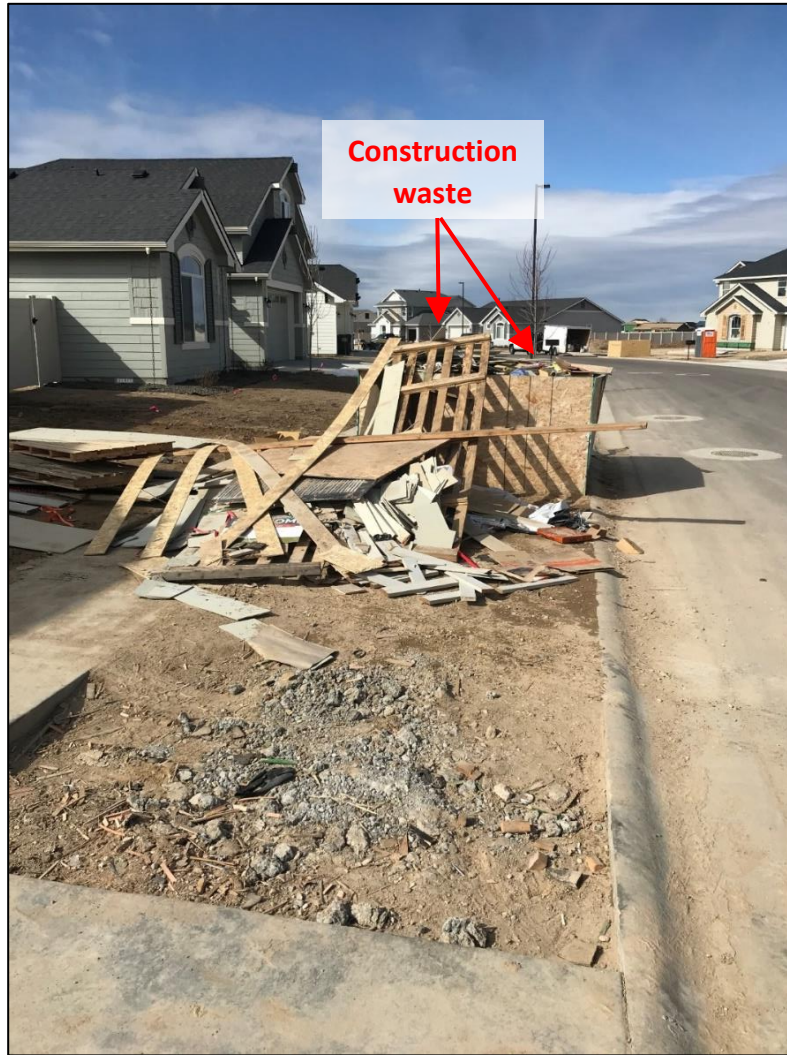
**Photograph 9.** View, facing east, of uncontained construction waste and an uncovered plywood container containing construction waste outside of house lot 2009 at the center of the Site on North Windmill Way.

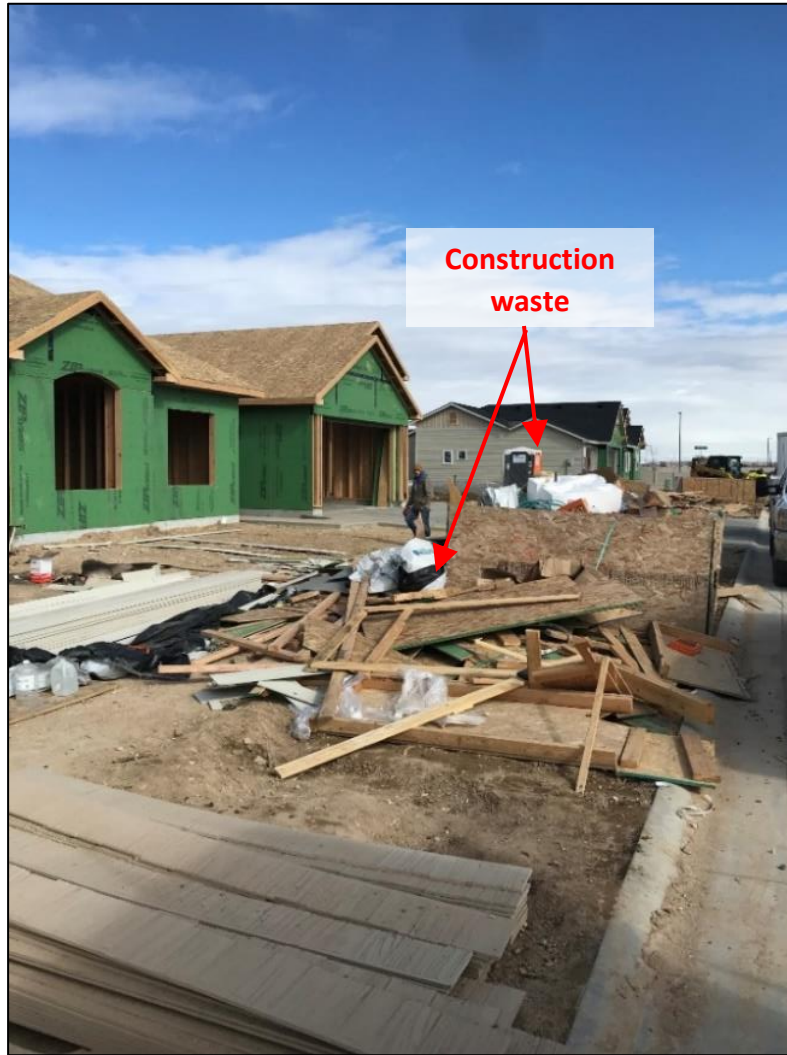
**Photograph 10.** View, facing east, of uncontained construction waste and an uncovered plywood container containing construction waste outside of house lot 876 on the western end of East Sweet Pearl Street.

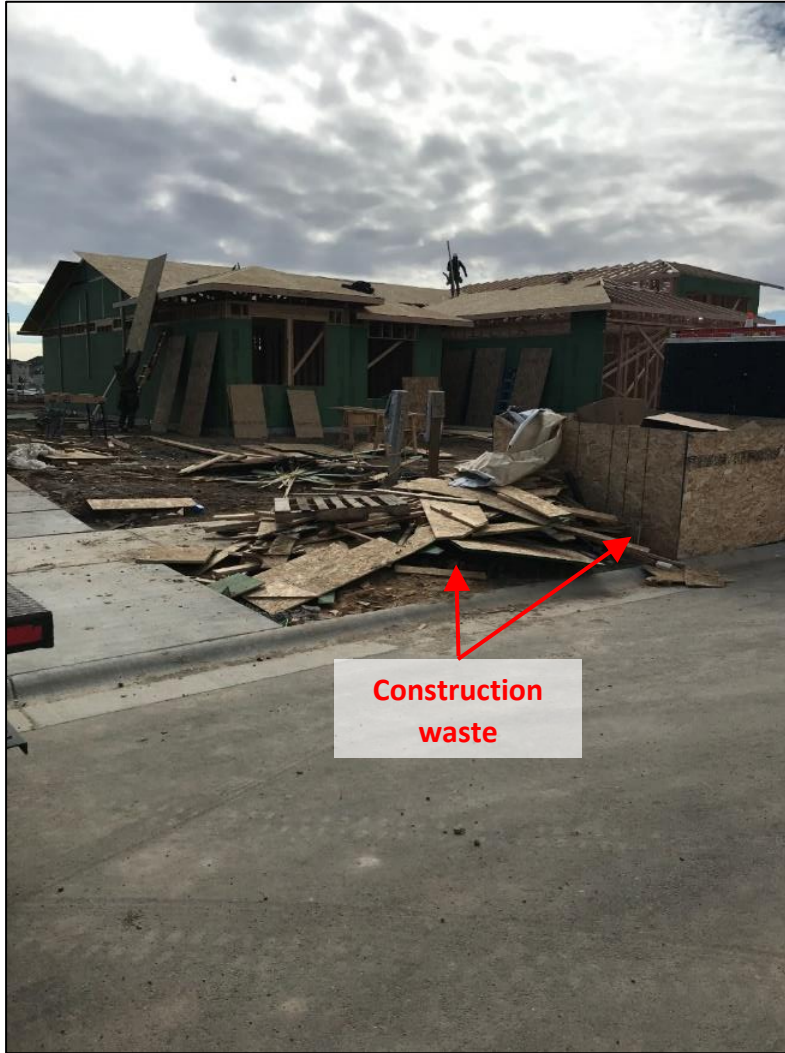
**Photograph 11.** View, facing south, of uncontained construction waste and an uncovered plywood container containing construction waste at the southern end of North Elk Creek Avenue.

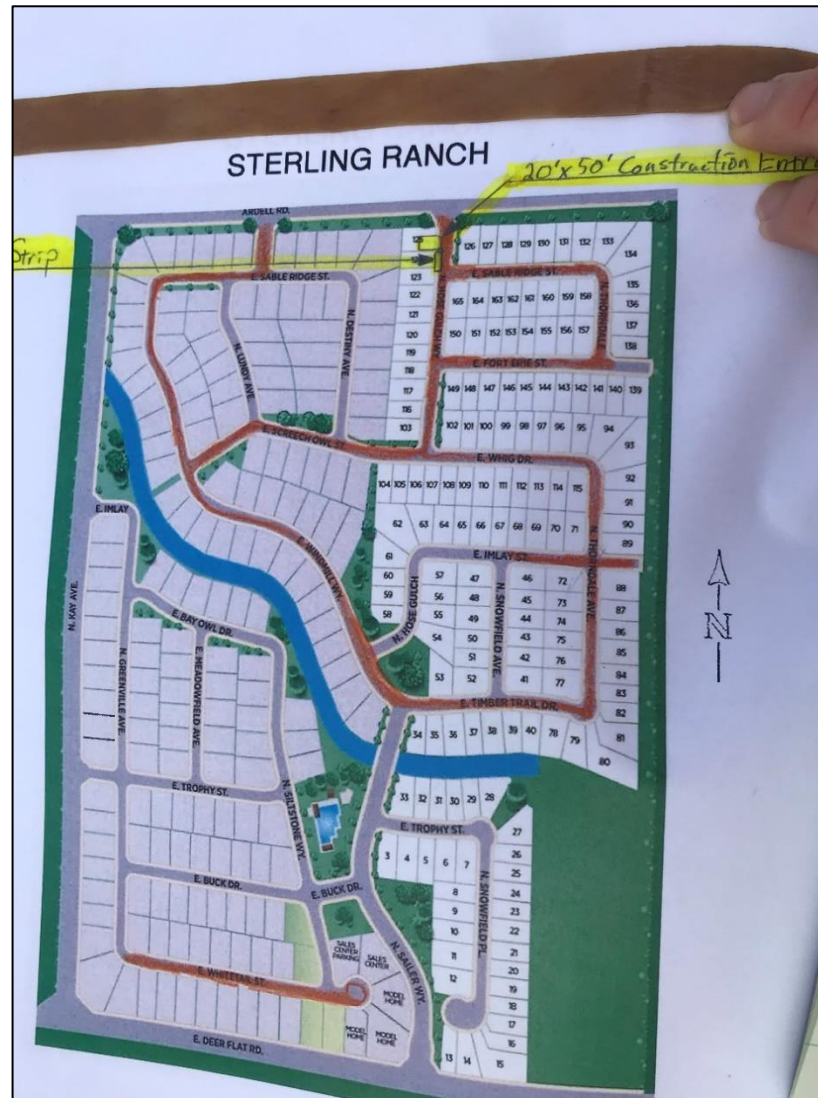
During the initial onsite records review, we observed that the Site map did not include all minimum information as required by Part 7.2.4 of the Permit. Specifically, the Site map did not identify the elements required by Part 7.2.4.b through 7.2.4.j of the Permit. Mr. Calhoun stated that additional Site maps existed that depicted the required elements, but at the time of the inspection, they could not be located (refer to Attachment B, Exhibit 2).

**Exhibit 2.** Image of the Site map provided by Site representatives on the date of the inspection. Note that the Site map does not identify the elements required by Part 7.2.4.b through 7.2.4.j of the Permit. The Site map is not replicated in the SWPPP. Note that the road names are inconsistent with the names observed on Site and on iMap app.
