**UNITED STATES ENVIRONMENTAL PROTECTION AGENCY  
REGION 5  
77 WEST JACKSON BOULEVARD  
CHICAGO, ILLINOIS 60604**

**SUBJECT:** CLEAN AIR ACT INSPECTION REPORT  
North American Stevedoring Company, Chicago, Illinois

**Facility Name:** North American Stevedoring Company (NASCO)

**Purpose of Inspection:** Verify the installation of ambient air monitors at NASCO

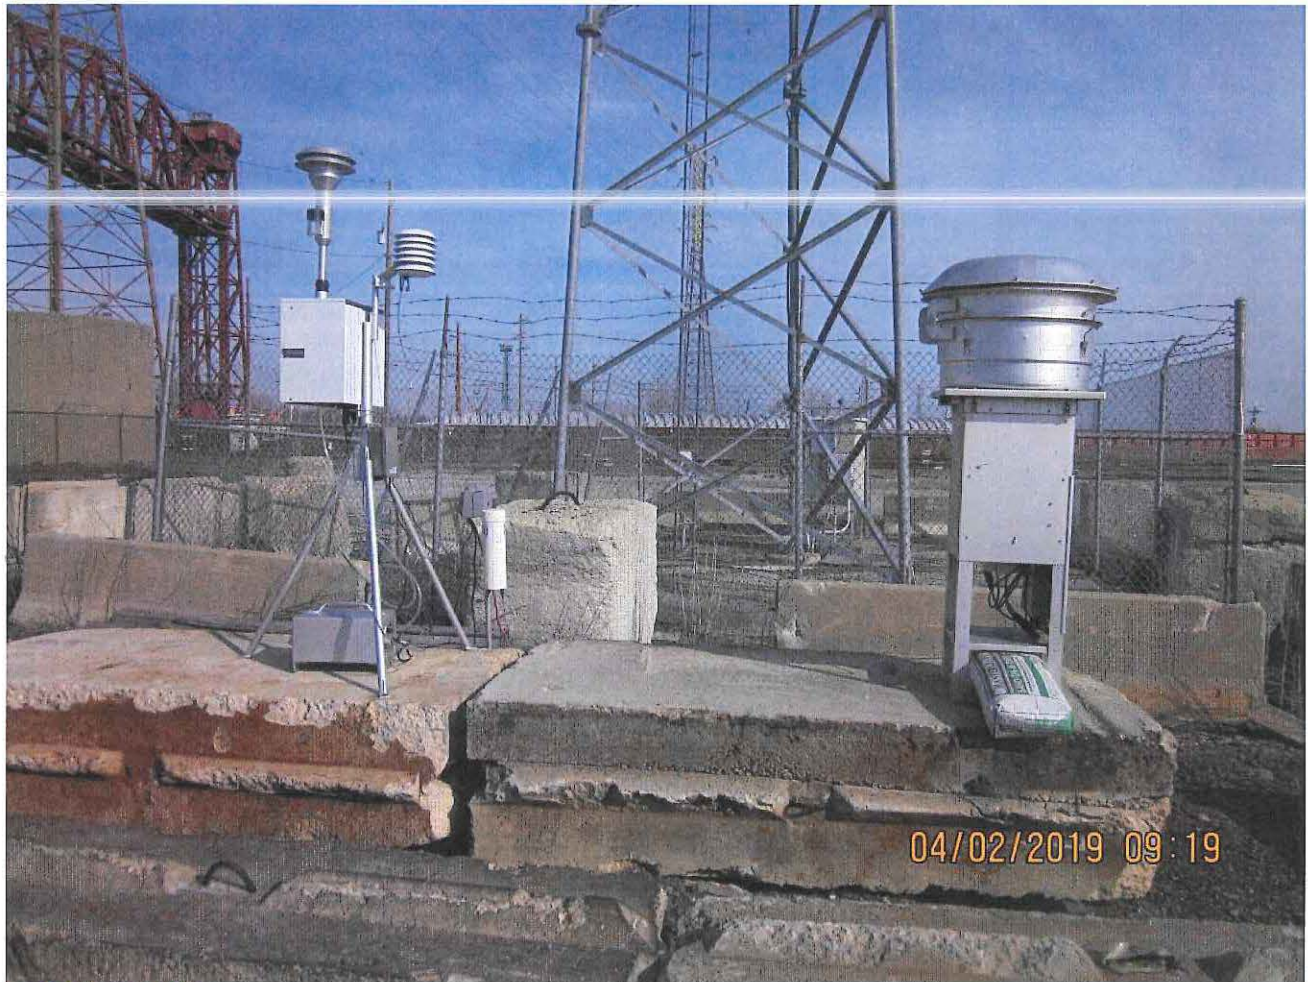
1: IMG\_0001.JPG

Location: North American Stevedoring Company  
Photographer: Patrick Miller  
Date/Time: 4/2/2019 9:19 AM  
Camera Direction: Northwest  
Description: Co-located air monitors at Location 3. FRM monitor (right) and FEM continuous monitor (left)

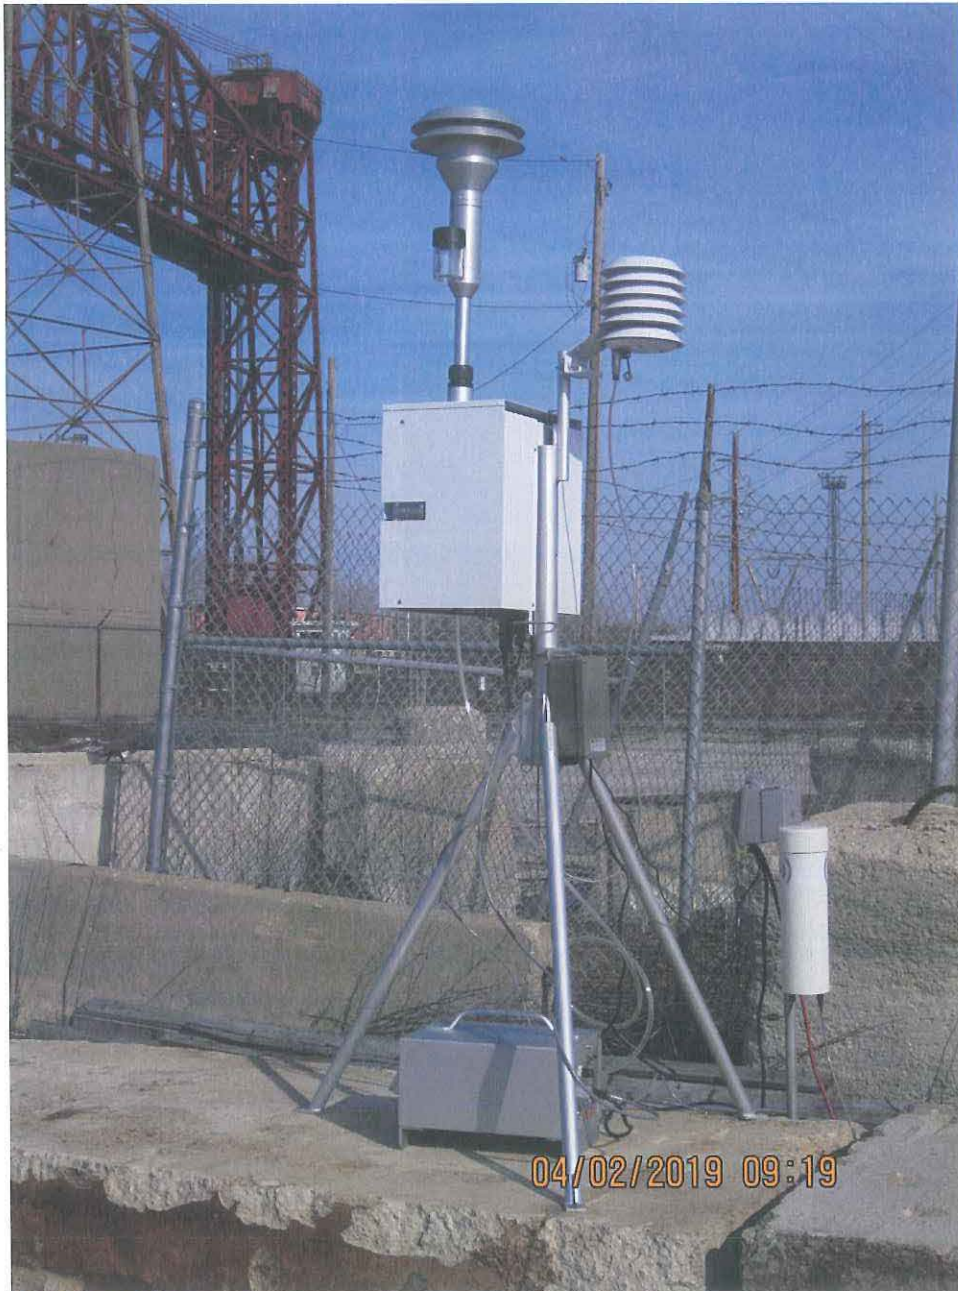
2: IMG\_0002.JPG

Location: North American Stevedoring Company  
Photographer: Patrick Miller  
Date/Time: 4/2/2019 9:19 AM  
Camera Direction: Northwest  
Description: FEM continuous monitor at Location 3

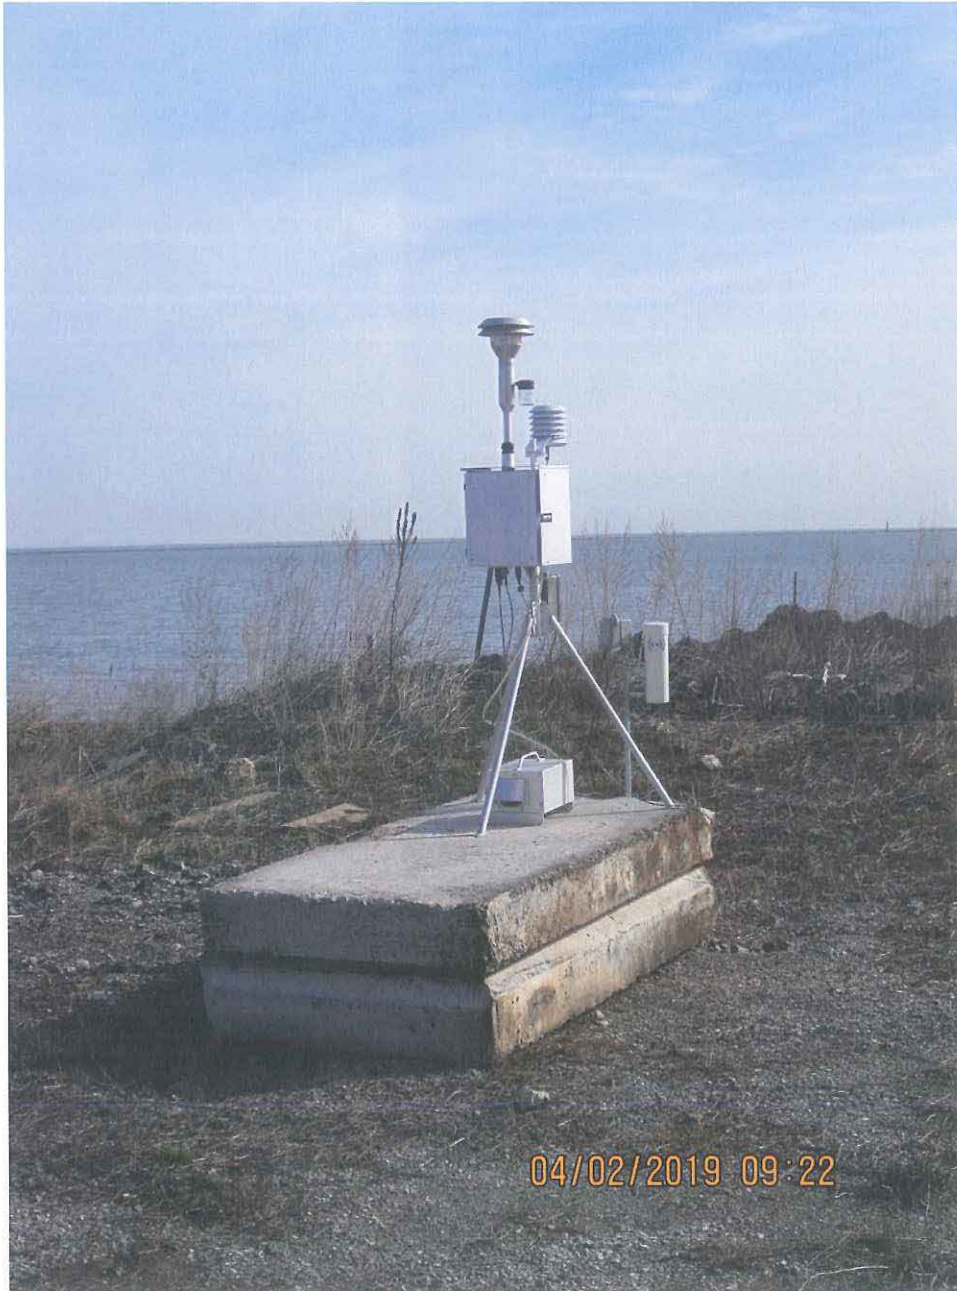
4: IMG\_0004.JPG

Location: North American Stevedoring Company  
Photographer: Patrick Miller  
Date/Time: 4/2/2019 9:22 AM  
Camera Direction: Northeast  
Description: FEM continuous monitor at Location 1

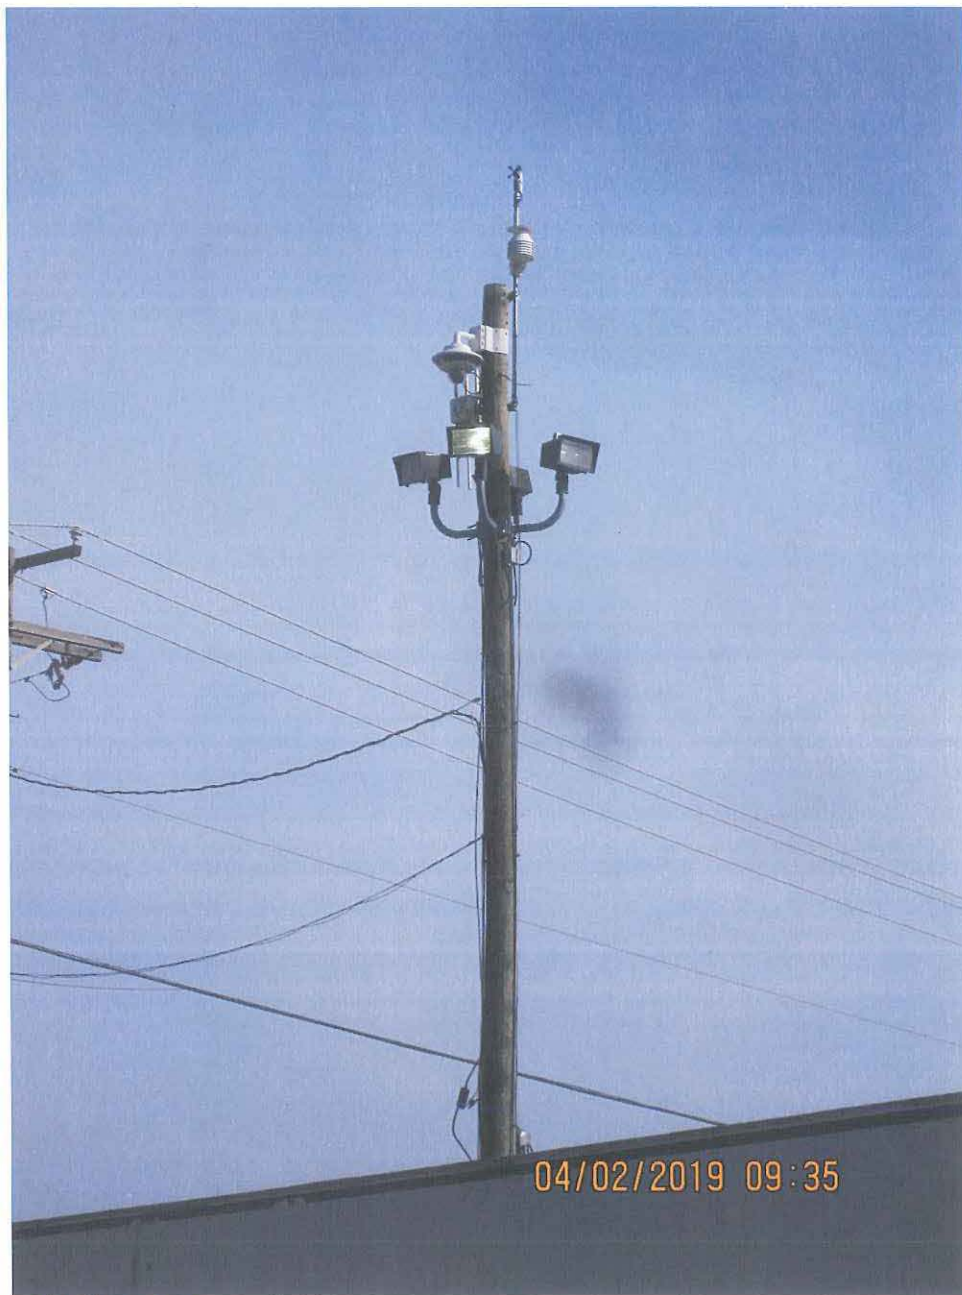
6: IMG\_0006.JPG

Location: North American Stevedoring Company  
Photographer: Patrick Miller  
Date/Time: 4/2/2019 9:35 AM  
Camera Direction: Northeast  
Description: Meteorological station
