## **RCRA Inspection Report**

Corning, Inc., Durham Facility  
1 Becton Circle  
Durham, North Carolina 27712

May 14, 2024, at 9:10 a.m.

Attachment 1- Corning Inc – Durham Facility  
RCRA Inspection Photographs

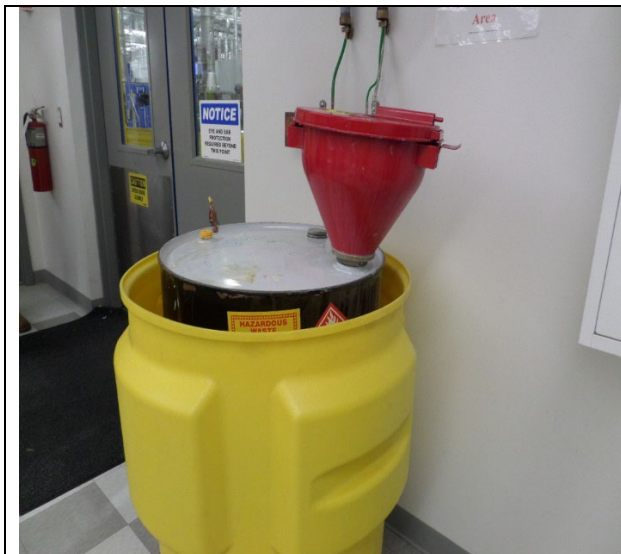
The inspectors observed a 55-gallon container inside a yellow overpack container, and a funnel inserted into the 55-gallon container. The inspectors observed the funnel's lid appeared closed and latched in position, the container was in good condition, labeled with the words hazardous waste, and labeled with an indication of the hazards. The entire hazardous waste label and hazard indicator label could not be read, unless standing directly over the container (Photograph 1). The inspectors recommended that the facility consider using a containment system that provides a clear view of the container labels.

Corning, Inc. -Durham Facility (Corning). Process Support Room. The inspectors observed labels on one 55-gallon container that were not clearly observed. Photograph 1 taken at 11:40 a.m.

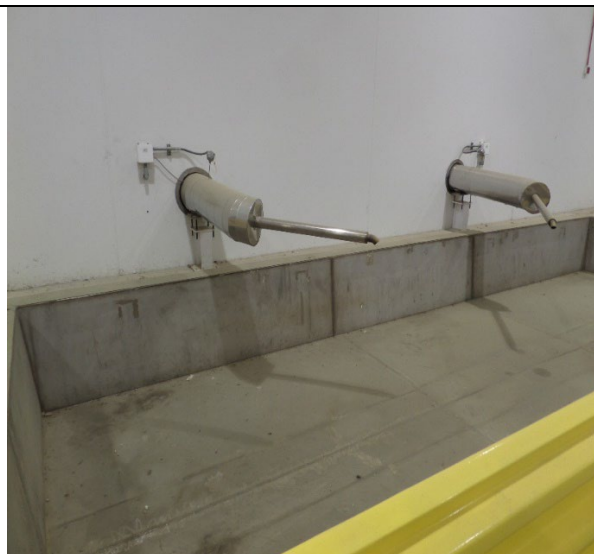
The salt shed is located on the south side of the wall from the ion-exchange units in a large room constructed with a concrete floor and enclosed with walls and a roof. The inspectors observed four open stainless-steel lined concrete pits (pit), secured with guard rails, measuring from top to bottom of each pit between 33 feet 2.5 inches to 32 feet 6.75 inches long by 12 feet 11 inches to 12 feet 3.5 inches wide by 3 feet 0.5 inches deep. Each of the three ion-exchange units discharge into a dedicated pit. Corning representatives indicated waste potassium nitrate is discharged through the pipe(s) as a molten liquid and begins to solidify as soon as it is stored in the pit. The solidified potassium nitrate is shipped to a designated facility

as hazardous waste (D001). Corning representatives indicated the potassium nitrate in each ion-exchange unit will need to be exchanged twice per year. The inspectors observed the pits were not storing waste potassium nitrate at the time of the inspection. The pits appeared clean and in good condition. The pits were not marked or labeled with the words hazardous waste or with an indication of the hazards at the time of this inspection (Photographs 2, 3, 4, 5, and 6).

Corning. Salt Shed. The inspectors observed four stainless-steel lined concrete pits (pit) that store potassium nitrate (D001) generated from the ion-exchange unit IOX-104. Photograph 2 taken at 11:55 a.m.

**Pursuant to 15A NCAC 13A .0107(a) [40 C.F.R. § 262.17(a)(2)], which incorporates 15A NCAC 13A .0110(j) [40 C.F.R. § 265.192(a)], and is a condition of the LQG Permit Exemption, owners or operators of new tank systems or components must ensure that the foundation, structural support, seams, connections, and pressure controls (if applicable) are adequately designed and that the tank system has sufficient structural strength, compatibility with the waste(s) to be stored or treated, and corrosion protection so that it will not collapse, rupture, or fail. The owner or operator must obtain a written assessment reviewed and certified by a qualified Professional Engineer in accordance with § 270.11(d) of this chapter attesting that the system has sufficient structural integrity and is acceptable for the storing and treating of hazardous waste.**

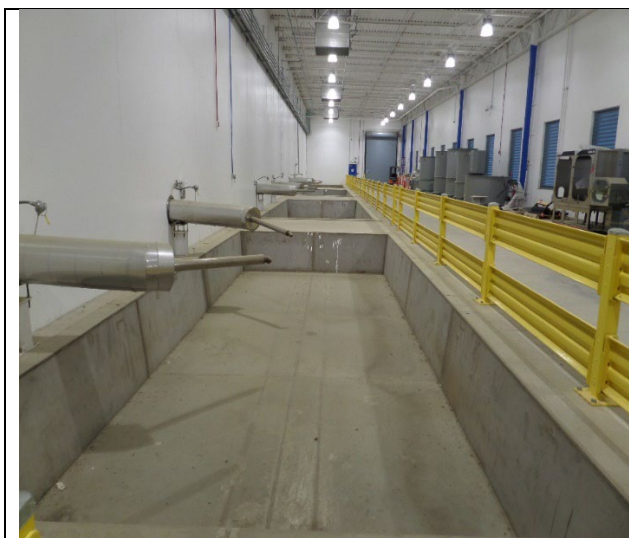
Corning. Salt Shed. The inspectors observed four stainless-steel lined concrete pits (pit) that store potassium nitrate (D001) generated from the ion-exchange unit IOX-104. Observed guard rails. Photograph 3 taken at 11:55 a.m.

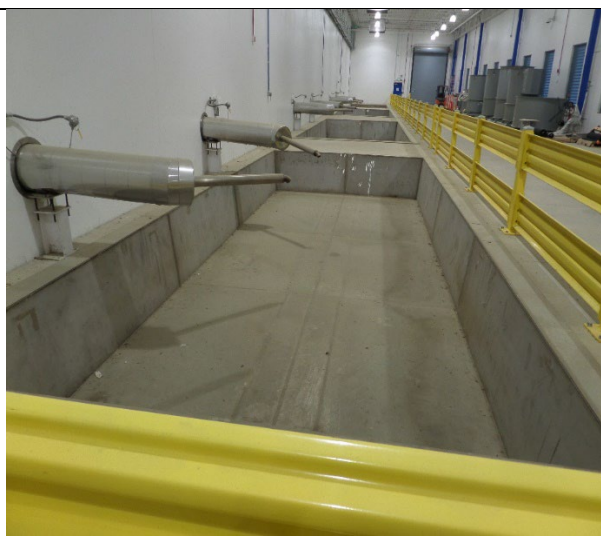
Corning. Salt Shed. The inspectors observed four stainless-steel lined concrete pits (pit) that store potassium nitrate (D001) generated from the ion-exchange unit IOX-104. Photograph 4 taken at 11:55 a.m.

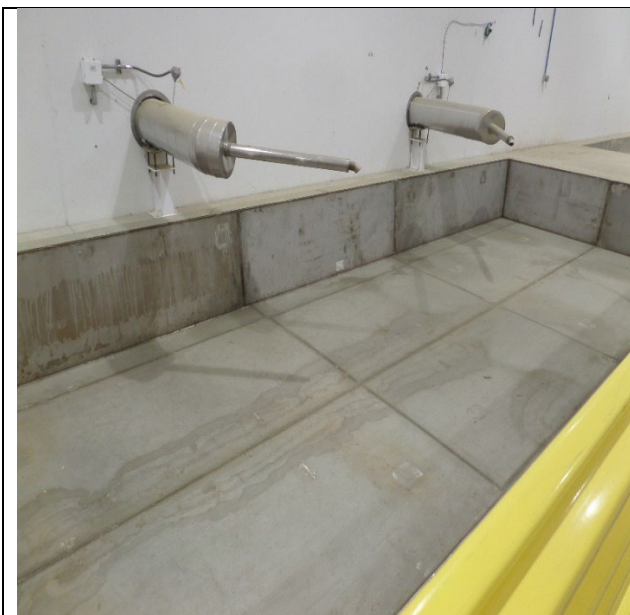
Corning. Salt Shed. The inspectors observed four stainless-steel lined concrete pits (pit) that store potassium nitrate (D001) generated from the ion-exchange unit IOX-102. Photograph 5 taken at 11:57 a.m.

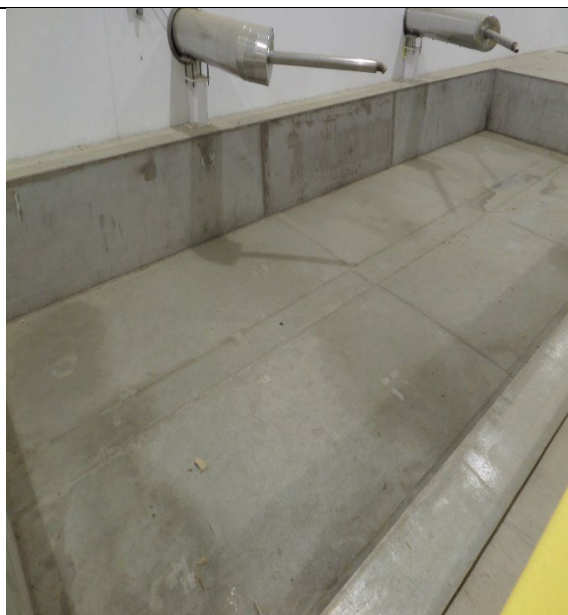
Corning. Salt Shed. The inspectors observed four stainless-steel lined concrete pits (pit) that store potassium nitrate (D001) generated from the ion-exchange unit IOX-103. Photograph 6 taken at 11:57 a.m.

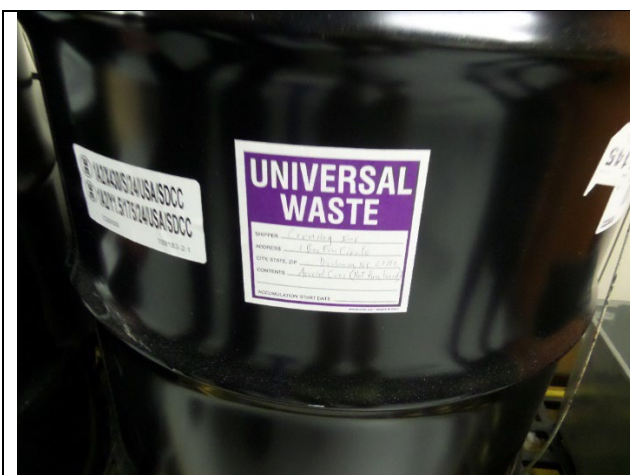
The inspectors also observed one closed 55-gallon container storing aerosol cans, in good condition, and labeled with the words universal waste. The inspectors observed the container was not marked with a date (Photograph 7).

Corning. CLS Indoor CAA. The inspectors observed one 55-gallon container of UW aerosol cans that was not marked with a date. Photograph 7 taken at 12:12 p.m.

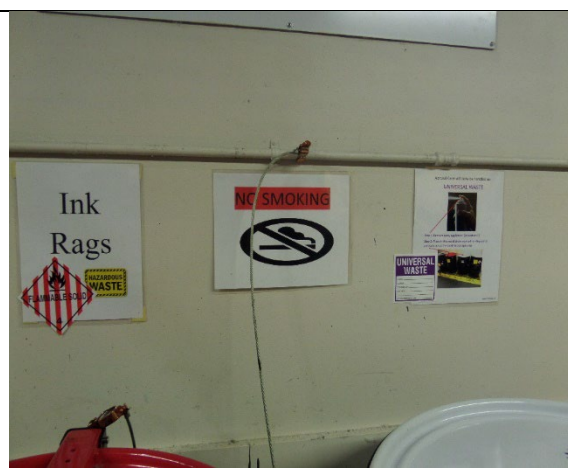
Corning operates a CAA in the CLS. The inspectors observed one 55-gallon container storing hazardous waste liquid (D001) with a funnel inserted into the container and one closed 55-gallon container storing hazardous waste solid (D001). The containers were in good condition, with aisle space, labeled with the words hazardous waste, labeled with an indication of the hazards, and marked with the date March 25, 2024, and May 8, 2024. The inspectors observed the lid on the funnel inserted in the container storing hazardous waste liquid did not appear to be closed. The inspectors observed a no smoking sign posted on the wall (Photograph 8).

Corning. CLS Indoor CAA. The inspectors observed the lid on the funnel inserted in the container storing hazardous waste liquid did not appear to be closed. The inspectors observed a no smoking sign posted on the wall. Photograph 8 taken at 12:13 p.m.

**Pursuant to 15A NCAC 13A .0107(a) [40 C.F.R. § 262.17(a)(1)(iv)(A)], which is a condition of the LQG Permit Exemption, a container holding hazardous waste must always be closed during accumulation, except when it is necessary to add or remove waste.**

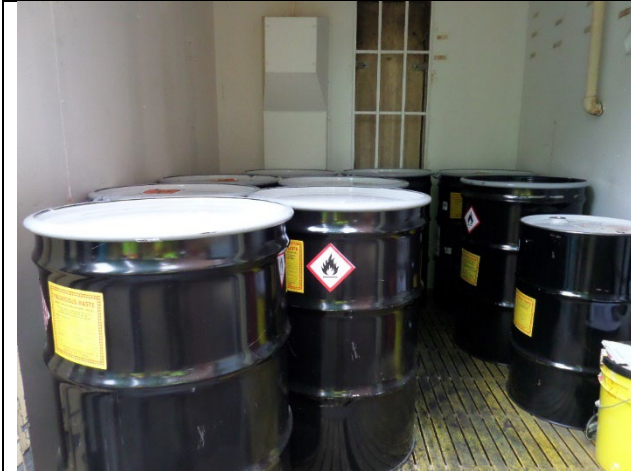
Corning operates an outdoor CAA. The CAA is constructed of steel with a grated floor, posted with a no smoking sign. The inspectors observed eight 55-gallon containers and one 35-gallon container storing hazardous waste. The containers were closed, in good condition, labeled with the words hazardous waste, labeled with an indication of the hazards, and marked with the dates in March and April 2024. The inspectors observed the earliest date was March 25, 2024. The inspectors observed the container aisle space was not maintained (Photograph 9).

Corning. Outdoor CAA. The inspectors observed the container aisle space was not maintained. Photograph 9 taken at 12:22 p.m.

**Pursuant to 15A NCAC 13A .0107(a) [40 C.F.R. § 262.17(a)(6)], which incorporates 15A NCAC 13A .0107(i) [40 C.F.R. § 262.255], and is a condition of the LQG Permit Exemption, a generator is required to maintain aisle space to allow the unobstructed movement of personnel, fire protection equipment, spill control equipment, and decontamination equipment to any area of facility operation in an emergency, unless aisle space is not needed for any of these purposes.**

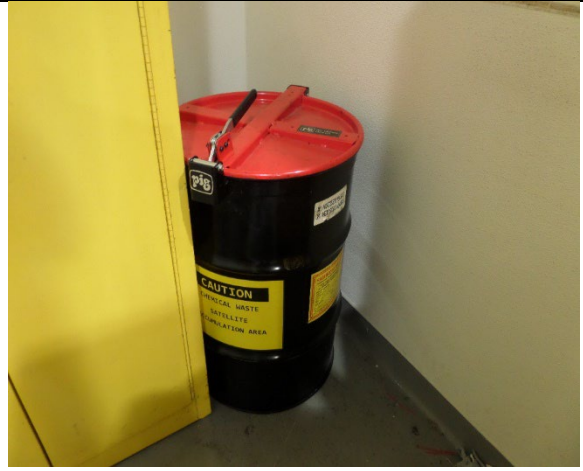
Molds are repaired in the shop. The inspectors observed one 55-gallon container storing hazardous waste. The container was closed, in good condition, labeled with the words hazardous waste, and labeled with an indication of the hazards. The inspectors also observed one 35-gallon container storing aerosol cans next to a yellow fire cabinet. The container was closed, in good condition, and labeled with the words hazardous waste. The inspectors observed the container was not marked or labeled with an indication of the hazards (Photograph 10).

Corning. Mold Shop. The inspectors observed one 35-gallon container storing aerosol cans labeled as hazardous waste. The inspectors observed the container was not marked or labeled with an indication of the hazards. Photograph 10 taken at 12:33 p.m.

**Pursuant to 15A NCAC 13A .0107(a) [40 C.F.R. § 262.15(a)(5)(ii)], which is a condition of the SAA Permit Exemption, a generator is required to mark or label its containers with an indication of the hazardous of the contents (examples include, but are not limited to, the applicable hazardous waste characteristic(s) (*i.e.*, ignitable, corrosive, reactive, toxic); hazard communication consistent with the Department of Transportation requirements at 49 CFR part 172 subpart E (labeling) or subpart F (placarding); a hazard statement or pictogram**

consistent with the Occupational Safety and Health Administration Hazard Communication Standard at 29 CFR 1910.1200; or a chemical hazard label consistent with the National Fire Protection Association code 704).

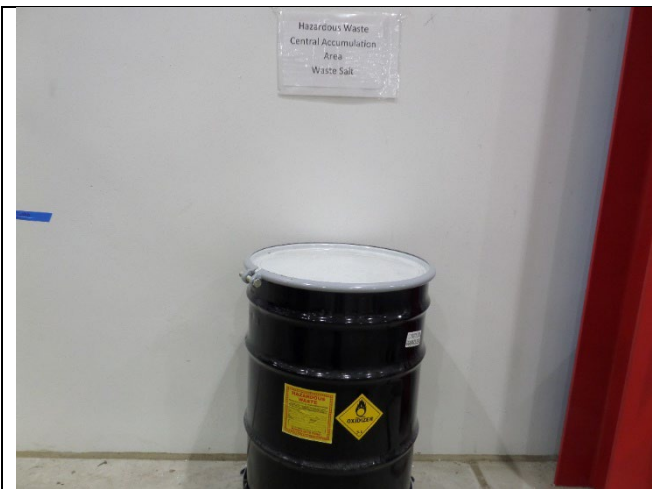
SAA containers storing residual waste salt in the ion-exchange unit are transferred to the CAA when full. The inspectors observed one 55-gallon container storing waste potassium nitrate in the CAA. The container was closed, in good condition, labeled with the words hazardous waste, labeled with an indication of the hazards, and marked with the date April 12, 2024 (Photographs 11 and 12).

Corning. Waste Salt CAA. The inspectors observed one 55-gallon container storing hazardous waste potassium nitrate (D001) in the CAA at the time of the inspection. Photograph 11 taken at 2:34 p.m.

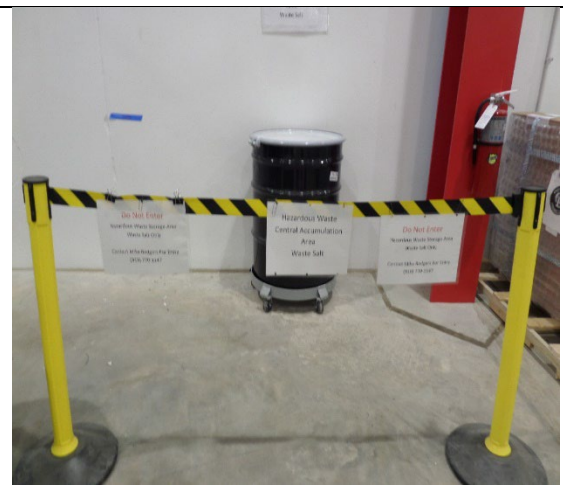
Corning. Waste Salt CAA. The inspectors observed one 55-gallon container storing hazardous waste potassium nitrate (D001) in the CAA at the time of the inspection. Photograph 12 taken at 2:34 p.m.
