**Compliance Evaluation Inspection Report**

East Sevier County Utility District STP

NPDES Permit Number: TN0060569

**Project No. CV-TN0060569-052024**

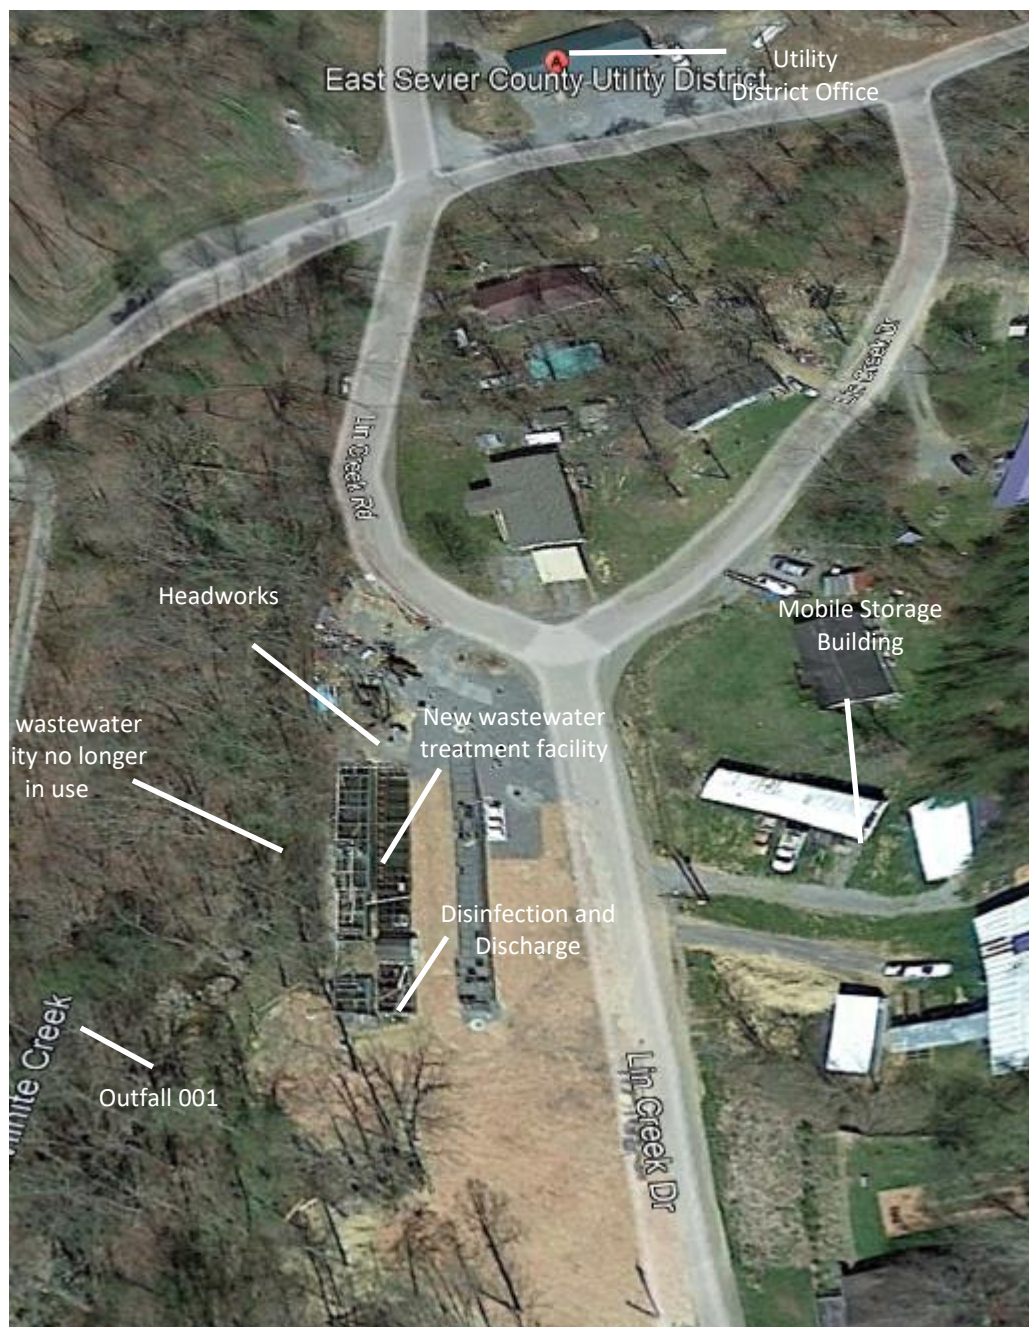
**Figure 1:** Aerial View of the ESCUD STP dated April 2022.

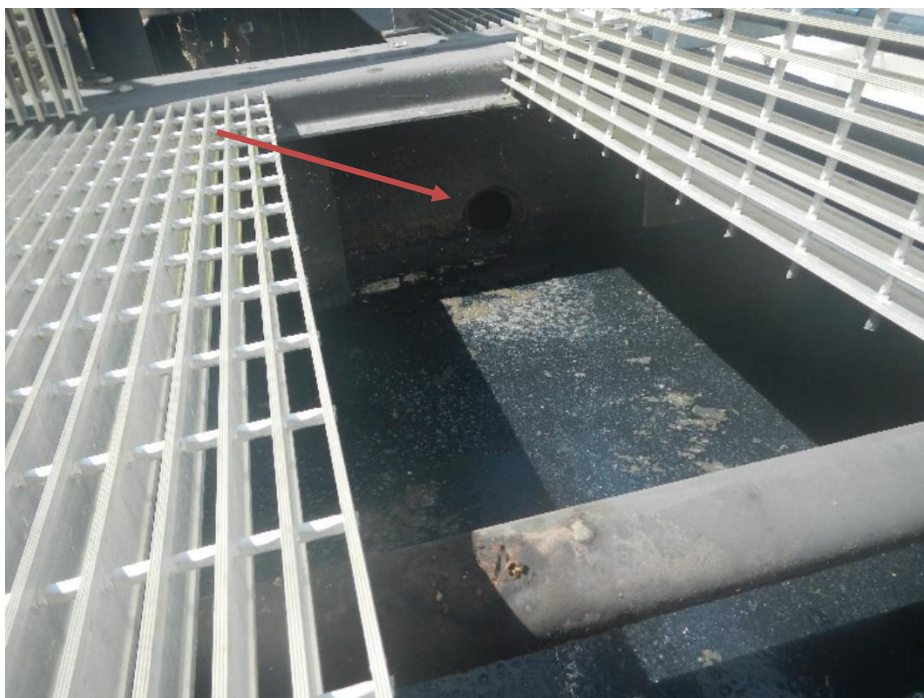
- Manual bar screen appeared clean and operational.
- Open hole in metal wall of the wasting area of plant results in improper movement of waste within the treatment train. Operator stated that several holes exist around the facility prior to install and required to be patched or plugged (Photo #1).

Photo 1: Hole located in wall of wasting tank section causing flow to move improperly through the facility.

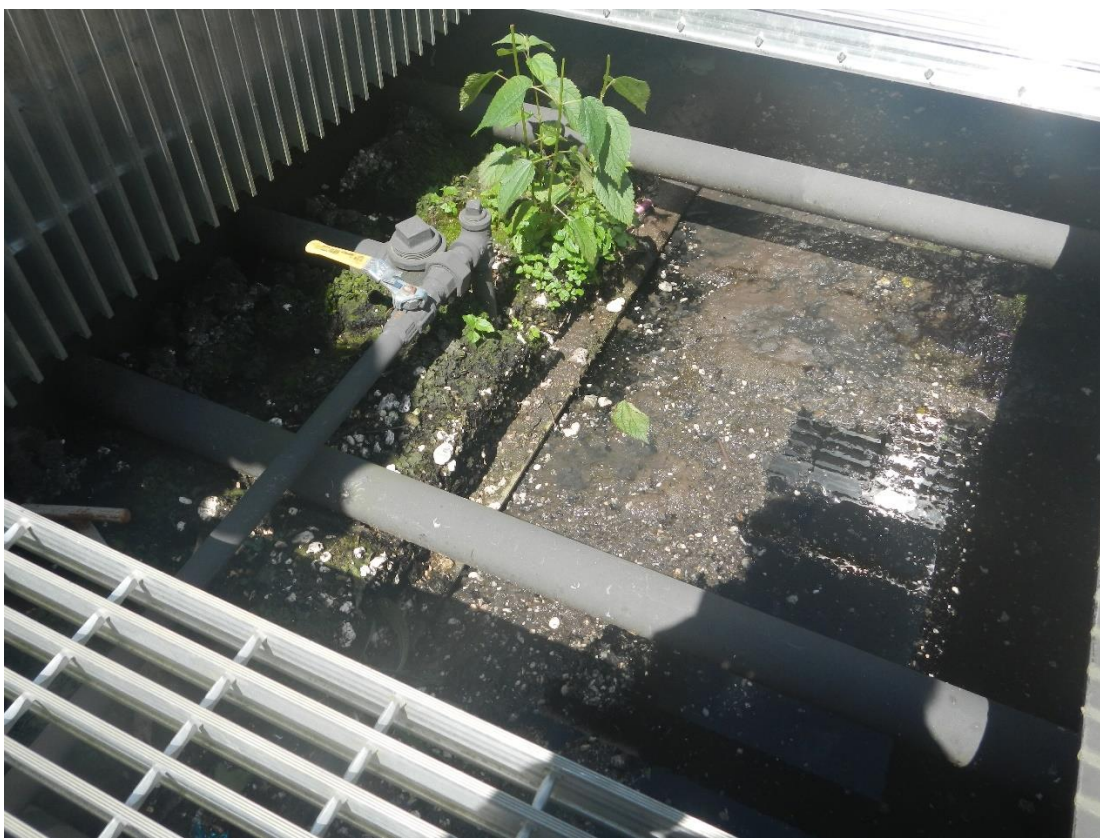
- The section of the plant which appeared to be utilized for clarification had significant sludge buildup with vegetation growing within the sludge (Photo #2).

Photo 2: Vegetation and clog within clarifier.

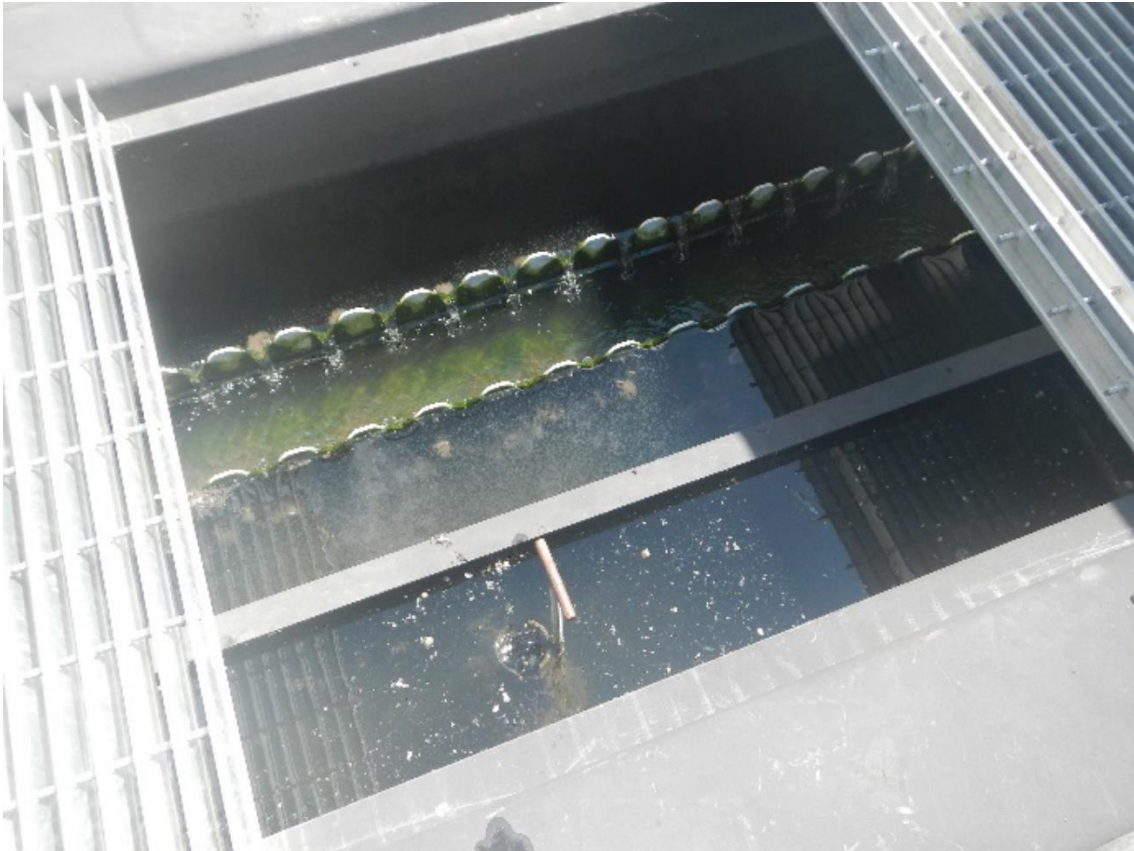
- The weirs in the clarification section of the plant appeared to be covered in algae and sludge due to reduced wastewater flow from clogged inlet section (Photos #3 and #4).

Photo 3: Algae and vegetation on weirs within clarifier.

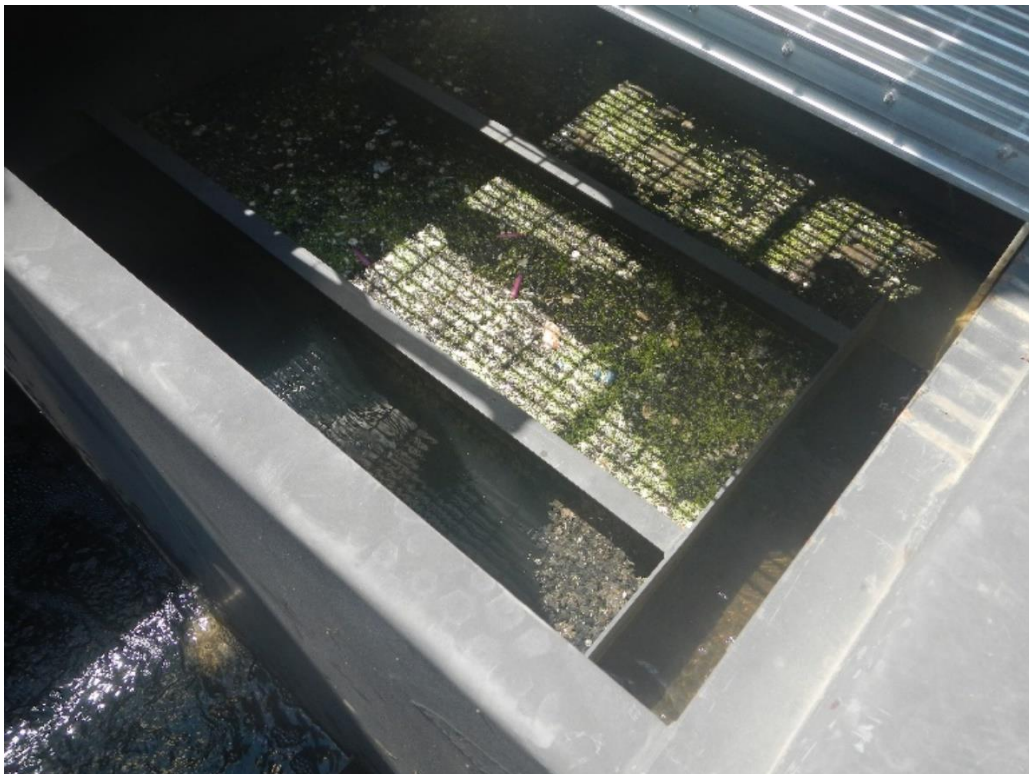
Photo 4: Sludge backup in clarifier.

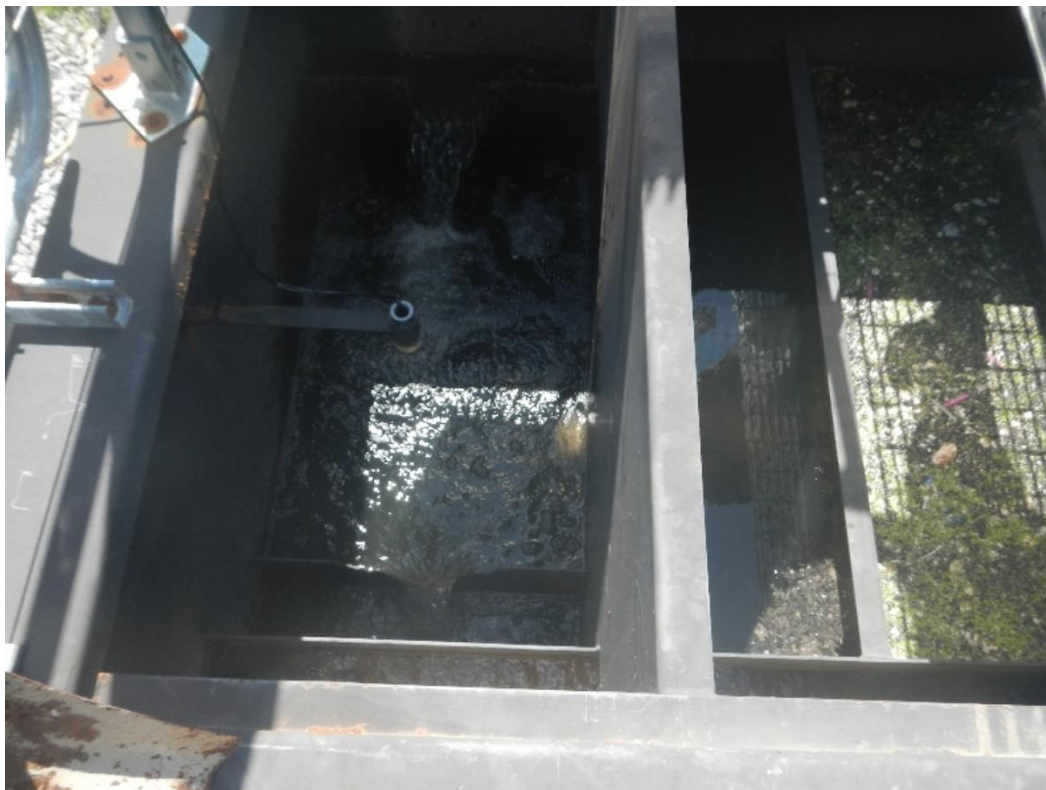
The effluent flow meter was attached to the rear wall section of the package plant and displayed a flow rate of 18.93 Gallons per minute (GPM). The calibration sticker noted on the effluent flow meter was no longer legible due to impact from the environment. The district contracts with a local contractor for calibration of the effluent ultrasonic flow meter and was able to produce a recent calibration record for the meter. No staff gauge was present at the v-notch weir located within the plant. A staff gauge appears to have never been installed during the construction of the package plant. Additionally, the facility staff were unsure of the size of the v-notch weir but estimated the weir to be approximately 18 inches. The flow under the effluent flow meter appeared turbulent (Photo #5).

Photo 5: Turbulent flow under ultrasonic flow meter

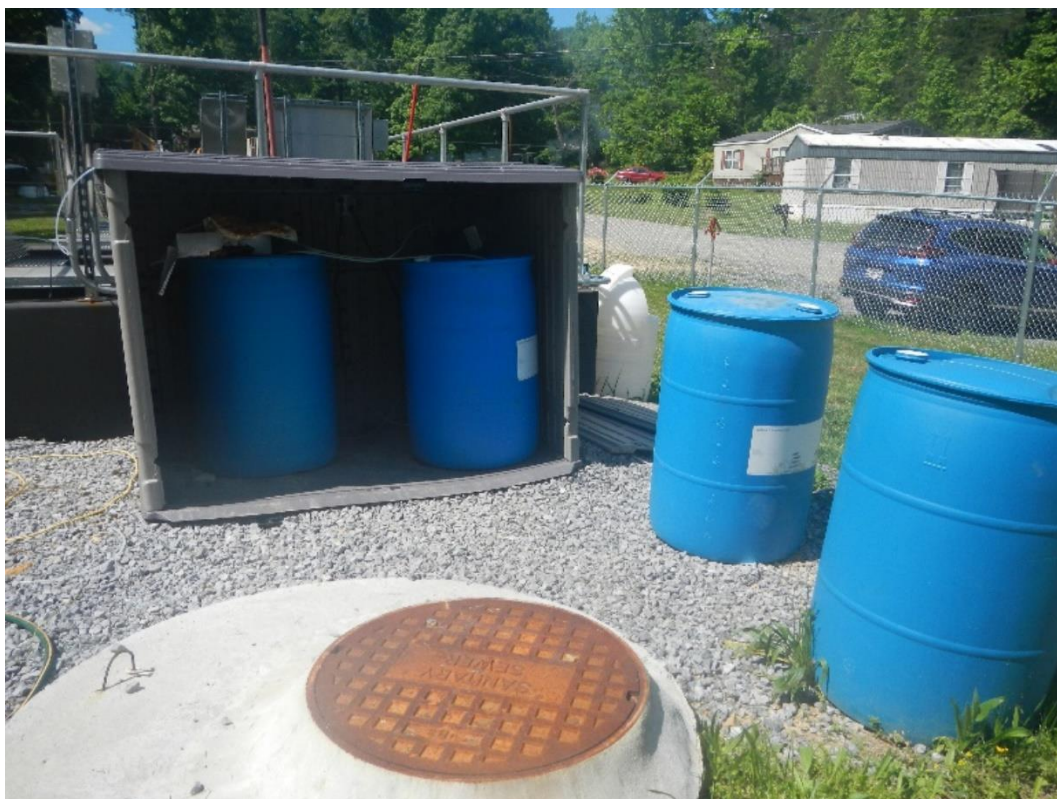
- A section of fence line around facility was damaged by a falling tree with a large portion of the tree remained overhanging the facility.
- The chlorination and dichlorination storage area was open and exposed to elements (Photo #6).

Photo 6: Open storage for chlorination/dechlorination chemicals.

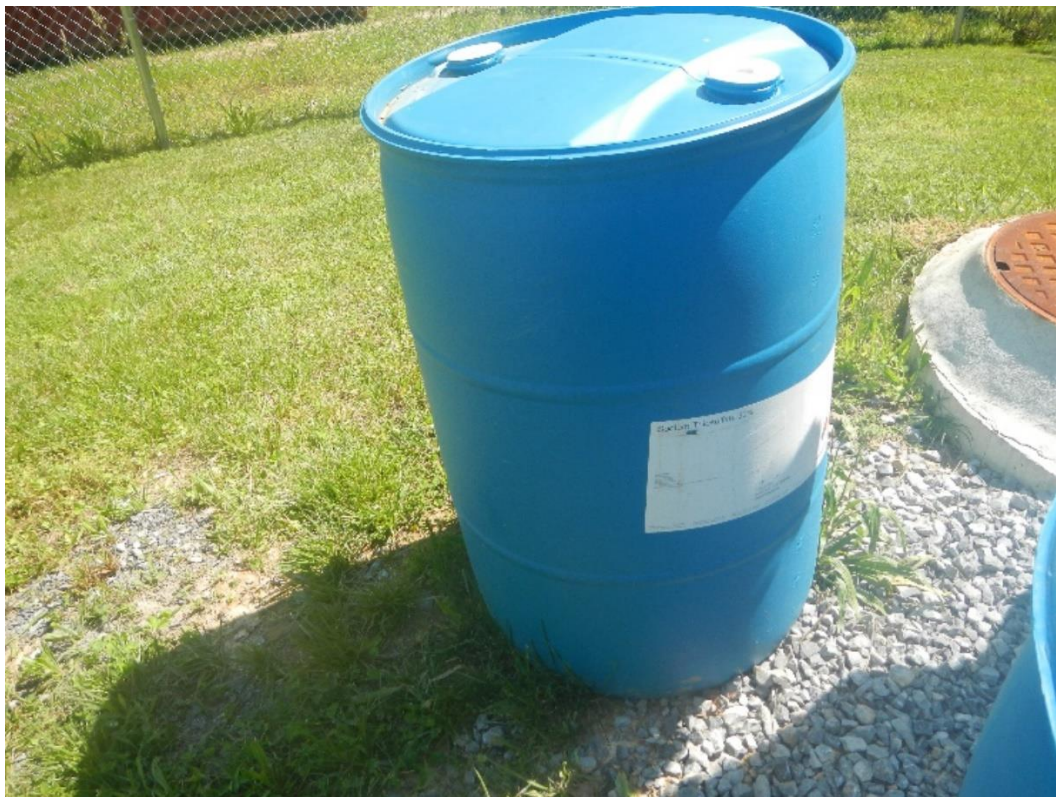
- Chemical drums were left outside exposed to the elements resulting in labeling being illegible (Photo #7).
- A staff gauge was not installed at v-notch weir.

Photo 7: Exposed chemical drums with faded labels.

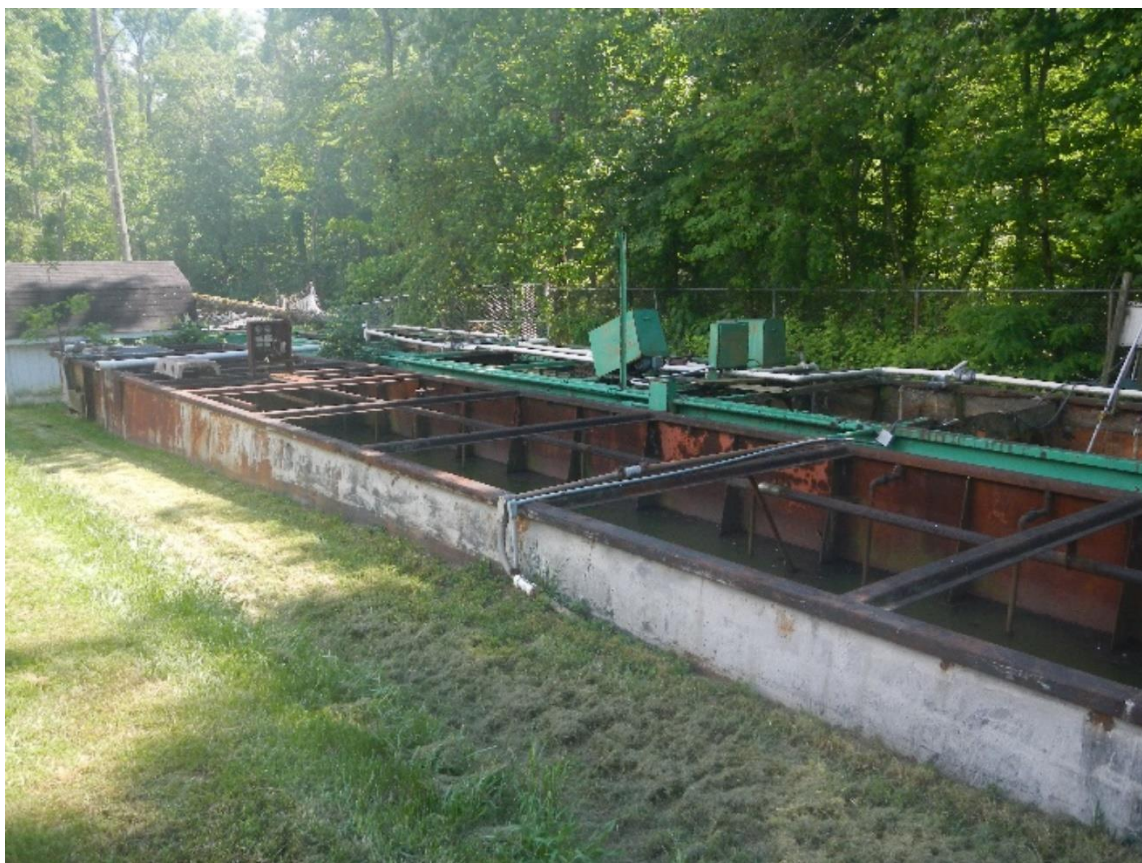
The District's current NPDES permit states that TSS, Total Nitrogen, Total Phosphorus, Total Ammonia-Nitrogen, and CBOD<sub>5</sub> should be measured and reported via a composite sample. The District does not own or operate a composite sampler. All samples are currently collected via a grab method. A composite sampler was noted on site but appeared non-operational and was located at the decommissioned wastewater package plant.

Photo 8: Decommissioned original package plant
