## **RCRA Inspection Report**

Trojan Battery Co – Lithonia  
5174 Minola Dr  
Lithonia, GA 30038

EPA ID#: GAD981266380  
NAICS #: 335910 Battery Manufacturer

8:45 AM February 4, 2025

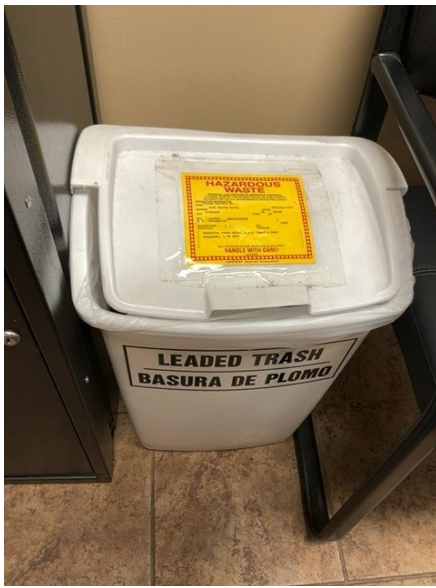
Trojan manages SAAs for PPE contaminated with lead in the wash area and throughout the facility process areas. Inspectors observed one small trash container just outside the door of the wash area (Photo 1). This container was closed and labeled with the words "Hazardous Waste Solid, Lead and Lead compounds."

Photo 1 – Lead contaminated PPE satellite container outside of wash room.

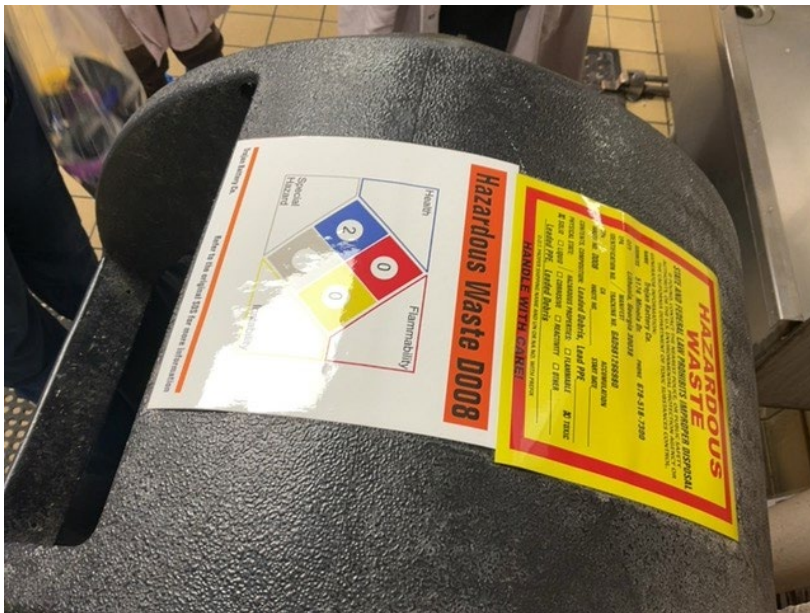
Inspectors observed three approximately 20-gallon trash containers used as SAA containers in the washroom. These containers were labeled with the words "Hazardous Waste, Leaded Debris, Leaded PPE" (Photo 2). The containers were marked as toxic and had NFPA diamonds with the words "Hazardous waste D008."

Photo 2 – PPE SAA label in wash room.

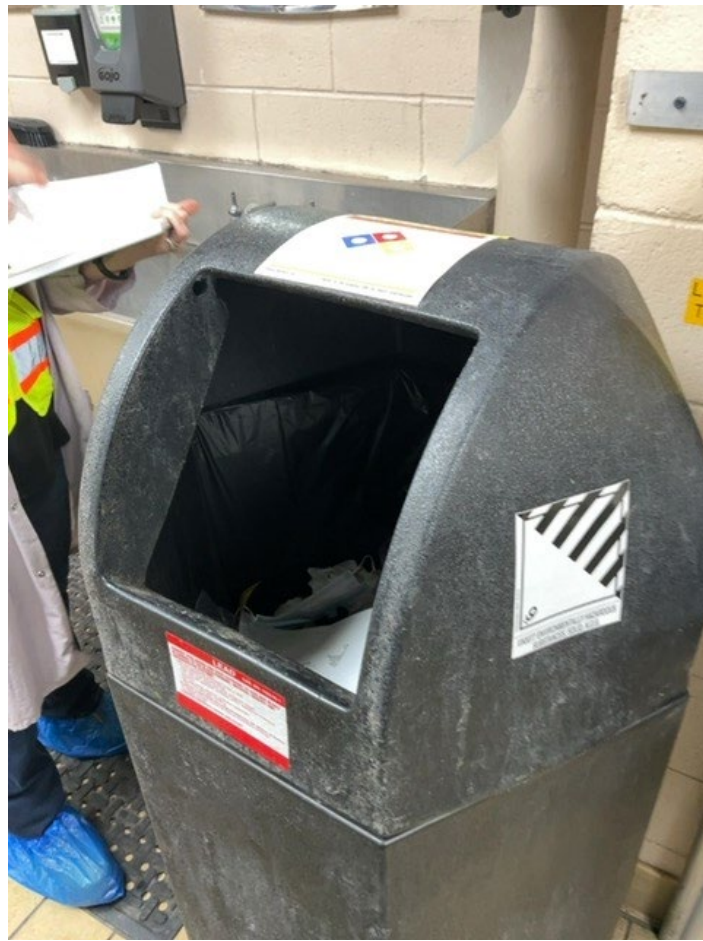
The wash area SAA containers were equipped with a domed lid with an opening on the side for depositing PPE waste (Photo 3). Facility representatives informed inspectors that this container was not closed because the wash area is used constantly throughout the day and personnel are actively adding waste to the container throughout the days. The containers are emptied at the end of each shift. Inspectors observed multiple personnel coming in and out of the washroom and adding waste to the container when in the wash area.

Photo 3 – SAA container lid in the wash area.

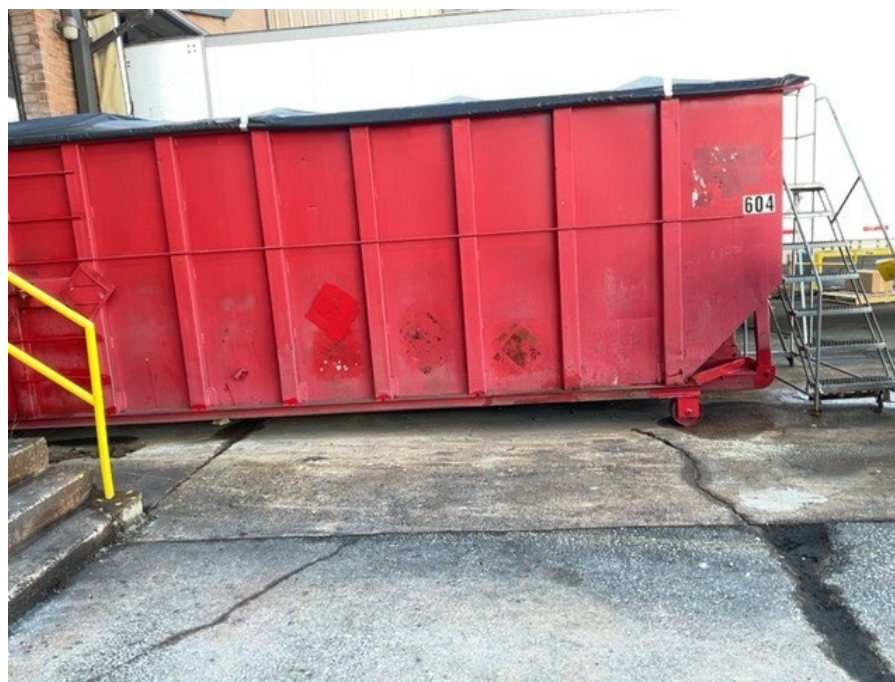
At the time of the inspection, the CAA consisted of a red 20-yard rollover container with a tarp securely fastened over the top placed against a dock (Photo 4). Facility representatives informed inspectors that the SAA containers for lead contaminated PPE throughout the facility are emptied here at the end of each shift. Inspectors observed a cardboard box on one end of the roll off container sticking out from underneath the tarp cover (Photo 5). Inspectors requested that facility representatives place the box fully inside the container so it could be properly closed and secured.

Photo 4 – CAA roll off container for lead contaminated PPE.

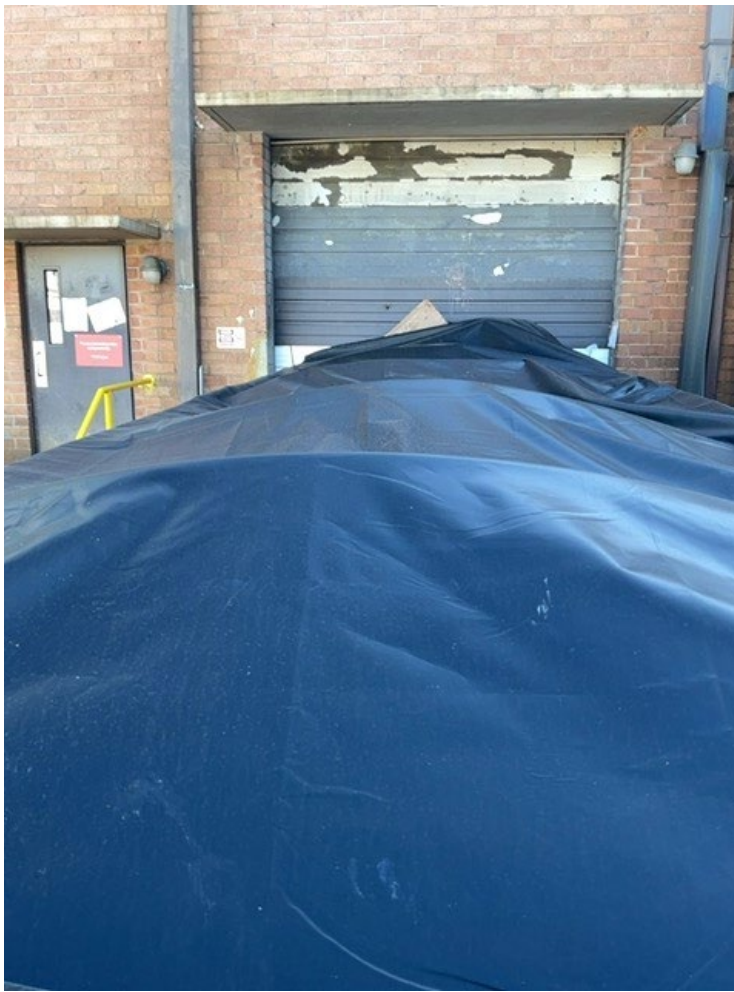
Photo 5 – Box  
observed to be  
sticking out of  
CAA roll off.

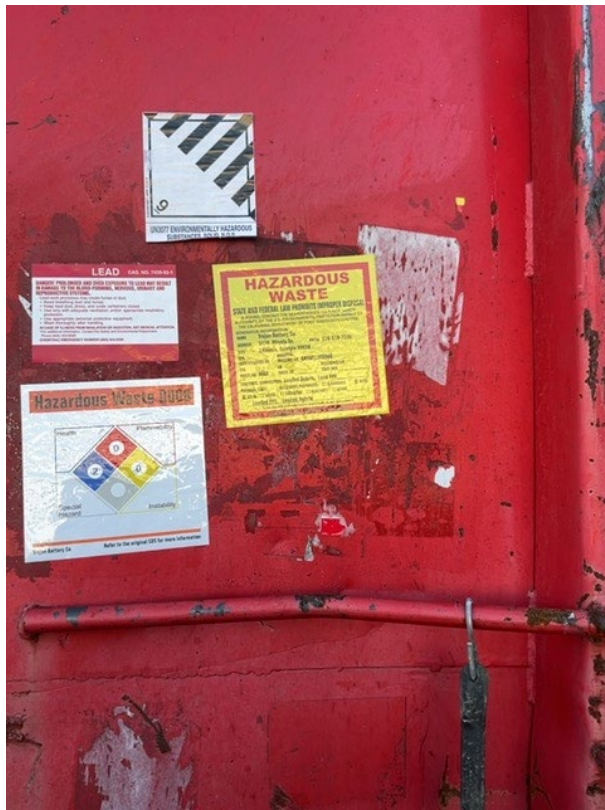
At the time of the CEI, the roll off container was labeled with the words, “Hazardous waste, Leaded PPE, Leaded Debris” (Photo 6). The label was marked as solid and toxic but missing an accumulation date. On March 6, 2025, Amanda Williams submitted photos of the label with an accumulation date added.

Photo 6 –  
Labeling on CAA  
container.

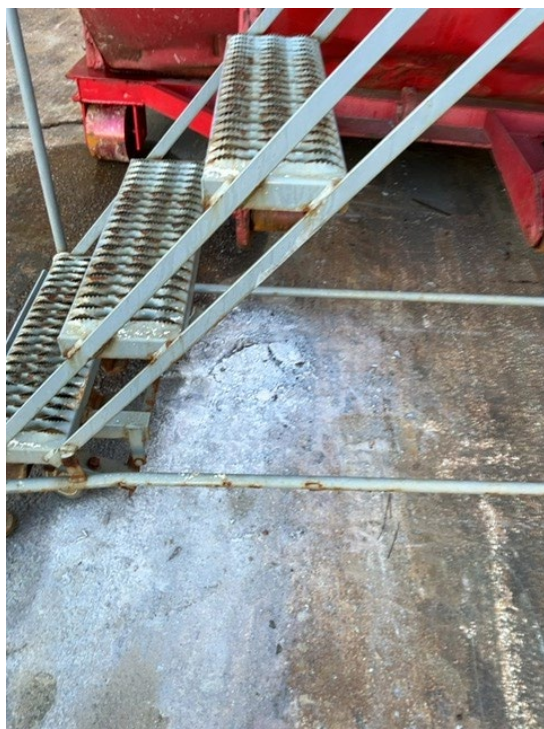
Inspectors observed a powdery white substance on the ground just outside of the roll off container (Photo 7). Inspectors requested that facility representatives clean up the spill and move all waste to a proper hazardous waste container. Inspectors went back to verify this spill had been addressed following the facility walk through.

Photo 7 – White  
powder spills  
observed outside  
of CAA roll off  
container.

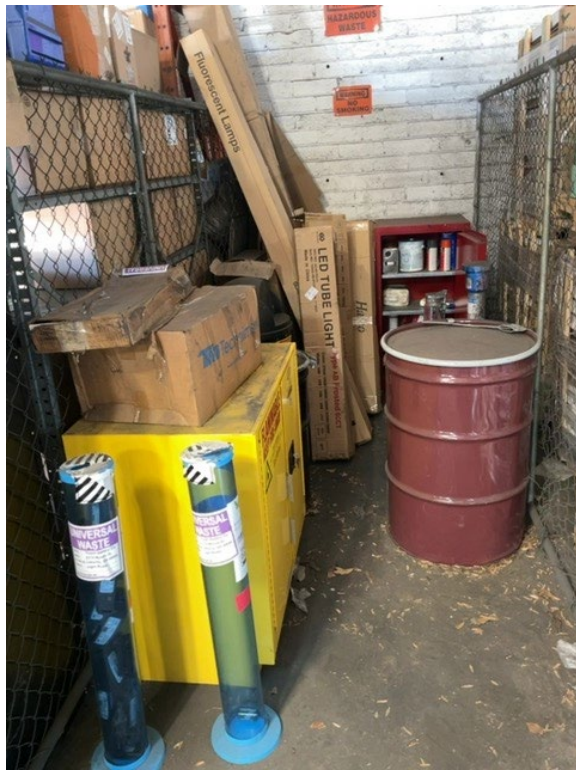
The facility manages universal waste lamps and batteries in a fenced cage in the corner of a warehouse used for product and equipment storage (Photo 8). At the time of the inspection, inspectors observed two plastic cylinders for accumulating alkaline universal waste batteries and seven cardboard boxes varying from 4ft to 8ft in length accumulating universal waste lamps.

Photo 8 –  
Universal waste  
cage.

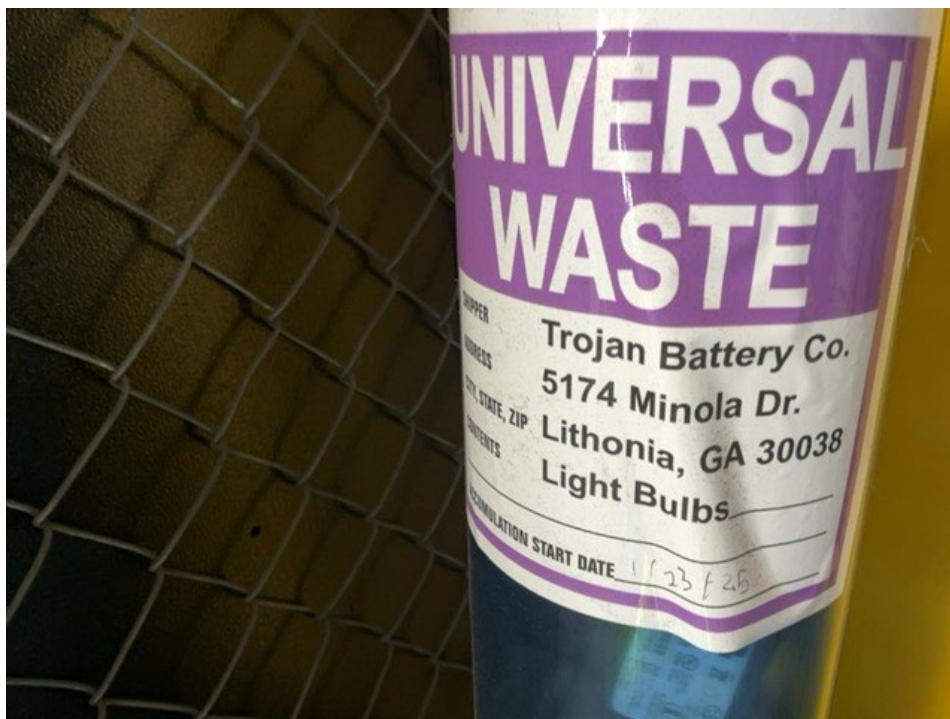
Photo 9 – Label  
on the universal  
waste battery  
containers  
incorrectly  
marked as  
universal waste  
lightbulbs  
observed during  
the CEI.

The universal waste and hazardous waste containers and labels were corrected on site and inspectors observed photos of the corrections during the CEI. Amanda Williams also sent photos of these containers properly labeled and closed following the inspection on March 6, 2025.

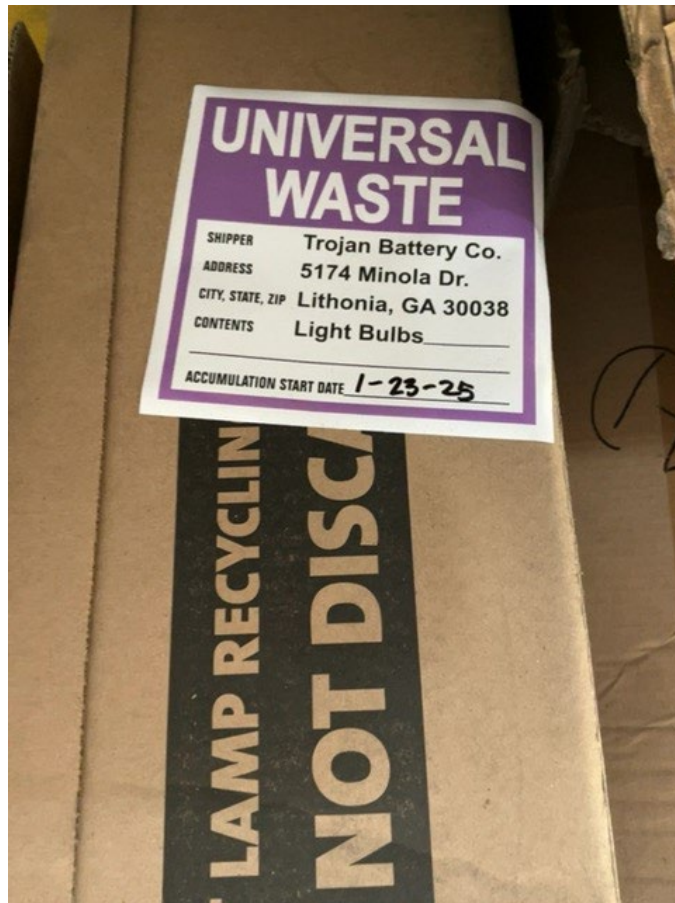
Photo 10 – Universal waste label observed on only one of the seven universal waste lamps container.

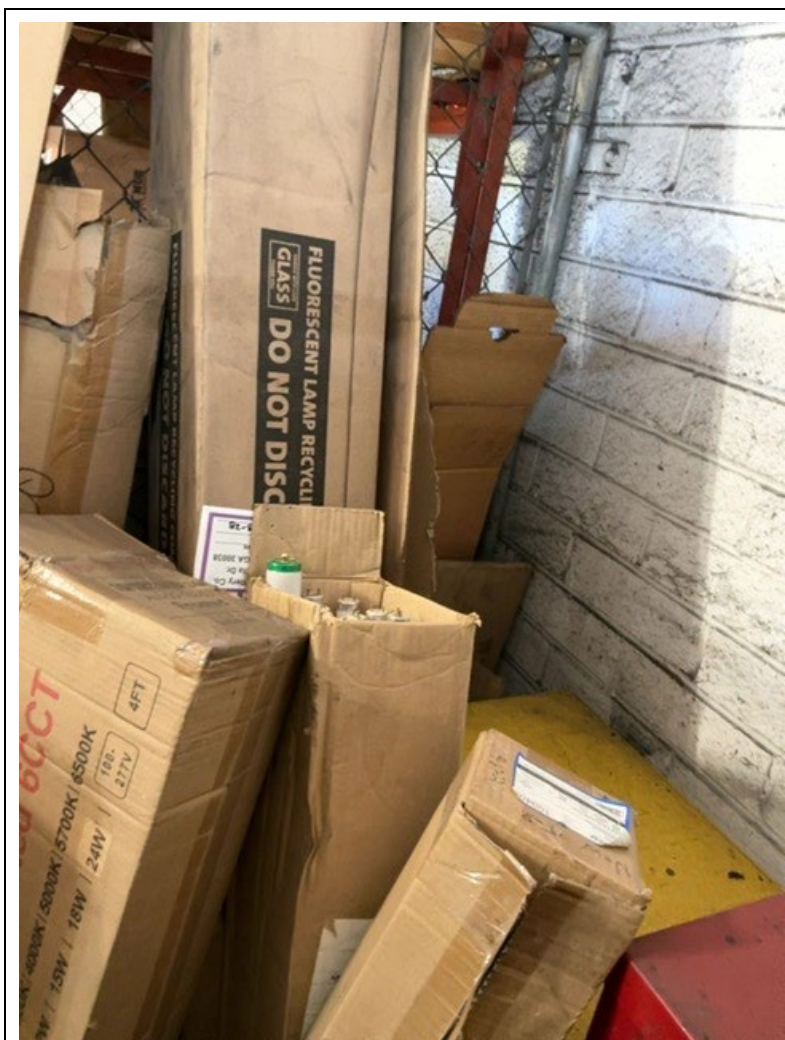
Photo 11 – Open boxes of universal waste lamps observed during the CEI.

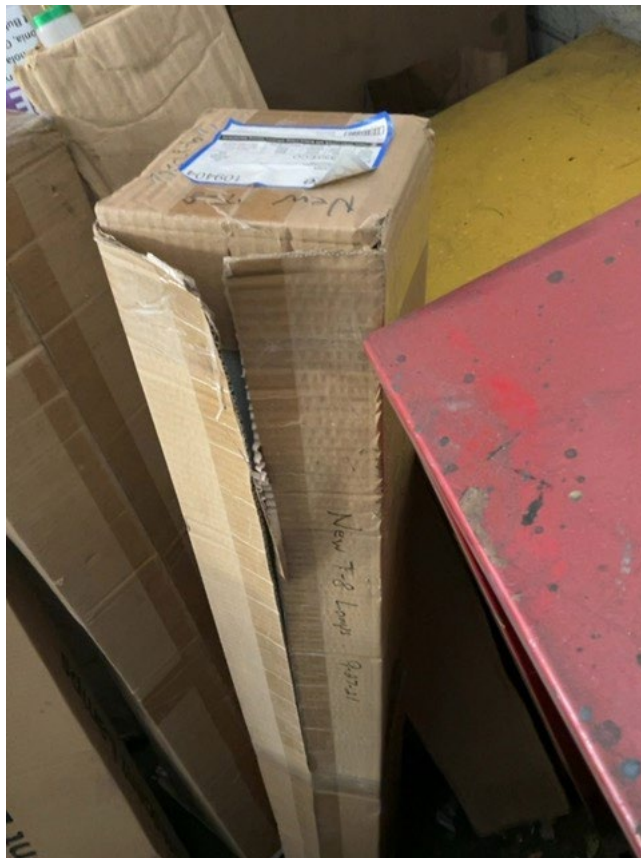
Photo 12 - Open box of universal waste lamps observed during the CEI.

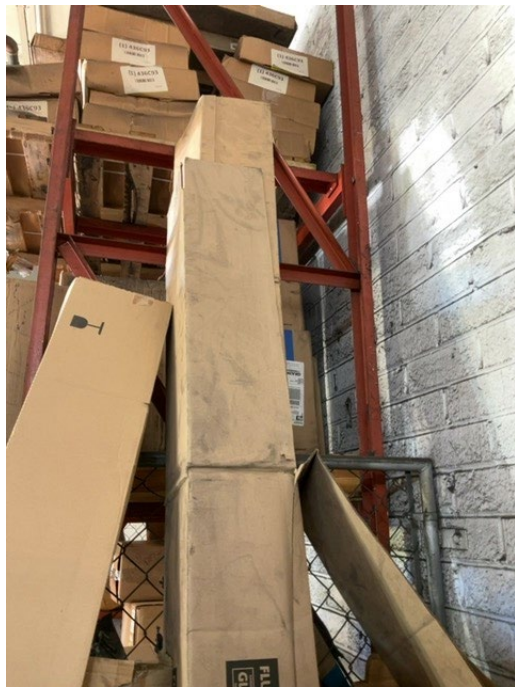
Photo 13 - Open box of universal waste lamps observed during the CEI.

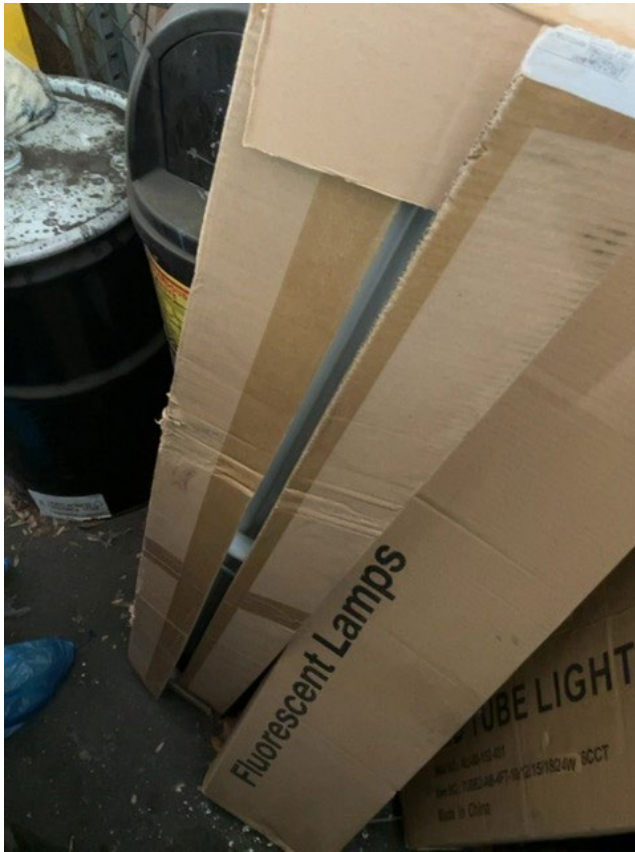
Photo 14 - Open box of universal waste lamps observed during the CEI.

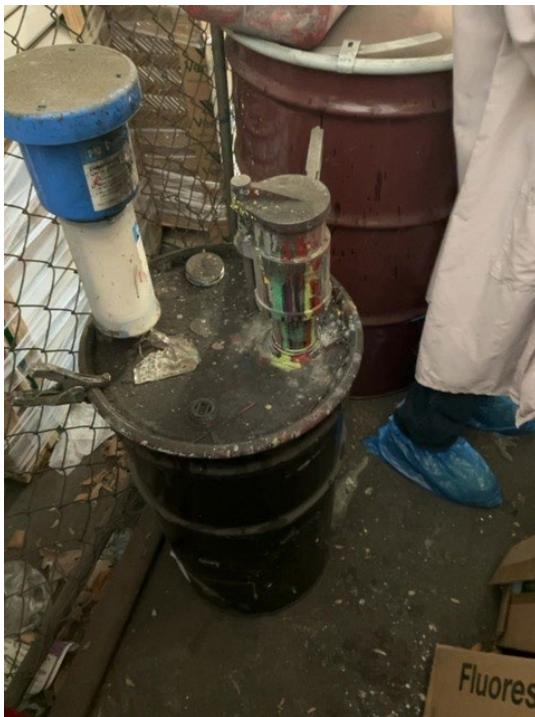
Photo 15 – Aerosol can puncture device attached to 15-gallon SAA container.

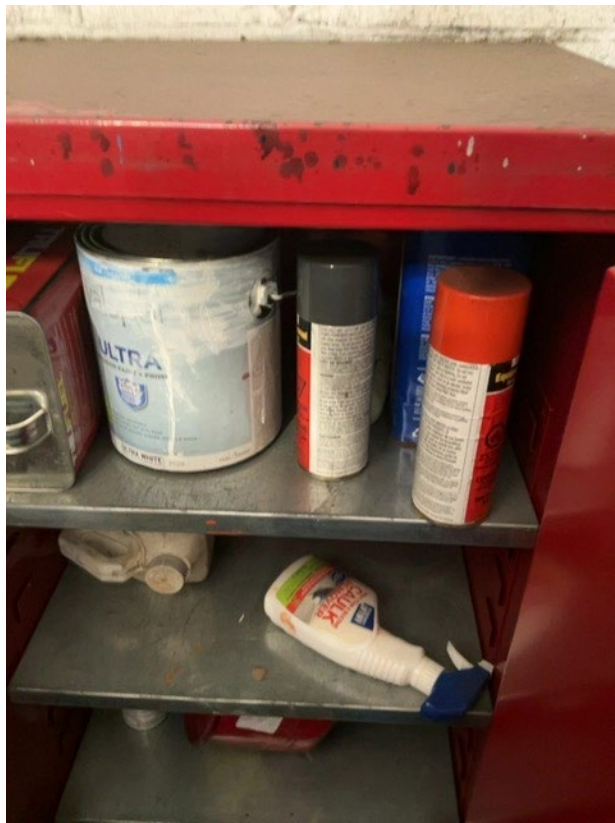
Inspectors also observed a flammable cabinet storing full product aerosol cans, empty gasoline containers, and a partially full, unlabeled paint can (Photo 16). Facility representatives informed inspectors that the paint can was leftover waste paint. Inspectors informed the facility that this container should be labeled as hazardous waste, marked with an indication of hazards and an accumulation date.

Photo 16 –  
Flammable  
cabinet with  
aerosol products  
and an unlabeled  
can of paint  
waste.

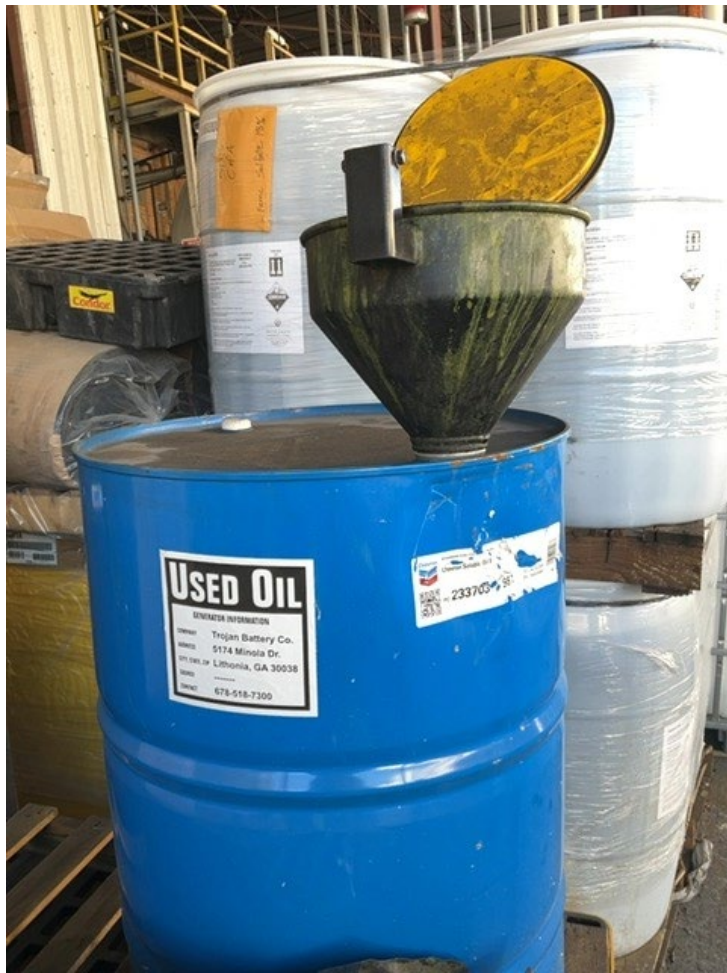
At the time of the CEI, inspectors observed one 55-gallon drum marked with a used oil and universal waste lamps label in the acid farm. Facility representatives informed inspectors that the universal waste label was put on by mistake and the container contains used oil. The universal waste label was removed on site. The drum had a funnel attached to the bung hole at the top which was open (Photo 17). This was closed on site.

Photo 17 – Open used oil drum observed in the acid farm.

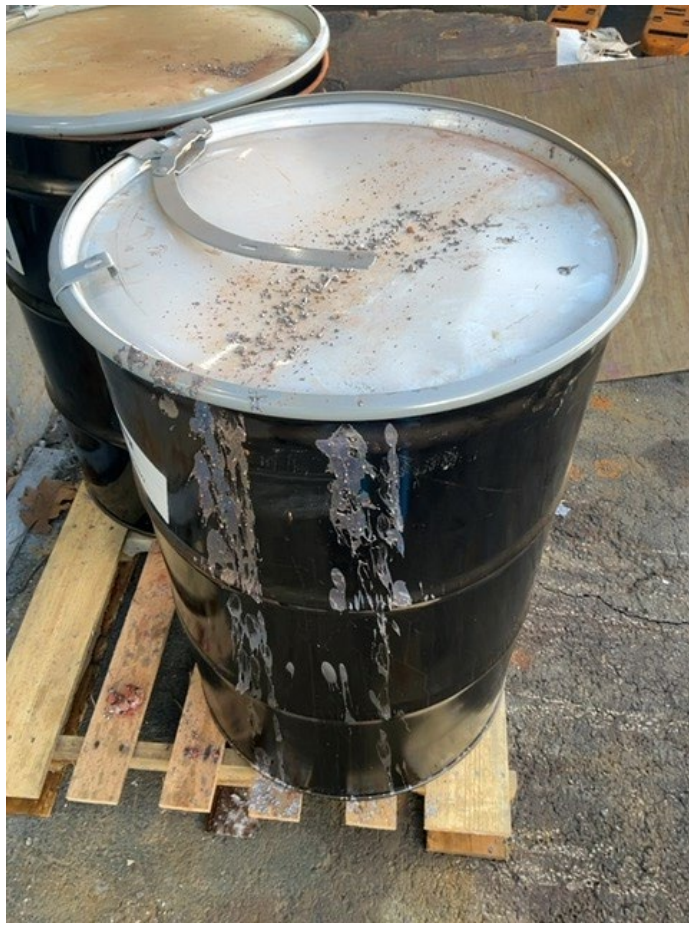
Inspectors observed three 55-gallon drums of lead scrap metal. This material is sent for recycling and is not managed as hazardous waste. The drums accumulating scrap lead were labeled with the words: LEAD, Danger: prolonged and over exposure to lead may result in damage to the blood-forming, nervous, urinary, and reproductive systems. Inspectors observed lead particles along the side of one of the scrap drums from spilling over when personnel added waste to the container (Photo 18). Inspectors recommended better housekeeping practices when adding waste. Lead powder was also observed on the ground in this area, similar to the spill observed in the CAA.

Photo 18 – Lead observed on the outside of a scrap container in the acid farm.

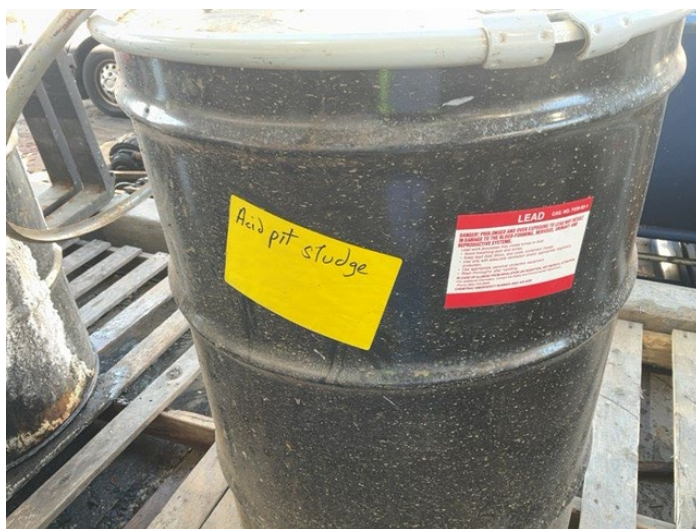
Inspectors observed six 55-gallon drums labeled as acid sludge and two 55-gallon drums labeled as wastewater treatment sludge (Photos 19 and 20). Facility representatives informed inspectors that the acid pit sludge is generated from the acid pit sump and does not actually contain acid. The wastewater treatment sludge is generated from cleaning the filter press in the wastewater treatment system. Both sludges are sent to a smelter and are not managed as hazardous waste. Inspectors observed an open 55-gallon drum marked as nonhazardous debris with a contains lead sticker. Following the inspection, facility representatives submitted photos of this container stating that it was replaced on February 4, 2025, with a 55-gallon trash container with a lid and is marked as a SAA toxic hazardous waste lead contaminated PPE.

Photo 19 – Acid pit sludge drum in the Acid Farm.

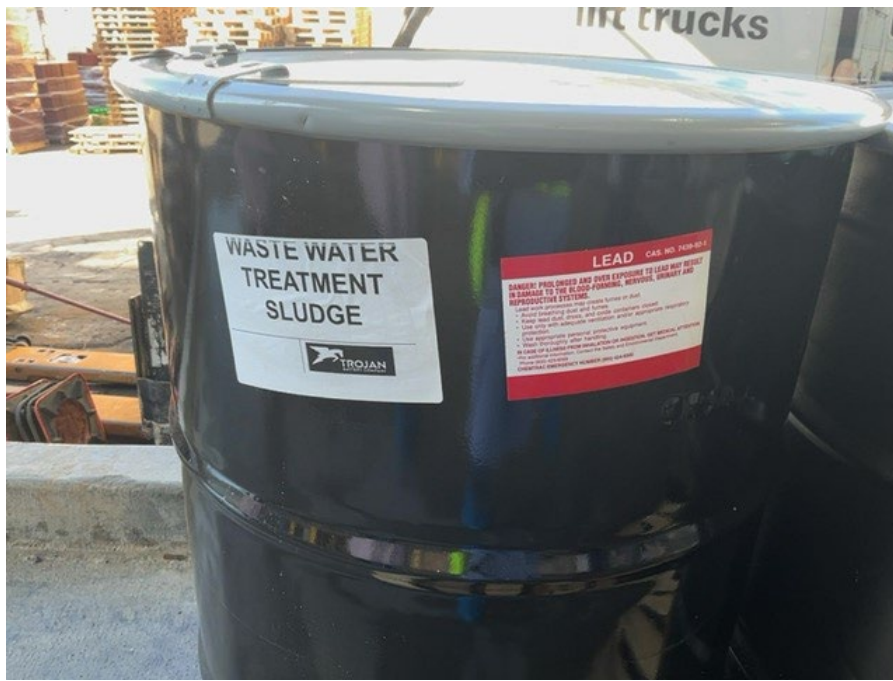
Photo 20 –  
Wastewater  
treatment sludge  
in the Acid Farm.

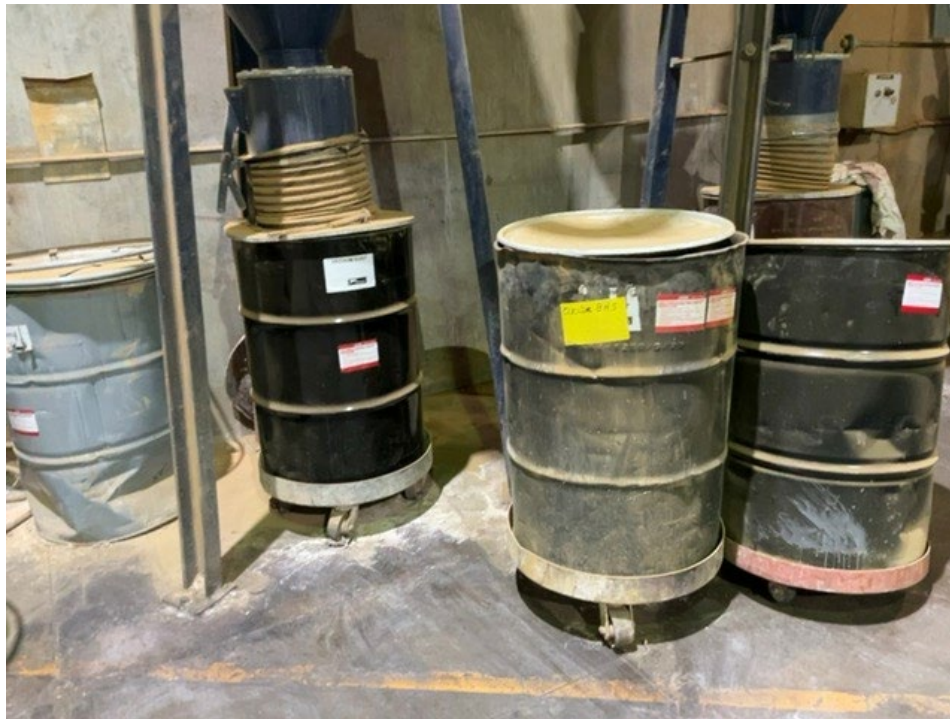
The oxide area houses four baghouses as part of the facility's the ventilation system. Inspectors observed four 55-gallon drums, one connected to each baghouse collecting dust (Photo 21). Facility representatives informed inspectors that this dust is sent to a smelter and is not managed as hazardous waste. Inspectors requested a copy of the waste profile for baghouse dust in the records review.

Photo 21 – Drum  
accumulating  
nonRCRA  
hazardous  
baghouse dust in  
the Oxide Area.

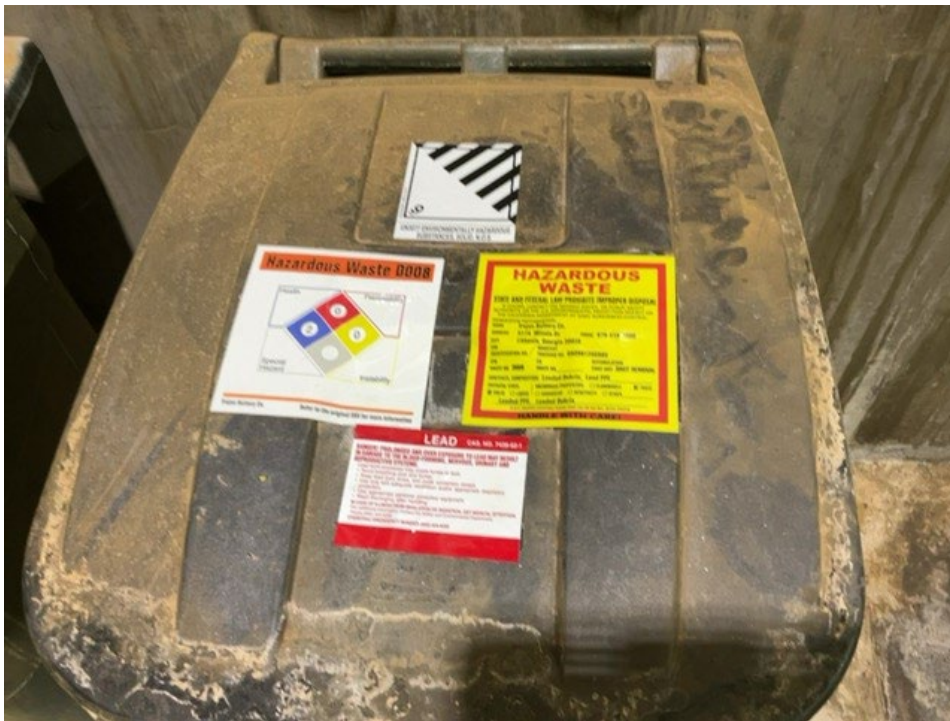
The SAA PPE containers were closed and labeled as hazardous waste exhibiting the characteristic of toxicity for lead (Photo 22). Inspectors observed spill kits, fire extinguishers, sprinklers, emergency showers and eye wash stations here and throughout the production areas of the facility.

Photo 22 –  
Hazardous Waste  
SAA PPE  
container in  
Oxide Area.

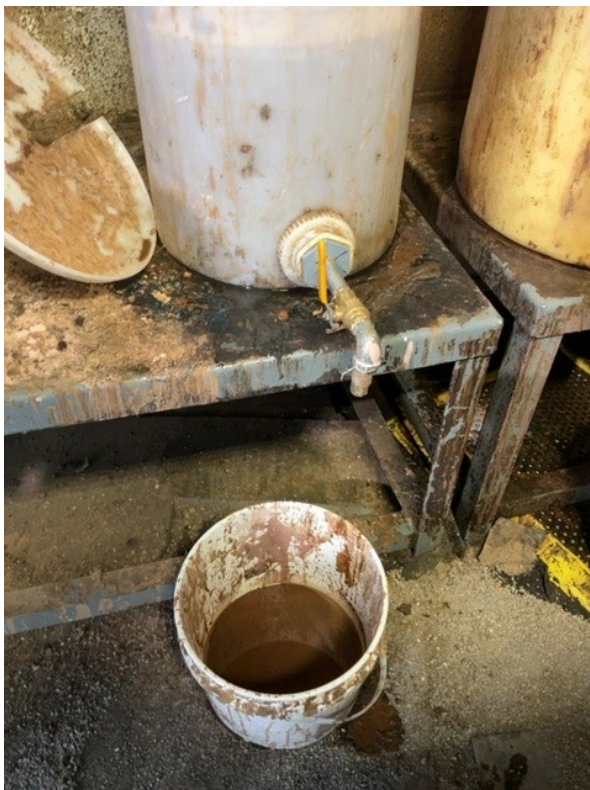
Inspectors observed an open 5-gallon bucket containing liquid under a machine churning cork solution (Photo 23). Facility representatives informed inspectors that this not waste and the residue would be added back to the machine.

Photo 23 –  
container  
accumulating  
cork residue to  
be reused in  
system in the  
Grid Casting Area.

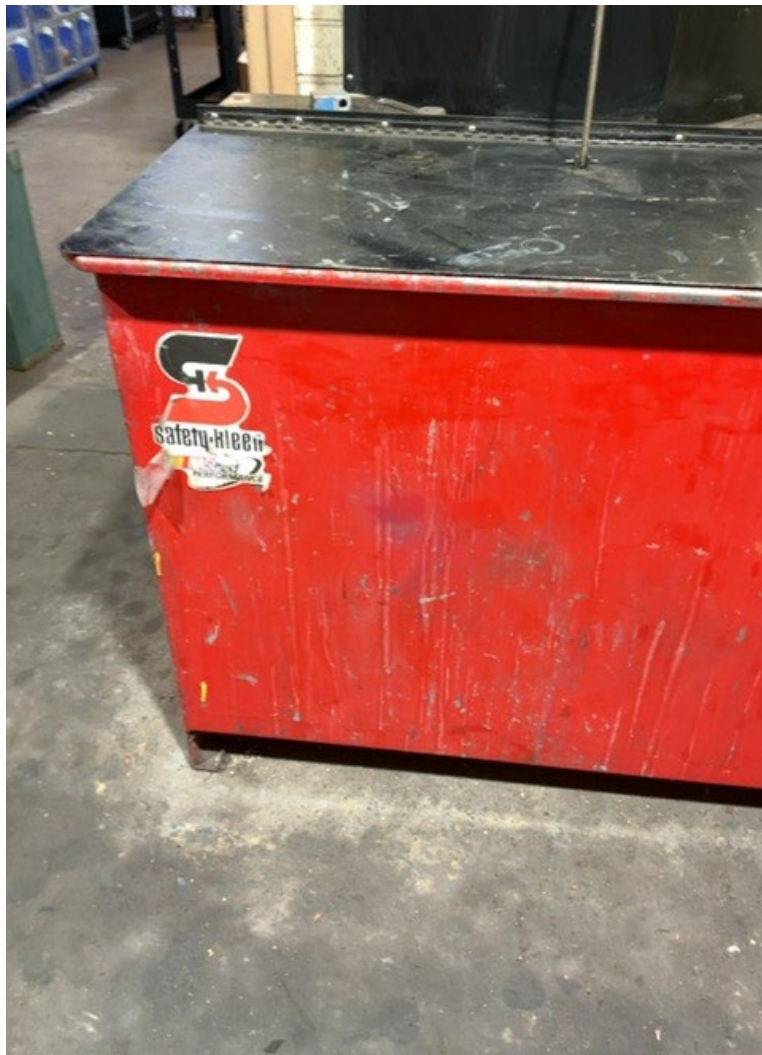
The facility operates a parts washer in the maintenance area (Photo 24). The solvent in the parts washed is continuously reused in the system and is not waste until it is picked up for disposal by Safety Kleen. Inspectors reviewed the safety data sheet for the parts washer solvent, which demonstrated the solvent has a flash point of 148 degrees Fahrenheit and is nonhazardous. After being used in the parts washer the solvent is shipped for disposal as D039 RCRA hazardous waste.

Photo 24 –  
Safety-Kleen  
parts washer in  
maintenance  
area.
