## Clean Water Act Section 404: Site Visit/Case Development

| Site Name | Joseph Yuknevich Property | | | | |

| Inspection Purpose | Follow-up site visit | | |

CWA 404 Inspection  
Joseph Yuknevich Residence  
2253 NY Route 300  
Shawangunk, NY

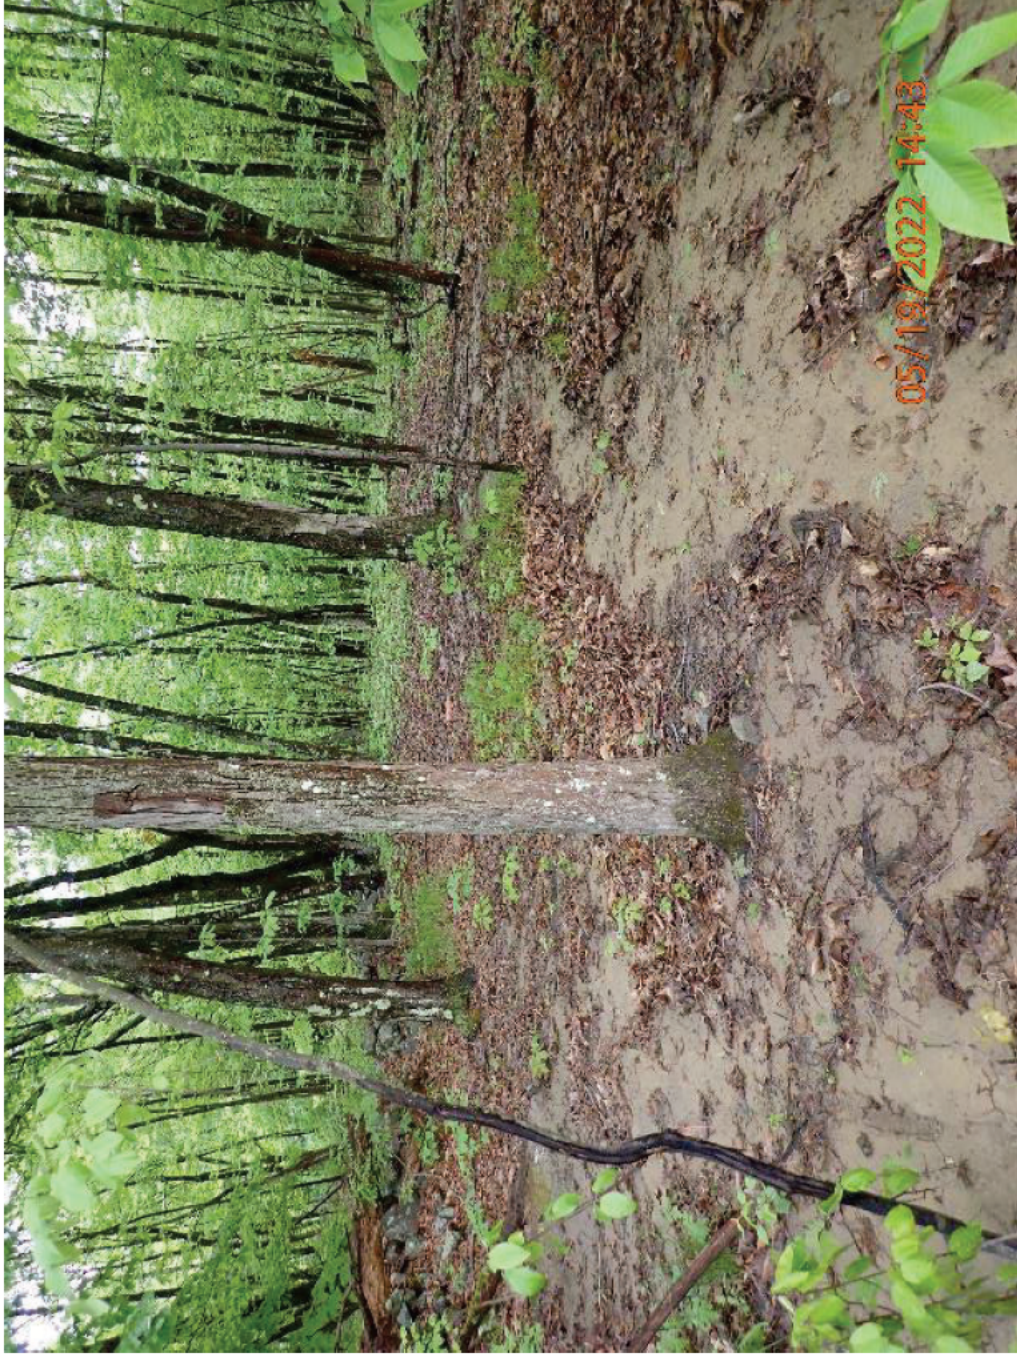
**Date:** 5/19/2022  
**Time:** 2:43 PM  
**Photographer:** SSA  
**Photo ID:** 1 – P5190337

(1/5) Panorama of fill material  
in forested upland area  
Western end of property

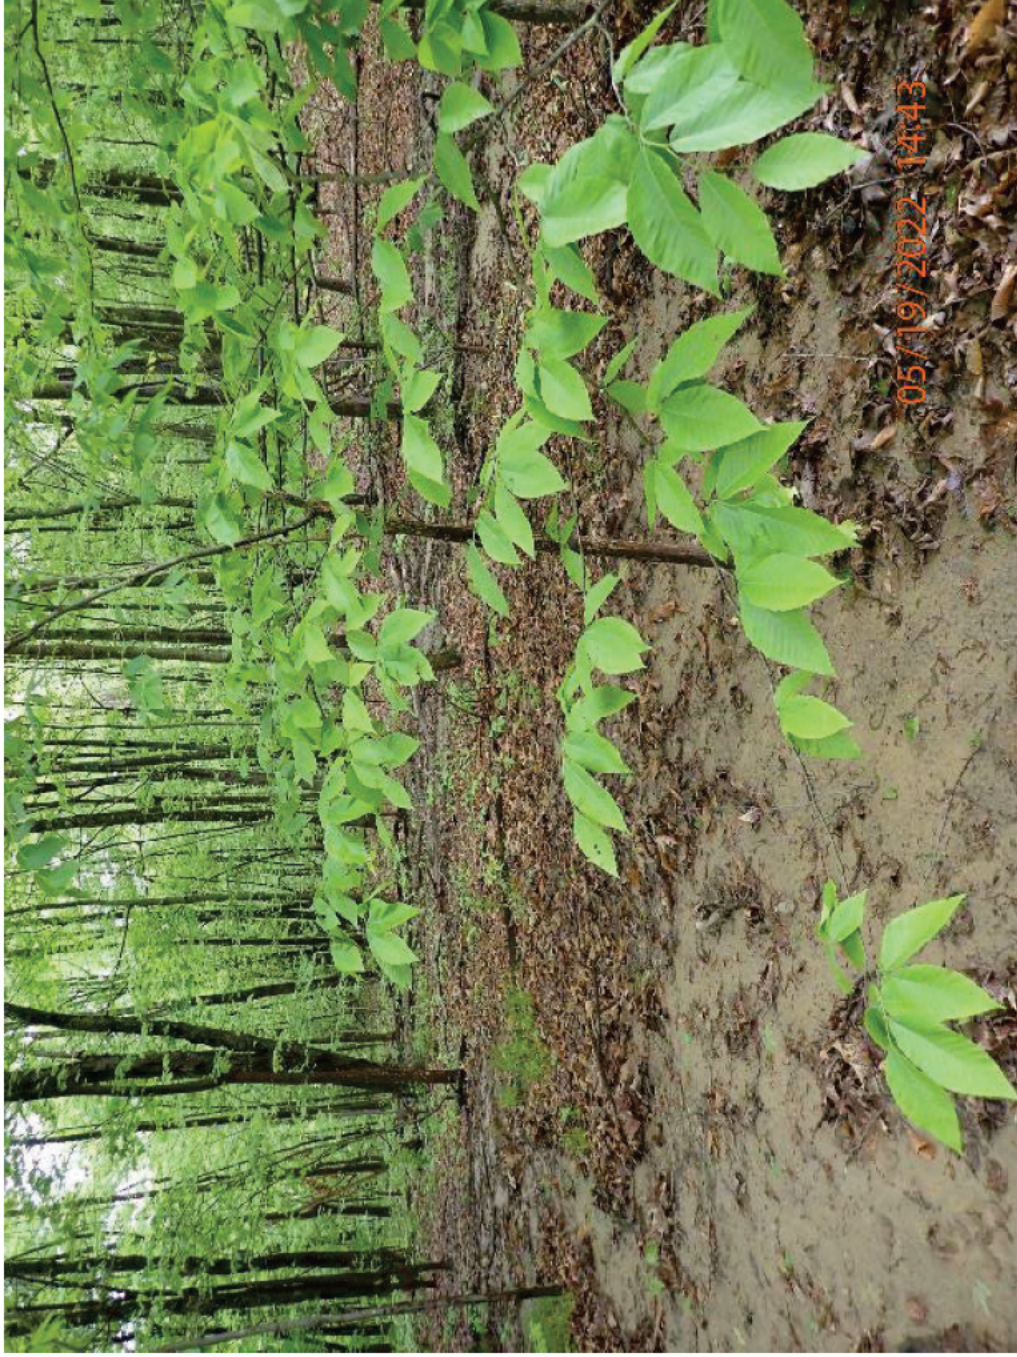
**Date:** 5/19/2022  
**Time:** 2:43 PM  
**Photographer:** SSA  
**Photo ID:** 2 – P5190338

(2/5) Panorama of fill material  
in forested upland area  
Western end of property

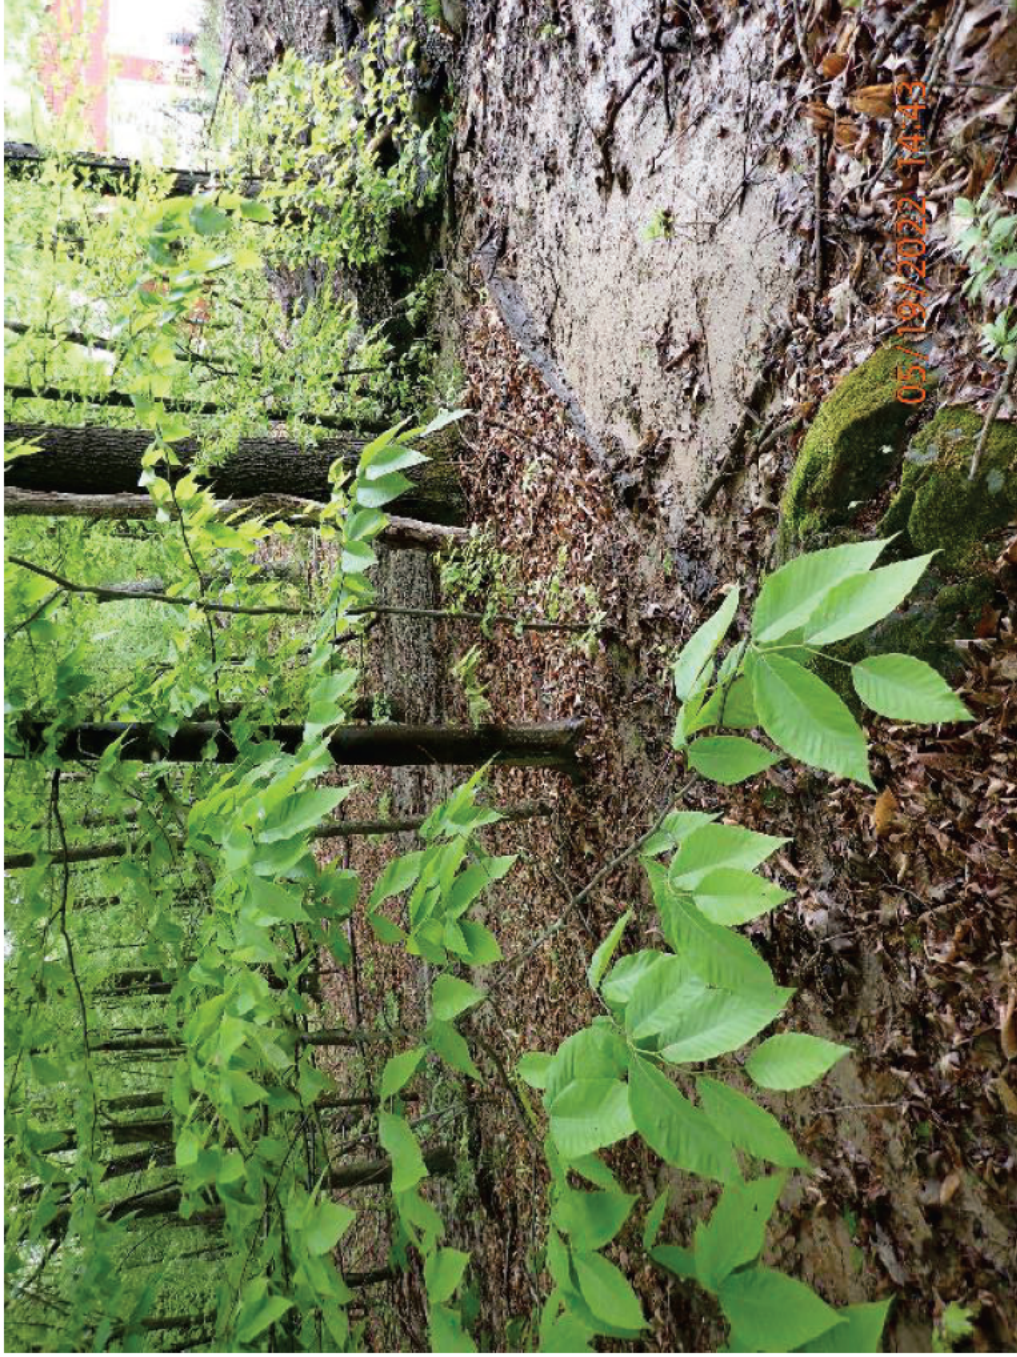
**Date:** 5/19/2022  
**Time:** 2:43 PM  
**Photographer:** SSA  
**Photo ID:** 3 – P5190339

(3/5) Panorama of fill material  
in forested upland area  
Western end of property

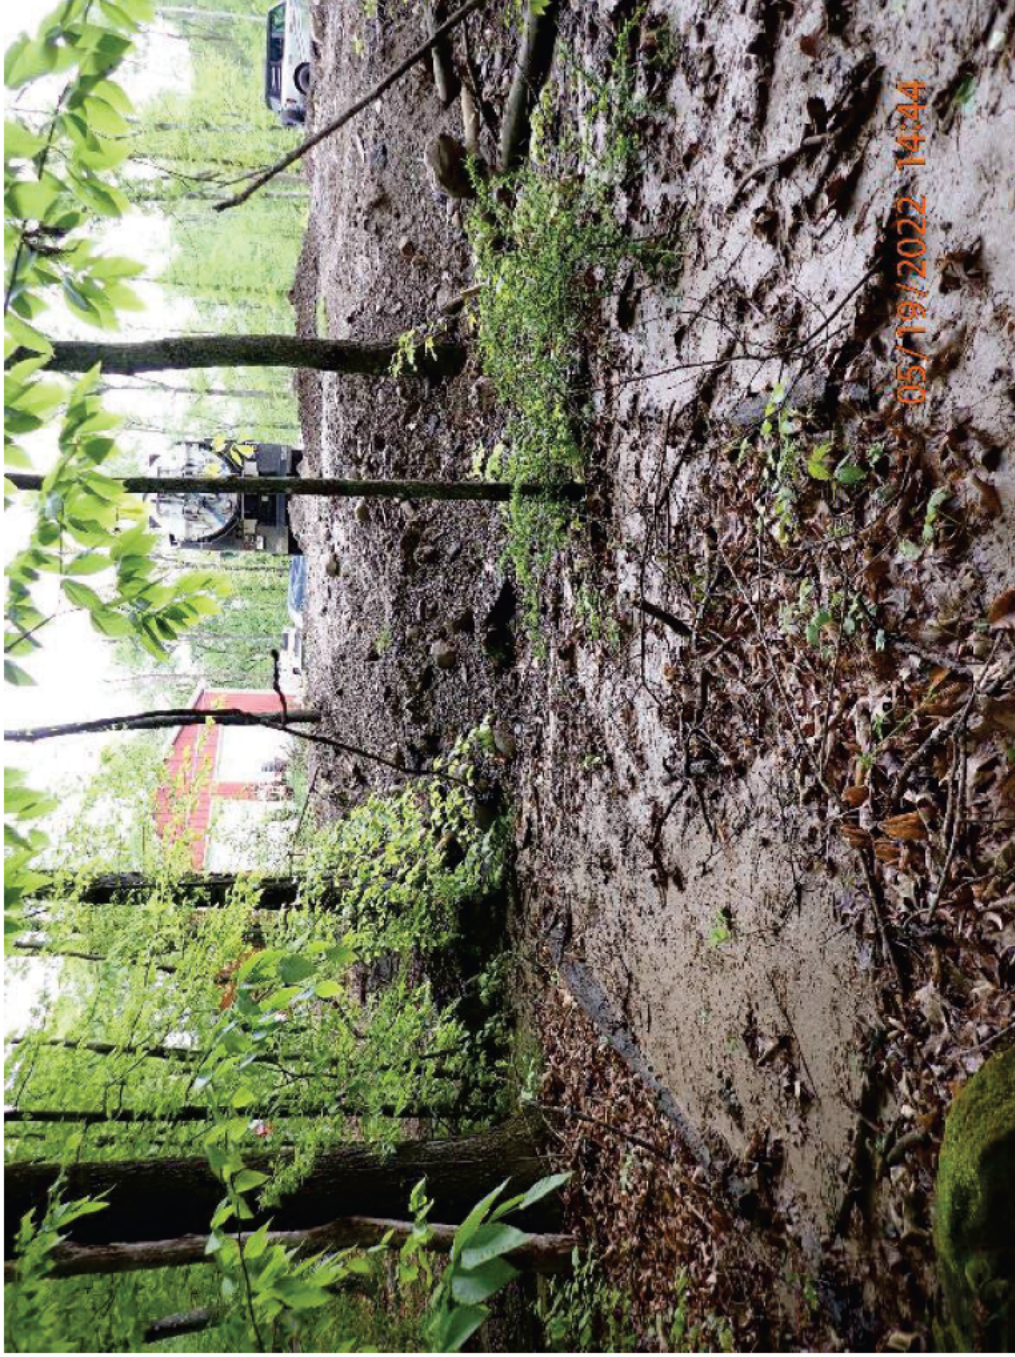
**Date:** 5/19/2022  
**Time:** 2:44 PM  
**Photographer:** SSA  
**Photo ID:** 4 – P5190340

(4/5) Panorama of fill material  
in forested upland area  
Western end of property

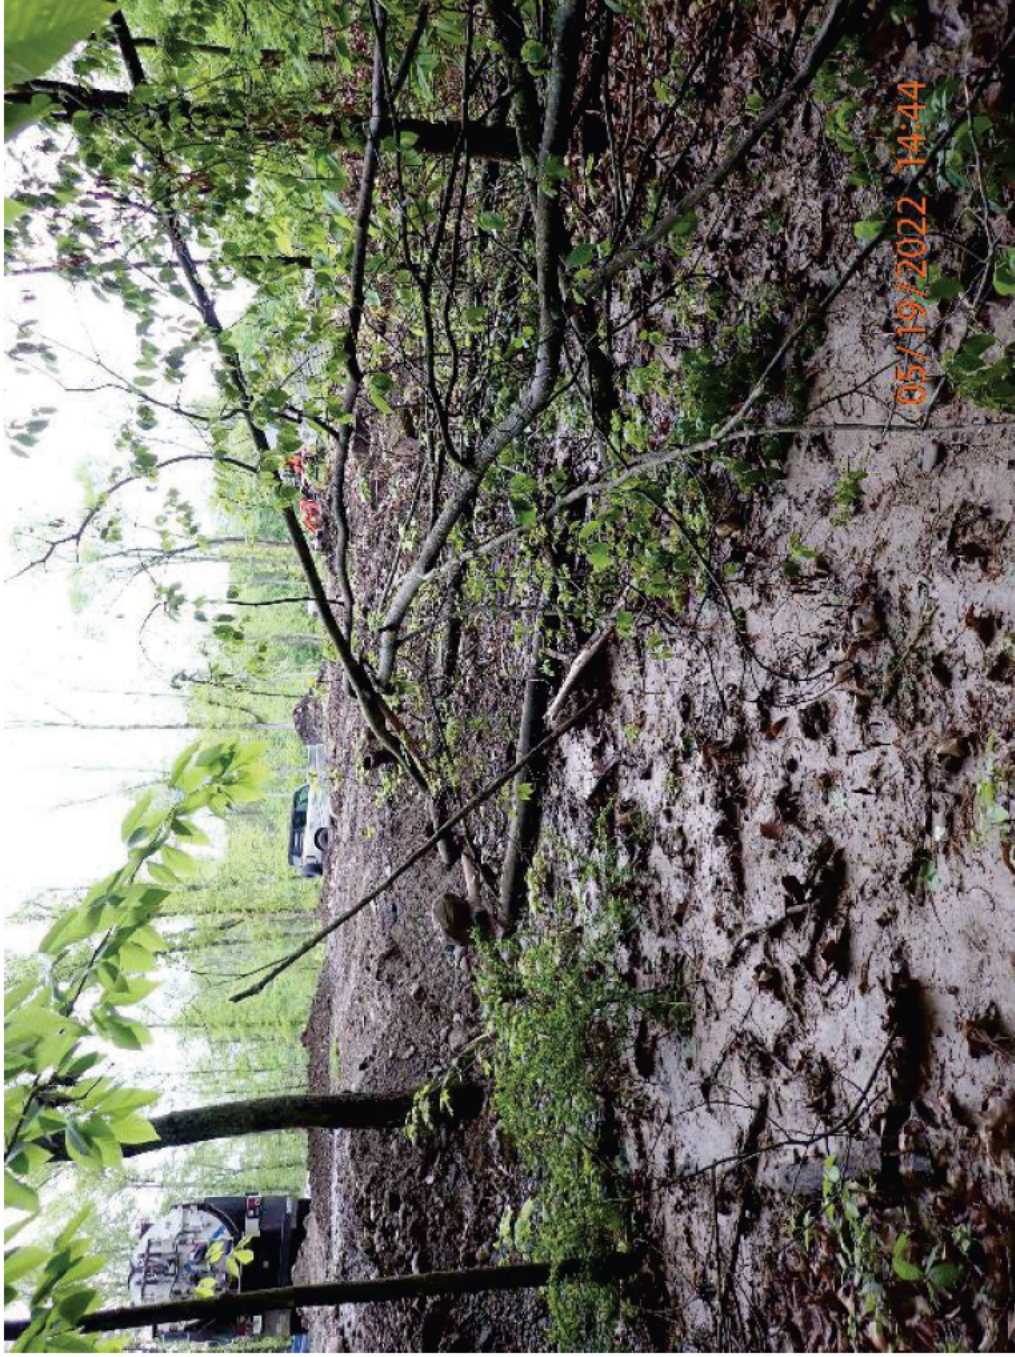
**Date:** 5/19/2022  
**Time:** 2:44 PM  
**Photographer:** SSA  
**Photo ID:** 5 – P5190341

(5/5) Panorama of fill material  
in forested upland area

Western end of property

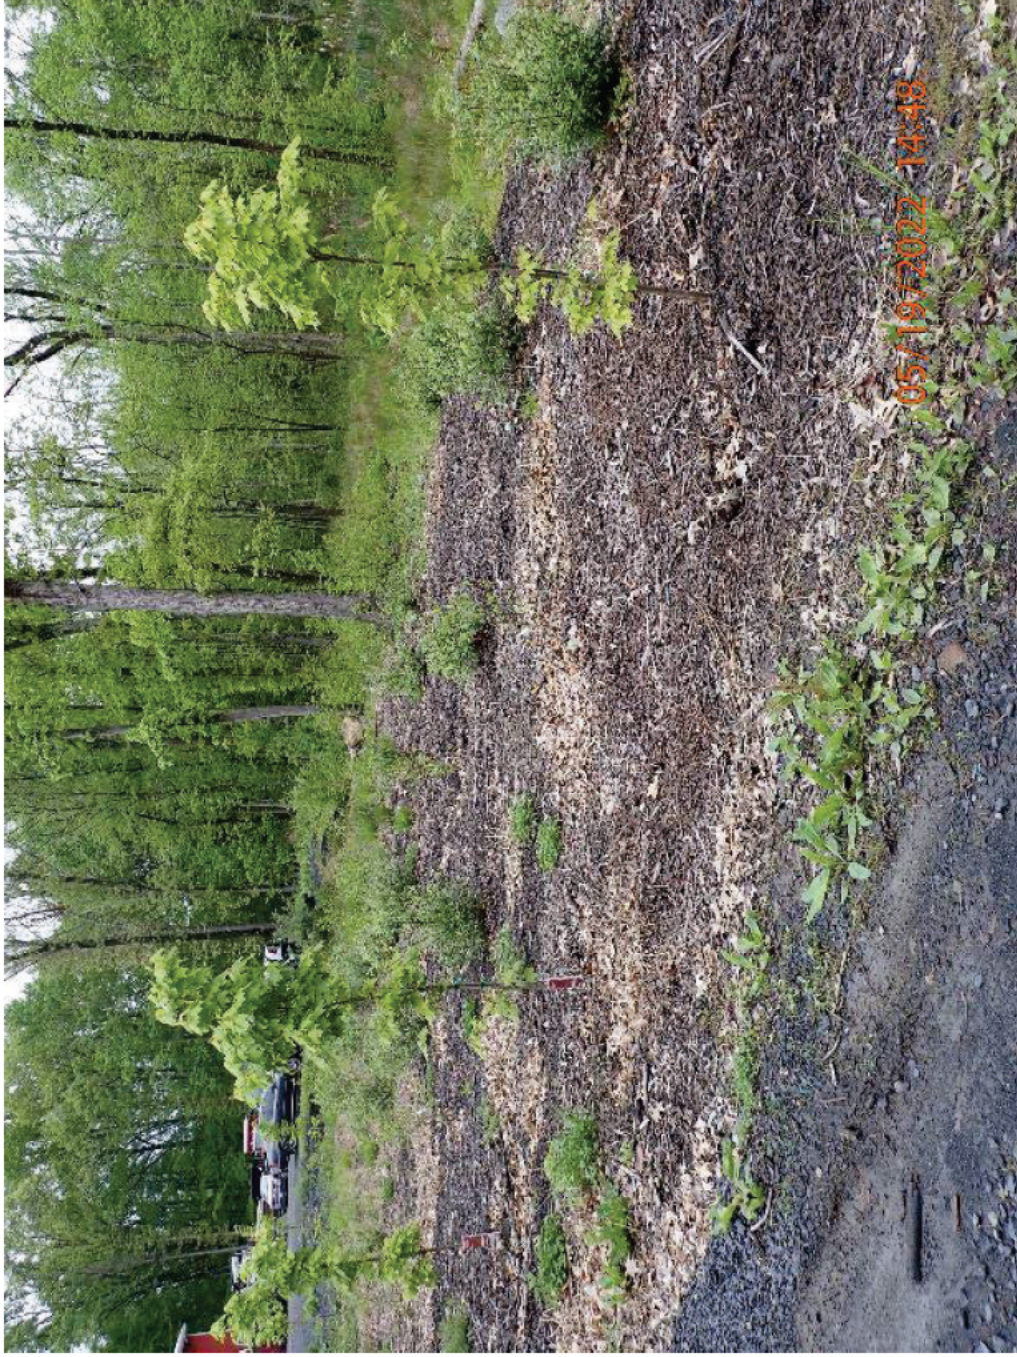
**Date:** 5/19/2022  
**Time:** 2:48 PM  
**Photographer:** SSA  
**Photo ID:** 6 – P5190342

**Description:**  
Wetland Mitigation Area

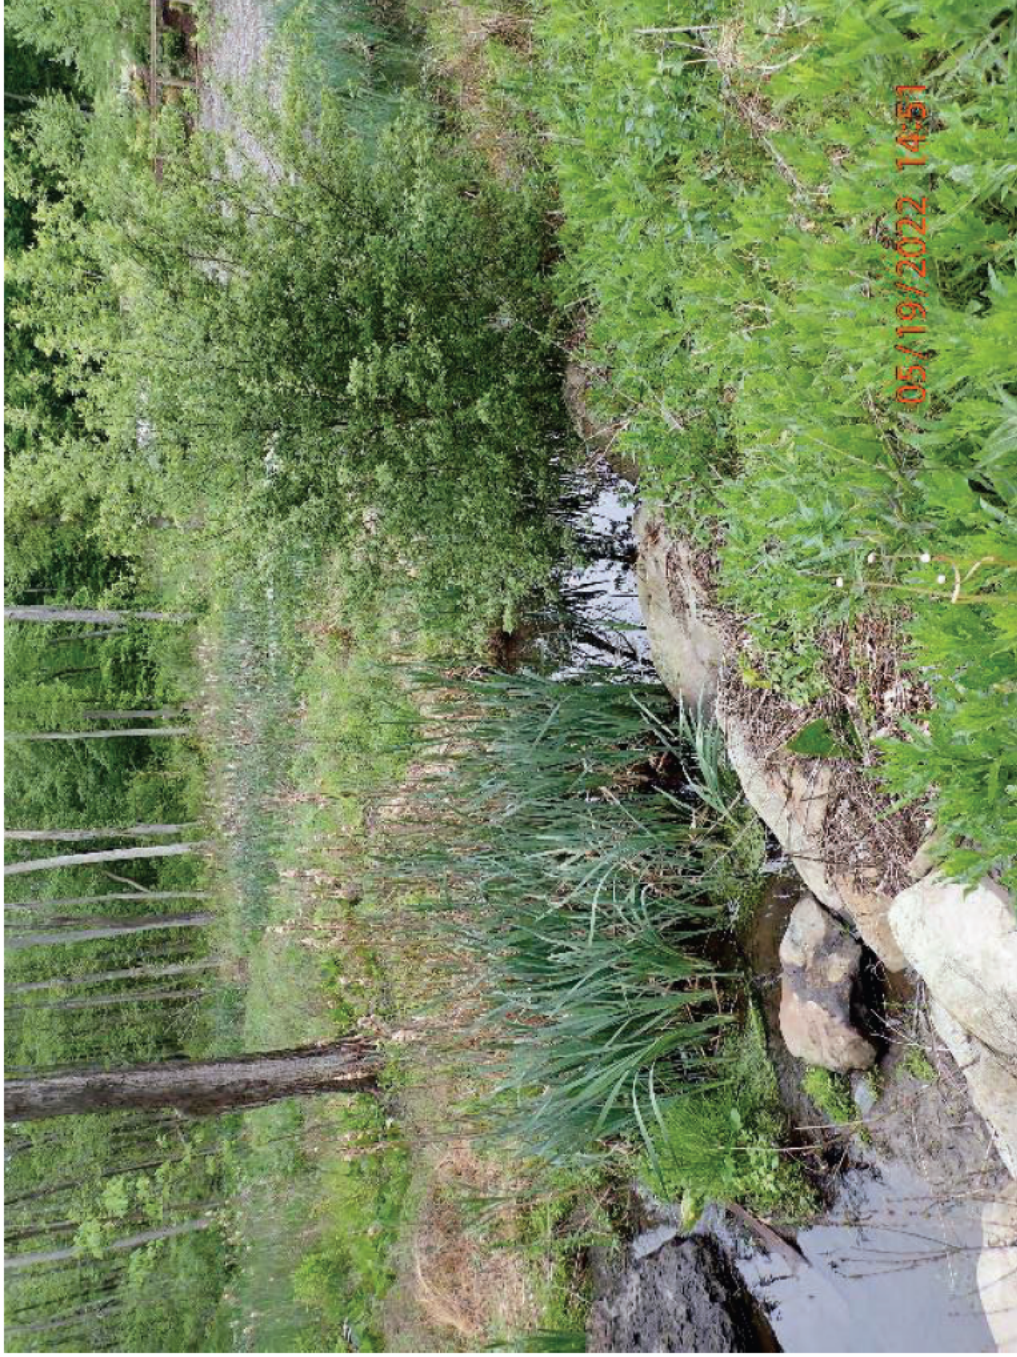
**Date:** 5/19/2022  
**Time:** 2:51 PM  
**Photographer:** SSA  
**Photo ID:** 9 – P5190345

**Description:**  
(3/3) Panorama of stream  
restoration area
