### INSPECTION REPORT

| <b>Company Name:</b> | Fairbanks Gold Mining, Inc. | | |
| <b>Facility or Site Name:</b> | Fort Knox Mine | | |

Type of inspection: CEI - Compliance Evaluation Inspection

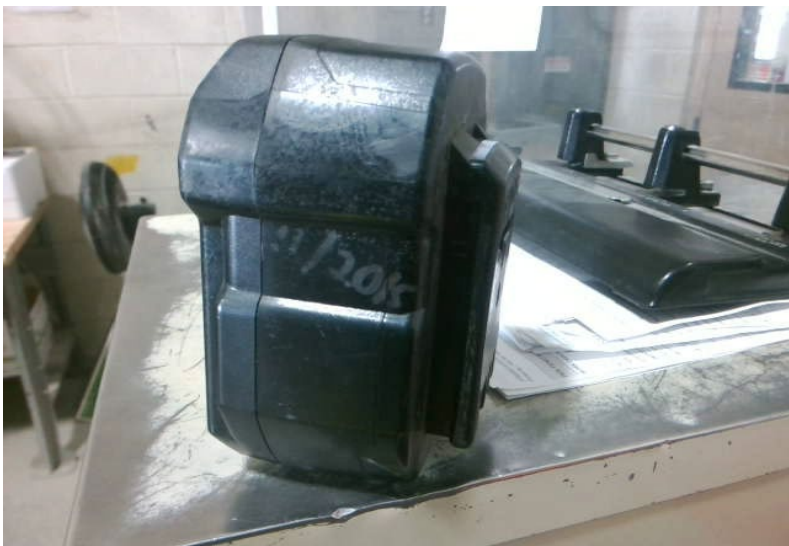
| IMG-20220510113805385172305.jpg | |

A battery was found inside the container that was marked with the date 11/2015. He found that the battery dated 11/2015 was from the onsite paramedics. Mr. Kinsey said he was told by the paramedics that the 11/2015 date marked on the side of the battery was the date it was placed into the equipment and not the date that it became a waste.

| View of waste battery marked with the date 11/2015. | |

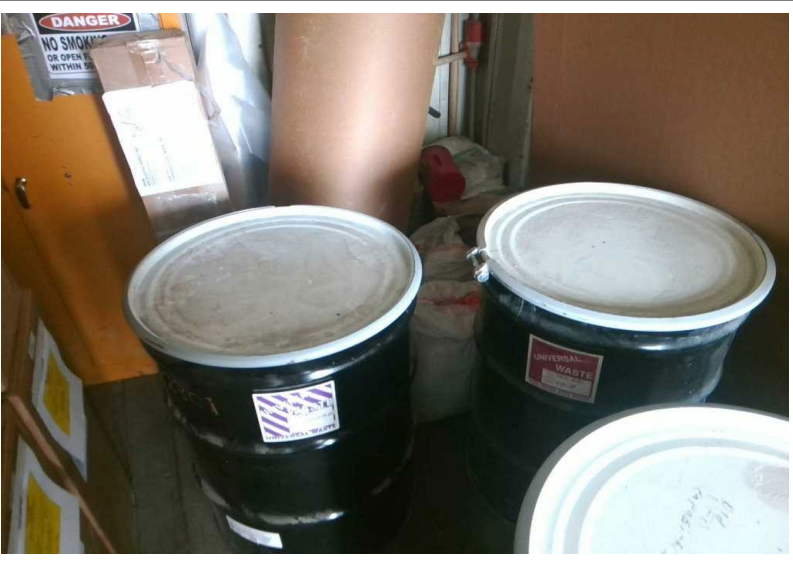
| <p>[Title]</p> <p>IMG-20220510120052052777810.jpg</p> <p>05/10/2022 12:00 PM (AKT)</p> <p>Jon Jones</p> <p>Barrel Storage Yard</p> <p>No CBI</p> <p>No PII</p> <p>View of two, 55-gallon containers holding universal waste bulbs that have been in accumulation for greater than one year.</p> | |

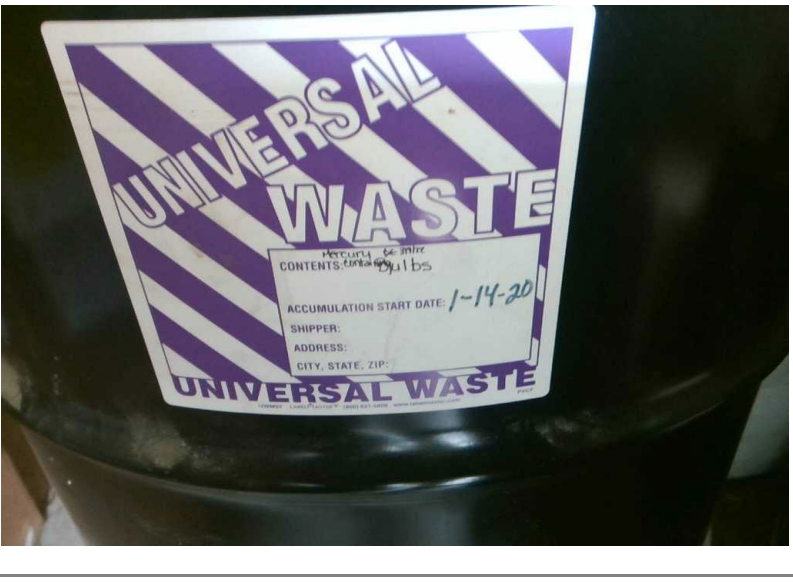
| <p>[Title]</p> <p>IMG-2022051012010111635820.jpg</p> <p>05/10/2022 12:01 PM (AKT)</p> <p>Jon Jones</p> <p>Barrel Storage Yard</p> <p>No CBI</p> <p>No PII</p> <p>Close-up view of the label, showing the accumulation start date of 1-14-20, indicating that the universal waste bulbs have been in accumulation for greater than one year.</p> | |

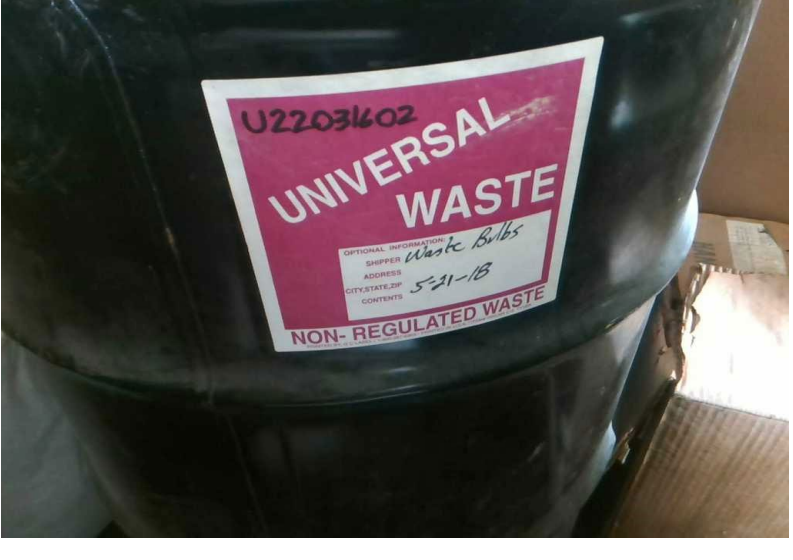
| <p>[Title]</p> <p>IMG-2022051012010717609325.jpg</p> <p>05/10/2022 12:01 PM (AKT)</p> <p>Jon Jones</p> <p>Barrel Storage Yard</p> <p>No CBI</p> <p>No PII</p> <p>Close-up view of the label, showing the accumulation start date of 5-21-18, indicating that the universal waste bulbs have been in accumulation for greater than one year.</p> | |

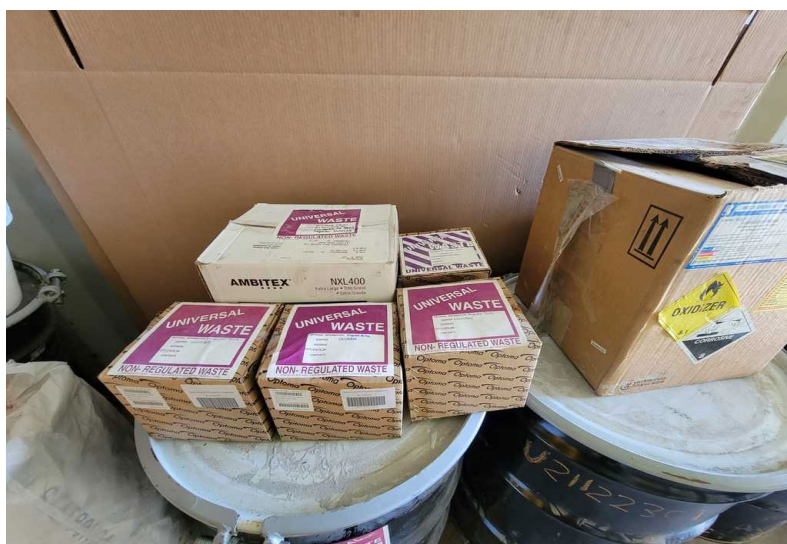
| Photo provided by facility, showing that the box containing the four-foot waste fluorescent lamps had been labeled as universal waste. |

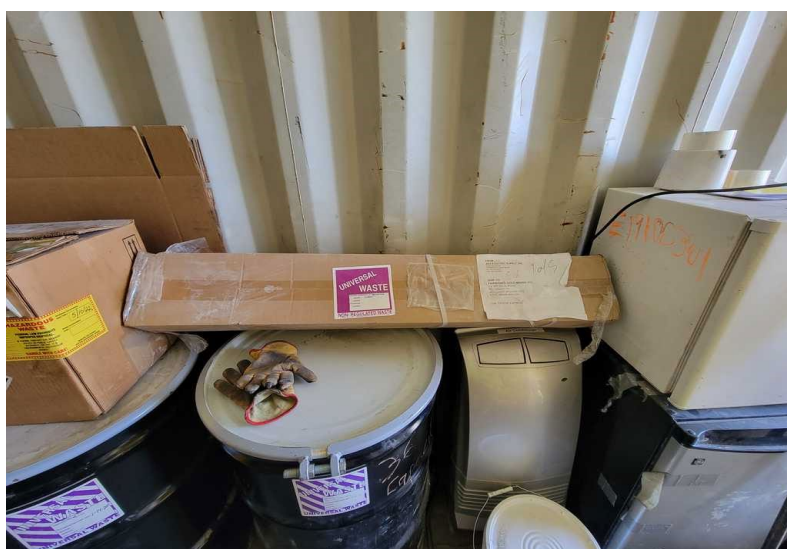
Labels in Connex 4.jpg

Photo provided by facility, showing that the eight boxes containing the waste refinery filters had been marked with hazard indicators.

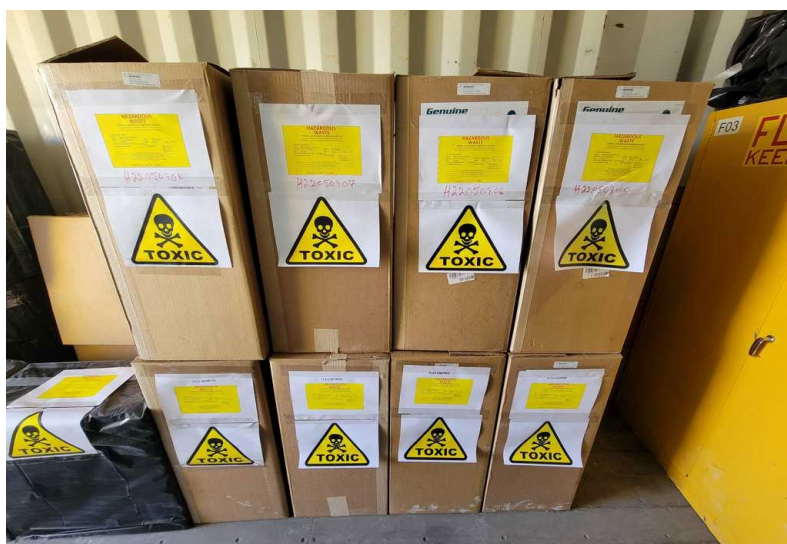
Labels in Connex 5.jpg

Photo provided by facility, showing that the five boxes containing the waste HEPA filters and three bags containing the waste UHF filters had been marked with hazard indicators.

| <p>Three bags of UHF (Ultra High Efficiency Filters) filters, each labeled as hazardous waste but not marked with a hazard indicator.</p> <p>Five boxes of HEPA filters, each labeled as hazardous waste but not marked with a hazard indicator.</p> <p>Eight boxes of refinery filters, each labeled as hazardous waste but not marked with a hazard indicator.</p> | <b>Citations:</b><br><br>262.16(b)(6)(i)(B) | <b>Sections:</b> |

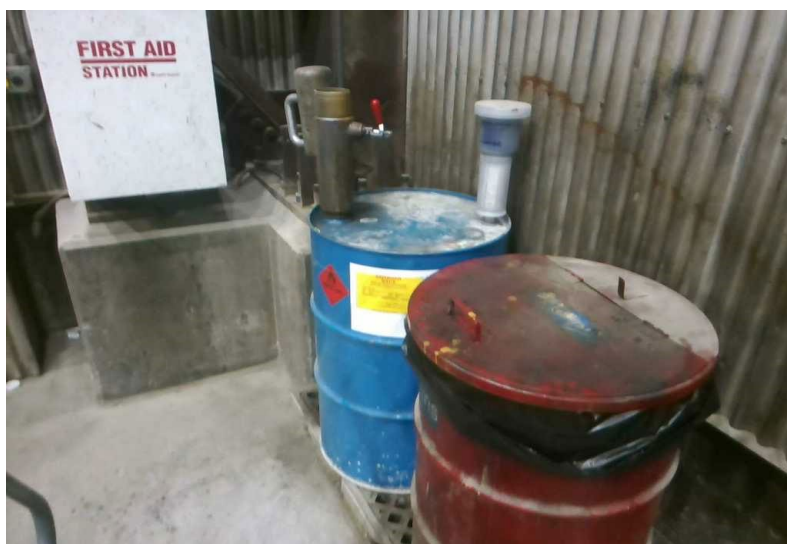
| IMG-202205101114361436762020.jpg |

| <p>While in the ALPM, I saw a 55-gallon container with an attached aerosol can popper. At the time of the inspection, the apparatus that punctures the waste aerosol cans was open and thus the container was not closed.</p> <p>Mr. Collingwood closed the container during the inspection.</p> | |

| View of 55-gallon container with attached aerosol can popper. The apparatus that punctures the waste aerosol cans, seen to the left, is open and thus the container is not closed. |

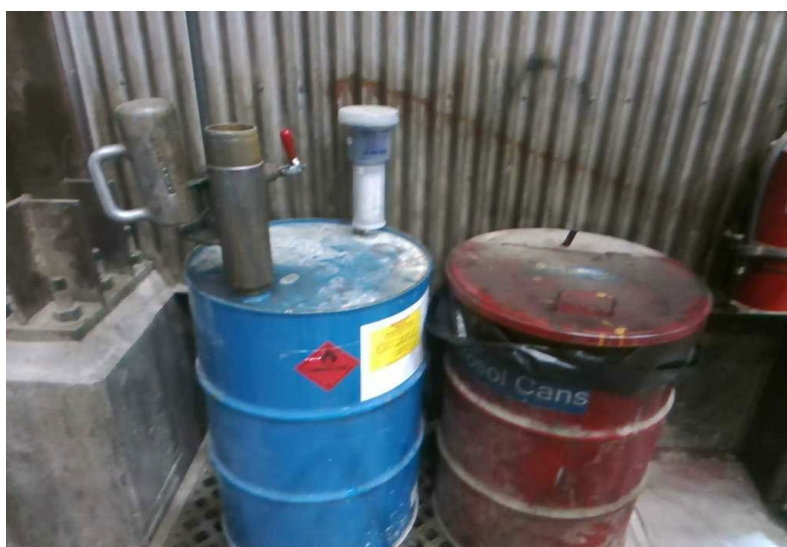
| IMG-202205101114451445837622.jpg |

| Another view of 55-gallon container with attached aerosol can popper. The apparatus that punctures the waste aerosol cans, seen to the left, is open and thus the container is not closed. |

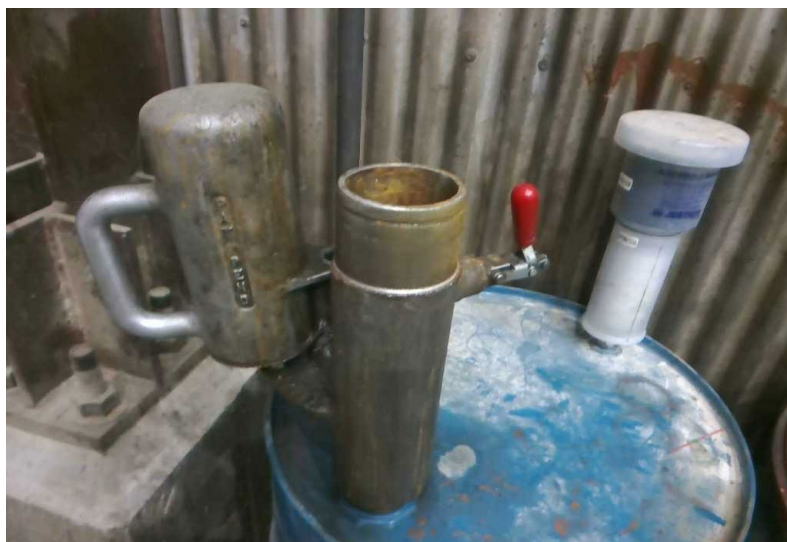
| IMG-202205101114531453852449.jpg |

| Close-up view of 55-gallon container with attached aerosol can popper. The apparatus that punctures the waste aerosol cans, seen to the left, is open and thus the container is not closed. |

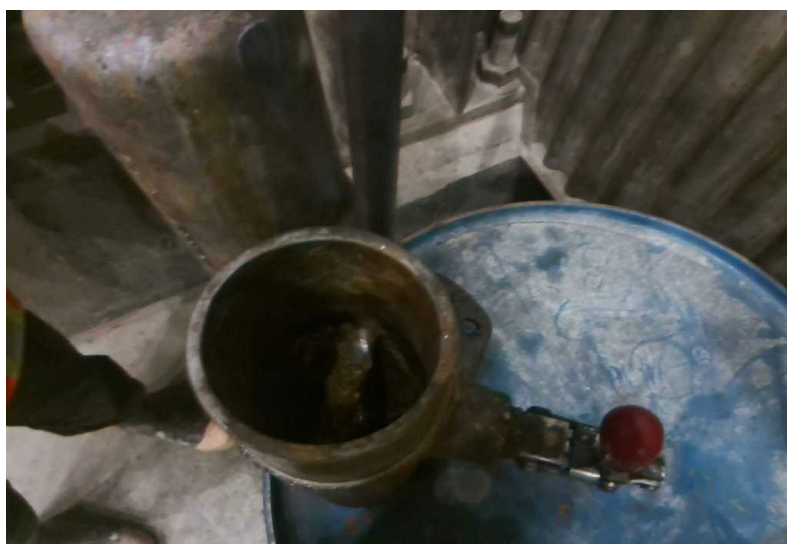
| IMG-202205101115451545714395.jpg |

| Close-up view, looking down into the attached aerosol can popper. The apparatus that punctures the waste aerosol cans is open and thus the container is not closed. |

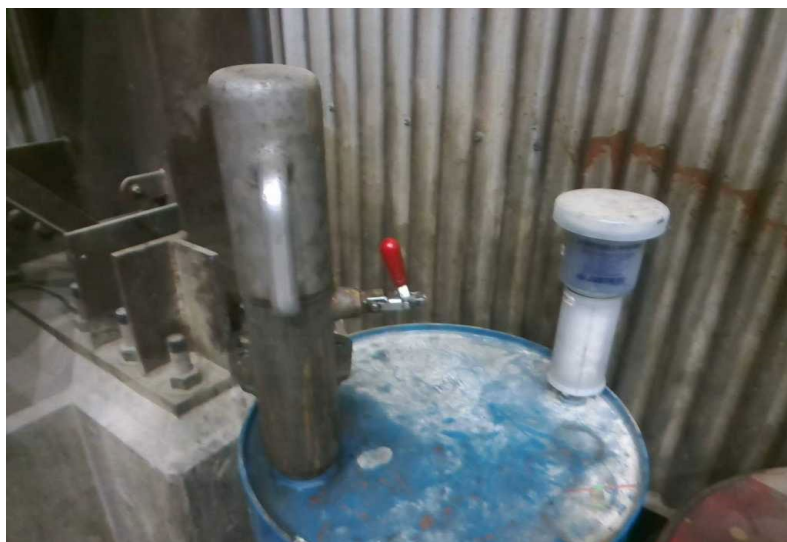
| IMG-202205101117411741757640.jpg |

| View of the attached aerosol can popper after Mr. Collingwood closed it during the inspection. |

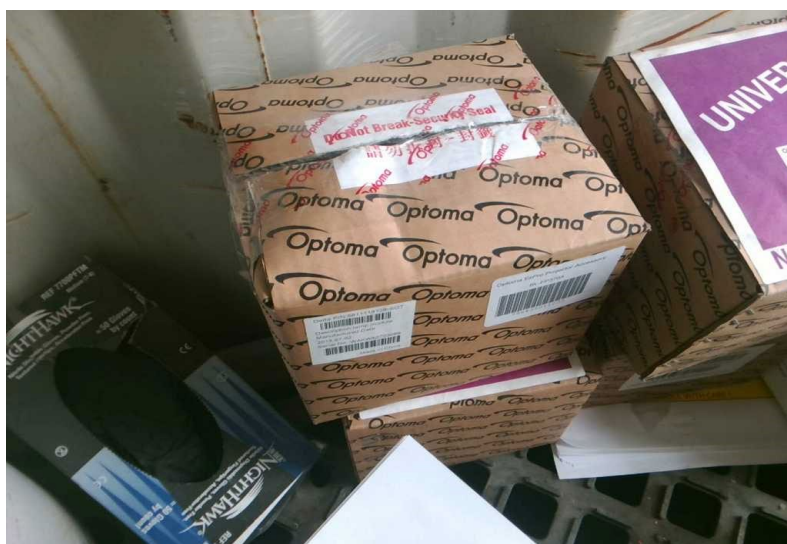
| IMG-20220510120646646903985.jpg |

| View of a small cardboard box containing a waste projector bulb that is not labeled as either "Universal Waste – Lamp," "Waste Lamp," or "Used Lamp." |

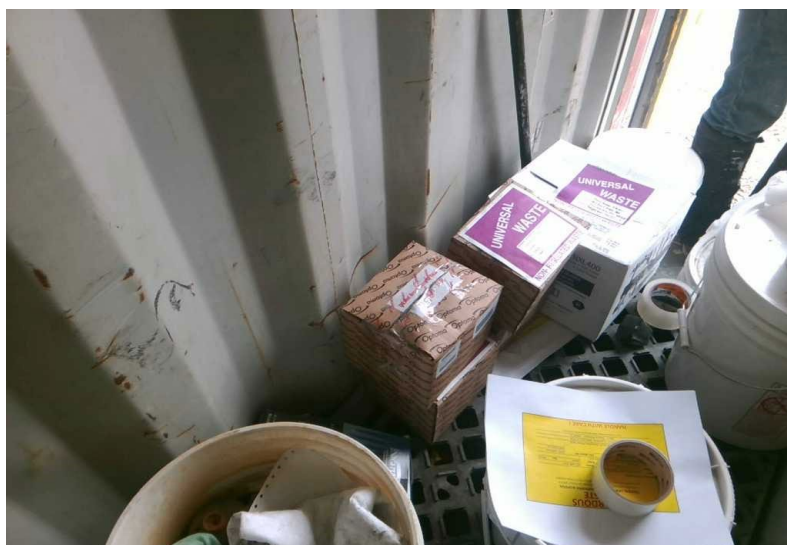
| IMG-20220510120759759740640.jpg |

| Another view of a small cardboard box containing a waste projector bulb that is not labeled as either "Universal Waste – Lamp," "Waste Lamp," or "Used Lamp." |

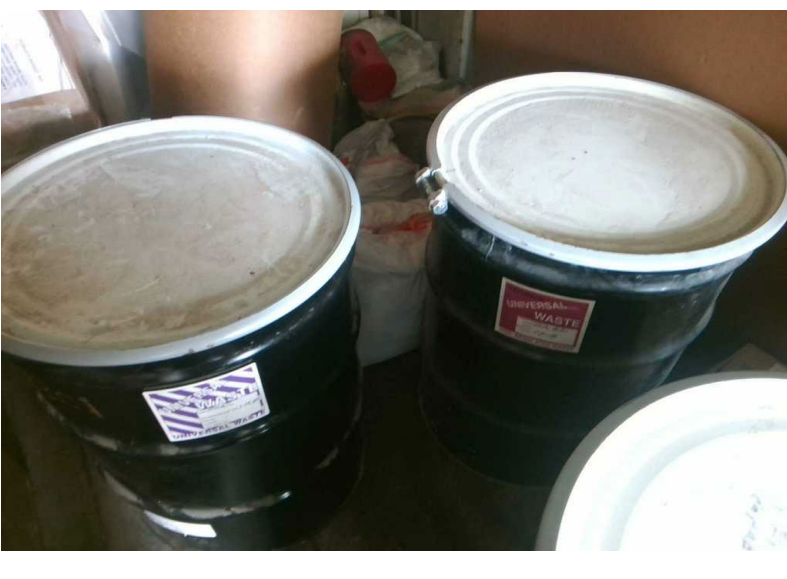
| <p>[Title]</p> <p>IMG-20220510120848848695723.jpg</p> <p>05/10/2022 12:08 PM (AKT)</p> <p>Jon Jones</p> <p>Barrel Storage Yard</p> <p>No CBI</p> <p>No PII</p> <p>View of two, 55-gallon containers of universal waste bulbs. One dated 1/14/20 and the other dated 5/21/18. Both have been in accumulation for greater than one year.</p> | |

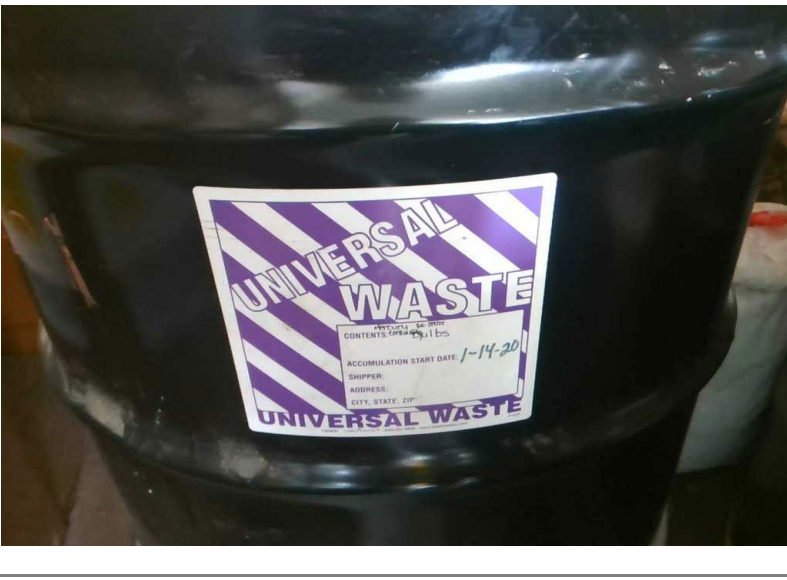
| <p>[Title]</p> <p>IMG-20220510120855855585888.jpg</p> <p>05/10/2022 12:08 PM (AKT)</p> <p>Jon Jones</p> <p>Barrel Storage Yard</p> <p>No CBI</p> <p>No PII</p> <p>Close-up view of the universal waste container dated 1/14/20.</p> | |

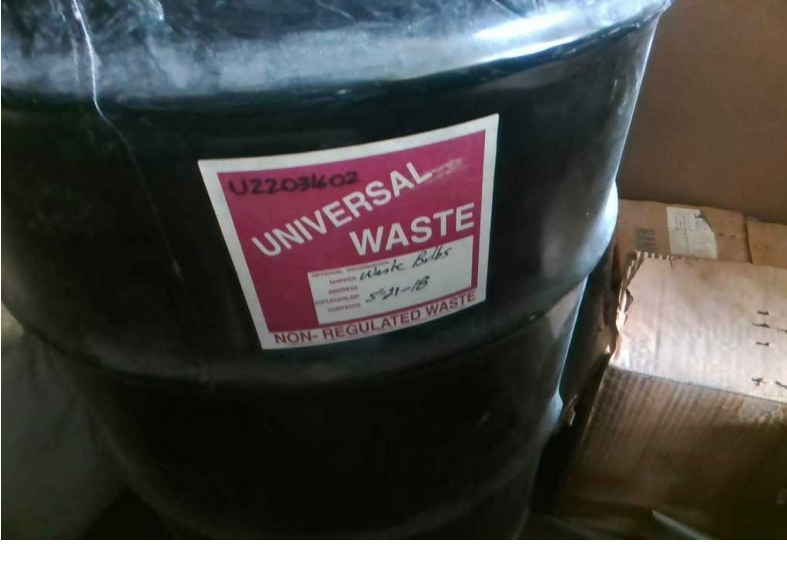
| <p>[Title]</p> <p>IMG-2022051012090292592115.jpg</p> <p>05/10/2022 12:09 PM (AKT)</p> <p>Jon Jones</p> <p>Barrel Storage Yard</p> <p>No CBI</p> <p>No PII</p> <p>Close-up view of the universal waste container dated 5/21/18.</p> | |

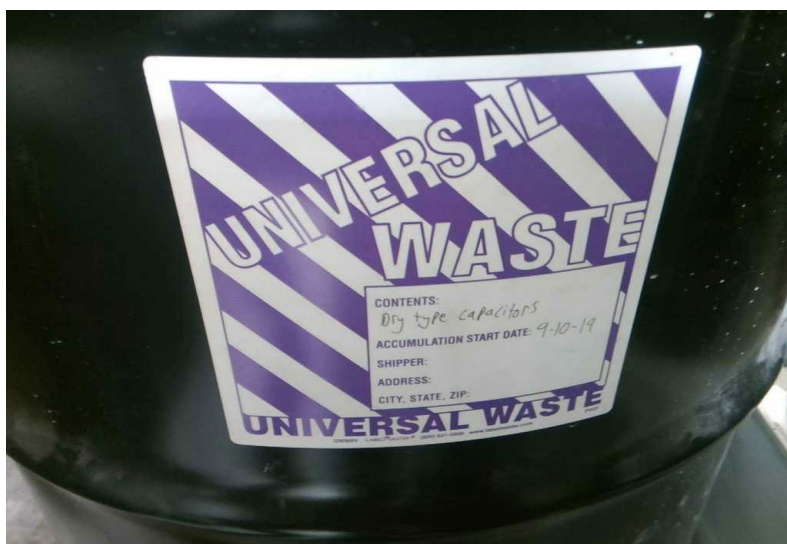
| IMG-202205101212291229670066.jpg |

| Close-up view of the label on the 55-gallon container of capacitors (dry type) labeled as universal waste and dated 9/10/19. |

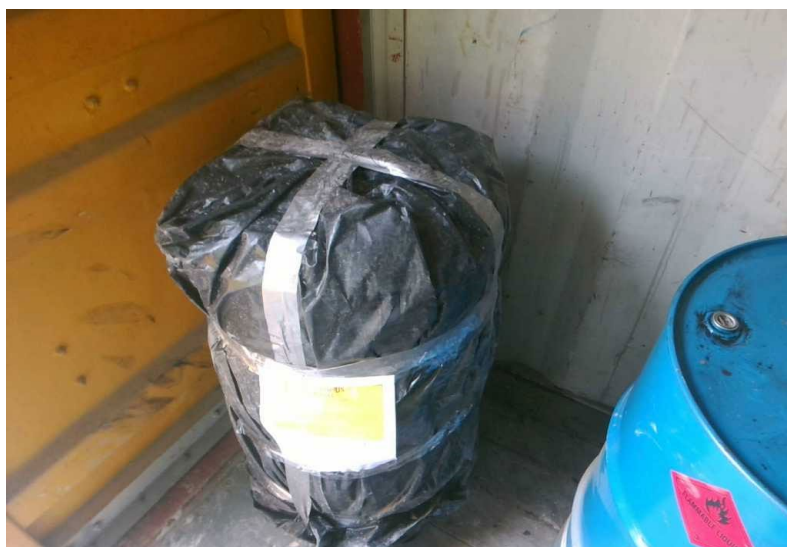
| IMG-202205101222442244812546.jpg |

| View of one of the three bags of waste UHF filters showing that it is not marked with a hazard indicator. |

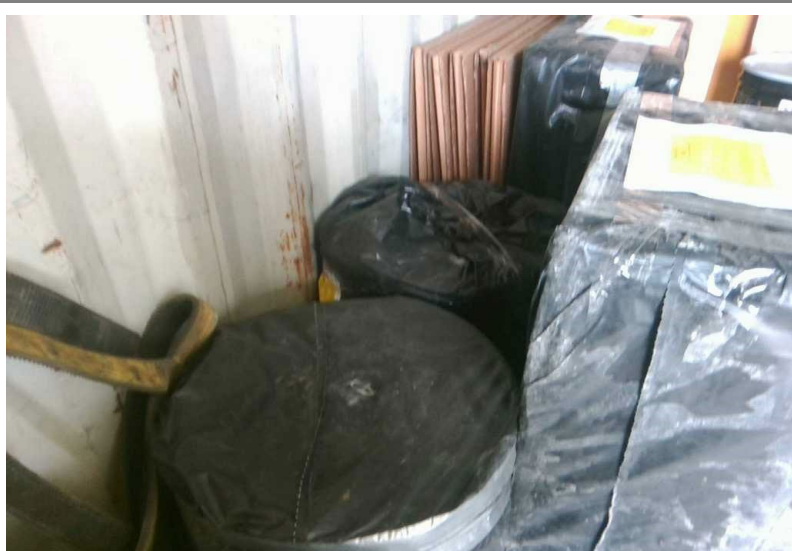
| IMG-202205101222492249768163.jpg |

| View of the other two bags containing the waste UHF filters. |

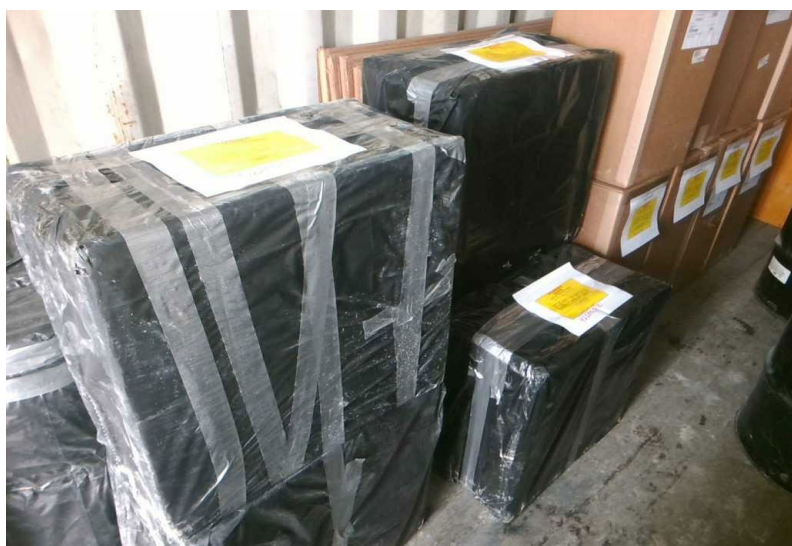
| IMG-202205101222572257985837.jpg |

| View of the five boxes of waste HEPA filters, showing that they are not marked with hazard indicators. |

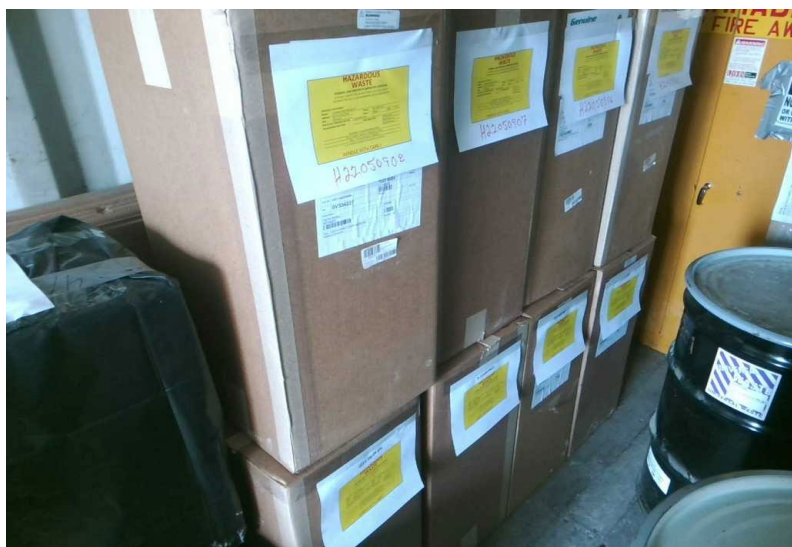
| IMG-20220510122307237929588.jpg |

| View of the eight boxes of waste refinery filters that are not marked with hazard indicators. |

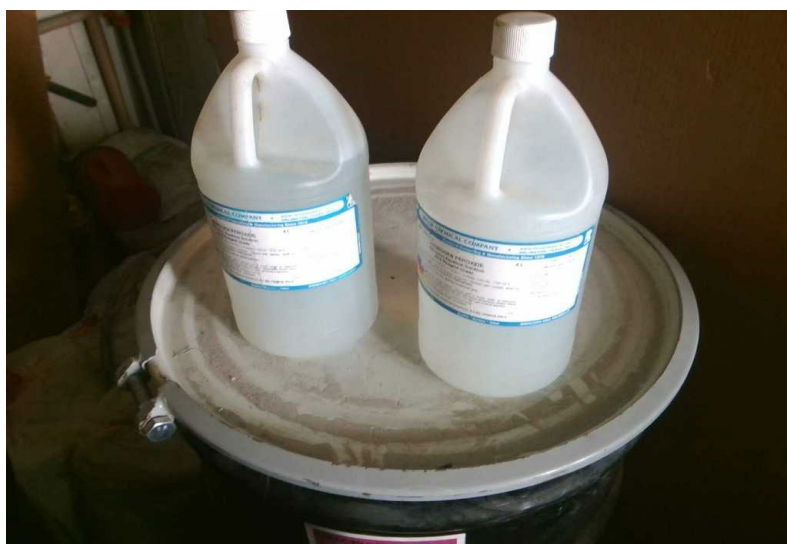
- Two waste containers of Hydrogen Peroxide. Facility personnel didn't know how long the waste had been in the Conex. At the time of the inspection, the facility had not performed a waste determination for the containers of Hydrogen Peroxide. I received photo documentation from the facility on 5/11/22 showing that the box containing two waste containers of Hydrogen Peroxide were labeled with the words "Hazardous Waste" and marked with hazard indicators.

| Close-up view of the two, one-gallon containers of waste Hydrogen Peroxide. |

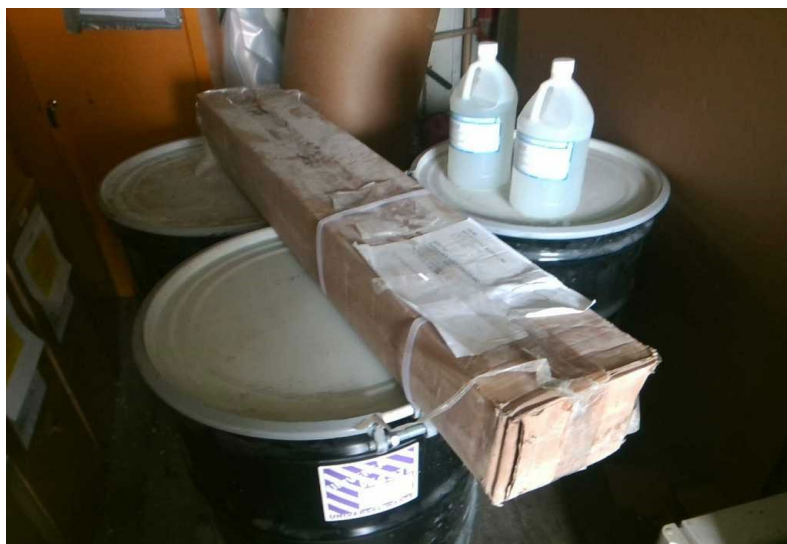
| IMG-202205101234323432686353.jpg |

- One box of four-foot, waste fluorescent lamps that was not labeled as either "Universal Waste – Lamps," "Used Lamps," or "Waste Lamps." The box of waste lamps was not dated, and facility personnel didn't know how old the box of lamps was. Non-hazardous waste manifest #173316B indicated that the last shipment of universal waste lamps left the facility on 12/09/21. I received photo documentation from the facility on 5/11/22 showing that the box was labeled as universal waste.

| View of box containing waste fluorescent lamps that is not labeled as either "Universal Waste – Lamps," "Waste Lamps," or "Used Lamps." |

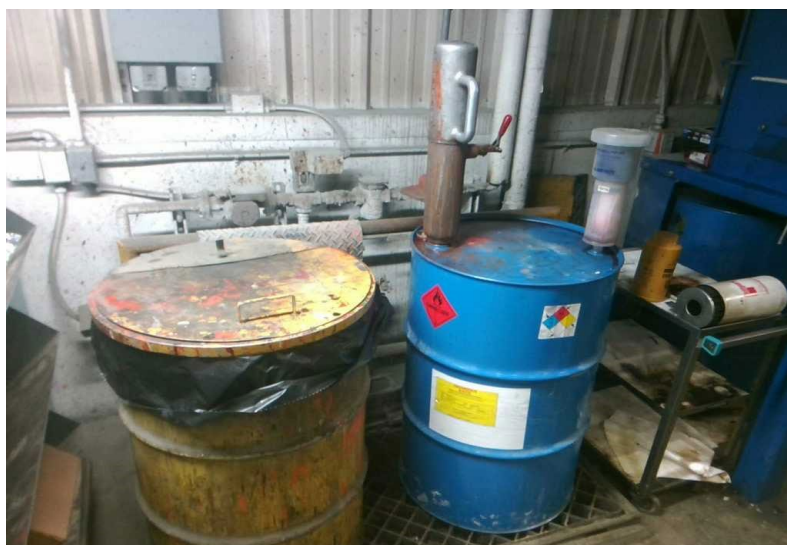
| IMG-202205101100510511000401.jpg |

| View of 55-gallon SAA container with attached aerosol can popper, adjacent to another container where the punctured cans are collected. According to Mr. Collingwood, the punctured aerosol cans are disposed of into the trash and not recycled. |

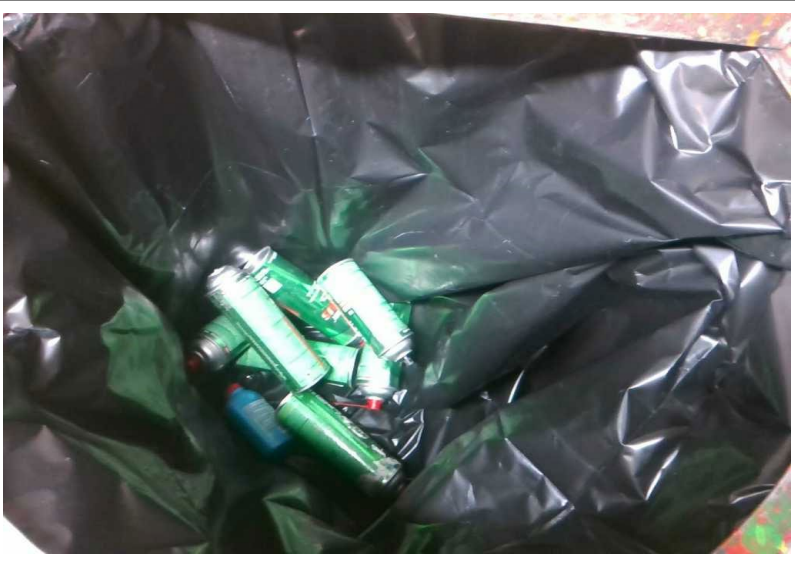
| <p>[Title]</p> <p>IMG-2022051011010313798348.jpg</p> <p>05/10/2022 11:01 AM (AKT)</p> <p>Jon Jones</p> <p>MEM shop - Mine Equipment Maintenance</p> <p>No CBI</p> <p>No PII</p> <p>View of the punctured aerosols in the trash.</p> | |

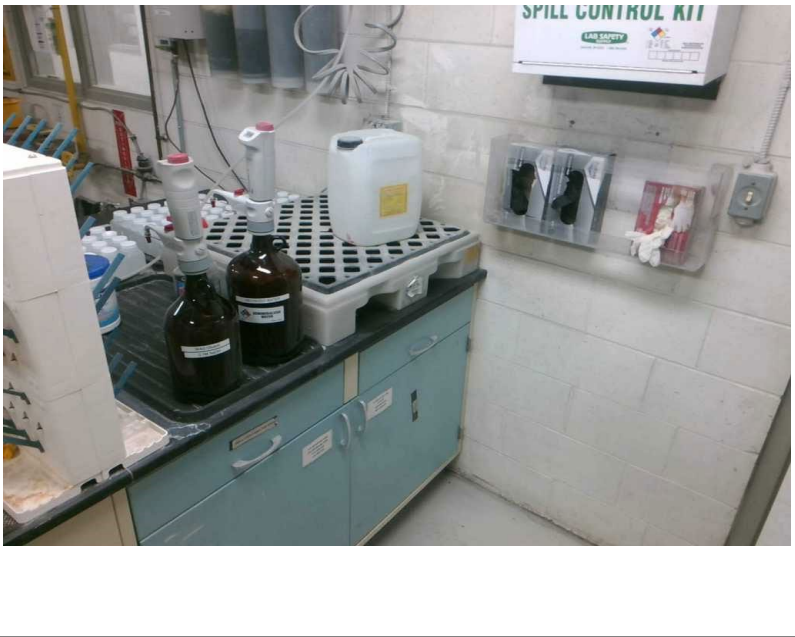
| <p>[Title]</p> <p>IMG-202205100927252725749808.jpg</p> <p>05/10/2022 09:27 AM (AKT)</p> <p>Jon Jones</p> <p>Mill Lab</p> <p>No CBI</p> <p>No PII</p> <p>View of a five-liter container that was being used as a satellite accumulation container for waste DIBK. The container seen here on the spill pallet, held several ounces of the waste. The container is seen here labeled with the words "Hazardous Waste."</p> | |

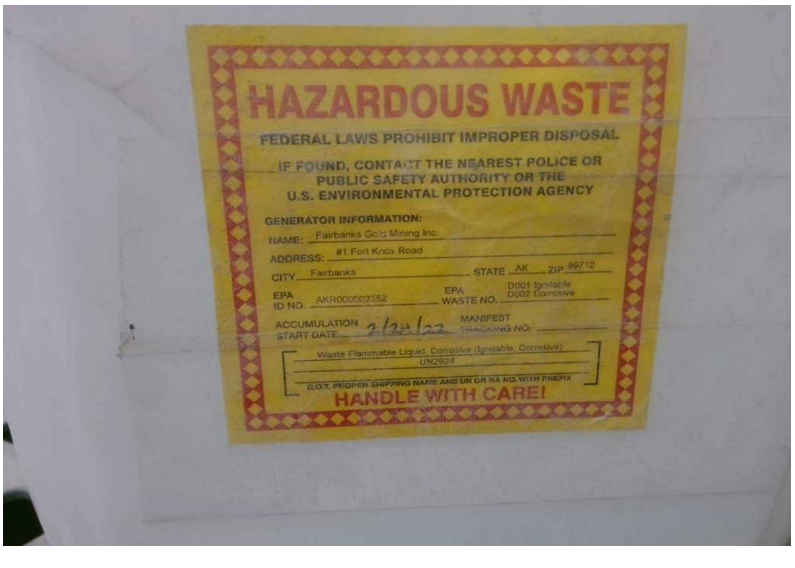
While at the Mill lab I met with Mr. Andrew Ivey, Lab supervisor. At the time of the inspection, I saw what Andrew Ivey, Lab Supervisor, said was a 5-liter container that was being used as a satellite accumulation container for the waste Diisobutyl Ketone (DIBK). The container held several ounces of the waste. The container was labeled with the words "Hazardous Waste," and was dated 2/24/22. Even though dated, the container was verified by Mr. Ivey as being a SAA container. The container was not marked with a hazard indicator.

| <p>At the time of the inspection, I saw a 5-liter container that was being used as a satellite accumulation container for waste Diisobutyl Ketone (DIBK). The container was not marked with a hazard indicator.</p> | <b>Citations:</b><br><br>262.16(b)(6)(i)(B) | <b>Sections:</b> |

| <p>[Title]</p> <p>IMG-202205100927362736668940.jpg</p> <p>05/10/2022 09:27 AM (AKT)</p> <p>Jon Jones</p> <p>Mill Lab</p> <p>No CBI</p> <p>No PII</p> <p>Close-up view of the container label, showing that there is no hazard indicator.</p> | |

| Mr. Ivey, applied a hazard indicator to the SAA container during the inspection. | | |

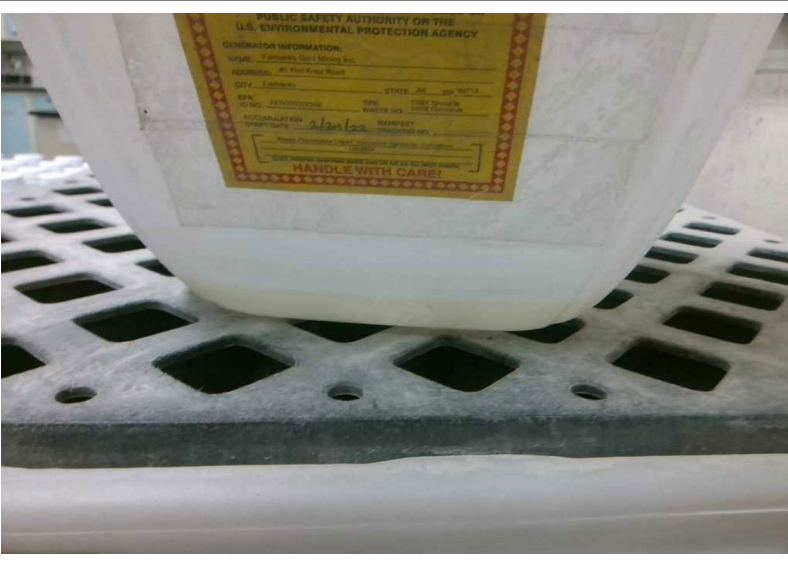
| <p>[Title]</p> <p>IMG-202205100927592759642185.jpg</p> <p>05/10/2022 09:27 AM (AKT)</p> <p>Jon Jones</p> <p>Mill Lab</p> <p>No CBI</p> <p>No PII</p> <p>Close-up view showing the liquid level in the container.</p> | |

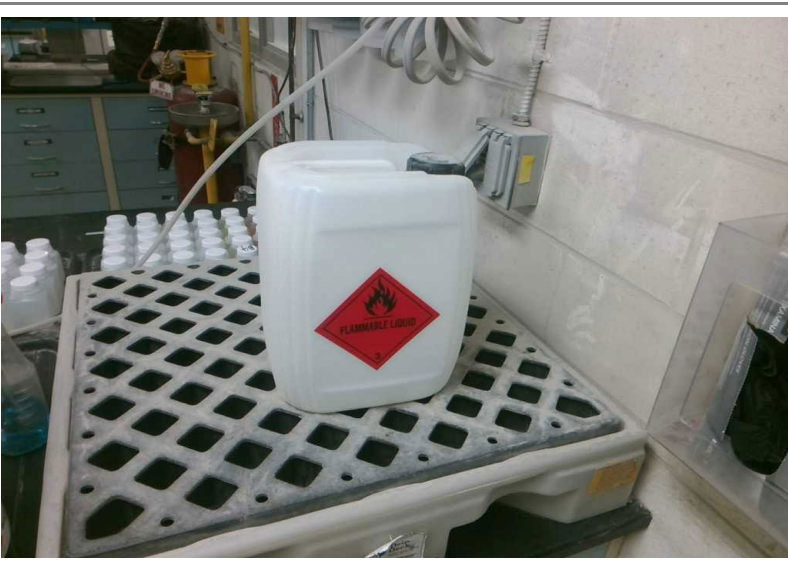
| <p>[Title]</p> <p>IMG-202205100930453045801166.jpg</p> <p>05/10/2022 09:30 AM (AKT)</p> <p>Jon Jones</p> <p>Mill Lab</p> <p>No CBI</p> <p>No PII</p> <p>Mr. Ivey, applied a hazard indicator to the opposite side of the SAA container during the inspection.</p> | |

Mr. Ivey applied a hazard indicator to the SAA container during the inspection.

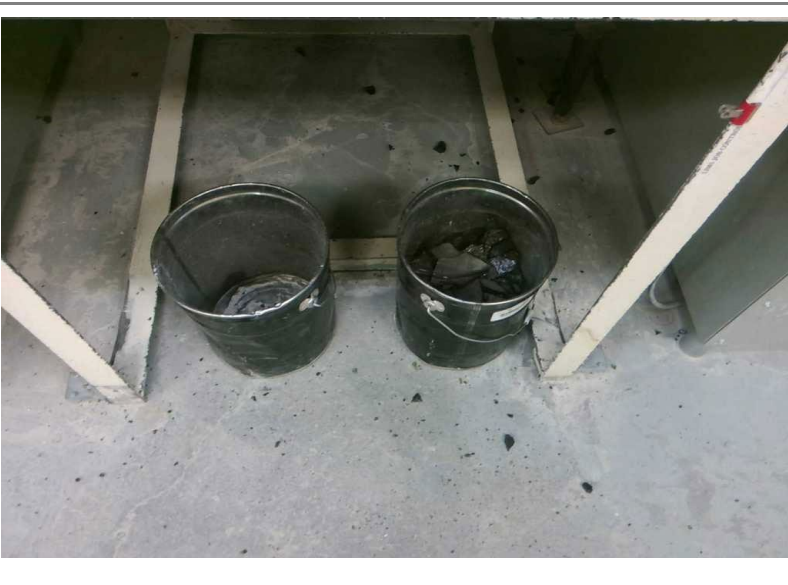
| <p>[Title]</p> <p>IMG-202205100940284028680806.jpg</p> <p>05/10/2022 09:40 AM (AKT)</p> <p>Jon Jones</p> <p>Mill/Fire Assay</p> <p>No CBI</p> <p>No PII</p> <p>Another close-up view of the containers that were being used to accumulate slag. According to Mr. Ivey, the slag is returned to the process.</p> | |

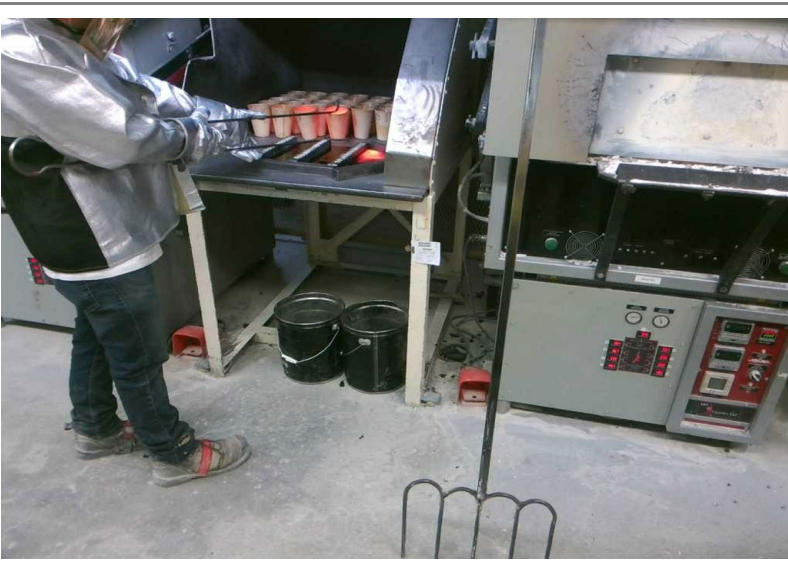
| <p>[Title]</p> <p>IMG-202205100942304230871304.jpg</p> <p>05/10/2022 09:42 AM (AKT)</p> <p>Jon Jones</p> <p>Mill/Fire Assay</p> <p>No CBI</p> <p>No PII</p> <p>Another view of the containers that were being used to accumulate slag. According to Mr. Ivey, the slag is returned to the process.</p> | |

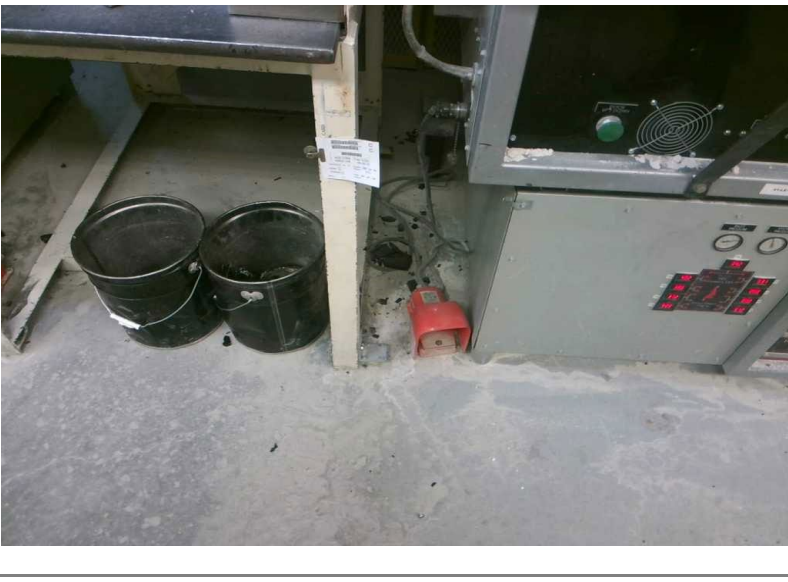
| <div>[Title]</div> <div>IMG-202205100944134413692705.jpg</div> <div>05/10/2022 09:44 AM (AKT)</div> <div>Jon Jones</div> <div>Mill/Fire Assay</div> <div>No CBI</div> <div>No PII</div> <div>Another close-up view of the containers that were being used to accumulate slag. According to Mr. Ivey, the slag is returned to the process.</div> | |

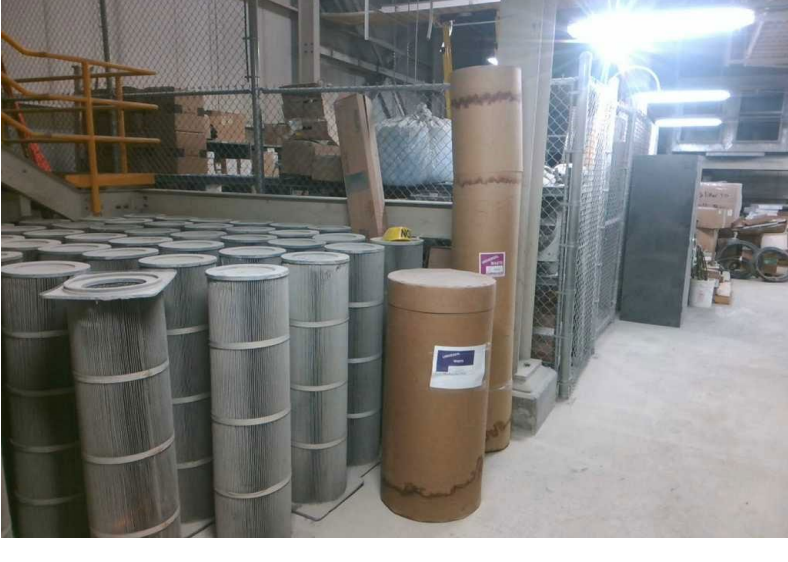
| <div>[Title]</div> <div>IMG-202205101253325332903401.jpg</div> <div>05/10/2022 12:53 PM (AKT)</div> <div>Jon Jones</div> <div>Mill/MCC -Motor Control Center</div> <div>No CBI</div> <div>No PII</div> <div>View of containers that hold universal waste lamps.</div> | |

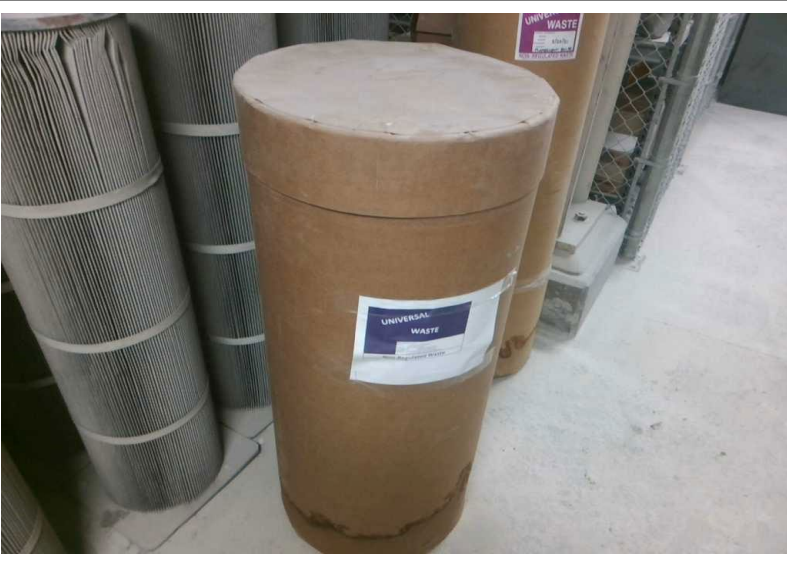
| <p>[Title]</p> <p>IMG-202205101253415341733260.jpg</p> <p>05/10/2022 12:53 PM (AKT)</p> <p>Jon Jones</p> <p>Mill/MCC -Motor Control Center</p> <p>No CBI</p> <p>No PII</p> <p>View of an undated container of four-foot waste fluorescent lamps that's being managed as universal waste.</p> | |

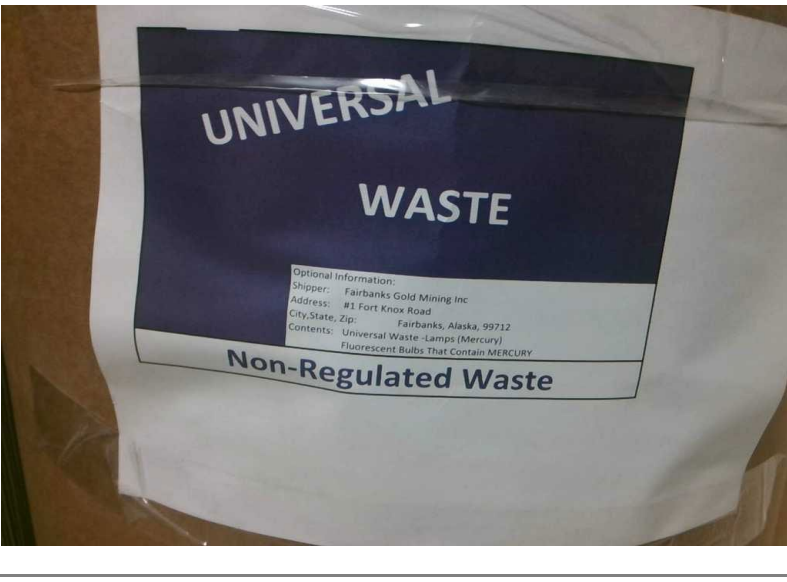
The container of four-foot waste lamps was not dated. Mr. Kinsey said the container of four-foot waste lamps was only about six months old at the most. Non-hazardous waste manifest #173316B indicated that the last shipment of universal waste lamps left the facility on 12/09/21. I received photo documentation from the facility on 5/11/22 showing that the container was marked with the date 12/09/21.

| <p>[Title]</p> <p>IMG-202205101253485348518739.jpg</p> <p>05/10/2022 12:53 PM (AKT)</p> <p>Jon Jones</p> <p>Mill/MCC -Motor Control Center</p> <p>No CBI</p> <p>No PII</p> <p>Close-up view of the label on the container of four-foot waste fluorescent lamps.</p> | |

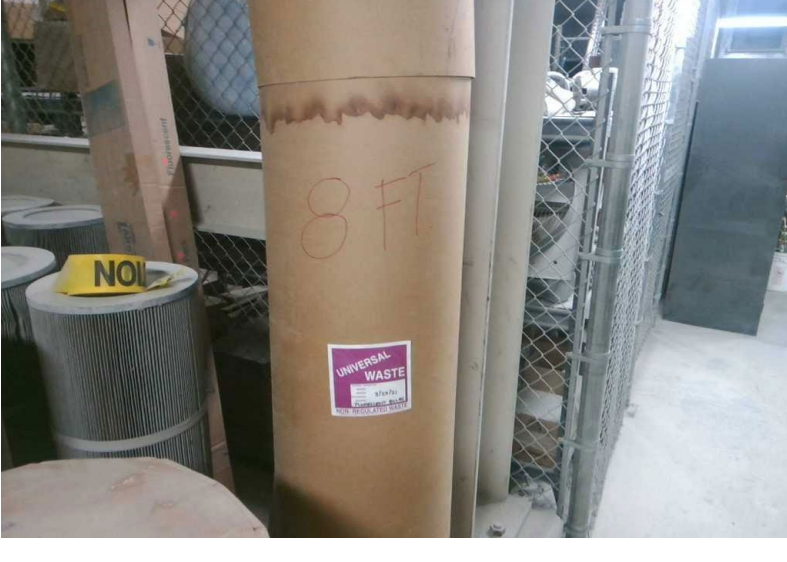
| <p>[Title]</p> <p>IMG-202205101253535353812502.jpg</p> <p>05/10/2022 12:53 PM (AKT)</p> <p>Jon Jones</p> <p>Mill/MCC -Motor Control Center</p> <p>No CBI</p> <p>No PII</p> <p>View of the container holding eight-foot waste fluorescent lamps.</p> | |
