## **RCRA Inspection Report**

PMC Organometallix, Inc.  
2316 or 2314 Highland Avenue  
Carrollton, Kentucky 41008  
EPA ID Number: KYD006373922

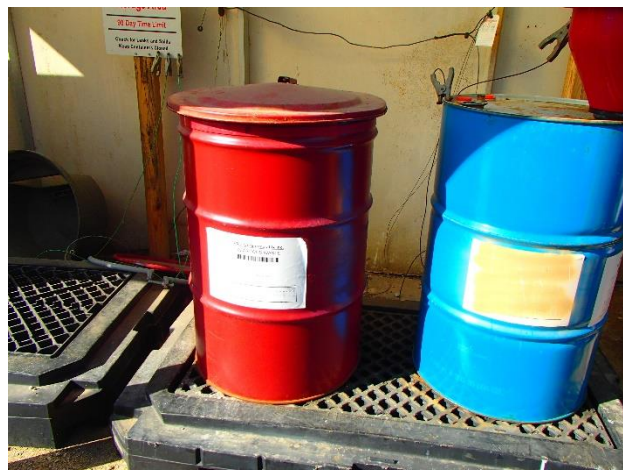
Outside the laboratory, PMC operated a CAA and stored one labeled 55-gallon container of corrosive solids dated 7/20/2021 and one container of nonhazardous waste (Photo 10). There were also three red 55-gallon containers of hazardous waste stored nearby (Photos 11-14). One container was labeled solvent contaminated lab wipes and TRS PPE (F003-flammable solids) and was dated 6/25/2021. When this container was opened, it was partially full of liquids and held a black trash bag of waste. This waste determination as a flammable solid did not match the waste in the container. The lid was unable to be reclosed due to an improperly working drum lid. The second container was labeled as “Methyl Tin Waist” [sic] (D001/D002/waste flammable liquid corrosive), with an indication of the hazards of its contents, and was dated 8/18/2021. This lid for this container was rusting. The third container was labeled as Methyl Tin and was dated

Photo 10, CAA outside Laboratory.

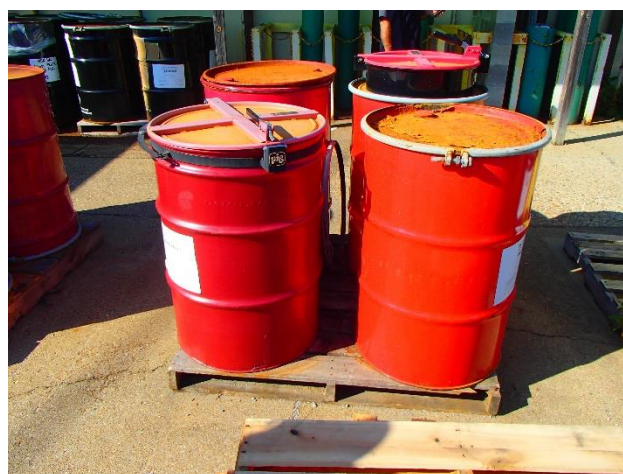
Photo 11: CAA outside Laboratory.

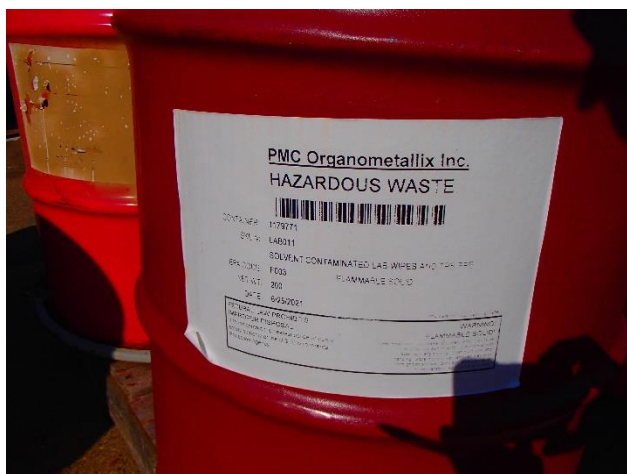
Photo 13: CAA outside Laboratory.

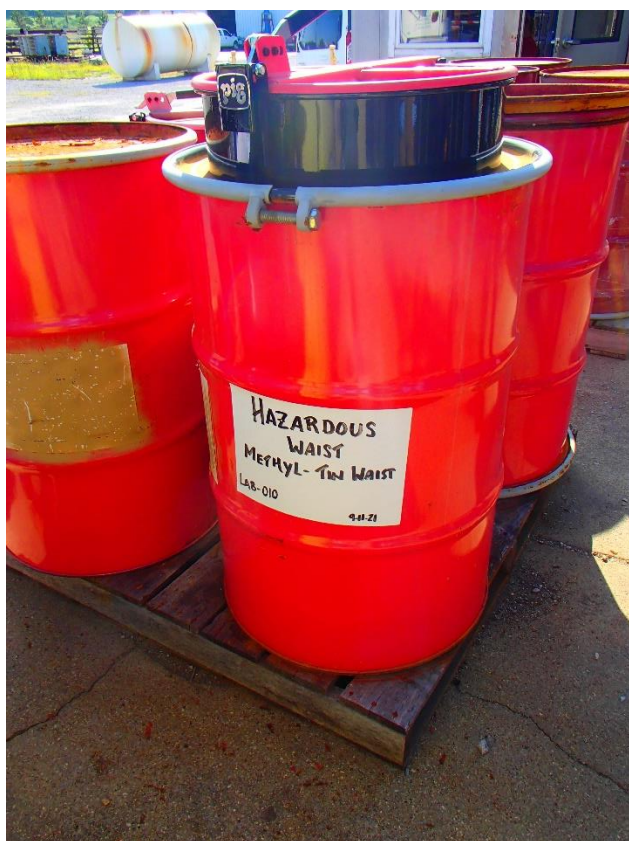
9/11/2021; this container had a Pig closure device on the drum lid (Photo 14). This container was not labeled with an indication of the hazard.

Photo 14: CAA outside Laboratory.

**Pursuant to 401 KAR 39:080, Section 1(1) [40 C.F.R. § 262.17(a)(5)(i)], which is a condition of the LQG Permit Exemption, a generator must mark or label its containers with the following: an indication of the hazards of the contents clearly visible for inspection on each container.**

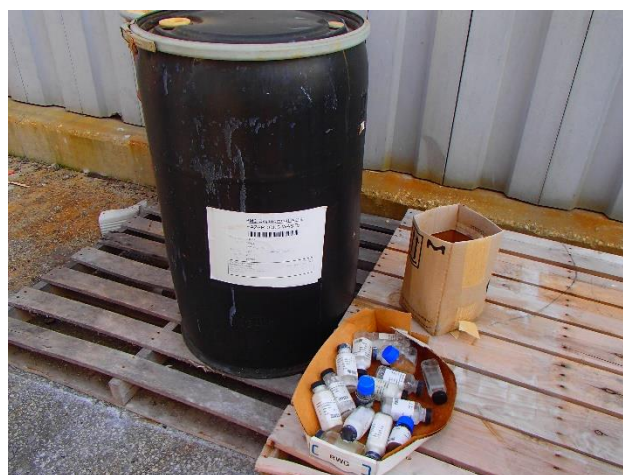
At CAA BD005, the inspection team noted one black poly 55-gallon container of hazardous waste labeled as DBTC and Trash (D002-corrosive solid) and dated 8/12/2021 (Photos 17-18).

Photo 17: BD005 CAA.

Photo 18: BD005 CAA.

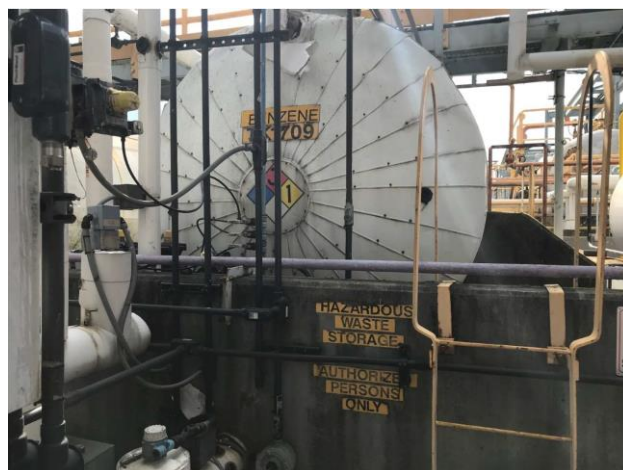
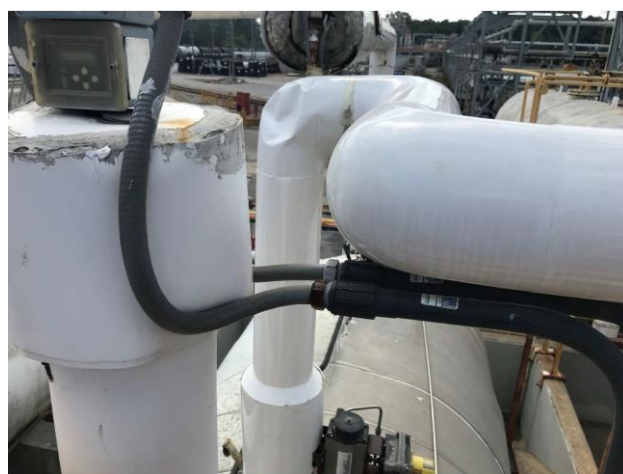
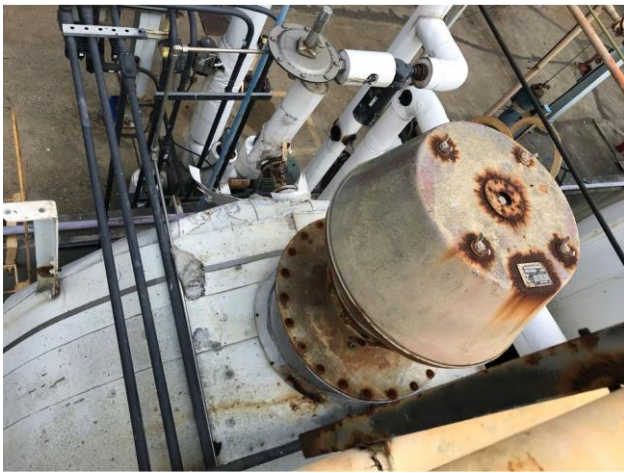
PMC is operating a CAA hazardous waste storage tank, TK 1709, for storing benzene waste. This tank was properly labeled. The inspection team noted that the insulation around the tank had begun to buckle (Photos 21-24). Additional areas on the tank had insulation that was removed or missing. The insulation observations were not noted on the inspection records of this area.

Photo 21: CAA TK 1709.

Photo 22: CAA TK 1709.

Photo 23: CAA TK 1709.

Photo 24: CAA TK 1709.

**Pursuant to 401 KAR 39:080, Section 1(1) [40 C.F.R. § 262.17(a)(2)], which incorporates 40 C.F.R. § 265.195(b), and is a condition of the LQG Permit Exemption, a generator accumulating hazardous waste in tanks must conduct inspections at least once each operating day: (1) Overfill/spill control equipment (e.g., waste-feed cutoff systems, bypass systems, and drainage systems) to ensure that it is in good working order; (2) Above ground portions of the tank system, if any, to detect corrosion or releases of waste; and (3) The construction materials and the area immediately surrounding the externally accessible portion of the tank system, including the secondary containment system (e.g., dikes) to detect erosion or signs of releases of hazardous waste (e.g., wet spots, dead vegetation).**

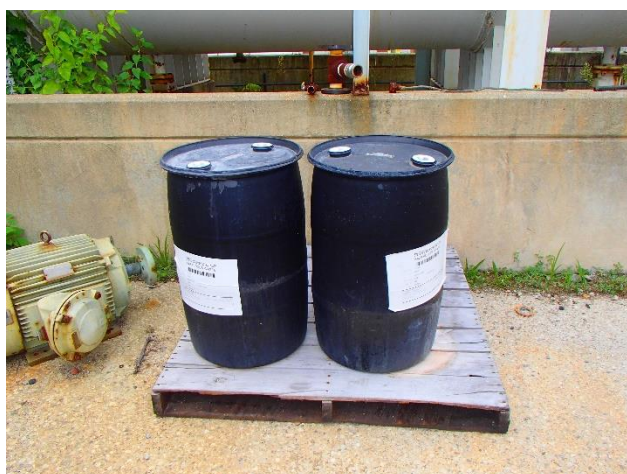
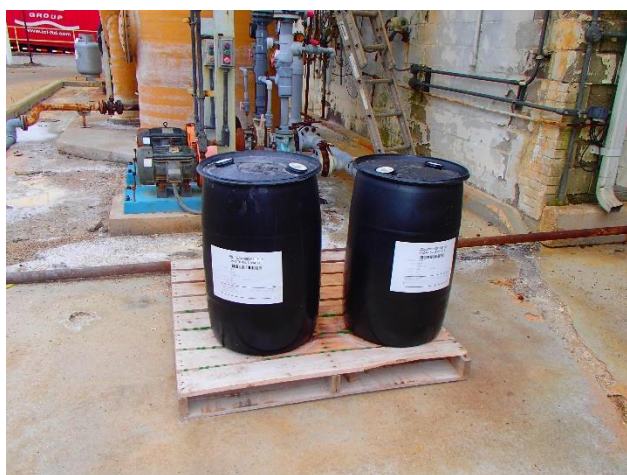
At CAA BD022, PMC was storing four black poly 30-gallon containers on the day of the inspection (Photos 19-20). Three of the containers were not labeled. One container was labeled as hazardous waste, toxic solids, and labeled with an accumulation start date of 9/5/2020 (>90 days). These containers were closed and in good condition. The facility labeled these containers while the inspectors were on site as hazardous waste and included an accumulation start date of 9/5/2021 but also stated that these four containers were generated at the same time as the labeled container (9/5/2020) last year. It appeared that the person making the label mislabeled these containers with an inaccurate date. Also, in this area there were three supersacks partially full of rusted metal parts. Facility personnel stated that these parts were packing material for the scrubber and will be reused.

Photo 19: BD022 CAA.

Photo 20: BD022 CAA.

**Pursuant to 401 KAR 39:080 Section 1(1) [40 C.F.R. § 262.17(a)(5)(i)(A-C)] Labeling and marking of containers and tanks, which is a condition of the LQG Permit Exemption, an LQG must mark or label its containers with the following: (A) the words “Hazardous Waste”; (B) an indication of the hazards of the contents; and (C) the date upon which each period of accumulation begins clearly visible for inspection on each container.**

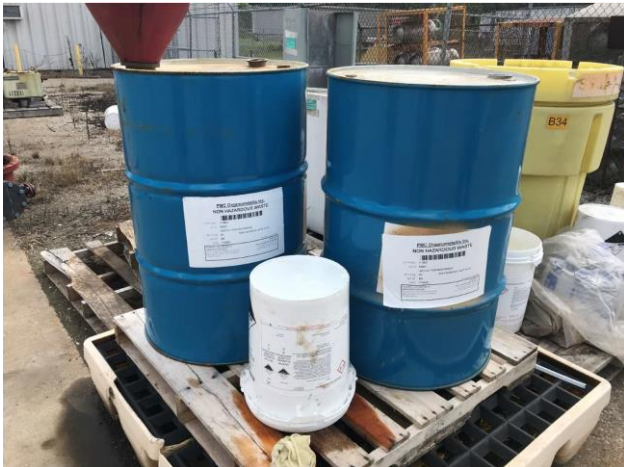
At the time of the inspection, PMC was storing two 55-gallon used oil containers that were in good condition and labeled (Photo 25). PMC accumulates aerosol cans and punctures them in a device attached to a 55-gallon metal SAA container (Photo 26). This container was in good condition and labeled. The punctured cans are placed into a metal recycling bin (Photo 27).

Photo 25: BD034 Maintenance Used Oil Storage.

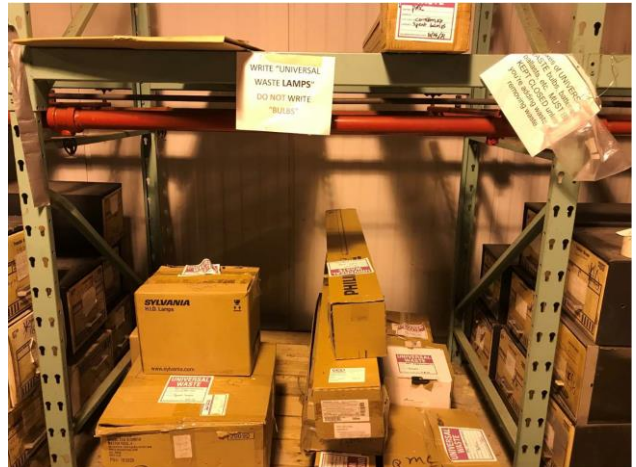
Area B-25 is designated for storage of universal wastes. There were five 4-foot boxes of universal waste lamps, three boxes for misc. waste lamps, and four boxes of universal waste batteries. The oldest date was 12/13/2020 (Photos 28-29). There were four book-sized lead acid batteries on the shelf outside of the locked universal waste storage room. These batteries were not labeled, and the staff were unsure of how long they had been in this location (Photo 30). Two of the batteries were dated “8-18-11” and “3-26-15.” The facility stated that batteries are managed as universal waste.

Photo 28: BD0025 Universal Waste Storage.

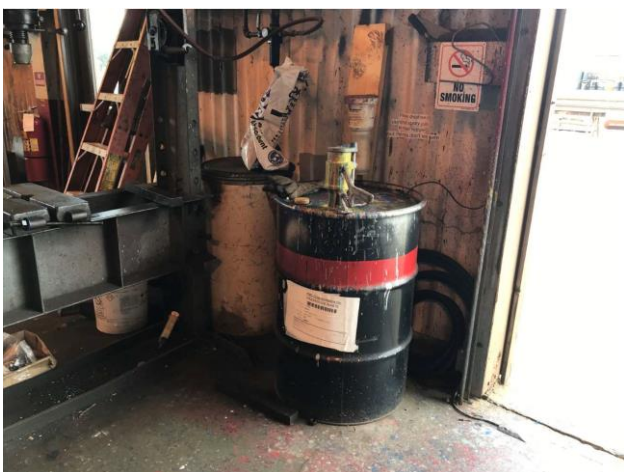
Photo 26: BD034 Maintenance aerosol can puncture device.

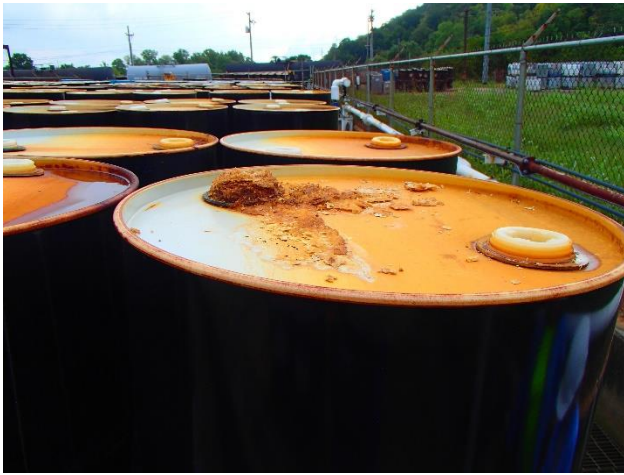
On Pad B-65, 9S20, the inspection team noted one container that had hazardous waste expelled through the bung hole. There was some waste accumulated on the lid of this container (Photo 36). This container was not considered to be closed. There were two containers with bulging lids that were rusting (Photos 37-41). These containers did not appear to be in good condition (see table above for observations).

Photo 36: Waste on top of container on Permitted Pad 65.

**Pursuant to Permit Condition III.K.7, Management of Containers: The Permittee shall manage and inspect the containers in accordance with 40 CFR Part 264.173 and 264.174 as well as according to the container management system, and container layout and configuration delineated in Attachment D, illustrated in Figures D-1.2 and D-1.3. Containers will not be stacked more than two (2) high. Only stable containers and containers with no physical damage may be stacked. The Permittee shall keep all containers closed during storage, except when it is necessary to add or remove waste, and shall not open, handle, or store containers in a manner which may rupture the container or cause it to leak.**

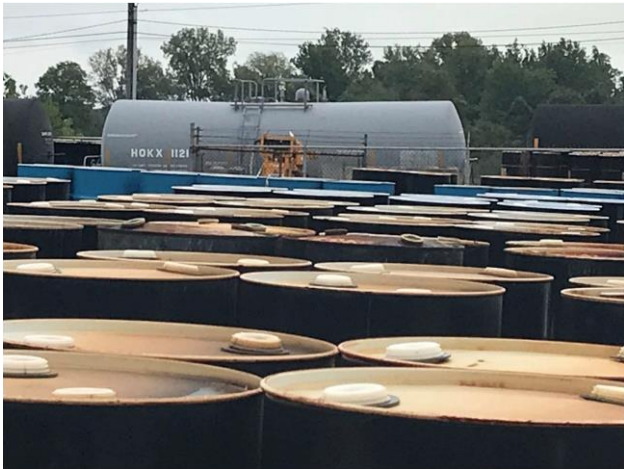
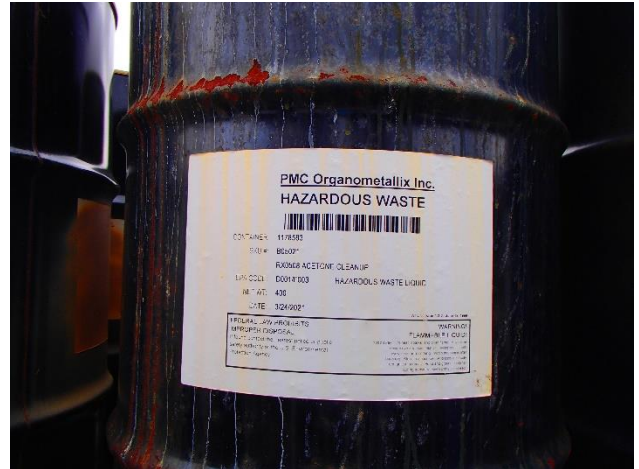
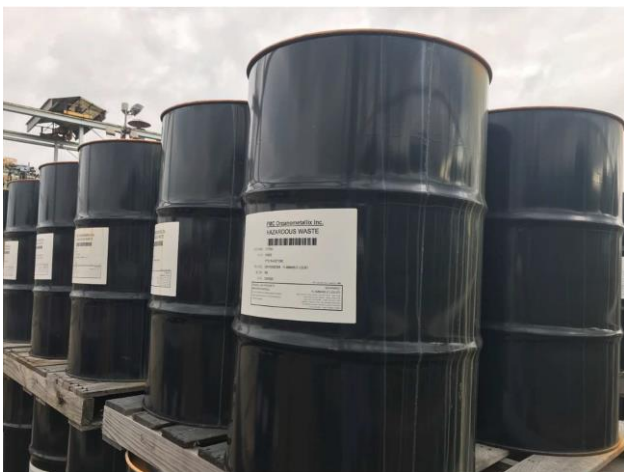
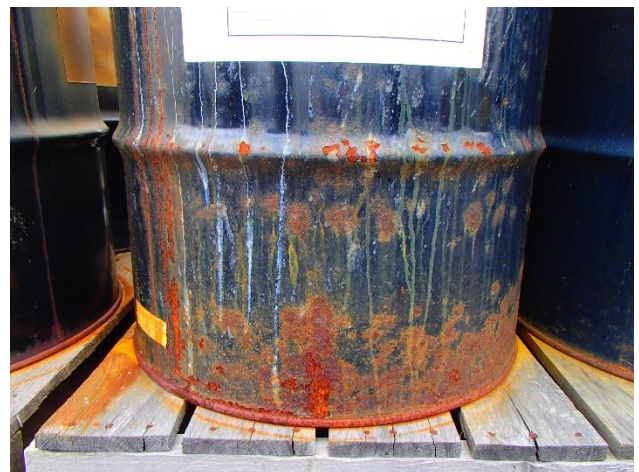
| Section | Number of Containers | Oldest Date | Comments |
|---|---|---|---|
| 9S20 | 473 55-gallon containers<br>5 250-gallon containers | 10/12/2020 | Two bulging and rusting containers (numbers 1178584 and 1178583); one container with HW on outside of container |

Photo 39: Bulging/Rusting containers on Permitted Pad 65.

Photo 37: Bulging/Rusting containers on Permitted Pad 65.

Photo 40: Bulging/Rusting containers on Permitted Pad 65.

Photo 38: Bulging/Rusting containers on Permitted Pad 65.

Photo 41: Bulging/Rusting containers on Permitted Pad 65.

**Pursuant to Permit Condition III.K.5, Condition of Containers: The Permittee shall comply with all requirements set forth under 40 CFR Part 264.171, to ensure that all hazardous waste containers are in good condition. If a container holding hazardous waste is not in good condition (e.g. severe rusting, apparent structural defects) or if it begins to leak, the Permittee shall transfer the hazardous waste from such container to a container that is in good condition or otherwise manage the waste in compliance with the conditions of this Permit. [40 CFR Part 264 - Subpart I].**

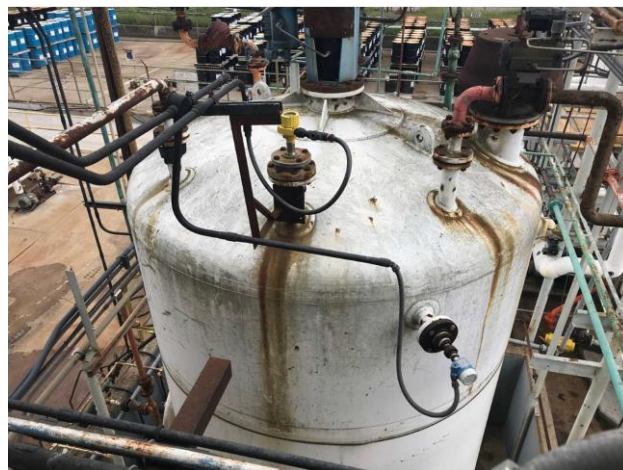
Permitted tanks TK-5204A and CAA tank TK-5205 are utilized by PMC to store hazardous waste solvents that are fed into the incinerator as fuel. The inspection team observed CAA tank TK 2505 which is located next to the hydropulper (Photos 44-45). This tank appeared to be in good condition and labeled. Facility representatives were later able to identify that the accumulation start date was 8/13/2021. PMC should ensure that accumulation start dates for each hazardous waste tank are easily accessible. These dates are not marked on the tanks. The inspection team noted that Tank 5204A was showing signs of surficial rusting in multiple locations and around the base of the tank (Photos 62-64). PMC should ensure that these rusting areas do not lead to failure of tank integrity. PMC did not comment on the surficial rust on the inspection records but later stated that this tank passed a recent third-party integrity test. PMC was in the process of connecting a recently installed permitted tank, TK-5204B (Photo 65).

Photo 45: TK 2505.

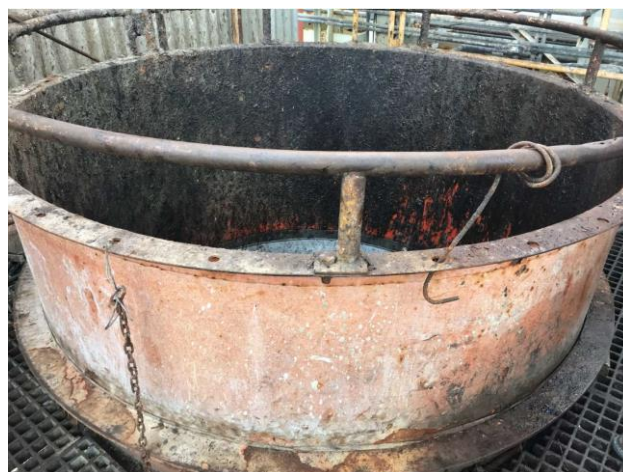
PMC empties containers of hazardous waste into the permitted treatment hydropulper with water to generate waste solids (slurry) (Photos 46-47). The inspection team noted one 5-gallon plastic pail of aerosol cans on the container prep platform below the maw of the hydropulper. This container was open on the day of the inspection and not labeled with either the words “Hazardous Waste” or with the indication of the hazard. The aerosol cans appeared to be discarded and rusting (Photo 47). The inspection team also noted one 5-gallon pail of waste material and discarded Tyvek in the solid waste dumpster in this area (Photos 48-49). PMC had not conducted a hazardous waste determination on these wastes.

Photo 46: Hydropulper.

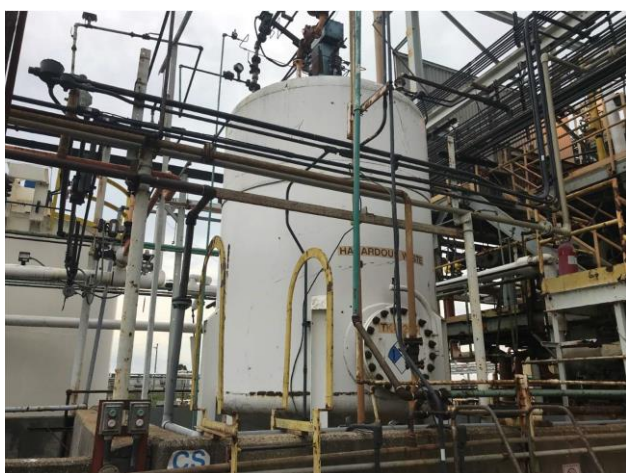
Photo 44: TK 2505.

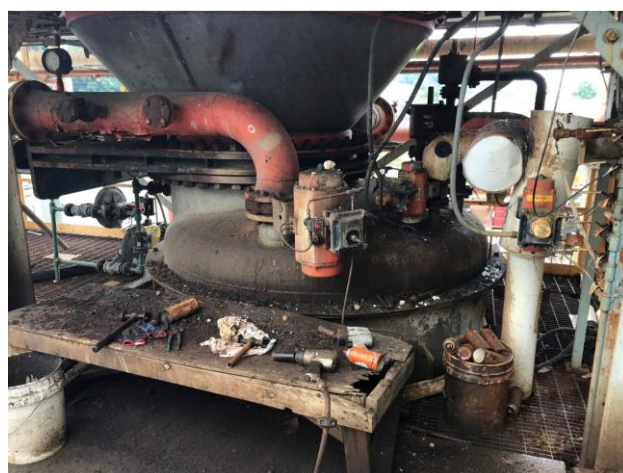
Photo 47: Hydropulper.

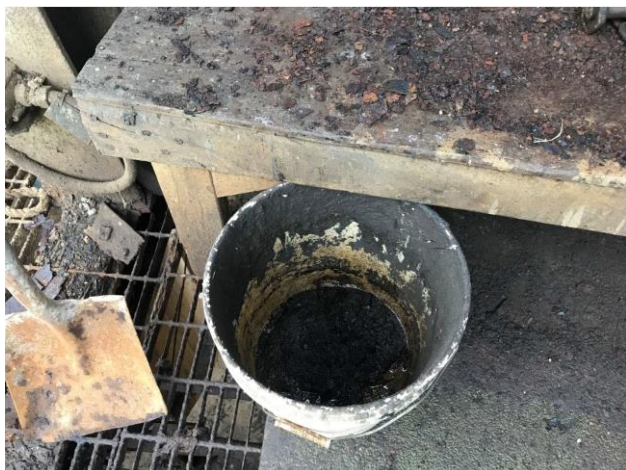
Photo 48: Pail of unknown waste.

Photo 49: Tyvek in solid waste dumpster.

**Pursuant to 401 KAR 39:080 Section 1 [40 C.F.R. § 262.11], a person who generates a solids waste as defined in 40 C.F.R. § 261.2, must determine if that waste is a hazardous waste.**

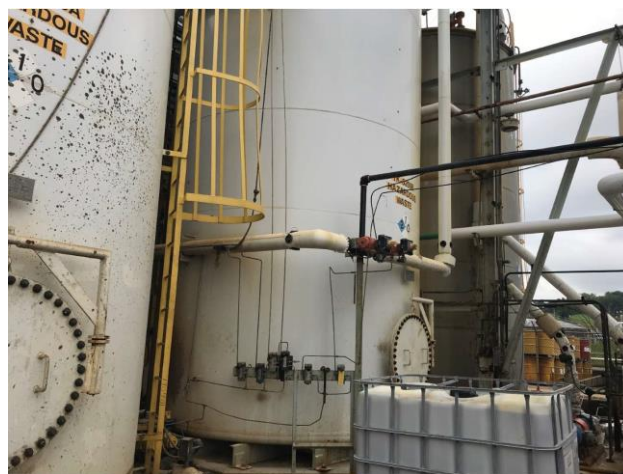
The waste solids are pumped to one of three permitted hazardous waste slurry tanks: TK-5209A, TK-5209B, and TK-5210. One tank is feeding the kiln, one is being filled, and the third is being analyzed to determine appropriate feed rates to meet emission permit limits. These three tanks appeared to be in good condition and properly labeled on the day of the inspection (Photos 50-57). The secondary containment near tank TK-5210 had multiple cracks (Photos 55-60). PMC representatives scaled each slurry tank and conducted air monitoring of the multiple closure devices during the inspection. One closure device (agitator) measured 1350 ppm on top of TK-5209B. The monitoring point exceeds the 500-ppm limit for Subpart CC (Photo 61). No other measurements above 500 ppm were noted. It is unknown if repairs to this device were initiated after the conclusion of the inspection.

Photo 52: Slurry Tanks TK-5209B.

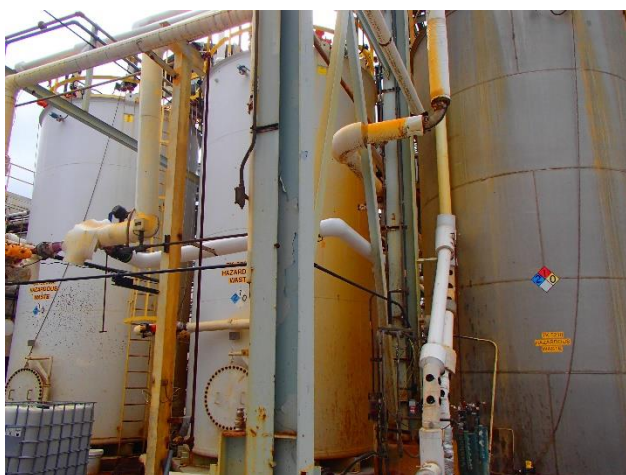
Photo 50: Three Slurry Tanks.

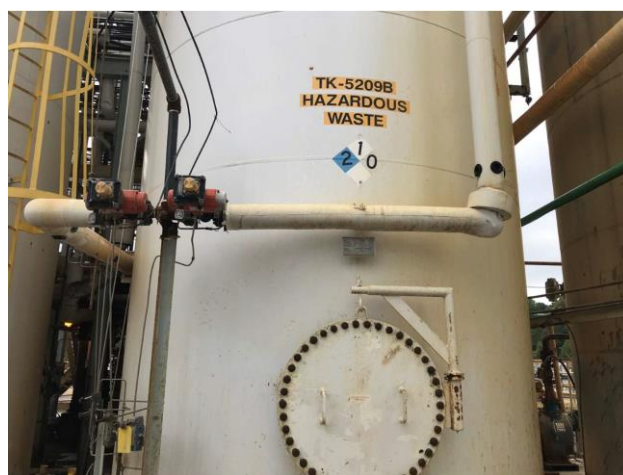
Photo 53: Slurry Tank TK-5209B.

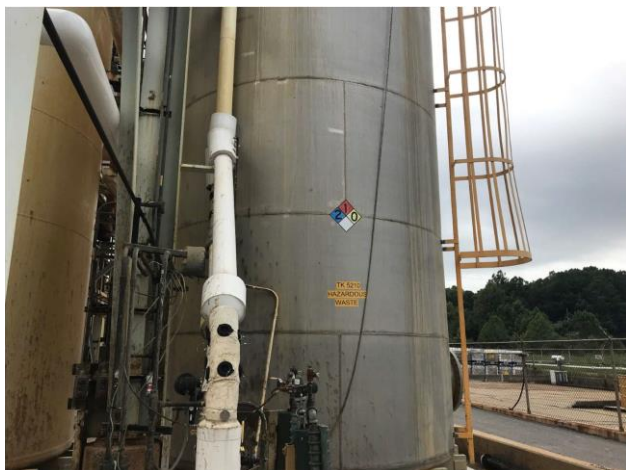
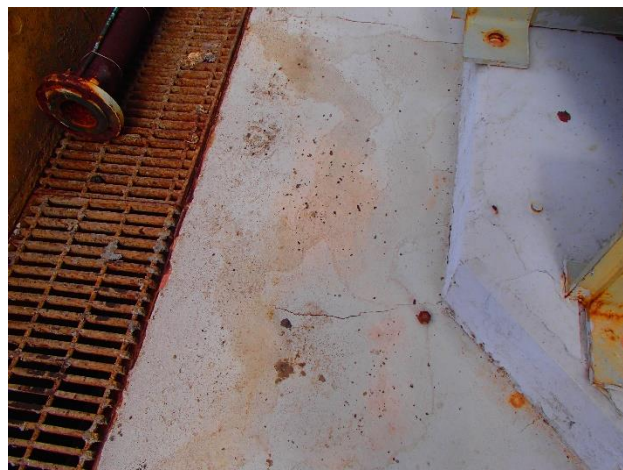
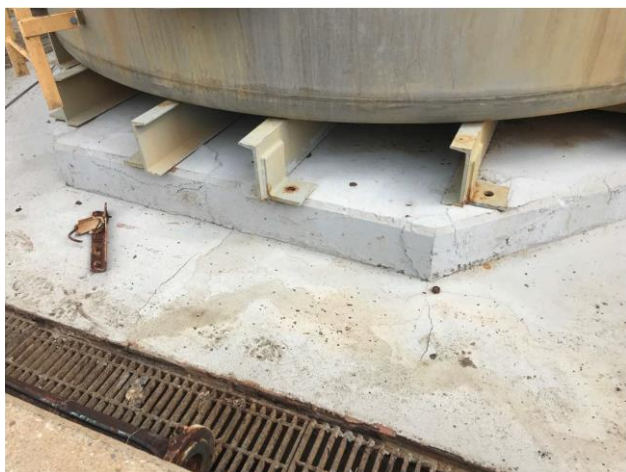
Photo 57: Cracks in secondary containment near Slurry Tank TK-5210.

Photo 55: Cracks in secondary containment near Slurry Tank TK-5210.

Photo 58: Cracks in secondary containment near Slurry Tank TK-5210.

Photo 59: Cracks in secondary containment near Slurry Tank TK-5210.

Photo 60: Cracks in secondary containment near Slurry Tank TK-5210.

**Pursuant to Permit Condition III.L.7.4 The Permittee shall manage the secondary containment systems for the tank systems in accordance with Attachment D of this Permit, and 40 CFR Part 264.193. The Permittee shall maintain an impervious coating which is**

**free of cracks, gaps, or other deterioration on all containment system surfaces which may be exposed to hazardous wastes or hazardous constituents (or releases of hazardous constituents).**

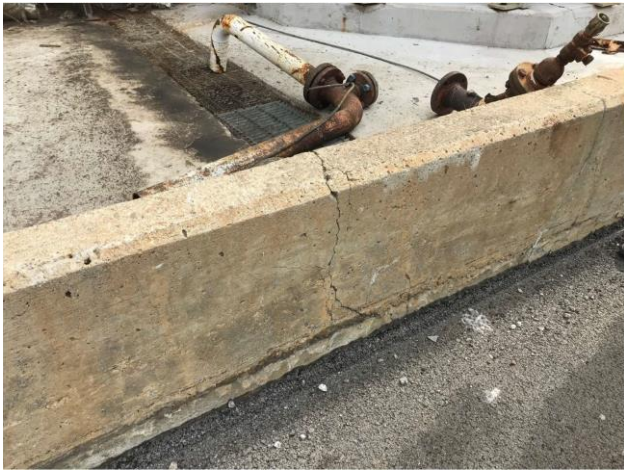
Pursuant to Permit Condition III.L.7.4 The Permittee shall manage the secondary containment systems for the tank systems in accordance with Attachment D of this Permit, and 40 CFR Part 264.193. The Permittee shall maintain an impervious coating which is free of cracks, gaps, or other deterioration on all containment system surfaces which may be exposed to hazardous wastes or hazardous constituents (or releases of hazardous constituents).

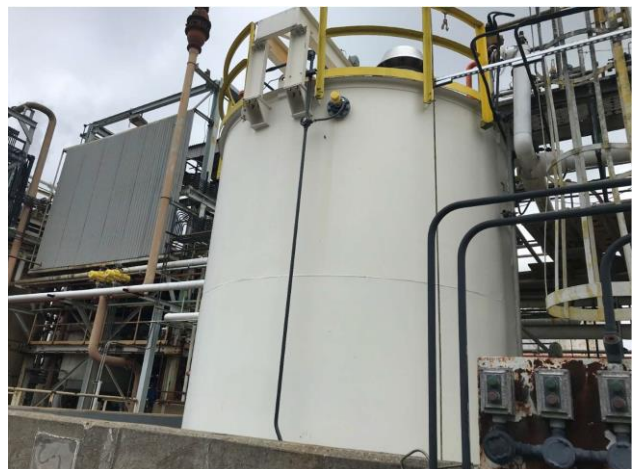
Photo 65: Tank 5204B.
