## **RCRA Inspection Report**

The Sherwin Williams Company  
90 Carson Road  
Birmingham, Alabama 35215  
EPA ID No: ALD078964970

November 03, 2021

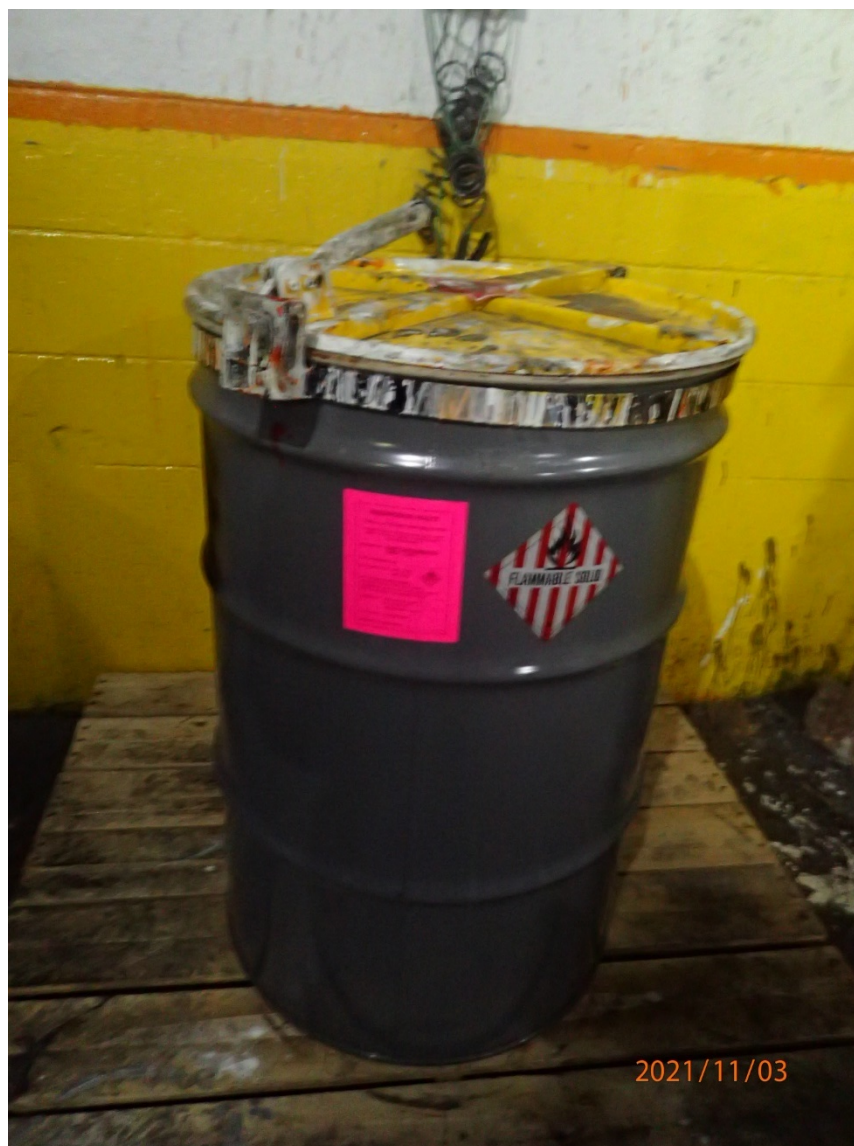
**Photo 1:** One (1) 55-gallon drum of paint contaminated debris in different, closed, labeled “Hazardous Waste”, and marked with an indication of hazard.

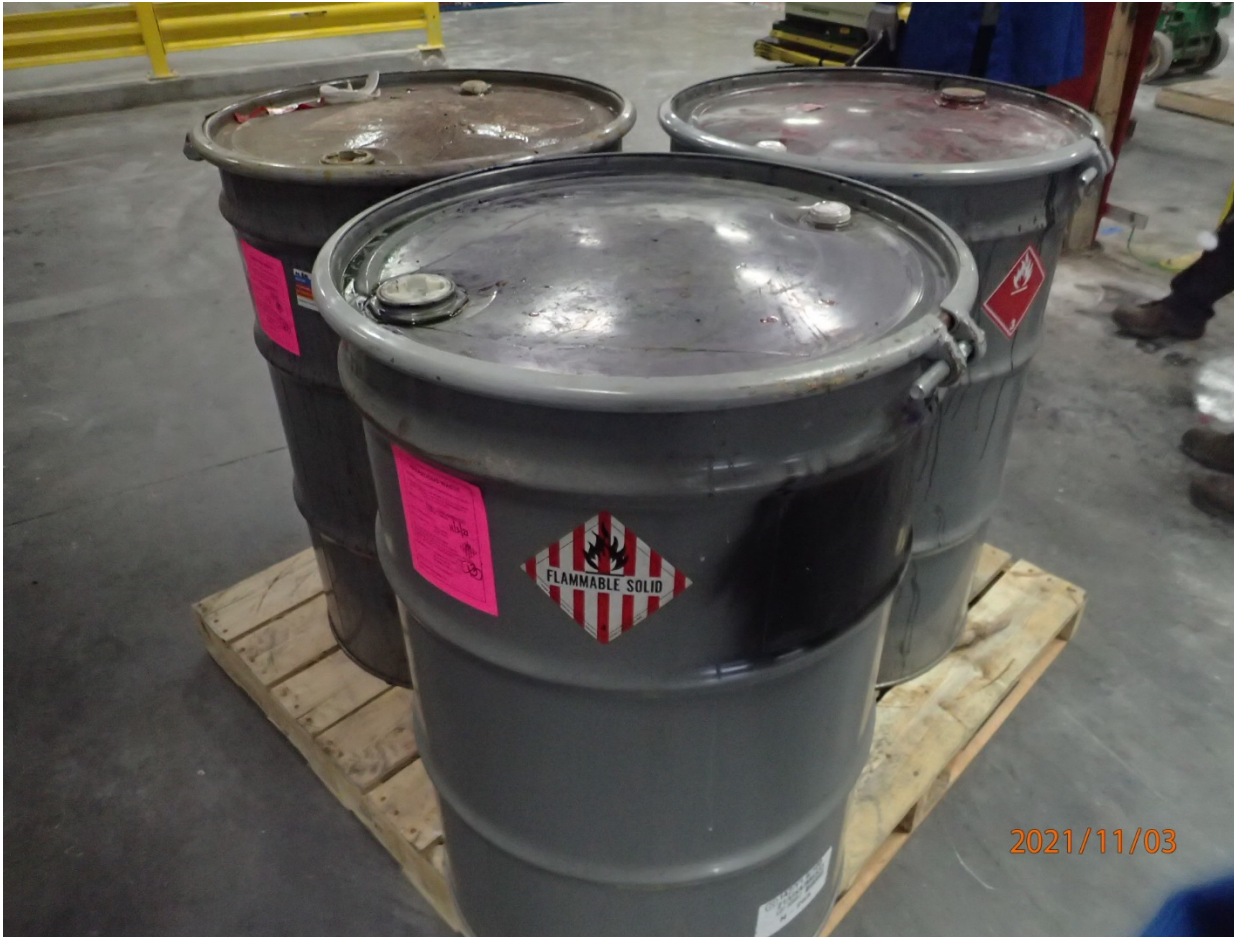
- Three (3) 55-gallon drums of paint-contaminated debris, each generated from separate

washes of different pieces of machinery. The containers were closed, labeled, dated, and marked with an indication of hazard. The containers were on a pallet to be sent to the 90-day central accumulation area. (Photo #2)

**Photo 2:** Three (3) 55-gallon drums of paint-contaminated debris generated from three different washes of machinery. The containers were closed, labeled, dated, and marked with an indication of hazard. The containers were on a pallet to be sent to the 90-day central accumulation area.

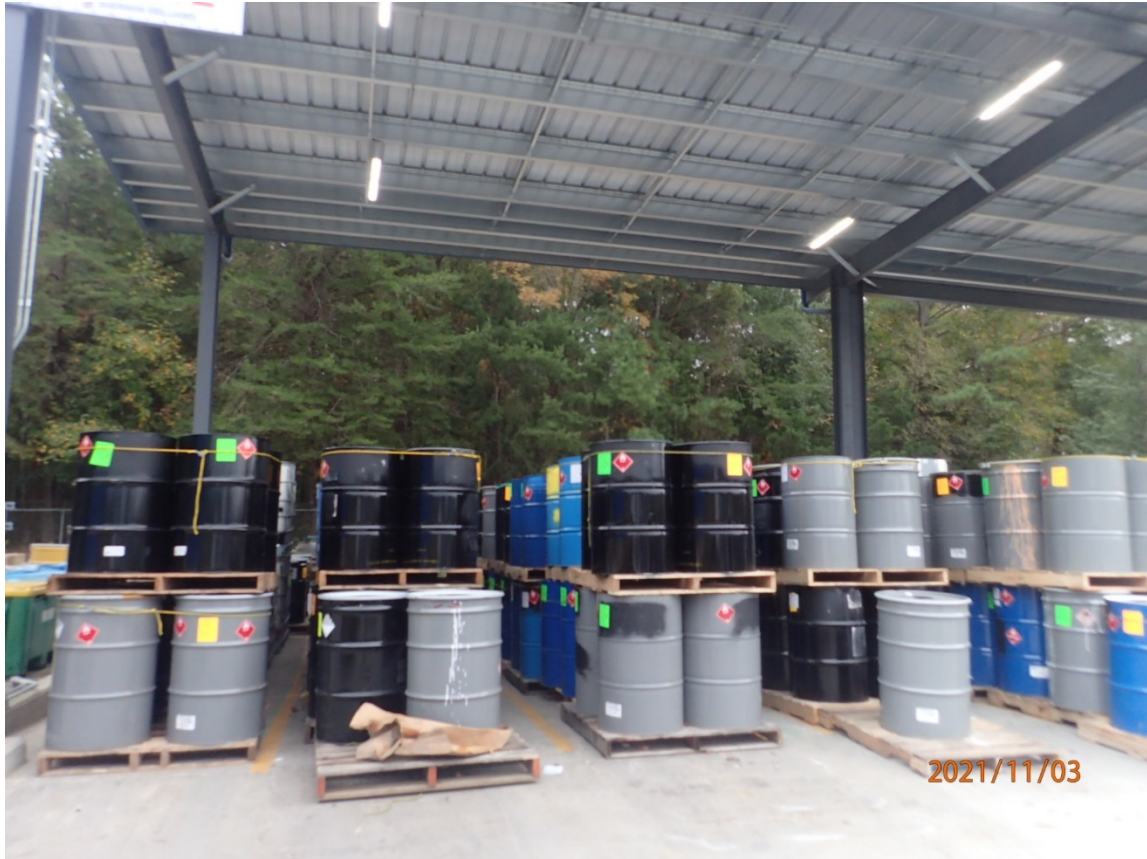
The CAA is located next to Building C under a corrugated roof and on top of a concrete floor with a secondary containment sump. The concrete floor appeared to be in good condition with no signs of cracks. There were six (6) rows of hazardous waste drums and totes. The aisle space was a bit narrow for the first two rows and was quickly addressed after the inspection with photos sent to the inspectors via email. There were approximately 298 55-gallon drums and three (3) 250-gallon totes of hazardous waste. The oldest dated container was 09/08/2021 which below the 90-day storage limit. All containers of hazardous waste were in good condition, closed, dated, labeled with the words “Hazardous Waste”, and marked with an indication of hazard. (Photos #3 and #4).

**Photo 3:** 90-Day CAA

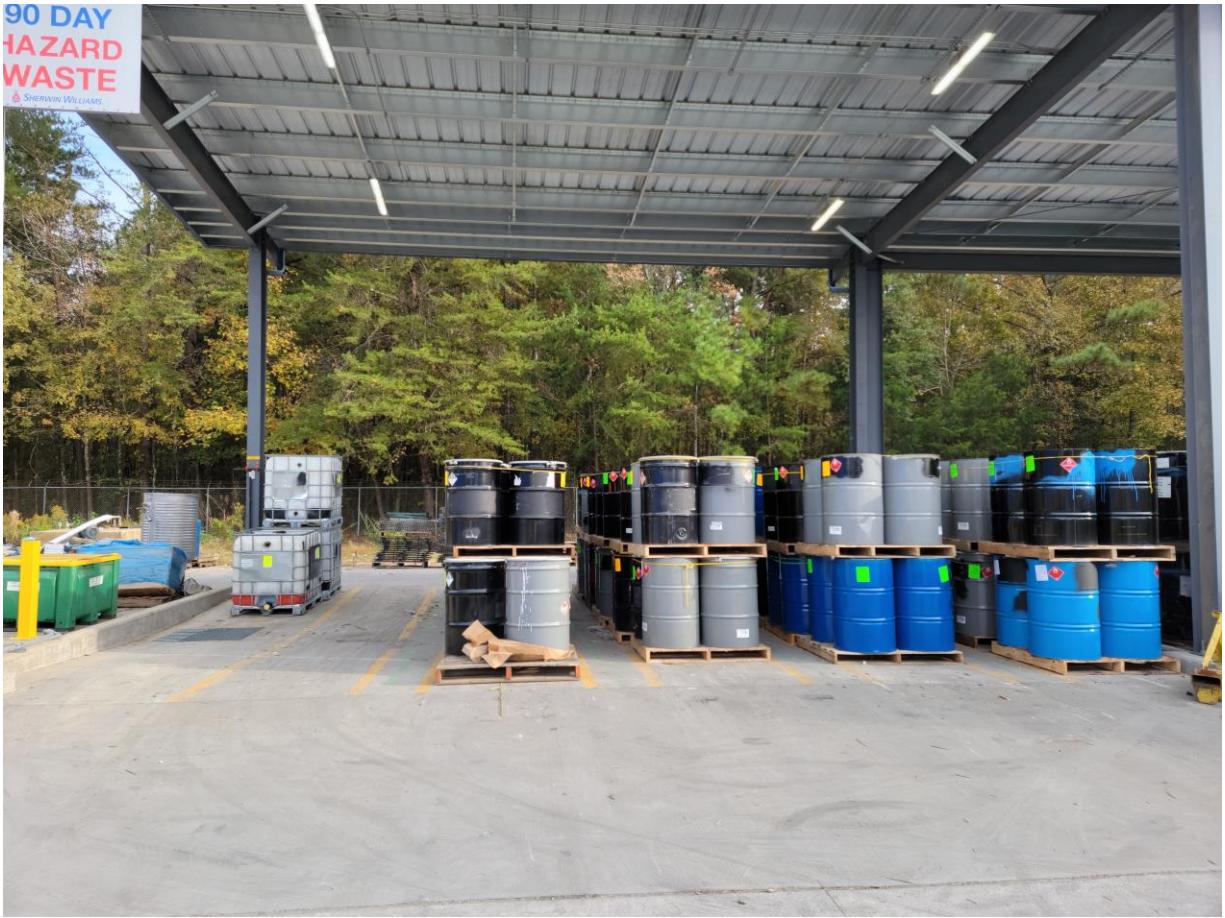
**Photo 4:** 90-Day CAA with more aisle space in between rows.

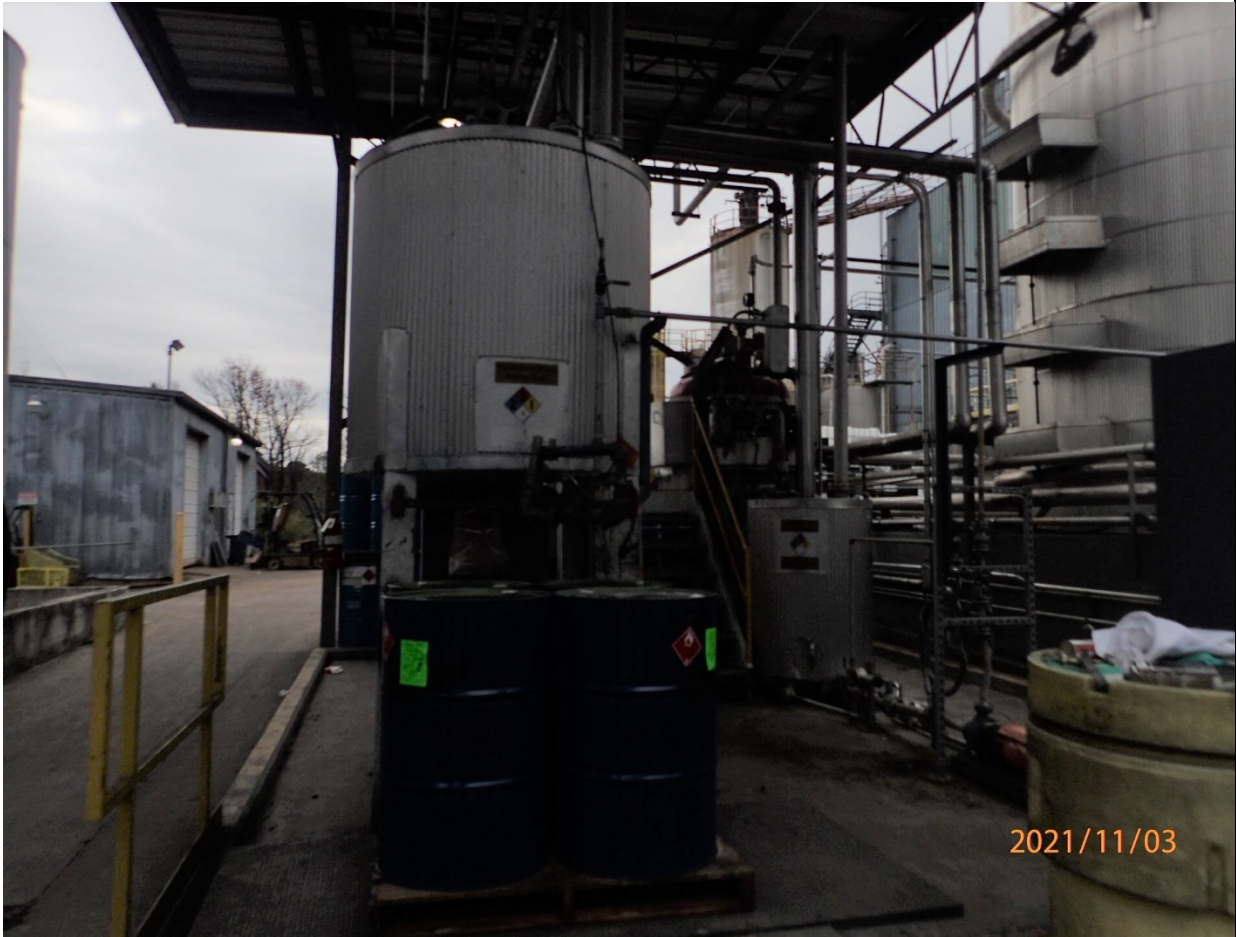
The solvent reclamation unit is located next to the facility’s tank farm and next to the loading and unloading area for the tank farm, surrounded by concrete berms and on a concrete pad (Photo #5). The solvent reclamation unit is connected to a 200-gallon storage tank for clean and recovered solvent and a 750-gallon storage tank for hazardous waste still bottoms (Photo #6). The still bottom tank was labeled “Hazardous Waste Tank Sludge” and marked with an indication of hazard. The solvent reclamation unit generates about four (4) 55-gallon drums a day of still bottoms after a reclamation cycle which are then moved to the CAA. The inspectors observed:

**Photo 5:** Solvent Reclamation Unit.

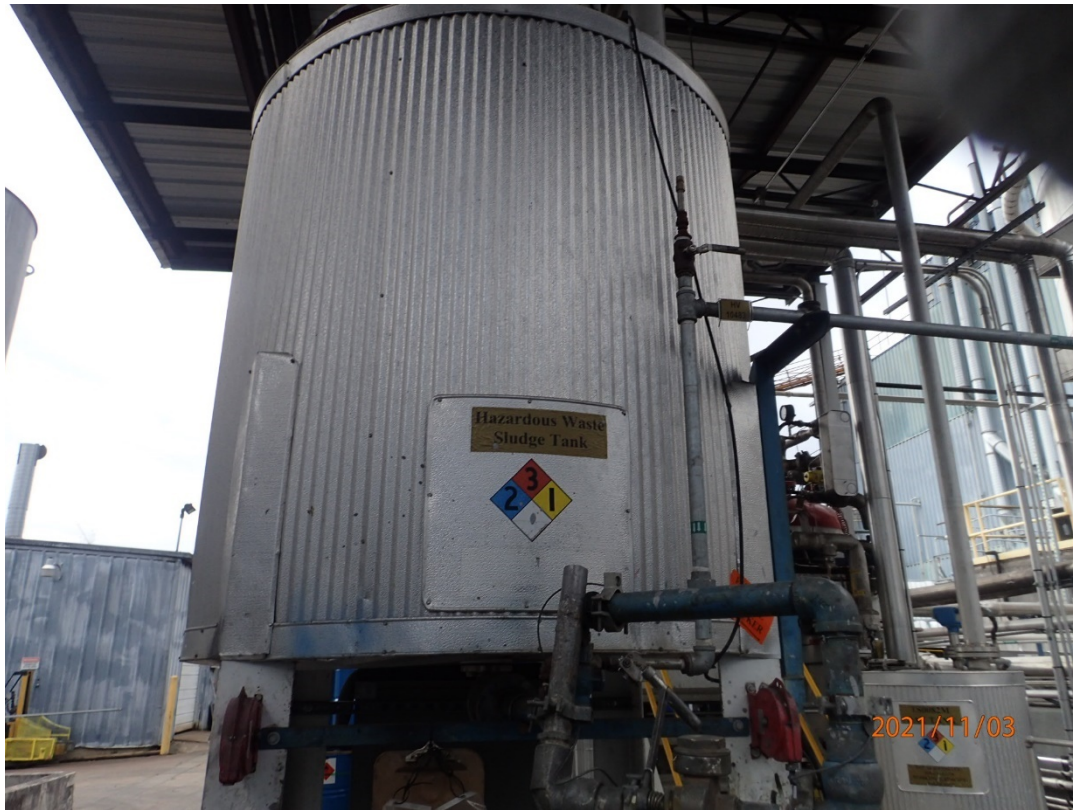
**Photo 6:** 750-gallon storage tank for hazardous waste still bottoms labeled “Hazardous Waste Tank Sludge” and marked with an indication of hazard.

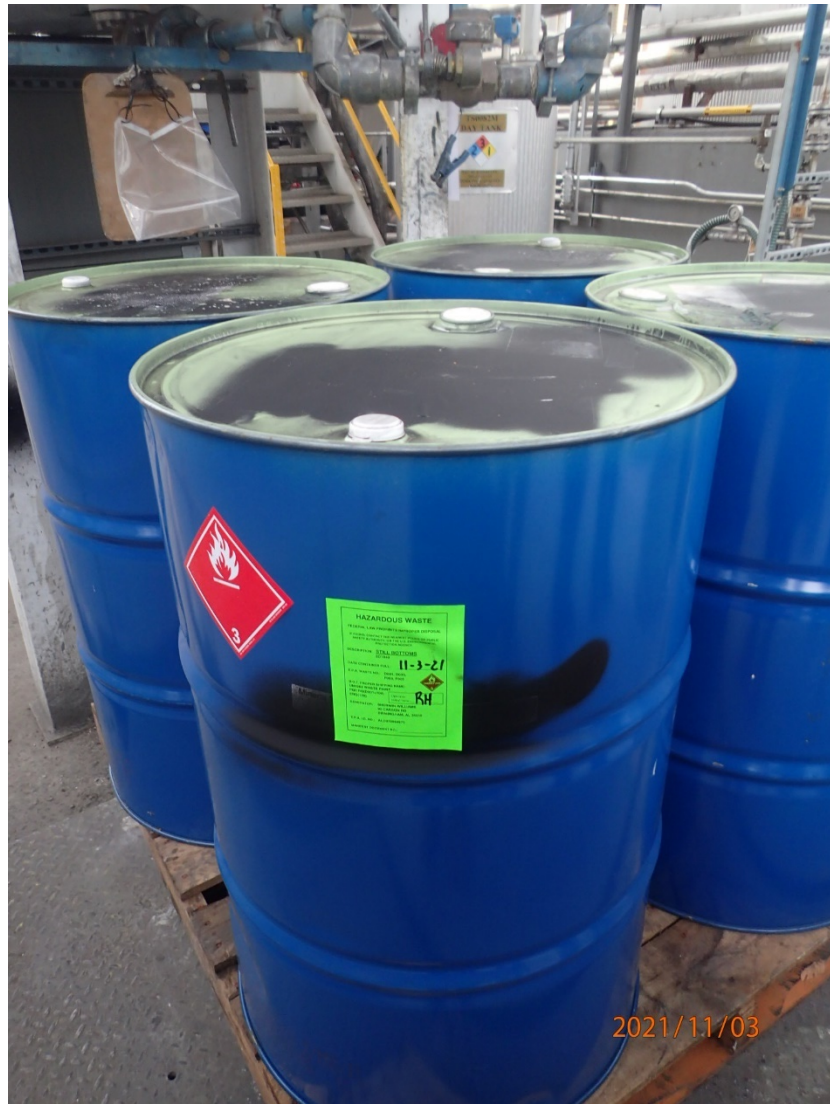
- Four (4) 55-gallon drums of solvent still bottoms, closed, labeled “Hazardous Waste”, marked with an indication of hazard, and dated 11/3/2021. (Photo #7)

**Photo 7:** Four (4) 55-gallon drums of solvent still bottoms, closed, labeled "Hazardous Waste", marked with an indication of hazard, and dated 11/3/2021.

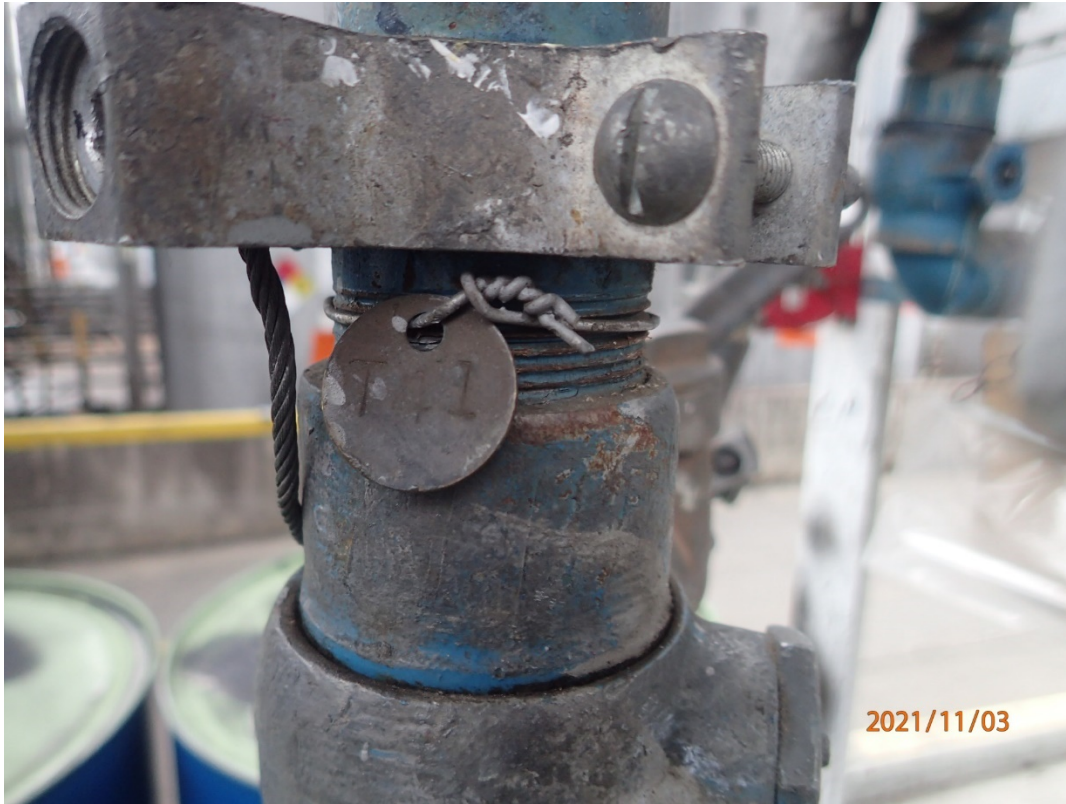
The ancillary equipment (flanges, pumps, valves, end caps, etc.) on tank lines used to transfer hazardous waste within the solvent reclamation unit and hazardous waste sludge tank appeared to be tightly sealed and in good condition with no missing equipment. The ancillary equipment was marked/ tagged as required by Subpart BB. The tags however were illegible due to dirt/ dust. (Photo #8)

**Pursuant to ADEM Admin. Code r. 335-14-6-.28 [40 C.F.R. § 264.1050(d)], Each piece of equipment to which this subpart applies shall be marked in such a manner that it can be distinguished readily from other pieces of equipment.**

**Photo 8:** The ancillary equipment on the solvent reclamation unit and still bottoms tank were marked/tagged as required by Subpart BB. The tags however were illegible due to dirt/ dust.

This was corrected and photos of the tags were submitted to the inspectors on the day of the inspection. (Photo #9)

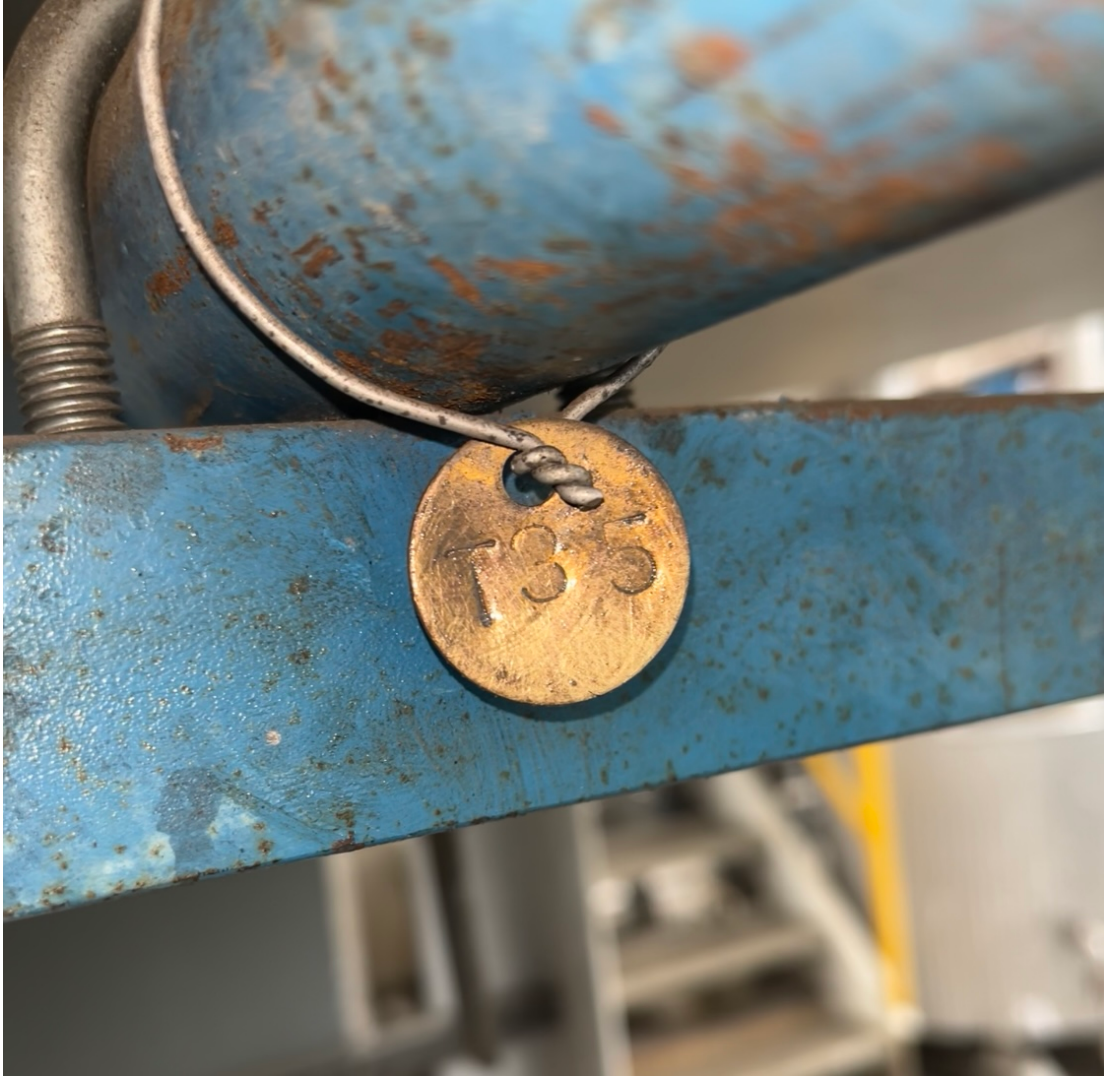
**Photo 9:** Illegible tags were cleaned, and photos of the tags were submitted to the inspectors on the day of the inspection.

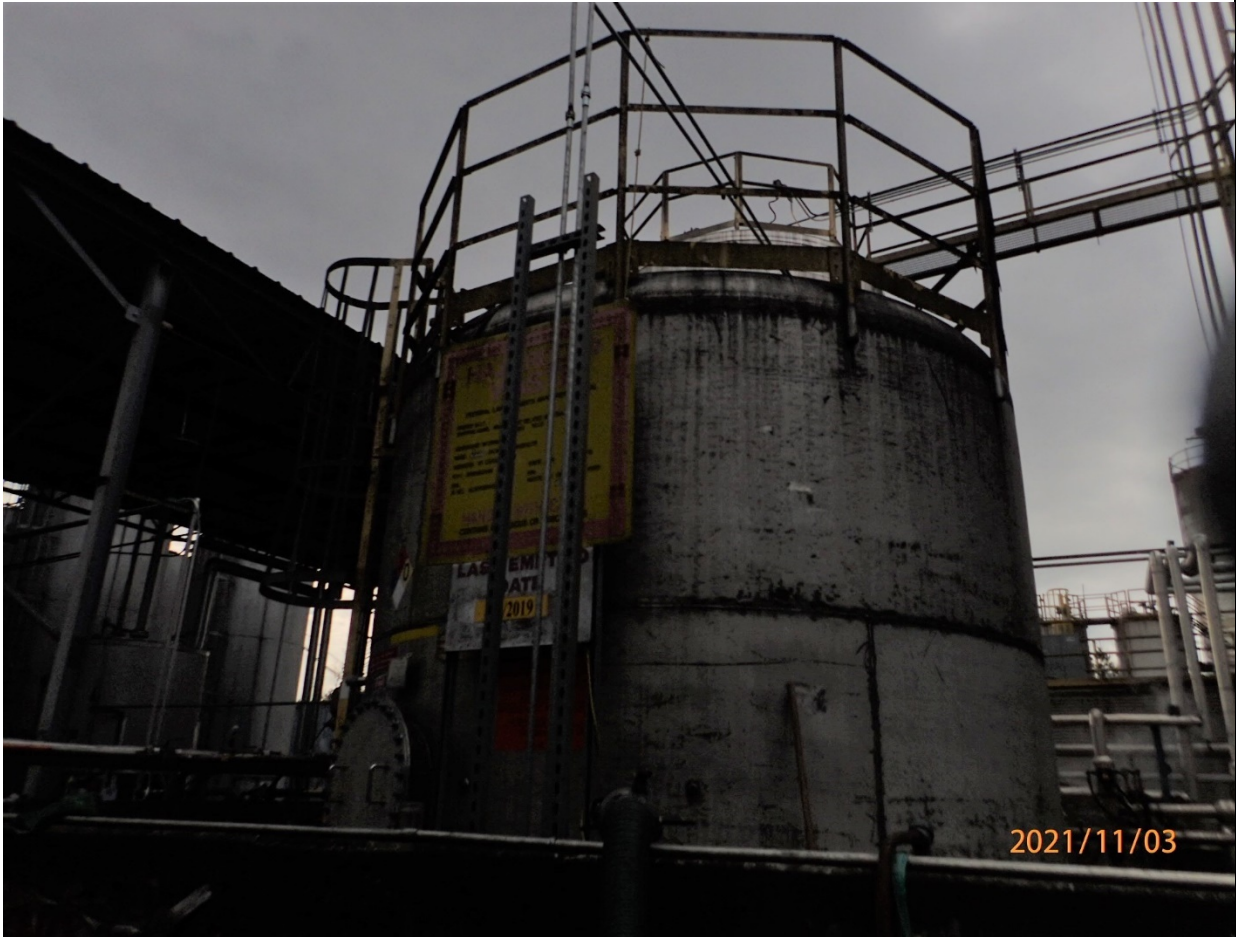
Tank 58 was labeled “Hazardous Waste” “Dirty Thinner” and marked with an indication of hazard. The tank appeared in good condition. At the time of the inspection the tank had a last emptied date of 09/04/2019. (Photo #10, #11, and #12) Mr. Nelson stated that the date posted was not the most current emptied date and that the tank is emptied on a monthly basis. Manifest records for the dirty thinner waste and tracking logs for tank levels were provided to show evidence that the tank is being emptied on a monthly basis. The facility is in the process of changing the signage for the last emptied date in order to have the date updated each time the tank is emptied.

**Photo 10:** Tank 58 12,000-gallons, was labeled “Hazardous Waste” “Dirty Thinner” and marked with an indication of hazard.

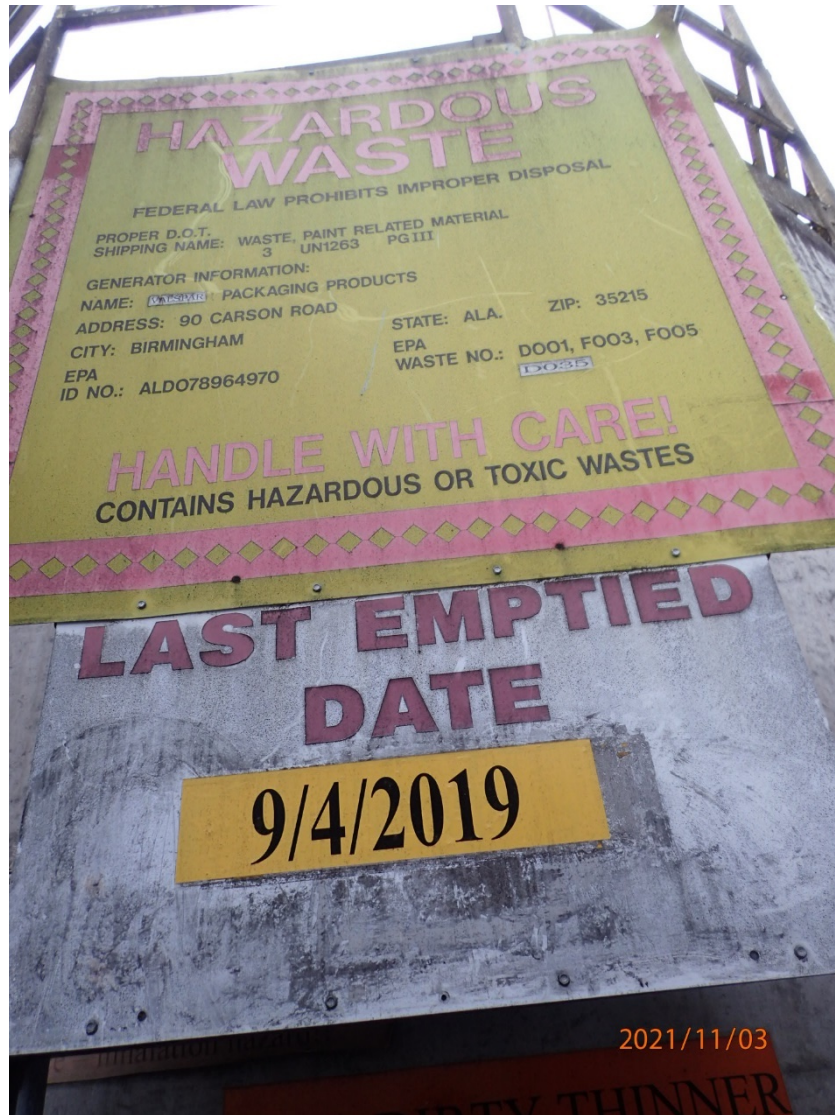
**Photo 11:** Incorrect last emptied date based on facility representatives and tank volume and shipment documents provided.

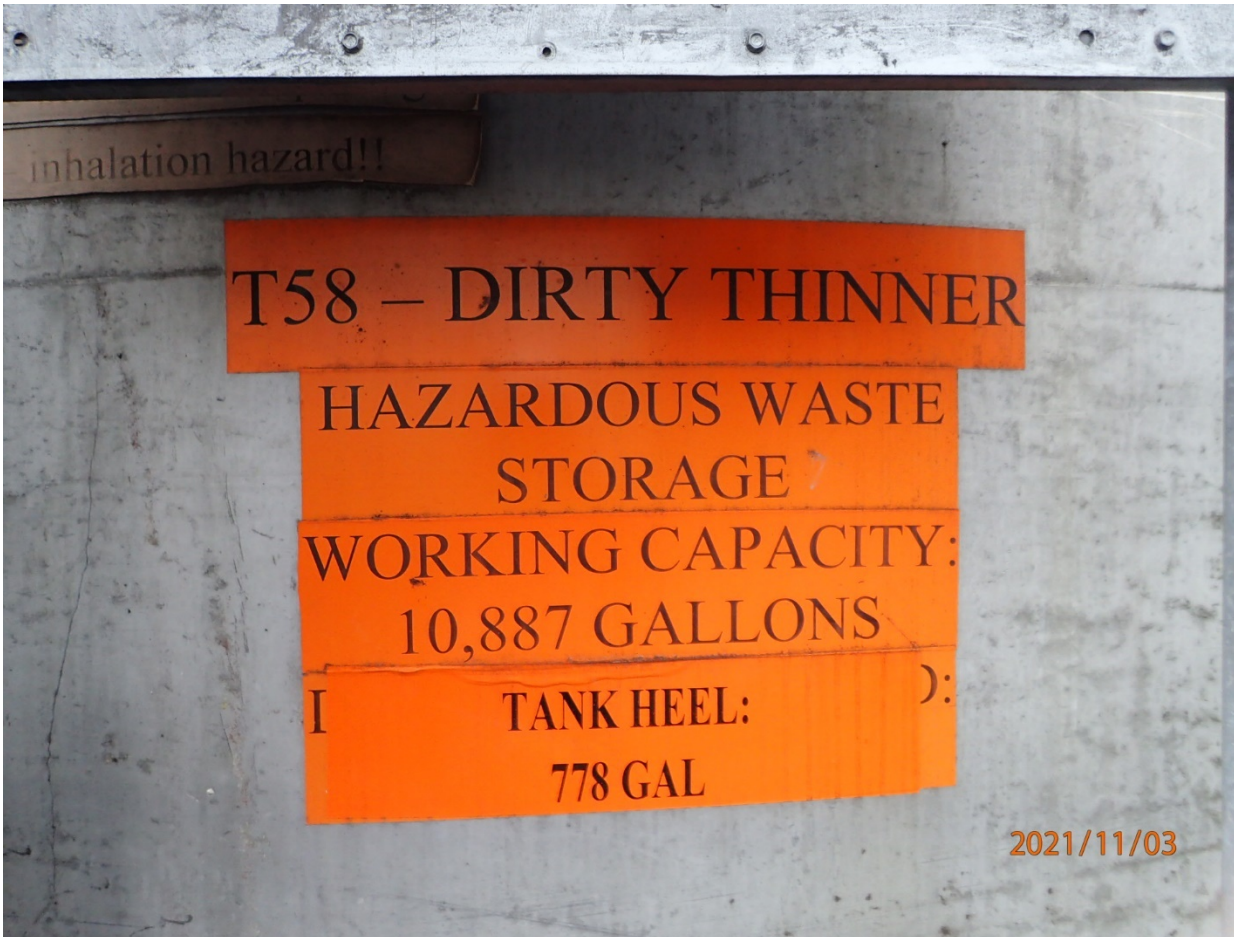
**Photo 12:** Tank 58 Label below the yellow Hazardous Waste label.

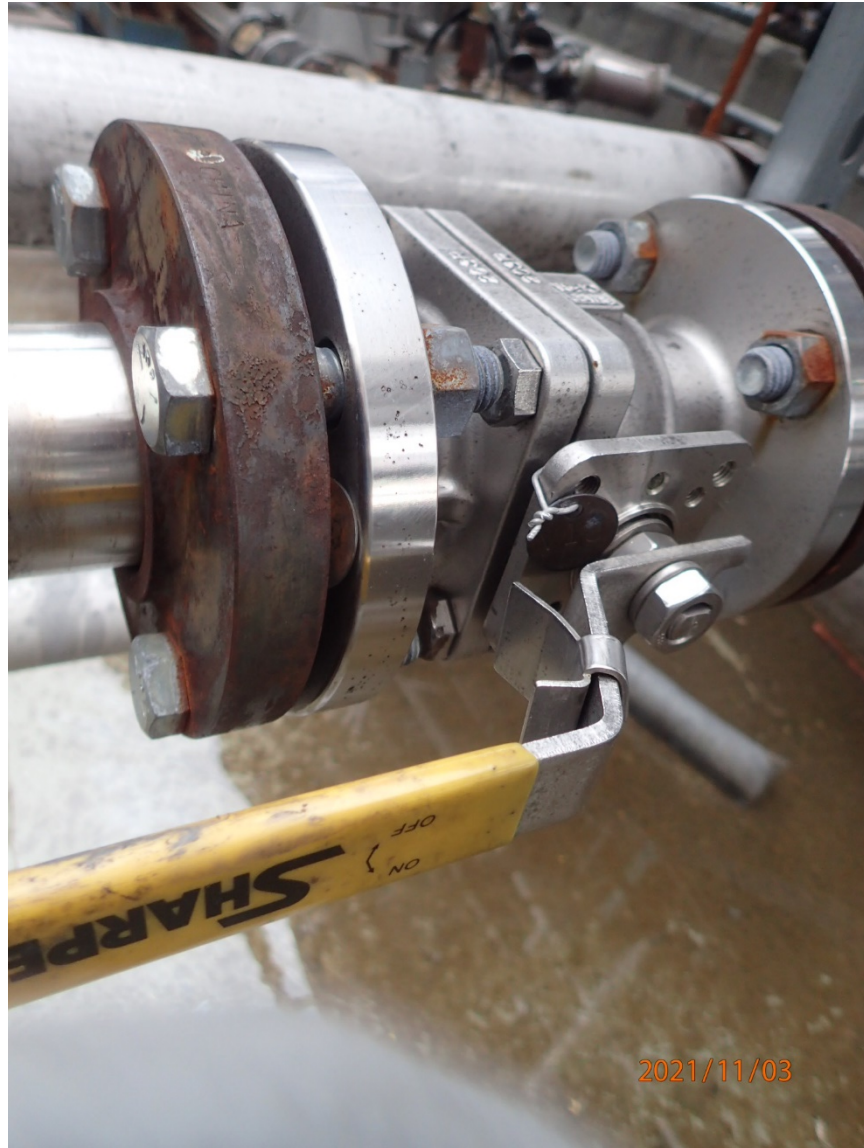
The ancillary equipment (flanges, pumps, valves, end caps, etc.) on tank lines used to transfer hazardous waste within the solvent reclamation unit and hazardous waste sludge tank appeared to be tightly sealed and in good condition with no missing equipment. The ancillary equipment was marked/ tagged as required by Subpart BB. The tags however were illegible due to dirt/ dust. (Photo #13)

**Pursuant to ADEM Admin. Code r. 335-14-6-.28 [40 C.F.R. § 264.1050(d)], Each piece of equipment to which this subpart applies shall be marked in such a manner that it can be distinguished readily from other pieces of equipment.**

**Photo 13:** The ancillary equipment was marked/ tagged as required by Subpart BB. The tags however were illegible due to dirt/ dust.

This was corrected and photos of the tags were submitted to the inspectors on the day of the inspection.

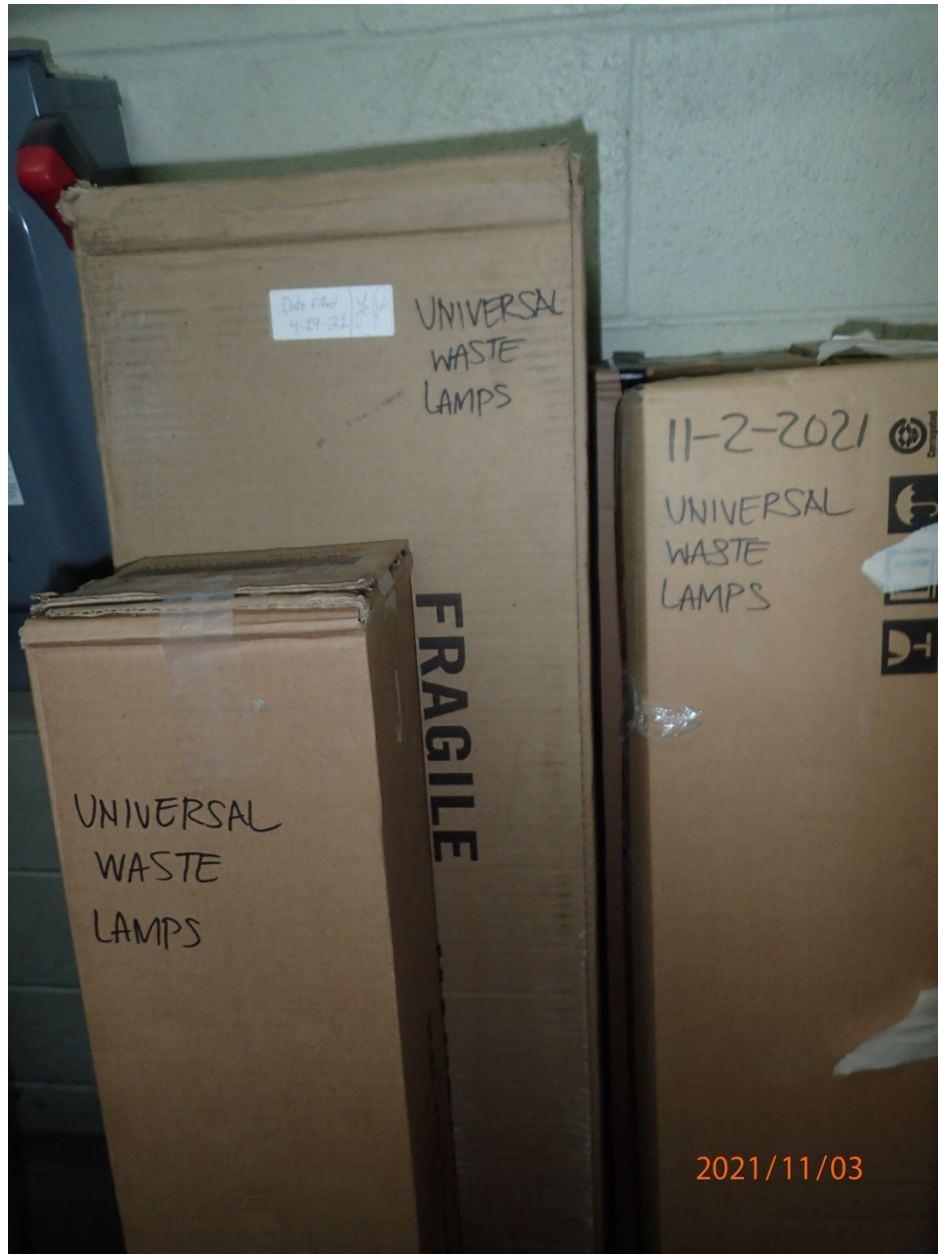
Universal waste is stored in an enclosed room in Building C. The inspectors observed the following universal waste (Photo 14):

- Ten (10) cardboard boxes with spent fluorescent lamps, closed, labeled “Universal Waste” Lamps, and dated. 04/19/2021 was the oldest date.

**Photo 14:** Universal Waste Fluorescent Lamps.

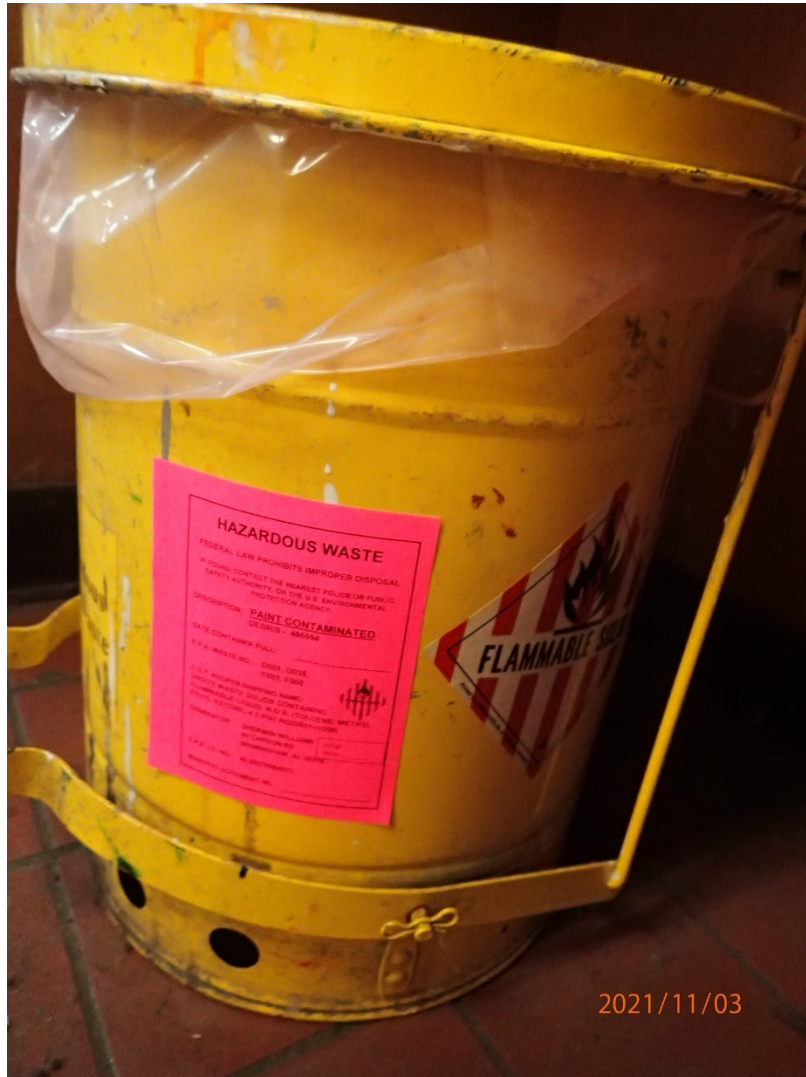
- Two (2) 5-gallon containers of dirty thinner containing aluminum, closed, marked with an indication of hazard but missing a “Hazardous Waste” label.
- Six (6) 5-gallon containers of hazardous waste solids, closed, labeled “Hazardous Waste”, but missing a marking for an indication of hazard.

**Pursuant to ADEM Admin. Code r 335-14-3.01(5)(a)5 [40 CFR 262.15(a)(5)], a generator must mark or label its container with the following: (i) The words “Hazardous Waste” and (ii) An indication of the hazards of the contents (examples include, but are not limited to, the applicable hazardous waste characteristic(s) (i.e., ignitable, corrosive, reactive, toxic); hazard communication consistent with the Department of Transportation requirements at 49 CFR part 172 subpart E (labeling) or subpart F (placarding); a hazard statement or pictogram consistent with the Occupational Safety and Health Administration Hazard Communication Standard at 29 CFR 1910.1200; or a chemical hazard label consistent with the National Fire Protection Association code 704).**

**Photo 15:** Six (6) 5-gallon containers of hazardous waste solids, closed, labeled “Hazardous Waste”, but missing a marking for an indication of hazard. New hazardous waste labels that included an indication of hazard were placed on the six containers missing an indication of hazard during the inspection.

The hazardous waste labels were added to the two containers that were missing it during the inspection. New hazardous waste labels that included an indication of hazard were placed on the six containers missing an indication of hazard during the inspection. (Photos #15 and #16)

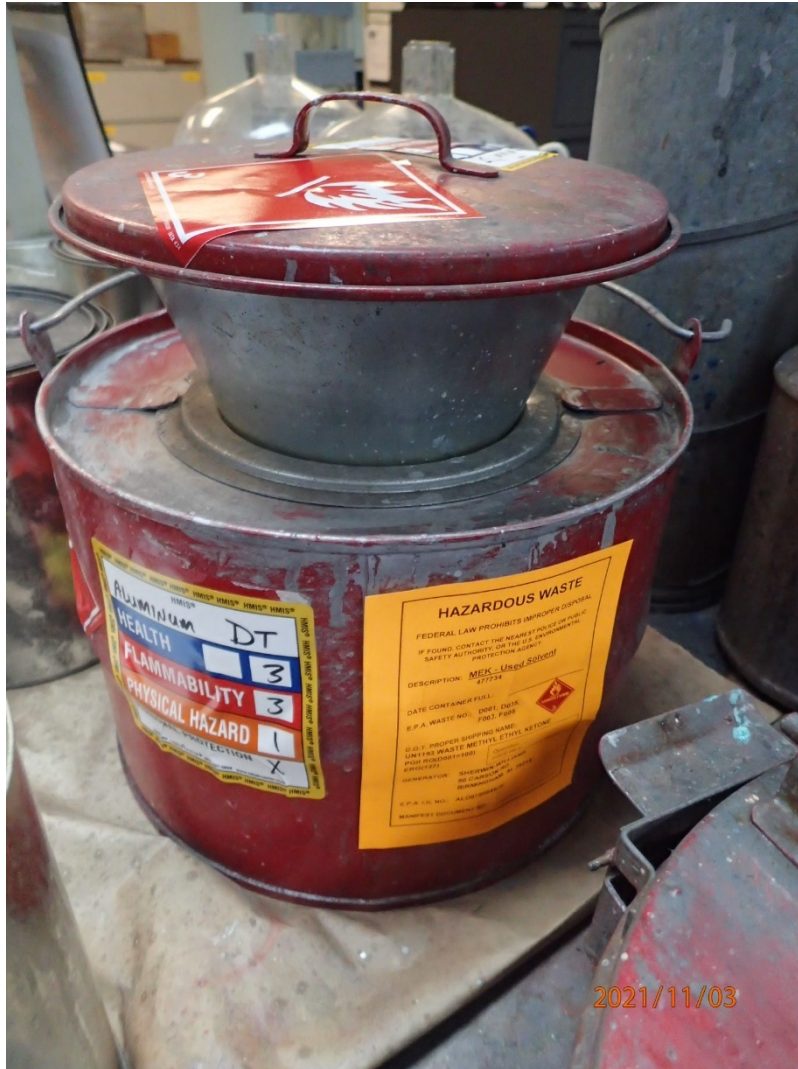
**Photo 16:** Two (2) 5-gallon containers of dirty thinner containing aluminum, closed, marked with an indication of hazard but missing a “Hazardous Waste” label. The hazardous waste labels were added to the two containers that were missing it during the inspection.
