**Region 6 - Enforcement & Compliance Assurance Division**  
**INSPECTION REPORT**

| Regulatory Program(s) | Water (CWA) Brine Program (Oil & Gas inspection) | |
| Company Name: | <b>4R Operating Company, LLC</b> | |
| Facility Name: | <b>Williams Tank Battery</b> | |

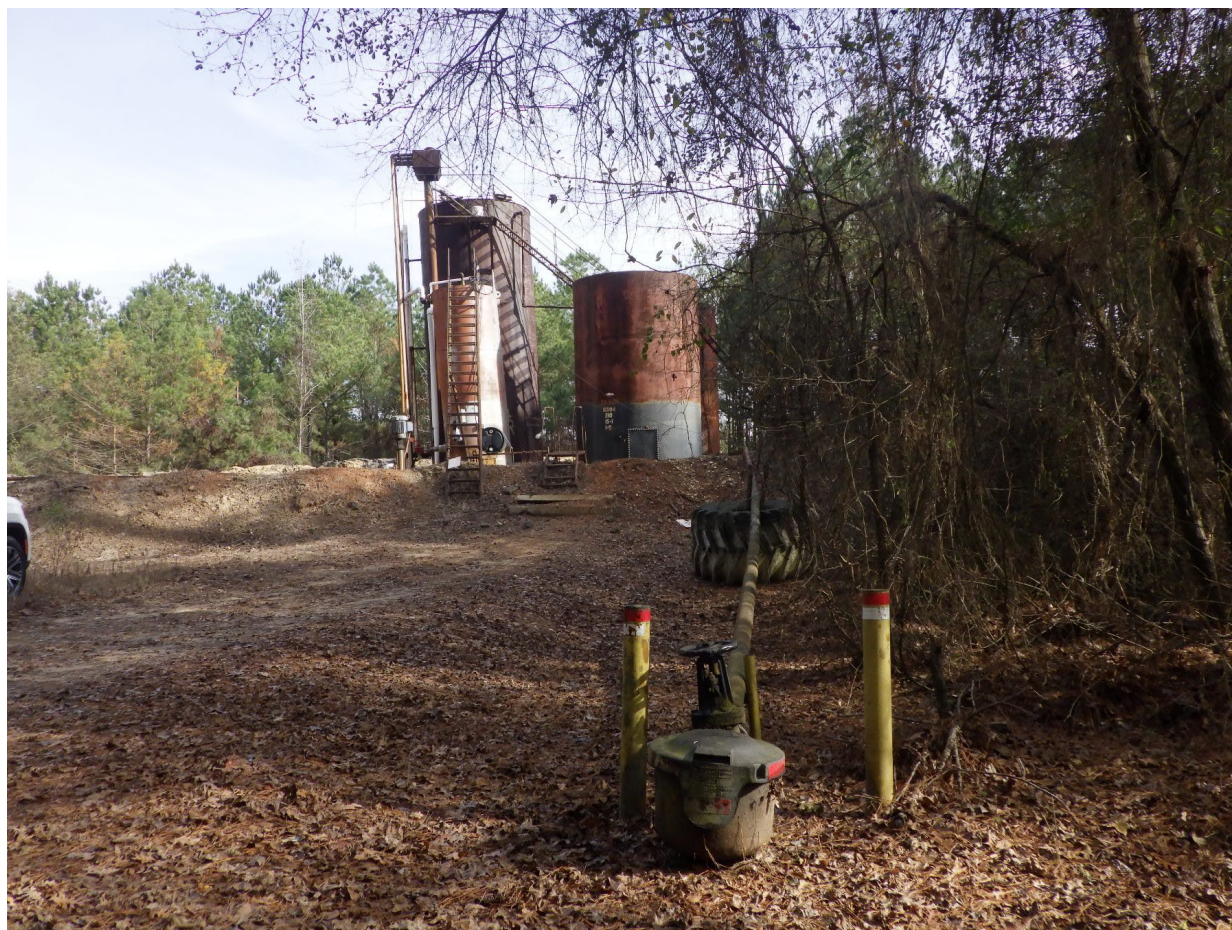
I observed the facility, pumps, and secondary containment with the separator and storage tanks; see Appendix 1 (Photograph Log), Photo No. 1 and No. 2. For additional GPS location and photo metadata, see Appendix 1.

| Description: | The photo was taken facing east-northeast and shows an overview of the facility. | | |

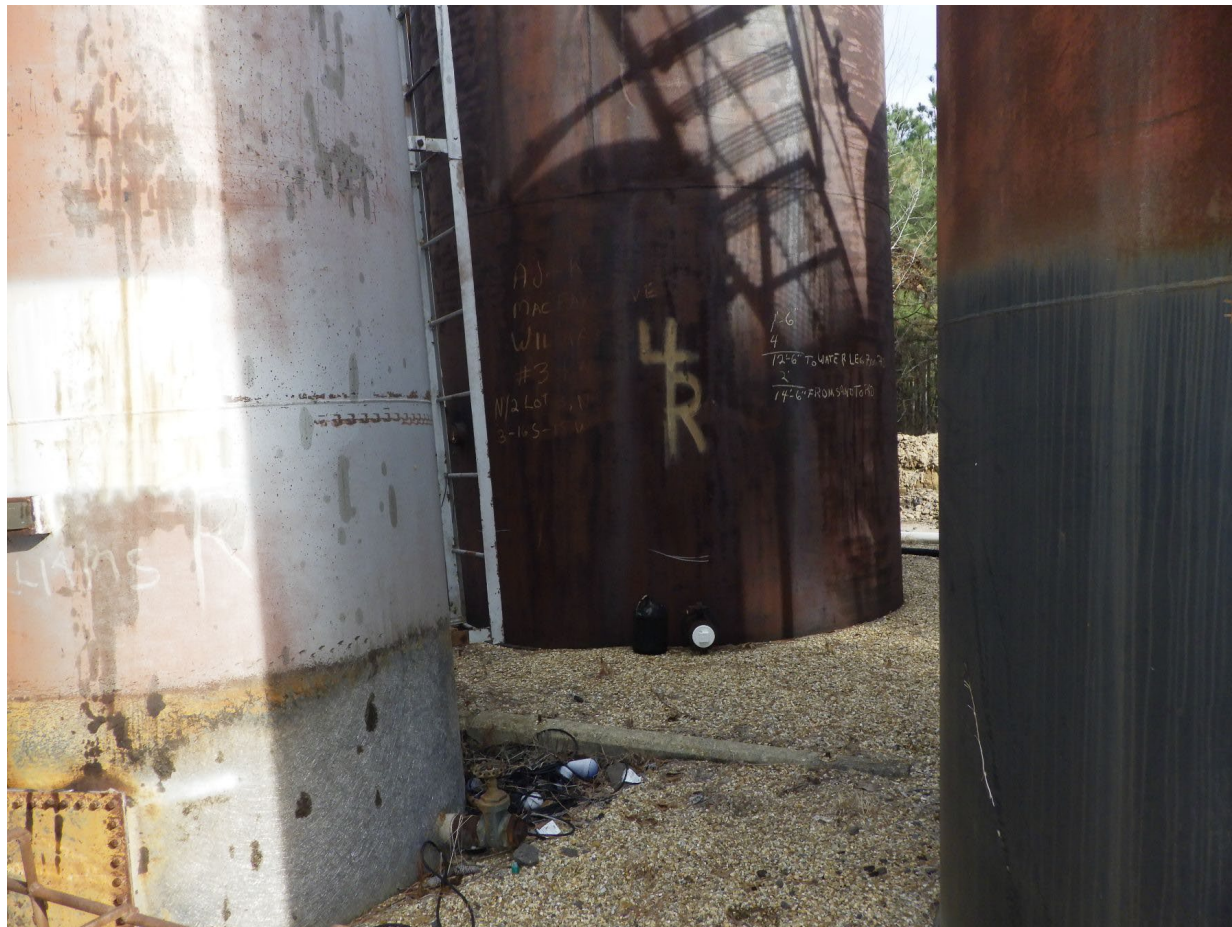
Photo No. 2

I observed signage on a tank at the facility, but did not observe a facility sign, see Photo No. 2. The facility information on the tank was not legible and did not match AOGC records.

- Lack of legible signage at the facility that does not match AOGC records.
- Loose oil inside secondary containment
- Leaking pump

| Description: | The photo was taken facing north-northeast and shows facility information on a storage tank. | | |

Inspector will conduct follow-up phone calls with the company representatives over the coming weeks and months to ensure areas of concern are properly addressed.

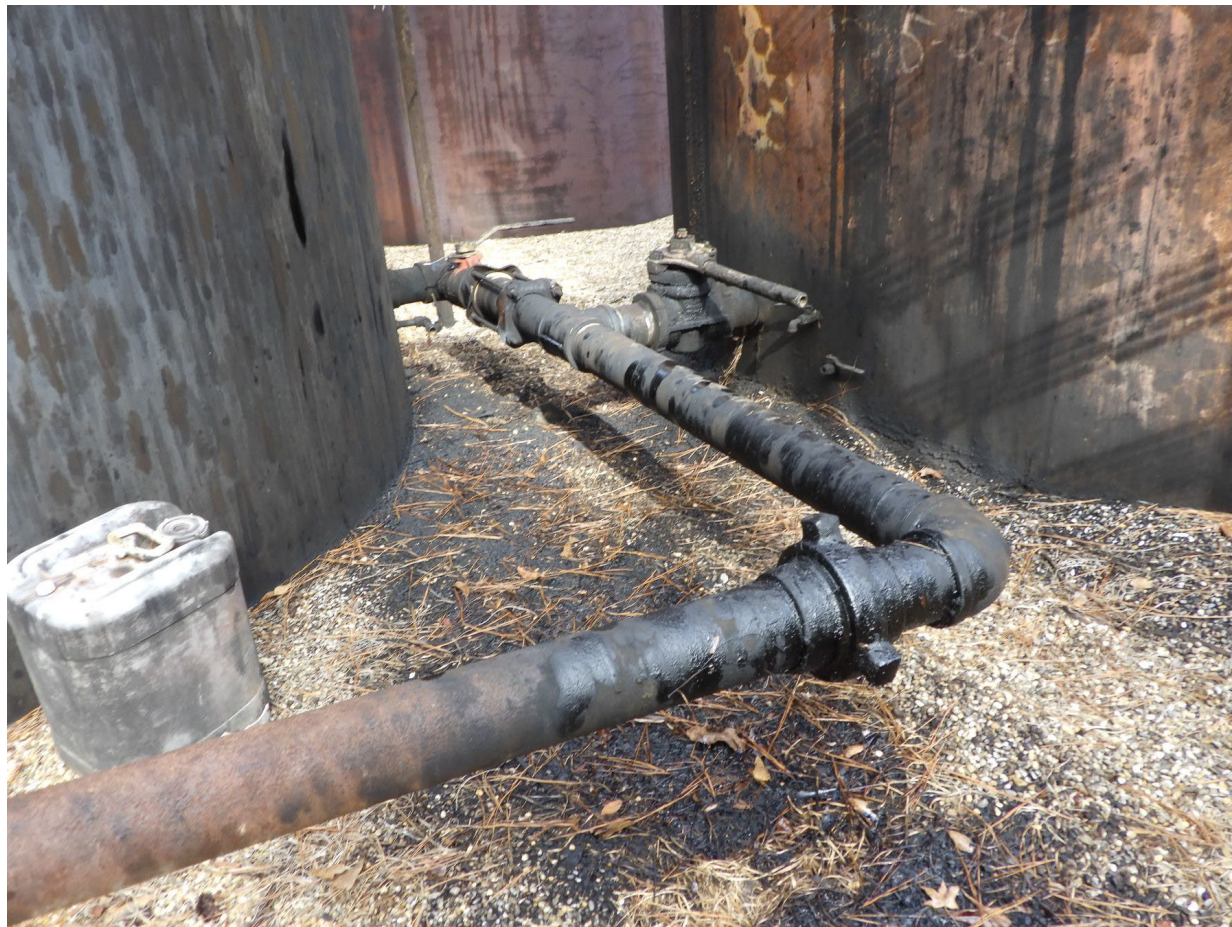
Photo No. 3

I observed loose oil below piping connected to tanks inside secondary containment, see Photo No. 3.

| Description: | This photo was taken facing northeast and shows loose oil under piping inside secondary containment. | | |

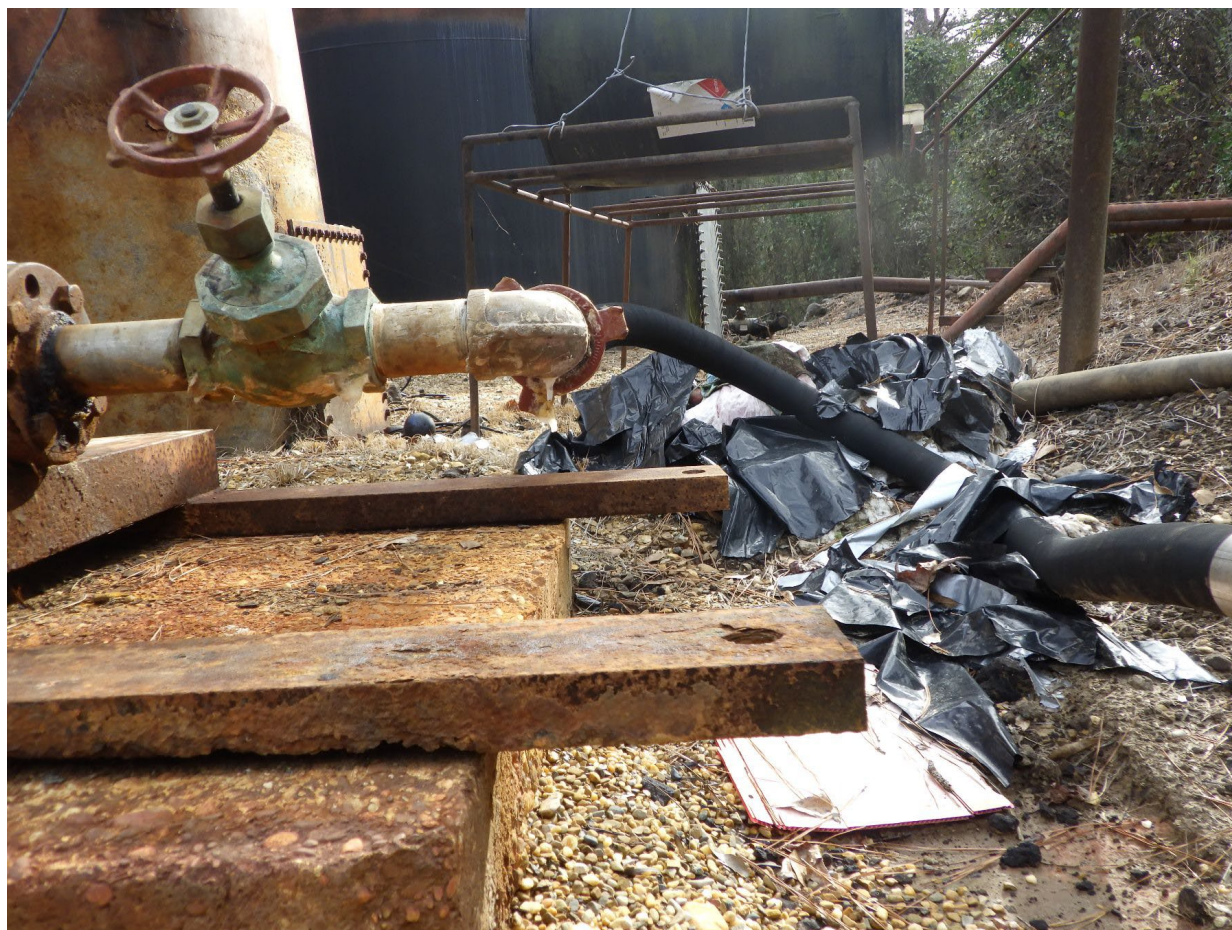
Photo No. 4

I observed a leaking pump, see Photo No. 4.

| Description: | This photo was taken facing southwest and shows a leaking pipe on from a pump. | | |
