## **RCRA Inspection Report**

Lighting Resources LLC  
1007 SW 16<sup>th</sup> Ln  
Ocala, FL 34471

EPA ID#: FLR000070565  
NAICS #: 562920 – Materials Recovery  
Facilities

August 8, 2023 10:22 a.m.

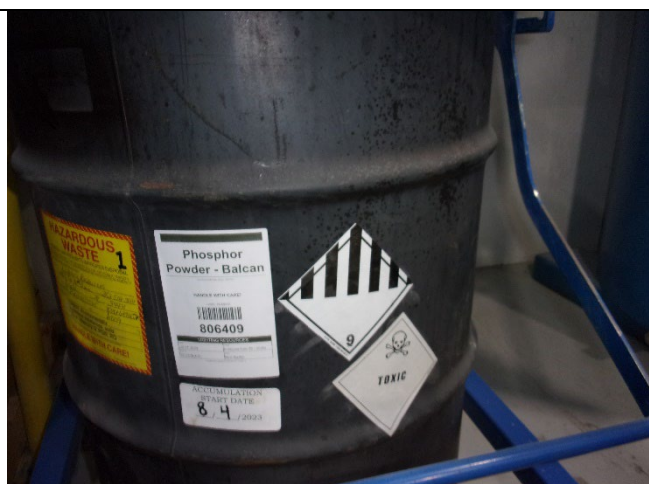
LR manages a SAA in the Balcan Room for managing hazardous waste phosphor powder that is generated by processed fluorescent lamps. The inspectors observed two (2) 55-gallon containers in this SAA. The containers were located under two (2) phosphor powder collection points for accumulating the phosphor powder, and they were equipped with a drum cover lid, which were closed. The first container was closed, dated, labeled D009 hazardous waste solid (mercury), and identified with an indication of the hazards of the contents (Figure 13 and 14). The second container observed was closed, dated, properly labeled, and identified with an indication of the hazards of the contents (Figure 15).

Figure 13: 12:47 PM Balcan Room  
One 55-gallon SAA container of phosphor powder observed.

Figure 14: 12:47 PM Balcan Room  
One 55-gallon SAA container of phosphor powder observed with hazardous waste label and indication of the hazards of the contents.

Figure 15: 12:51 PM Balcan Room  
One 55-gallon SAA container of phosphor powder observed.

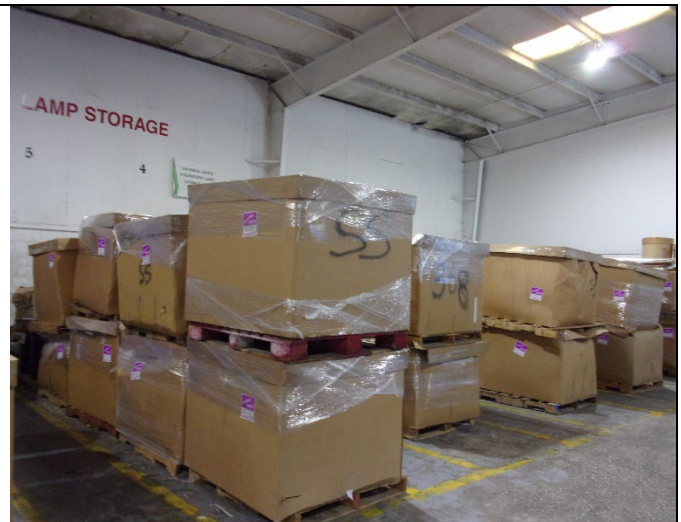
No containers were observed in these areas at the time of the facility walkthrough. However, at the end of the inspection, facility personnel notified inspectors that the facility had stored fluorescent lamps with shatter shields from one tractor trailer outside Warehouse C (Figures 24 through 26). See section titled “Outside Warehouse C” for more details.

Figure 24: 5:07 PM Rows 2 and 3  
Stored fluorescent lamps with shatter shields from one tractor trailer outside Warehouse C.

Figure 25: 5:08 PM Rows 2 and 3  
Stored fluorescent lamps with shatter shields from one tractor trailer outside Warehouse C.

Figure 26: 5:08 PM Rows 2 and 3  
Container label for one Gaylord box from tractor trailer outside Warehouse C.
