**Inspection Report Addendum for Well: MT22326-10303**  
**Inspection Date: 10/24/2023**

| <b>U.S. Environmental Protection Agency</b><br><b>Region 8</b> | | <b>UIC PHOTOGRAPHIC LOG</b> | |
| <b>Facility Location:</b><br>MT22326-10303 (Tribal Max 1-2817), Glacier County, UT | | <b>Photographer:</b><br>Gary Wang | <b>Camera:</b><br>Ricoh WG-5 |

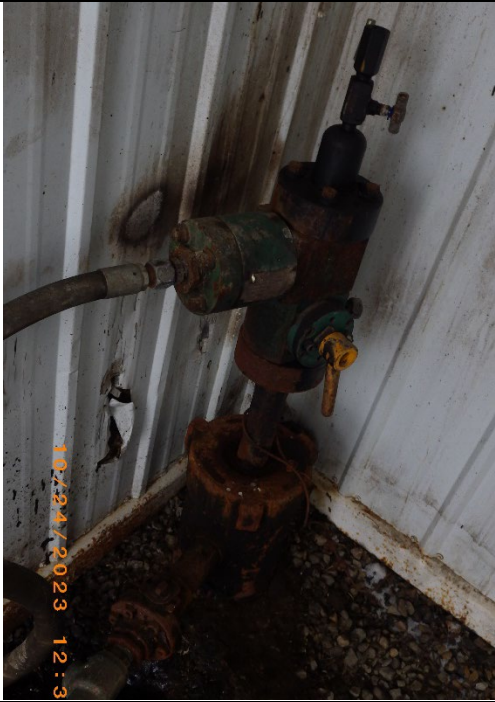
| <b>Photo No.</b><br>3 of 5 | <b>Time:</b><br>12:38 pm | | |

| <b>Photo Description:</b><br>Closer photo of well head. | | | |

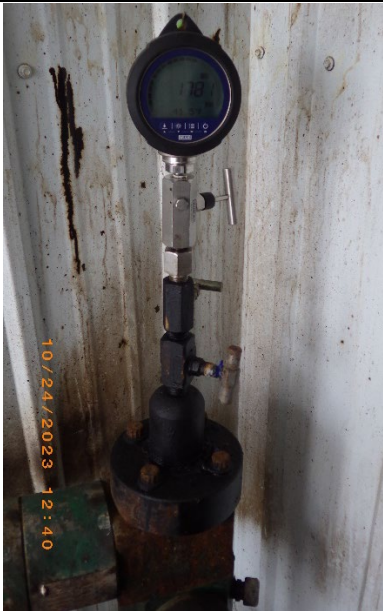
| <b>Photo No.</b><br>4 of 5 | <b>Time:</b><br>12:40 pm | | |

| <b>Photo Description:</b><br>EPA's digital pressure gauge on the tubing read 1781 psi on a 3000-psi range gauge.<br><br>MAIP for well is 2630 psi. | | | |

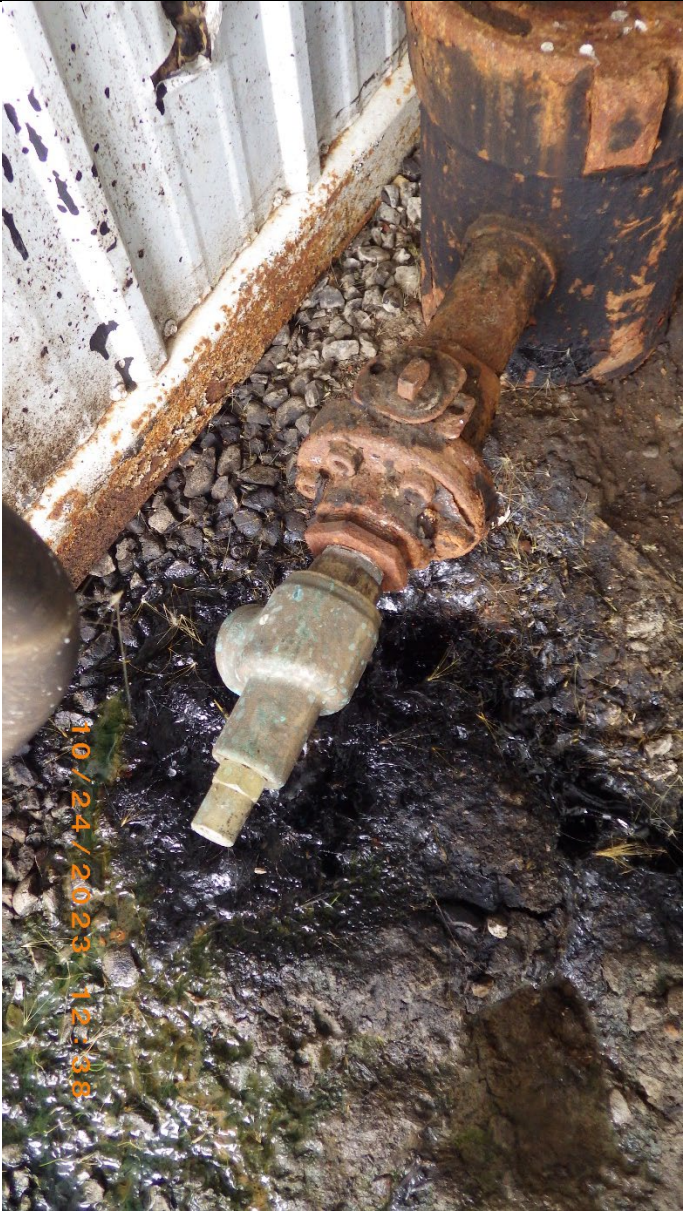
| <b>Photo Description:</b><br><br>Popoff valve observed on tubing-casing annulus. Operator indicated that popoff valve was set at 300 psi.<br><br>A slight drip was observed to come from the pop-off valve during inspection which appears to be the potential source of the puddle around the well. | | | |
