## **RCRA Inspection Report**

Arch Wood Protection Inc.  
1579 Kopper Road  
Conley, Georgia 30288  
Clayton County

EPA ID: GAD000821934  
NAICS: 325320 - Pesticide and Other Agricultural  
Chemical Manufacturing

March 18, 2024, at 9:10 a.m. EDT

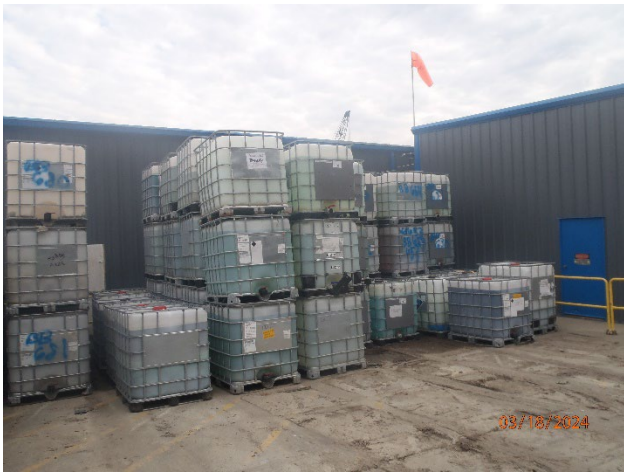
Picture 1 – Rework Area with empty totes

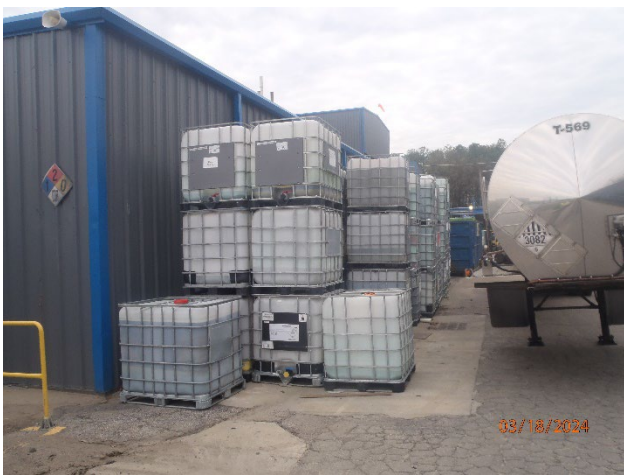
The tour began at tote storage area near the entrance of the facility. Mr. Maitland explained that during the weekend he consolidated 40 275-gallon totes into a railcar for shipment to a sister facility in Washington state. The empty totes were stockpiled in the Rework Area for reuse. The inspectors observed totes filled with liquid (Pictures 1-2). Mr. Kersting explained that the totes contained washwater that would be reused in the process and that Mr. Maitland was tasked with reducing the volume of totes. Some of the totes had written markings on the side to identify the contents or the area where the tote was generated. Mr. Kersting explained that the facility was a zero-discharge plant and all the wastewater from the processes would eventually be reused at the plant.

Picture 2 – Rework Area

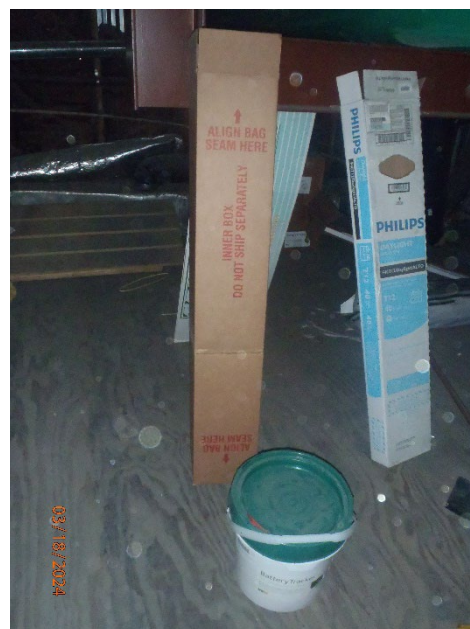
The universal waste was stored in the loft of the Maintenance Shop. The inspectors observed three 4-foot boxes of universal waste lamps. Two boxes were not closed or dated, and one box was not labeled. Two 5-gallon containers of universal waste batteries that were closed, labeled, and dated. Mr. Maitland closed, labeled, and dated the boxes during the inspection.

Picture 5 – Maintenance universal waste storage

**Pursuant Ga. Comp. R. and Regs. 391-3-11-.18 [40 C.F.R. § 273.13(d)], a SQHUW must manage universal waste lamps in a way that prevents releases of any universal waste or component of a universal waste to the environment.**

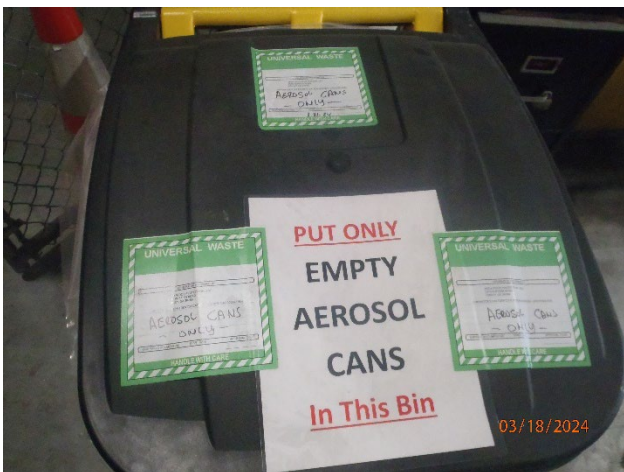
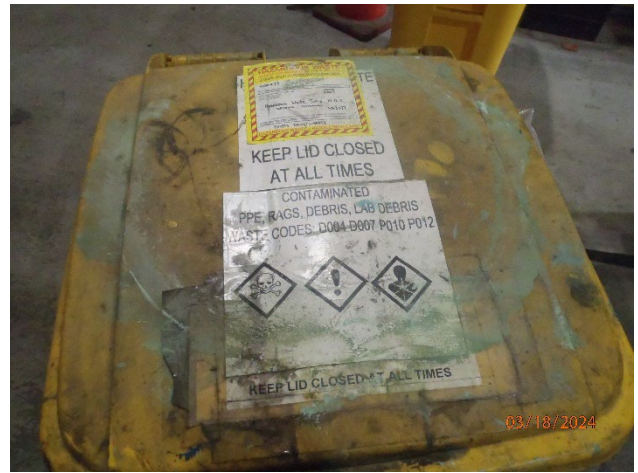
The Maintenance Shop had two satellite accumulation containers (Pictures 3-4). At the time of the inspection, the maintenance staff had emptied the contents of the two yellow wheeled trash cans into an open metal bin. The bin was then moved to another area. The inspectors observed that the trash cans were closed and labeled. The first container was labeled Universal Waste Aerosol Cans and the second container was labeled Hazardous Waste.

Picture 4 – Maintenance SAA roll-off cart

Picture 3 – Maintenance SAA roll-off cart

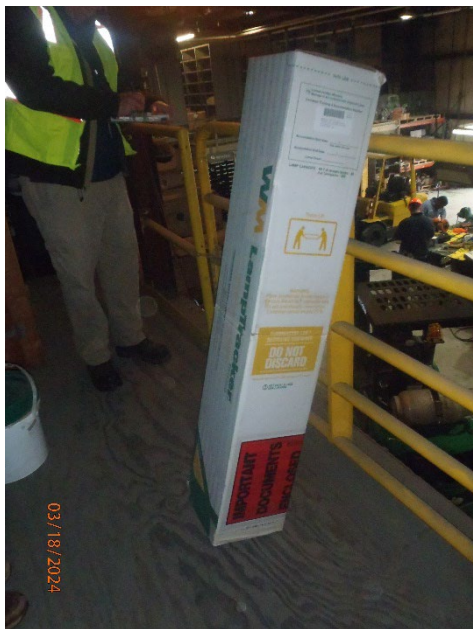
Picture 6 – Maintenance universal waste lamps

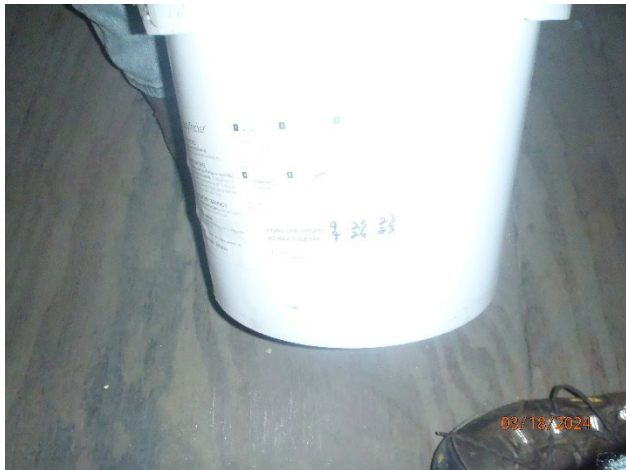
Picture 7 – Maintenance universal waste batteries

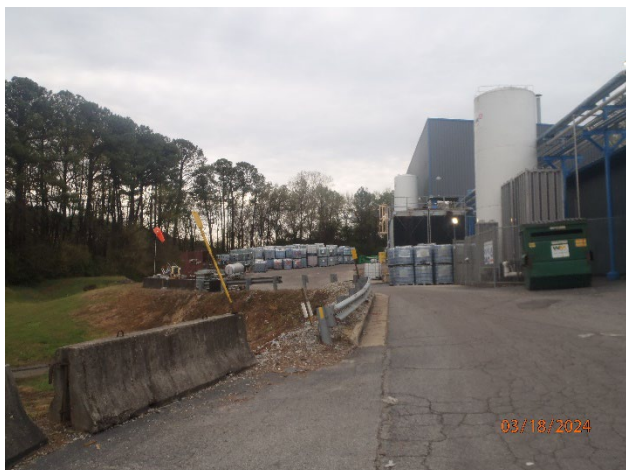
The Copper Plant is used to manufacture Chemonite® ACZA, liquid borate, Wolman® Copper Azole/CA-C, and copper oxide. The inspectors observed numerous 275-gallon containers staged outside the Copper Plant (Pictures 8-9). Mr. Kersting explained that the materials were generated within the Copper Plant and accumulated in the containers for reuse in copper production. The inspectors entered the Copper Plant and observed the following:

The inspectors observed numerous 275-gallon containers stored near the Copper Plant and the Copper Oxide Plant (Picture 8). The inspectors inquired about the status of the material in the containers and Mr. Kersting stated the materials in the containers were generated from various production processes within the facility and were accumulated in the 275-gallon containers for reuse in the facility's production. The inspectors also asked about the length of time the containers had been stored in this area and others, and Mr. Kersting stated that he, Mr. McEachern, and Mr. Maitland were recently employed at the facility, and tasked to clean up the issues caused by the previous management and staff. The gentlemen were aware that some of the 275-gallon containers had been stored on site for longer than a year. The inspectors requested the container inventory, the contents of each container, the length of time and number of containers on site.

Picture 8 – Copper Plant and Rework Container Storage

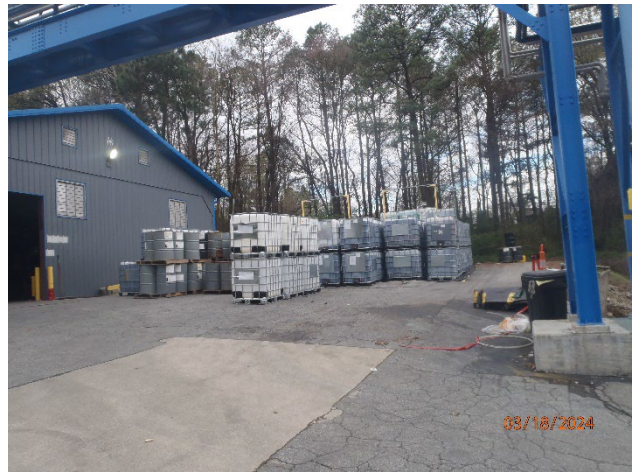
Picture 9 – Copper Plant Rework Area

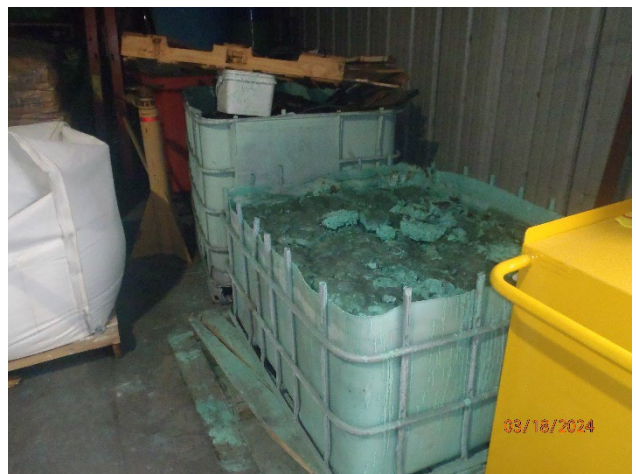
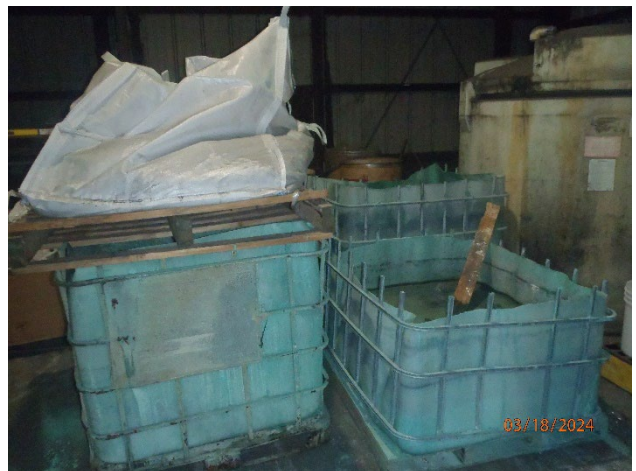
- Five 275-gallon containers of copper carbonate to be reworked (Pictures 10-11). The tops of the containers were cut off. At the time of the inspection, some of the containers of copper carbonate appeared to have discarded debris mixed with copper carbonate; and
- Supersacks of copper oxide (Picture 12). Mr. Kersting explained this is raw material used in the copper production. The inspectors noted that the raw material was being wasted on the floor and stated that to Mr. Kersting.

Picture 10 – Copper Plant tote of copper carbonate to rework

Picture 11 – Copper Plant tote of copper carbonate to rework

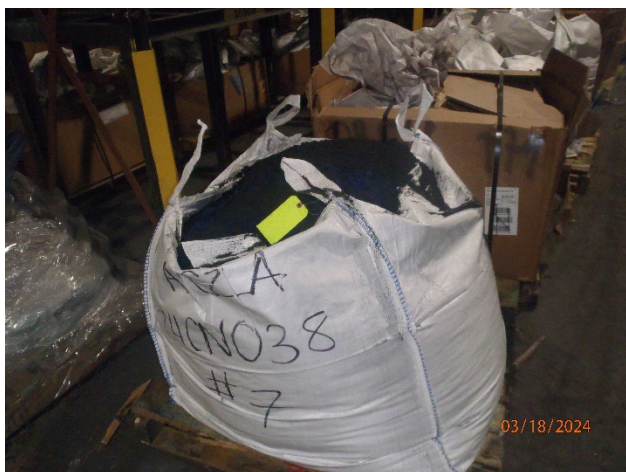
Picture 12 – Copper Plant supersack of copper oxide

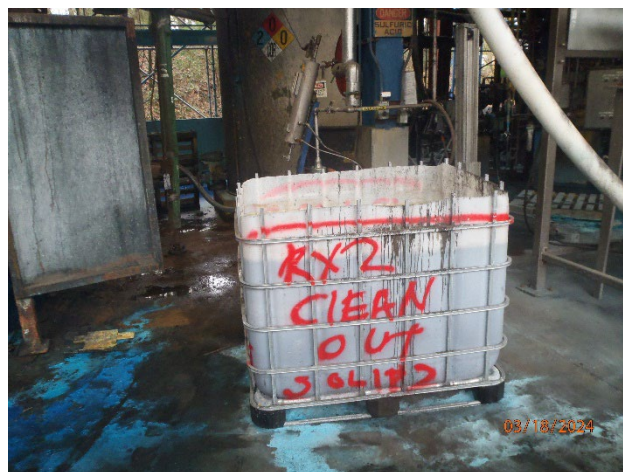
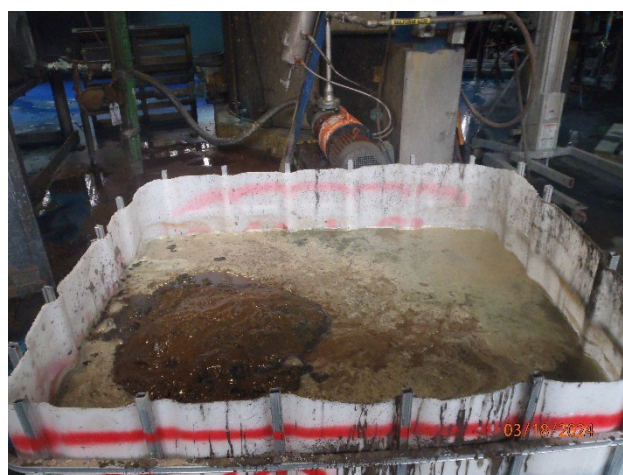
- A 275-gallon container of reactor cleanout (Pictures 15-16). When asked, Mr. Kersting and Mr. McEachern did not know if the reactor cleanout was hazardous. The inspectors stated a hazardous waste determination was required.

Picture 15 – Copper Oxide Plant reaction cleanout tote

Picture 16 – Copper Oxide Plant reaction cleanout tote

**Pursuant to Ga. Comp. R. and Regs. 391-3-11-.08(1) [40 C.F.R. § 262.11], a person who generates a solid waste, as defined in Ga. Code Ann. §12-8-62(20) [40 C.F.R. § 261.2], must make an accurate determination as to whether that waste is a hazardous waste in order to**

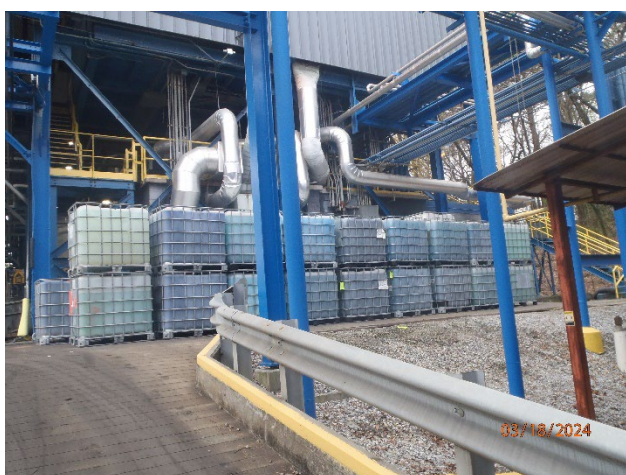
Outside the Copper Plant was a small rework area for the Copper Oxide Plant that was adjacent to the Copper Plant (Picture 13). Several 275-gallon containers of rework material were observed in this area. Inside the Copper Oxide Plant, the inspectors observed the following:

Picture 13 – Copper Oxide Plant totes to be reworked

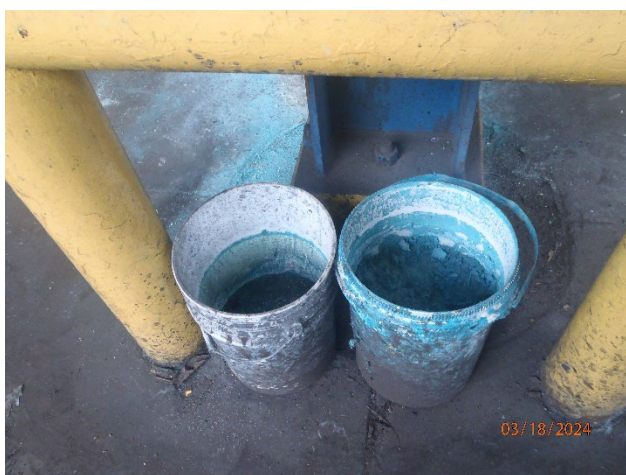
- One satellite accumulation area (SAA) container for personal protection equipment that had recently been emptied. The container was closed and labeled; and
- Two 5-gallon containers of unknown blue material (Picture 14). When asked, Mr. Kersting and Mr. McEachern stated they were not sure what the material was and why it was left there, but they would have the contents identified. The inspectors stated a hazardous waste determination was required.

Picture 14 – Copper Oxide Plant containers of unknown material

**Pursuant to Ga. Comp. R. and Regs. 391-3-11-.08(1) [40 C.F.R. § 262.11], a person who generates a solid waste, as defined in Ga. Code Ann. §12-8-62(20) [40 C.F.R. § 261.2], must make an accurate determination as to whether that waste is a hazardous waste in order to ensure wastes are properly managed according to applicable RCRA regulations articulated in Ga. Comp. R. and Regs. 391-3-11-.08(1) [40 C.F.R. § 262.11].**

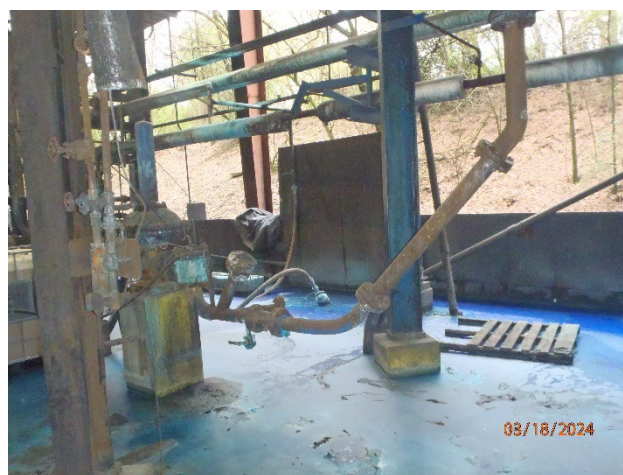
Picture 17 – Copper Oxide Plant sump area

**Pursuant to Ga. Comp. R. and Regs. 391-3-11-.08(1) [40 C.F.R. § 262.17(a)(6)], which incorporates Ga. Comp. R. and Regs. 391-3-11-.08(1) [40 C.F.R. § 262.251], and is a condition of the LQG Permit Exemption, a generator is required to maintain and operate its facility to minimize the possibility of a fire, explosion, or any unplanned sudden or non-sudden release of hazardous waste or hazardous waste constituents to air, soil, or surface water which could threaten human health or the environment.**

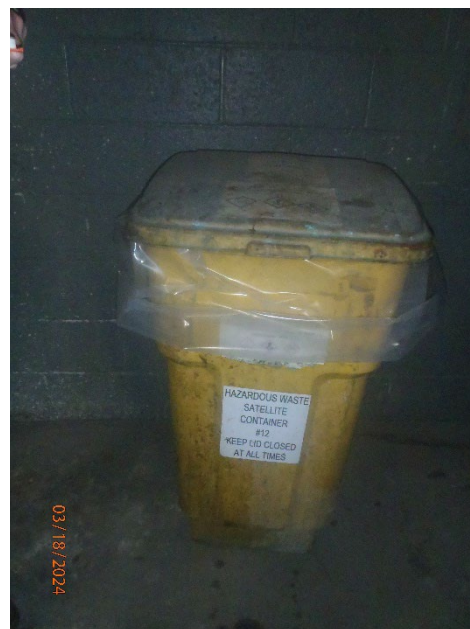
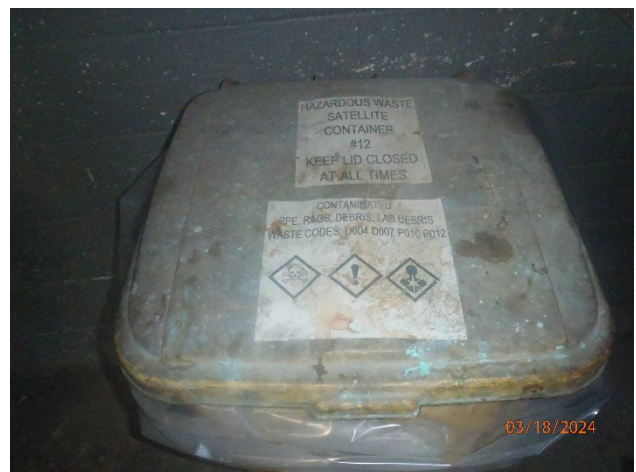
The Mix Plant had four SAA containers for personal protective equipment staged throughout the two-floor building (Pictures 21-22). The containers were observed closed and labeled. Downstairs, in the Mix Plant, was a three-sided bin that was labeled as an SAA (Pictures 23-24). Inside the bin, were several trash bags of spent personal protective equipment and had a net tarp covering the top. The bin was covered, labeled, but not dated. The inspectors explained that the bin was over 55-gallons and was not an SAA but a central accumulation area (CAA) and should have a start accumulation date.

Picture 21 – Mix Plant SAA

Picture 22 – Mix Plant SAA label

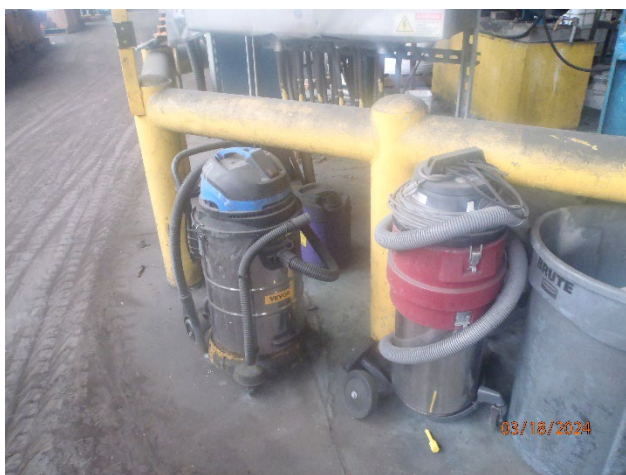
- Two vacuums used to remove excess material inside the secondary containment area (Picture 19). However, the vacuums were not working at the time of the inspection; and
- A large plastic bag of spent filter bags from the copper metal ammonia process that was installed in 2022 (Picture 20). The process sat idle for 18 months, but recently operated on March 16<sup>th</sup> and 17<sup>th</sup>, thus generating the spent filter bags. Mr. Kersting and Mr. McEachern did not know if the spent filters were hazardous. The inspectors stated a hazardous waste determination was required.

Picture 19 – Copper Oxide Plant vacuums

**Pursuant to Ga. Comp. R. and Regs. 391-3-11-.08(1) [40 C.F.R. § 262.17(a)(6)], which incorporates Ga. Comp. R. and Regs. 391-3-11-.08(1) [40 C.F.R. § 262.251], and is a condition of the LQG Permit Exemption, a generator is required to maintain and operate its facility to minimize the possibility of a fire, explosion, or any unplanned sudden or non-sudden release of hazardous waste or hazardous waste constituents to air, soil, or surface water which could threaten human health or the environment.**

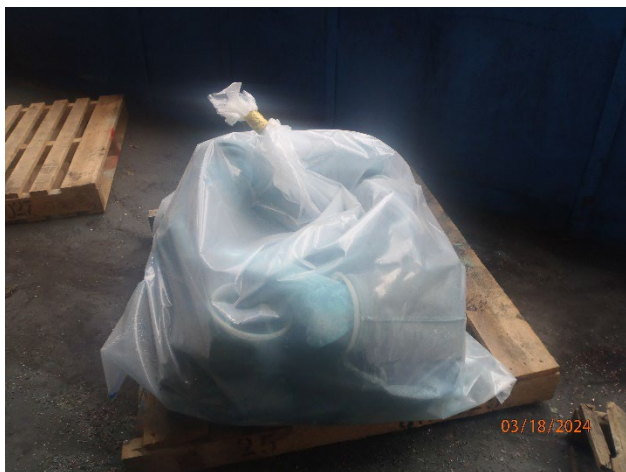
Picture 20 – Copper Oxide Plant bag of spent filter bags

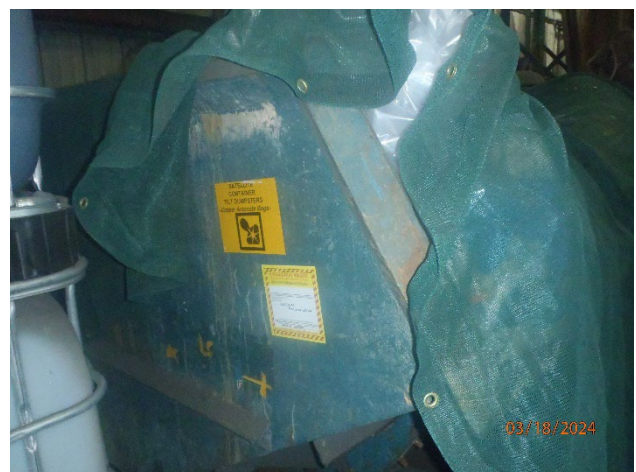
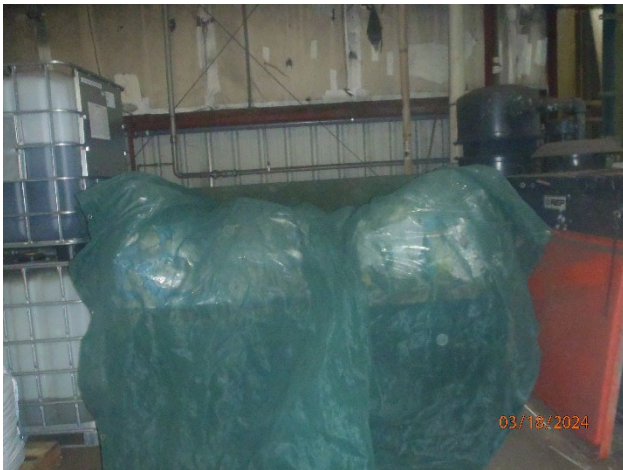
Picture 23 – Mix Plant CAA bin

Picture 24 – Mix Plant CAA bin

**Pursuant to Ga. Comp. R. and Regs. 391-3-11-.08(1) [40 C.F.R. § 262.17(a)(5)(i)], which is a condition of the LQG Permit Exemption, a generator must mark or label its containers with the following: the words “Hazardous Waste”; an indication of the hazards of the contents; and the date upon which each period of accumulation begins clearly visible for inspection on each container.**

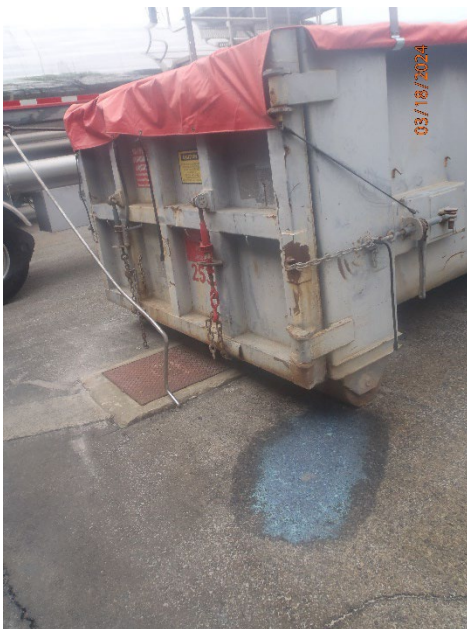
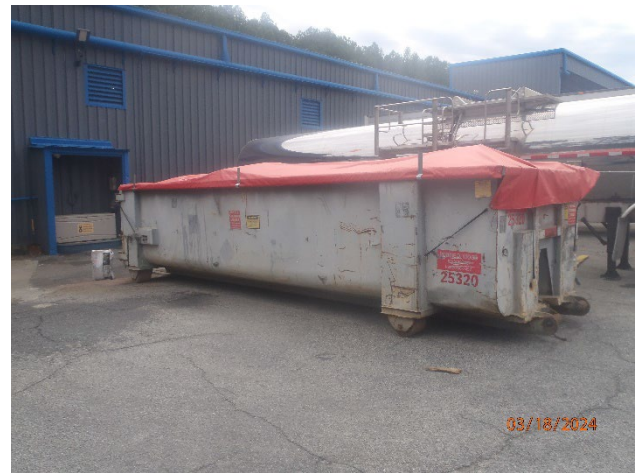
Outside the Mix Plant was a 20-cubic yard roll-off of hazardous waste (Pictures 25-28). At the time of the inspection, the roll-off was leaking hazardous waste onto the ground. Water was observed on the tarp covering the roll-off, and Mr. Kersting released the rainwater to the ground. However, Mr. Kersting nor Mr. McEachern could determine the cause of the leak. Absorbent was applied to the release during the inspection. The roll-off was observed closed, labeled, and dated February 1, 2024.

Picture 27 –90-Day HW Roll-off

Picture 25 – 90-Day HW Roll-off with leak

Picture 28 –90-Day HW Roll-off

Picture 26 –90-Day HW Roll-off label

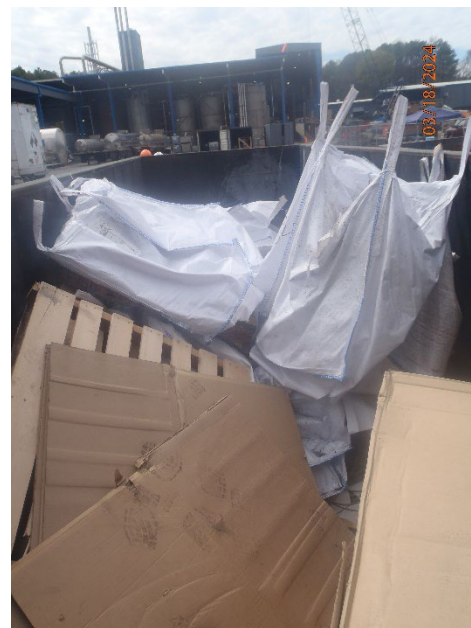
A trash roll-off was observed in this area (Picture 29). No hazardous waste was observed inside the roll-off.

Picture 29 – Garbage Roll-off

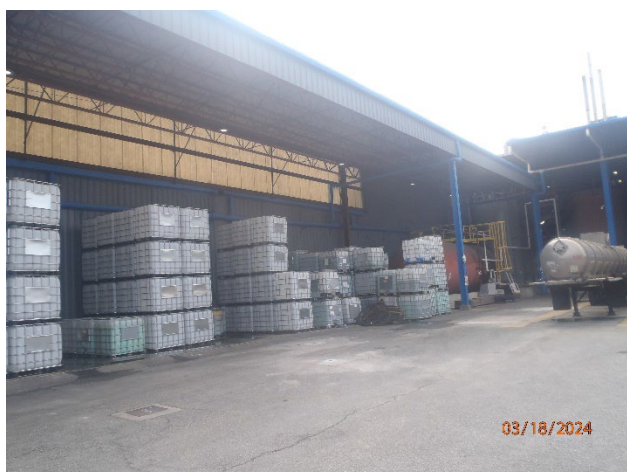
Outside the doors of the Mix Plant was a rework area with numerous 275-gallon containers (Picture 30). Mr. Kersting explained that containers would be reused in the Mix Plant process and were being stored in the secondary containment area. However, the inspectors observed that several containers were outside the secondary containment area and expressed concern that if a forklift and any other heavy machinery pierced and/or damaged one or more totes that the rework material would be released into the storm drains.

Picture 30 – Mix Plant Rework Area

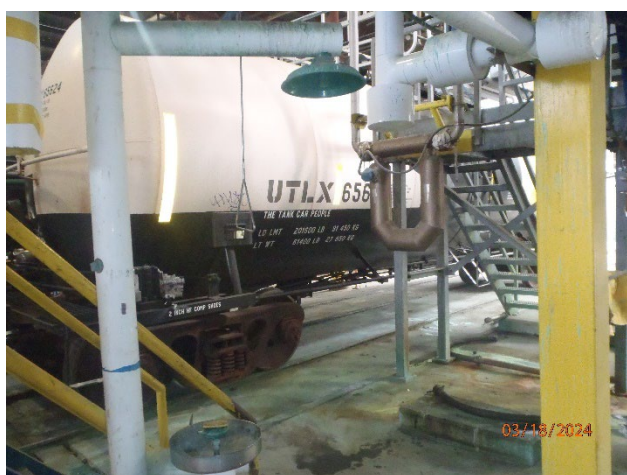
The truck loading area contained an 18,000-gallon railcar being loaded with ammonia rework material to be sent to the Washington facility for reuse (Picture 31). An SAA for personal protective equipment and discarded rags was observed closed and labeled.

Picture 31 – Truck Loading Area

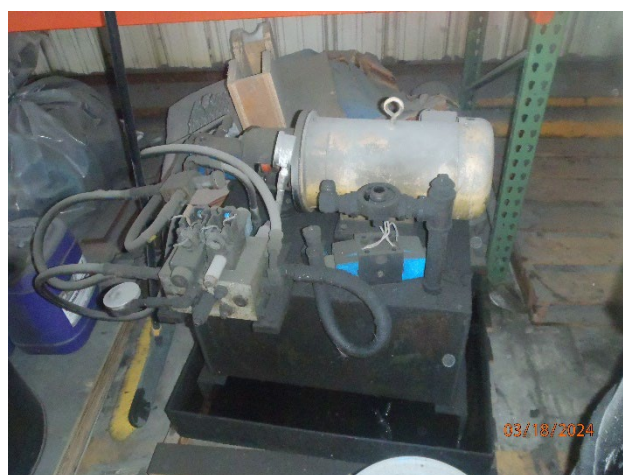
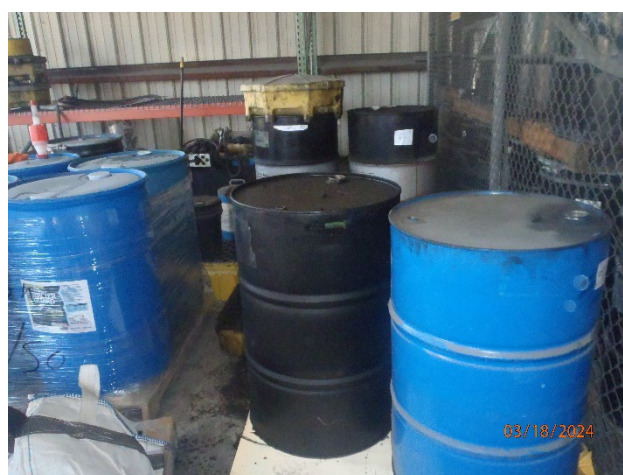
Further inside the three-sided warehouse was a used oil storage area (Pictures 34-35). The inspectors observed obsolete equipment to be discarded with used hydraulic oil inside the secondary containment, two 55-gallon used oil containers with funnels sitting on secondary containment filled with used oil, and a release of used oil on the ground beside the secondary containment. The inspectors stated that the secondary containments were not storage and required to be cleaned out and empty in the event of a release. The used oil released to the ground needed to be cleaned up with absorbent to prevent further release to the environment.

Picture 34 – Three-Sided Warehouse used hydraulic oil

Picture 35 – Three-Sided Warehouse used oil storage

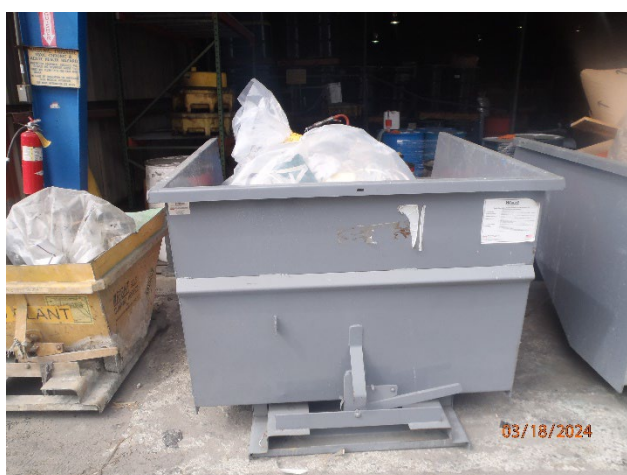
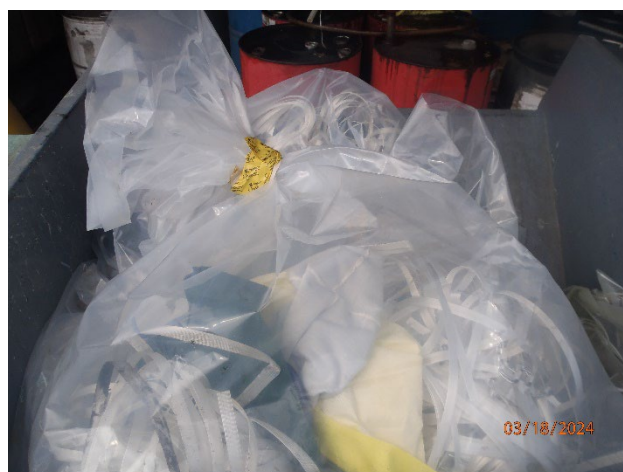
The inspectors observed one small yellow three-sided bin and two large gray 3-sided bins. The middle gray bin contained bags of discarded personal protective equipment collected from around the facility that morning. The bin was not closed, not labeled, and no start accumulation date. The inspectors explained that by moving the hazardous waste from the SAA containers into this bin, a CAA was created. Mr. Maitland immediately had the bin labeled and dated.

Picture 33 – Three-Sided Warehouse CAA

Picture 32 – Three-Sided Warehouse CAA

**Pursuant to Ga. Comp. R. and Regs. 391-3-11-.08(1) [40 C.F.R. § 262.17(a)(5)(i)], which is a condition of the LQG Permit Exemption, a generator must mark or label its containers with the following: the words “Hazardous Waste”; an indication of the hazards of the contents; and the date upon which each period of accumulation begins clearly visible for inspection on each container.**

**Pursuant to Ga. Comp. R. and Regs. 391-3-11-.08(1) [40 C.F.R. § 262.17(a)(1)(iv)], which is a condition of the LQG Permit Exemption, (A) a container holding hazardous waste must always be closed during accumulation, except when it is necessary to add or remove waste; and (B) A container holding hazardous waste must not be opened, handled, or stored in a manner that may rupture the container or cause it to leak.**

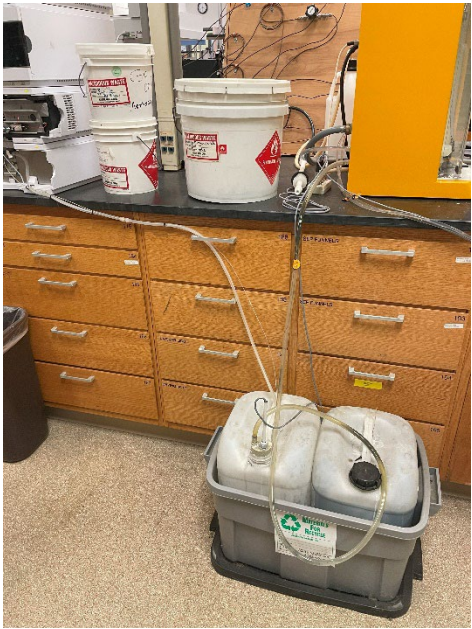
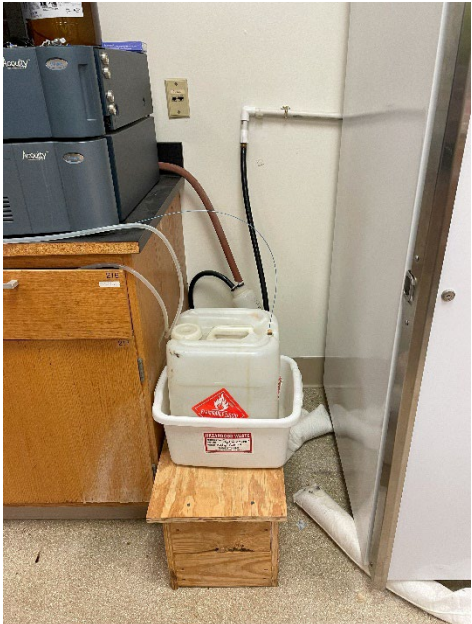
- The Tech Center had several small SAA containers located throughout the lab (Pictures 36-40). The containers were observed closed and labeled;
- The CAA located in the Pilot Plant, was a gaylord container with a plastic liner (Pictures 41-42). The container held discarded personal protective equipment and debris, and was observed closed, labeled, and dated March 5, 2024;

Picture 36 – Tech Center Lab SAA

Picture 38 – Tech Center Lab SAA

Picture 37 – Tech Center Lab SAA

Picture 39 – Tech Center Lab SAA

Picture 40 – Tech Center Lab SAA

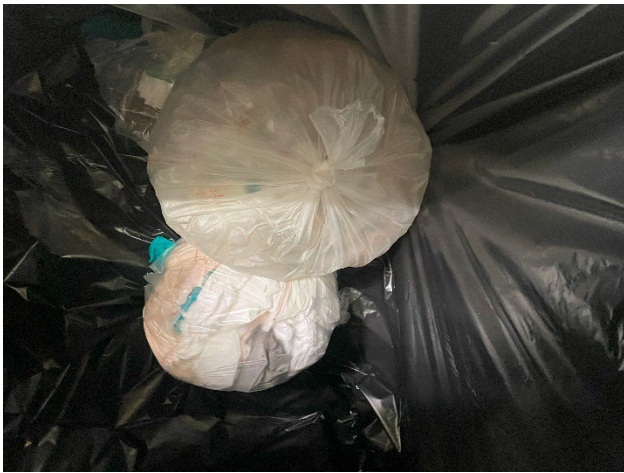
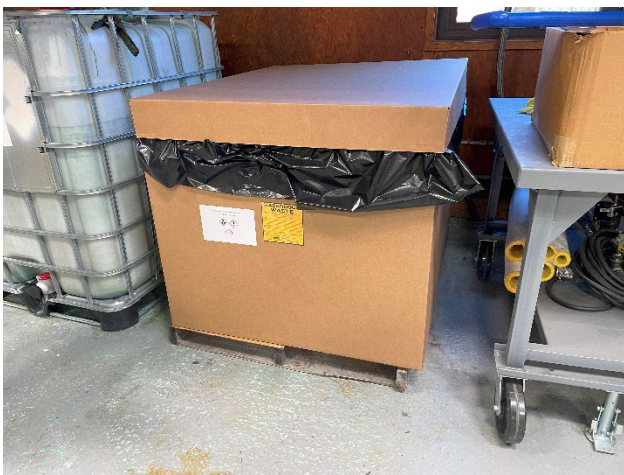
Picture 41 – Tech Center Pilot Plant CAA

Picture 42 – Tech Center Pilot Plant CAA

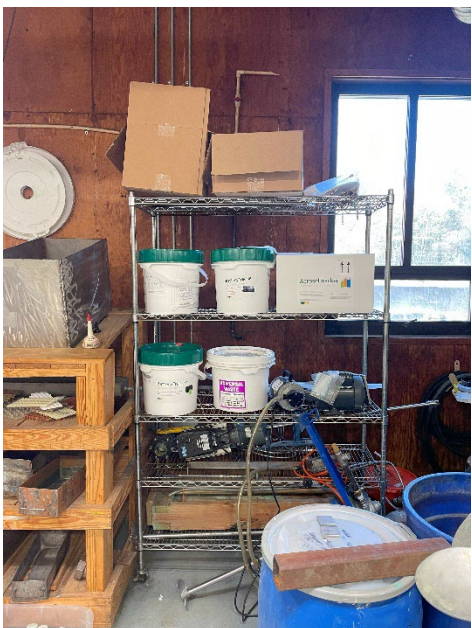
- The universal waste storage was a shelving unit with a one-gallon container of spent batteries that was closed, labeled, and dated (Picture 43);
- A yellow metal flammable storage cabinet held with a 30-gallon container of hazardous waste flammable liquid (Pictures 44-45). The container was an SAA that was closed and labeled; and

Picture 43 – Tech Center Pilot Plant UW Storage

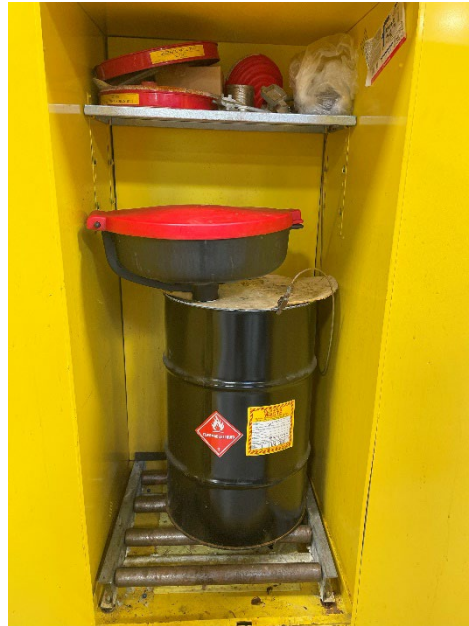
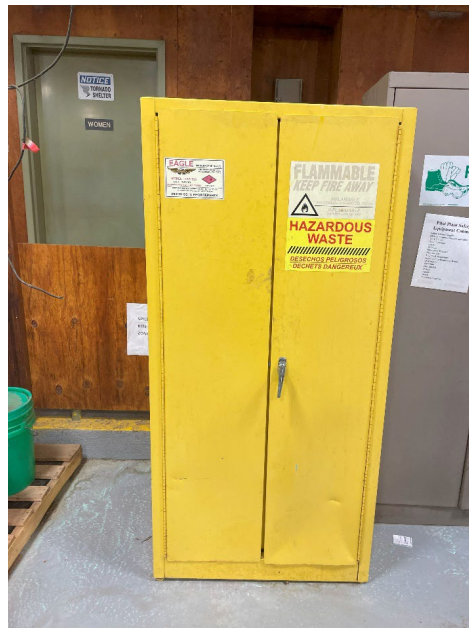
Picture 44 – Tech Center Pilot Plant flammable cabinet SAA

Picture 45 – Tech Center Pilot Plant flammable cabinet SAA

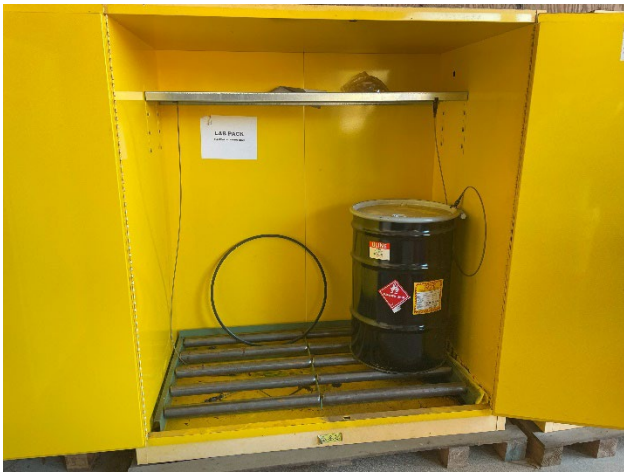
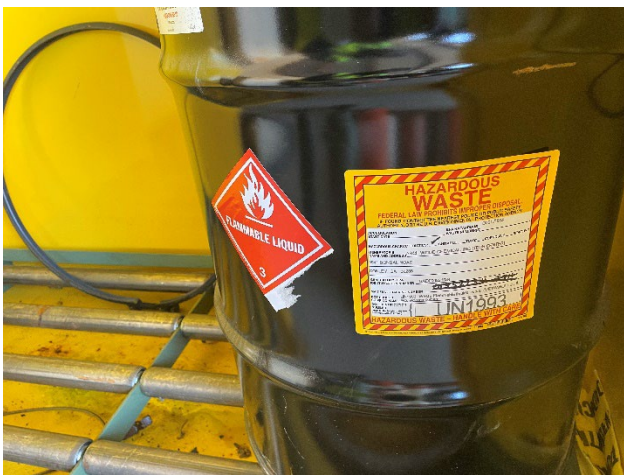
- The outside shed contained a yellow flammable metal cabinet which was the lab pack CAA. Inside was a 55-gallon container labeled Waste Liquid Flammable that was closed (Picture 46-47). A four-foot container of universal waste lamps was observed closed, labeled, and dated January 3, 2024 (Pictures 48-49).

Picture 46 – Tech Center Outside Shed Lab Pack CAA

Picture 47 – Tech Center Outside Shed Lab Pack CAA

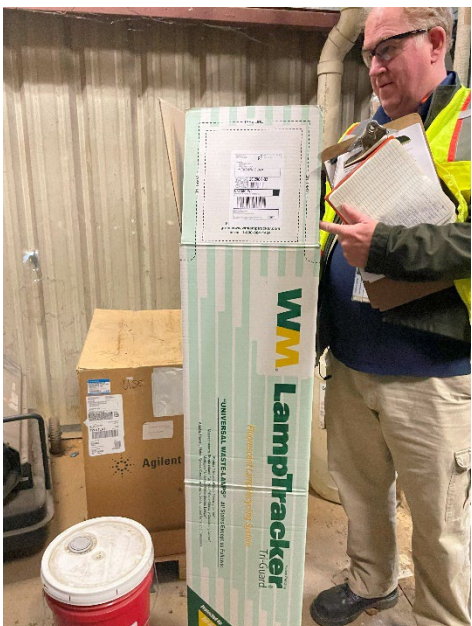
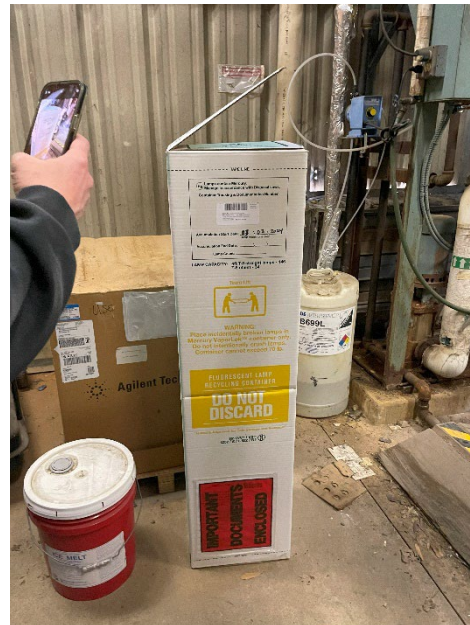
Picture 49 – Tech Center Outside Shed UW Storage

Picture 48 – Tech Center Outside Shed UW Storage
