## PHOTO LOG

| Facility Name: | Gloster Chips |
| EPA Media: | Stormwater - Industrial |

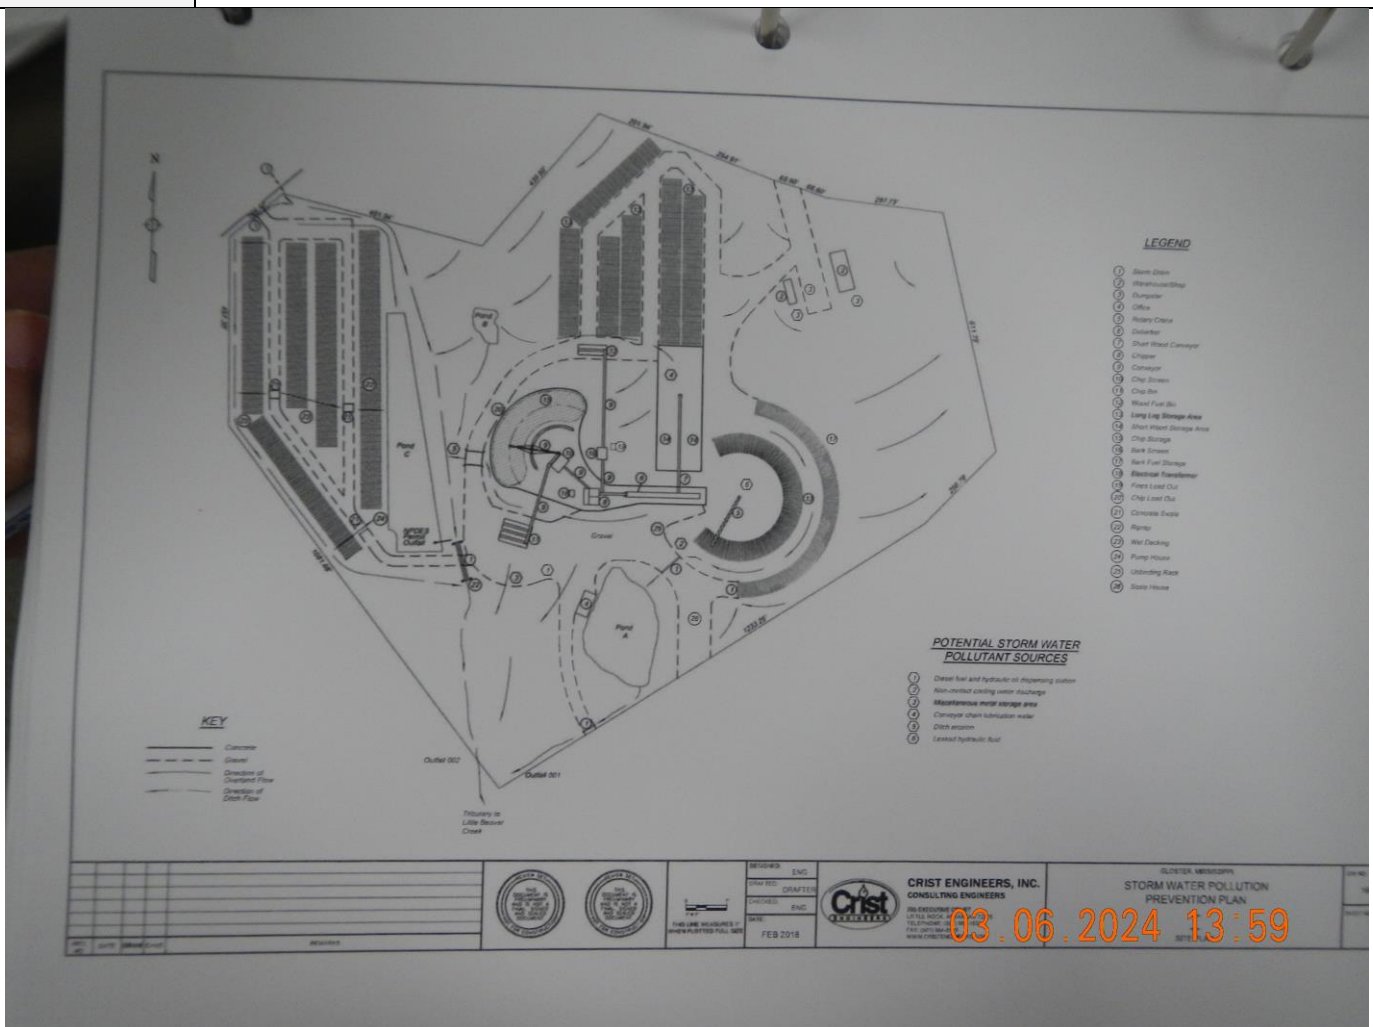
| Photo ID: | DSCN2958.JPG |

| Description: | Site map from the SWPPP, dated February 2018 |

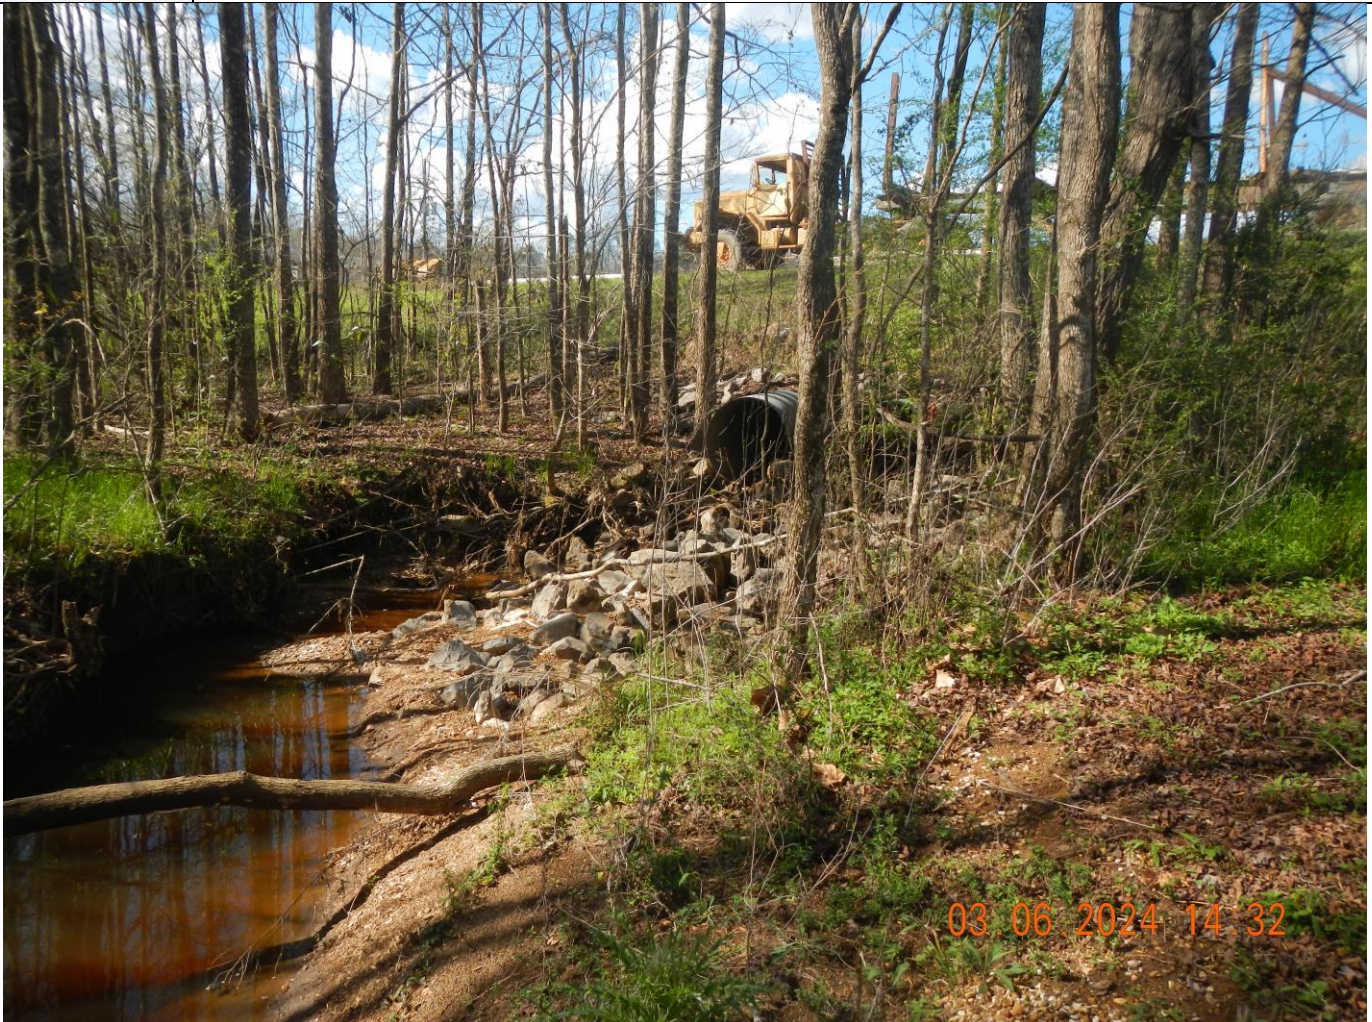
| <b>Photo ID:</b> | DSCN2959.JPG |

| <b>Description:</b> | Looking upgradient at Outfall #2. This outfall discharges water collected by the swale in photo DSCN29560. When the low level drainage system of the wet deck recirculation pond is engaged, it also drains through Outfall #2 via the swale, as shown in photo DSCN2962. |

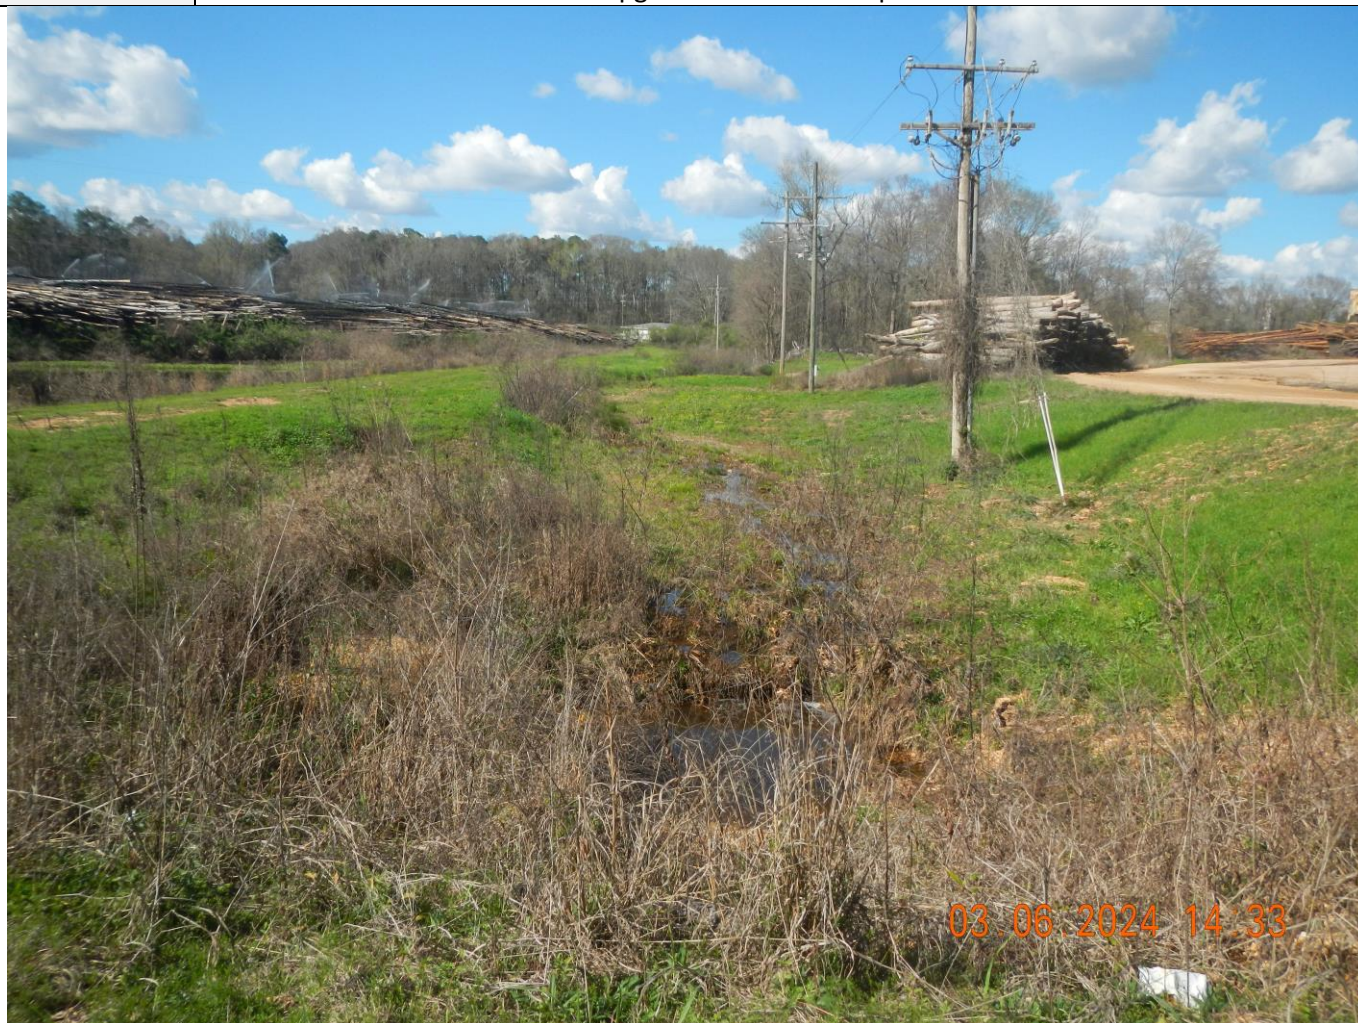
| <b>Photo ID:</b> | DSCN2960.JPG |

| <b>Description:</b> | Looking upgradient at a vegetated swale through the site, which discharges via Outfall #2 (shown in photo DSCN2959). Swale receives runoff from the mill area (photos DSCN2976P. An additional view of the swale at a location farther upgradient is shown in photo DSCN2975. |

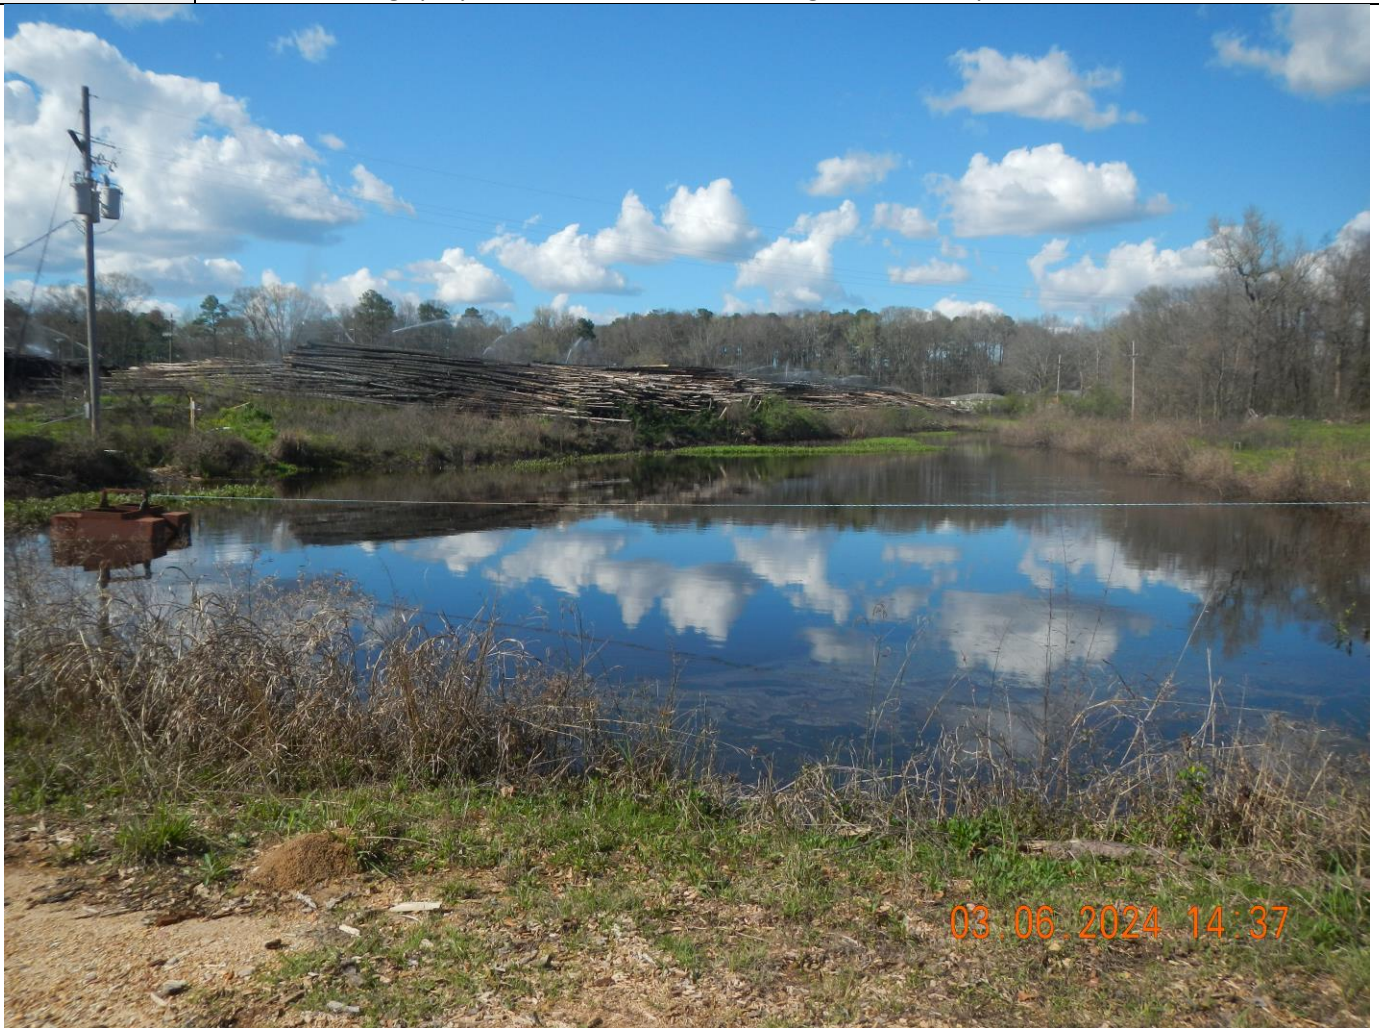
| <b>Photo ID:</b> | DSCN2961.JPG |

| <b>Description:</b> | View of the Wet Deck Log Spray (WDLS) recirculation pond. Discharge from this pond, which is also routed through Outfall #2, is covered under MDEQ's WDLS General Permit. Water is pumped out and used for log spray down, as shown in the background of the picture. |

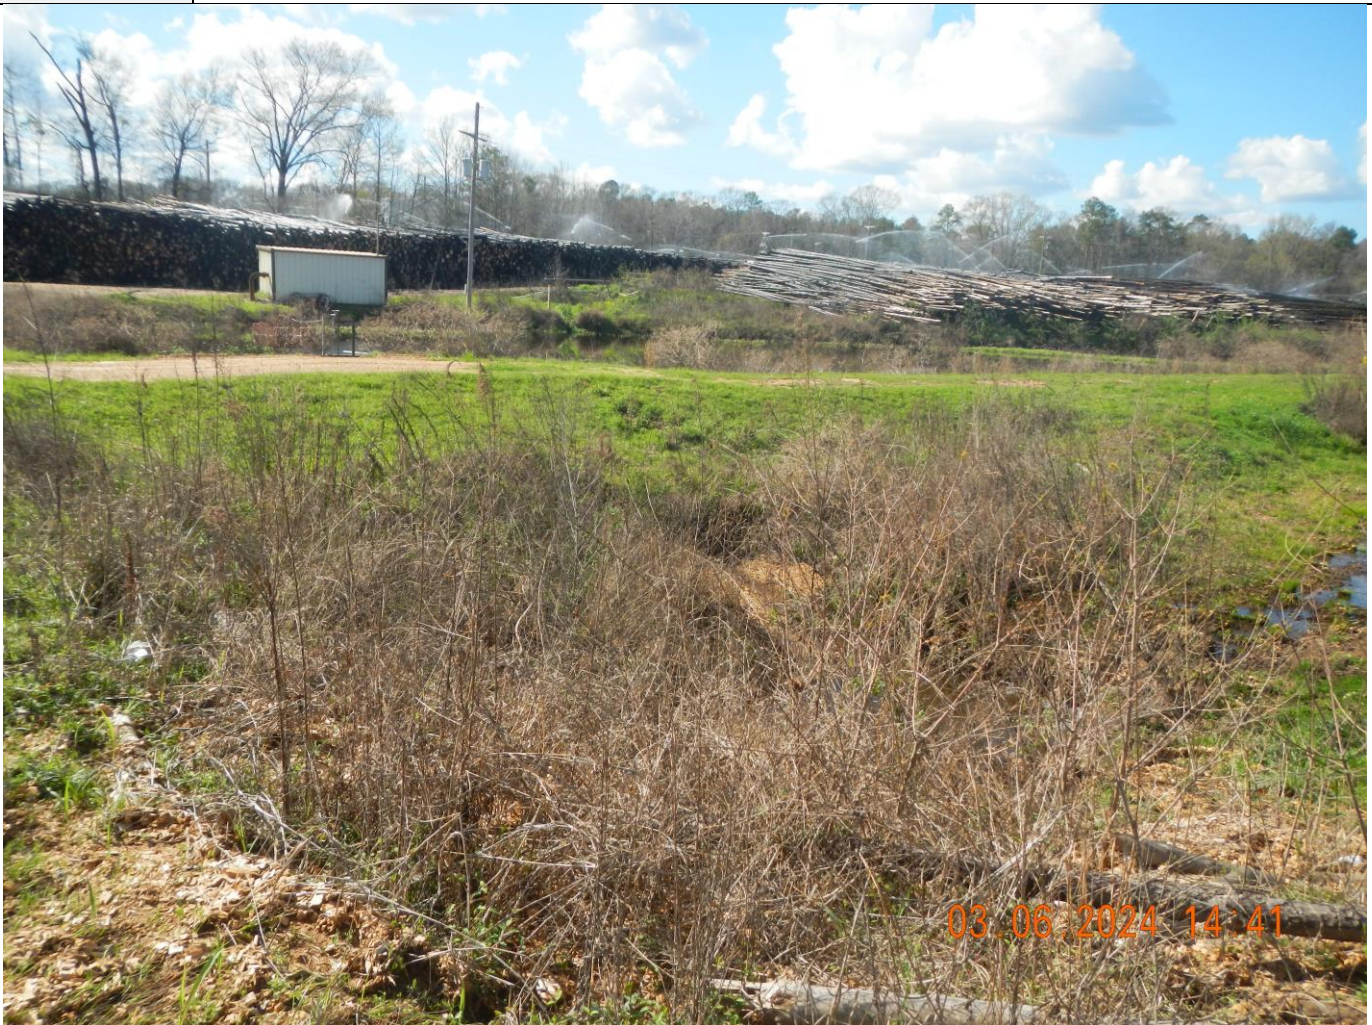
| <b>Photo ID:</b> | DSCN2962.JPG |

| <b>Description:</b> | Looking upgradient at the connection of the WDLS recirculation pond (in the background) to the drainage swale, which discharges via Outfall #2 |

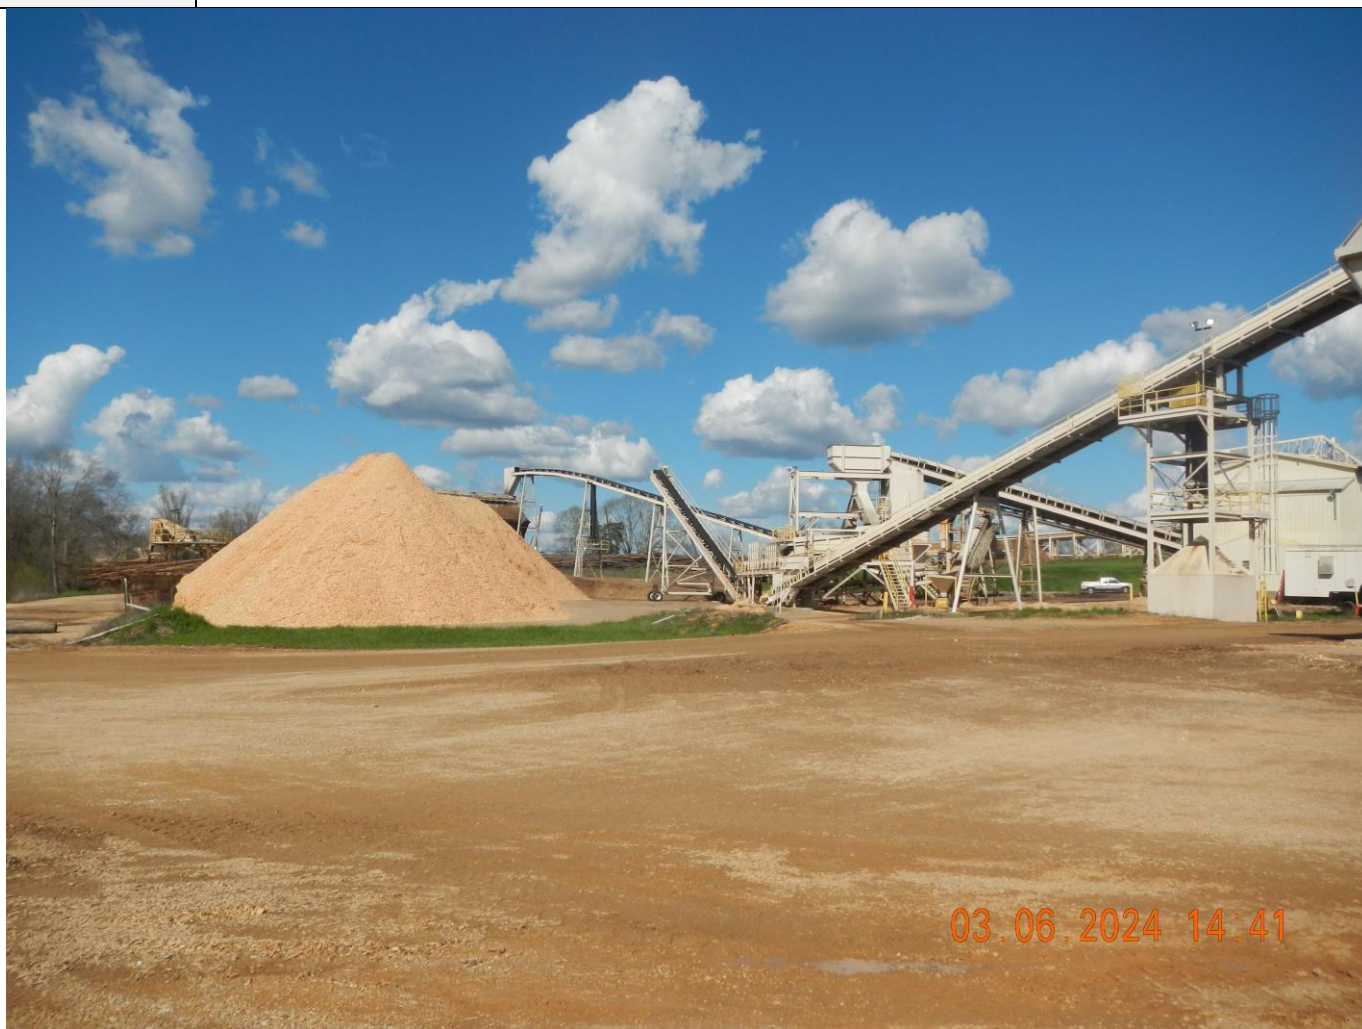
| <b>Photo ID:</b> | DSCN2963.JPG |

| <b>Description:</b> | Wood chips awaiting shipment are stockpiled outdoors. Front end loaders will load the chips into trucks for shipment. |

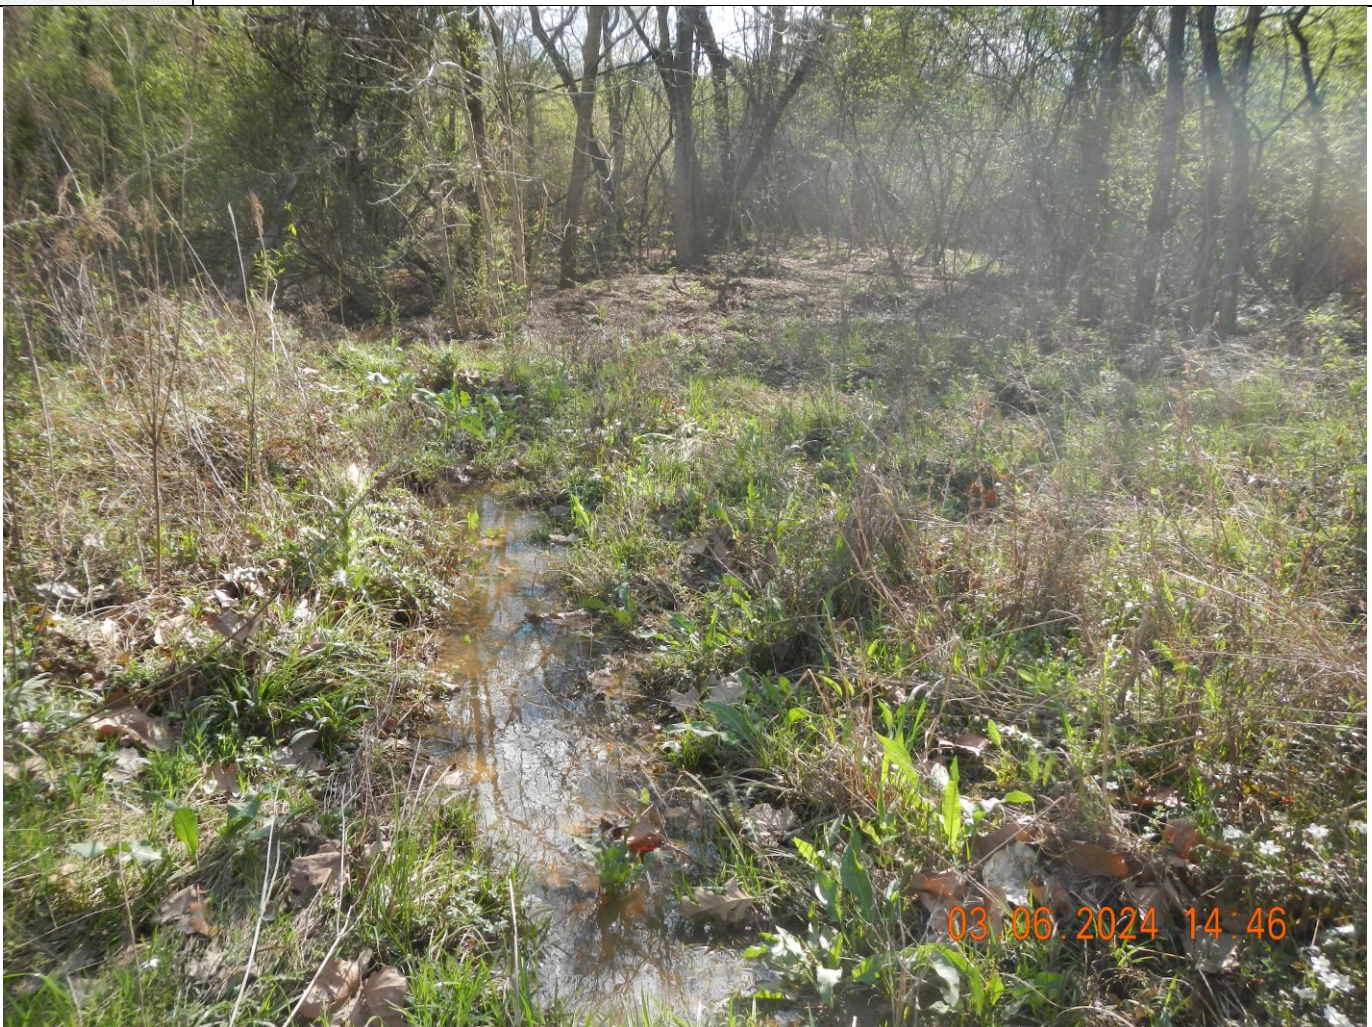
| <b>Photo ID:</b> | DSCN2964.JPG |

| <b>Description:</b> | Looking downgradient. Outfall #1 flows into the same receiving water as Outfall #2 at a point farther downstream of Outfall #2. |

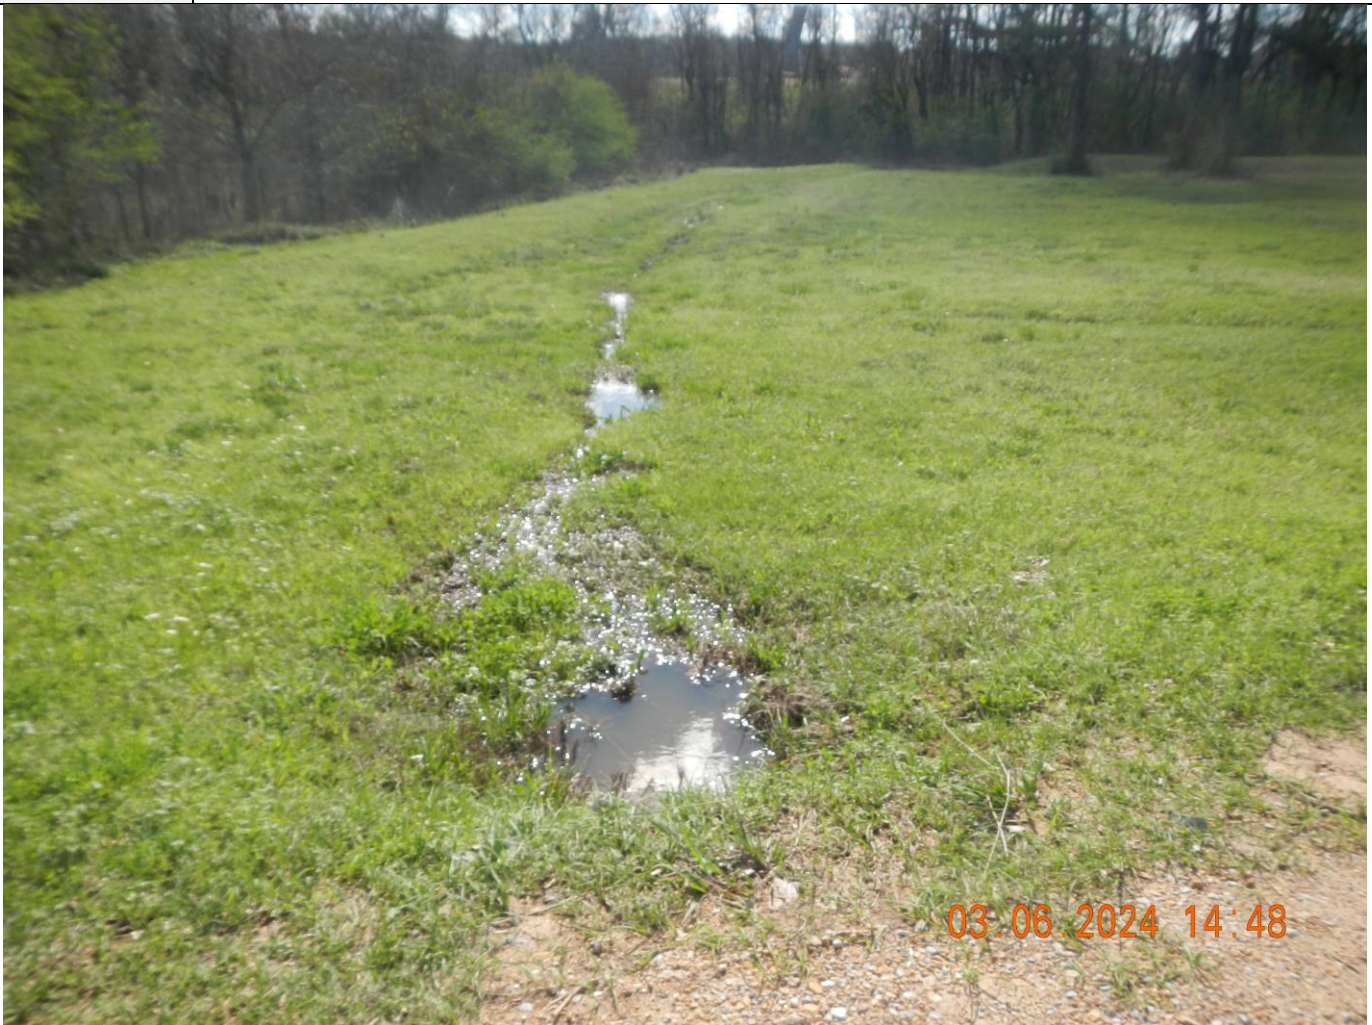
| <b>Photo ID:</b> | DSCN2965.JPG |

| <b>Description:</b> | Looking downgradient at the conveyance between the southern retention pond (shown in photo DSCN2966) and Outfall #1. |

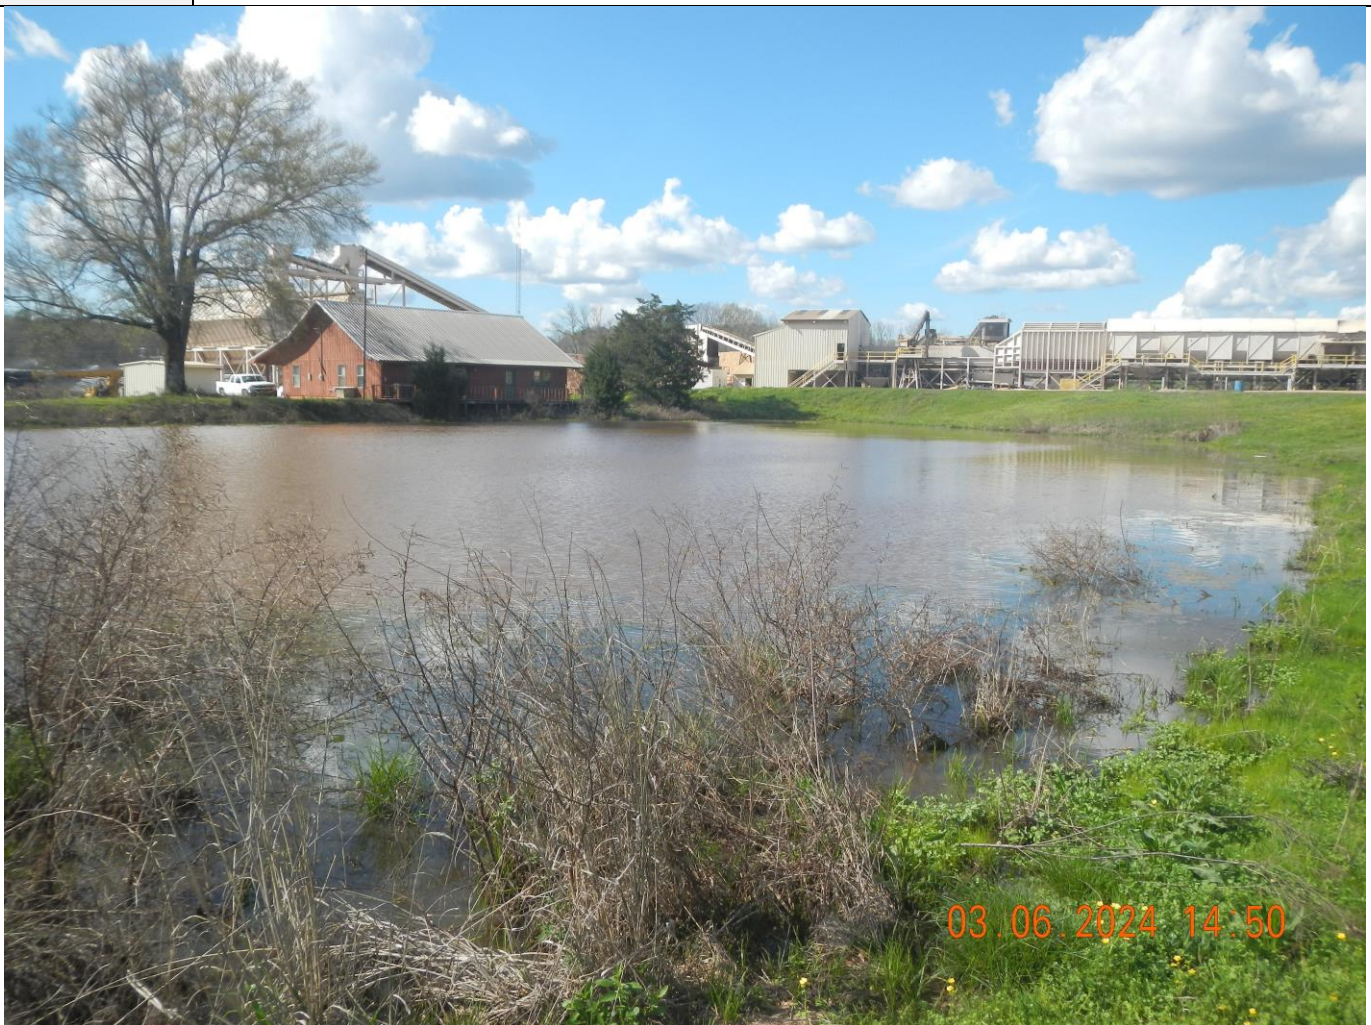
| <b>Photo ID:</b> | DSCN2966.JPG |

| <b>Description:</b> | View of retention pond. According to facility personnel, it only discharges during or following rain events. |

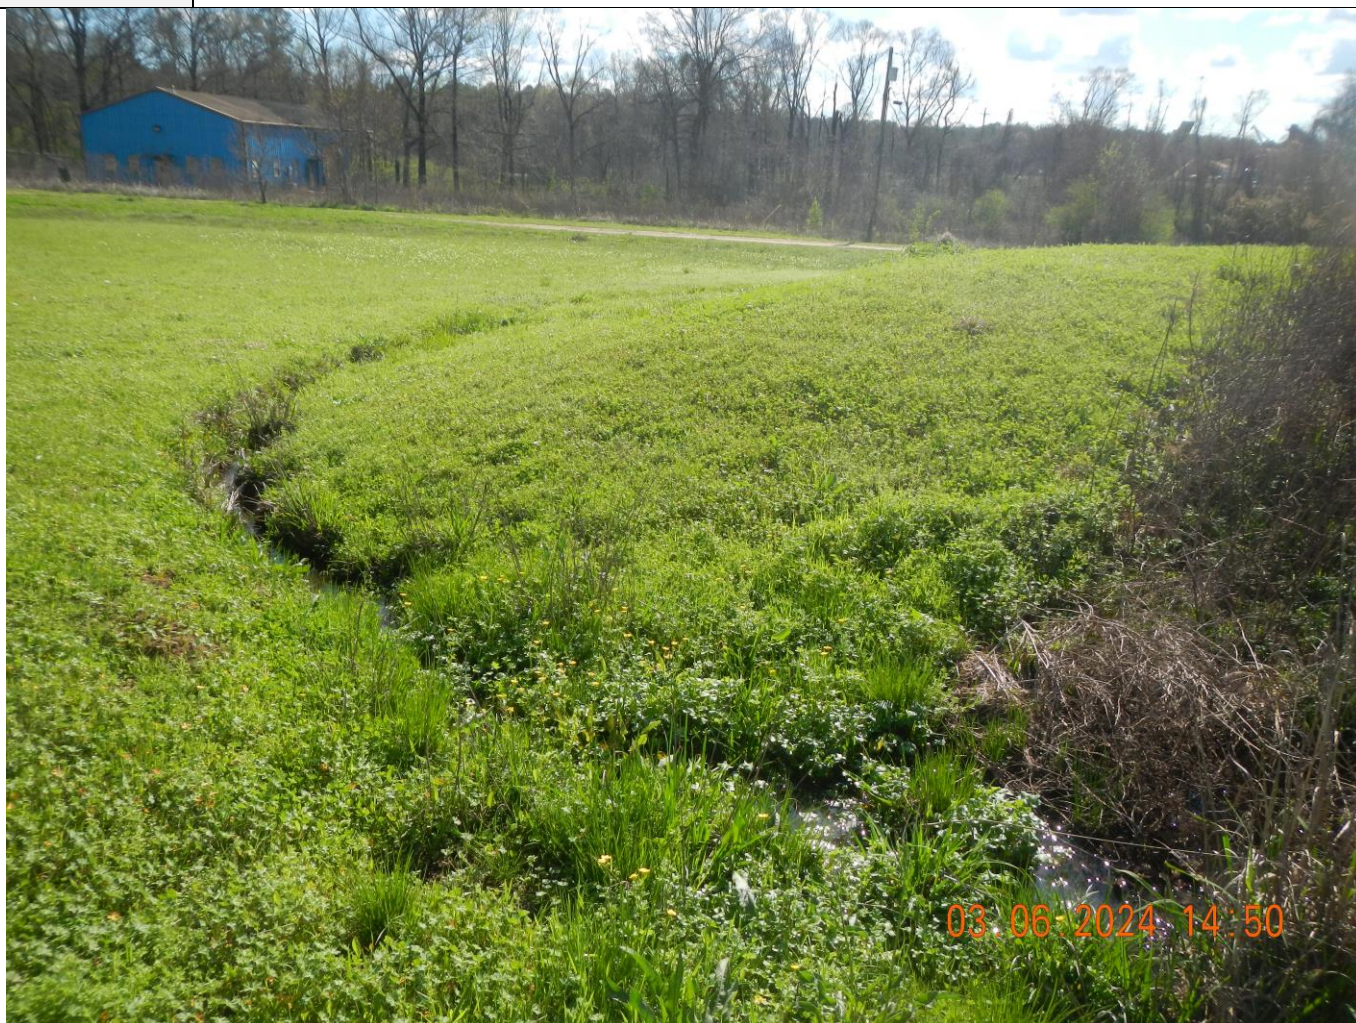
| <b>Photo ID:</b> | DSCN2967.JPG |

| <b>Description:</b> | Looking downgradient at the outlet from the retention pond shown in photo DSCN2966. Water eventually discharges via Outfall #1 via the conveyance shown in photos DSCN2964-2965. |

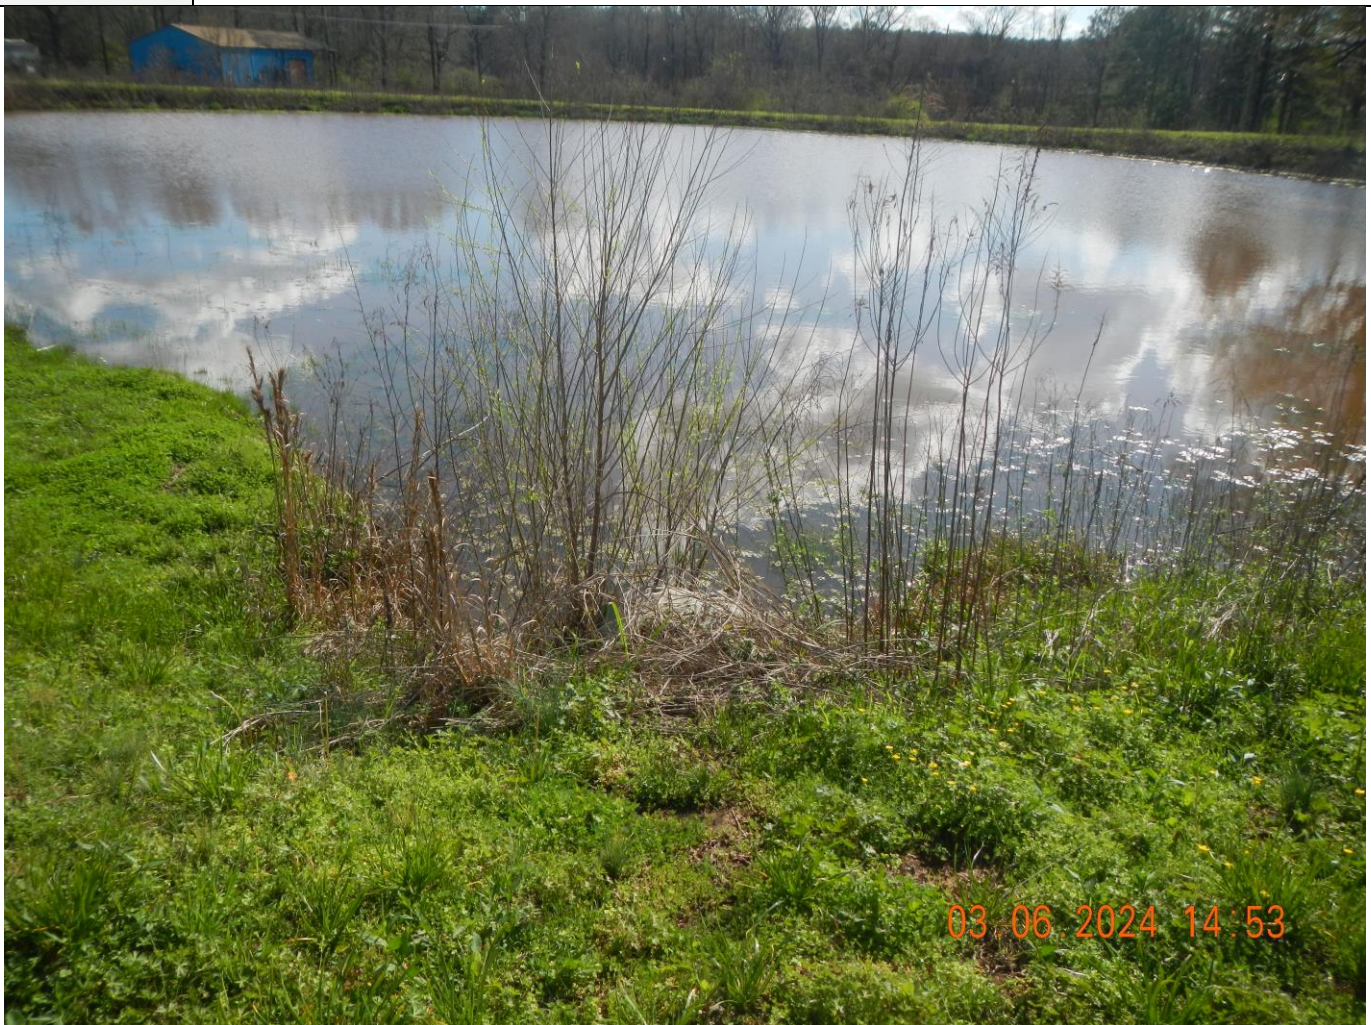
| <b>Photo ID:</b> | DSCN2968.JPG |

| <b>Description:</b> | The drainage system around the log storage area discharges into the retention pond via the outlet shown here. The inlet of this structure is shown in photo DSCN2969. |

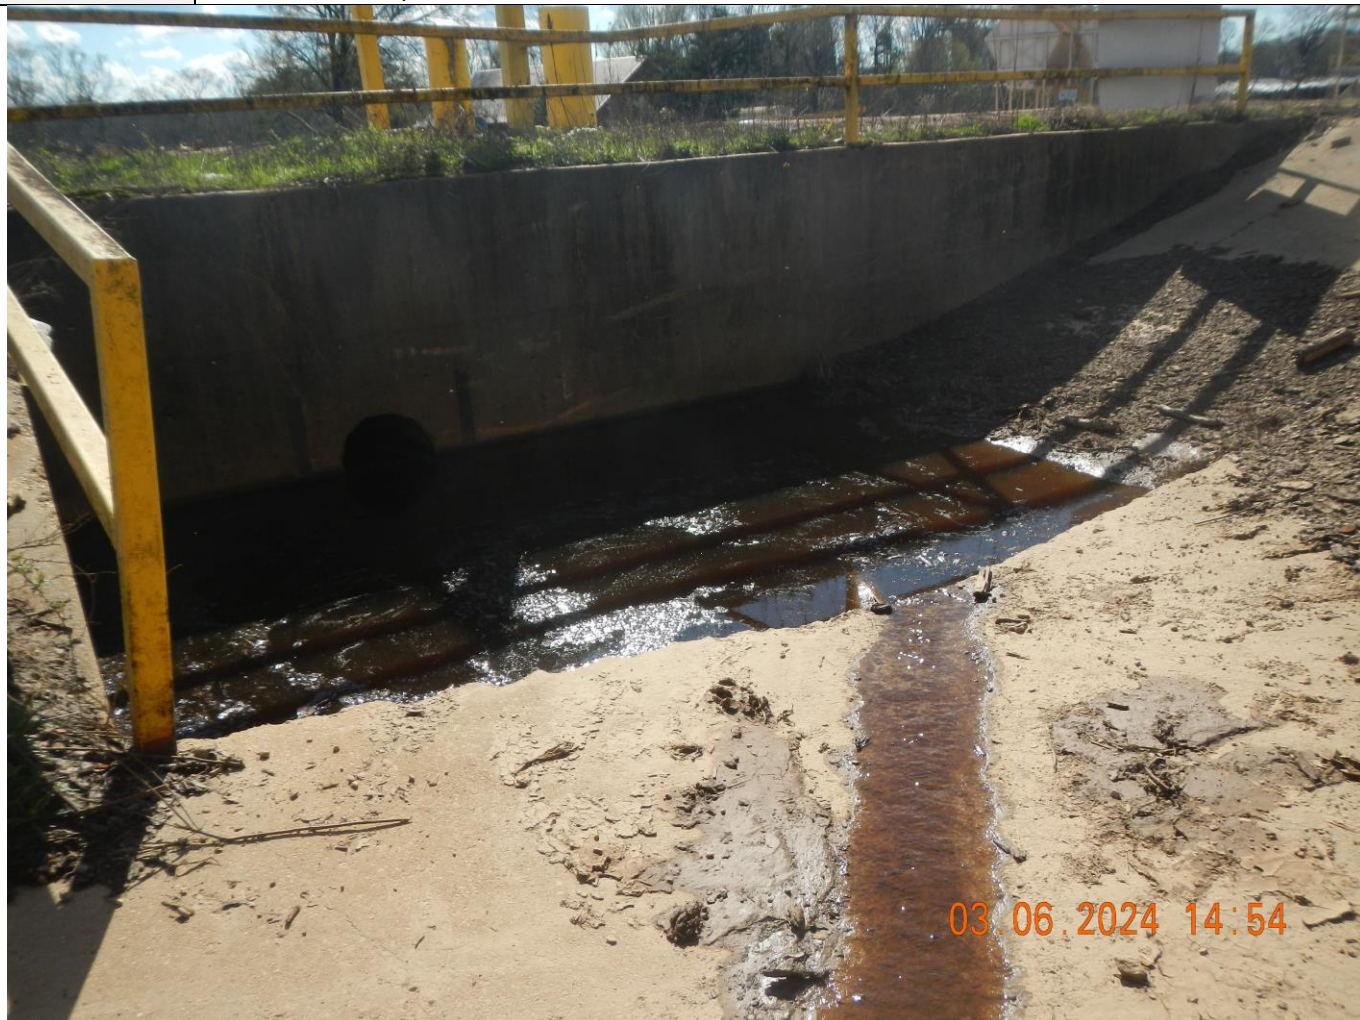
| <b>Description:</b> | Looking downgradient. An upgradient view of this location is shown in photo DSCN2970. This concrete detention basin receives runoff from the log storage area around the rotary crane. According to facility personnel, this basin was recently cleaned out a few months ago (circa November 2023). |

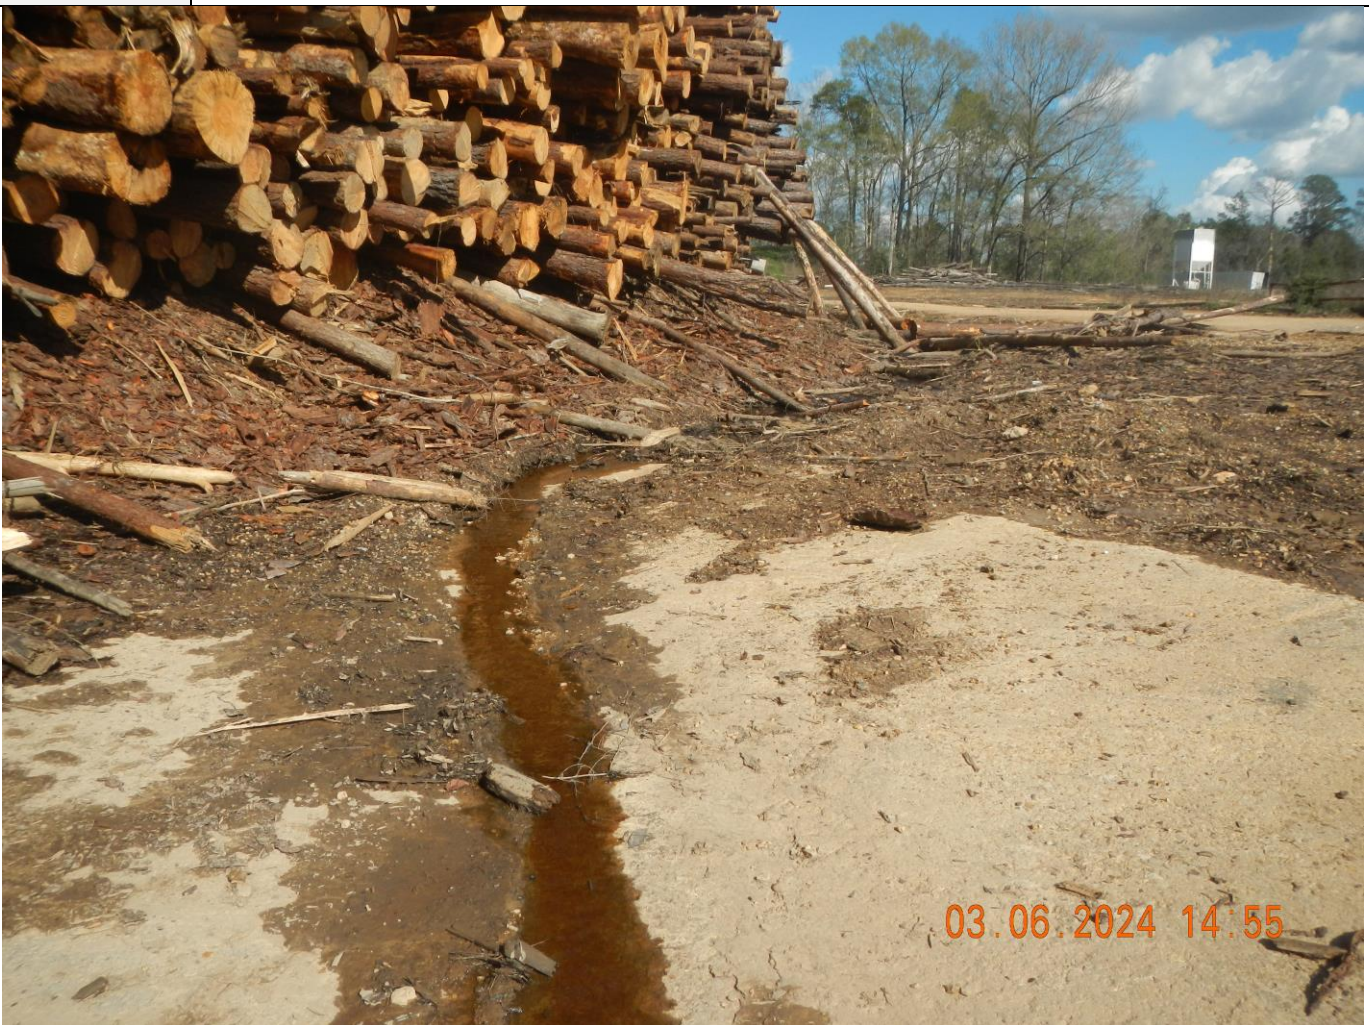
| <b>Photo ID:</b> | DSCN2970.JPG |

| <b>Description:</b> | Upgradient view of the conveyance around the radial crane and storage area. |

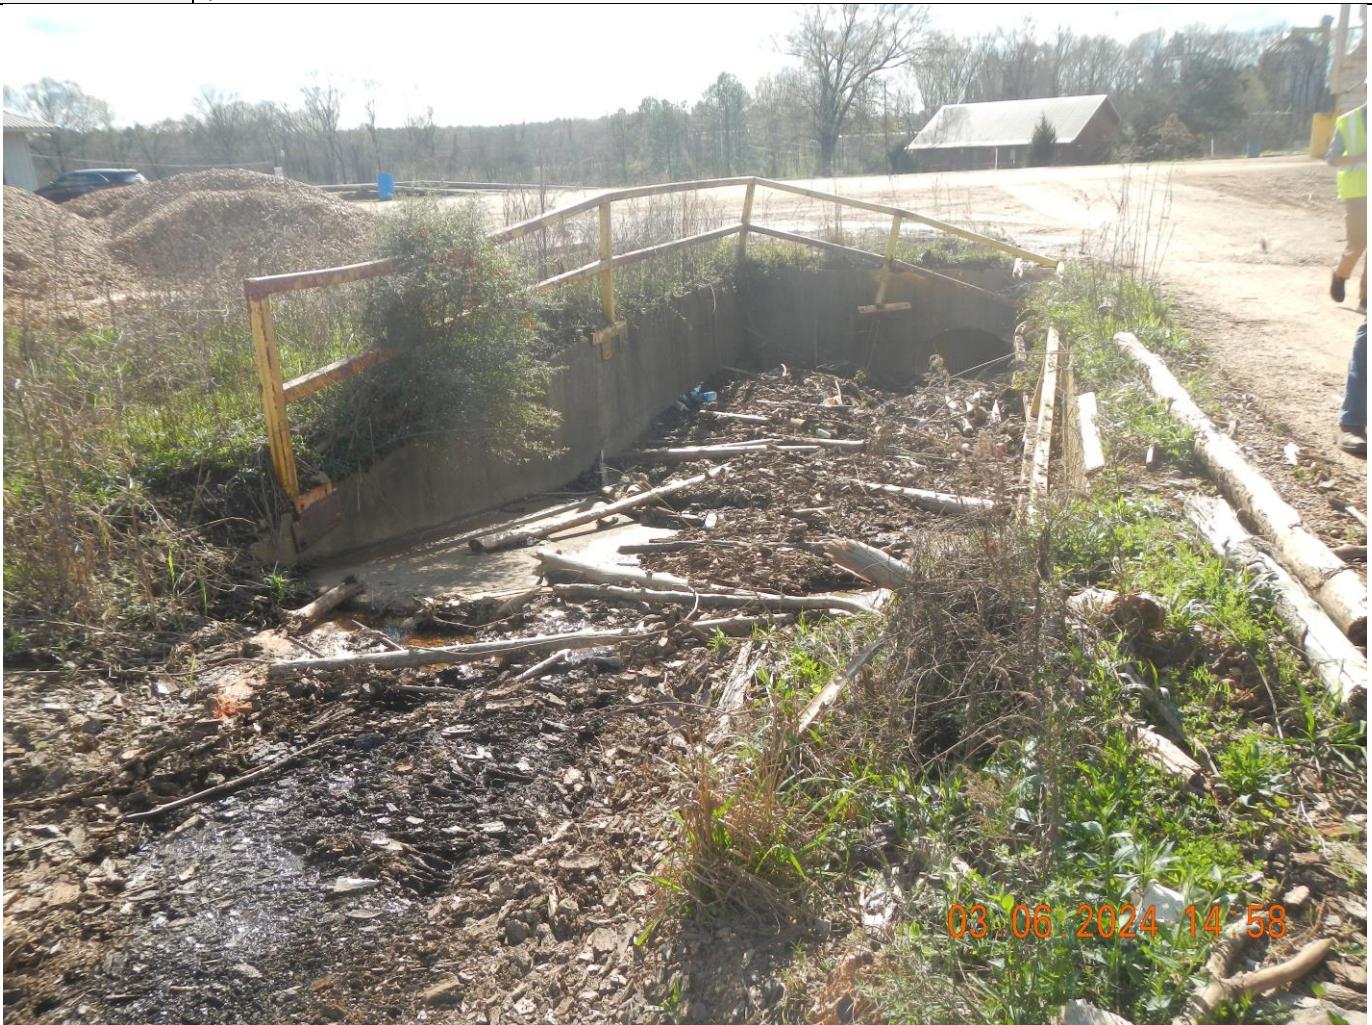
| <b>Photo ID:</b> | DSCN2971.JPG |

| <b>Description:</b> | Location of an additional detention basin which receives runoff from the dry storage area. Water from this basin discharges directly into the basin shown in DSCN2969. According to facility personnel, this basin is scheduled to be cleaned later in the week. |

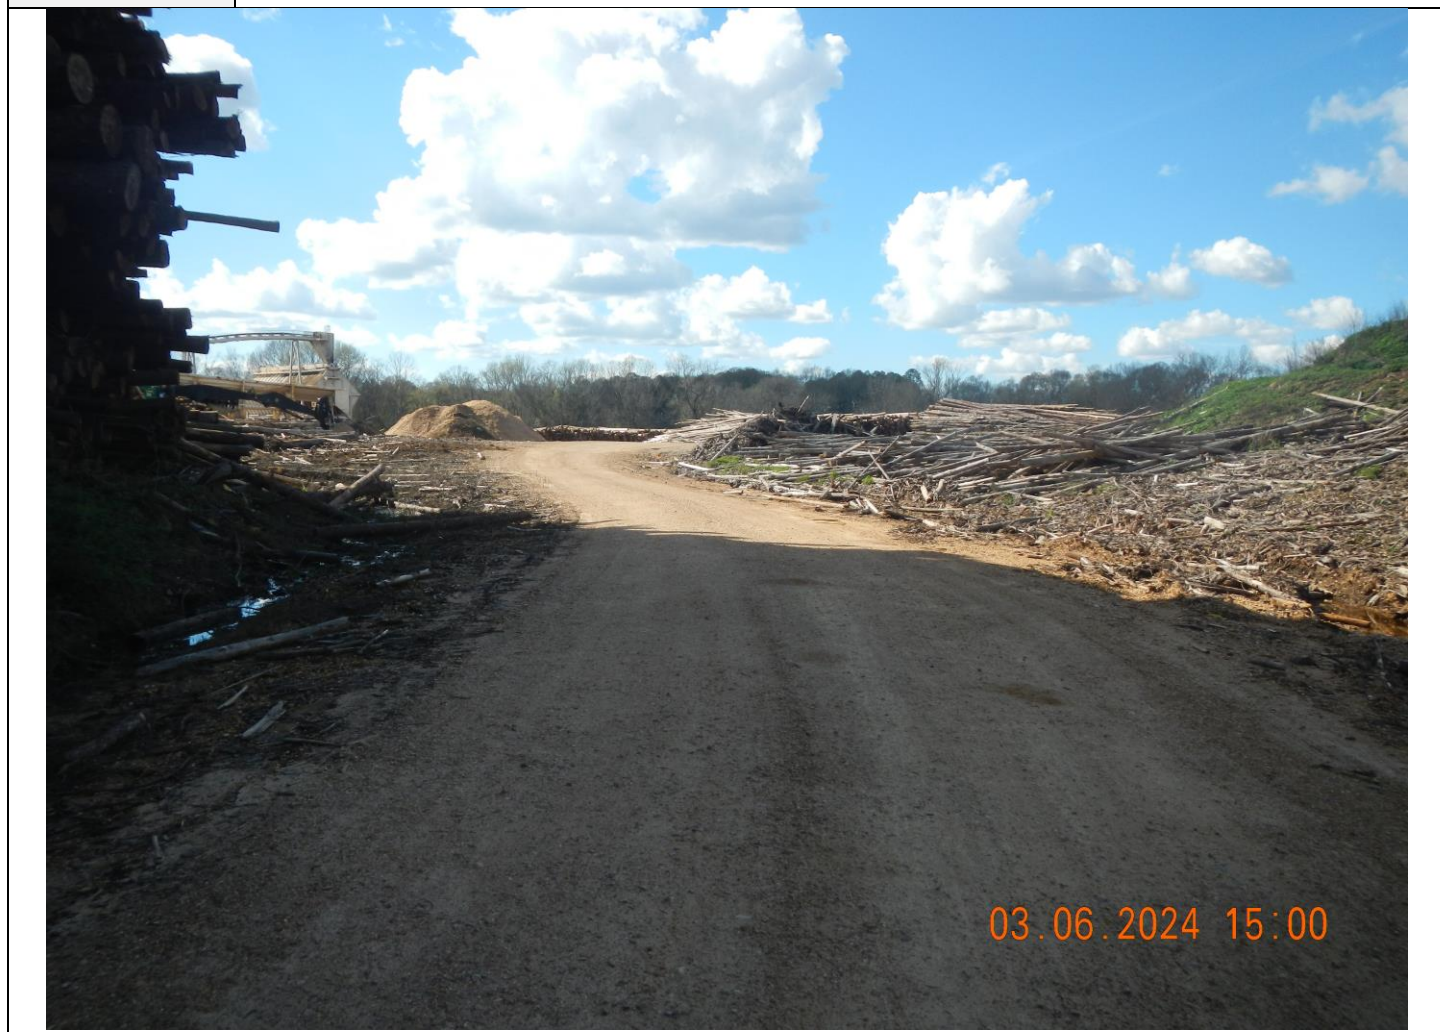
| <b>Photo ID:</b> | DSCN2972.JPG |

| <b>Description:</b> | View of gravel road around the log storage area, looking upgradient. The conveyance shown in photo DSCN2970 begins at approximately this location as a roadside ditch. |
