## PHOTO LOG

| Facility Name: | Gloster Chips |
| EPA Media: | Stormwater - Industrial |

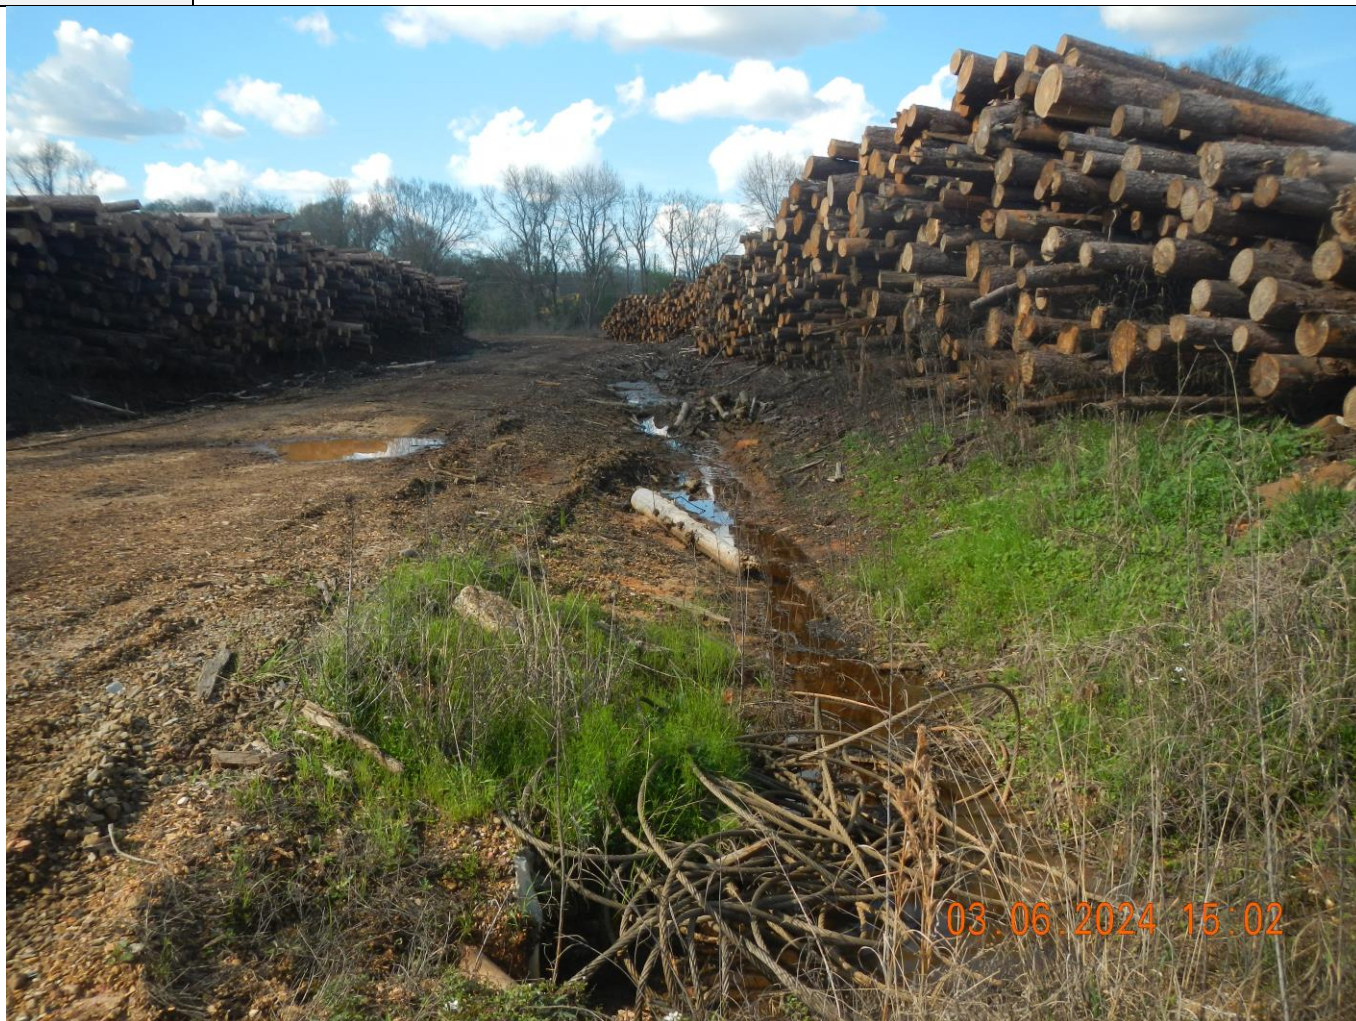
| <b>Photo ID:</b> | DSCN2973.JPG |

| <b>Description:</b> | Looking upgradient at an additional view of log storage area. Water drains towards photographer, and then along roadside ditch towards the photographer's left. |

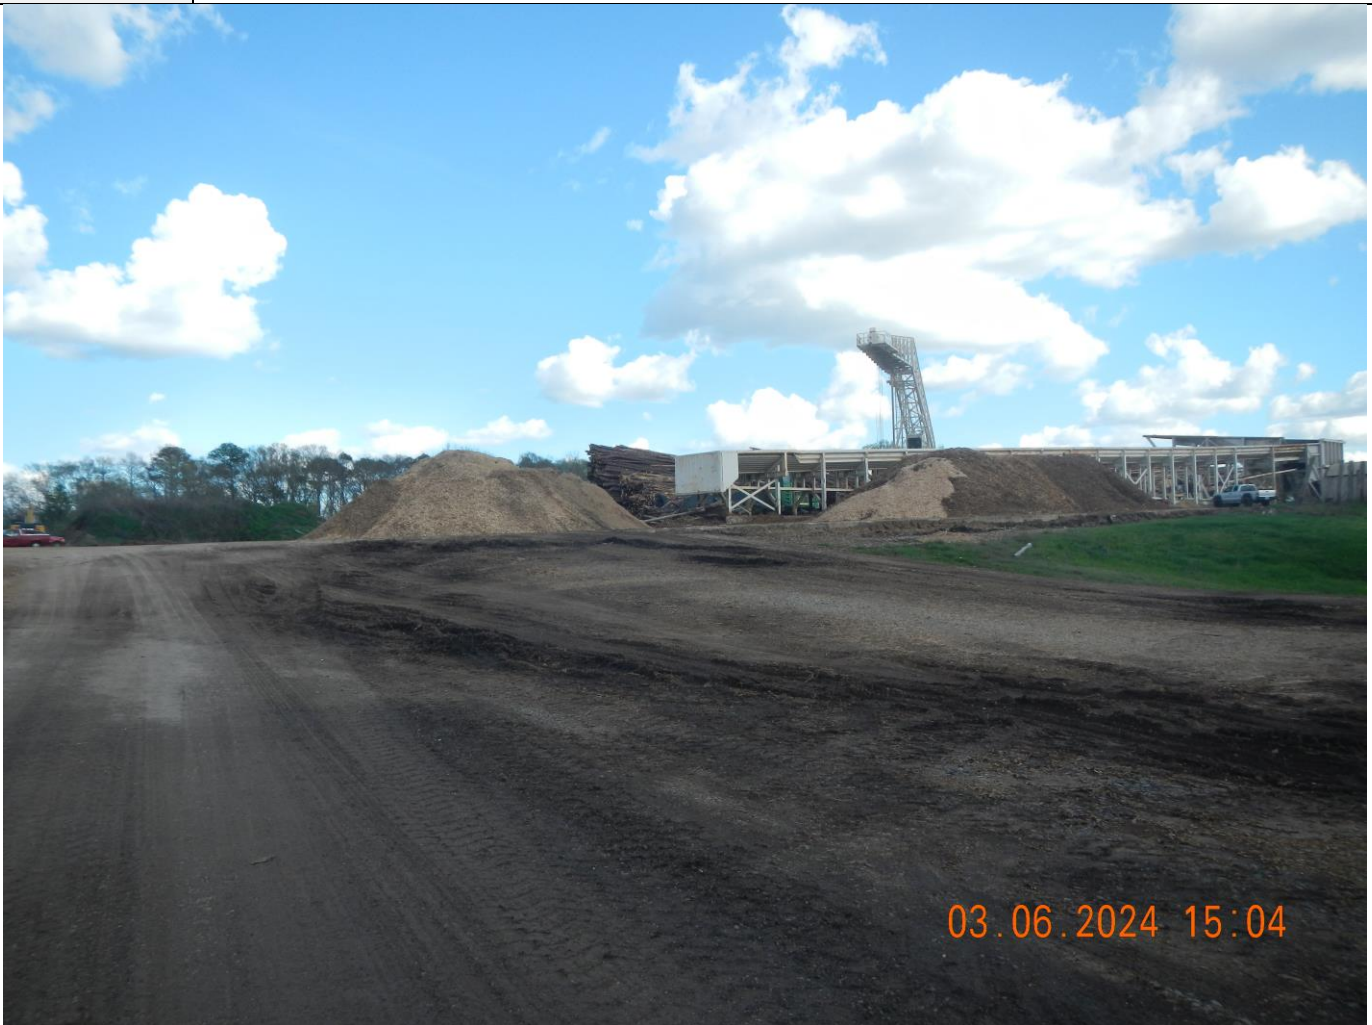
| <b>Photo ID:</b> | DSCN2974.JPG |

| <b>Description:</b> | View of product, which will be used for mulch. |

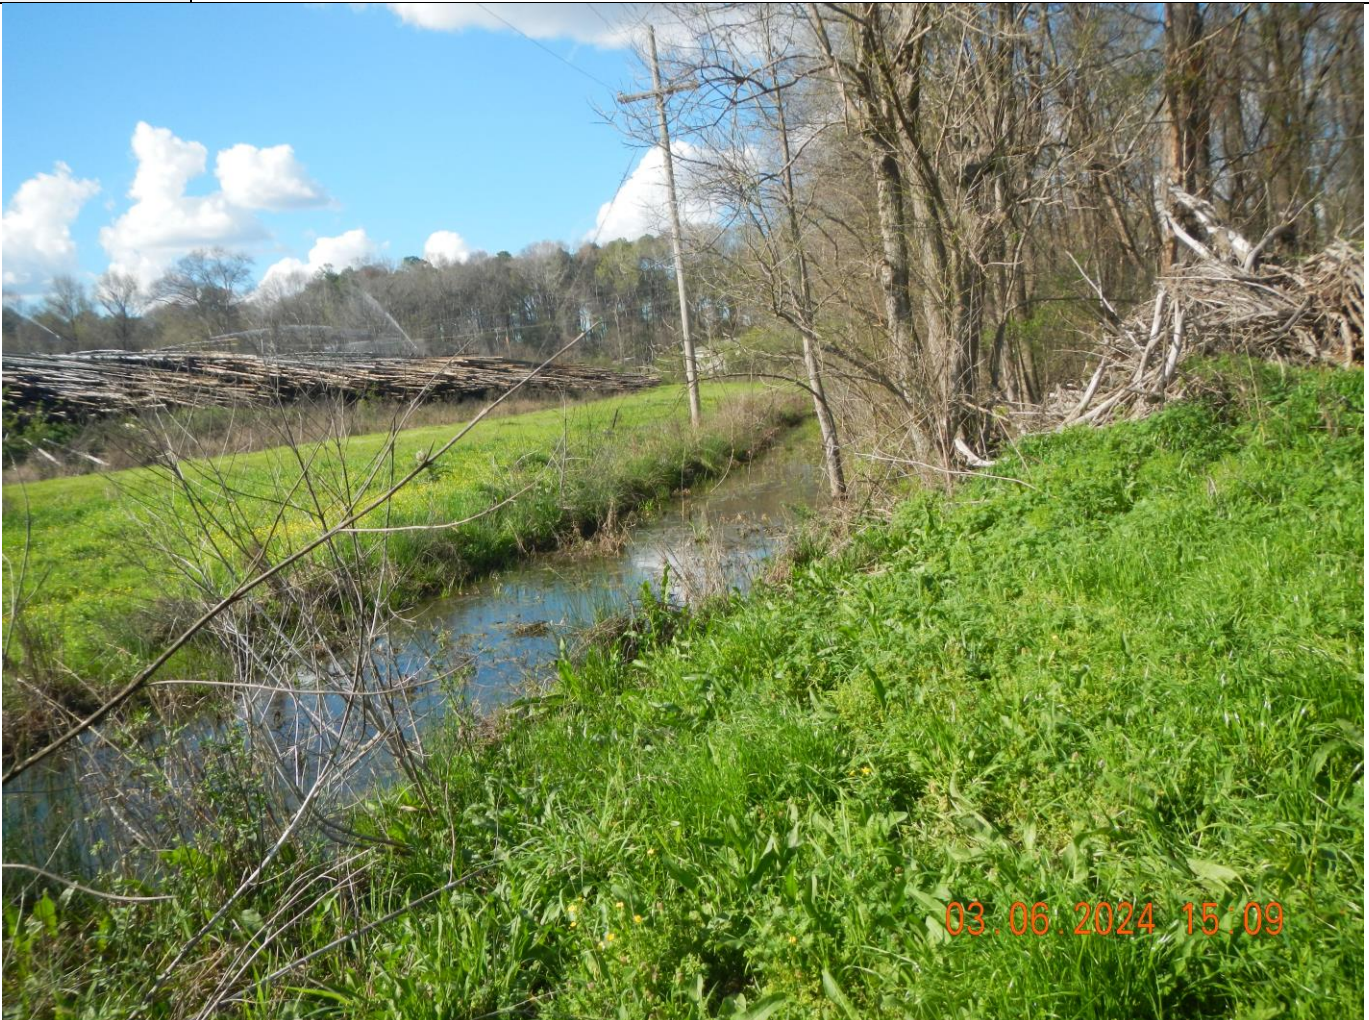
| <b>Photo ID:</b> | DSCN2975.JPG |

| <b>Description:</b> | Looking upgradient at the mid-site drainage feature, also shown in photo DSCN2960. There is a low area in the wooded area in the upper right quadrant of the photograph that was also holding water. This area appears to be labelled as Pond B on the SWPPP site map. |

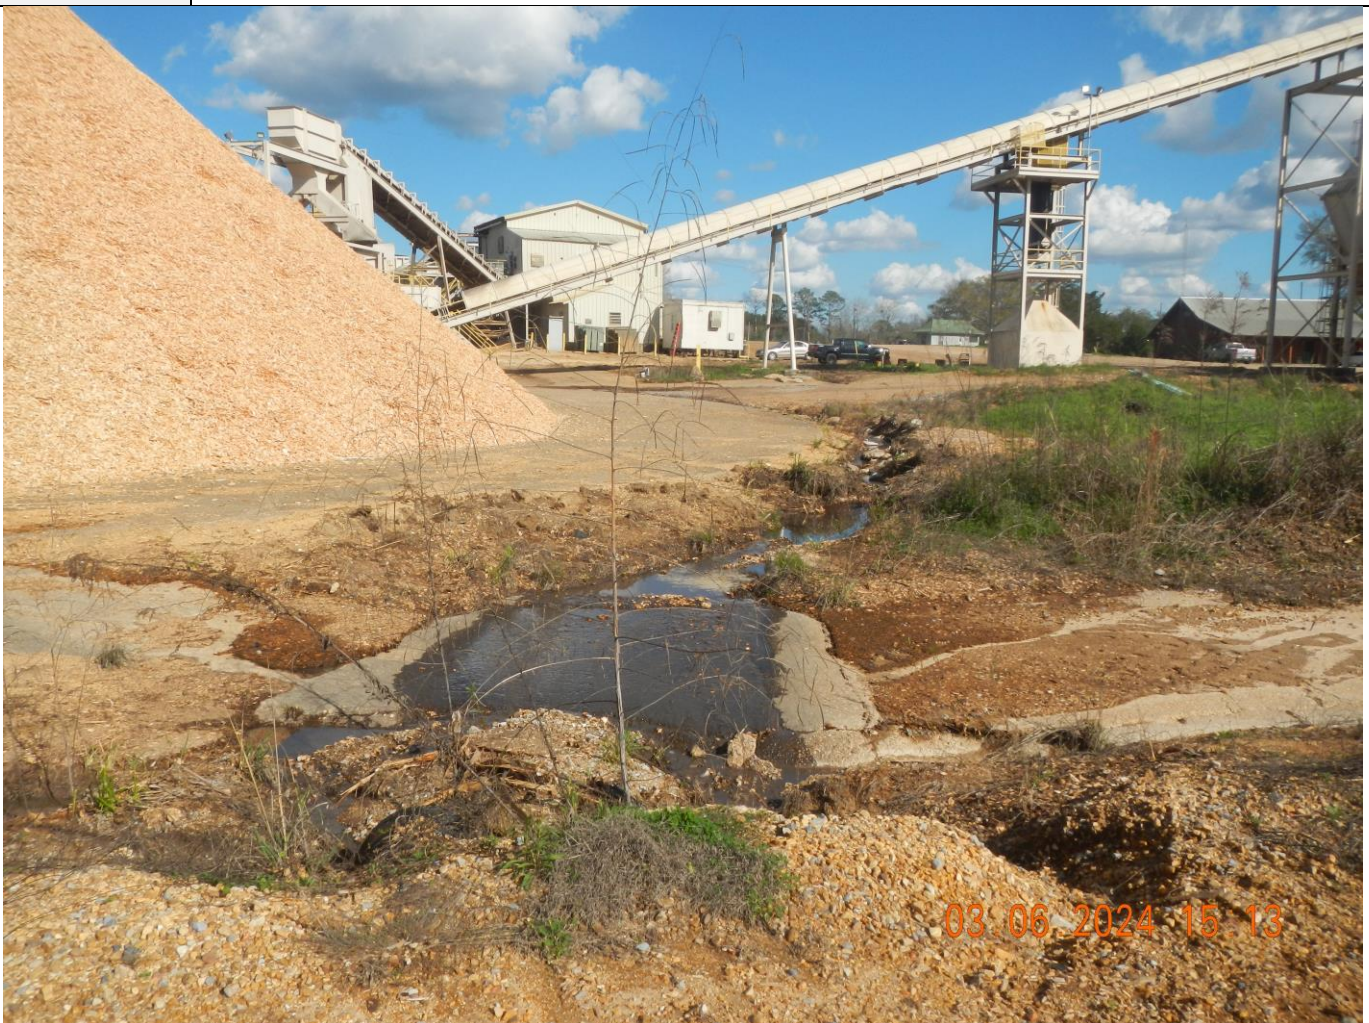
| <b>Photo ID:</b> | DSCN2976.JPG |

| <b>Description:</b> | Looking upgradient. Runoff from the chipper/processing area is conveyed into the mid-site swale. See also photo DSCN2976. |

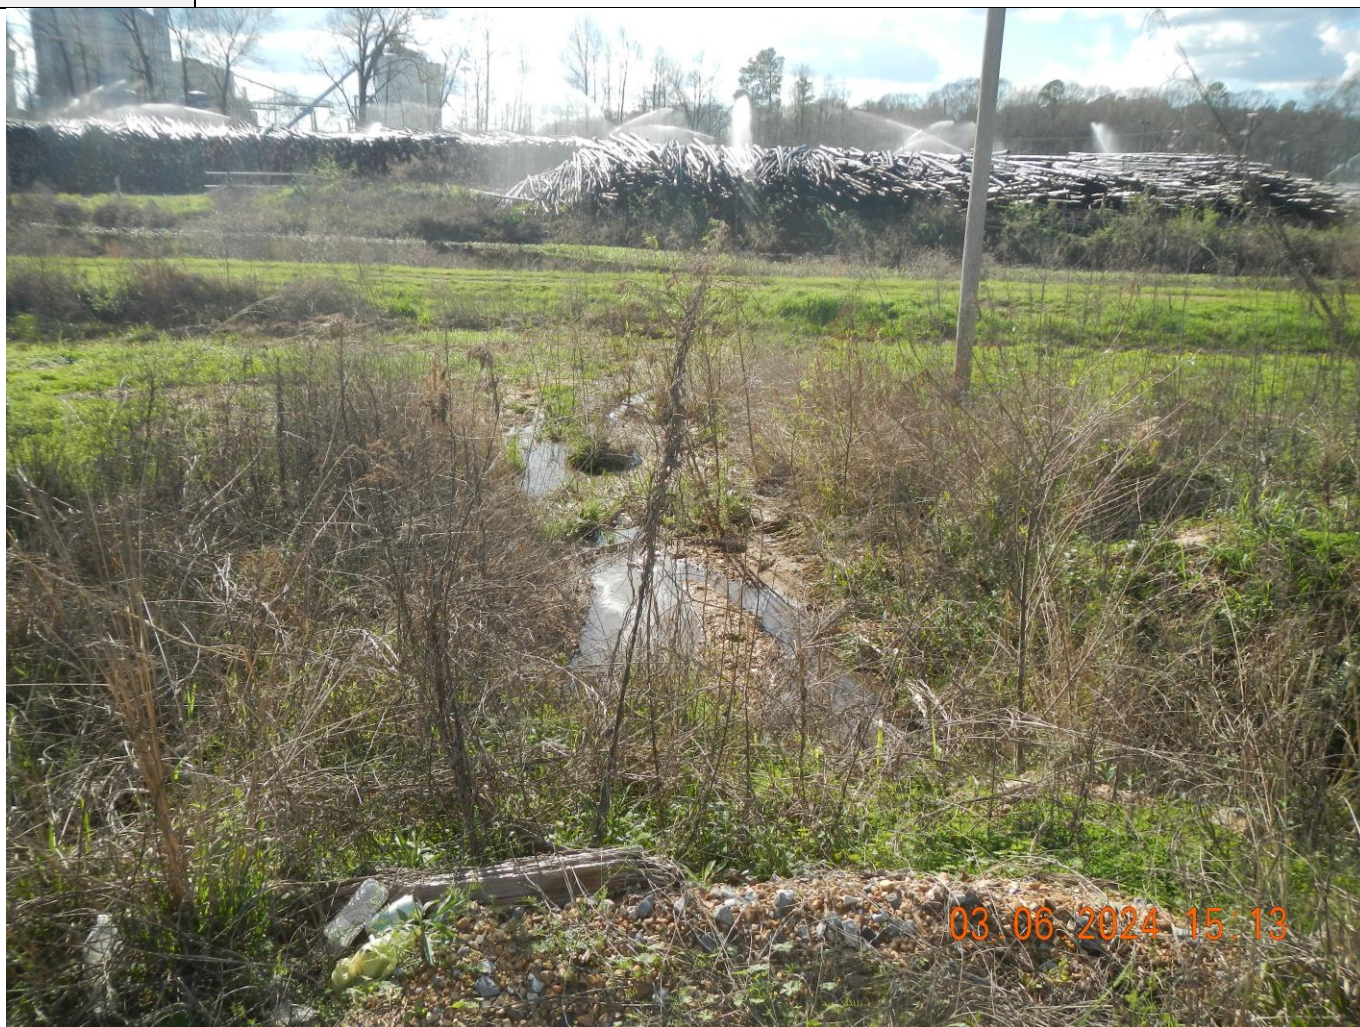
| <b>Photo ID:</b> | DSCN2977.JPG |

| <b>Description:</b> | Downgradient view of the location shown in photo DSCN2976. Water from the processing area is conveyed into the mid-site ditch. |

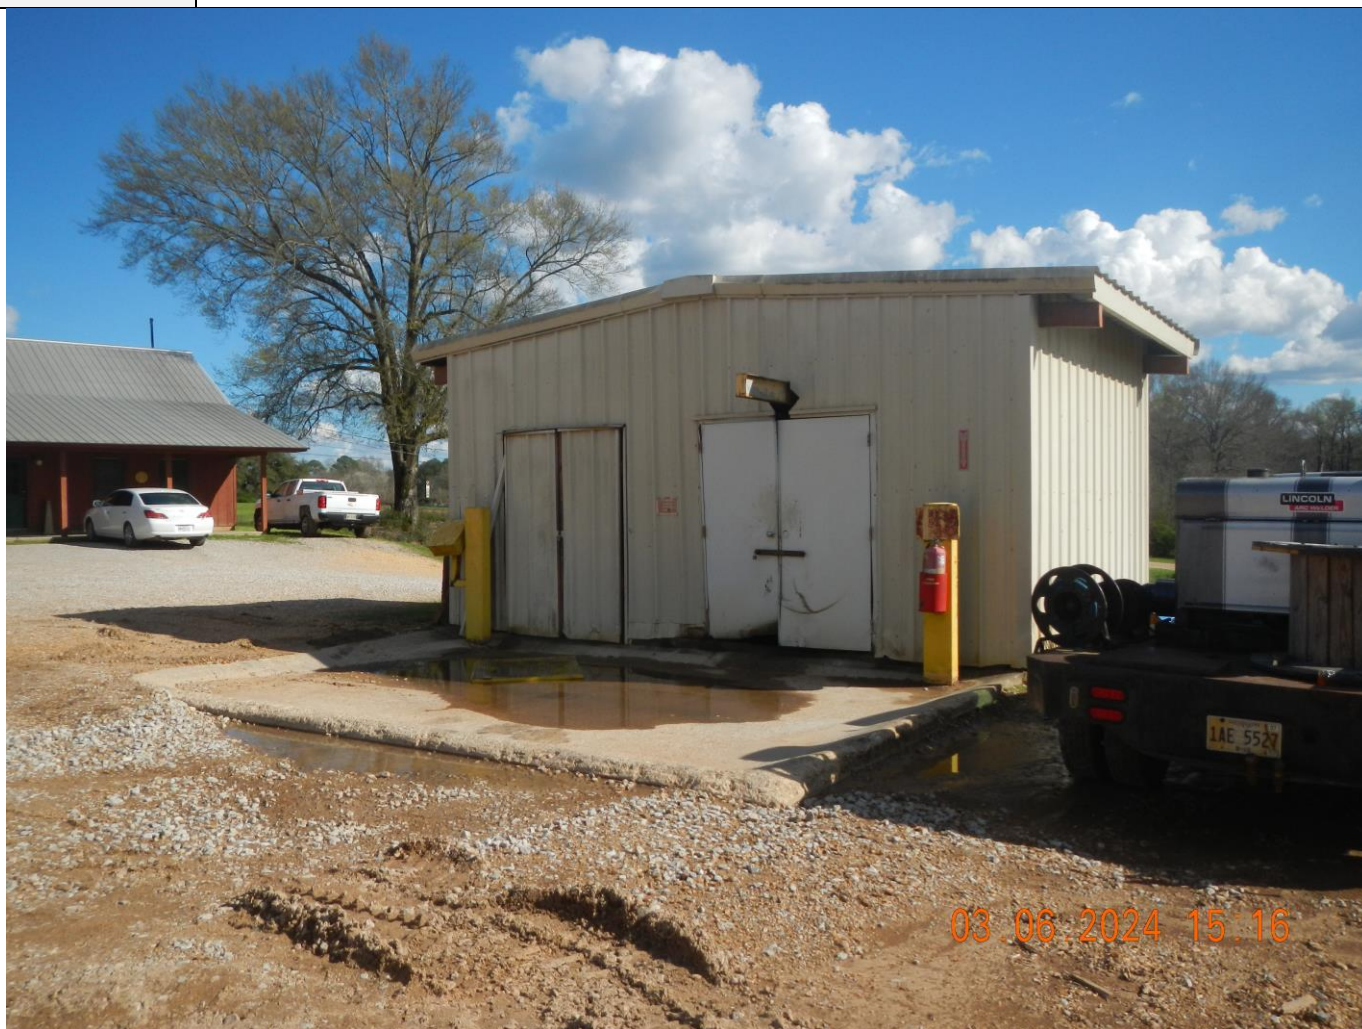
| <b>Photo ID:</b> | DSCN2978.JPG |

| <b>Description:</b> | Diesel fuel, miscellaneous oils, and DEF are stored here. |
