## **RCRA Inspection Report**

GE Aviation Ceramic Matrix Composites  
25235 One Aviation Way, SW  
Madison, Alabama 35756  
Madison County  
EPA ID No. ALR000061796

January 27, 2022

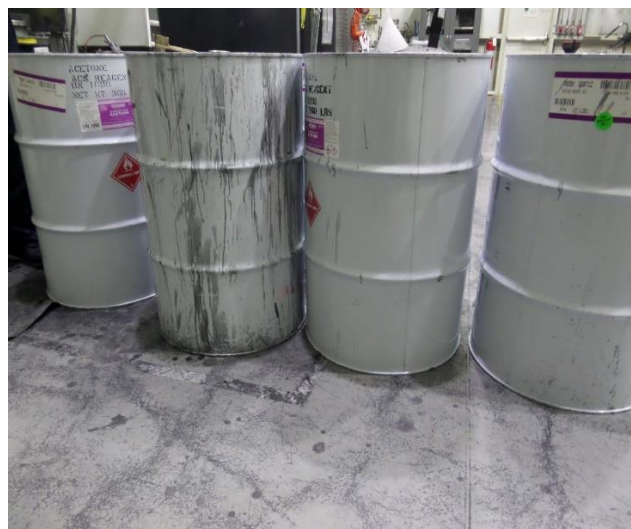
Located next to the distillation units the inspector observed four 55-gallon containers storing waste solvent. The inspector observed the containers were closed, in good condition, with aisle space, labeled with a flammable hazard indicator and were marked with the words “spent acetone”. The inspector observed the containers were not marked or labeled with the words “Hazardous Waste”, not marked with an accumulation start date and not marked or labeled with EPA hazardous waste numbers (Photographs 4 and 5). Ms. Hinson indicated that the spent acetone is generated and accumulated in various facility satellite accumulation area (SAA) containers, prior to transferring for distillation. Ms. Hinson indicated that weekly container inspection records of the area were not available. The inspector observed secondary containment, restricted unauthorized entry and signs posted at the entrance to the building.

Slurry Building Solvent Recovery Area. The inspector observed four 55-gallon containers accumulating spent acetone in the rear area. The containers were not marked/labeled as HW, not marked with dates, and not marked with waste codes. Photograph 4 taken at 10:59 a.m.

On January 29, 2022, the EPA received an email from the facility with photographs showing the containers storing hazardous waste were labeled with the words hazardous waste, marked with a date, marked with the EPA hazardous waste numbers, and moved to the 90-Day.

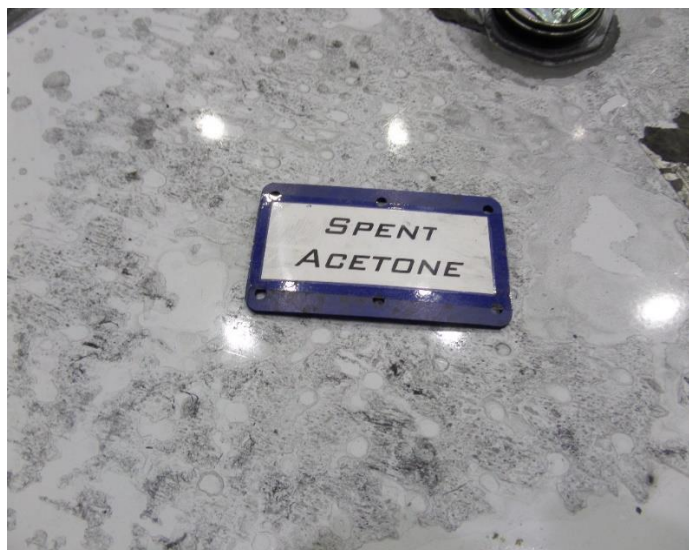
Slurry Building Solvent Recovery Area. The inspector observed four 55-gallon containers accumulating spent acetone in the rear area. The containers were not marked/labeled as HW, not marked with dates, and not marked with waste codes. Photograph 5 taken at 10:59 a.m.

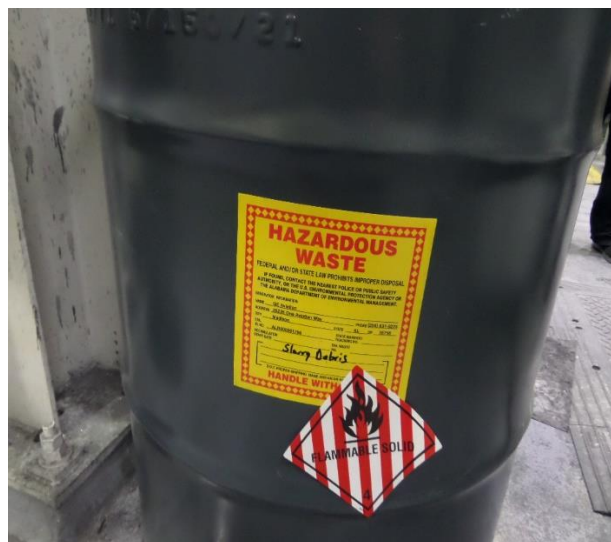
Slurry Building Slurry Cleaning Station. The inspector observed one 55-gallon SAA container accumulating HW slurry debris. Photograph 6 taken at 11:02 a.m.

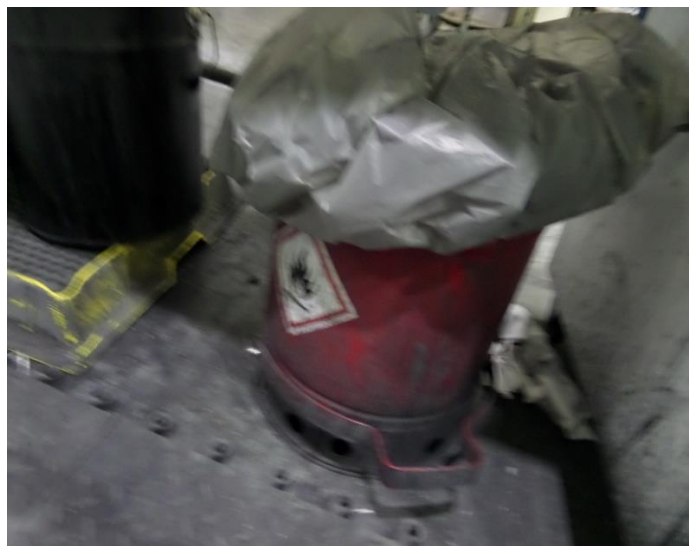
The equipment used to produce the slurry is cleaned in this booth. The inspector observed one 5-gallon SAA red safety container under the cleaning booth storing hazardous waste solids. The inspector observed the container was closed, in good condition, labeled with a hazard indicator. The inspector observed the container was not marked or labeled with the words “Hazardous Waste” (Photograph 7).

Slurry Building Slurry Cleaning Station. The inspector observed one 5-gallon SAA container accumulating acetone contaminated rags. The container was not marked or labeled with the words Hazardous Waste. Photograph 7 taken at 11:06 a.m.

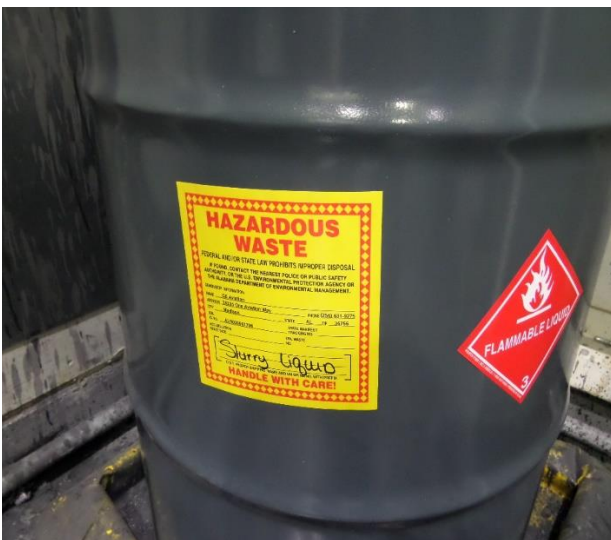
In the rear corner of the Slurry Building the inspector observed one 55-gallon SAA container storing hazardous waste slurry liquid from the cleaning booth and the slurry booth. The inspector observed the container was closed, in good condition, labeled with the words “Hazardous Waste” and labeled with a flammable hazard indicator (Photograph 8).

Slurry Building Slurry Bottle Area. The inspector observed one 55-gallon SAA container accumulating hazardous waste slurry. Photograph 8 taken at 11:10 a.m.

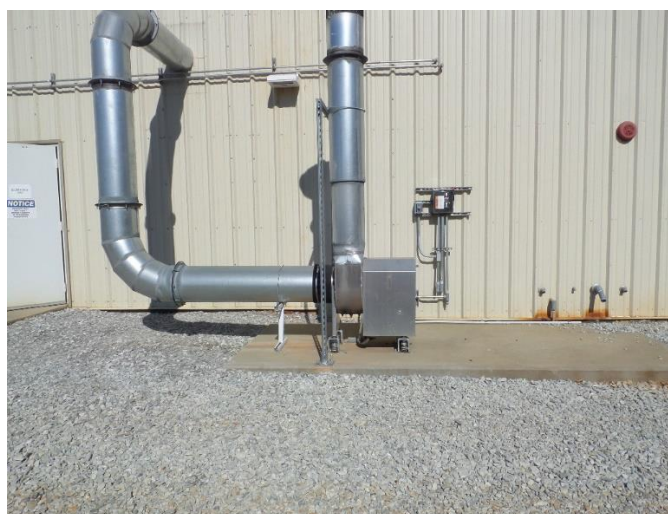
Slurry Building Outdoor Vent System. The inspector observed a ventilation system to exhaust emissions from the distillation units. Photograph 9 taken at 11:13 a.m.

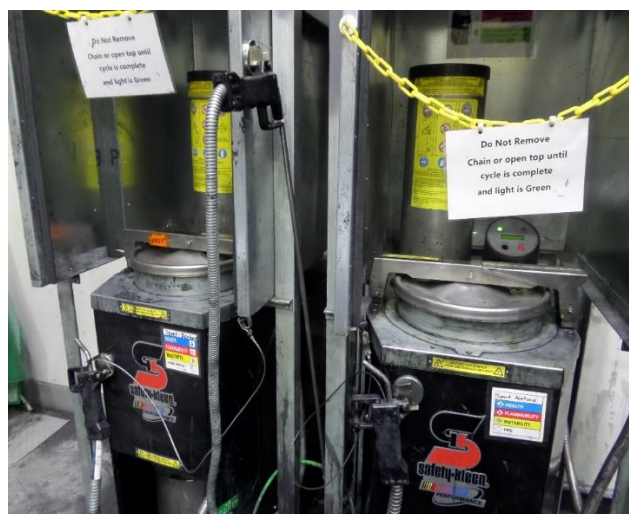
In this area the slurry that is used to coat the tape is produced and the facility conducts distillation operations to reclaim solvent. The inspector observed two 5-gallon solvent distillation units (Photograph 10). The distillation unit emissions are vented to the outdoors (Photograph 9). Still bottoms generated from the distillation operation is accumulated in the containers of hazardous waste slurry debris/waste in the 90-Day.

Slurry Building Distillation Area. The inspector observed two distillation units to recover spent acetone. Emissions are vented outdoors. Photograph 10 taken at 11:17 a.m.

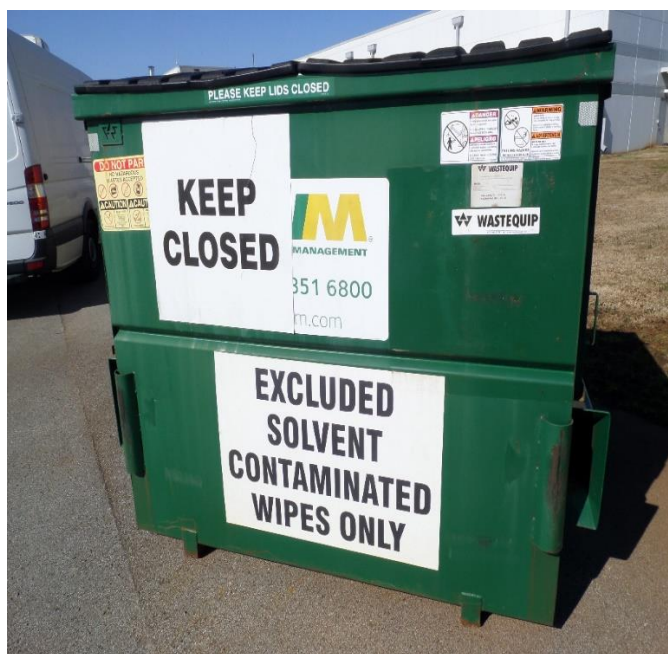
The inspector observed a general trash container labeled with the words “Excluded Solvent-Contaminated Wipes Only” on an asphalt area in front of the Slurry Building. Ms. Hinson indicated the solvent contaminated wipes are accumulated in 5-gallon containers throughout the facility. When full, they are transferred in plastic bags to the trash container, prior to off-site

disposal. The inspector observed the trash container was empty and appeared dry (Photograph 11).

Area Adjacent to Slurry Building The inspector observed a trash container for solvent contaminated wipes. Photograph 11 taken at 11:23 a.m.

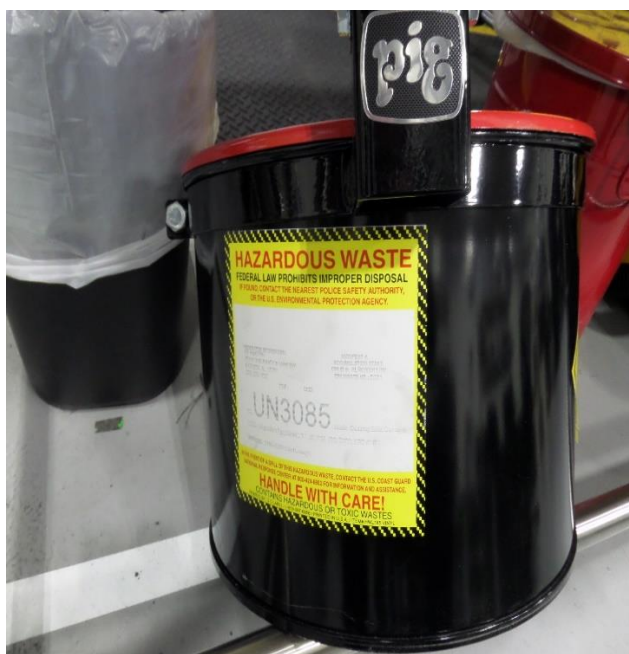
Located under a laboratory table the inspector observed one 5-gallon SAA container for waste magnesium perchlorate that appeared empty. The container was closed and labeled with the words “Hazardous Waste” (Photograph 12).

Quality Laboratory. The inspector observed one 5-gallon SAA container for waste magnesium perchlorate. The container receives waste from a container in the fume hood. Photograph 12 taken at 1:13 p.m.

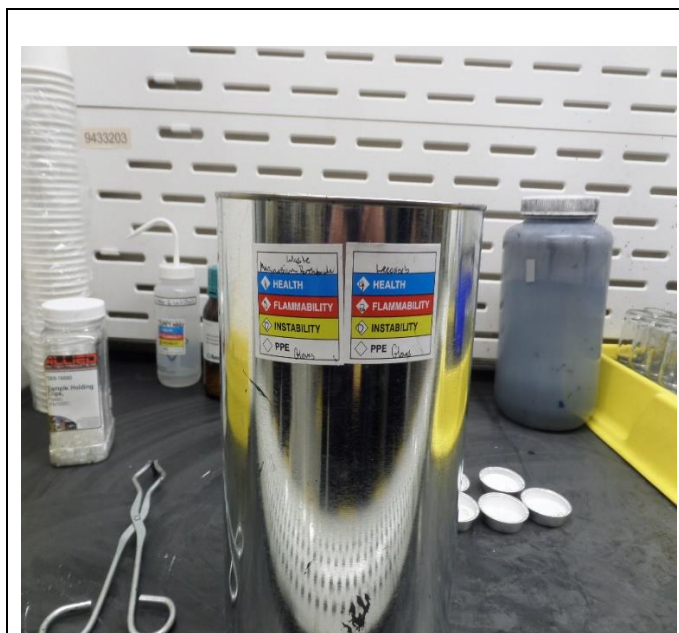
The inspector observed a closed one-gallon metal SAA container in a fume hood storing waste magnesium perchlorate gloves. The container was not marked or labeled with the words “Hazardous Waste” (Photograph 13).

Quality Laboratory. The inspector observed a one-gallon container for waste magnesium perchlorate in a fume hood. The container was not marked or labeled with words Hazardous Waste. Photograph 13 taken at 1:15 p.m.

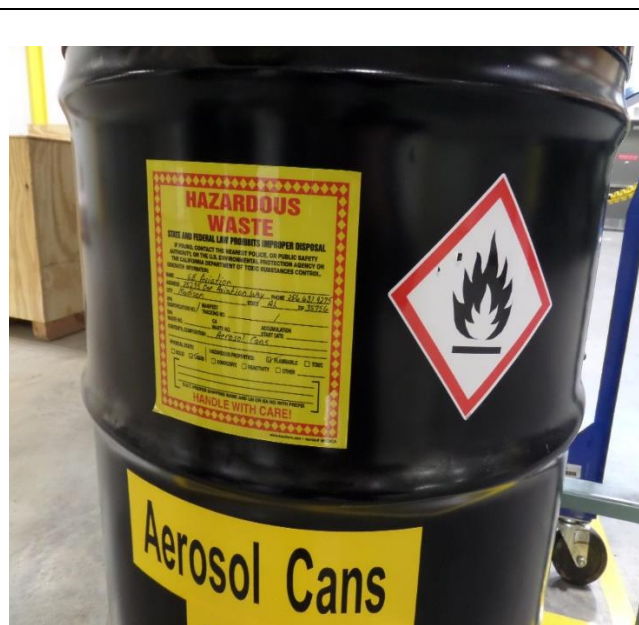
The inspector observed one 55-gallon SAA container storing waste aerosol cans. The inspector observed the container was closed, in good condition, labeled with the words “Hazardous Waste”, and labeled with a flammable hazard indicator (Photograph 14).

Fiber Quality Laboratory – Hallway. The inspector observed one 55-gallon SAA container accumulating aerosol cans. Photograph 14 taken at 1:39 p.m.
