## **RCRA Inspection Report**

First Quality Printing and Packaging LLC  
335 Masters Blvd.  
Anderson, South Carolina 29626  
Anderson County

EPA ID No. SCR000776526

December 6, 2022, 10 a.m.

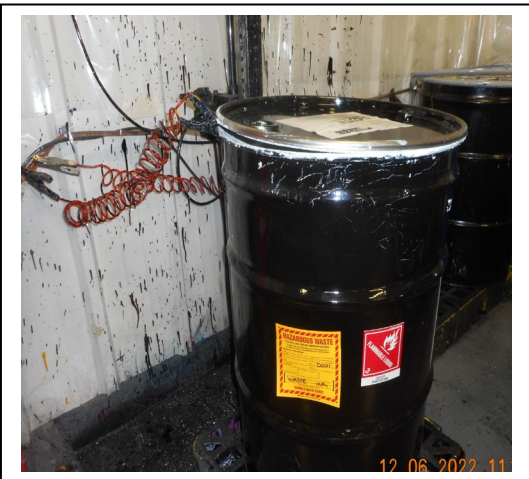
The inspectors observed an open 55-gallon satellite container of waste printing ink (EPA Waste Code D001) near the ink storage/mixing area (Photo #1).

Photo #1 - open 55-gallon satellite container of waste printing near the ink storage/mixing area.

**Pursuant to S.C. Code Ann. Regs. 61-79.262.17(a)(4) [40 C.F.R. § 262.17(a)(4)], which is a condition of the SAA Permit Exemption, (A) a container holding hazardous waste must always be closed during accumulation, except when it is necessary to add or remove waste; and (B) A container holding hazardous waste must not be opened, handled, or stored in a manner that may rupture the container or cause it to leak.**

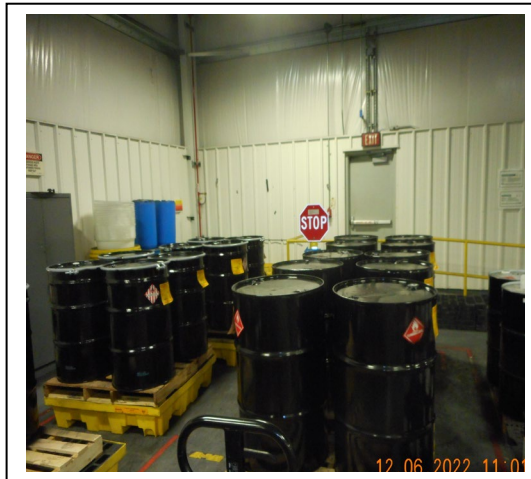
In the less than 90-day hazardous waste storage area (central accumulation area-CAA), the inspectors observed signs posted on the wall with the words "Danger – Hazardous Waste Storage Area Unauthorized Persons Keep Out" and "Danger No Smoking No Open Flames and No Sparks." Located on wooden pallets the inspectors observed ten closed 55-gallon containers of spent solvent (EPA Waste Code D001) marked "Hazardous Waste," "Flammable Liquids," and dated with accumulation start dates of 12/5/22, 12/3/22, 12/2/22, 12/11/22, 12/4/22, 12/3/22, 12/1/22, 12/1/22, 12/4/22, and 12/5/22 (Photo #2). This area was designated for storage of "Spent Solvent Only." The facility representative stated that spent solvent containers will be sent to Superior Recycling to recover solvent.

Next to the spent solvent drums, there were three 55-gallon containers of flammable solids (EPA Waste Code D001) dated 12/4/22, 12/6/22, and 11/20/22; five 55-gallon containers of waste

printing ink (EPA Waste Code D001) dated 12/2/22, 11/29/22, 12/1/22, 12/6/22, and 12/4/22; one 55-gallon container of still bottoms (EPA Waste Code D001 and F003) dated 11/17/22. The containers were marked “Hazardous Waste” and with an indication of the hazards of the contents. In a corner, there was a closed empty 55-gallon containers of aerosol cans marked “Universal Waste” and dated 6/14/22.

Photo #2 – 90-day hazardous waste storage area.

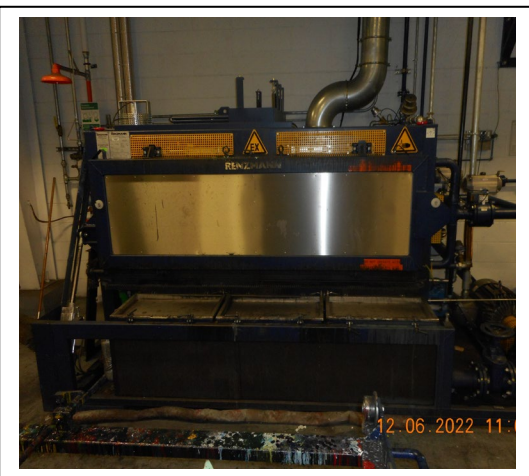
FQP&P uses a Renzmann press part cleaning machine for small and large press parts, doctor blades, pans, anilox sleeves and rollers and miscellaneous items (Photo #3). Rotating spray heads and solvent jets ensure that small pieces in the production process are cleaned to a sanitary level for food packaging. The spent solvent from the parts washer is collected in a 55-gallon container and sent to the on-site distillation unit for solvent recovery located near the Renzmann press part cleaning machine.

Photo #3 - Renzmann press part cleaning machine.

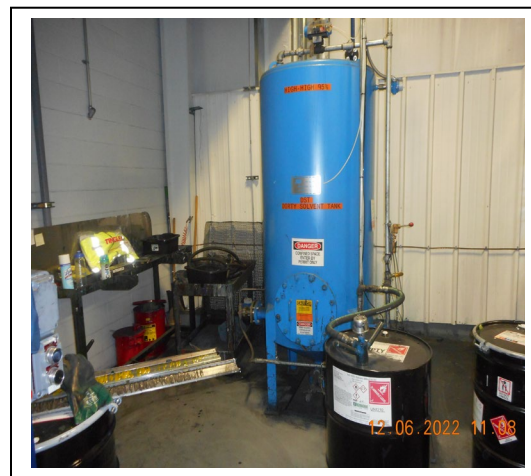
Next to the Renzmann press part cleaning machine area, there was a 150-gallon spent solvent tank (Photo #4) and a 100-gallon solvent recovery (distillation) unit (Photo #5). The spent solvents are generated from the “turbo wash” process of the printing presses located in the Printing Press Hall and the press parts cleaning machine located in the Ink Storage Room. The spent solvent with solids and other impurities generated from the two locations are evaluated for re-useable solvent quality and accordingly either sent to the 150-gallon spent solvent storage tank for distillation process or stored in 55-gallon containers for disposal in the less than 90-day hazardous waste storage area. Re-useable spent solvent is pumped from the 150-gallon tank to the 100-gallon distillation unit which uses heat to separate solids and impurities. The reclaimed solvent is pumped to a reclaimed solvent tank and still-bottom is collected in a 55-gallon container. During the inspection, the 55-gallon still-bottom container was marked “Flammable Liquids” but not marked “Hazardous Waste.” Once the 55-gallon still bottom container is full then container is moved to the less than 90-day hazardous waste storage area. The reclaimed solvent from the distillation process is subsequently drummed and re-used in the printing process.

The inspectors observed that the 150-gallon spent solvent tank was marked “Dirty Solvent Tank” and “High-High 95%” and with a “Flammable” hazard of the contents (Photo #4). The tank was not marked with the words “Hazardous Waste” or had an accumulation start date.

Photo #4 - 150-gallon spent solvent tank.

**Pursuant to S.C. Code Ann. Regs. 61-79.262.15(a)(5) [40 C.F.R. § 262.15(a)(5)], which is a condition of the SAA Permit Exemption, a generator is required to mark or label its containers (i) with the words “Hazardous Waste.”**

**Pursuant to S.C. Code Ann. Regs. 61-79.262.17(a)(5)(i) [40 C.F.R. § 262.17(a)(5)(i)], which is a condition of the LQG Permit Exemption, a generator must mark or label its containers with the following: the words “Hazardous Waste,” and the date upon which each period of accumulation begins clearly visible for inspection on each container.**

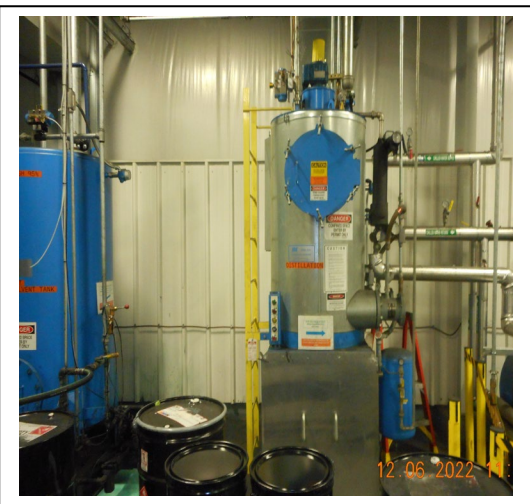
Photo # 5 - 100-gallon solvent recovery (distillation) unit.

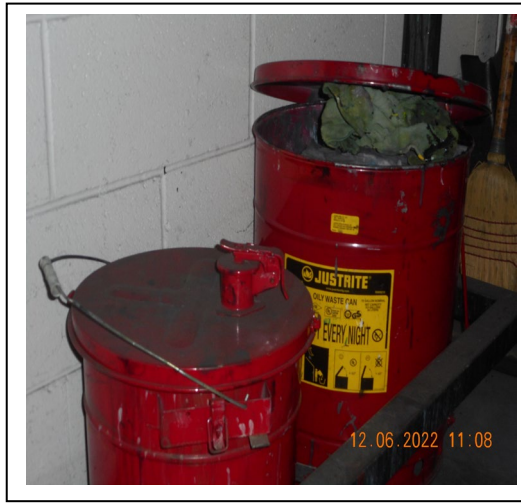
The inspectors observed a 5-gallon step can container accumulating solvent rags between the corner of parts washer and distillation unit area (Photo #6). The open container was marked “Oily Waste Can.” The facility representative indicated that the rags are managed as excluded solvent rags.

Photo #6 – One 5-gallon step can container accumulating solvent rags.

**Pursuant to S.C. Code Ann. Regs. 61-79.261.4(a)(26)(i) [40 C.F.R. § 261.4(a)(26)(i)], solid wastes which are not hazardous wastes exclusion - the solvent-contaminated wipes, when accumulated, stored, and transported, are contained in non-leaking, closed containers that are labeled “Excluded Solvent-Contaminated Wipes.” The containers must be able to contain free liquids, should free liquids occur. During accumulation, a container is considered closed when there is complete contact between the fitted lid and the rim, except when it is necessary to add or remove solvent-contaminated wipes. When the container is full, or when the solvent-contaminated wipes are no longer being accumulated, or when the container is being transported, the container must be sealed with all lids properly and securely affixed to the container and all openings tightly bound or closed sufficiently to prevent leaks and emissions.**

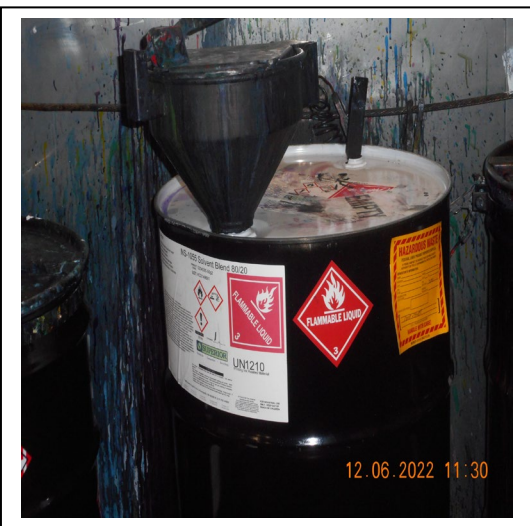
- One closed 55-gallon container of non-hazardous scrap metal;
- One closed 55-gallon container of flammable solids (EPA Waste Code D001) marked “Hazardous Waste”;
- 55-gallon open latched container of spent solvent (EPA Waste Code D001) marked “Hazardous Waste” with an indication of the hazard of the contents (Photo #7);
- One closed 55-gallon gray container of solvent containing wipes marked “Waste Wipes Only,” “No Free Liquids,” and “Excluded Solvent-Contaminated Wipes.” The markings were illegible because of paint splash on the labels;
- One closed 55-gallon blue container of solvent containing wipes marked “Used Blue Microfiber Wipes Only,” “No Free Liquids,” and “Excluded Solvent-Contaminated Wipes”;
- One open 5-gallon container of solvent wipes. The container was not marked “Excluded Solvent-Contaminated Wipes” (Photo #8).

Photo #7 - open latched container of spent solvent marked "Hazardous Waste" with an indication of the hazard of the contents.

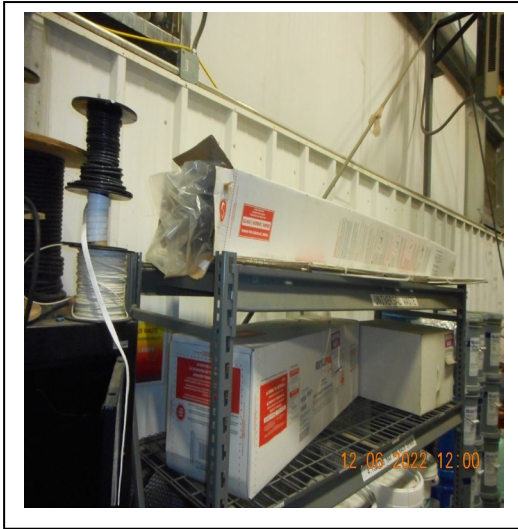
- One open 8-ft long box of waste lamps marked “Universal Waste - Lamps” and dated 8/12/22 (Photo #9);
- One closed 5-ft long box of waste lamps marked “Universal Waste - Lamps” and dated 8/16/22;

Photo #9 – An open 8-ft long box of waste lamps marked “Universal Waste Lamps” and dated 8/12/22.

**Pursuant to S.C. Code Ann. Regs. 61-79.273.13(d)(1) [40 C.F.R. § 273.13(d)(1)], a SQHUW must contain any lamp in containers or packages that are structurally sound, adequate to prevent breakage, and compatible with the contents of the lamps. Such containers and packages must remain closed and must lack evidence of leakage, spillage or damage that could cause leakage under reasonably foreseeable conditions.**
