INSPECTION REPORT

South Webster WWTP

Inspection Date: November 9th, 2022

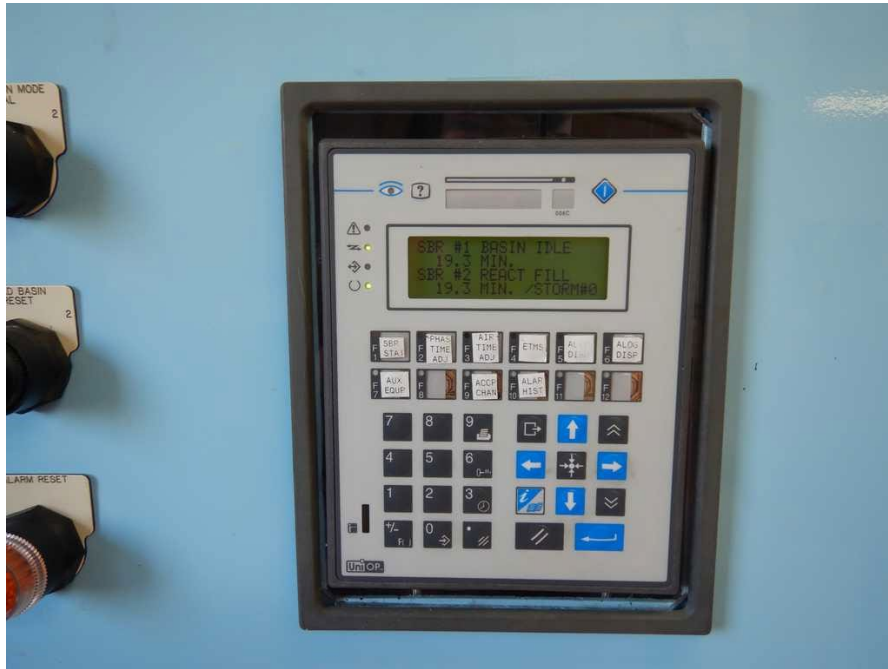
HMI System Control Panel	DSCN0331.JPG	
11/09/2022 09:23 AM	Photographer: Megan Zale	
WWTP office building	No CBI	No PII

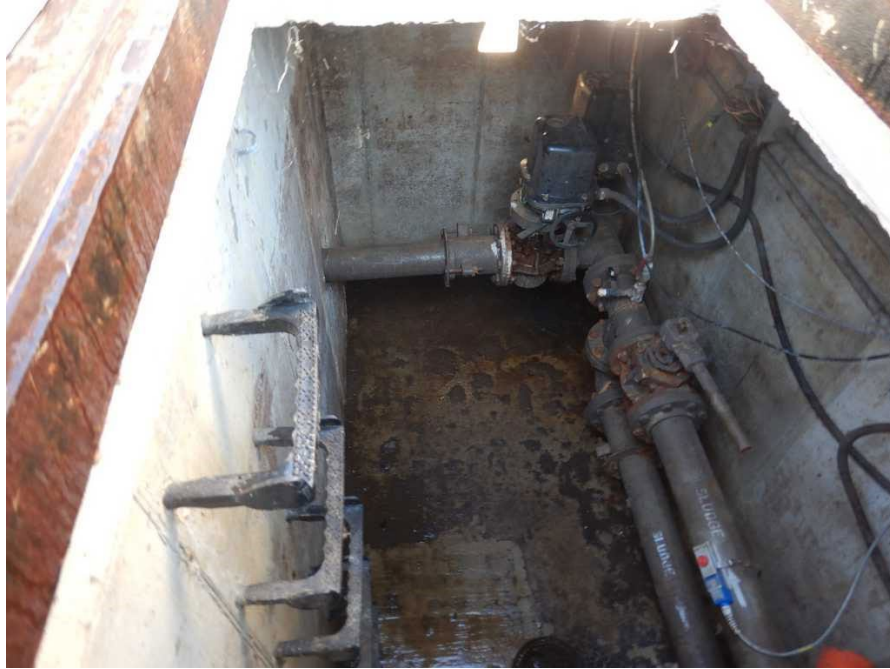
Influent force main	DSCN0333.JPG	
11/09/2022 09:31 AM	Photographer: Megan Zale	
At WWTP, south of office building	No CBI	No PII

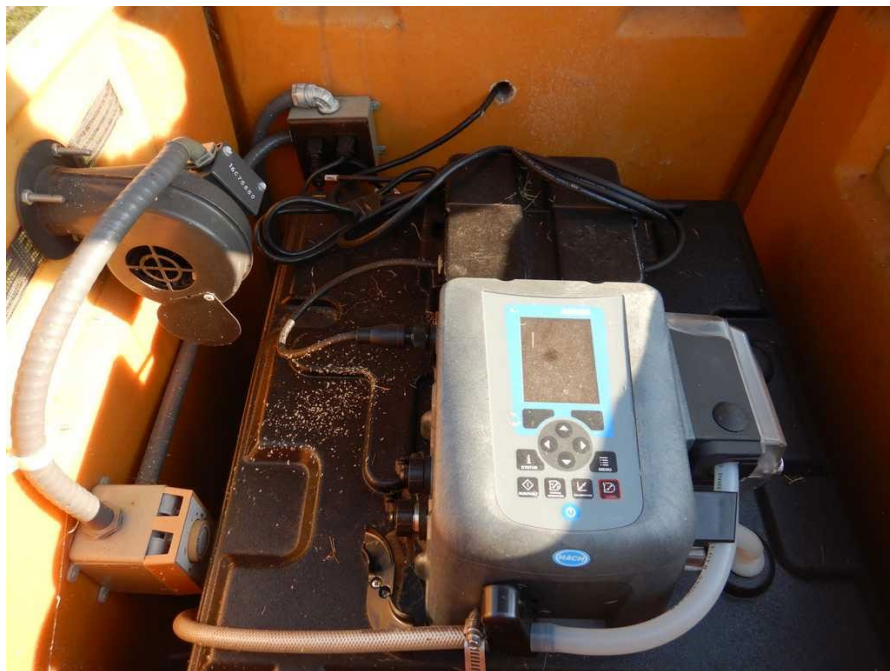
Influent composite sampler readout screen	DSCN0334.JPG	
11/09/2022 09:32 AM	Photographer: Megan Zale	
At WWTP, south of office building	No CBI	No PII

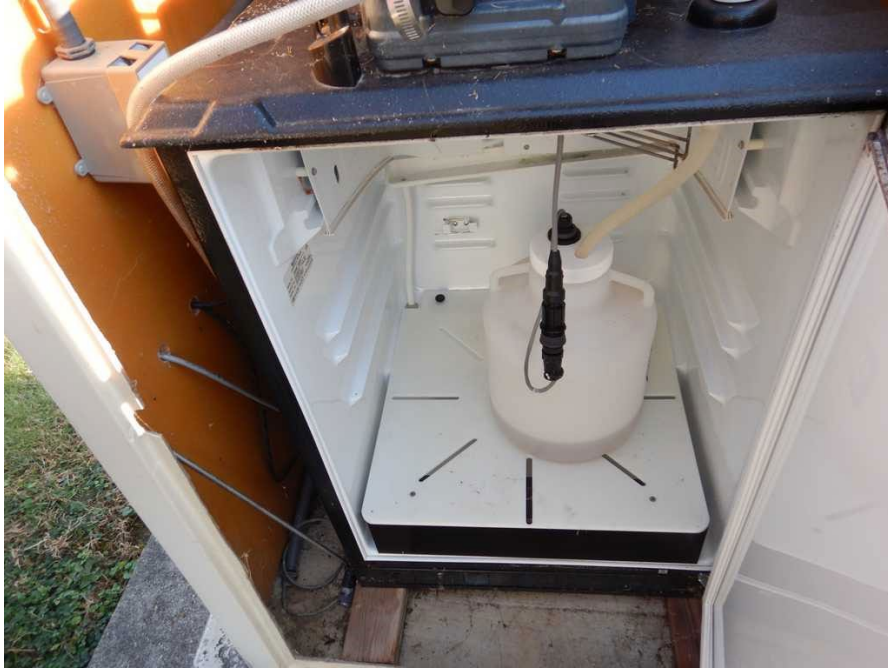
Location: Treatment	
Observation #: MZ2-OB-002	Date: 11/09/2022
EPA did not observe a wet thermometer in the influent autosampler’s refrigerator.

Influent sampler refrigerator	DSCN0335.JPG	
11/09/2022 09:32 AM	Photographer: Megan Zale	
At WWTP, south of office building	No CBI	No PII

AOC Reference #: MZ2-OB-002	Location: Treatment
<p>Regulation and/or Permit Requirement</p> <p>Regulation: 40 CFR Part 136 Table II: Required Containers, Preservation Techniques, and Holding Times, footnote 18: “Aqueous samples must be preserved at ≤6 °C.”; Permit requirement: Part III Item 2.A: General Conditions - Facility Operation and Quality Control: “All wastewater treatment works shall be operated in a manner consistent with the following: A. At all times, the permittee shall maintain in good working order and operate as efficiently as possible all treatment or control facilities or systems installed or used by the permittee necessary to achieve compliance with the terms and conditions of this permit. Proper operation and maintenance also includes adequate laboratory controls and appropriate quality assurance procedures.”</p>	
<p>AOC:</p> <p>No wet thermometer in influent composite sampler refrigerator. The computer panel for the automatic composite sampler did not appear to be set up to read the refrigerator temperature.</p>

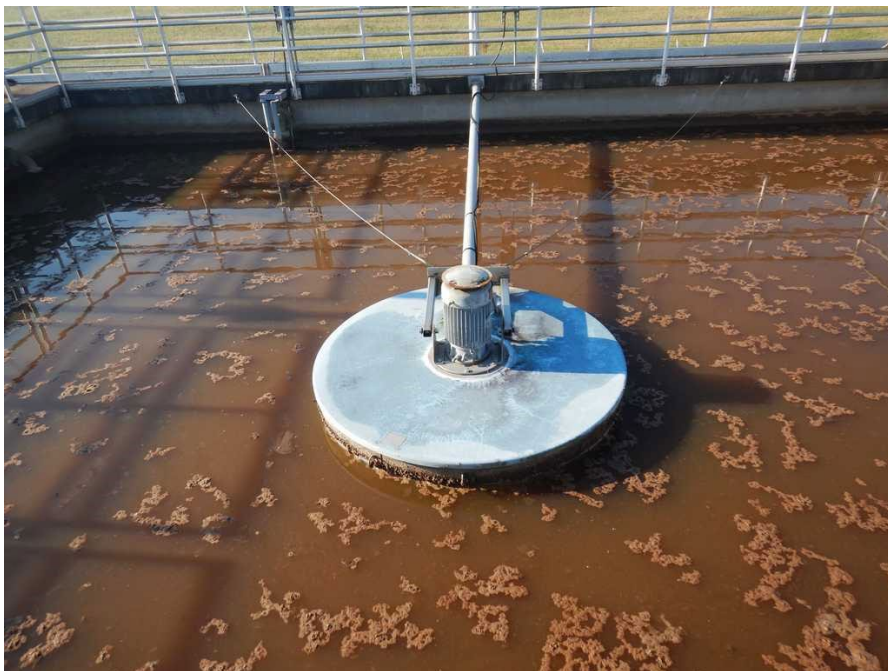
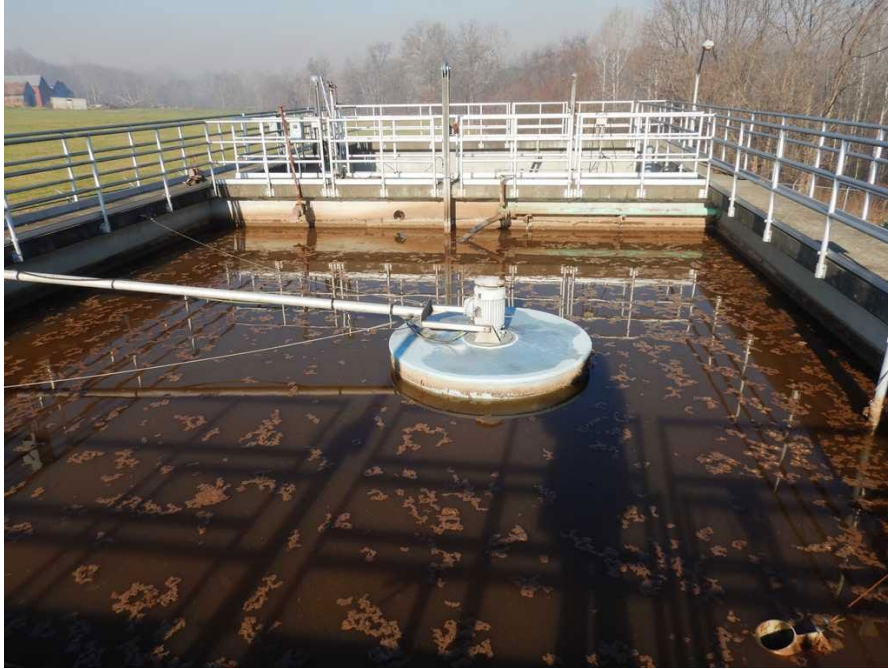
Sludge holding tank/digester	DSCN0336.JPG	
11/09/2022 09:40 AM	Photographer: Megan Zale	
WWTP facility, south of office building	No CBI	No PII

Sludge holding tank/digester	DSCN0337.JPG	
11/09/2022 09:41 AM	Photographer: Megan Zale	
WWTP facility, south of office building	No CBI	No PII

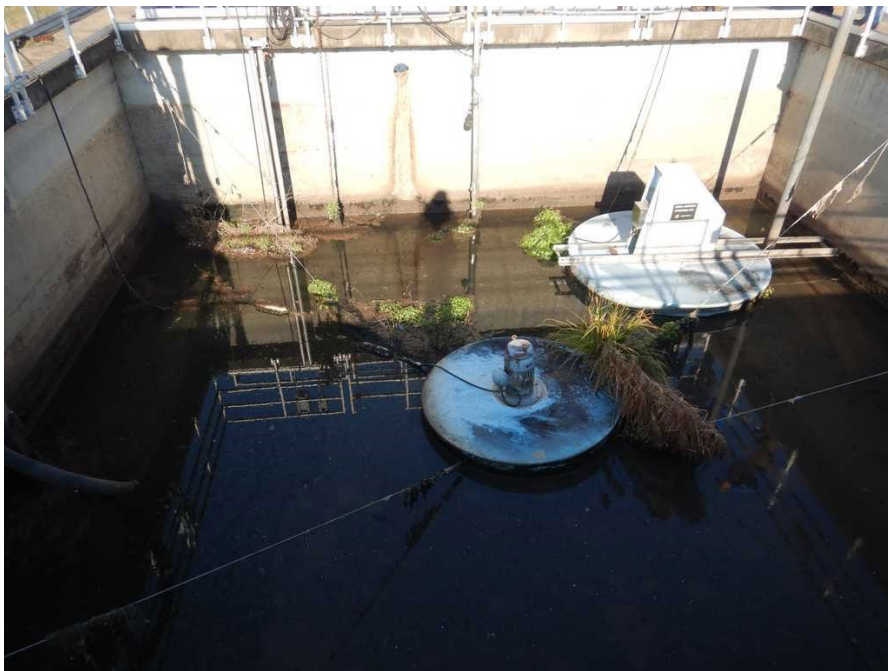
EPA observed some vegetation growing in the SBRs

SBR1 in decant phase. Decanter in upper right corner of photo.	DSCN0338.JPG	
11/09/2022 09:41 AM	Photographer: Megan Zale	
WWTP facility, south of office building	No CBI	No PII

- Vegetation in SBRs not a hindrance to plant performance. SBR design makes it difficult to deal with vegetation mats. Have to raise the wastewater level in the units to remove vegetation.

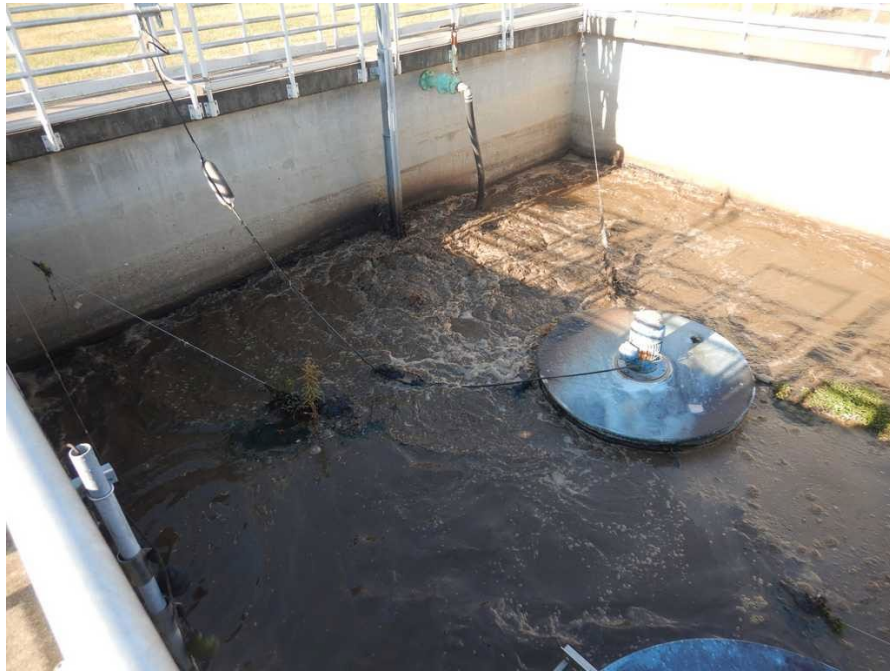
SBR2 in mix fill phase	DSCN0339.JPG	
11/09/2022 09:44 AM	Photographer: Megan Zale	
WWTP facility, south of office building	No CBI	No PII

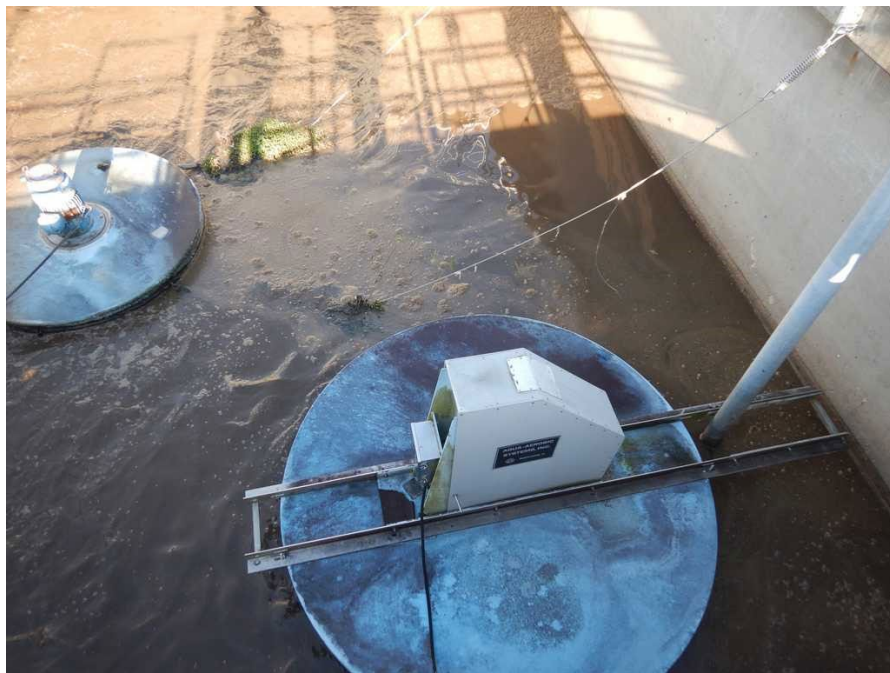
SBR2 decanter	DSCN0340.JPG	
11/09/2022 09:44 AM	Photographer: Megan Zale	
WWTP facility, south of office building	No CBI	No PII

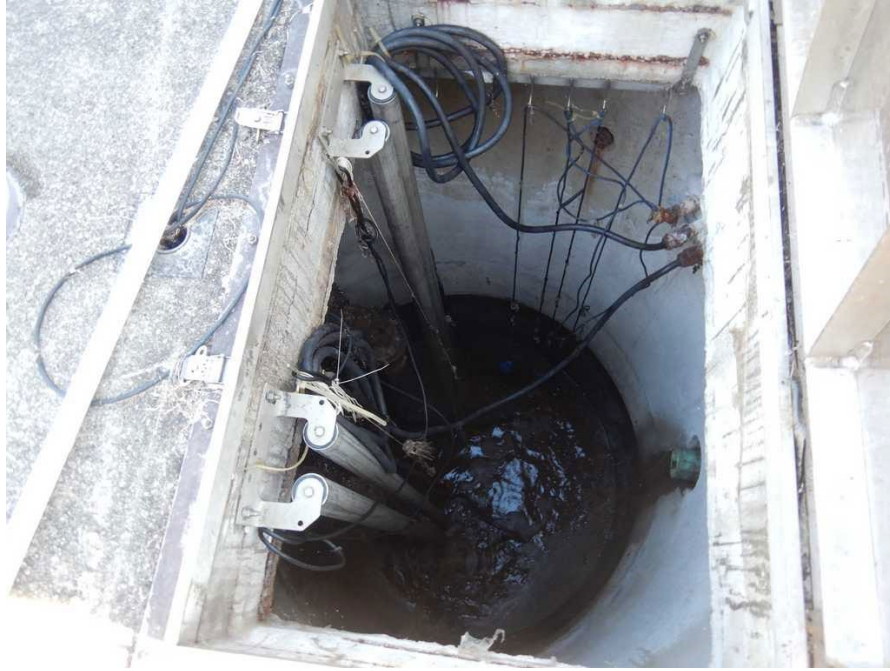
Decant pump station	DSCN0341.JPG	
11/09/2022 10:03 AM	Photographer: Megan Zale	
WWTP facility, south of office building	No CBI	No PII
Notes: Everything from maintenance building, including toilet, flows here.

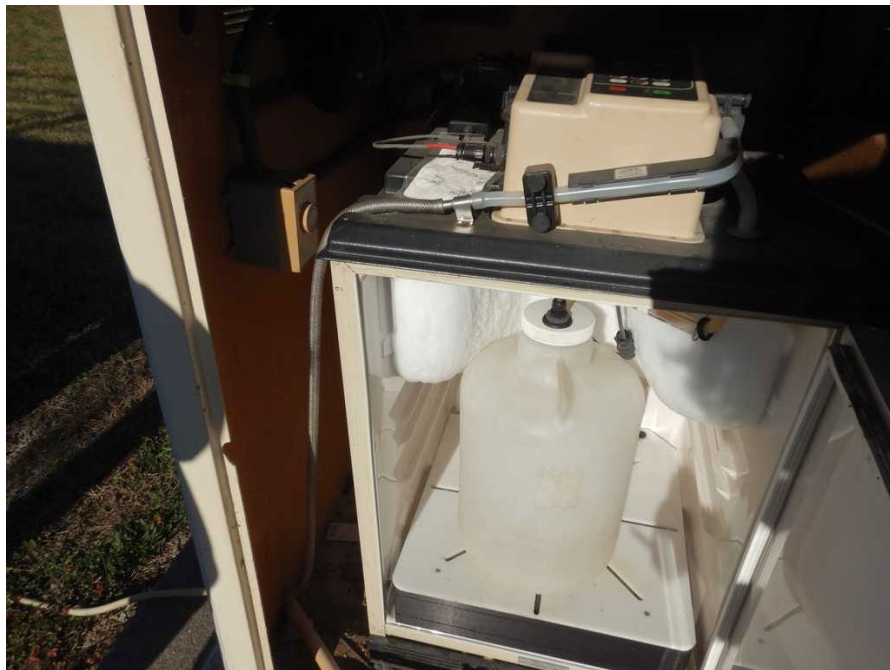
Effluent composite sampler refrigerator did not have a wet thermometer. Refrigerator door was propped open to defrost the refrigerator which had iced over around the collection jug. The unit had a visible thermostat to control temperature.

Effluent composite sampler	DSCN0342.JPG	
11/09/2022 10:04 AM	Photographer: Megan Zale	
WWTP facility, west of office building	No CBI	No PII
Notes: Sigma 900 model. The refrigerator had iced over, and staff was defrosting it during the inspection to remove the ice build-up.

AOC Reference #: MZ2-OB-009	Location: Treatment
Regulation and/or Permit Requirement	
<p>Regulation: 40 CFR Part 136 Table II: Required Containers, Preservation Techniques, and Holding Times, footnote 18: "Aqueous samples must be preserved at ≤ 6 °C.";</p> <p>Permit requirement: Part III Item 2.A: General Conditions - Facility Operation and Quality Control: "All wastewater treatment works shall be operated in a manner consistent with the following: A. At all times, the permittee shall maintain in good working order and operate as efficiently as possible all treatment or control facilities or systems installed or used by the permittee necessary to achieve compliance with the terms and conditions of this permit. Proper operation and maintenance also includes adequate laboratory controls and appropriate quality assurance procedures."</p>	
AOC:	
Effluent composite sampler refrigerator did not have a wet thermometer. Refrigerator door was propped open to defrost the refrigerator which had iced over around the collection jug. The unit had a visible thermostat to control temperature.

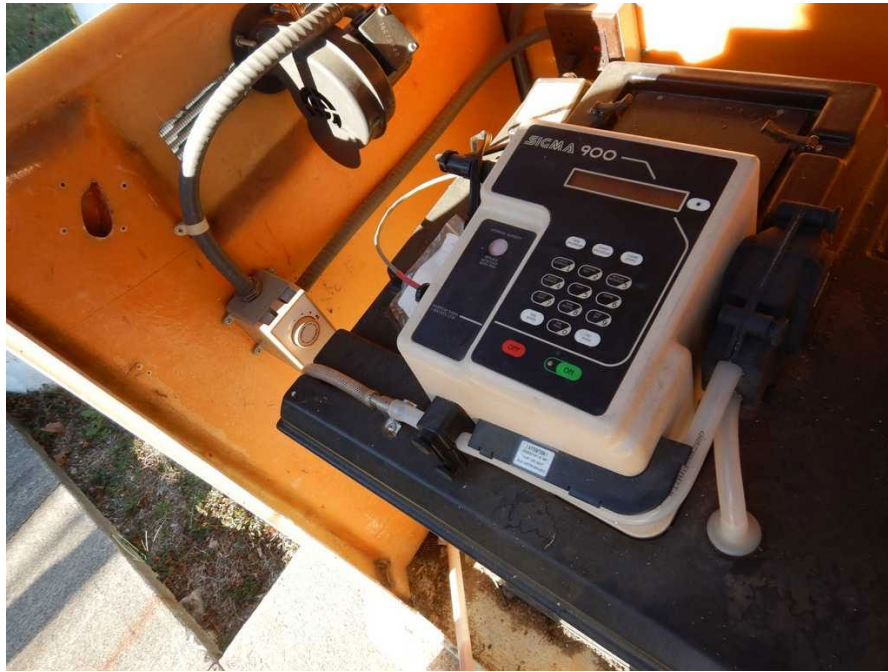
Effluent composite sampler readout screen	DSCN0343.JPG	
11/09/2022 10:05 AM	Photographer: Megan Zale	
WWTP facility, west of office building	No CBI	No PII

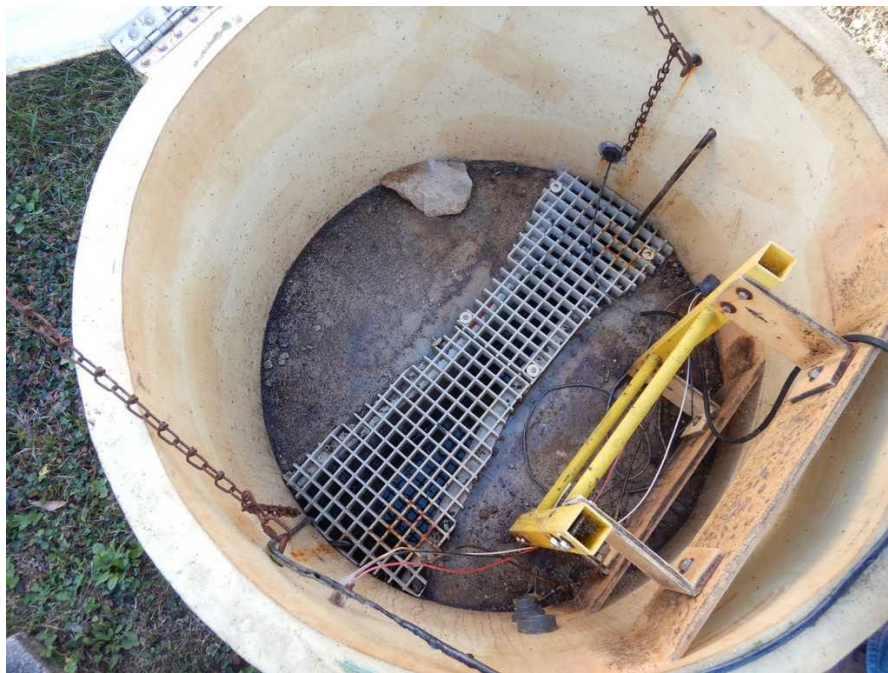
Effluent flow meter with flume	DSCN0344.JPG	
11/09/2022 10:07 AM	Photographer: Megan Zale	
WWTP facility, west of office building	No CBI	No PII

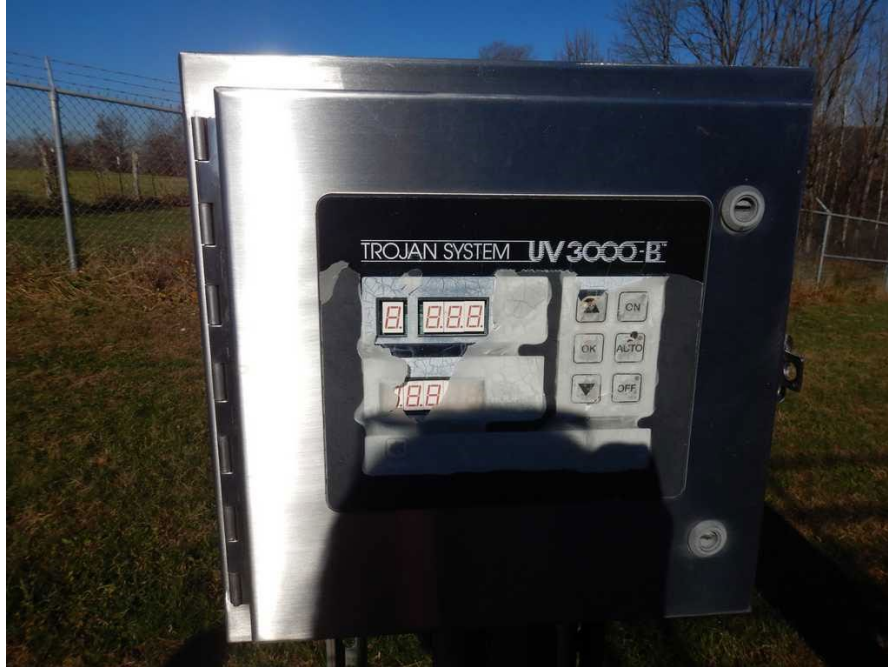
UV treatment system controls	DSCN0345.JPG	
11/09/2022 10:12 AM	Photographer: Megan Zale	
WWTP facility, west of office building	No CBI	No PII

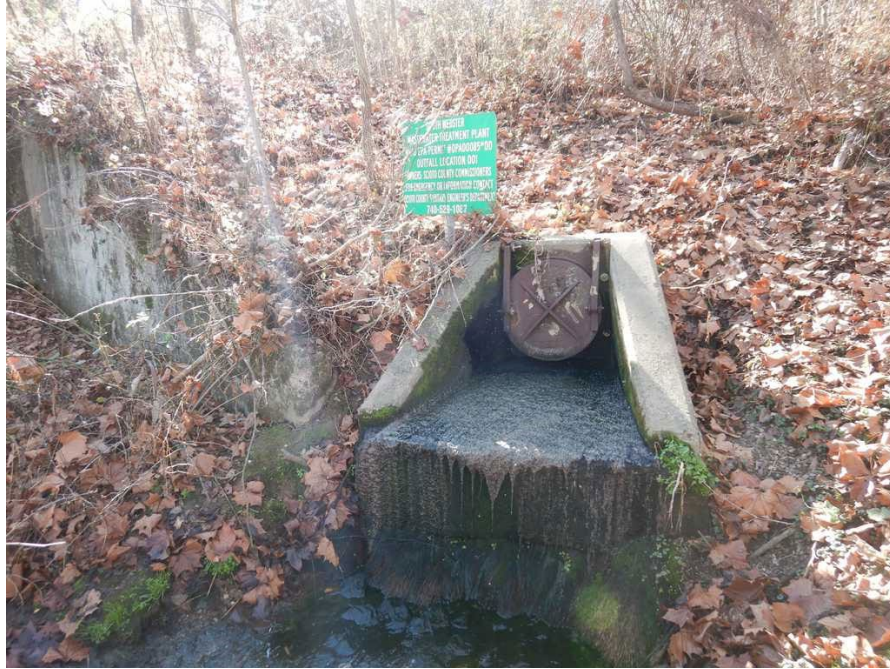
Outfall 001	DSCN0347.JPG	
11/09/2022 10:17 AM	Photographer: Megan Zale	
Skull Creek, northwest of WWTP facility	No CBI	No PII

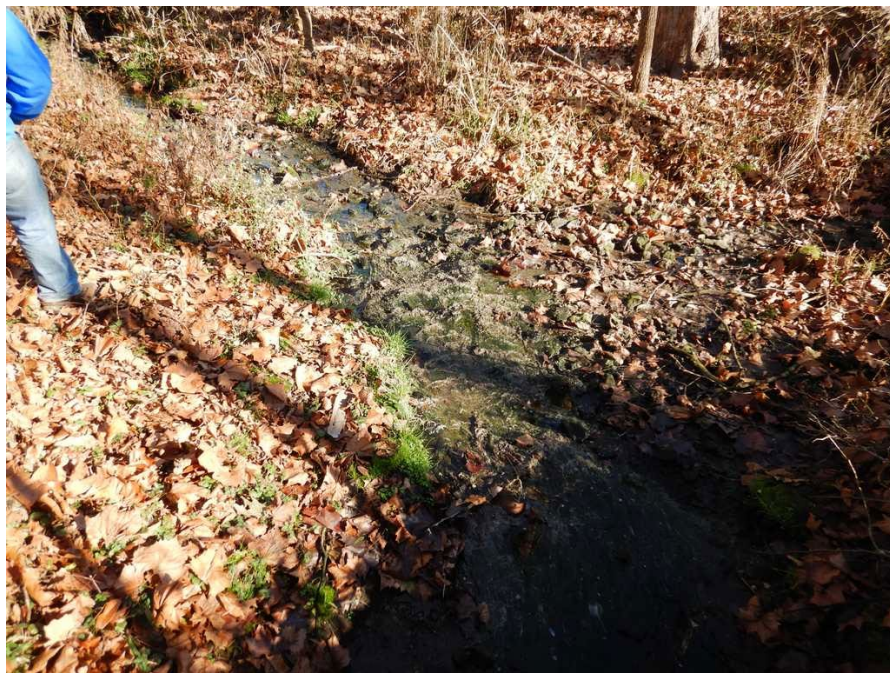
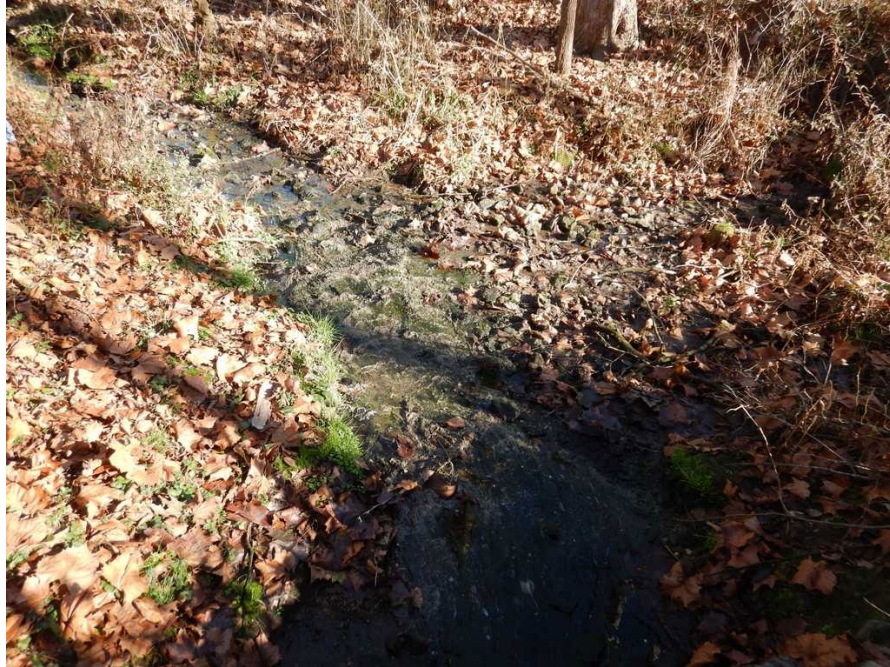
Location: Receiving stream	
Observation #: MZ2-OB-001	Date: 11/09/2022
EPA observed algal mats in the receiving stream.

Flow pathway from outfall towards the receiving stream	DSCN0348.JPG	
11/09/2022 10:18 AM	Photographer: Megan Zale	
Skull Creek, northwest of WWTP facility	No CBI	No PII
Notes: Algal mats observed

Flow pathway from the outfall towards the receiving stream	DSCN0349.JPG	
11/09/2022 10:18 AM	Photographer: Megan Zale	
Skull Creek, northwest of WWTP facility	No CBI	No PII
Notes: Algal mats observed

- They will hang up list of emergency numbers
- Despite algal mats in receiving stream, facility is not losing sludge. They clean trash out of stream regularly.

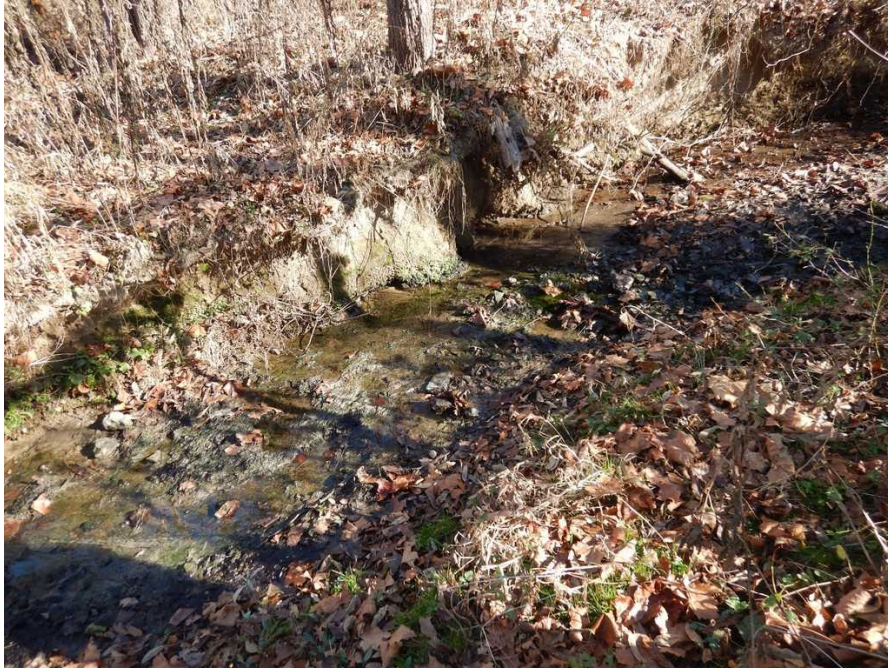
Downstream between outfall and downstream sample location	DSCN0351.JPG	
11/09/2022 10:22 AM	Photographer: Megan Zale	
Skull Creek, north of Outfall 001	No CBI	No PII

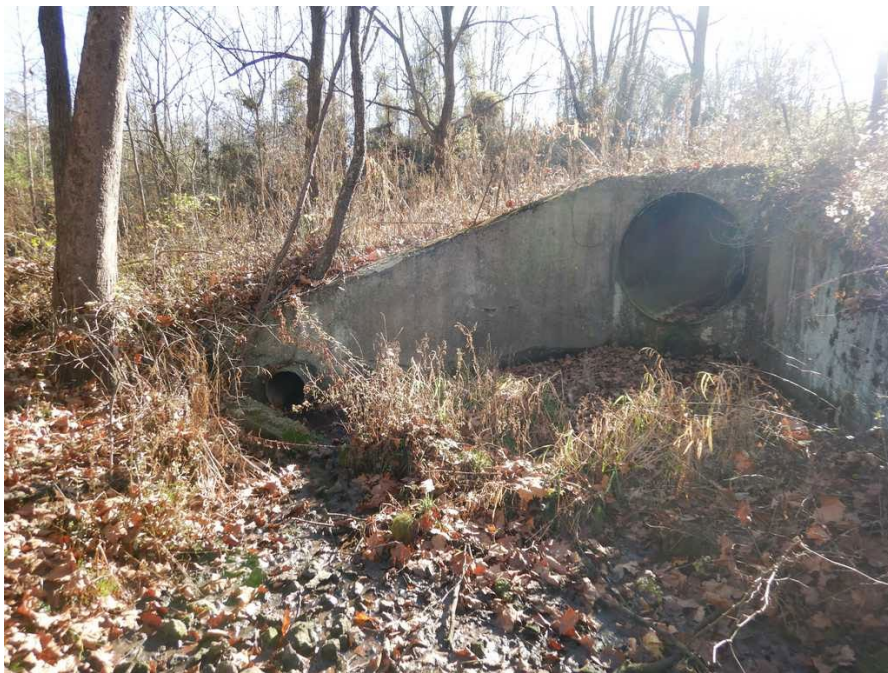
Discharge pipes from the abandoned reservoir adjacent to outfall 001.	DSCN0352.JPG	
11/09/2022 10:23 AM	Photographer: Megan Zale	
Skull Creek, north of WWTP facility	No CBI	No PII
